Murray Canyon Creek
Alpine County, California

2005 Stream & Riparian Habitat Survey Report

Carson Ranger District
Humboldt-Toiyabe National Forest

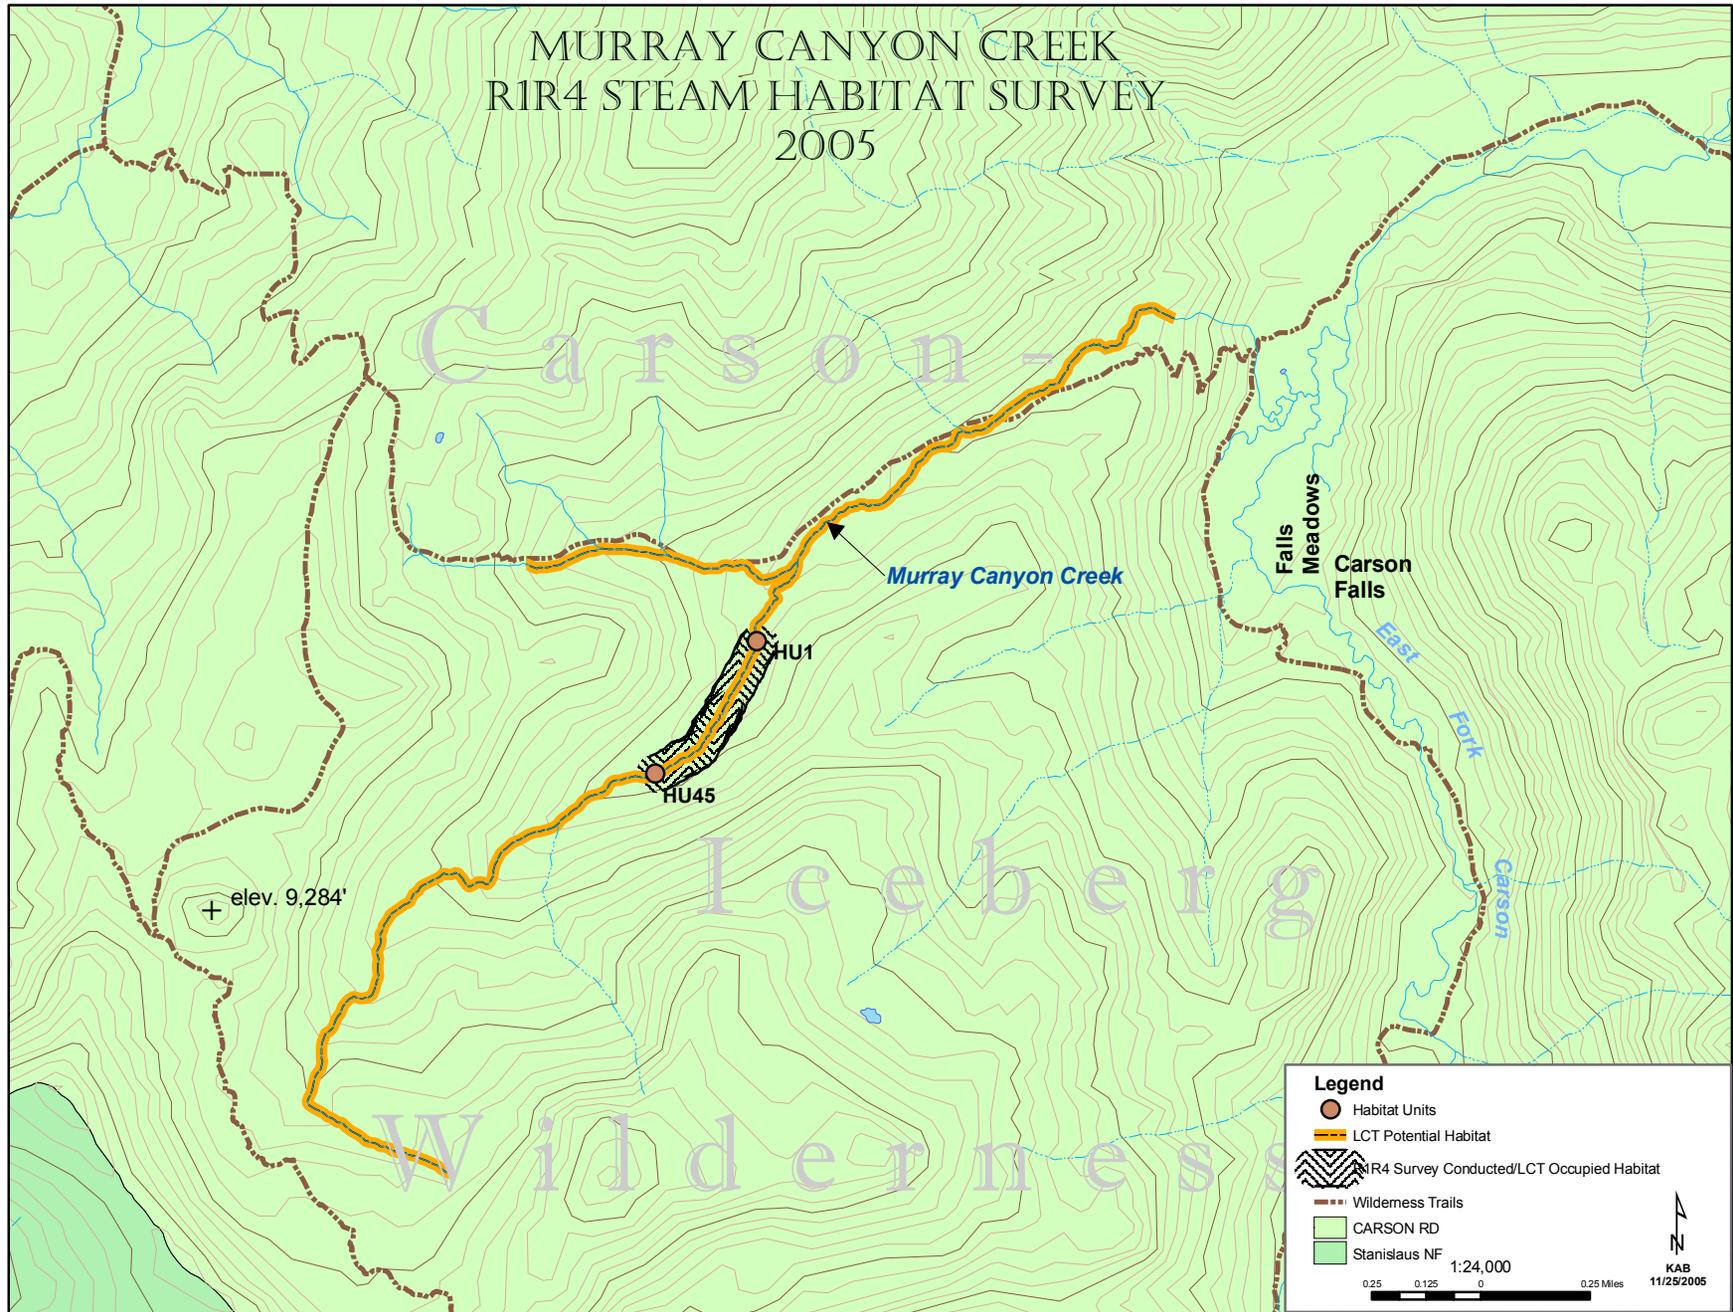
Map 2: Murray Canyon Creek, Carson Ranger District, R1R4 stream survey reach and potential Lahontan cutthroat trout habitat.

The Murray Canyon Creek R1R4 survey reach began just upstream of a permanent fish barrier that is located near Site 6 (Maps 1 and 2). The survey reach was approximately 0.60 miles in length and ended at a tributary that enters Murray Canyon Creek from the river right side. No seasonal or permanent fish barriers were identified within the R1R4 survey reach. Lahontan cutthroat trout were seen throughout the survey area.

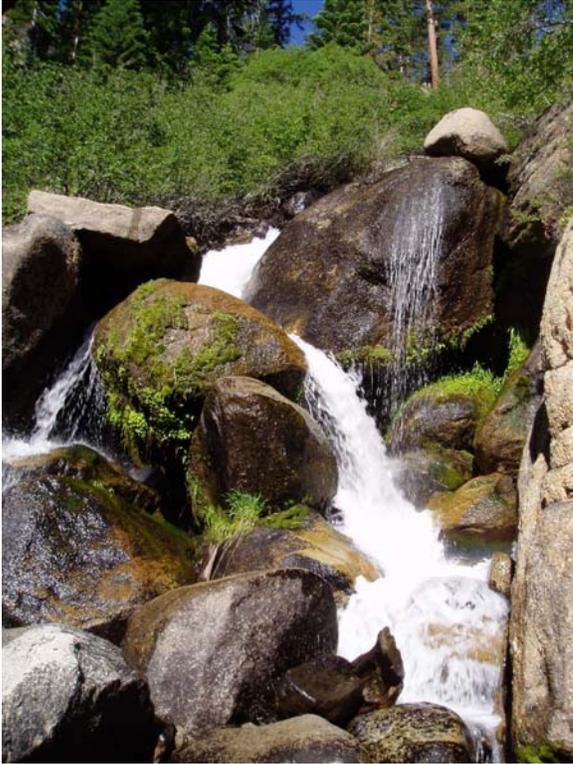
Four permanent fish barriers and 3 seasonal fish barriers (Map 1) were identified within the Murray Canyon Creek watershed. The lowermost permanent fish barrier (Photos 1-3) is located just downstream of Site 1. The other permanent fish barriers are located at Site 3 (Photo 9), just upstream of Site 6 (Photo 14), and just downstream of Site 10 (Photo 23). The 3 seasonal fish barriers are located at Site 5 (Photo 12), Site 6 (Photo 13), and just upstream of Site 9 (Photo 22).

Photo 1: Murray Canyon Creek, Carson Ranger District, permanent fish barrier, downstream of Site 1. Photo was taken on 16 July 2005.

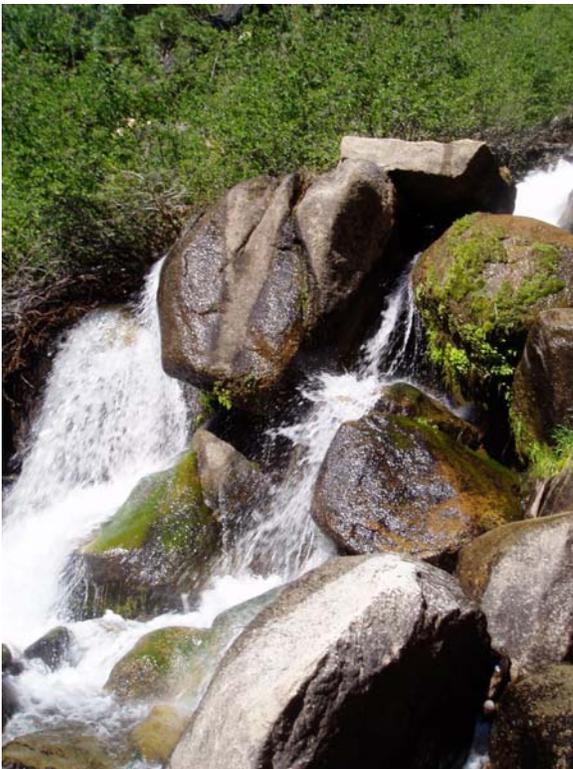
Photo 2: Murray Canyon Creek, Carson Ranger District, permanent fish barrier, downstream of Site 1. Photo was taken on 16 July 2005.

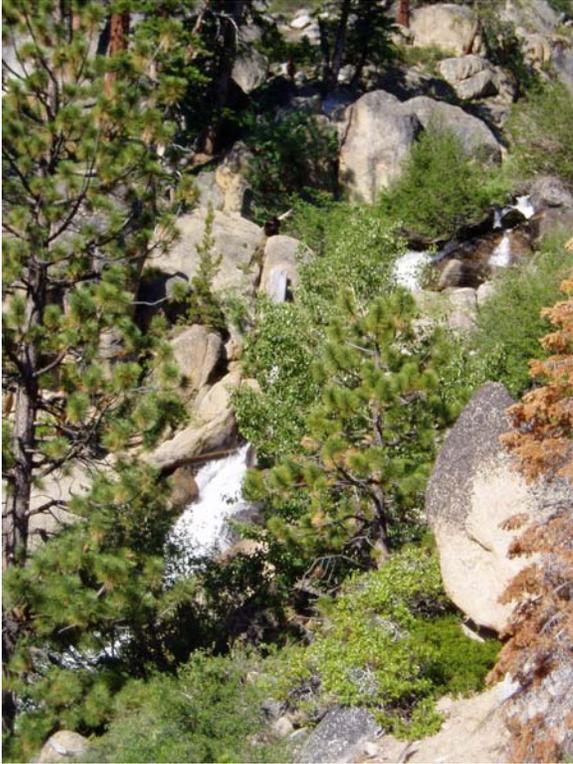
Photo 3: Murray Canyon Creek, Carson Ranger District, permanent fish barrier, downstream of Site 1. Photo was taken on 16 July 2005.

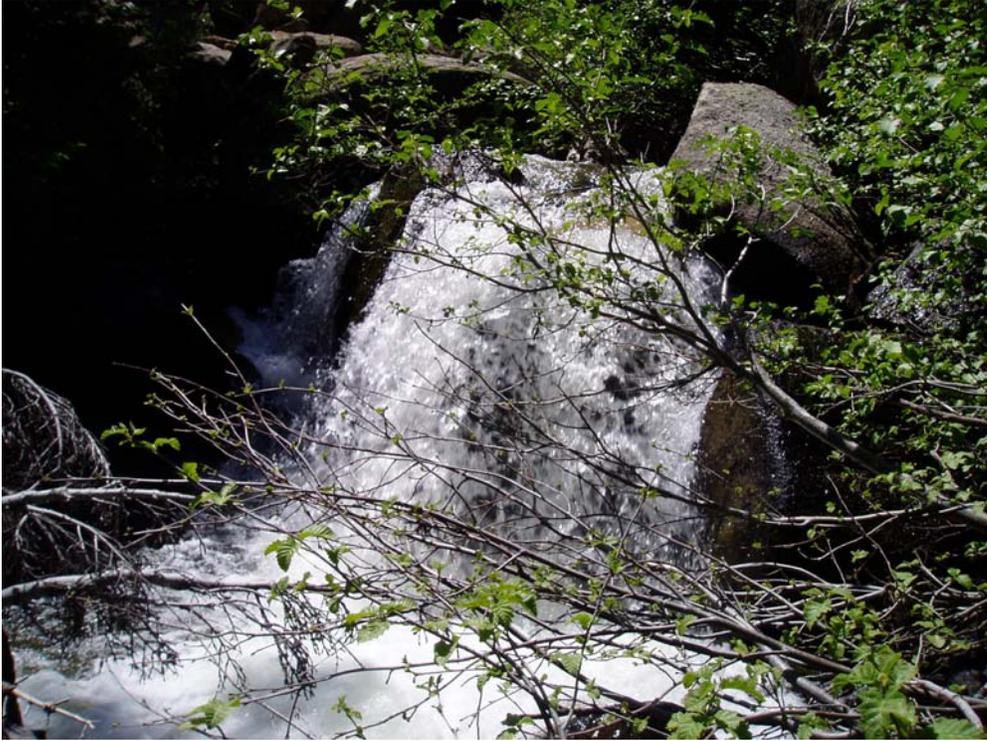
Photo 9: Murray Canyon Creek, Carson Ranger District, Site 3, permanent fish barrier. The permanent fish barrier is approximately 10 feet high. Photo was taken on 16 July 2005.

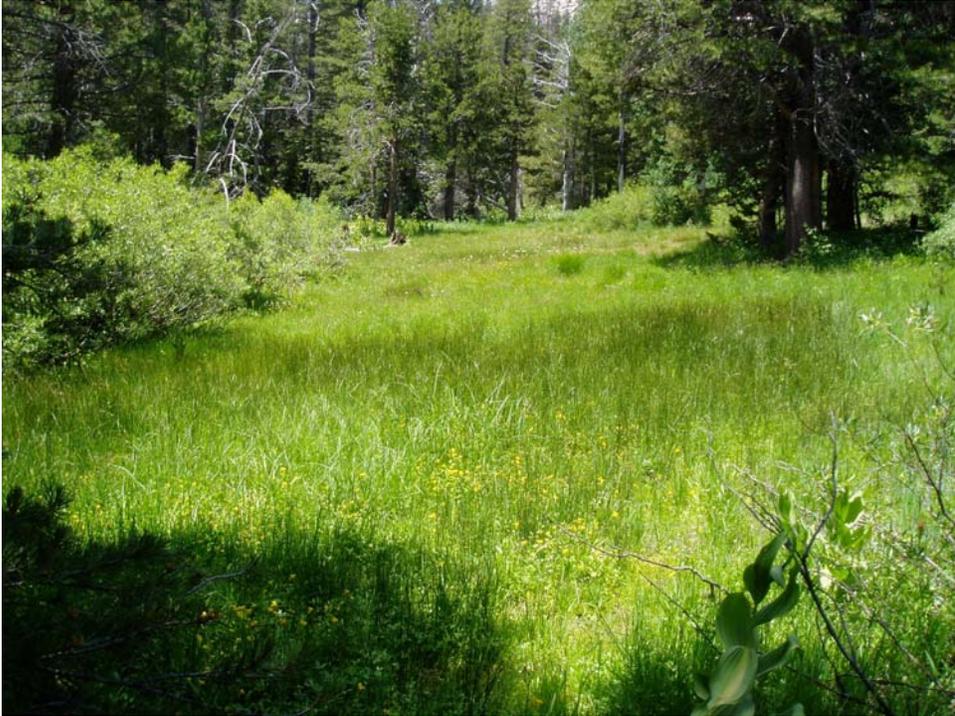
Photo documentation of the stream condition and the upland vegetative condition occurred at Site 1 (Photos 4-5), Site 2 (Photo 7-8), Site 4 (Photo 11), Site 7 (Photos 15-17), Site 8 (Photos 18-19), Site 9 (Photos 20-21), and Site 10 (Photo 24). Another photo point occurs between Site 1 and site 2 (Photo 6) and another photo point occurs between Site 3 and Site 4 (Photo 10). Not all the photo points had GPS locations recorded due to the difficulty to receive enough GPS satellites from the Murray Canyon Creek drainage. The vegetative condition appeared to be in good condition for the area. The HTNF did not find any evidence of recent grazing occurring within the Murray Canyon Creek watershed.

Photo 11: Murray Canyon Creek, Carson Ranger District, upland meadow at Site 4. Photo was taken on 16 July 2005.

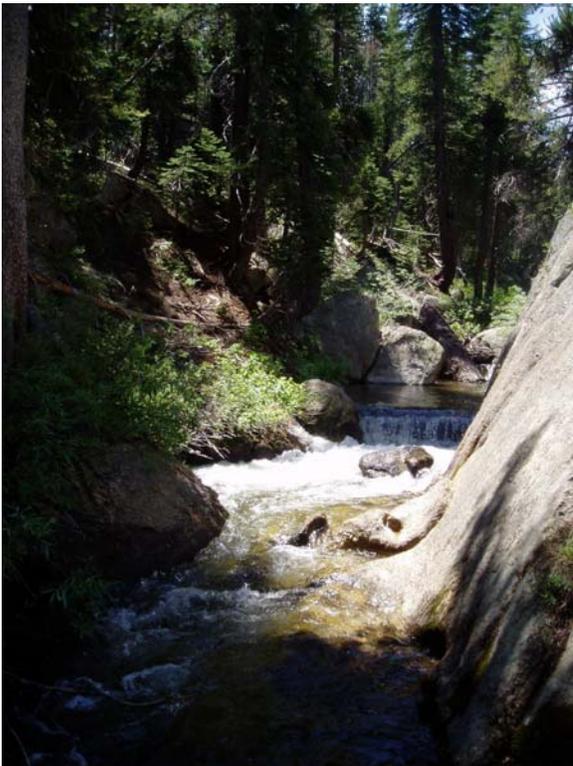
Photo 12: Murray Canyon Creek, Carson Ranger District, Site 5, seasonal fish barrier. The seasonal fish barrier is approximately 3 feet high. Photo was taken on 16 July 2005.

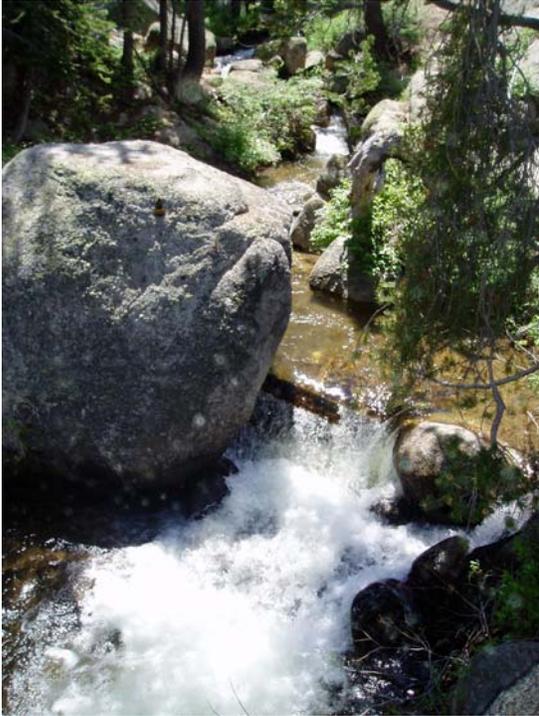
Photo 13: Murray Canyon Creek, Carson Ranger District, Site 6, seasonal fish barrier. The seasonal fish barrier is approximately 3 feet high. Photo was taken on 16 July 2005.

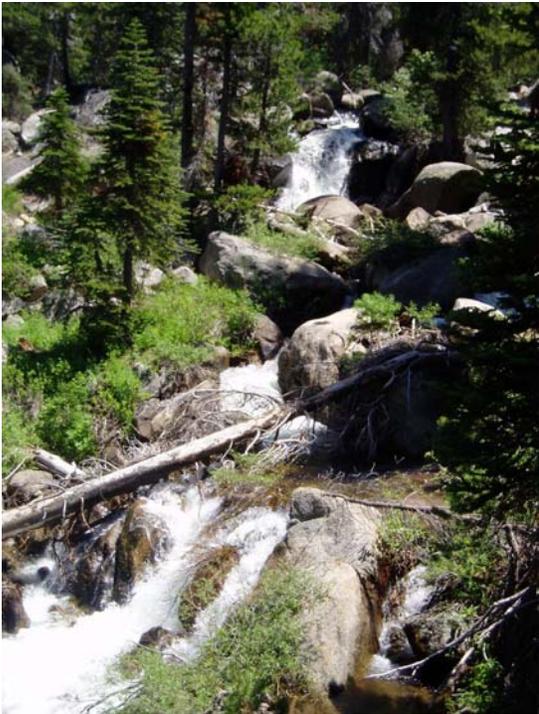
Photo 14: Murray Canyon Creek, Carson Ranger District, permanent fish barrier just upstream of Site 6. The permanent fish barrier is approximately 25 feet high. Photo was taken on 16 July 2005.

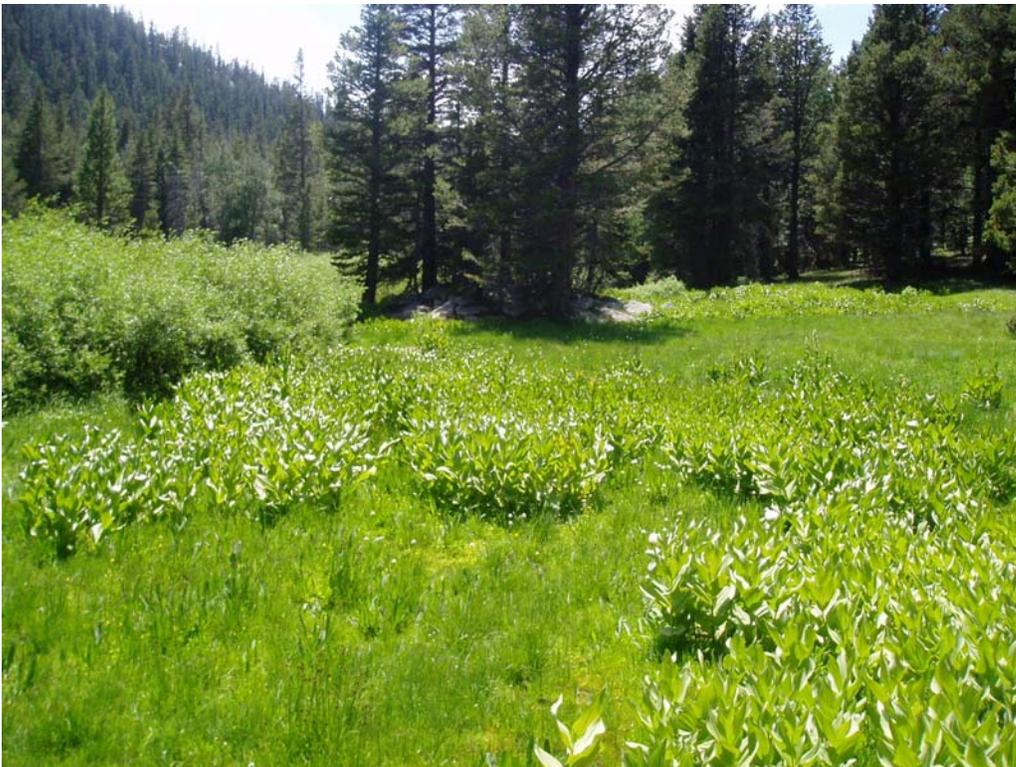
Photo 16: Murray Canyon Creek, Carson Ranger District, upland meadow at Site 7. Photo was taken on 16 July 2005.

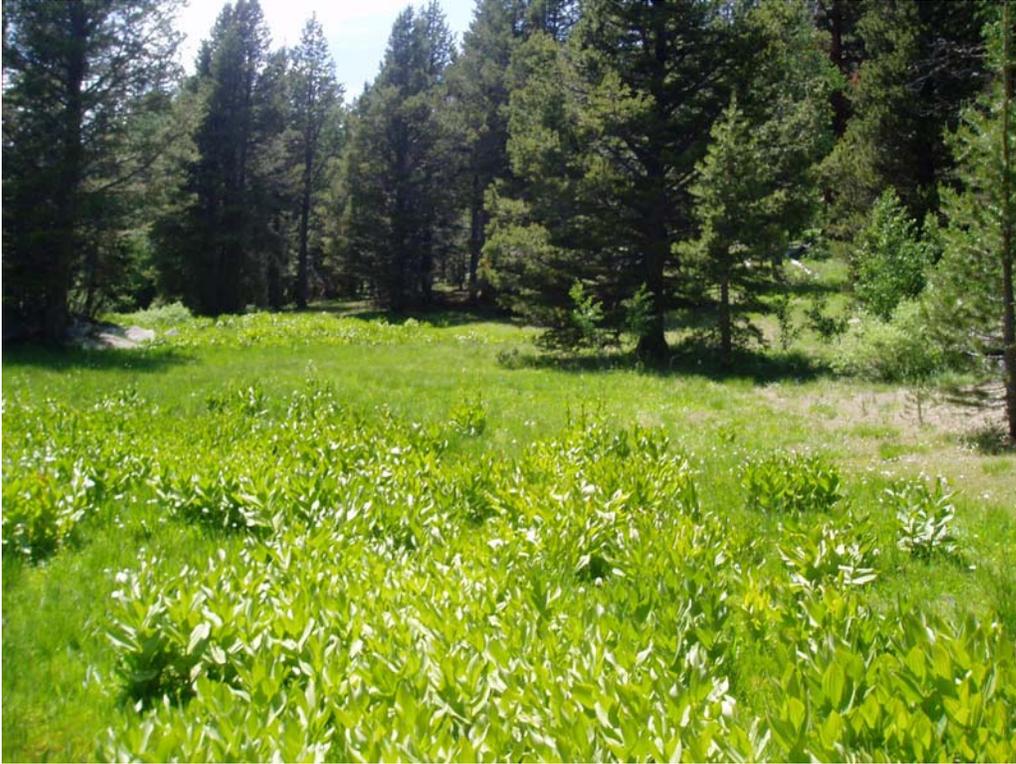
Photo 17: Murray Canyon Creek, Carson Ranger District, upland meadow at Site 7. Photo was taken on 16 July 2005.

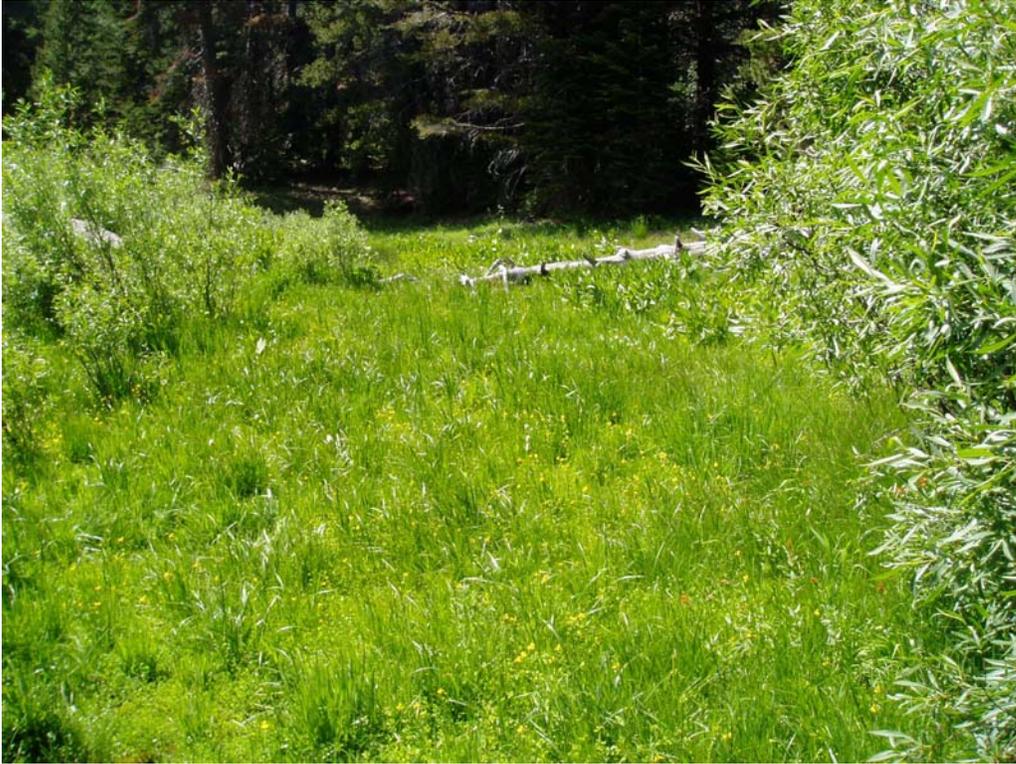
Photo 19: Murray Canyon Creek, Carson Ranger District, upland meadow at Site 8. Photo was taken on 16 July 2005.

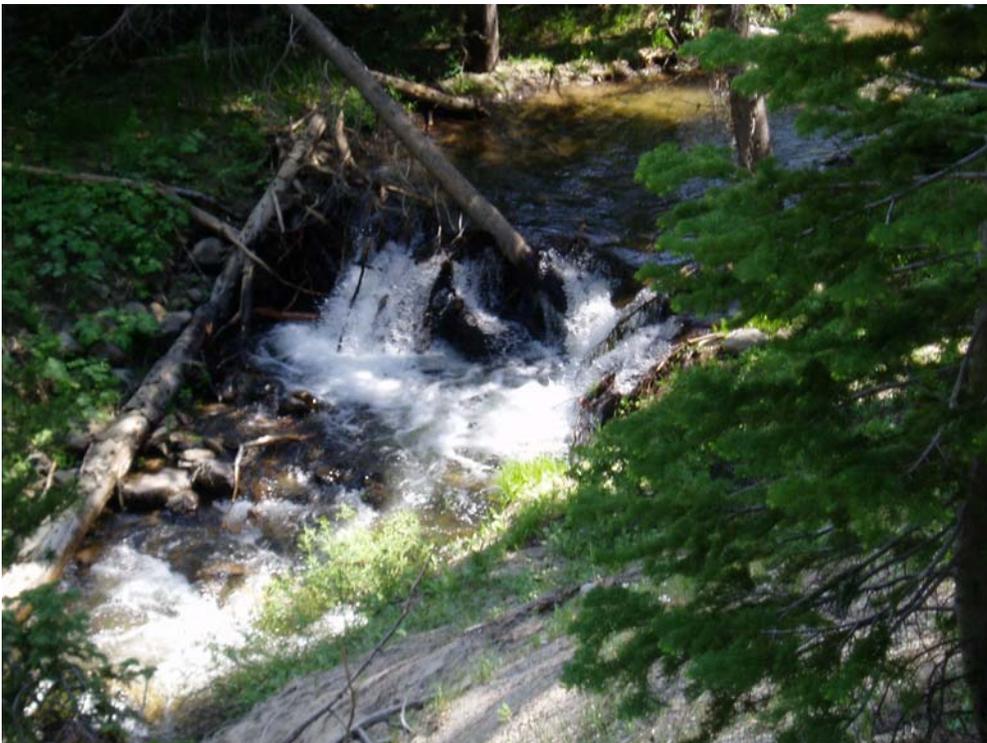
Photo 22: Murray Canyon Creek, Carson Ranger District, seasonal fish barrier just upstream of Site 9. The seasonal fish barrier is approximately 4 feet high. Photo was taken on 16 July 2005.

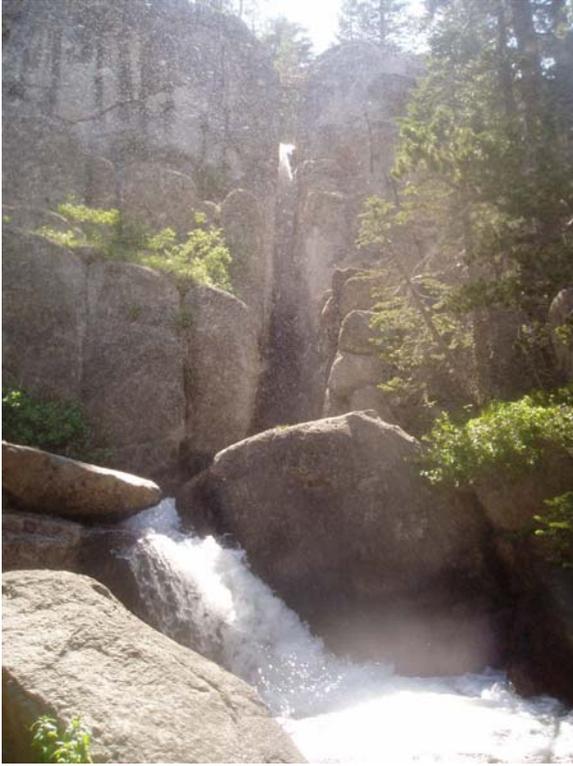
Photo 23: Murray Canyon Creek, Carson Ranger District, permanent fish barrier between Site 9 and Site 10. The permanent fish barrier is approximately 100 feet high. Photo was taken on 16 July 2005.
