PLEASANT VALLEY CREEK

Alpine County, California

2006 Stream Habitat Survey Report

Carson Ranger District: Humboldt-Toiyabe National Forest

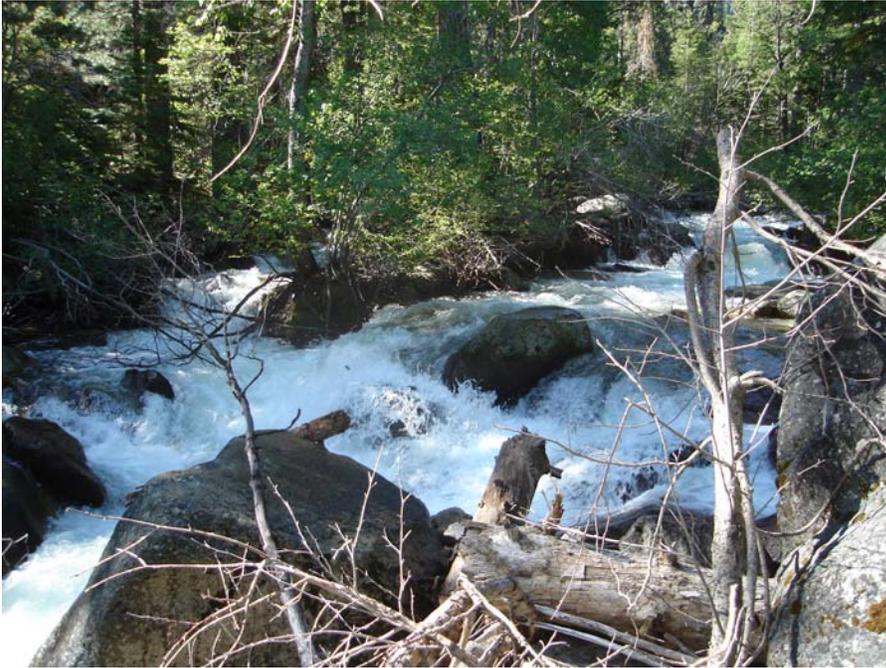
Site 1: Pleasant Valley Creek, Carson Ranger District. Upstream photograph taken at the survey start point shows the cascades prevalent in this reach. This site is located at UTM: N: 4280861 & E: 253373, Elev. 6102 ft (1860 m).

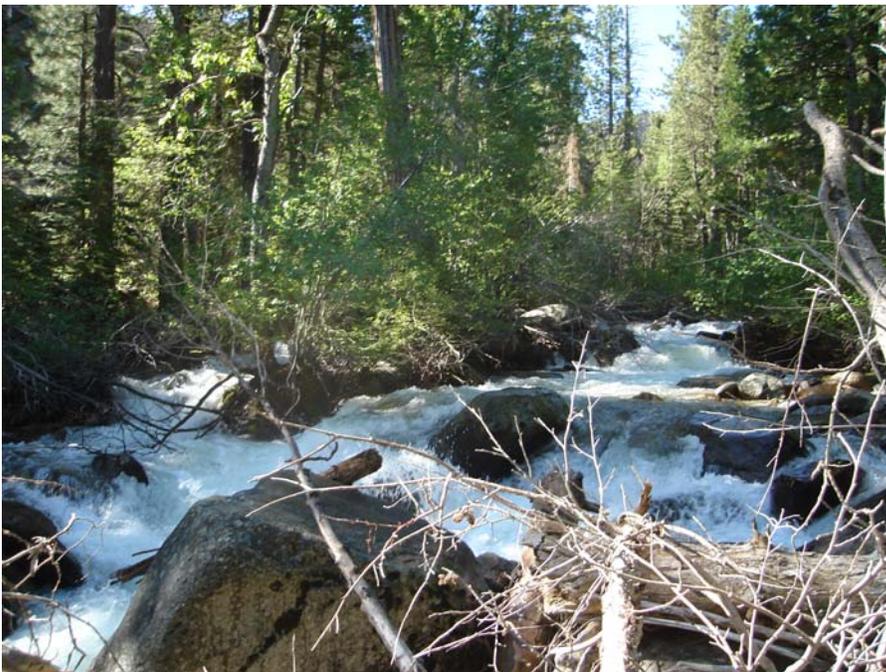
Site 2: Pleasant Valley Creek, Carson Ranger District. Upstream photo showing a seasonal barrier 1.5-3.0 ft tall with a max pool depth of 1.0-3.0 ft. This site is located at UTM: N: 4280848 & E: 253319, Elev. 6083 ft (1854m).

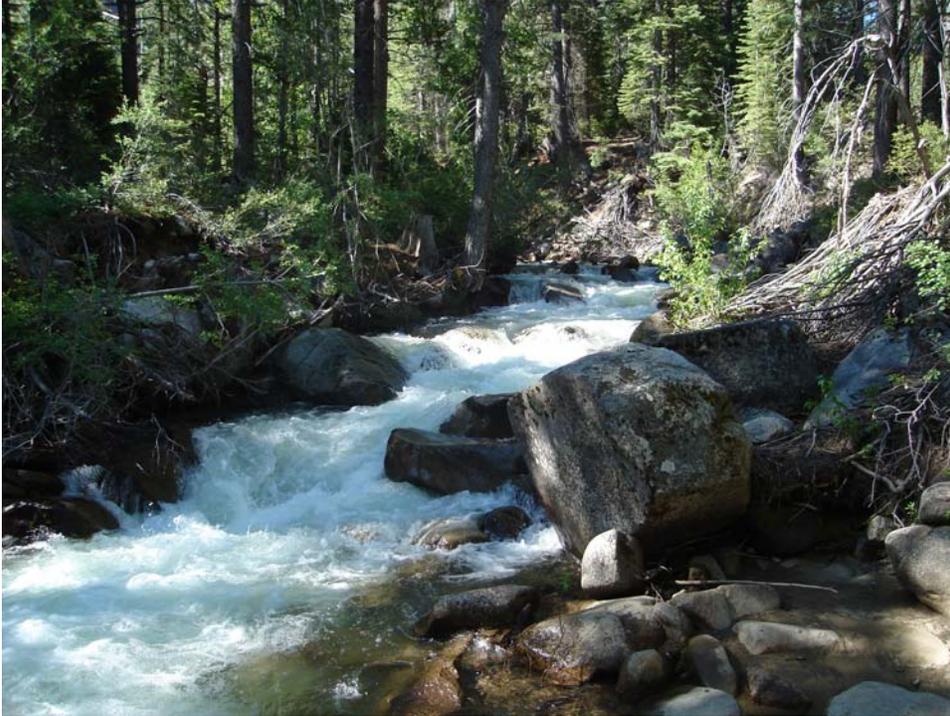
Site 3: Pleasant Valley Creek, Carson Ranger District. Upstream photo showing a typical cascade sequence. This site is located at UTM: N: 4280801 & E: 253286, Elev. 6079 ft (1853 m).

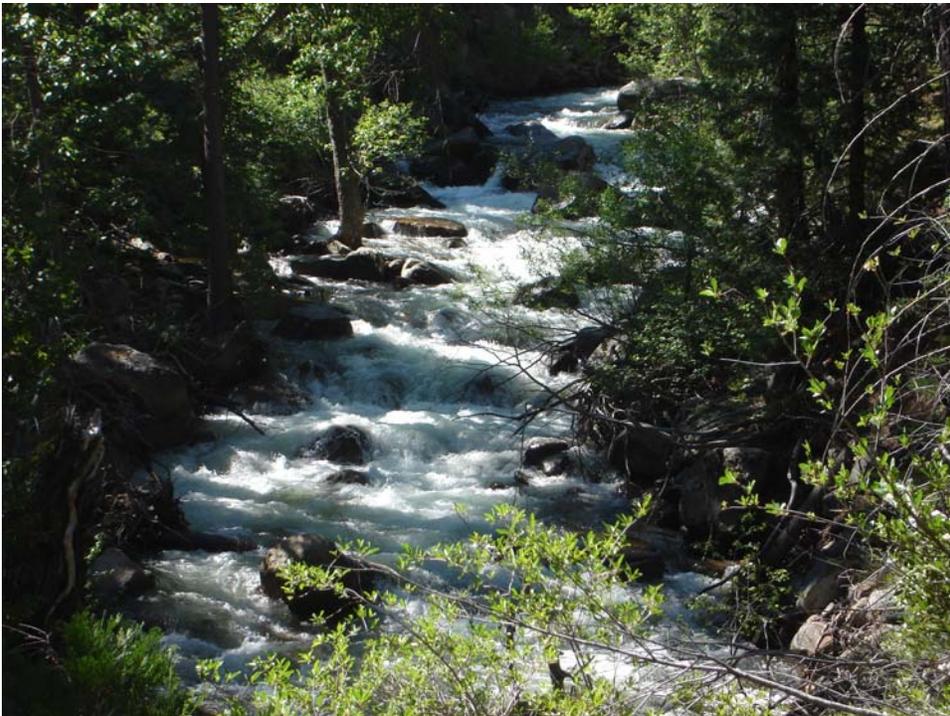
Site 4: Pleasant Valley Creek, Carson Ranger District. Upstream photo showing more cascades and high-velocity water. This site is located at UTM: N: 4280784 & E: 253268, Elev. 6033 ft (1839 m).

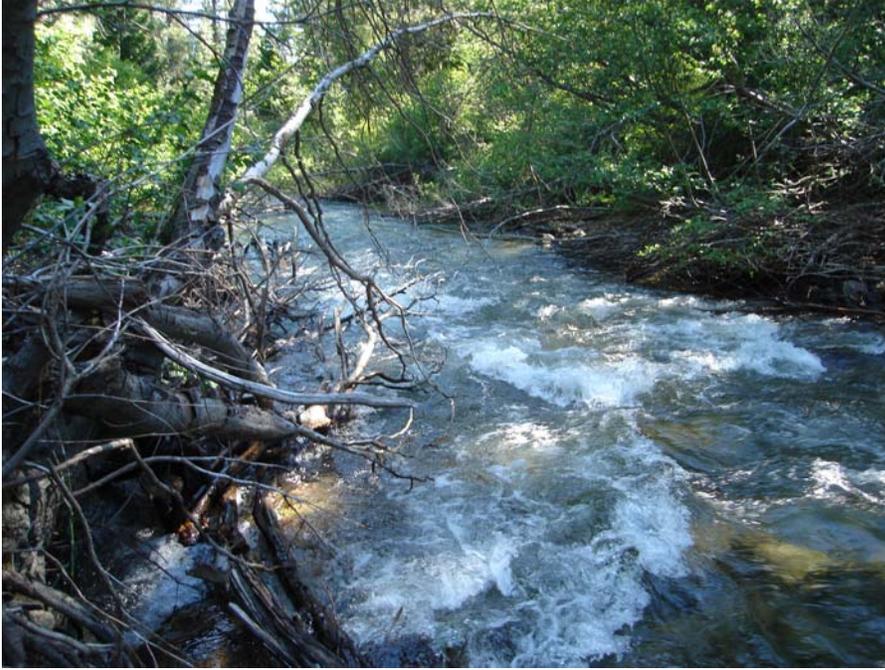
Site 5: Pleasant Valley Creek, Carson Ranger District. Downstream photo of a lower gradient reach. This site is located at UTM: N: 4280512 & E: 453209, Elev. 6109 ft (1862 m).

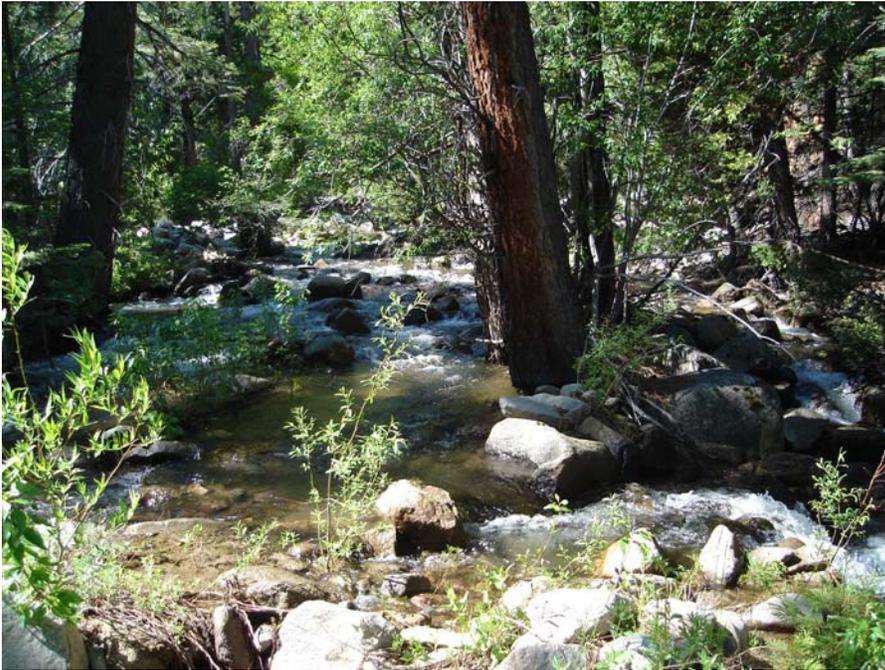
Site 6: Pleasant Valley Creek, Carson Ranger District. Upstream photo of a braided channel. This site is located at UTM: N: 4280406 & E: 253038, Elev. 6083 ft (1854 m).

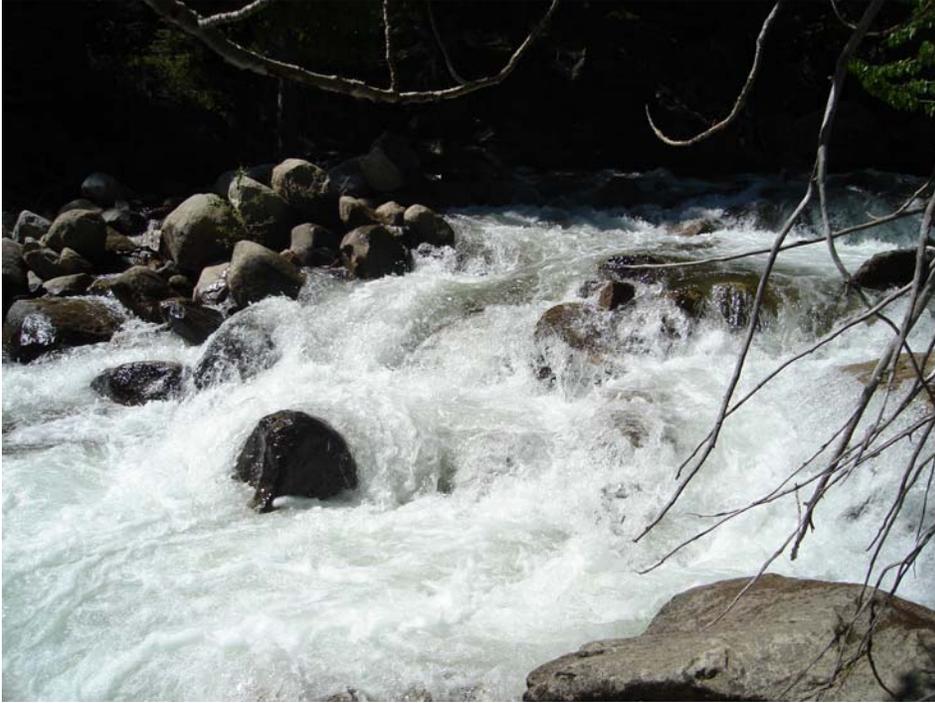
Site 7: Pleasant Valley Creek, Carson Ranger District. Upstream photo of a seasonal fish barrier formed by a series of 2-3 foot cascades, with average pool depths of 1.5-2.5 ft. (values estimated for safety). This site is located at UTM: N: 4280358 & E: 252990, Elev. 6175 ft (1882 m).

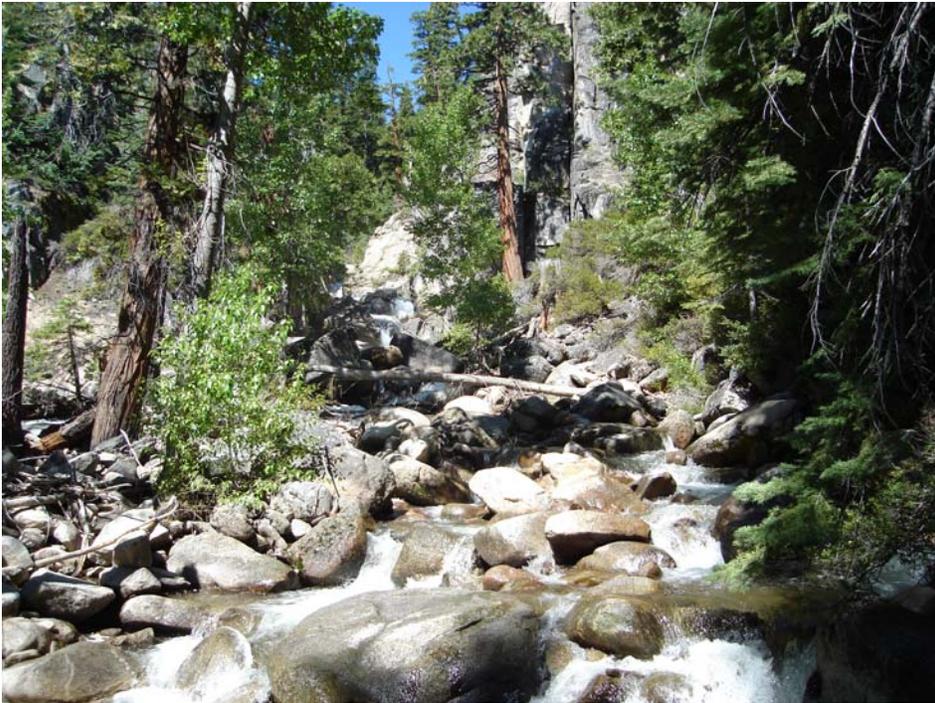
Site 8: Pleasant Valley Creek, Carson Ranger District. Upstream photo of a permanent fish barrier formed by a series of varying sized waterfalls, estimated at 2.0-10.0 ft in height. This site is located at UTM: N: 4280362 & E: 252910, Elev. 6201 ft (1890 m).

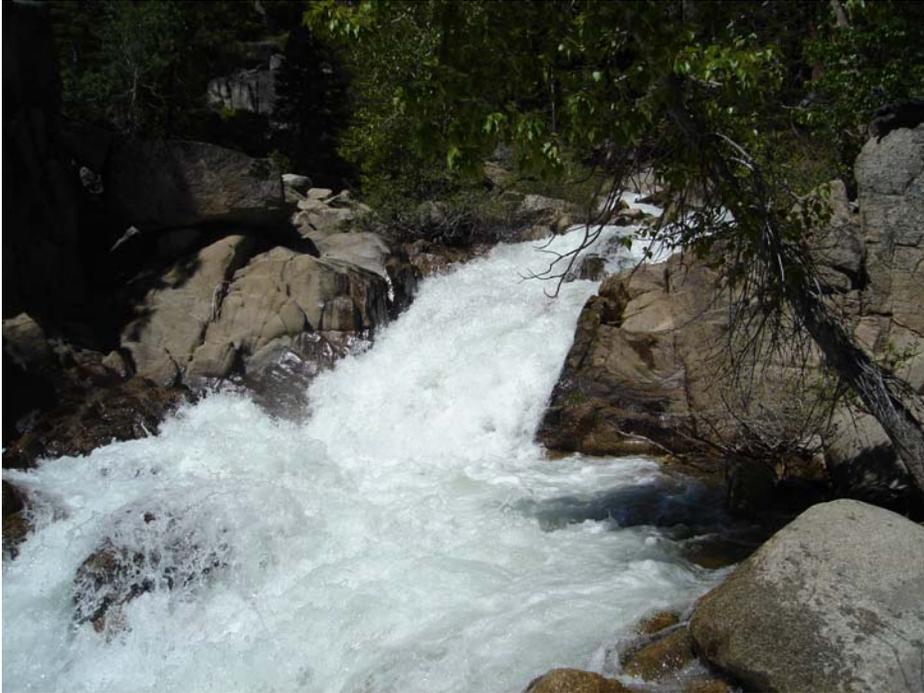
Site 9: Pleasant Valley Creek, Carson Ranger District. Upstream photo of a naturally occurring waterfall: a permanent fish barrier 16.0 ft high with a pool depth of 3-4 ft. This site is located at UTM: N: 4280269 & E: 252680, Elev. 6257 ft (1907 m).

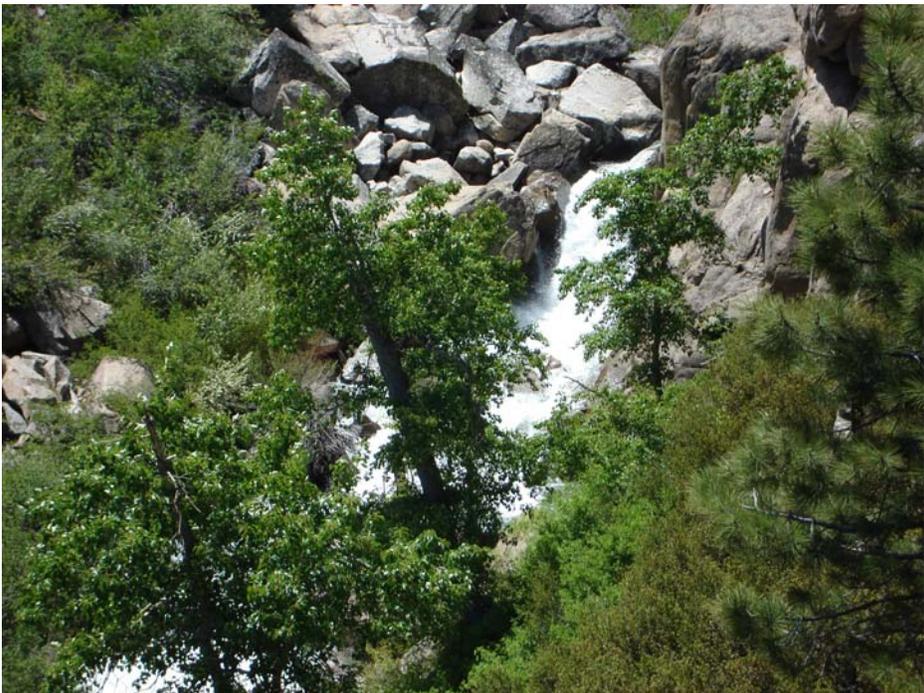
Site 10: Pleasant Valley Creek, Carson Ranger District. A permanent fish barrier is formed by waterfalls ranging in height from 2-20 ft. This site is located at UTM: N: 4280016 & E: 252323 Elev. 6762 ft (2061 m).

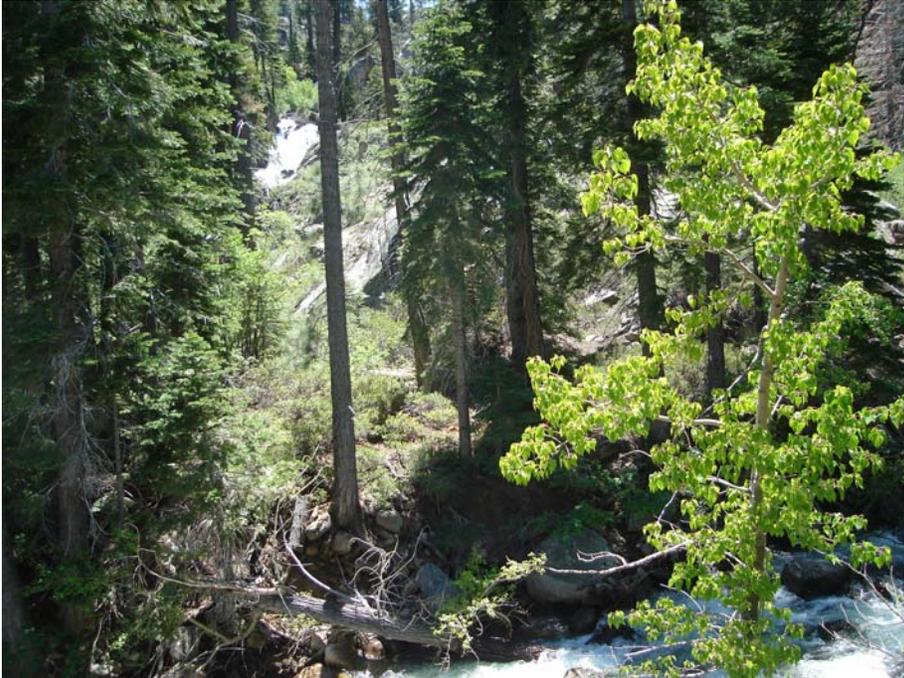
Site 11: Pleasant Valley Creek, Carson Ranger District. Cross-sectional photo of a cascading tributary that enters on river right from the Raymond Peak area (contributing 40% of flow). This site is located at UTM: N: 4279940 & E: 251964, Elev. 6837 ft (2084 m).

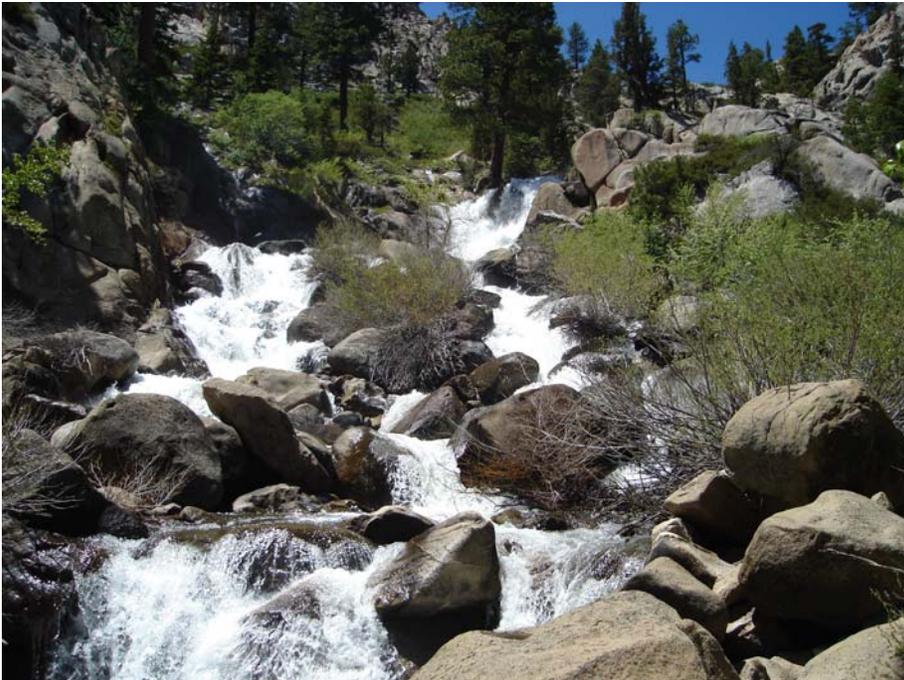
Site 12: Pleasant Valley Creek, Carson Ranger District. Upstream photo showing more cascades and permanent fish barriers. This site is located at UTM: N: 4279925 & E: 251846, Elev. 6870 ft (2094 m).

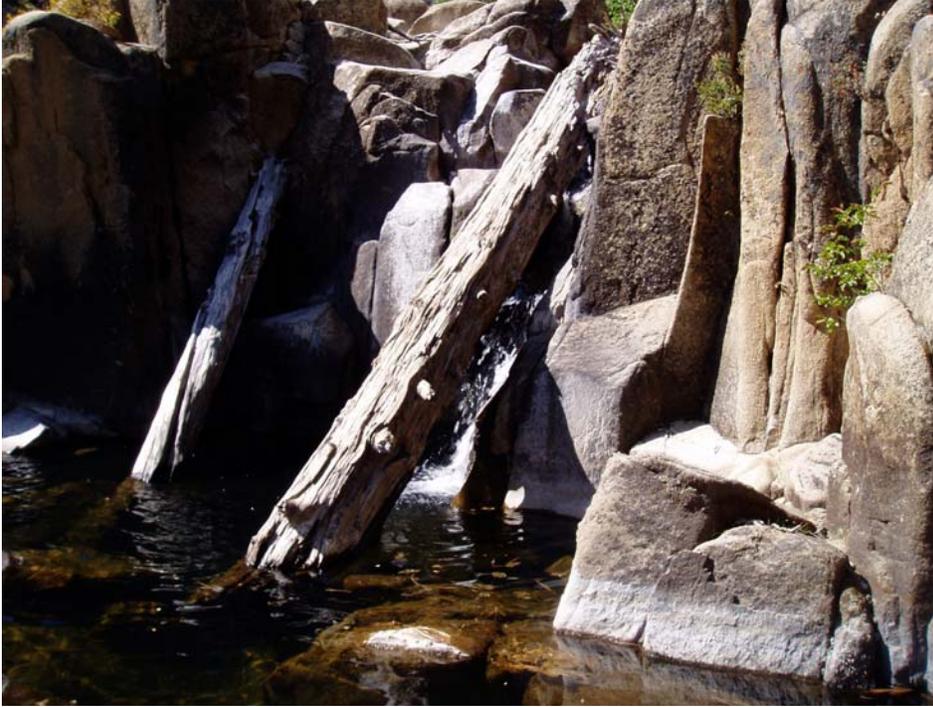
The section between Site 1 and Site 13 is a steep cascading reach with multiple seasonal and permanent fish barriers. Upstream of Site 13 Pleasant Valley Creek is a small and slow moving stream. Jeff Davis Creek contributes roughly 80% of the flow to Pleasant Valley Creek at Site 15, above which point Pleasant Valley Creek is nearly stagnant (September 2006).

Site 13: Pleasant Valley Creek, Carson Ranger District. Upstream photo of a permanent fish barrier. Above this point the stream gradient is low and flows are minimal. This site is located at UTM: N: 4280156 & E: 251437, Elev. 7372 ft (2247 m).

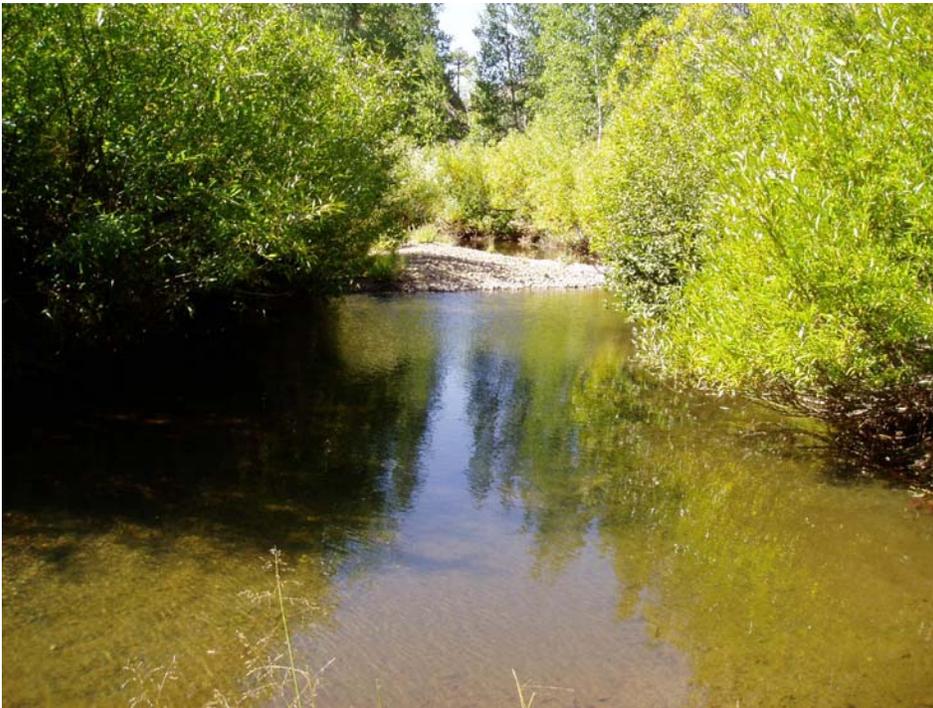
Site 14: Pleasant Valley Creek, Carson Ranger District. Upstream photo showing stream habitat characteristic of this reach: the water is slow to stagnant. This site is located at UTM: N: 4280202 & E: 251342, Elev. 7359 ft (2243 m).

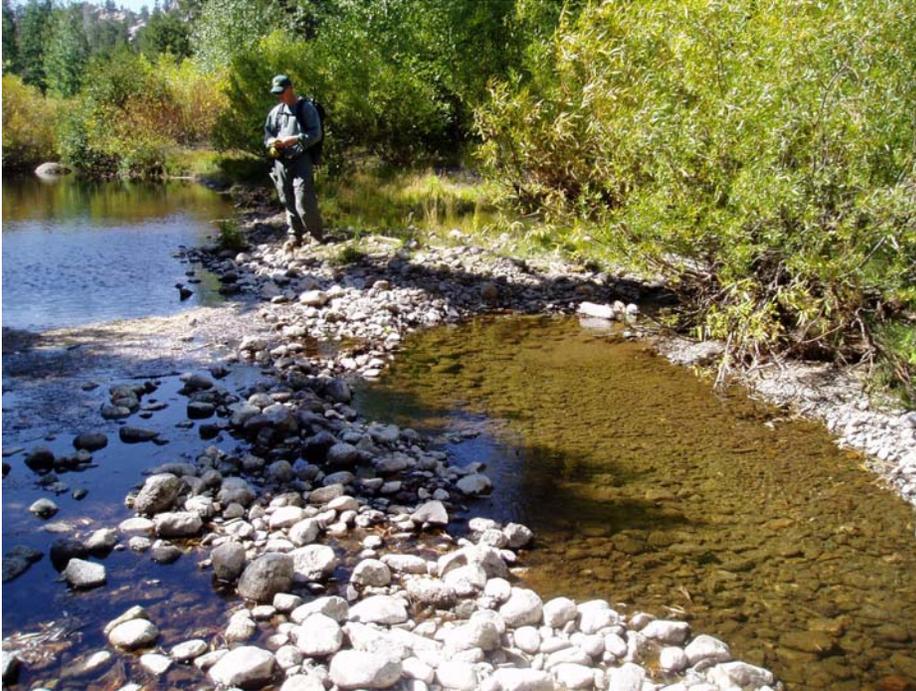
Site 15: Pleasant Valley Creek, Carson Ranger District. Upstream photo of confluence with Jeff Davis Creek, which enters river left and contributes 80% of flow to Pleasant Valley Creek. This site is located at UTM: N: 4279873 & E: 250921, Elev. 7359 ft (2243 m).

2. Investigate the water management schedules for the several reservoirs in the upper part of the watershed, and investigate the possibility of allocating more water to flow into Pleasant Valley Creek during the driest part of the year.

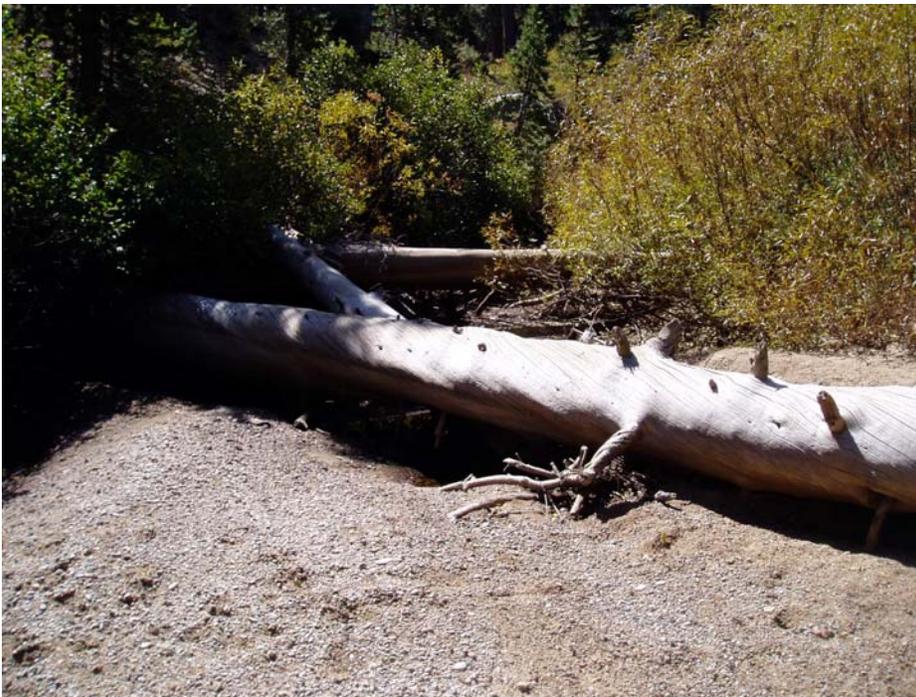
Site 16: Pleasant Valley Creek, Carson Ranger District. Above this point the stream consists of disconnected ponds and pools. This site is located at UTM: N: 4279654 & E: 250681, Elev. 7369 ft (2246 m).

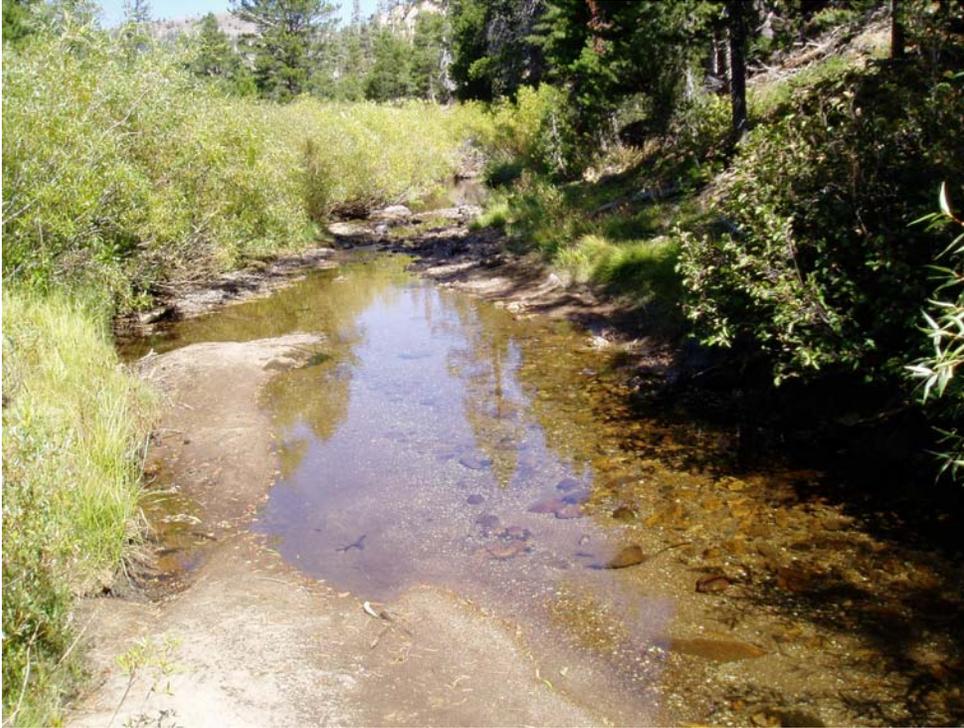
Fish were sighted in the uppermost reaches of Pleasant Valley Creek, including in isolated pools or ponds at Site 17 and Site 18. The refugia these fish occupy are completely isolated by a dry streambed. Fish habitat in Pleasant Valley Creek is disconnected and limited in quantity. Because of the steep gradient in the lower section and low flows and ponding in the upper section, Pleasant Valley Creek should not be considered suitable for sustainable LCT habitat.

Site 17: Pleasant Valley Creek, Carson Ranger District. Six small unidentified fish were sighted in this stagnant pool. This site is located at UTM: N: 4278875 & E: 250405, Elev. 7375 ft (2248 m).

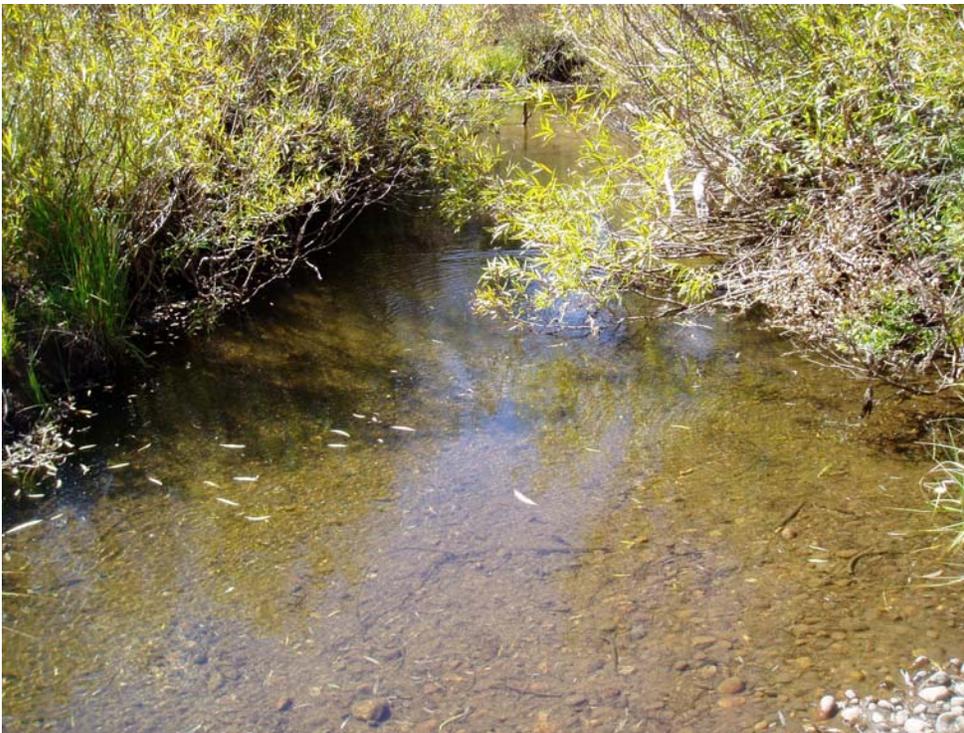
Site 18: Pleasant Valley Creek, Carson Ranger District. Two 6-7 inch salmonids were sighted in this isolated pool. This site is located at UTM: N: 4278345 & E: 249822, Elev. 7388 ft (2252 m).

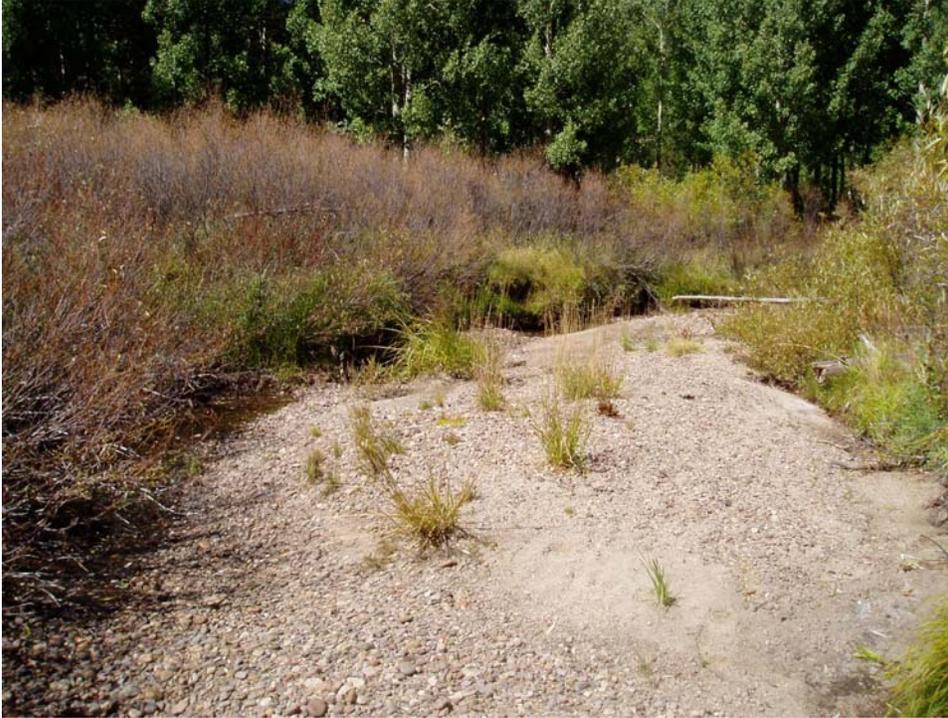
Site 19: Pleasant Valley Creek, Carson Ranger District. An upstream photo from the survey end point shows a dry streambed. This site is located at UTM: N: 4278344 & E: 249796, Elev. 7382 ft (2250 m).

1. Consider the 3.4 mile section of Pleasant Valley Creek between Site 1 and Site 19 as having no potential LCT habitat. Pleasant Valley Creek probably offers approximately 6 miles of potential LCT habitat downstream of Site 1 on the privately owned fly fishing preserve. If possible, obtain permission to conduct a stream habitat survey downstream of Site 1 to verify this presumption. If 6 miles of potential LCT habitat exist downstream of Site 1, consider Pleasant Valley
