# **RAYMOND CANYON CREEK**

Alpine County, California

2006 Stream Habitat Survey Report

Carson Ranger District: Humboldt-Toiyabe National Forest

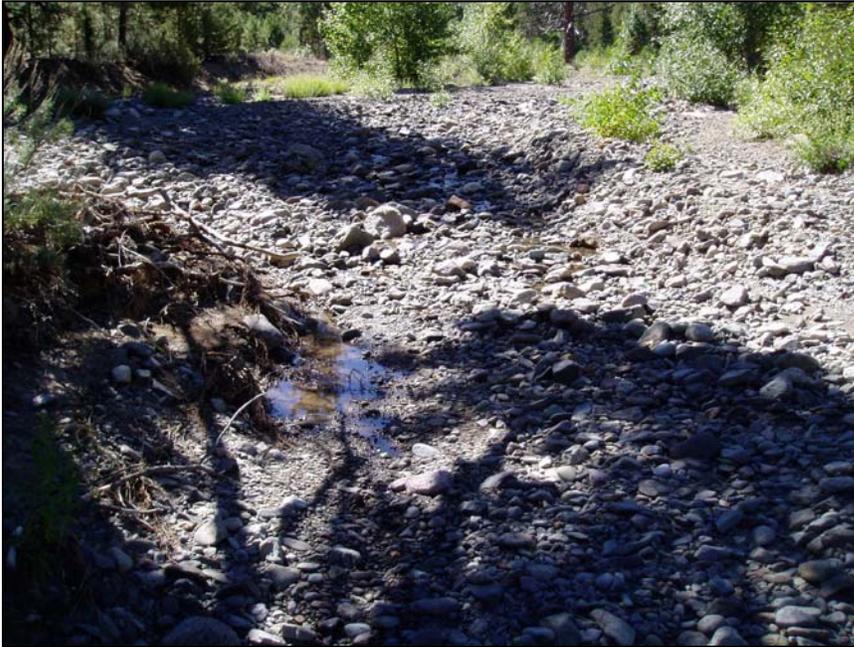
**Site 1:** Raymond Canyon Creek, Carson Ranger District. Upstream photo shows a dry stream bed where the mainstem goes subsurface in the valley. Water has been diverted out of the main stem in two locations upstream. This site is located at UTM: N: 4281633 & E: 254599, Elev. 5973 feet (1821m).

At the survey start point (Site 1) the stream goes subsurface and the main channel is dry downstream of that point. Upstream of this location are two diversions at Site 6 and at Site 2, which divert an estimated 25 percent and 80-90 percent of flow, respectively. Therefore, the discharge at Site 1 is approximately 12 percent of that value above Site 6. The diversion at Site 6 is clearly man-made, as it contains plastic sheeting and plywood. At Site 2 the stream may naturally braid; however, a disproportional amount of water flows river left and there is visible evidence that a gravel bar has been enhanced to create this disproportion.

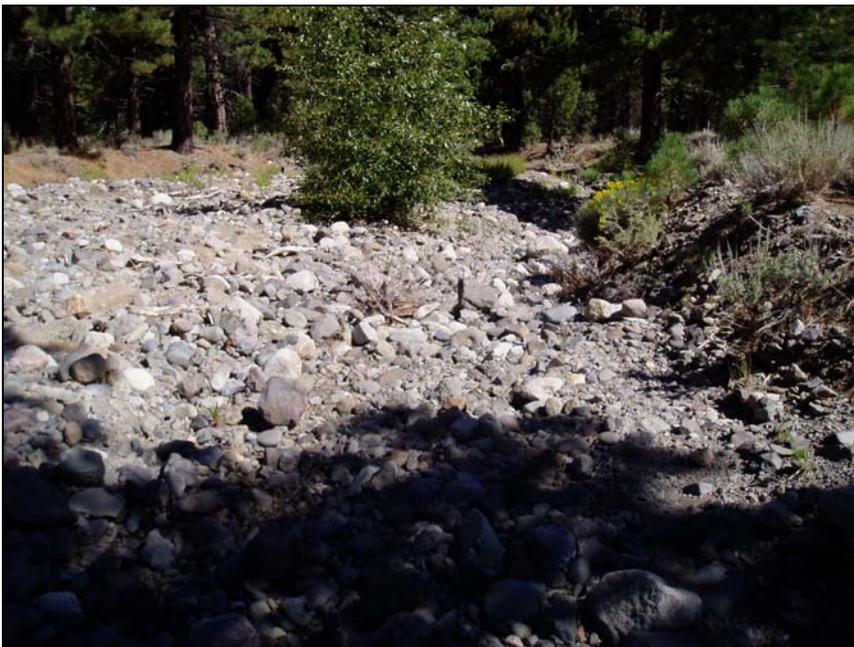
**Site 1:** Raymond Canyon Creek, Carson Ranger District. Downstream photo of dry streambed. This site is located at UTM: N: 4281633 & E: 254599, Elev. 5973 feet (1821m).

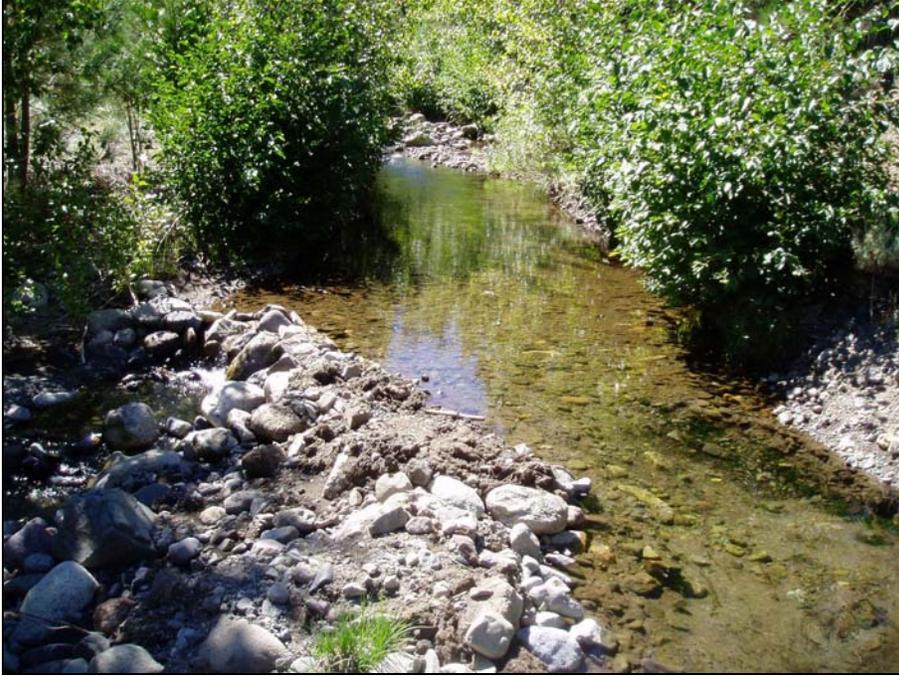
**Site 2:** Raymond Canyon Creek, Carson Ranger District. Upstream photo of a diversion, which sends approximately 80-90% of flow into a side channel, the destination of which is unknown. This site is located at UTM: N: 4281454 & E: 254643, Elev. 5943 feet (1812m).

1. Consider the 0.23 mile section of Raymond Canyon Creek between Site 11 and Site 13 as potential LCT habitat and consider Raymond Canyon Creek a low candidate for restoration.
2. Investigate the destination and impacts of the diversion canals located at Site 2 and Site 6. Ensure that fish are not subject to terminal trips into irrigated pasture, and similarly ensure that water users are staying within the confines of their adjudicated rights.
3. Contact the private landowner to obtain permission to survey Raymond Canyon Creek upstream of Site 13.

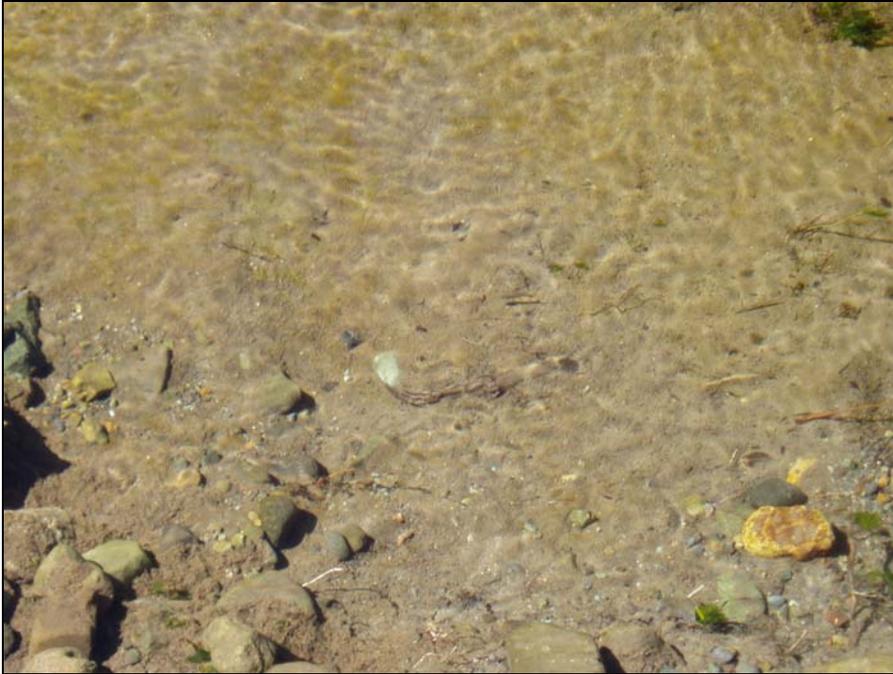
**Site 2:** Raymond Canyon Creek, Carson Ranger District. Photo shows a close-up look at a location within the diversion where several fish were seen. This site is located at UTM: N: 4281454 & E: 254643, Elev. 5943 feet (1812m).

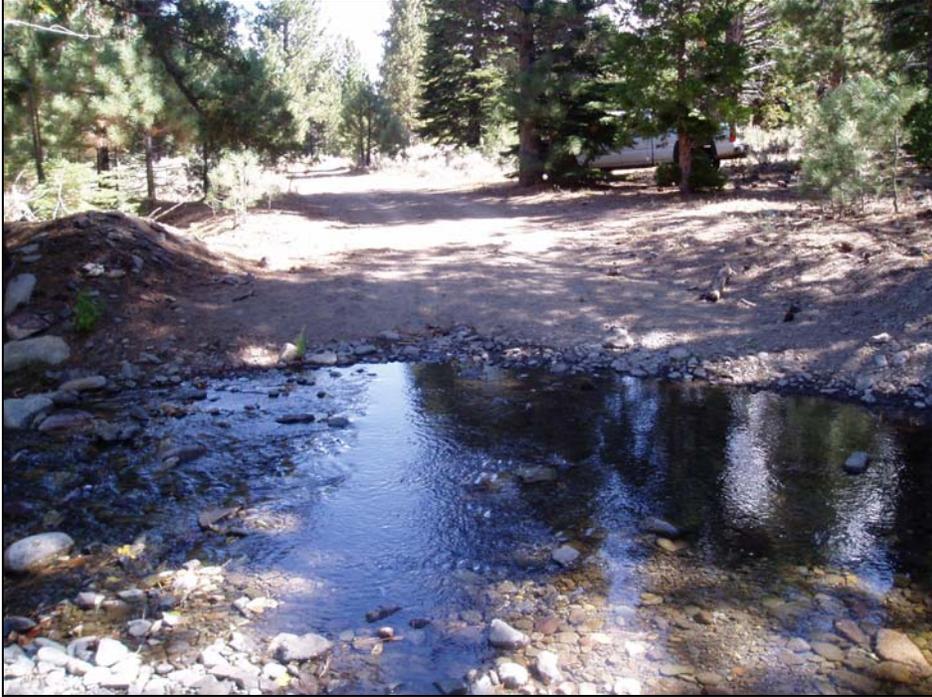
**Site 3:** Raymond Canyon Creek, Carson Ranger District. Cross-sectional view of ford crossing where Road 094 crosses the stream. Access to the road requires crossing private property. This site is located at UTM: N: 4281394 & E: 254717, Elev. 5888 feet (1795m).

The fish sighted at Sites 2 and Site 4 occupy the lower reach where the gradient is low to moderate, and between Site 11 and Site 13 the gradient is also low to moderate, though no fish were sighted in this reach. A road-stream crossing at Site 3 provides a potential source of sediment to the stream; however, because this road is located behind a locked gate on private property, the usage is likely minimal.

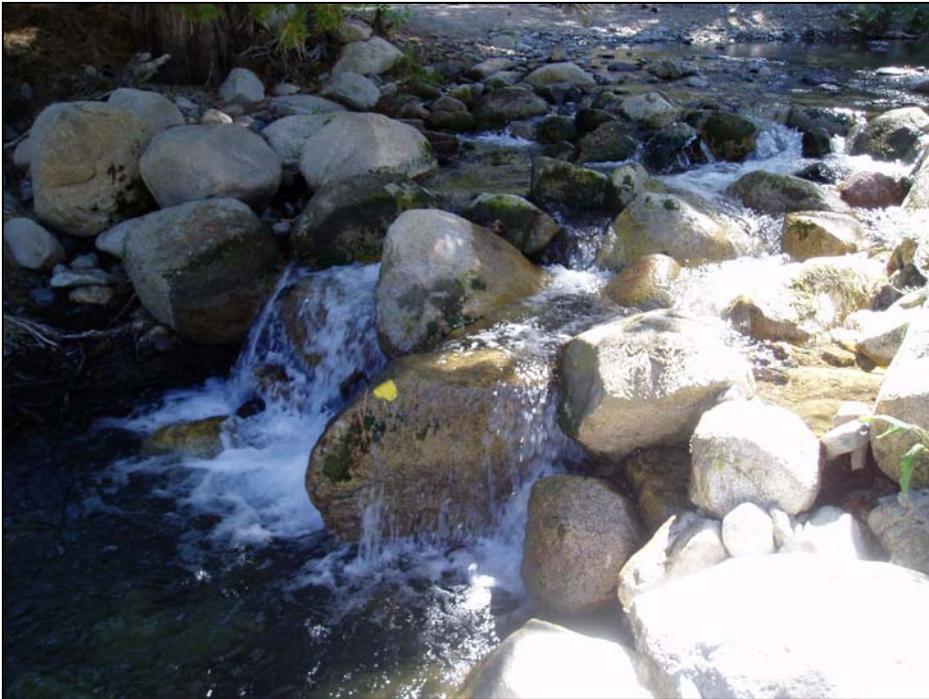
**Site 3:** Raymond Canyon Creek, Carson Ranger District. Upstream view towards the road-stream crossing. This site is located at UTM: N: 4281394 & E: 254717, Elev. 5888 feet (1795m).

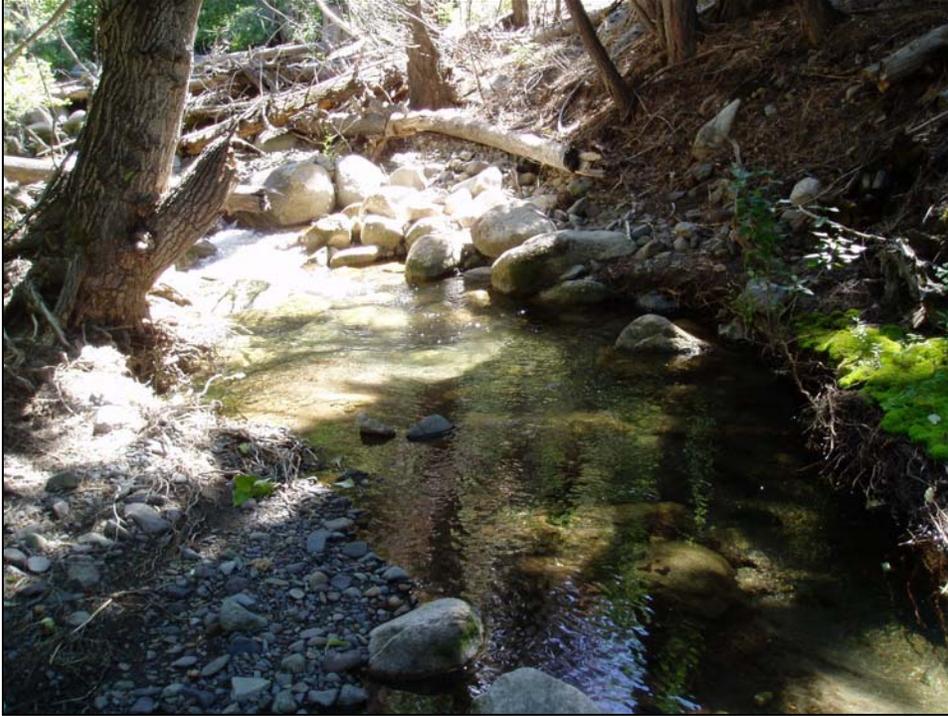
**Site 4:** Raymond Canyon Creek, Carson Ranger District. A large fish was sighted in this pool. This site is located at UTM: N: 4281262 & E: 254784, Elev. 5927 feet (1807m).

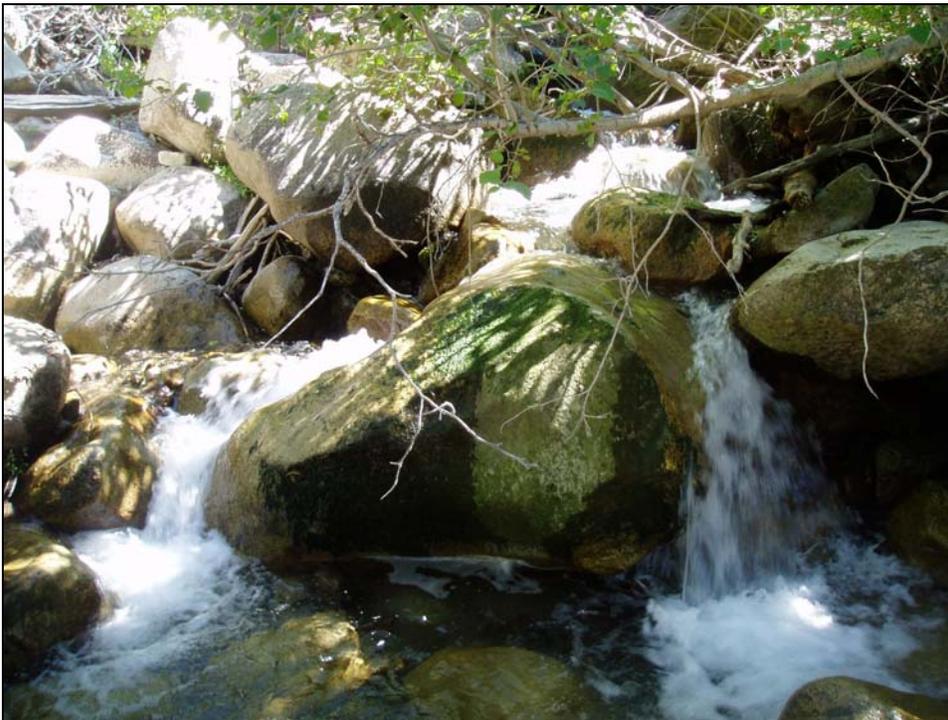
**Site 5:** Raymond Canyon Creek, Carson Ranger District. Upstream view of a 4.0 foot tall seasonal barrier (max. pool depth 1.75 feet). This point marks the downstream end of a steep section of stream. This barrier is located at UTM: N: 4281265 & E: 254893, Elev. 6078 feet (1853m).

The segment of stream between Site 5 and Site 10 is steep and divided by four significant barriers. The permanent barriers at Sites 8 & 10 are 8.0 and 5.2 feet tall, and the seasonal barriers at Sites 5 & 7 are 4.0 and 4.9 feet tall, respectively. Naturally occurring fish passage through this reach is impossible, and fish movement is severely inhibited.

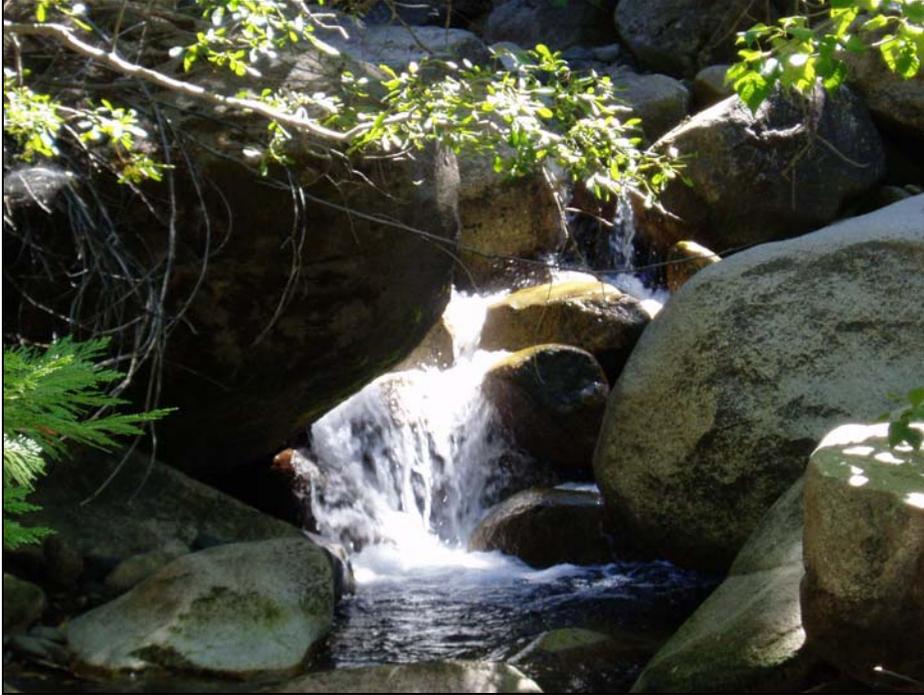
**Site 5:** Raymond Canyon Creek, Carson Ranger District. Upstream view of another sizeable seasonal barrier. This barrier is located at UTM: N: 4281265 & E: 254893, Elev. 6078 feet (1853m).

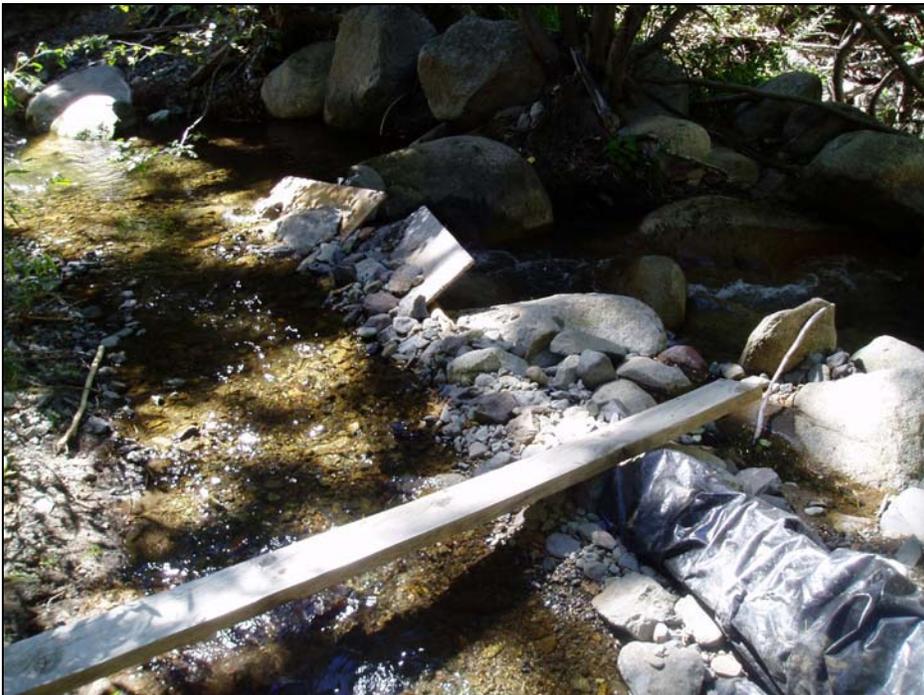
**Site 6:** Raymond Canyon Creek, Carson Ranger District. Upstream view of a flashboard diversion. Note the use of plastic and plywood. Approximately 25% of total flow is diverted river right. This site is located at UTM: N: 4281298 & E: 254968, Elev. 6160 feet (1878m).

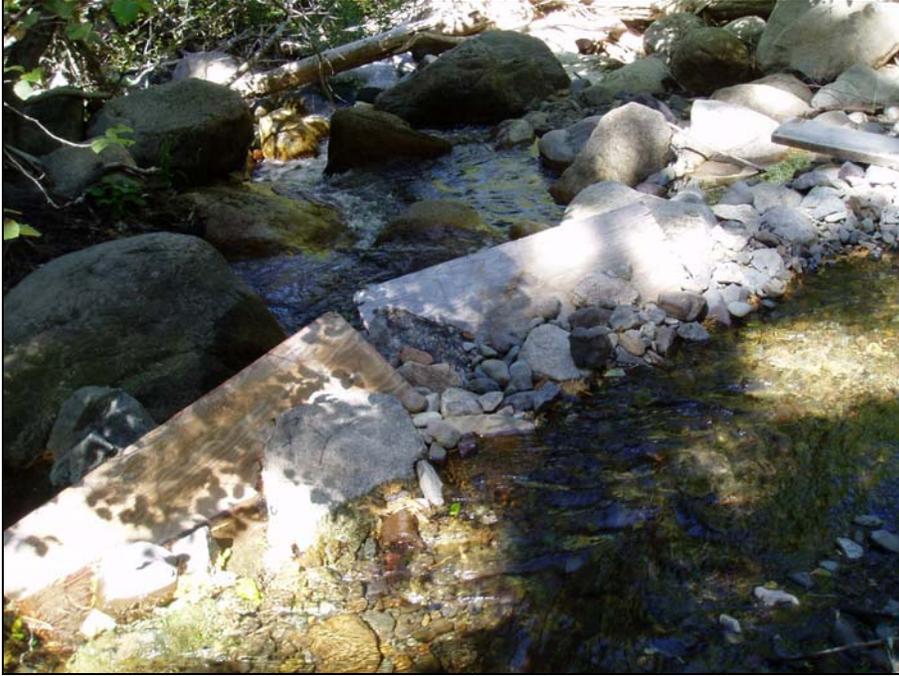
**Site 6:** Raymond Canyon Creek, Carson Ranger District. Downstream view of diversion. Mainstem is shown on left side of photo. This site is located at UTM: N: 4281298 & E: 254968, Elev.6160 feet (1878m).

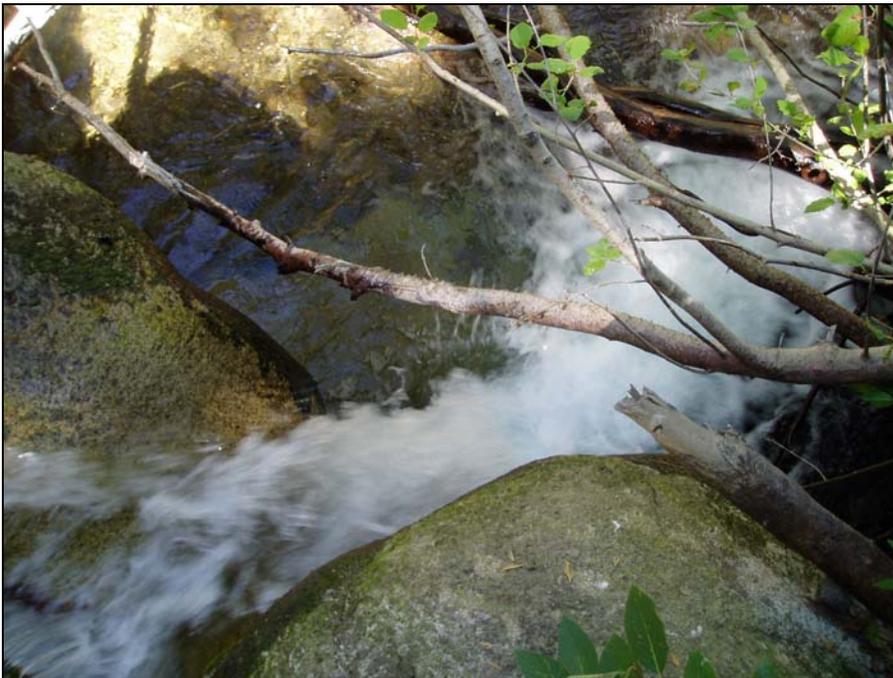
**Site 7:** Raymond Canyon Creek, Carson Ranger District. Downstream view of a large seasonal fish barrier: height 4.9 feet and maximum pool depth 2.75 feet. This site is located at UTM: N: 4281285 & E: 255018, Elev. 6094 feet (1858m).

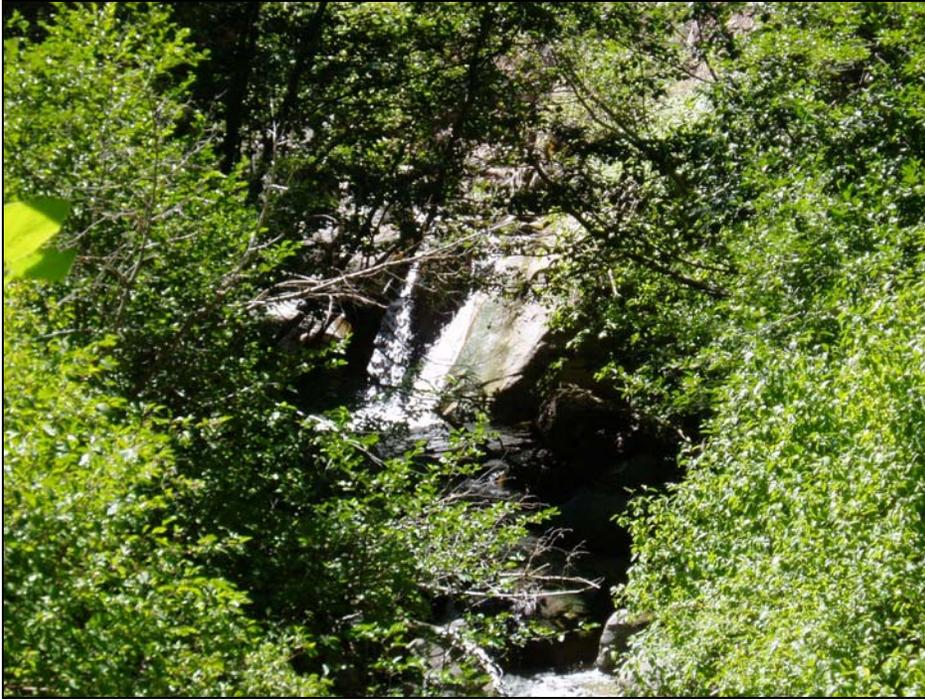
**Site 8:** Raymond Canyon Creek, Carson Ranger District. Distant upstream view of a permanent fish passage barrier. The waterfall is approximately 8.0 feet tall, with an estimated max. pool depth of 2.5-3.0 feet. This site is located at UTM: N: 4281051 & E: 255106.

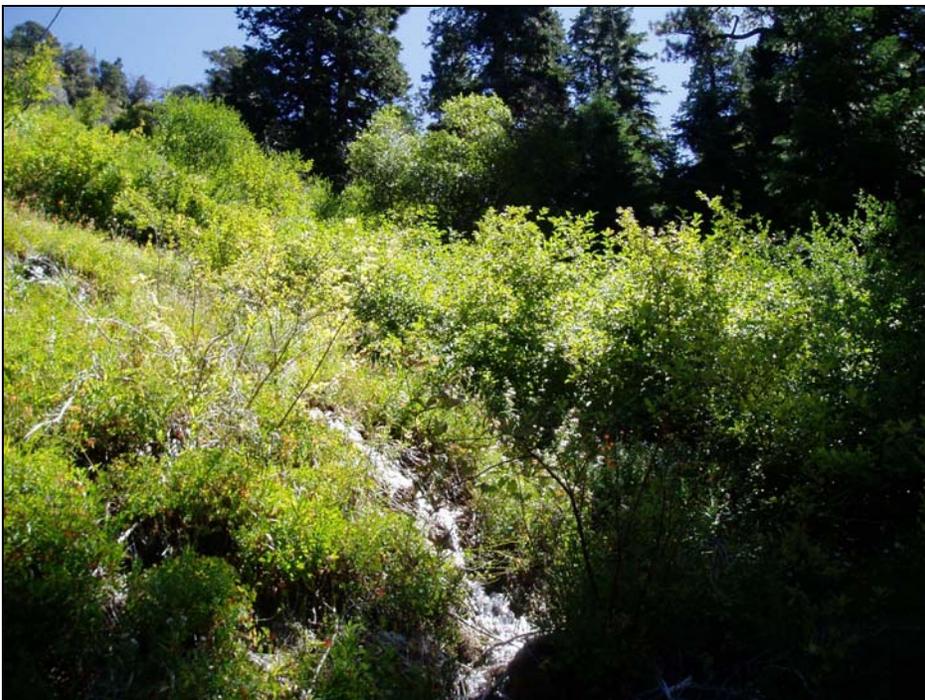
**Site 9:** Raymond Canyon Creek, Carson Ranger District. A small tributary enters river right, contributing roughly 1.0 percent of flow. This site is located at UTM: N: 4280385 & E: 255152.

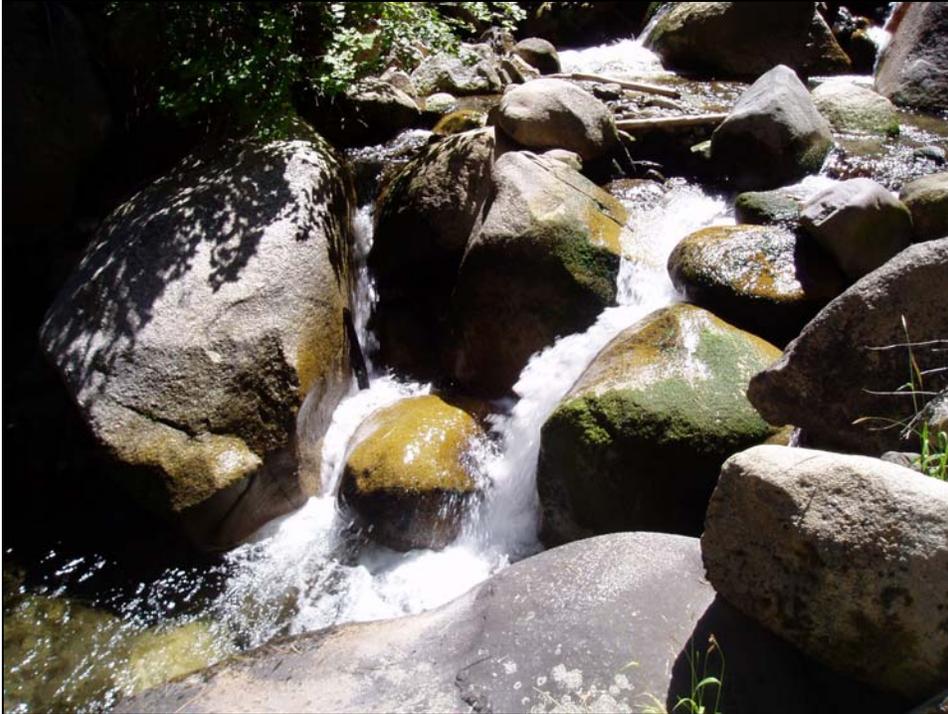
**Site 10:** Raymond Canyon Creek, Carson Ranger District. Photo shows a permanent barrier measuring 5.2 feet high with a pool depth of 3.2 feet. This site is located at UTM: N: 4280247 & E: 255191.

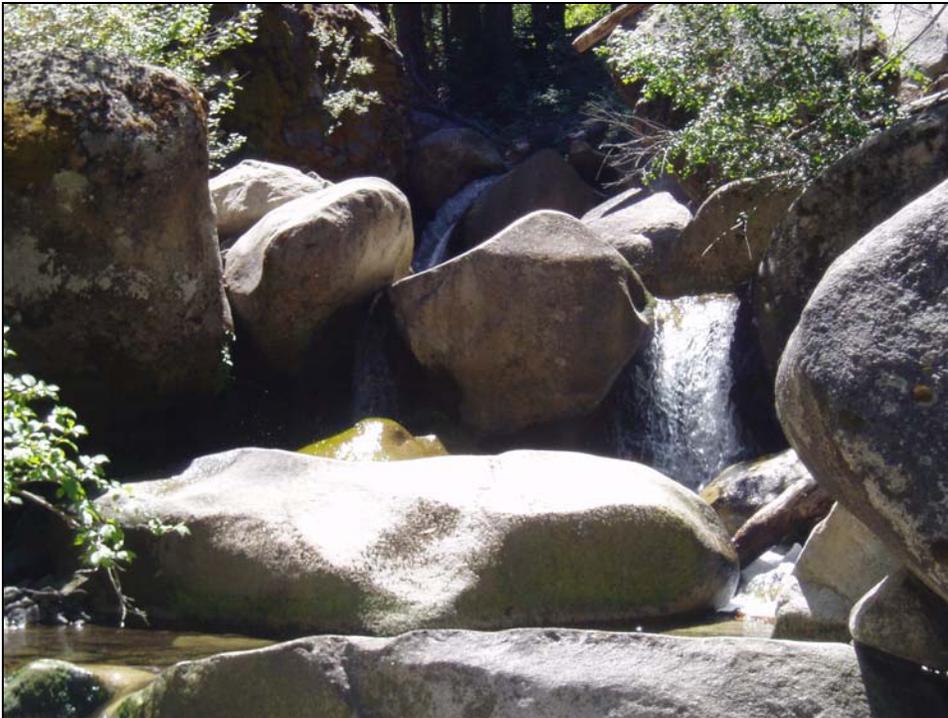
**Site 10:** Raymond Canyon Creek, Carson Ranger District. Just upstream of the first barrier are several other fish passage barriers. This site is located at UTM: N: 4280247 & E: 255191.

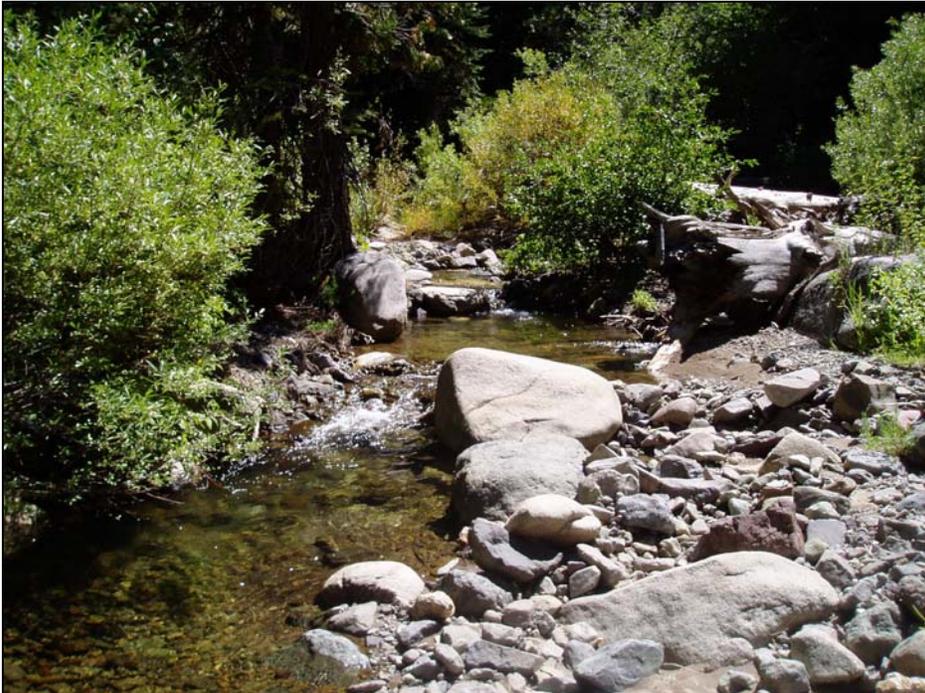
**Site 11:** Raymond Canyon Creek, Carson Ranger District. Upstream photo captures change in stream gradient. Potential LCT habitat exists in this reach. This site marks the upstream end of a steep section of stream (Sites 5-11). This site is located at UTM: N: 4280085 & E: 255228.

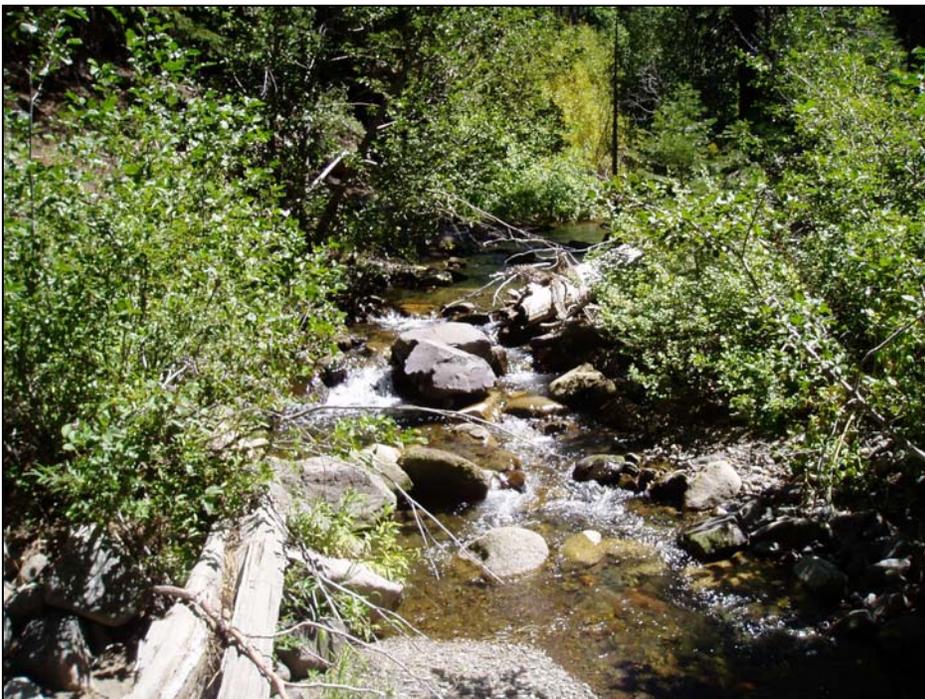
**Site 12:** Raymond Canyon Creek, Carson Ranger District. Potential fish habitat shown in photo. This site is located at UTM: 4280091 & E: 255252, Elev. 6452 feet (1967m).

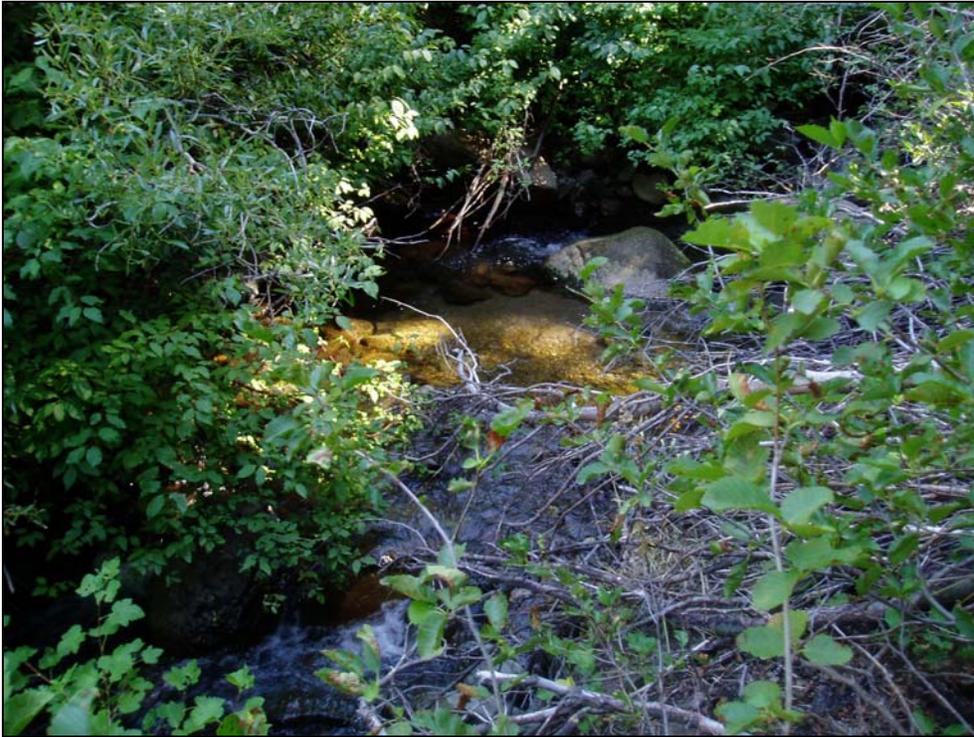
**Site 13:** Raymond Canyon Creek, Carson Ranger District. Upstream photo taken near a private property boundary. This site is located at UTM: 4279895 & E: 255282, Elev. 6580 feet (2006m).
