RAYMOND MEADOWS CREEK

2006 Stream Habitat Survey Report

Carson Ranger District: Humboldt-Toiyabe National Forest

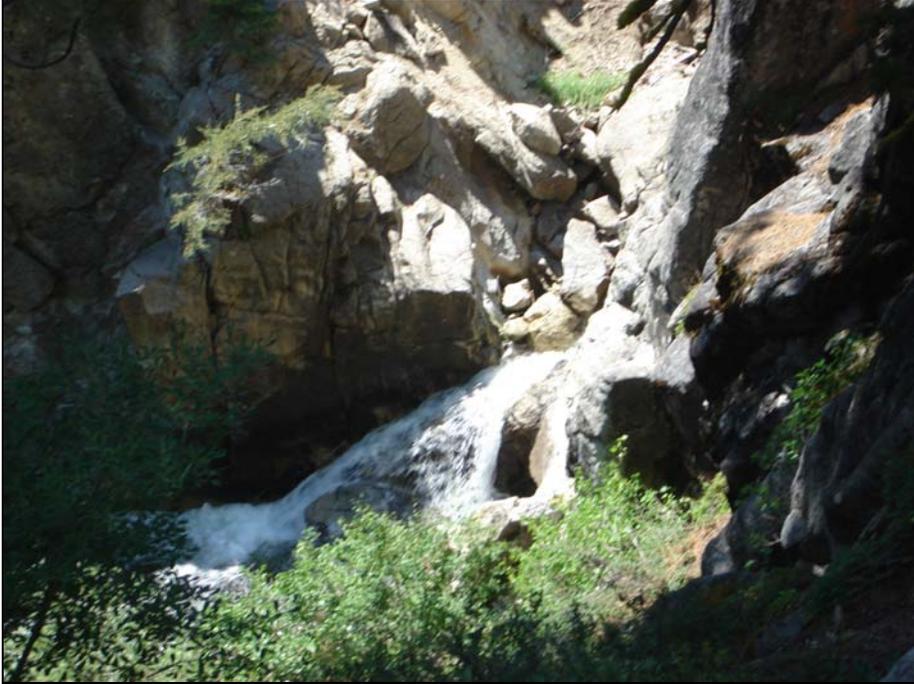
Site 1: Raymond Meadows Creek, Carson Ranger District. Upstream photo of Raymond Meadows Creek, taken from the survey start point just above the confluence with Silver Creek. This site is located at UTM: N: 4274220 & E: 256205.

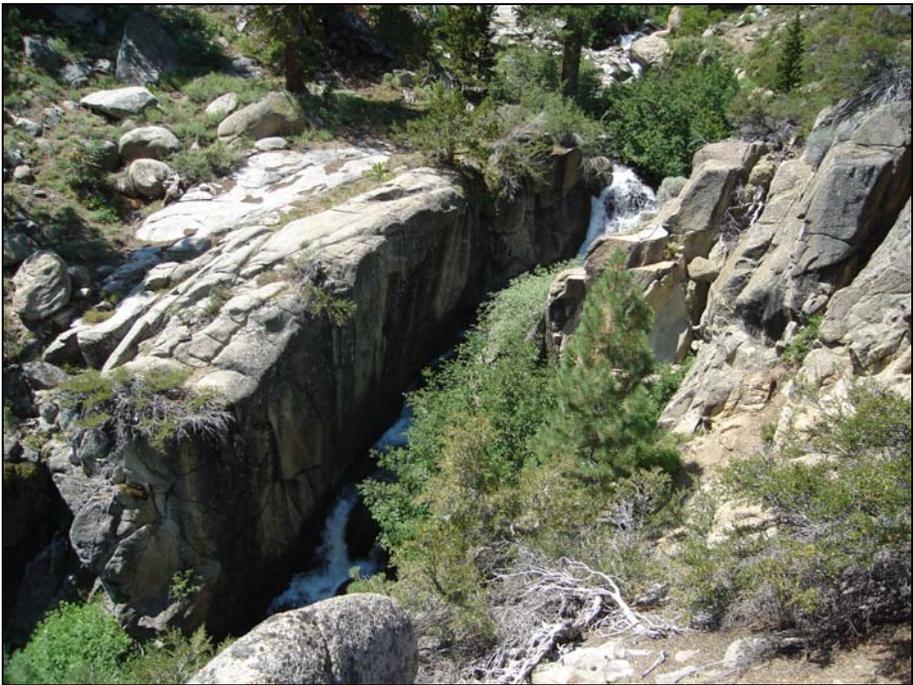
Site 2: Raymond Meadows Creek, Carson Ranger District. Upstream view of a permanent fish barrier with an estimated height of 15.0 feet, and max. pool depth of 2.0-4.0 feet. This site is located at UTM: N: 4274254 & E: 255971, Elev. 7439 feet (2268m).

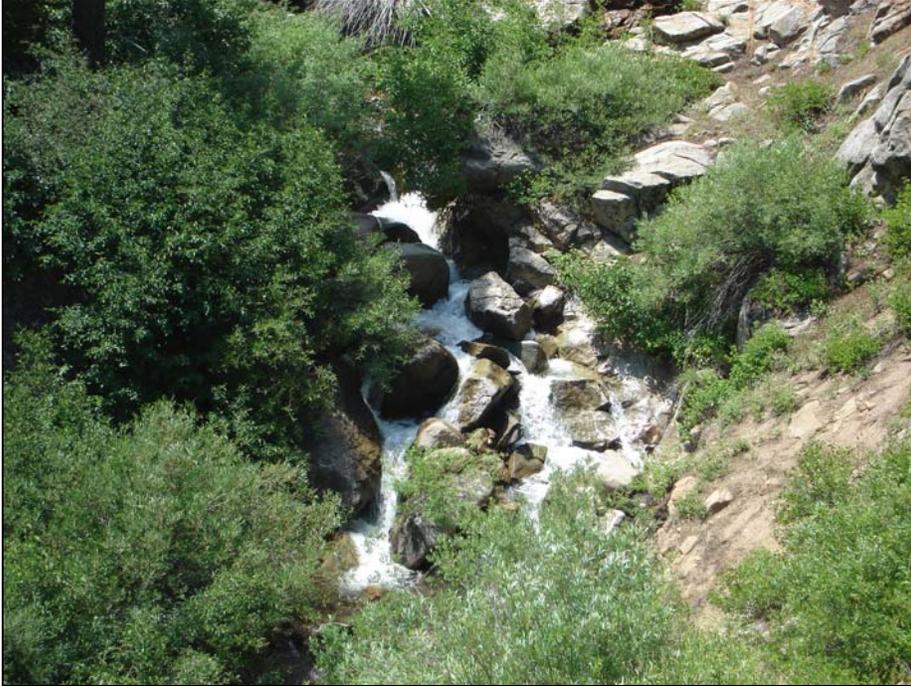
Site 3: Raymond Meadows Creek, Carson Ranger District. Upstream photo of permanent fish barrier, which is approximately 7.5 ft high, with a pool depth of 1-3 ft deep. This site is located at UTM: N: 4274222 & E: 255770, Elev. 7754 feet (2364m).

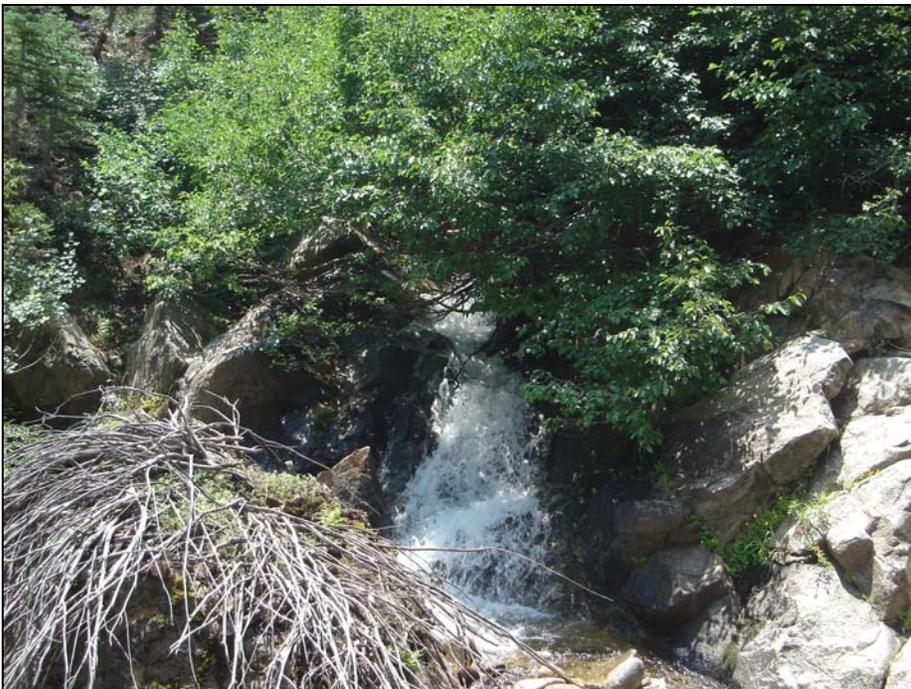
Site 4: Raymond Meadows Creek, Carson Ranger District. Photo of a 12-15 ft tall waterfall. Max. pool depth is 0.5 to 1.5 ft. This site is located at UTM: N: 4274249 & E: 255617, Elev. 7728 feet (2356m).

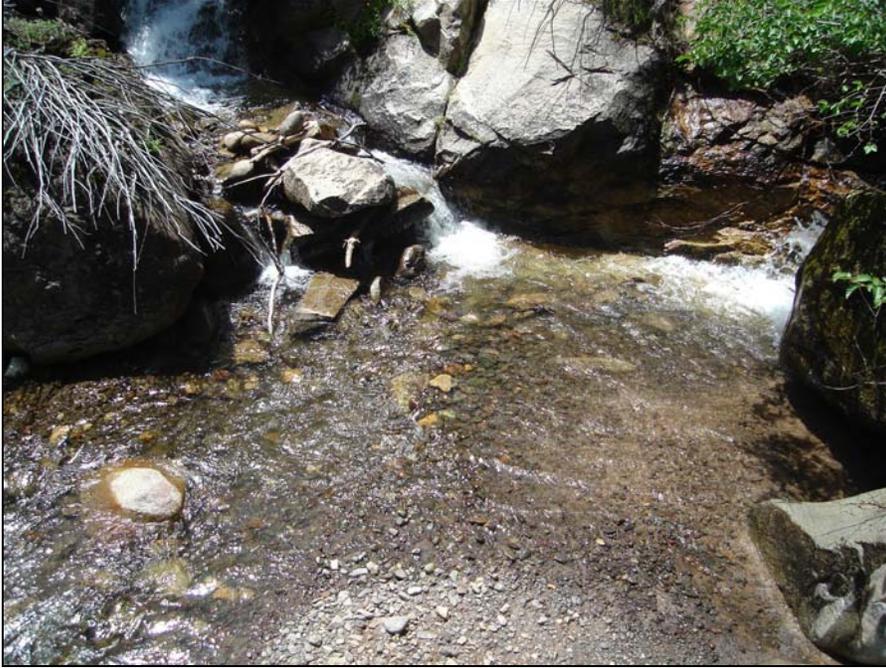
Site 5: Raymond Meadows Creek, Carson Ranger District. Upstream photo of the confluence of Eagle Creek (right) and Raymond Meadows Creek (left). This site is located at UTM: N: 4274250 & E: 255614, Elev. 7705 feet (2349m).

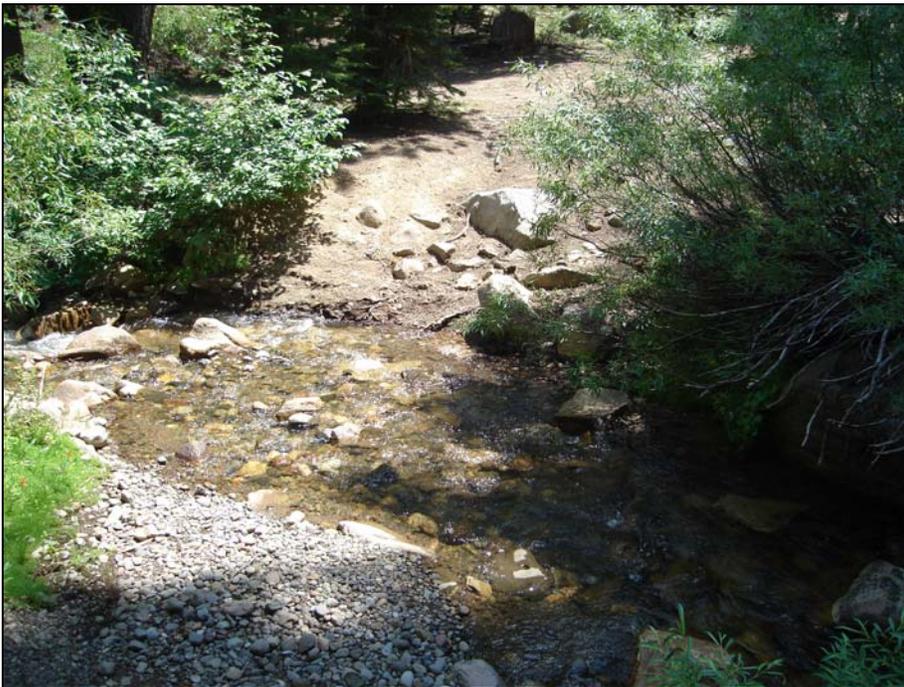
Raymond Meadows Creek is fairly isolated and therefore human impact is minimal. The road that crosses the stream at Site 6 showed little evidence of recent use. Upstream of Site 21 the Pacific Crest Trail crosses the headwaters, though impacts on the stream are negligible.

Site 6: Raymond Meadows Creek, Carson Ranger District. This road-stream crossing shows little use, and has a negligible impact on the stream. This site is located at UTM: N: 4274187 & E: 255567, Elev. 7695 feet (2346m).

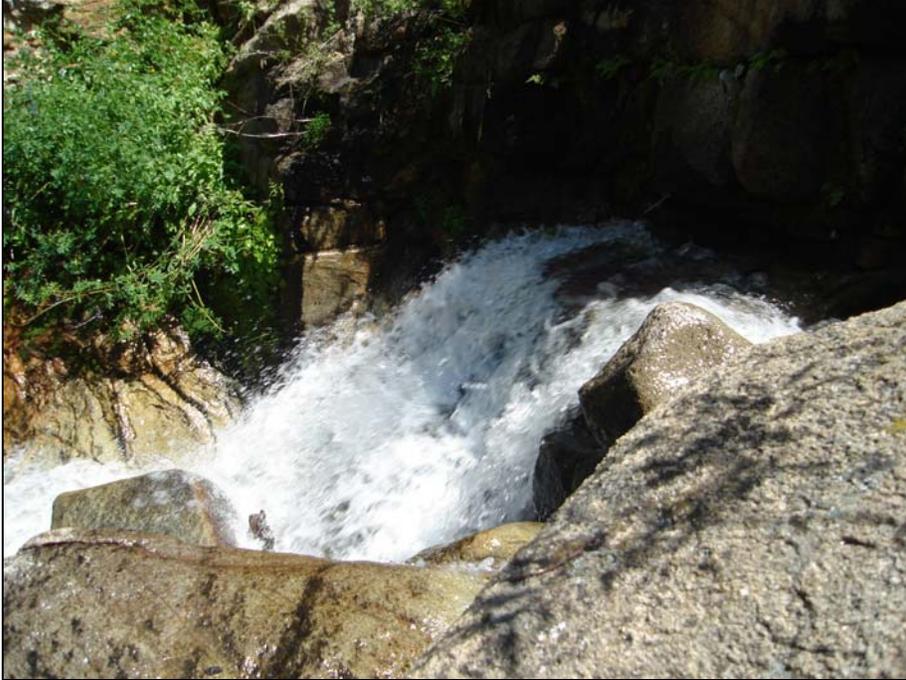
Site 7: Raymond Meadows Creek, Carson Ranger District. Cross-sectional view of an 8.0 ft high permanent barrier with a maximum pool depth of 1.5-2.0 ft. This site is located at UTM: N: 4274134 & E: 255546, Elev. 7806 feet (2380m).

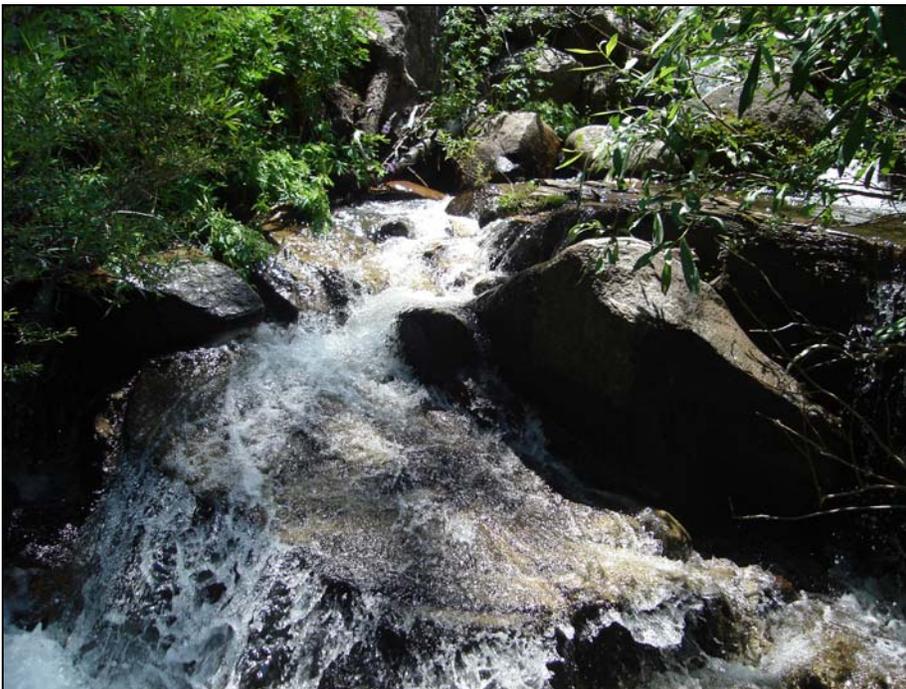
Site 8: Raymond Meadows Creek, Carson Ranger District. Upstream photo of a seasonal barrier with a height of 4.5 ft and a max. pool depth of 1.3 ft. This site is located at UTM: N: 4274098 & E: 255502.

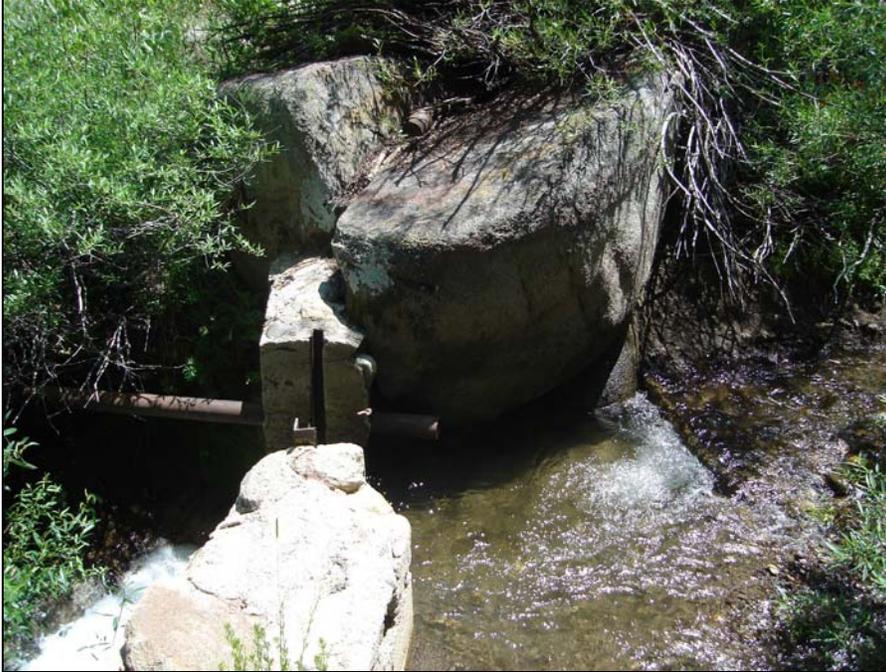
Site 9: Raymond Meadows Creek, Carson Ranger District. Cross-sectional photo of an artificial permanent fish barrier. The concrete footings are part of a flashboard dam that can be used to retain water. The barrier height without the board in is 4.0 feet, and the maximum pool depth is 1.4 feet. A pipe on the upstream end of the dam allows for water to be diverted. This site is located at UTM: N: 4274121 & E: 255456, Elev. 7905 feet (2410m).

4. Assess the efficiency and impact of the concrete diversion at Site 9 making sure it is not diverting a quantity of water that exceeds the adjudicated rights. Examine the possibilities of altering, enhancing, or replacing the diversion structure to provide fish connectivity through the site.

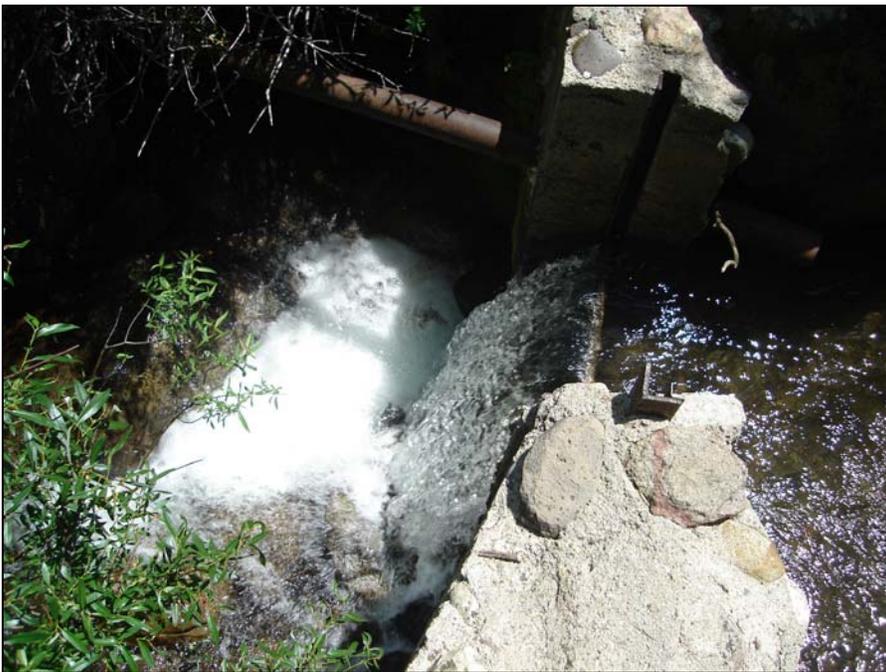
Site 9 cont: Raymond Meadows Creek, Carson Ranger District. A bird's eye view of the barrier. This site is located at UTM: N: 4274121 & E: 255456, Elev. 7905 feet (2410m).

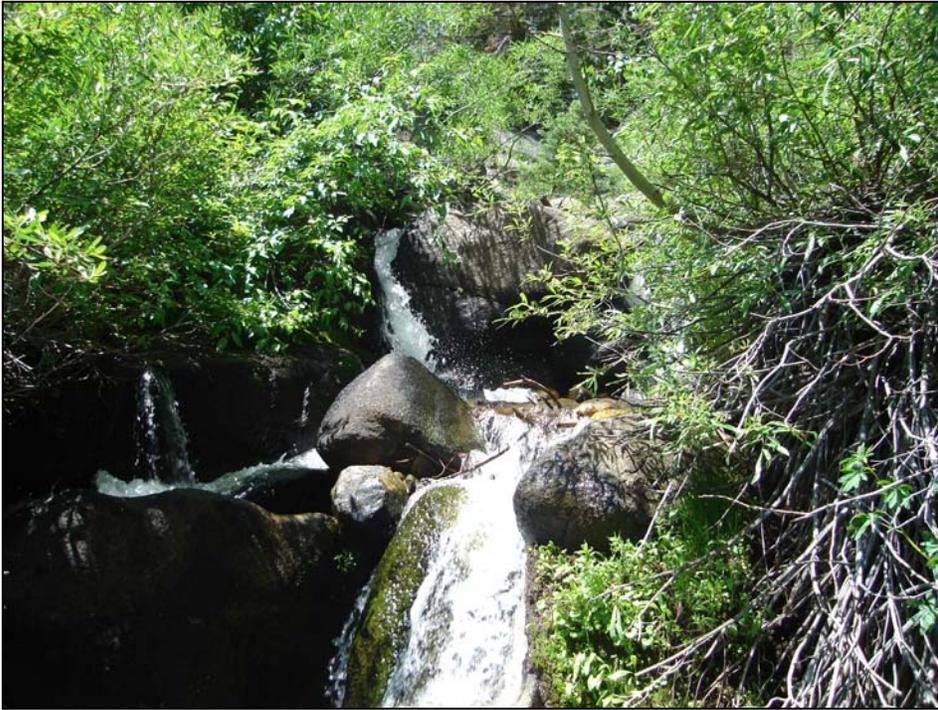
Site 10a: Raymond Meadows Creek, Carson Ranger District. Photo shows the downstream end of several consecutive drops that form a permanent barrier. This site is located at UTM: N: 4274084 & E: 255352, Elev. 7915 feet (2413m).

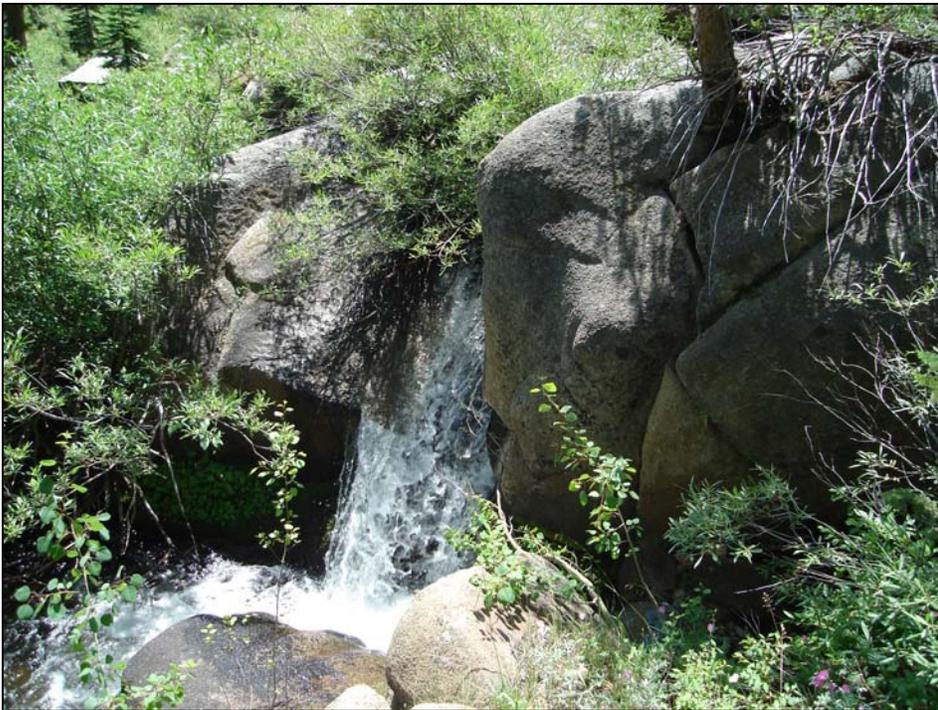
Site 10b: Raymond Meadows Creek, Carson Ranger District. This photo is from the river left bank looking at a 12.0 foot waterfall. This site is located at UTM: N: 4274084 & E: 255352, Elev. 7915 feet (2413m).

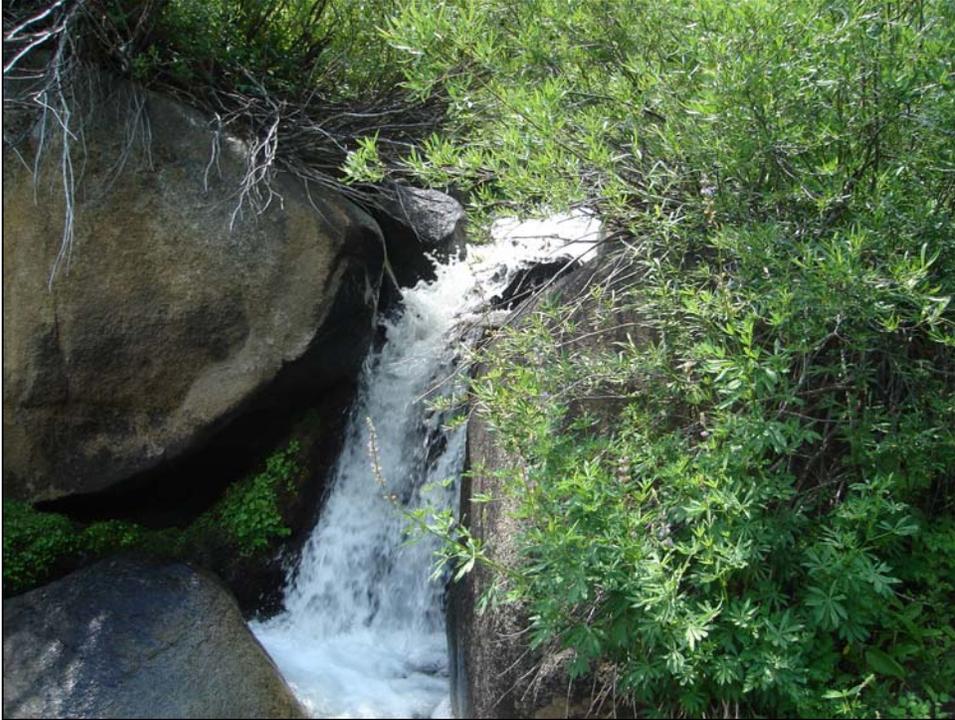
Site 10c: Raymond Meadows Creek, Carson Ranger District. Upstream photo of a 10.0 foot waterfall. This site is located at UTM: N: 4274084 & E: 255352, Elev. 7915 feet (2413m).

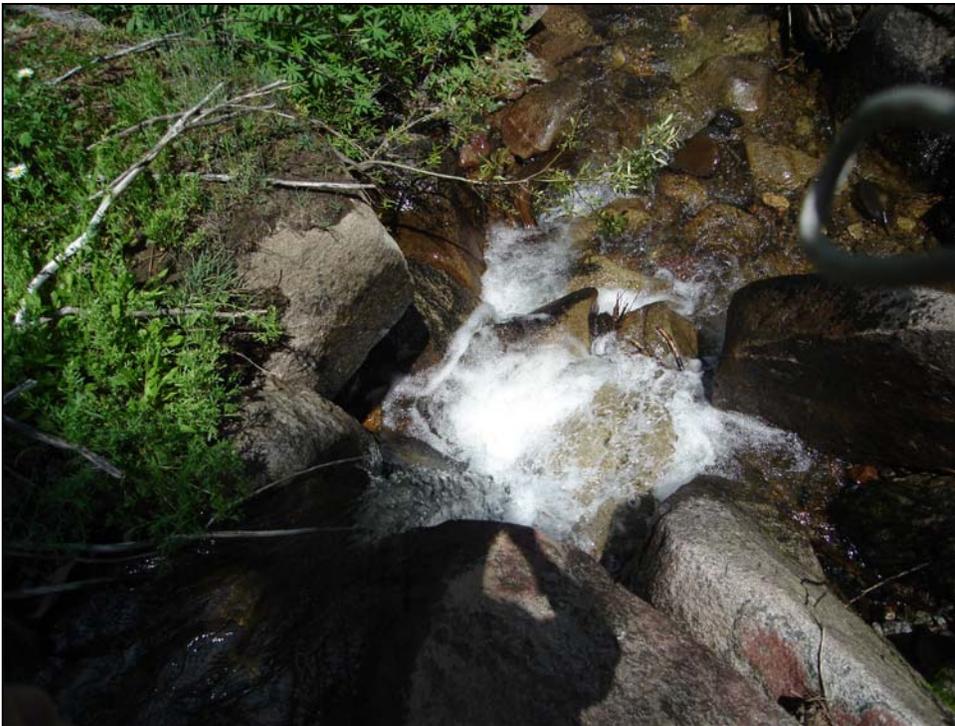
Site 11: Raymond Meadows Creek, Carson Ranger District. Photo of a 4.5 foot seasonal barrier with a maximum pool depth of 1.0 ft. This site is located at UTM: N: 4274059 & E: 255352, Elev. 8069 feet (2460m).

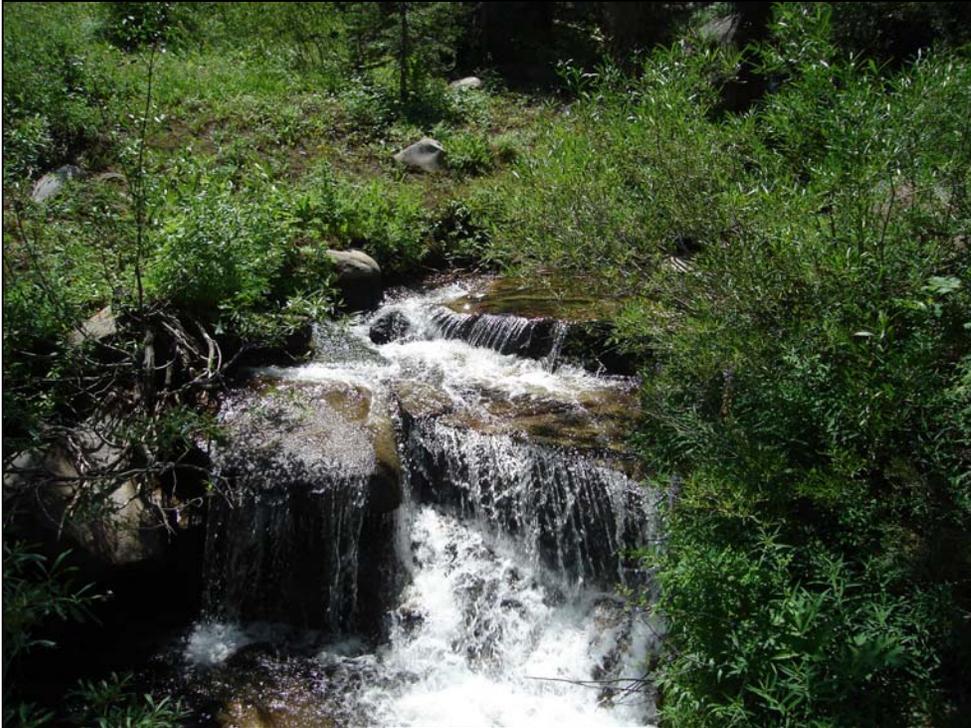
Site 12: Raymond Meadows Creek, Carson Ranger District. Upstream photo of a waterfall with a height of 5.0 feet and a max. pool depth of 1.8 feet. This site is located at UTM: N: 4274073 & E: 255055.

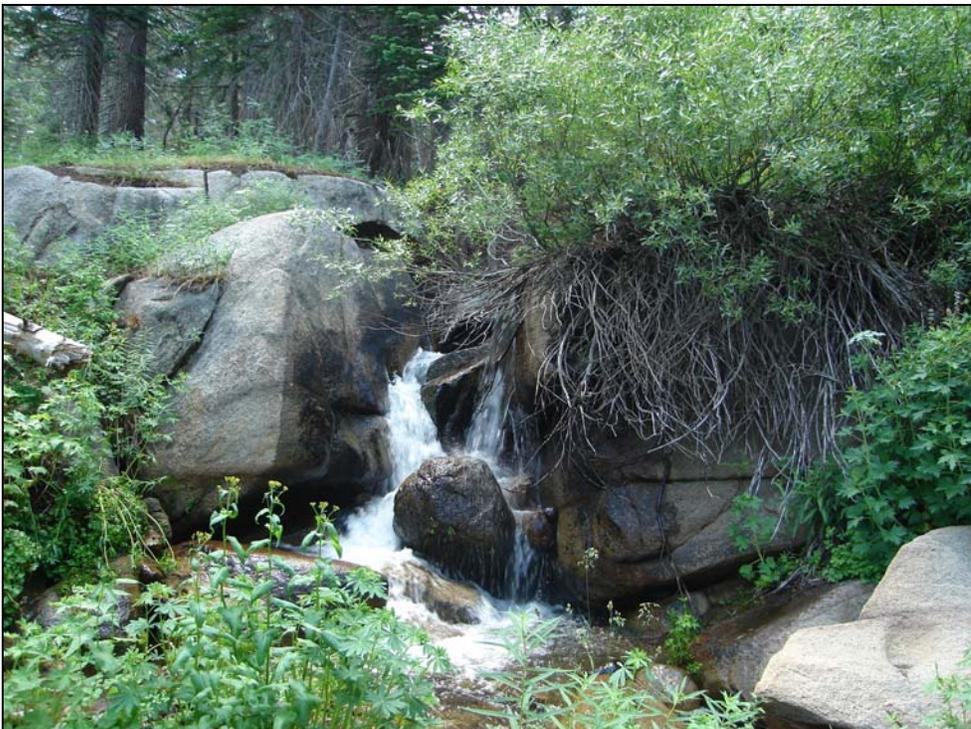
Site 13: Raymond Meadows Creek, Carson Ranger District. Upstream photo of a 9.0 foot waterfall (max. pool depth 1.0 foot). This site is located at UTM: N: 4274087 & E: 255030, Elev. 8144 feet (2483m).

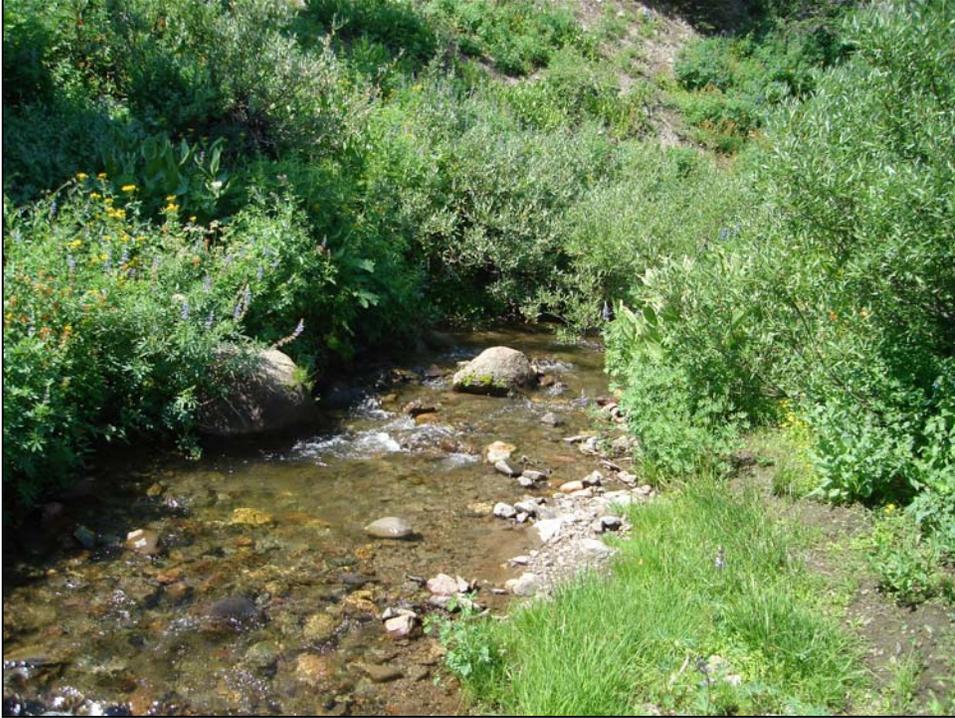
Site 14: Raymond Meadows Creek, Carson Ranger District. Photo of a short section of low gradient stream, bordered by abundant willows. This site is located at UTM: N: 4274008 & E: 254687, Elev. 8233 feet (2510m).

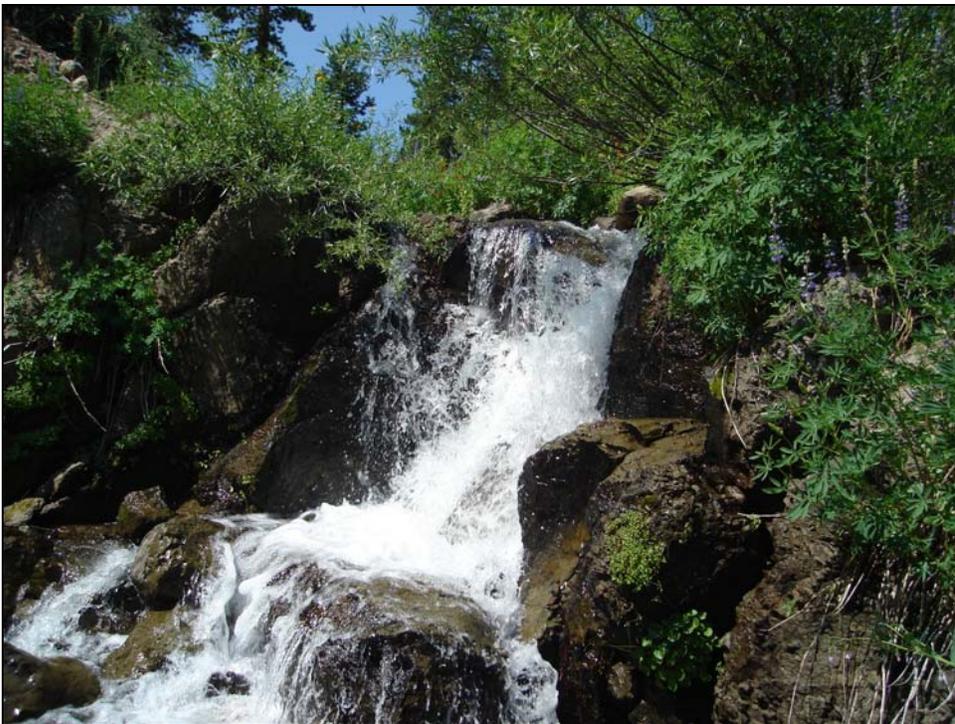
Site 15: Raymond Meadows Creek, Carson Ranger District. Upstream photo of a 13.0 foot waterfall that forms a permanent fish barrier (max. pool depth 1.2 feet). This site is located at UTM: N: 4273879 & E: 254448, Elev. 8243 feet (2513m).

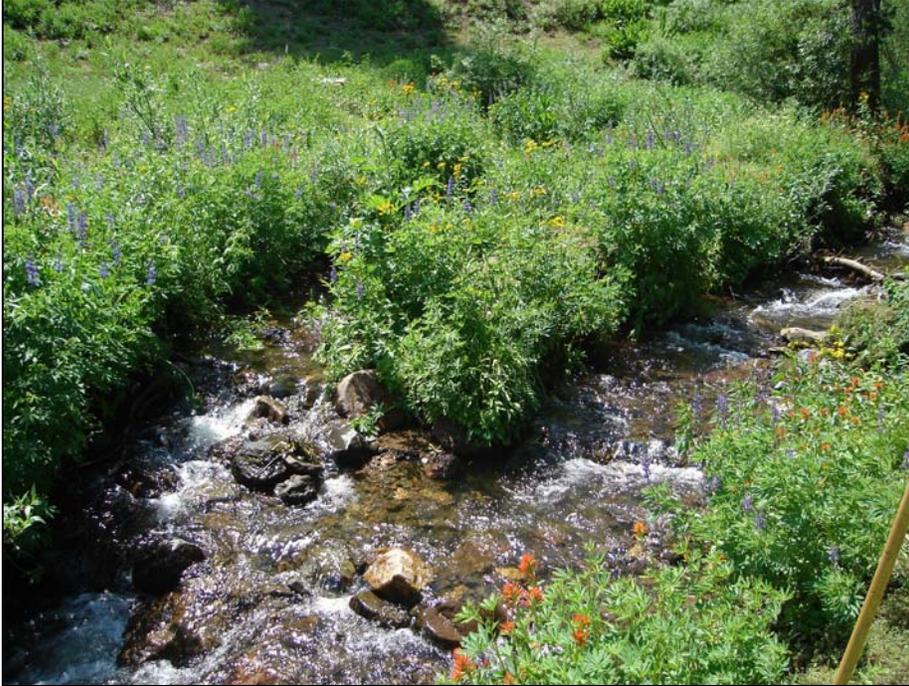
Site 16: Raymond Meadows Creek, Carson Ranger District. Upstream view of a small tributary that enters river right and contributes 30% of the total flow. This site is located at UTM: N: 4273858 & E: 254420, Elev. 8259 feet (2518m.)

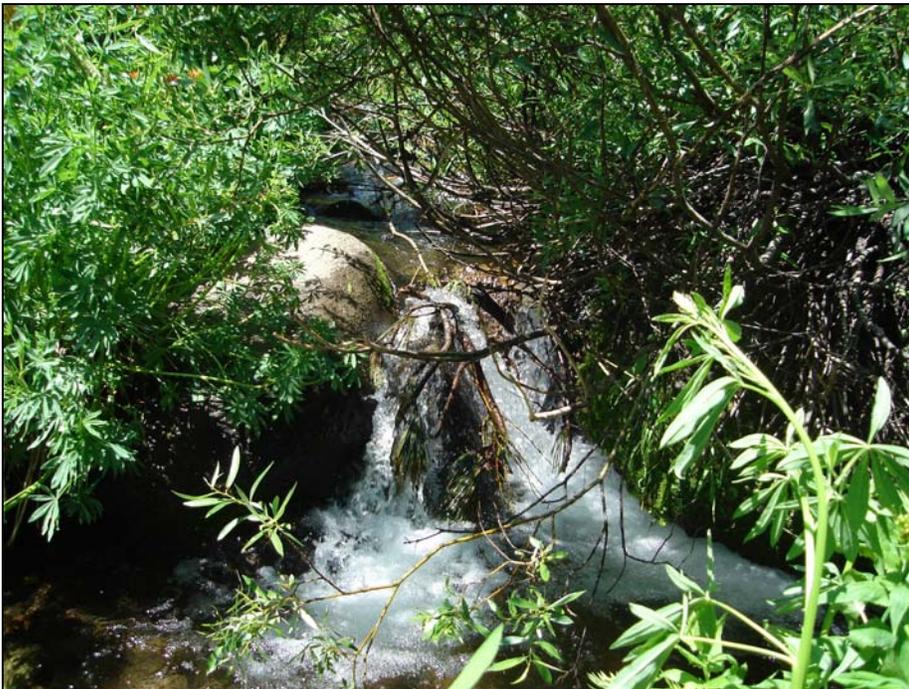
Site 17: Raymond Meadows Creek, Carson Ranger District. Photo shows a seasonal barrier with a height of 3.0 ft and maximum pool depth of 1.4ft. This site is located at UTM: N: 4273904 & E: 254262, Elev. 8295 feet (2529m).

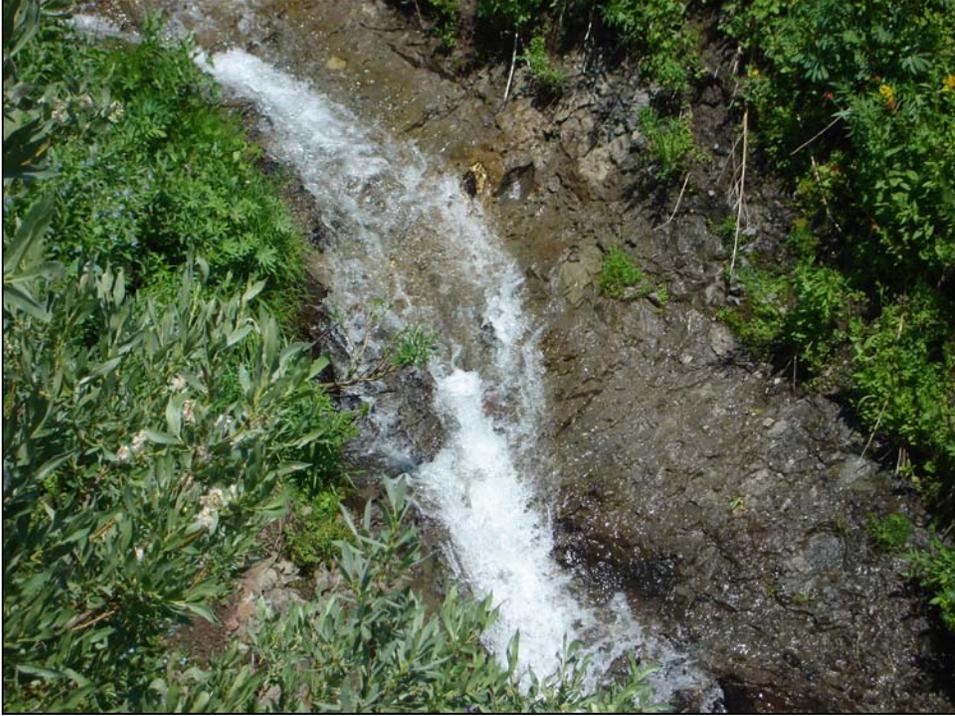
Site 18: Raymond Meadows Creek, Carson Ranger District. A 10-12 foot waterfall forms a permanent fish passage barrier (max. pool depth 1.5 feet). This site is located at UTM: N: 4273905 & E: 254217, Elev. 8371 feet (2552m).

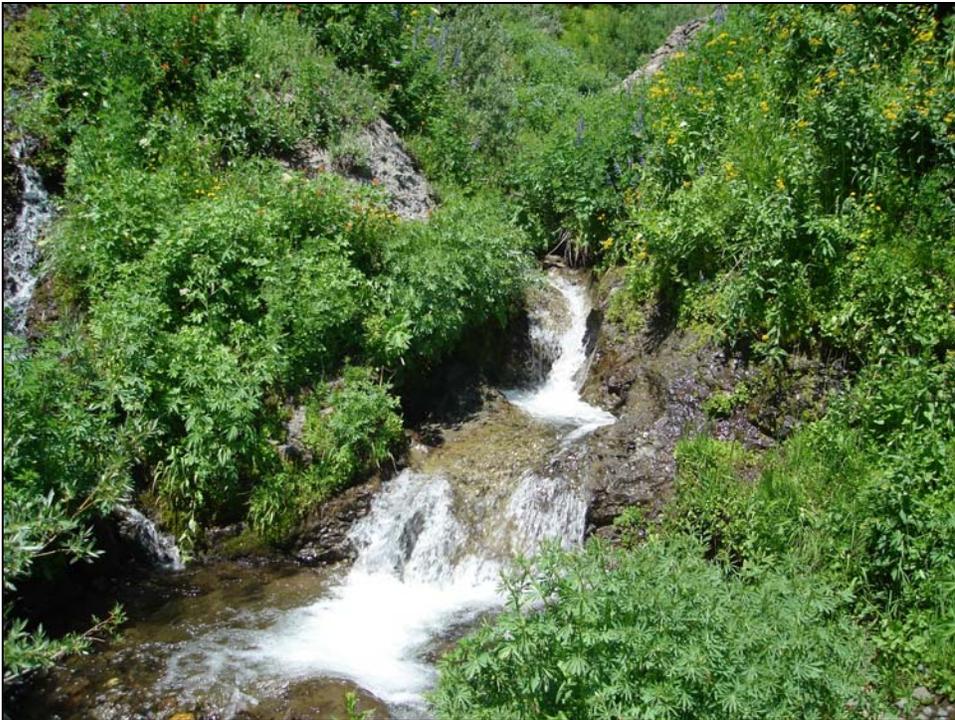
Site 18 cont.: Raymond Meadows Creek, Carson Ranger District. Photo shows the lower cascades. This site is located at UTM: N: 4273905 & E: 254217, Elev. 8371 feet (2552m)

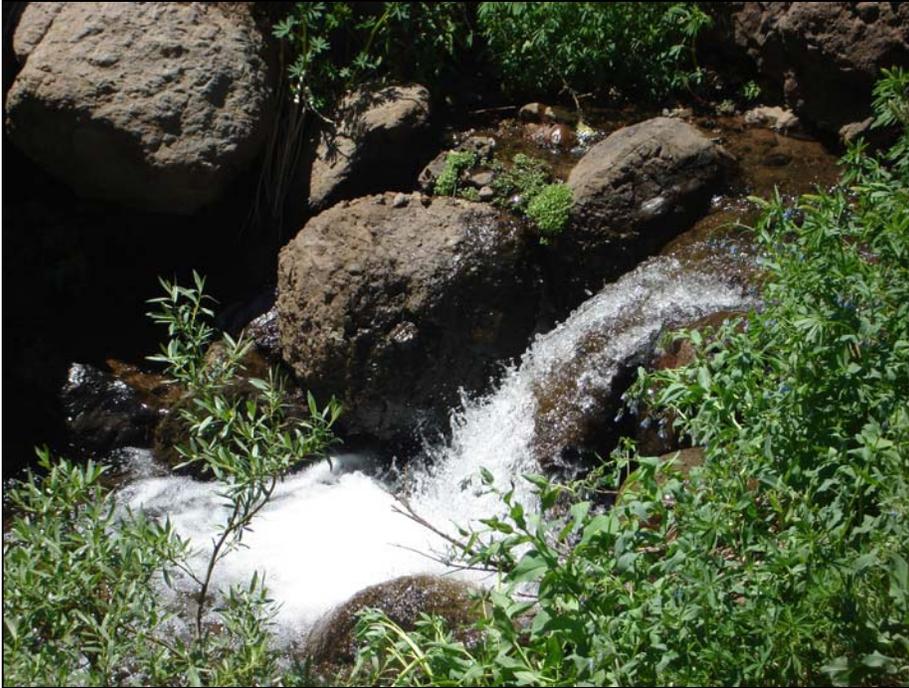
Site 19: Raymond Meadows Creek, Carson Ranger District. Cross-sectional view of a 4.2 foot waterfall, which has a pool depth of 1.3 ft. This site is located at UTM: N: 4273840 & E: 254047, Elev. 8439 feet (2573m).

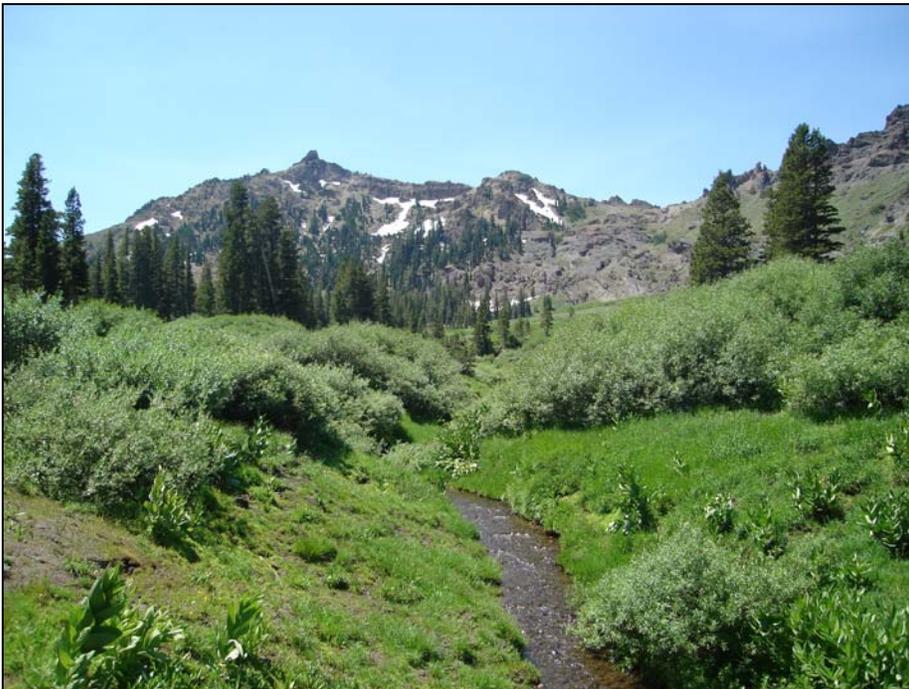
Site 20: Raymond Meadows Creek, Carson Ranger District, photo point. Upstream photo of a brushy, marshy, low-gradient reach. This site is located at UTM: N: 4275304 & E: 253724, Elev. 8541 feet (2604m).

1. Consider the 0.5 mile section of Raymond Meadows Creek between Site 19 and Site 21 as potential LCT habitat. Consider the 0.28 mile section directly upstream of Site 6 as occupied LCT habitat and consider Raymond Meadows Creek a low candidate for restoration.

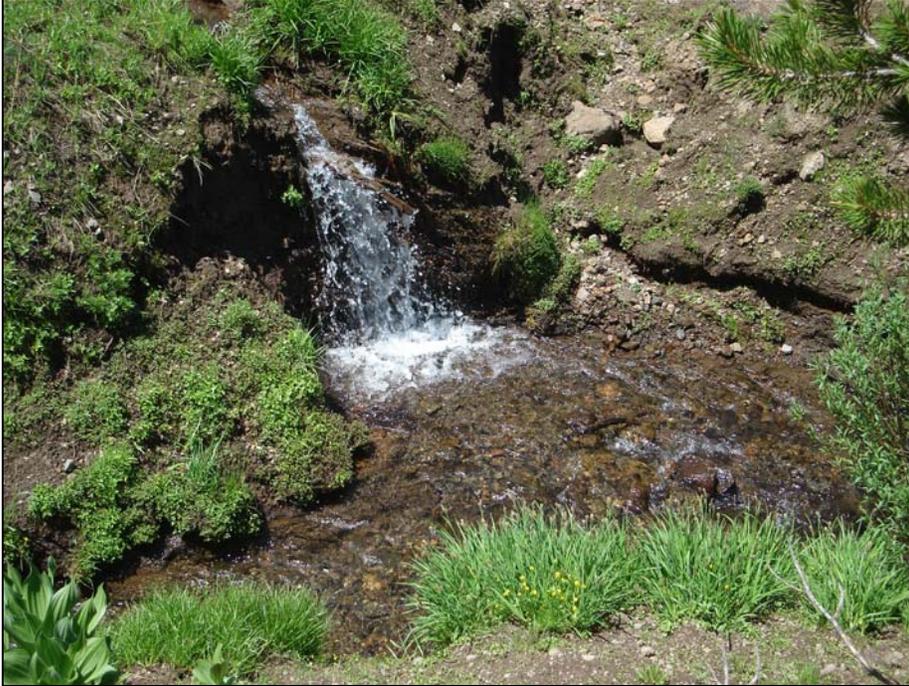
Site 21: Raymond Meadows Creek, Carson Ranger District. Photo taken at the survey end point shows one of several headwater branches that merge in the meadow. Individually these branches do not provide sustainable fish habitat. This site is located at UTM: N: 4273264 & E: 253611, Elev. 8597 feet (2621m).
