SILVER CREEK

Alpine County, California

2006 Stream Habitat Survey Report

Carson Ranger District: Humboldt-Toiyabe National Forest

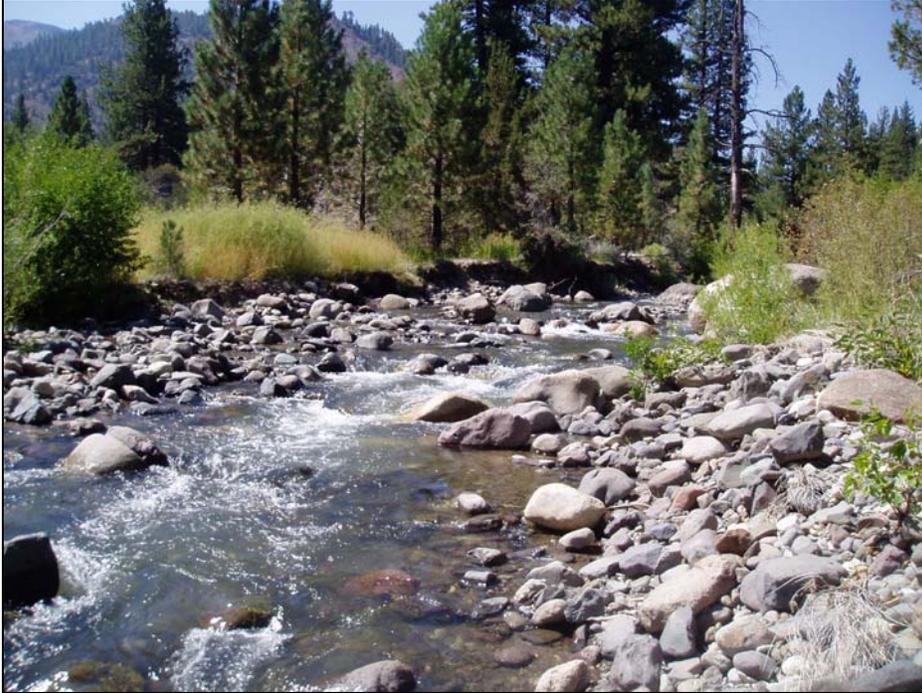
Site 1: Silver Creek, Carson Ranger District. Upstream photo of Silver Creek at the confluence with the East Fork Carson River. Silver Creek enters the East Fork on river left and contributes 33% of flow. This site is located at UTM: N: 4279216 & E: 263316 Elev. 5853 ft (1784 m).

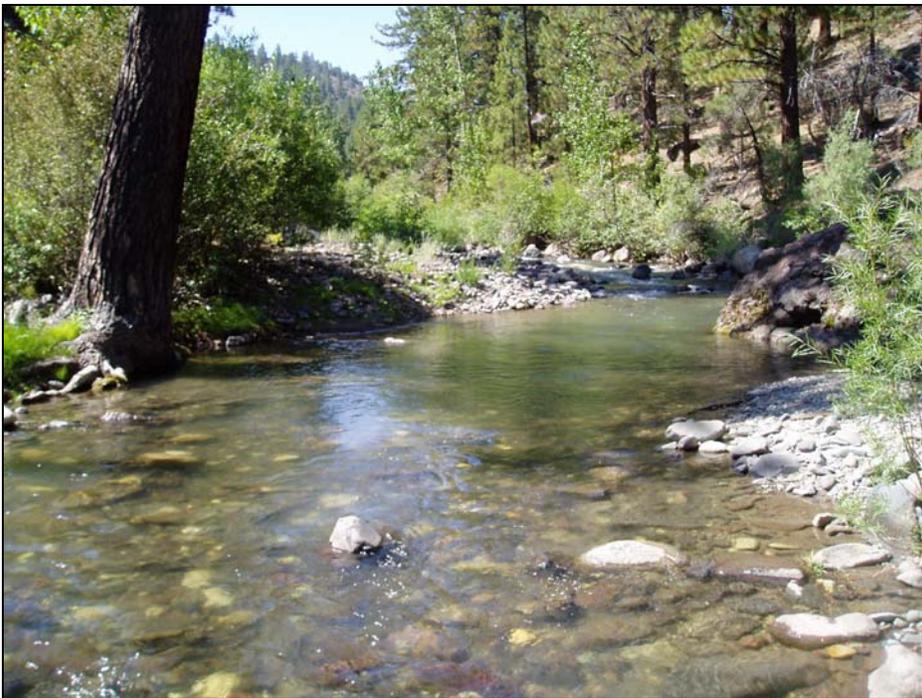
Site 2: Silver Creek, Carson Ranger District. Upstream photo of habitat characteristic of Silver Creek. This site is located at UTM: N: 4279116 & E: 263168, Elev. 5872 ft (1790 m).

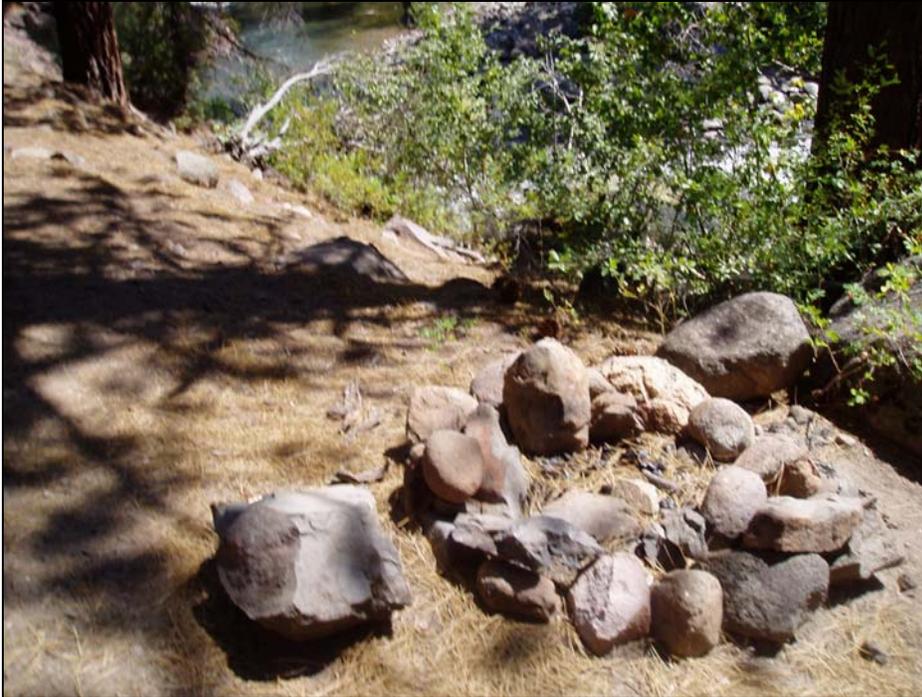
Site 3: Silver Creek, Carson Ranger District. Photo of a campsite on the left bank. This site is located at UTM: N: 4279101 & E: 263136, Elev. 5850 ft (1783 m).

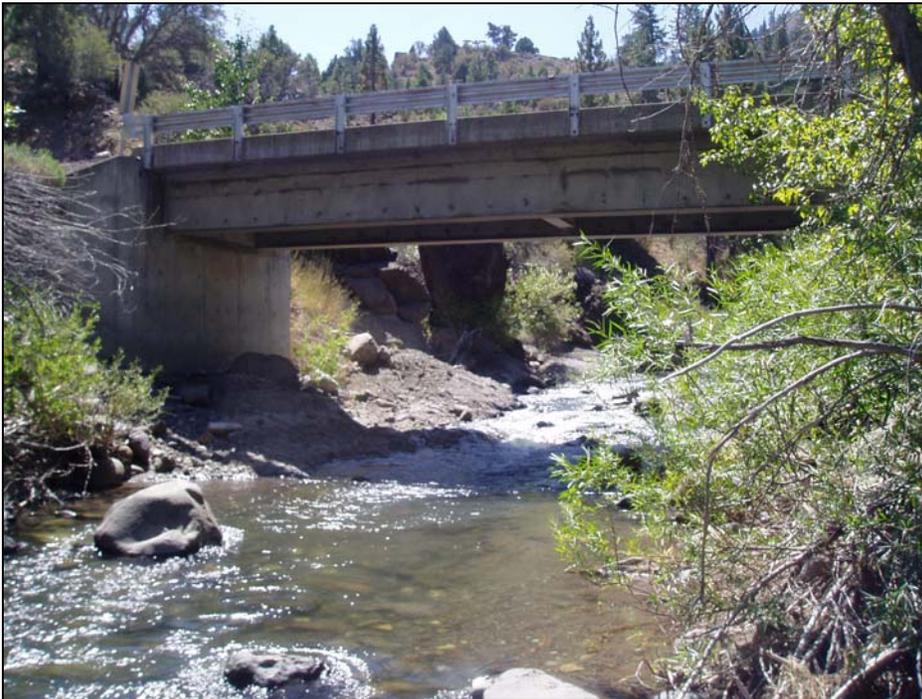
Site 4: Silver Creek, Carson Ranger District. Photo of a road-stream crossing where Wolf Creek Road crosses Silver Creek. Note the minor erosion concerns on the left and right banks. This site is located at UTM: N: 4278918 & E: 262959 Elev. 5882 ft (1793 m).

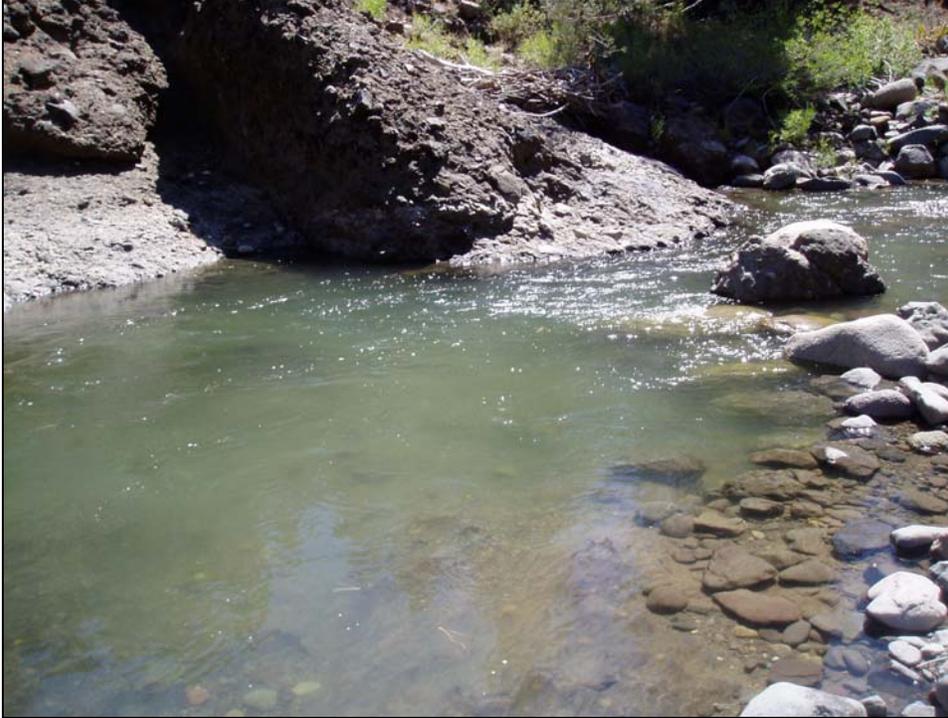
Site 5: Silver Creek, Carson Ranger District. Cross-sectional photo shows a pool where a small salmonid was sighted. This site is located at UTM: N: 4278875 & E: 262945, Elev. 5906 ft (1800 m).

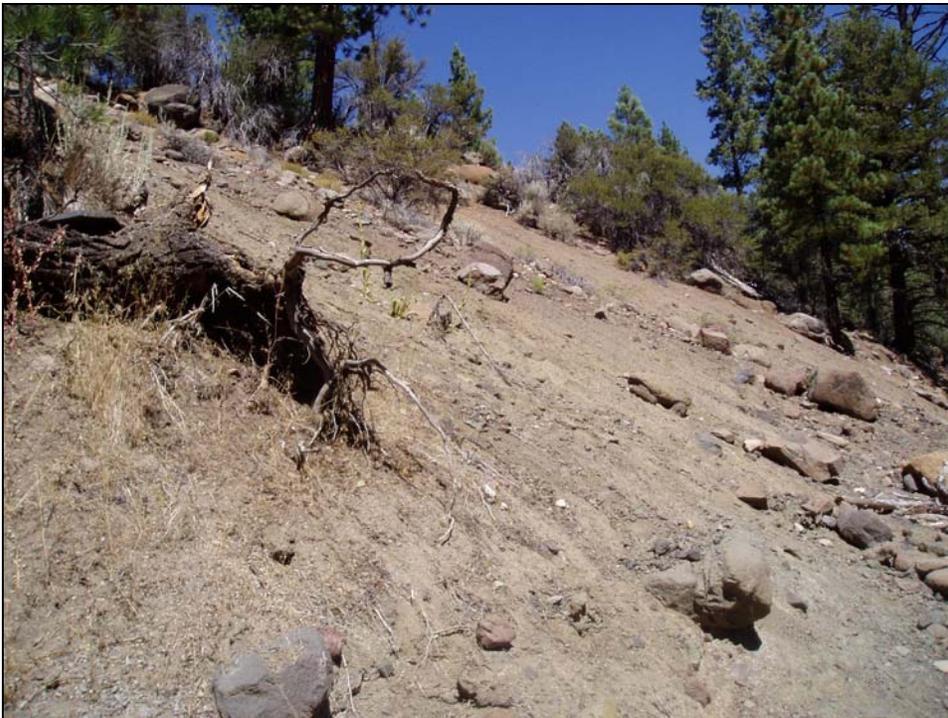
Site 6: Silver Creek, Carson Ranger District. A downstream photo showing the eroded left bank, this erosion is partially caused by the adjacent Highway 89. This site is located at UTM: N: 4278824 & E: 262779, Elev. 5922 ft (1805 m).

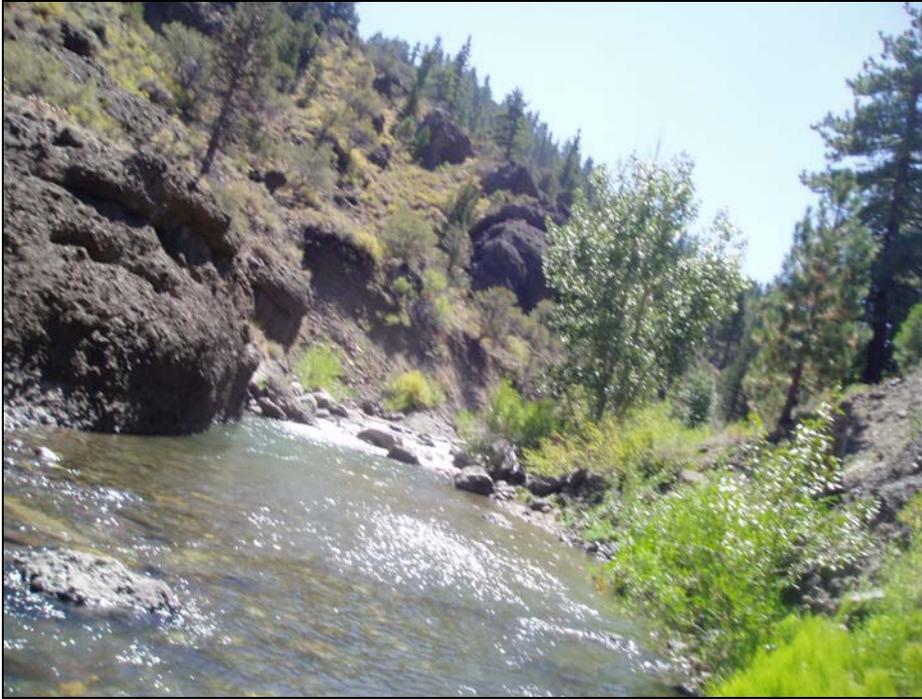
Site 7: Silver Creek, Carson Ranger District. Upstream photo. This site is located at UTM: N: 4278576 & E: 262456, Elev. 5984 ft (1824 m).

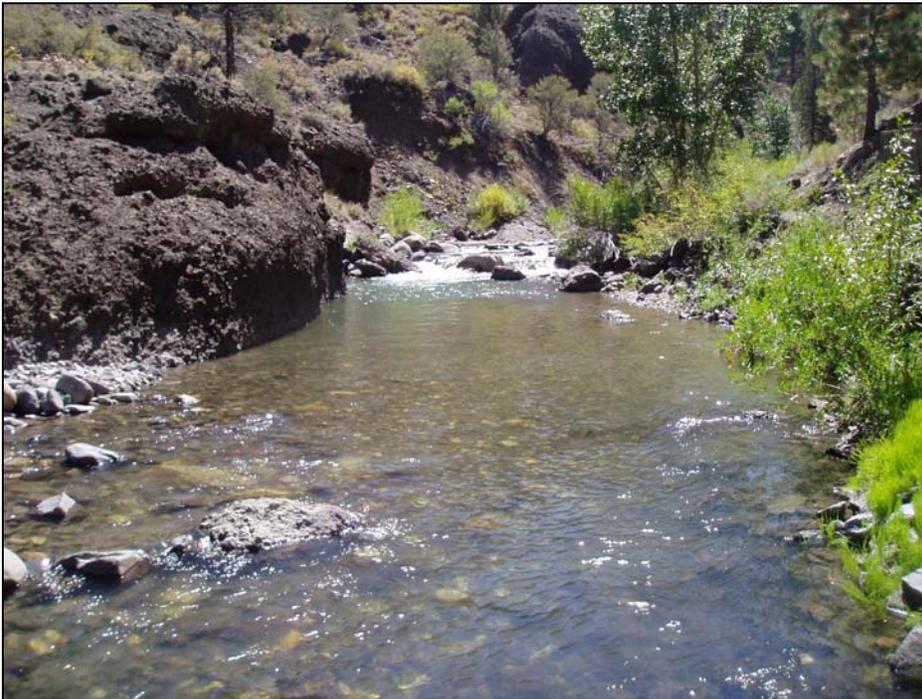
Site 8: Silver Creek, Carson Ranger District. Photo shows a deep pool within a narrow ravine. This site is located at UTM: N: 4278404 & E: 266207, Elev. 5971 ft (1820 m).

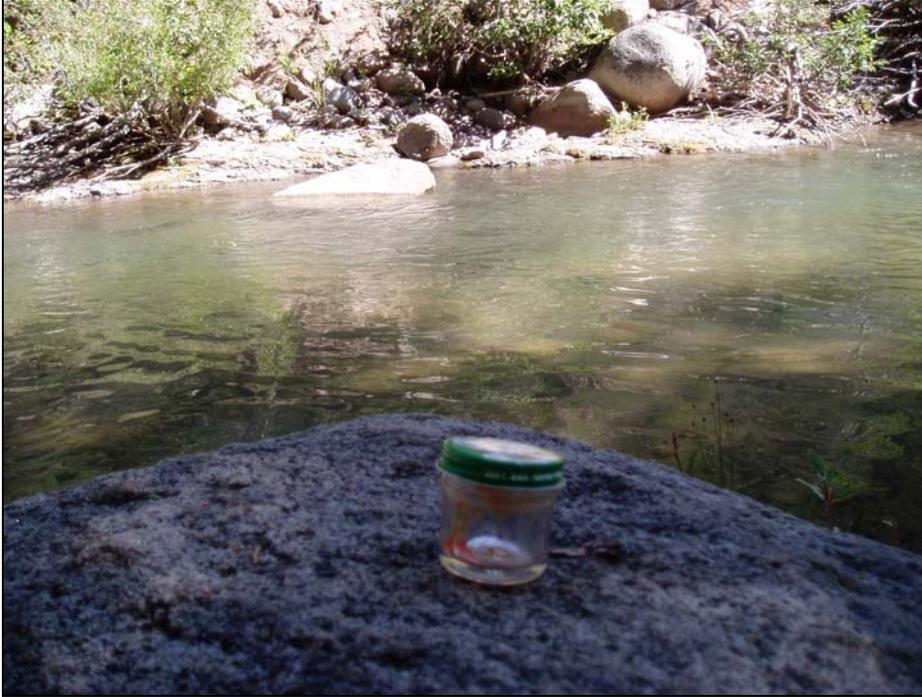
Site 9: Silver Creek, Carson Ranger District. Photo of a jar of salmon eggs found near a popular fishing hole. This site is located at UTM: N: 4278199 & E: 261801, Elev. 6046 ft (1843 m)

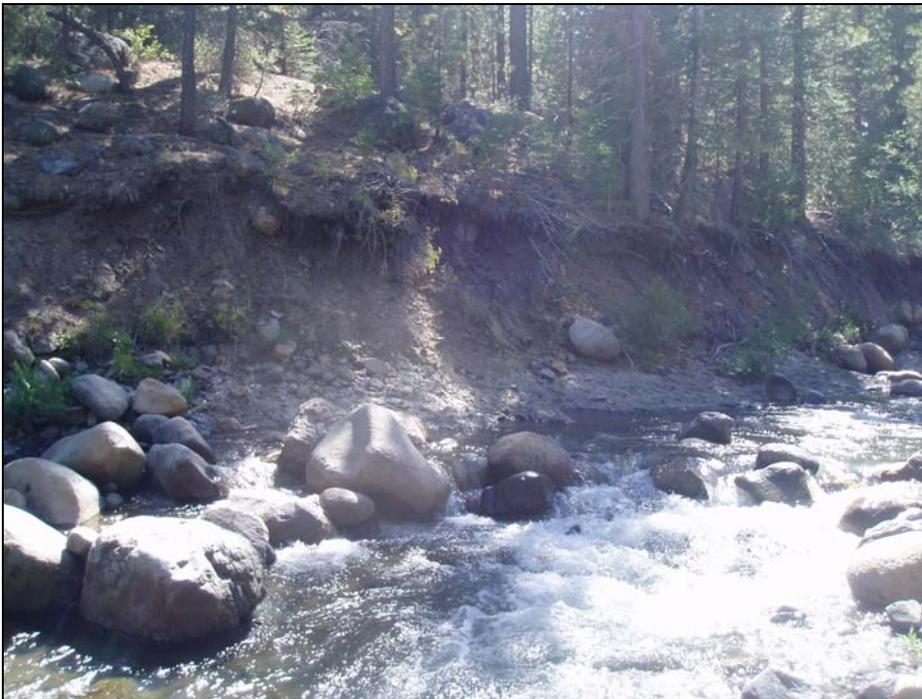
Site 10: Silver Creek, Carson Ranger District. A downstream photo showing an eroded right bank with dimensions 75m x 4 m. Appears to be naturally occurring. This site is located at UTM: N: 4278098 & E: 261650, Elev. 6066 ft (1849 m).

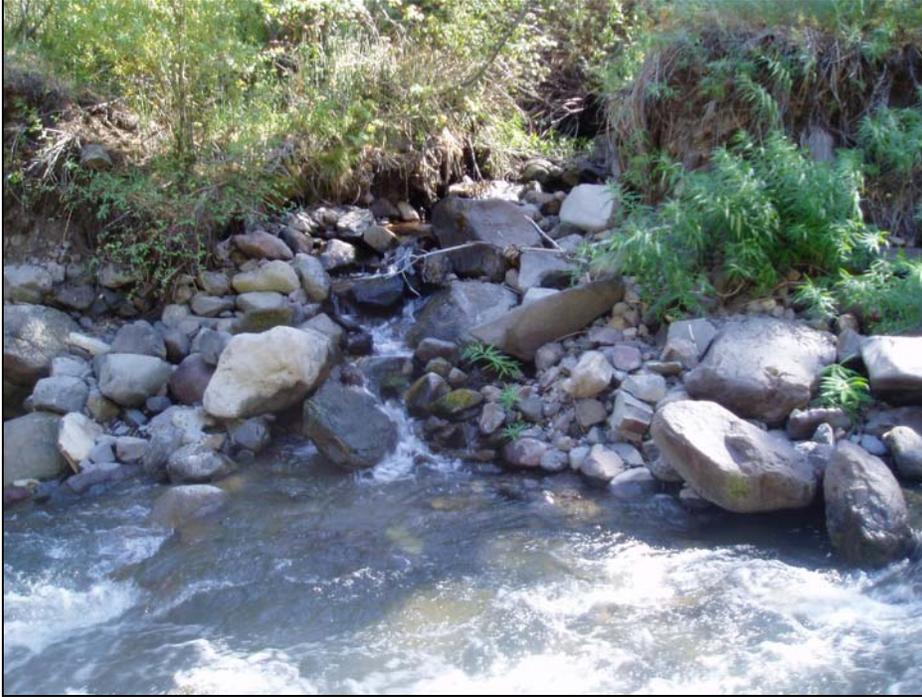
Site 11: Silver Creek, Carson Ranger District. Photo shows a small tributary entering on the right bank, contributing 5% of flow. This site is located at UTM: N: 4278063 & E: 261512, Elev. 6066 ft (1849 m).

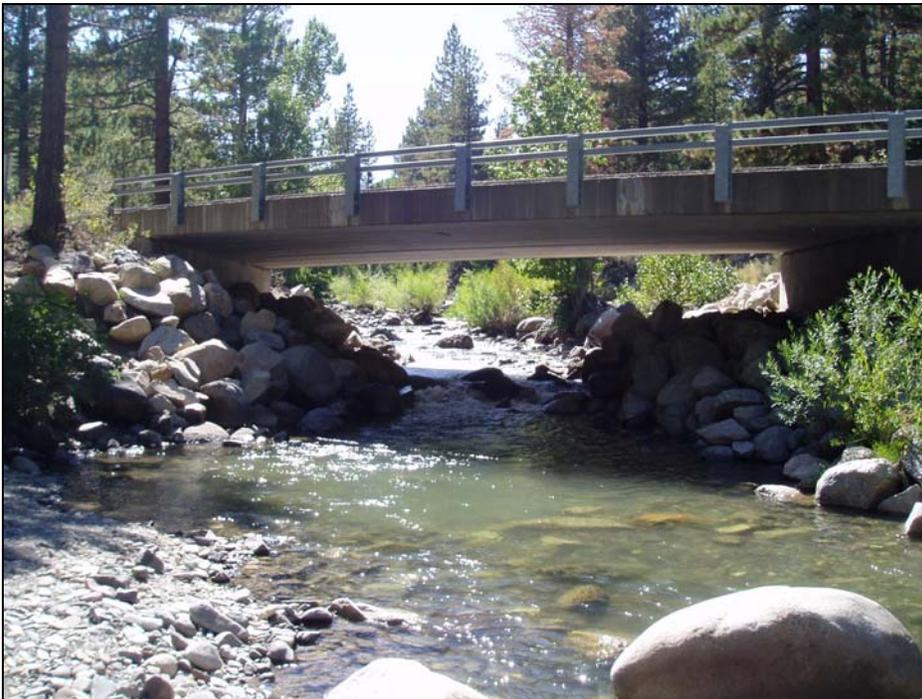
Site 12: Silver Creek, Carson Ranger District. Upstream photo of Highway 4 crossing Silver Creek. This site is located at UTM: N: 4278032 & E: 261425, Elev. 6093 ft (1857 m).

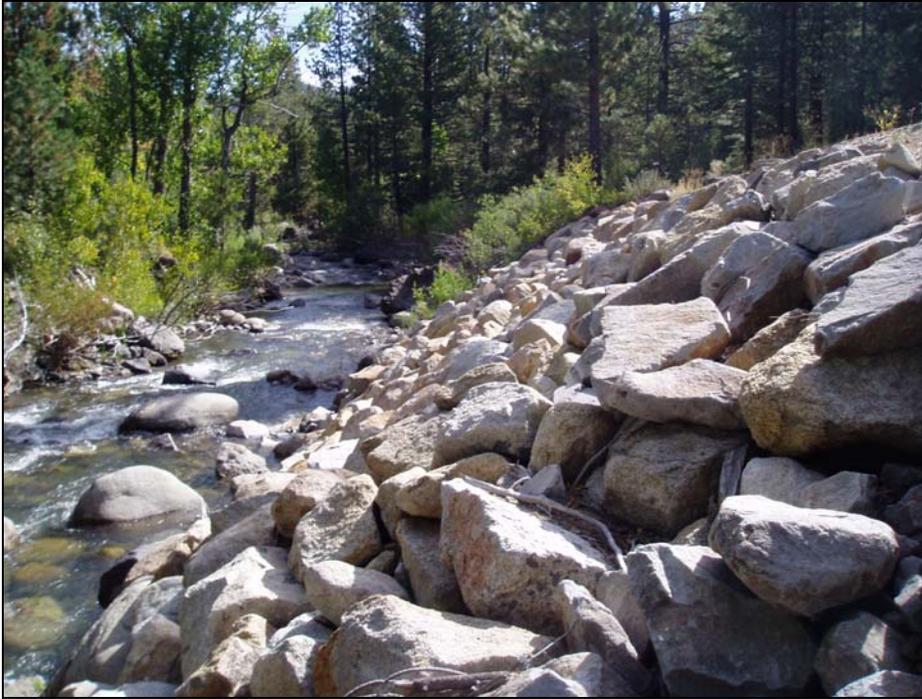
Site 13: Silver Creek, Carson Ranger District Downstream photo of rip-rap placed on the steep banks along highway 89. This site is located at UTM: N: 4277963 & E: 261271, Elev. 6106 ft (1861 m).

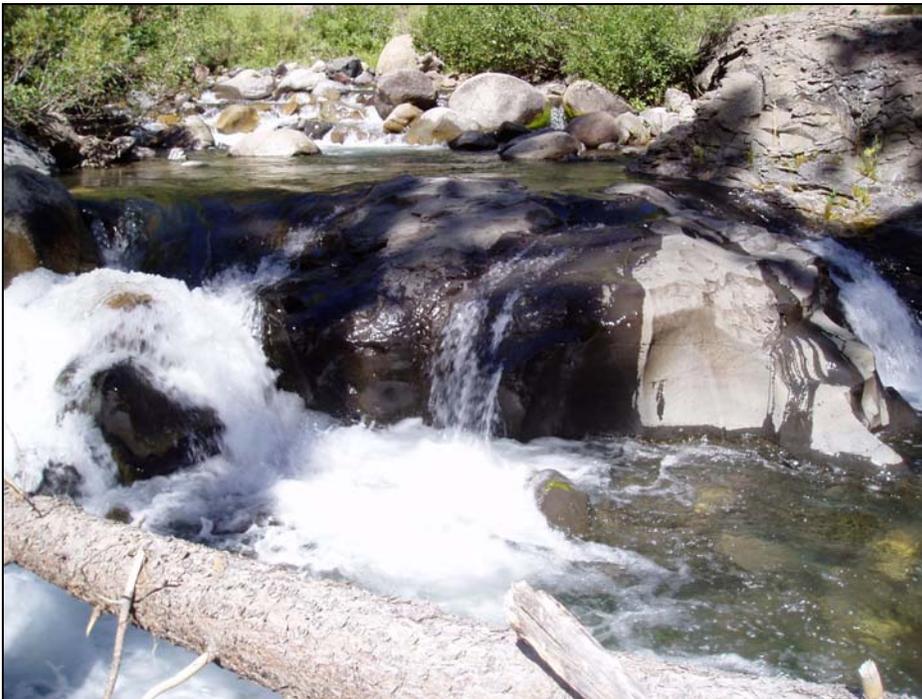
Site 14: Silver Creek, Carson Ranger District. Upstream photo of a seasonal fish barrier formed by a 4.5 ft waterfall with a max pool depth of 3.1 feet. This site is located at UTM: N: 4277746 & E: 260605, Elev. 6211 ft (1893 m).

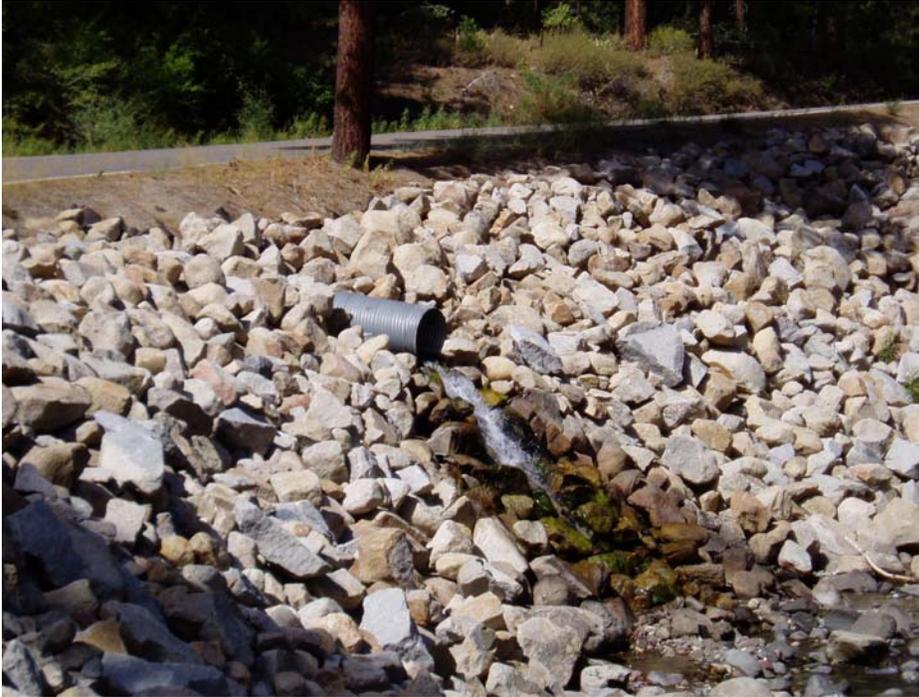
Site 15: Silver Creek, Carson Ranger District. Upstream photo of a tributary that enters on river right, and contributes 3% of flow. This site is located at UTM: N: 42777705 & E: 260515, Elev. 6224 ft (1897 m).

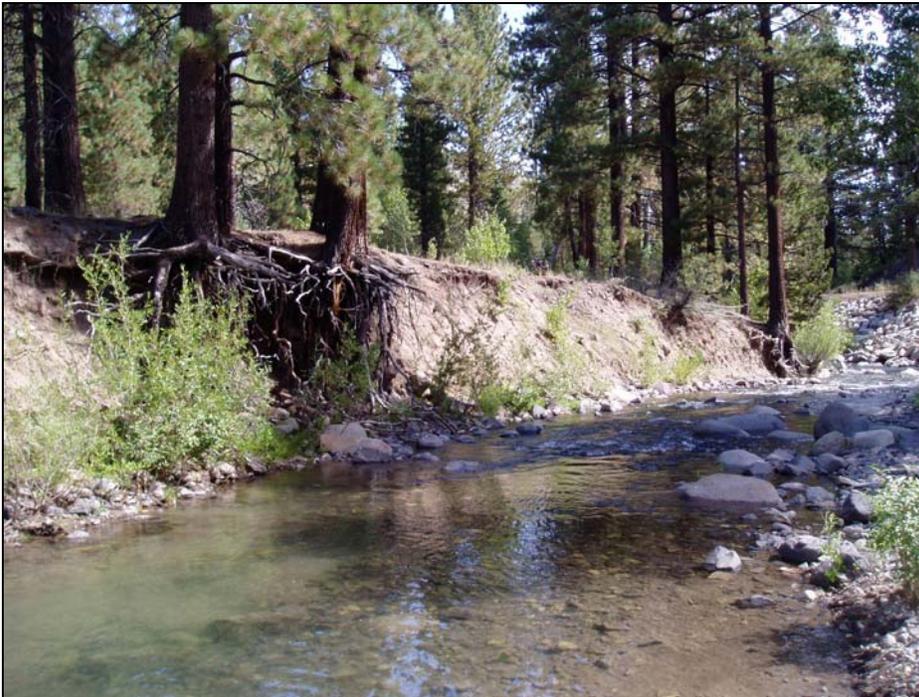
Site 16: Silver Creek, Carson Ranger District. Downstream photo of an erosion concern on left bank. This site is located at UTM: N: 4277664 & E: 260326, Elev. 6234 ft (1900 m).

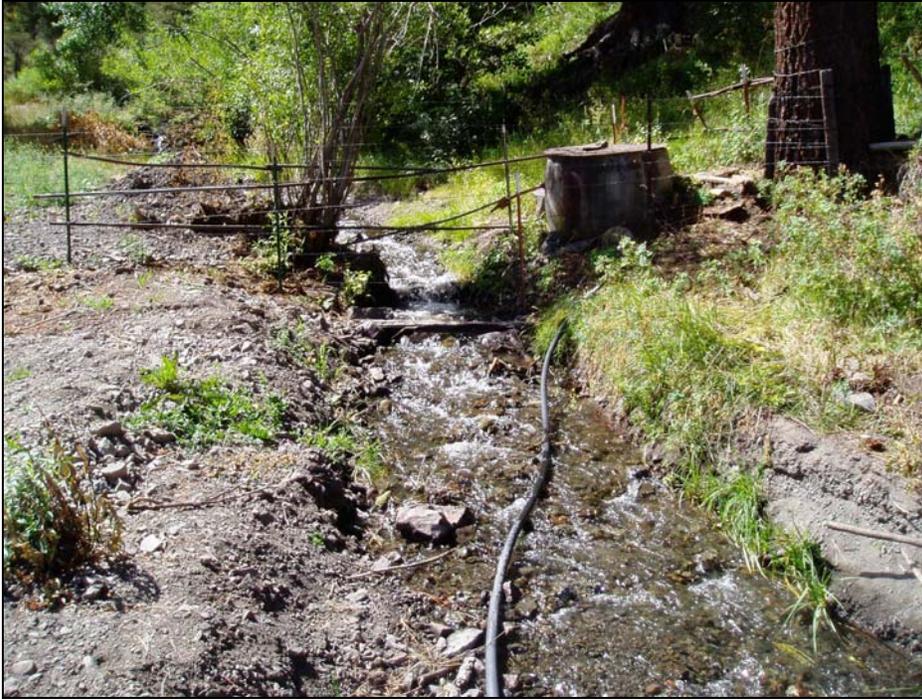
Site 17: Silver Creek, Carson Ranger District. An upstream photo of a tributary entering river right (contributes 3% of flow to the stream). This site is located at UTM: N: 4277192 & E: 259885, Elev. 6316 ft (1925 m).

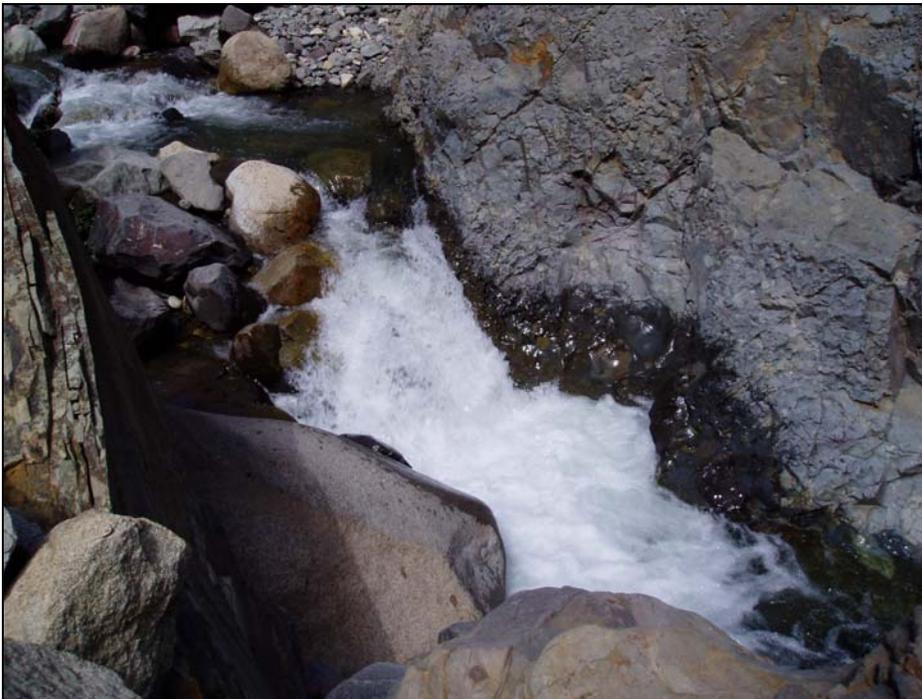
Site 18: Silver Creek, Carson Ranger District Upstream photo of a seasonal fish barrier formed by a fast moving chute, 3 ft in height. This site is located at UTM: N: 4277319 & E: 259609, Elev. 6312 ft (1924 m).

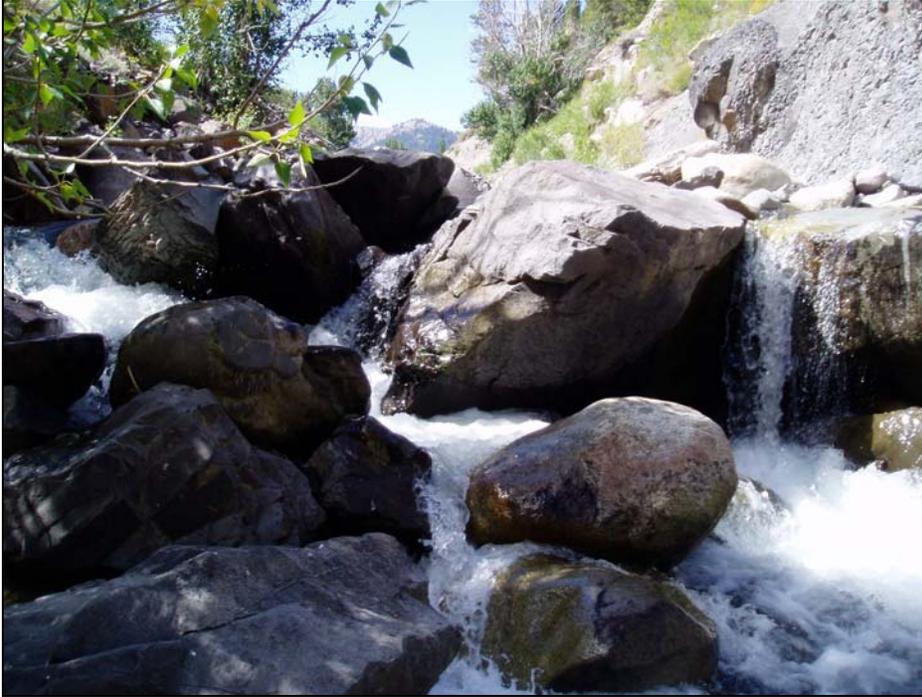
Site 19: Silver Creek, Carson Ranger District. Seasonal fish barrier formed by a long cascade, with overall height of 6.0 feet. (2.5 max pool depth). This site is located at UTM: N: 4277281 & E: 259545, Elev. 6329 ft (1929 m)

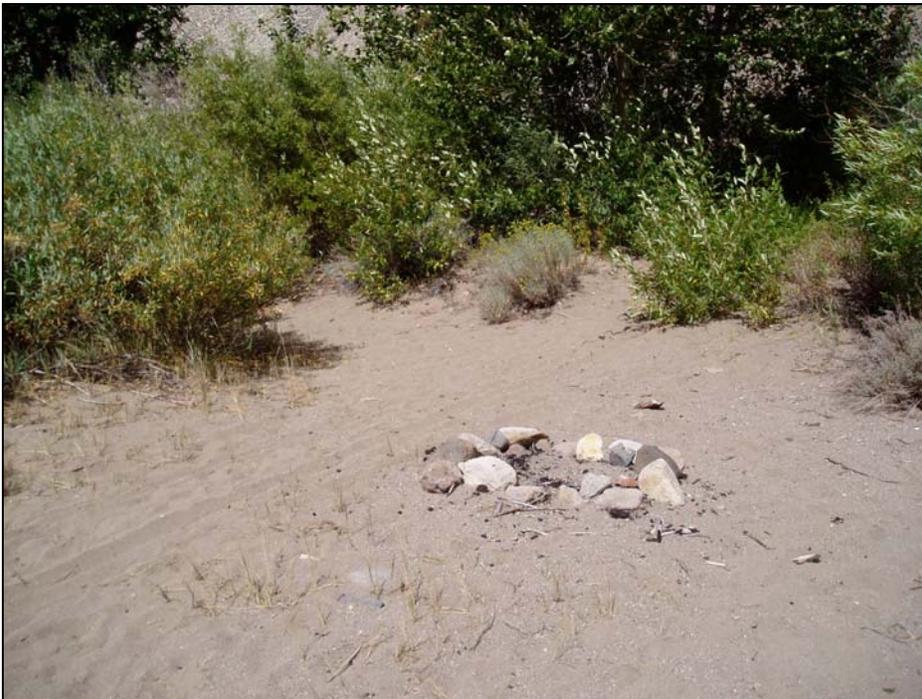
Site 20: Silver Creek, Carson Ranger District. Photo of a campsite located 4m from the stream on the right bank. This site is located at UTM: N: 4276893 N & E: 259303, Elev. 6394 ft (1949 m).

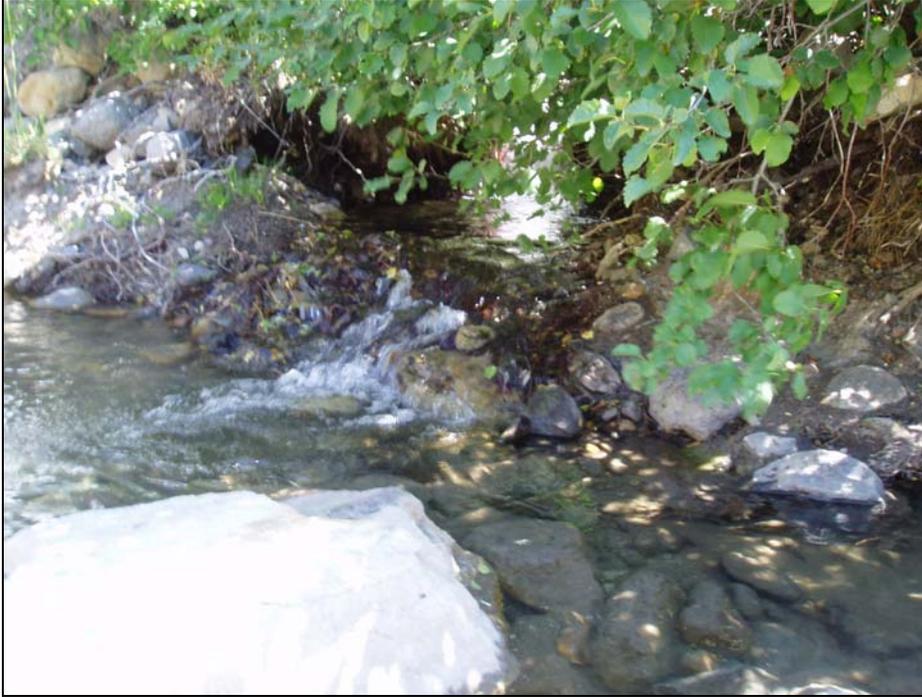
Site 21: Silver Creek, Carson Ranger District. A small tributary enters on river right contributing 2% of flow. This site is located at UTM: N: 4276848 & E: 259297, Elev. 6368 ft (1941 m).

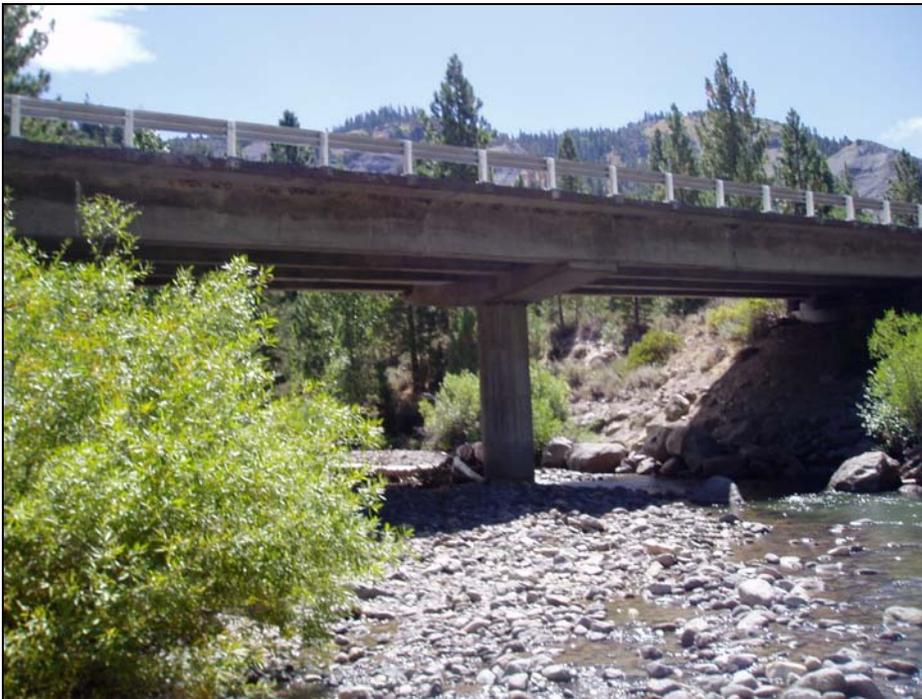
Site 22: Silver Creek, Carson Ranger District Upstream photo of a road-stream crossing (Highway 4). This site is located at UTM: N: 4276652 & E: 259204, Elev. 6414 ft (1955 m).

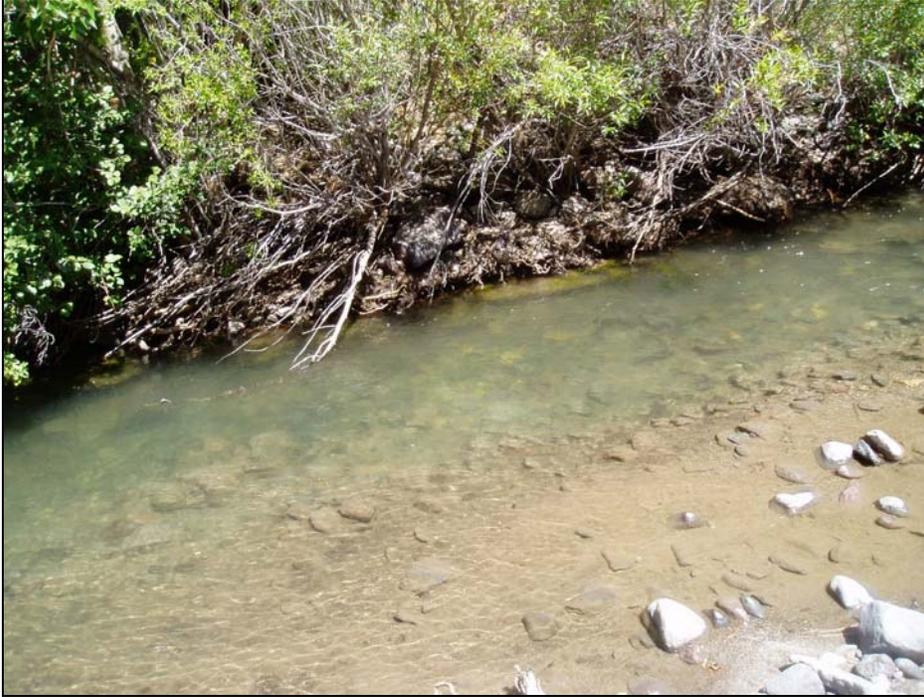
Site 23: Silver Creek, Carson Ranger District. A cross-sectional photo shows the right bank where a salmonid was sighted. This site is located at UTM: N: 4276647 & E: 259229, Elev. 6378 ft (1944 m).

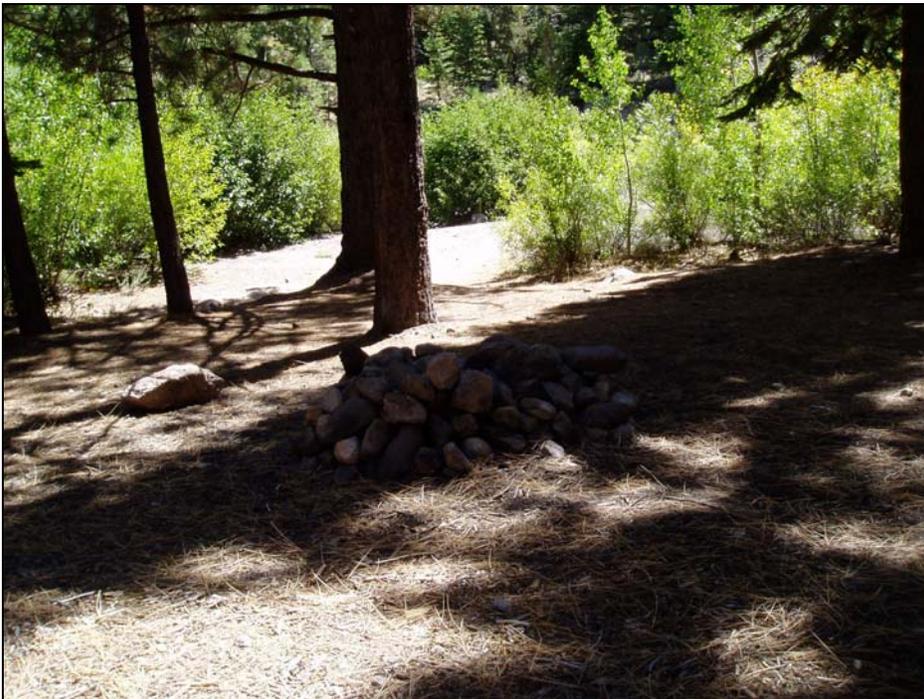
Site 24: Silver Creek, Carson Ranger District. Photo of a campsite with dimensions 20m x 20m, located 25m from the stream channel. This site is located at UTM: N: 4276167 & E: 258693, Elev. 6467 ft (1971 m).

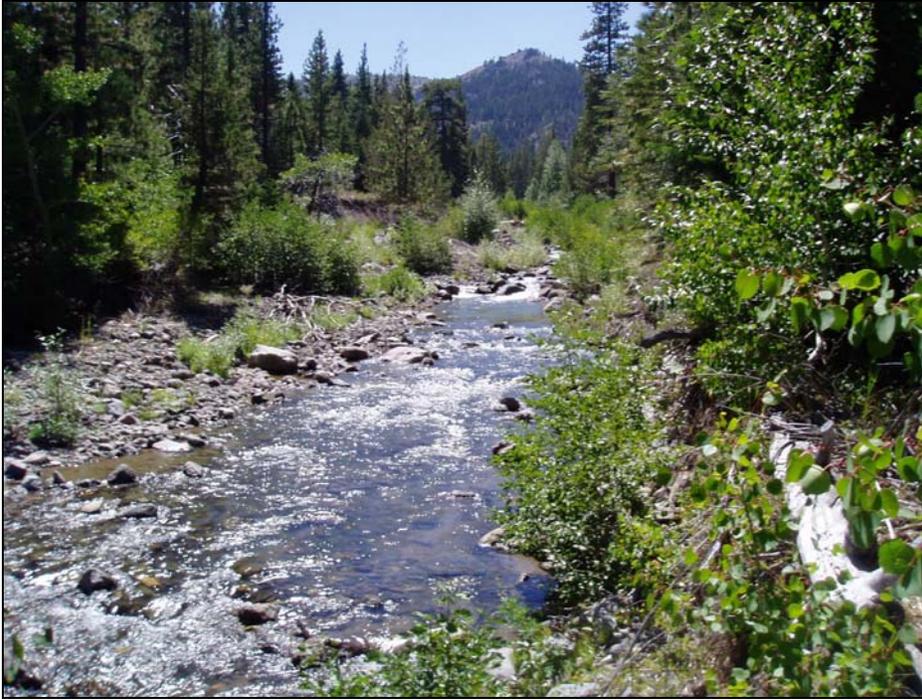
Site 25: Silver Creek, Carson Ranger District. Upstream photo showing general habitat characteristics. This site is located at UTM: N: 4275807 & E: 258292, Elev. 6539 ft (1993 m).

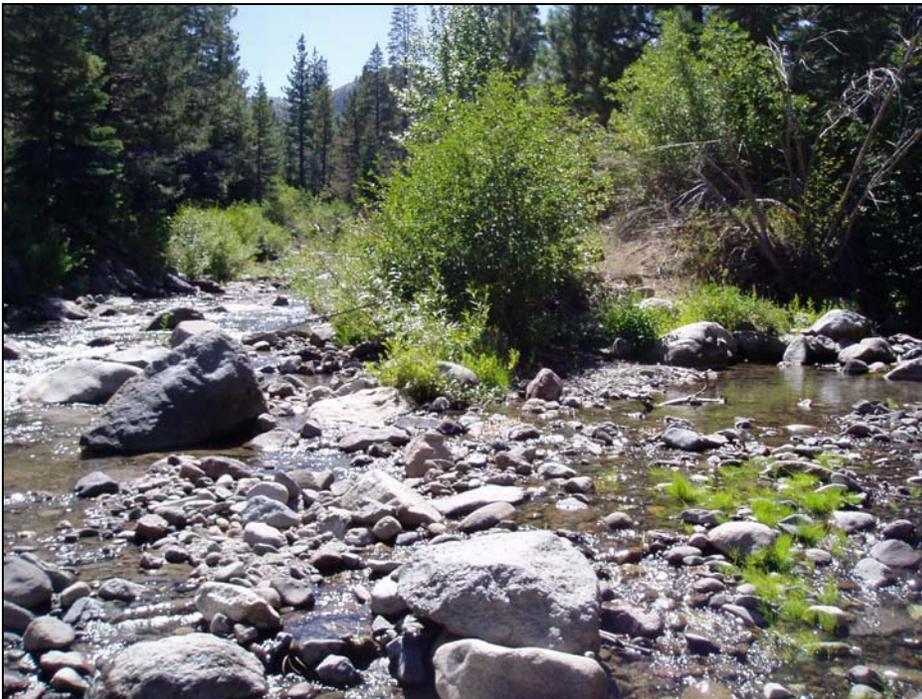
Site 26: Silver Creek, Carson Ranger District. Upstream photo shows the confluence of Pennsylvania Creek and Silver Creek. Pennsylvania enters river left and contributes 33% of flow. This site is located at UTM: N: 4275578 & E: 258106, Elev. 6542 ft (1994 m).

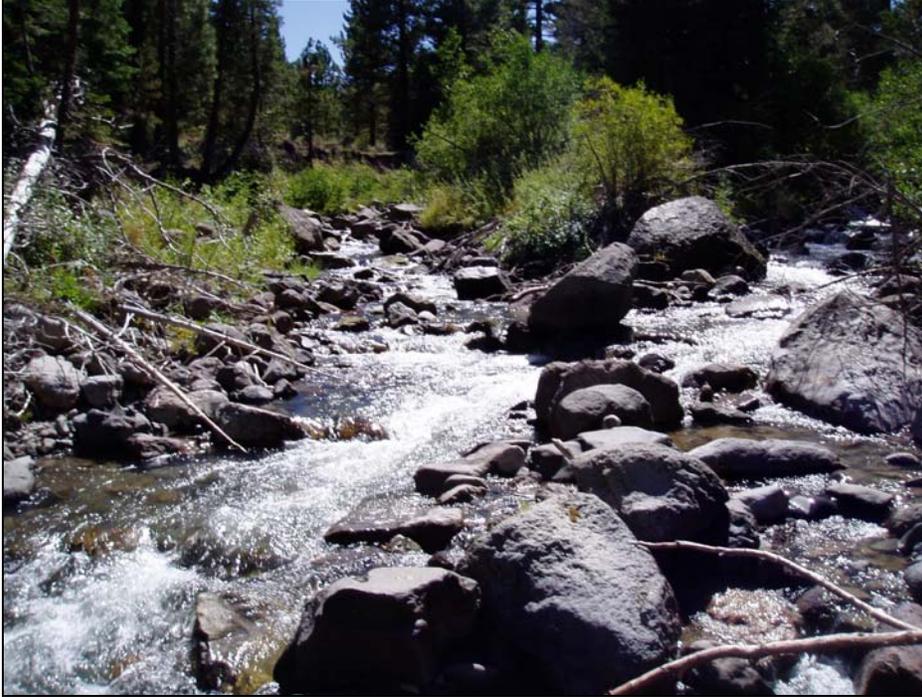
Site 27: Silver Creek, Carson Ranger District Upstream photo at the survey end showing Noble Creek (left) enter Silver Creek (right). Noble Creek and Silver Creek contribute nearly equal amounts of water. This site is located at UTM: N: 4275513 & E: 258030, Elev. 6555 ft (1998 m).

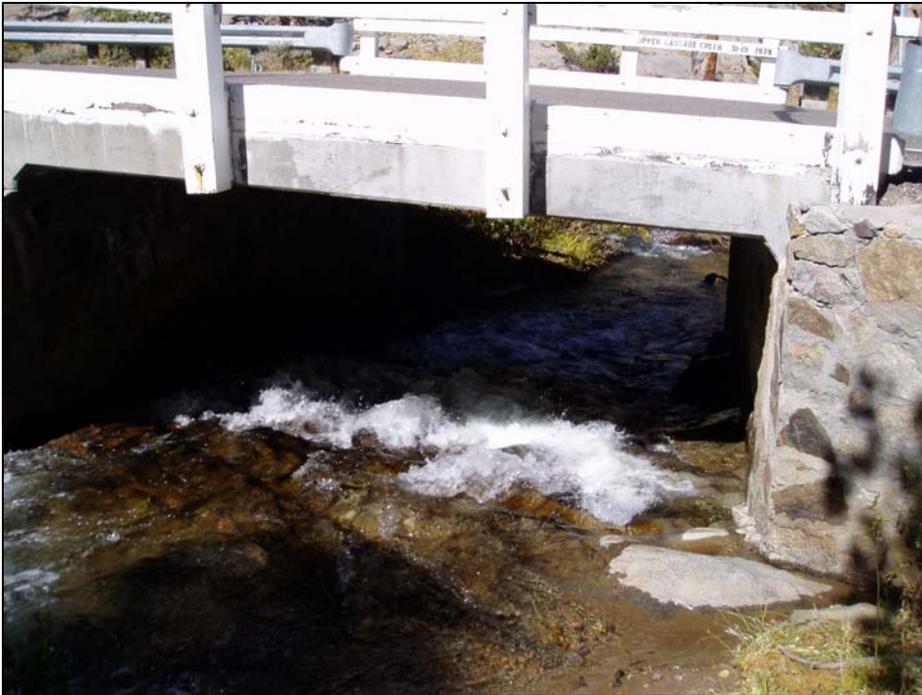
Site 28: Silver Creek, Carson Ranger District. Downstream view of a permanent fish barrier underneath a Highway 4 bridge. This site is located at UTM: N: 4273844 & E: 256015, Elev. 7675 feet (2340m).

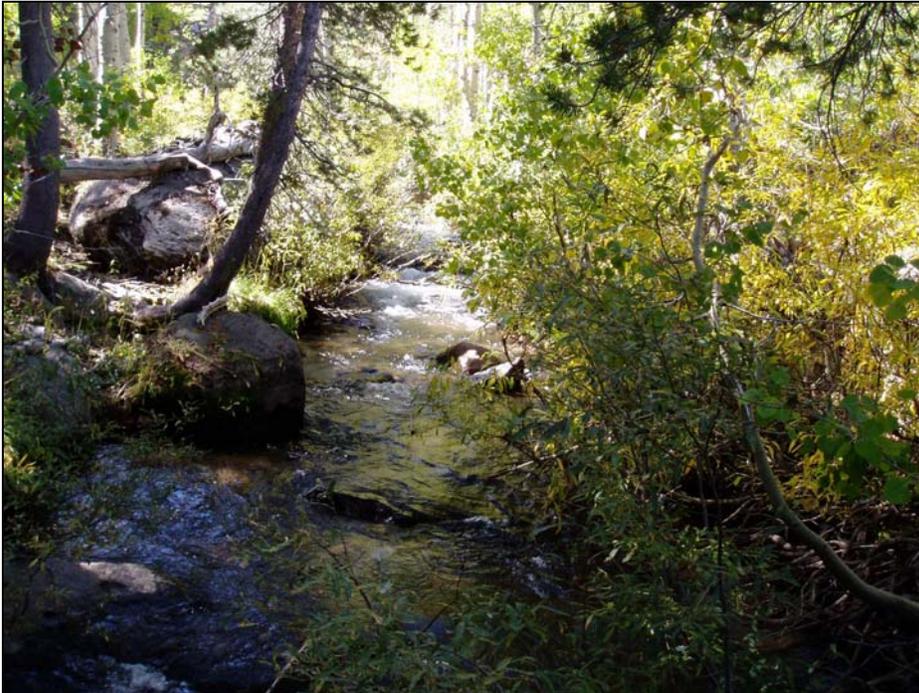
Site 29: Silver Creek, Carson Ranger District. Upstream photo shows habitat typical of this reach. This site is located at UTM: N: 4273831 & E: 255991, Elev. 7678 feet (2341m).

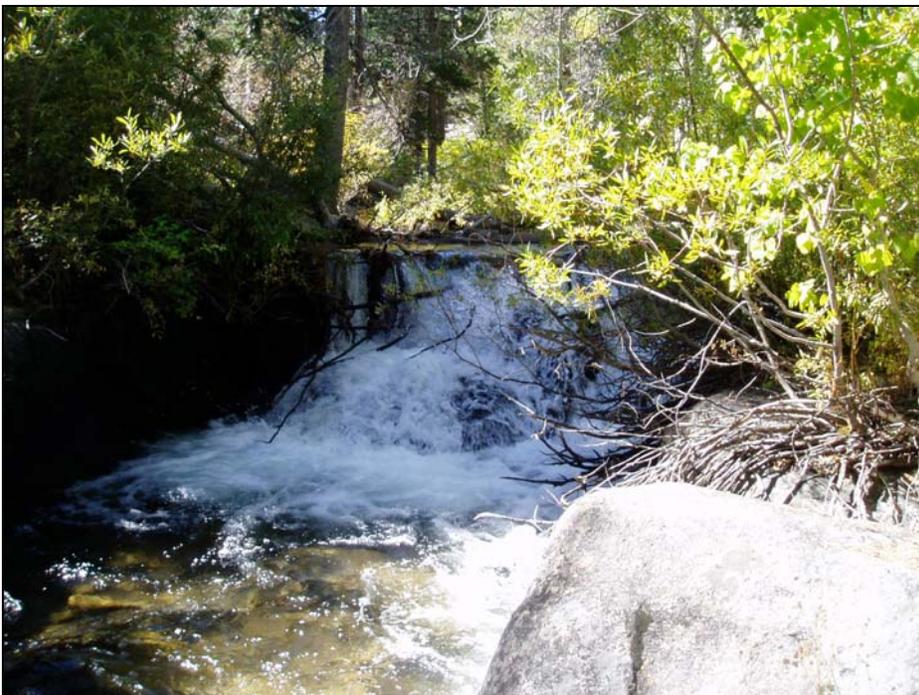
Site 30: Silver Creek, Carson Ranger District. Upstream photo of a seasonal fish barrier with a height of 4.0 feet, and a max. pool depth of 2.2 feet. This site is located at UTM: N: 4273795 & E: 255973.

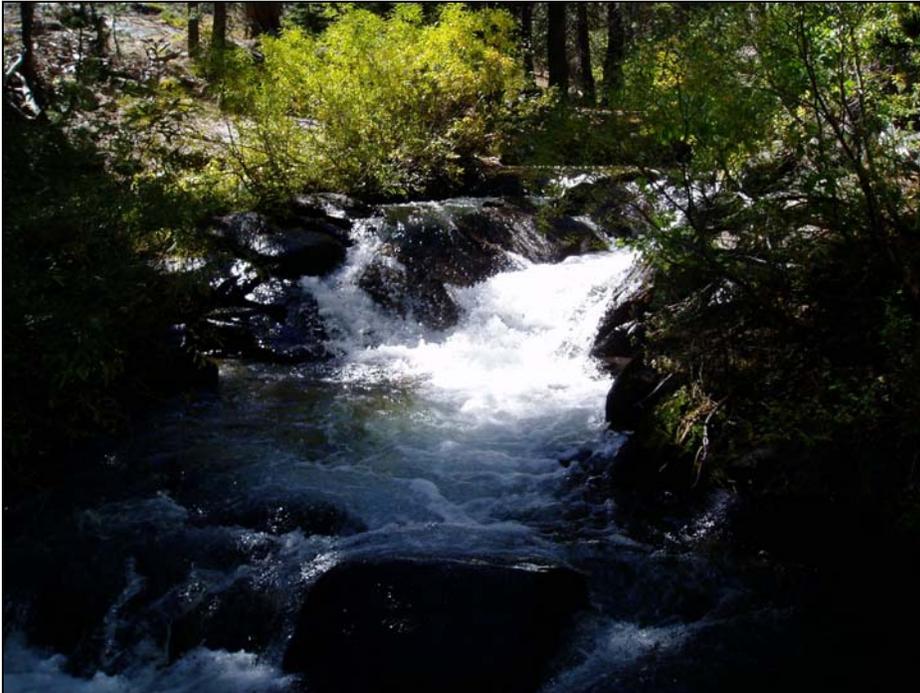
Site 31: Silver Creek, Carson Ranger District. Upstream photo of a waterfall with height 3.9 feet and a longitudinal distance of 10.0 feet. This site is located at UTM: N: 4273725 & E: 255935, Elev. 7774 feet (2370 m).

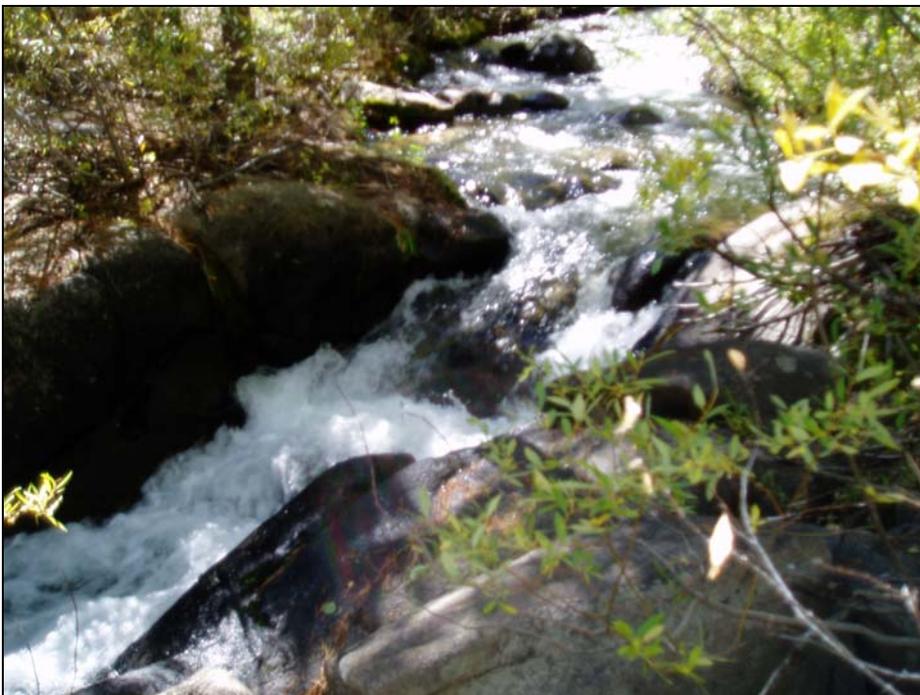
Site 32: Silver Creek, Carson Ranger District. Upstream photo of a seasonal barrier with a height of 3.0 feet, and a max. pool depth of 1.5 feet. This site is located at UTM: N: 4273728 & E: 255903, Elev. 7715 feet (2352m).

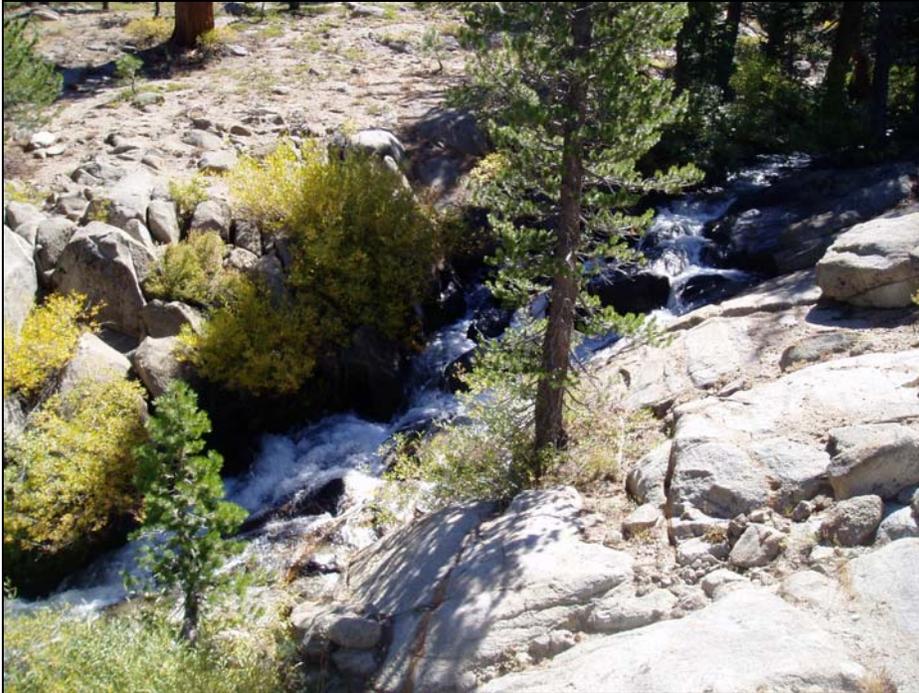
Site 33: Silver Creek, Carson Ranger District. Cross-sectional photo of a 50 foot long cascade sequence with a vertical height of 10.0 feet. This obstacle forms a permanent fish passage barrier. This site is located at UTM: N: 4273649 & E: 255869, Elev. 7734 feet (2358m).
