SILVER CREEK

Alpine County, California

2006 Stream Habitat Survey Report

Carson Ranger District: Humboldt-Toiyabe National Forest

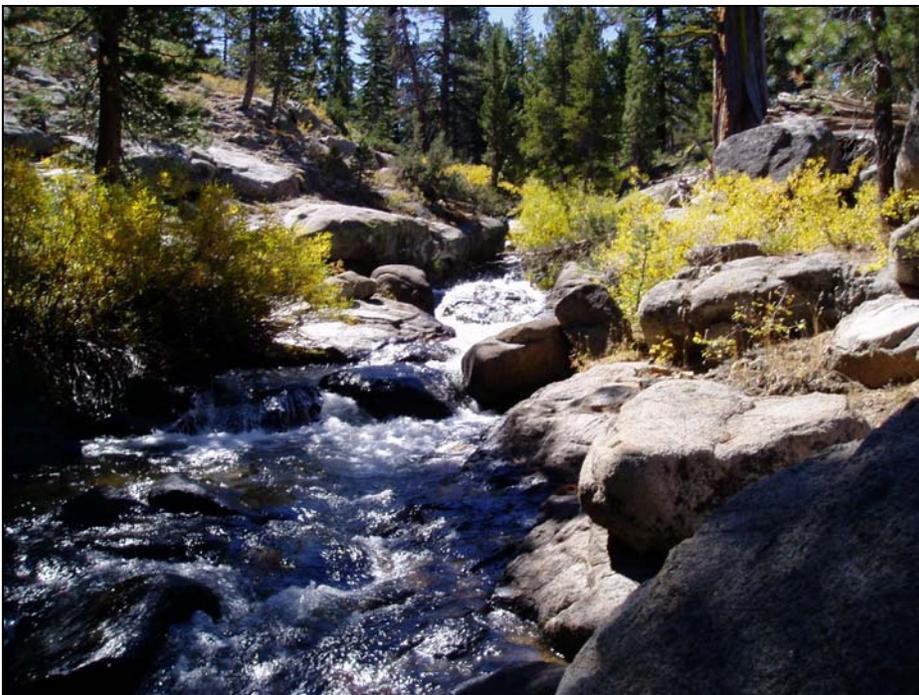
Site 34: Silver Creek, Carson Ranger District. A long longitudinal cascade forms a seasonal barrier. This site is located at UTM: N: 4273603 & E: 255844, Elev. 7718 feet (2353m).

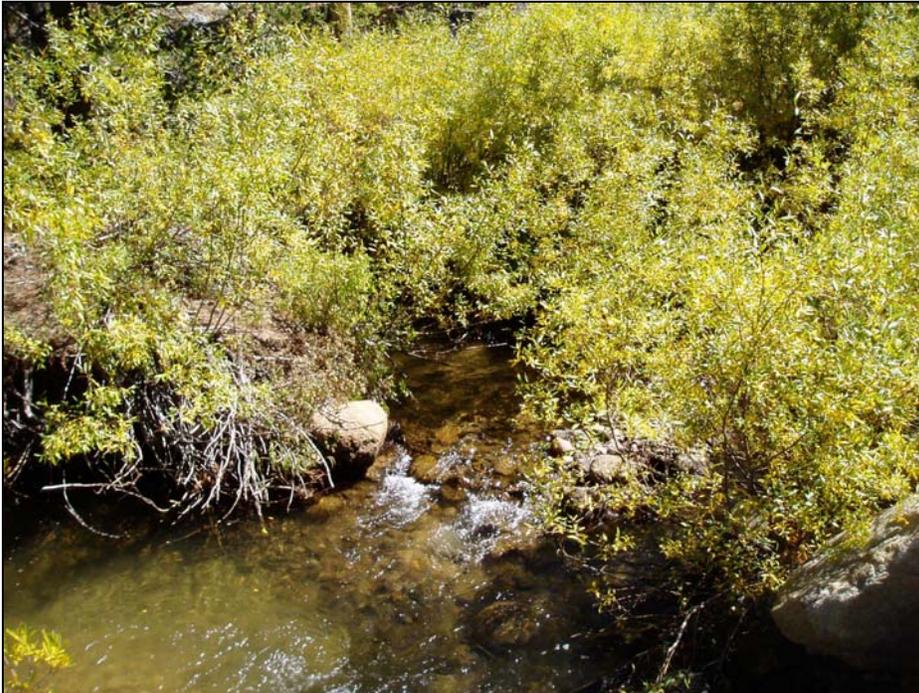
Site 35: Silver Creek, Carson Ranger District. A tributary enters on river right and contributes 60% of flow. This site is located at UTM: N: 4273071 & E: 255591, Elev. 7928 feet (2417m).

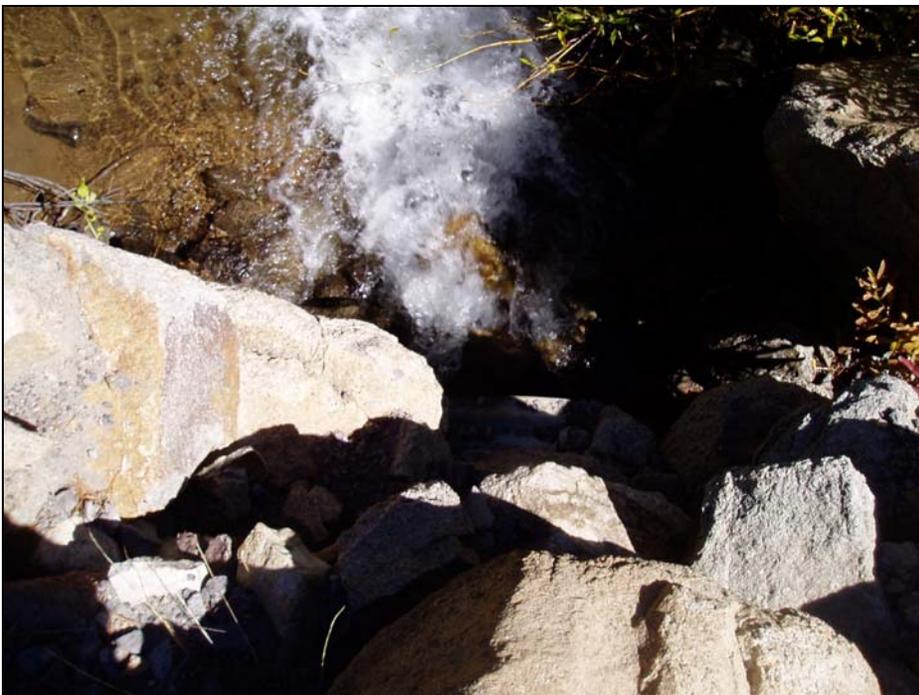
Site 36: Silver Creek, Carson Ranger District. Bird's eye view taken from above a culvert at a road-stream crossing. The culvert forms a permanent fish passage barrier. This site is located at UTM: N: 4273074 & E: 255592, Elev. 7885 feet (2404m).

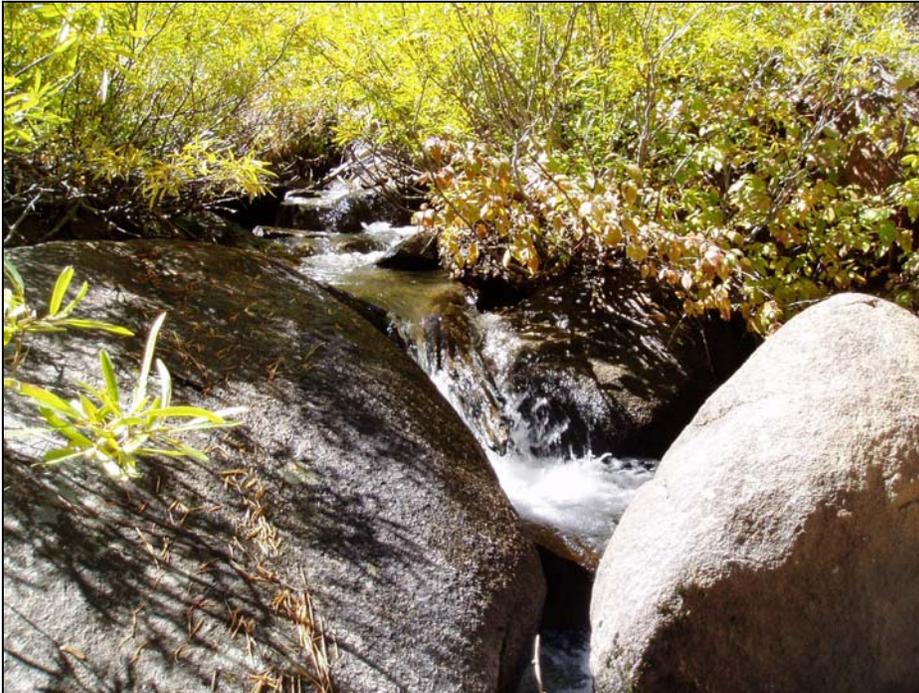
Site 37: Silver Creek, Carson Ranger District. A seasonal barrier is formed by a complex cascade sequence. This site is located at UTM: N: 4273042 & E: 255487, Elev. 7911 feet (2412m).

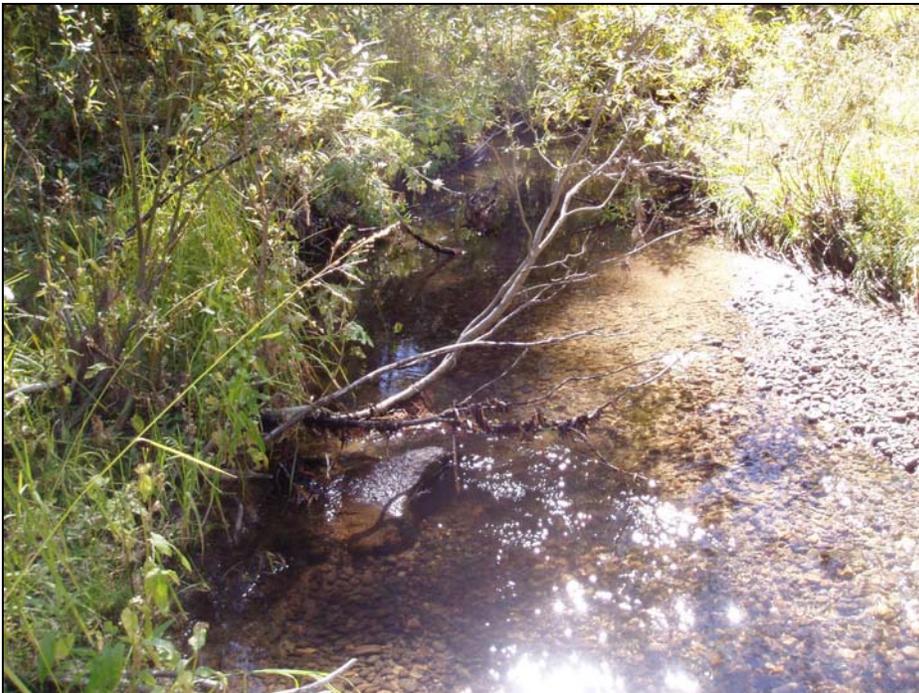
Site 38: Silver Creek, Carson Ranger District. A small brook trout was sighted in this pool within a low gradient reach. This site is located at UTM: N: 4272978 & E: 255385, Elev. 7938 feet (2420m).

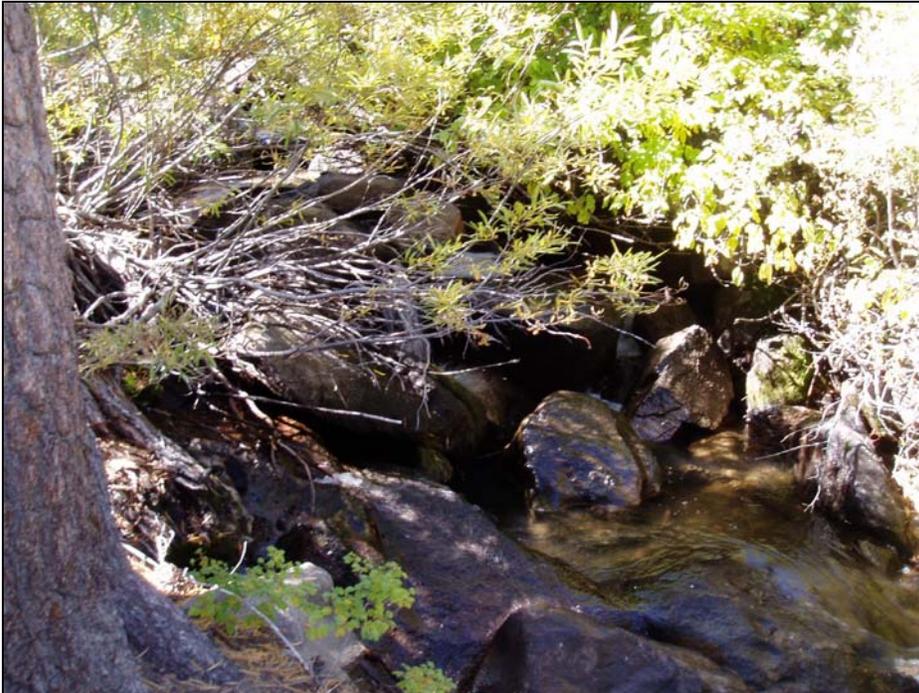
Site 39: Silver Creek, Carson Ranger District. A steep section of continuous cascades form a permanent barrier. This site is located at UTM: N: 4272985 & E: 2555263, Elev. 8036 feet (2450m).

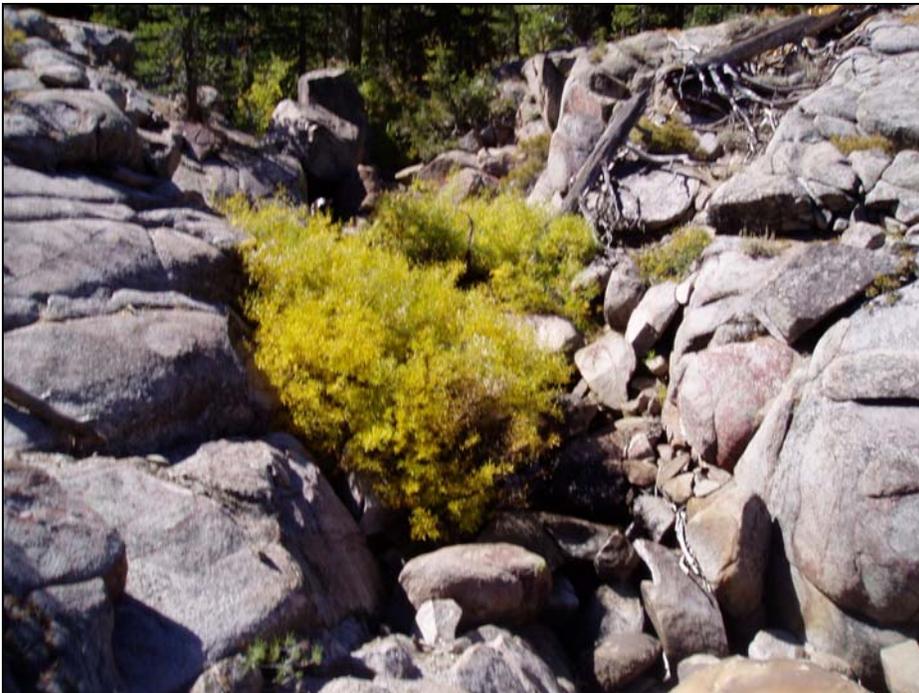
Site 39: Silver Creek, Carson Ranger District. A steep section of continuous cascades form a permanent barrier. This site is located at UTM: N: 4272985 & E: 255263, Elev. 8036 feet (2450m).

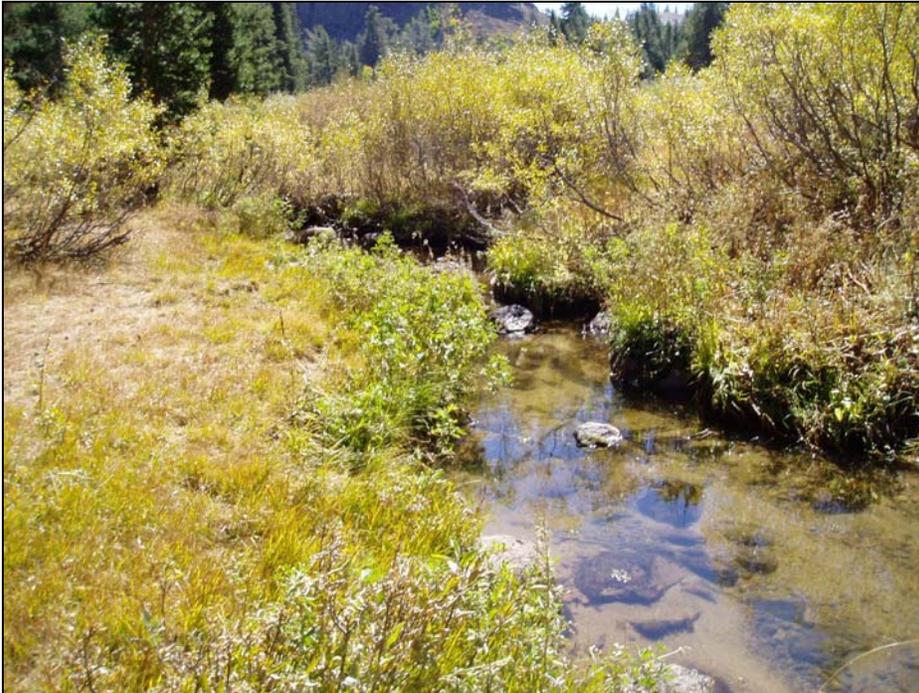
Site 40: Silver Creek, Carson Ranger District. Photo shows a small meadow where small brook trout are abundant. This site is located at UTM: N: 4272527 & E: 255103, Elev. 8141 feet (2482m).

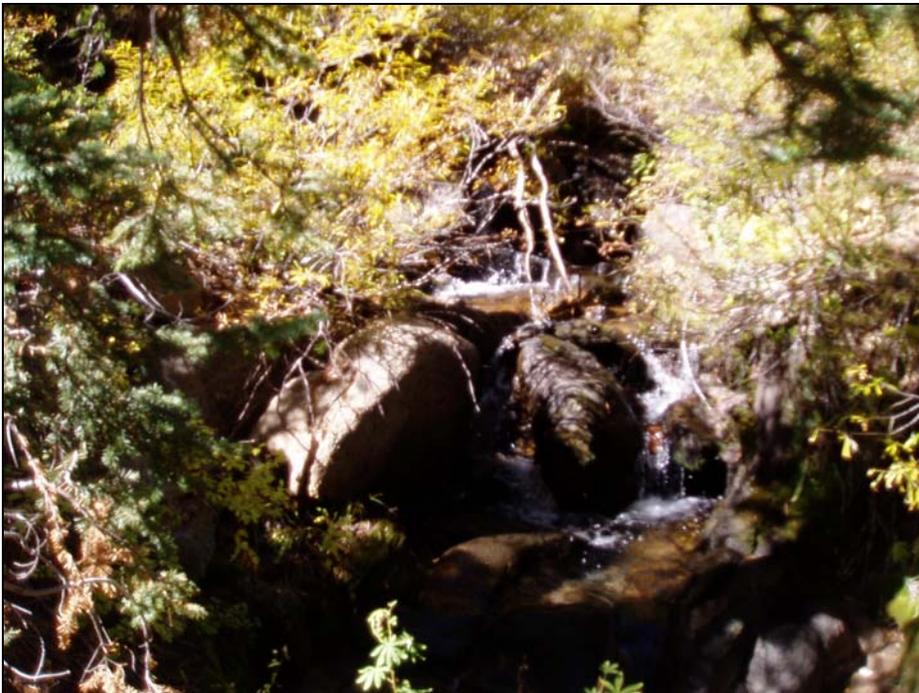
Site 41: Silver Creek, Carson Ranger District. Photo taken from the survey end point. Upstream of this site Silver Creek has a high gradient and therefore was not surveyed. This site is located at UTM: N: 4272225 & E: 254525, Elev. 8252 feet (2516m).
