# **WILLOW CREEK**

## 2006 Stream Habitat Survey Report

Carson Ranger District: Humboldt-Toiyabe National Forest

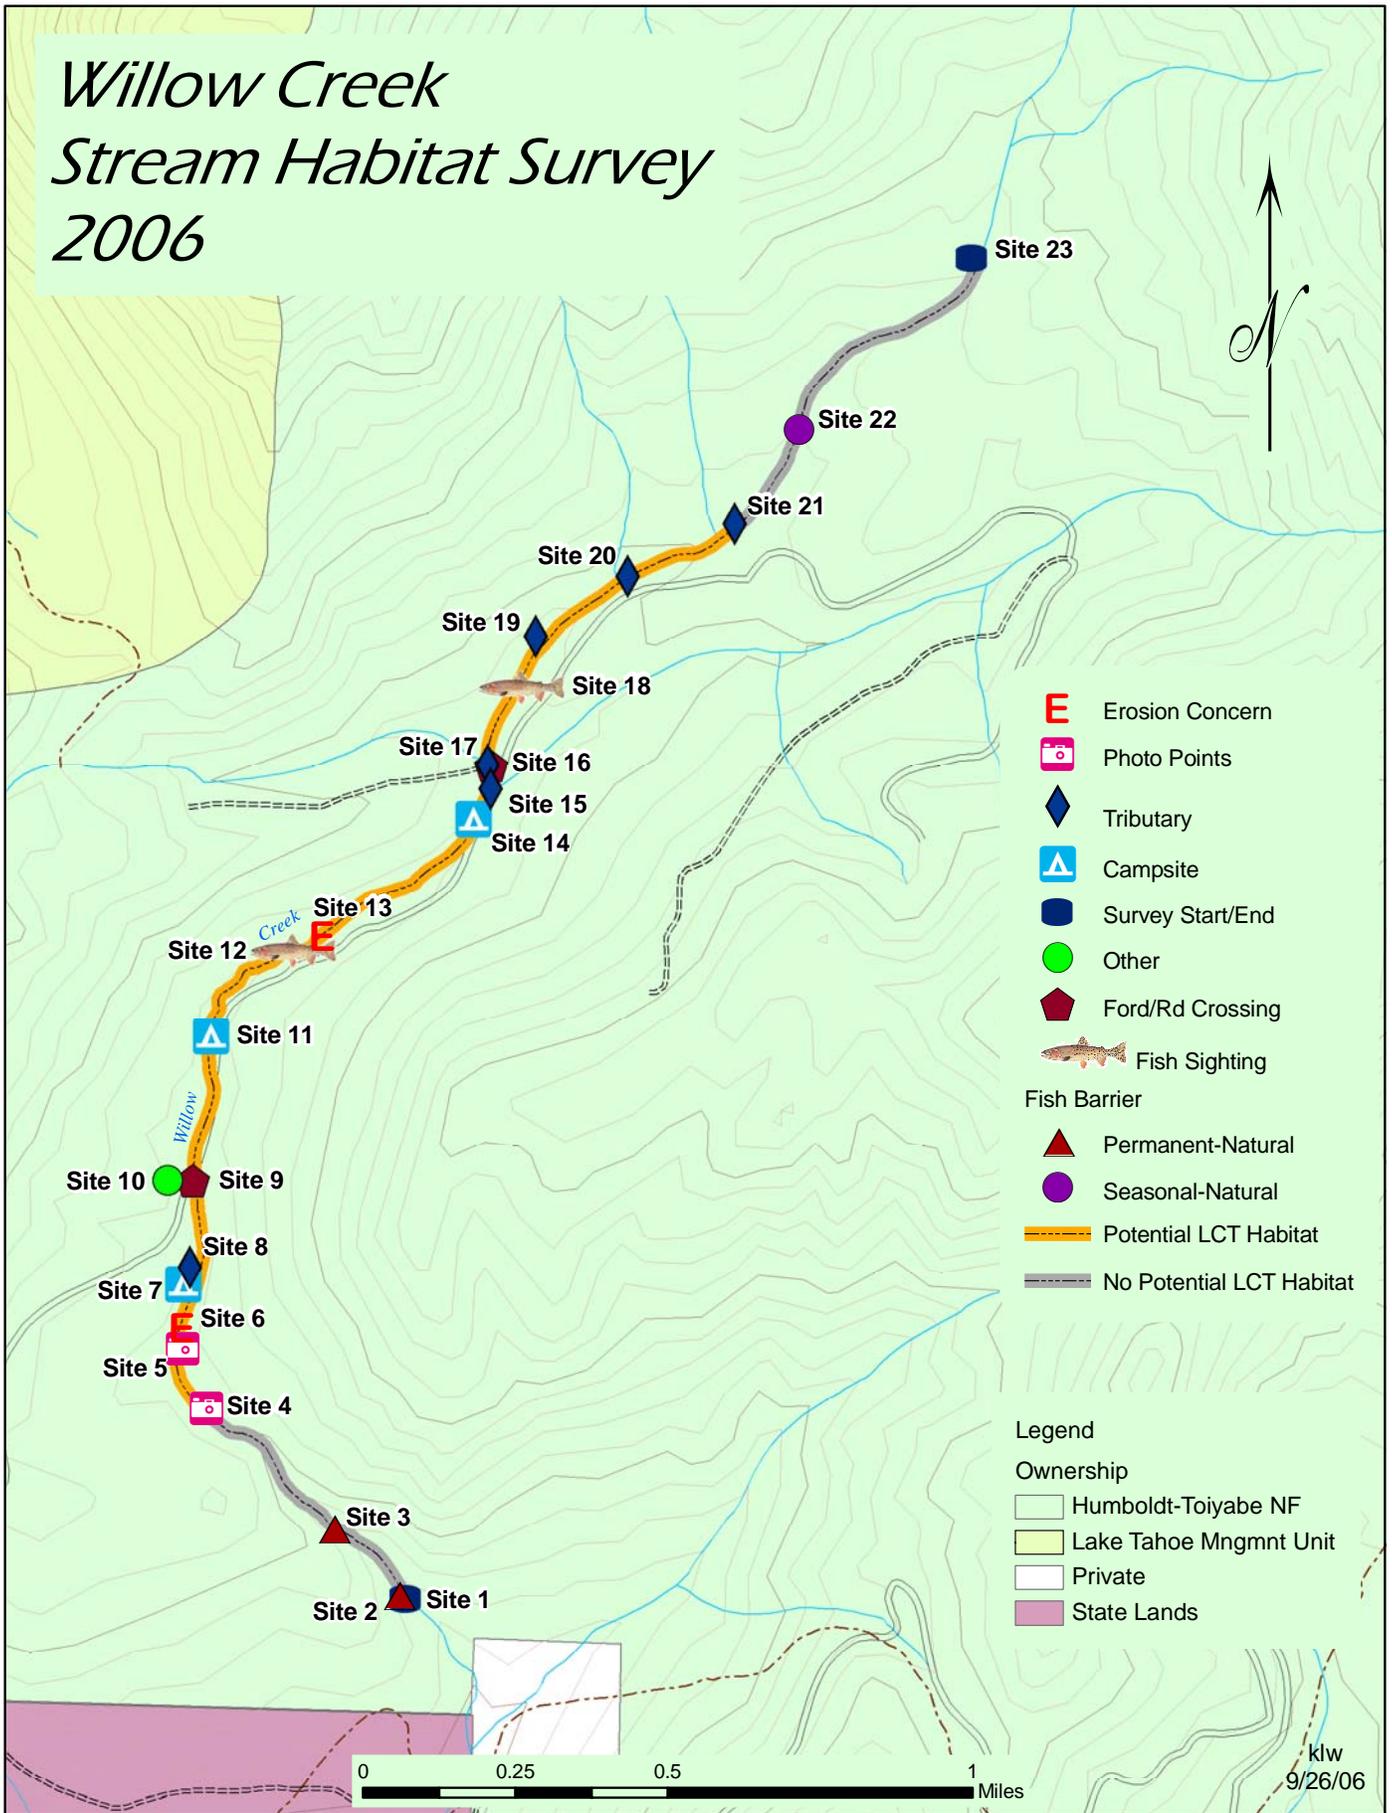
# Willow Creek Stream Habitat Survey 2006

Approximately 3.05 miles of Willow Creek were surveyed (Site 1-Site 23). Three fish barriers were documented (Sites 2, 3, and 22). Sites 2 and 3 are permanent barriers and the barrier at Site 22 is seasonal. Six tributaries were noted throughout the surveyed reach (Sites 8, 15, 17, 19, 20, & 21). Two fish sightings were documented (Sites 12 & 18). Three campsites were documented along the watercourse (Sites 7, 11, & 14). In addition, erosion concerns were noted at Site 6 and Site 13. Two road-stream crossings were identified where Forest Service Road 051 and a spur of 051 cross Willow Creek. Grazing impacts were noted at Site 10, though the impacts of cattle were present from Site 4-Site 20. The overall stream gradient is approximately 6.9 percent.

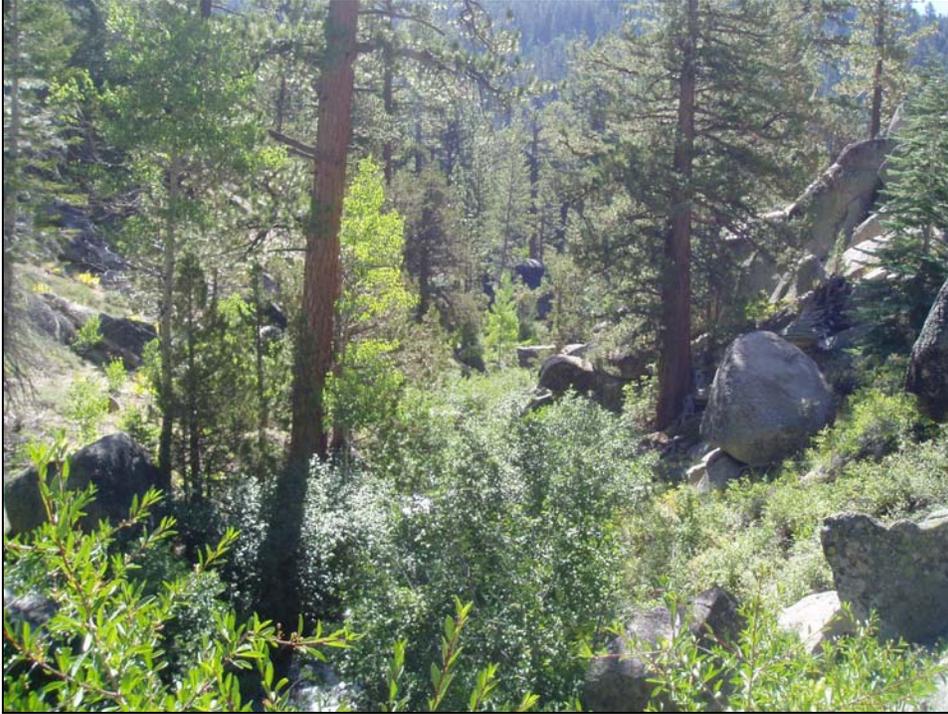
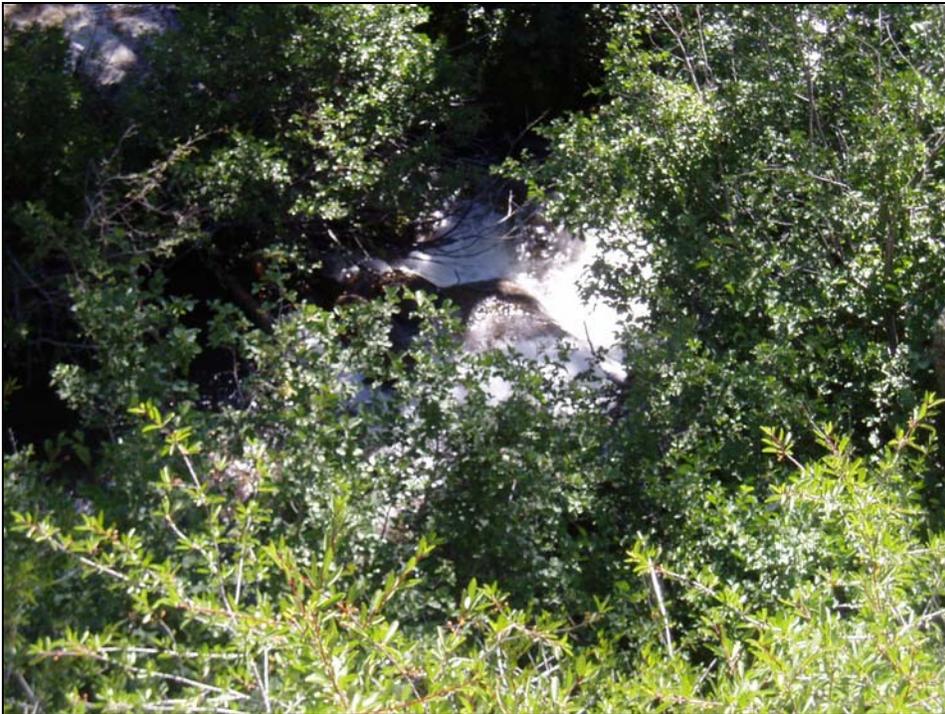
**Site 1:** Willow Creek, Carson Ranger District. Downstream view of canyon at survey start point. This site is located at UTM: N: 4299514 & E: 248019, Elev. 7669 feet (2338m).

**Site 1:** Willow Creek, Carson Ranger District. Bird's eye view of stream at the survey start point. This site is located at UTM: N: 4299514 & E: 248019, Elev.7669 feet (2338m).

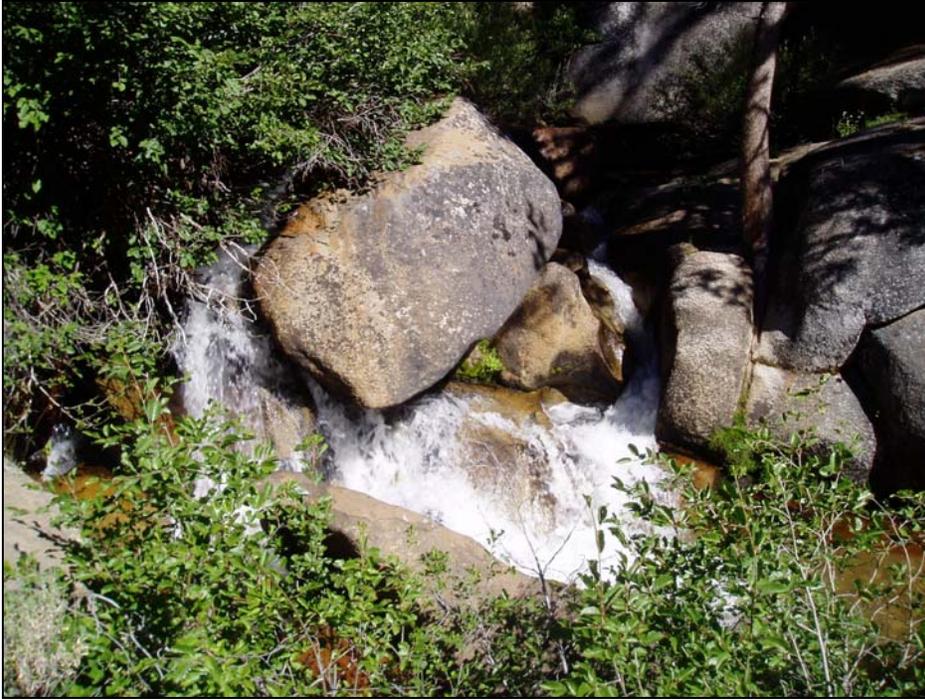
Roughly 1.9 miles of Willow Creek provide potential LCT habitat (Site 4 to Site 21). The reach between Site 1 and Site 4 is steep, containing at least two verified permanent fish passage barriers (Site 2 & Site 3). The waterfall at Site 2 is approximately 10 feet high, with a maximum pool depth of 2.75 feet. The fish barrier at Site 3 is at least 15 feet high, with a maximum pool depth of 4.0 feet. Therefore, the 0.44 mile section between Site 1 and Site 4 is unfavorable for LCT habitat and lacks continuity. The 1.9 mile section of potential LCT habitat is fed by multiple tributaries and has sustainable flows: approximately 4-5 cfs in late August. The reach provides a combination of runs, riffles, and pools. Fish were sighted at Site 12 and Site 18, reinforcing the idea that the stream can support fish. Grazing impacts were noticeable between Site 4 and Site 20. Cattle in the drainage are walking in the riparian zones as well as through the stream bed. Slumping stream banks may provide a source of extra sediment to Willow Creek. In addition, human impacts due to camping were also noticeable. The campsite at Site 7 was spread out roughly 15 meters from the water's edge. Trash piles, an outhouse, and broken chairs have been abandoned. At Site 14 a 20m x 20m campsite is located about 2 meters from the water. In addition, vehicles have driven down to the campsite and into the floodplain.

**Site 2:** Willow Creek, Carson Ranger District. Upstream photo of a 10-foot waterfall that creates a permanent fish passage barrier (max. pool depth 2.75 feet). This site is located at UTM: N: 4299518 & E: 247997, Elev. 7734 feet (2358m).

2. Consider the section of Willow Creek between Site 1 and Site 4, and the section between Site 21 and Site 23 as having no potential LCT habitat.
3. Discuss with ranchers/livestock managers the possibility of isolating a riparian corridor, and or limiting livestock access points to the creek. Consider cost-share in fencing these buffers.
4. Remove and disassemble all campsites within 100 feet of the stream.
5. Close and decommission all non-designated roads that lead to unwanted campsites and/or allow vehicles to drive onto stream banks.

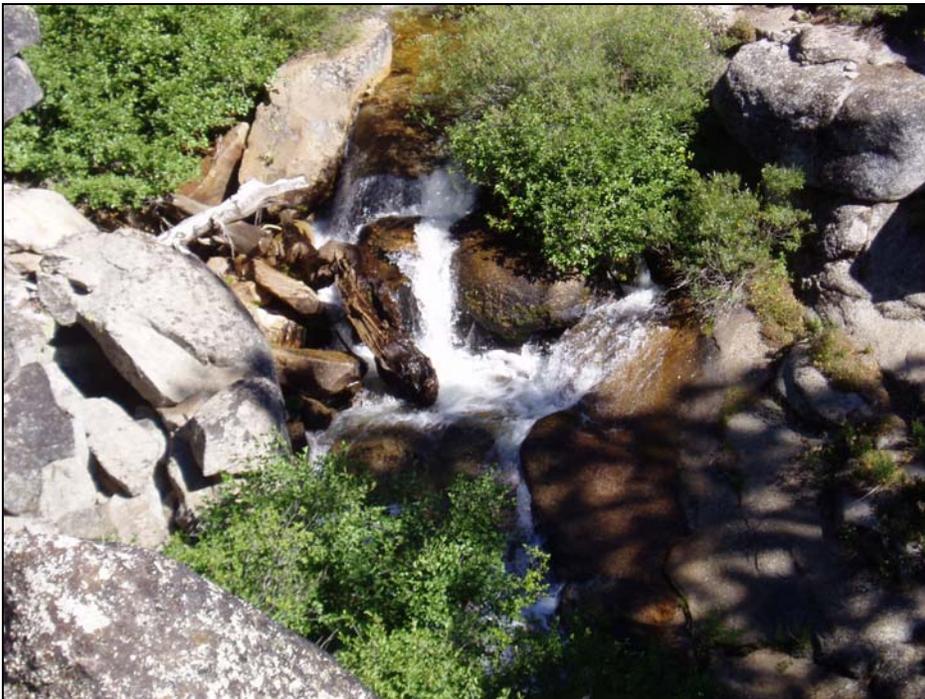
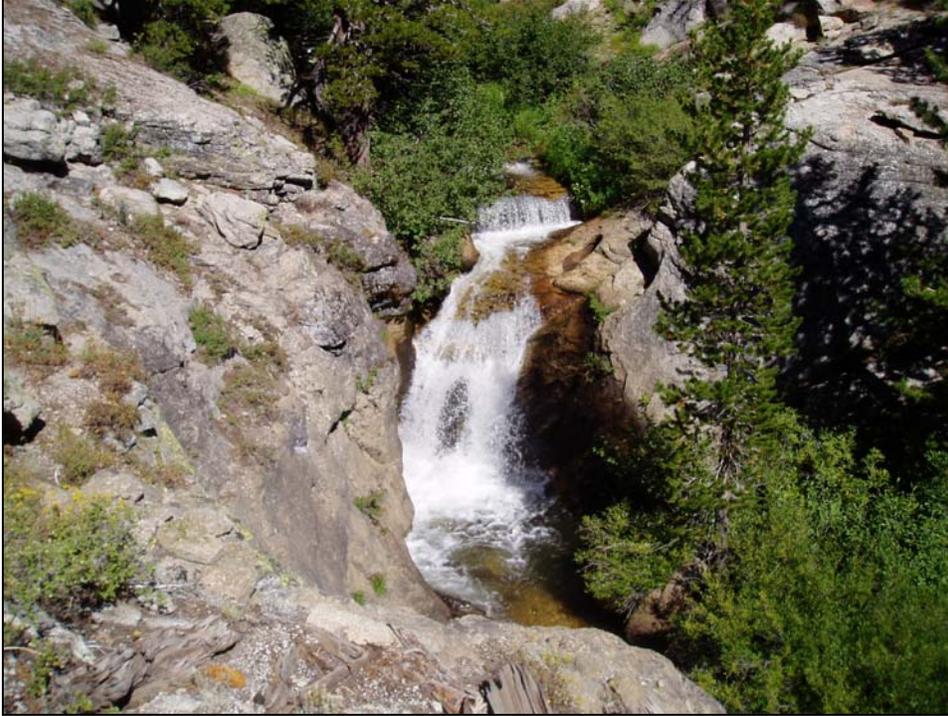
**Site 3:** Willow Creek, Carson Ranger District. A 15-foot waterfall with maximum pool depth 4.0 feet prevents fish passage. This site is located at UTM: N: 4299699 & E: 247825, Elev. 7921 feet (2415m).

**Site 3:** Willow Creek, Carson Ranger District. Upstream photo of another permanent barrier in this section of stream. This site is located at UTM: N: 4299699 & E: 247825, Elev. 7921 feet (2415m).

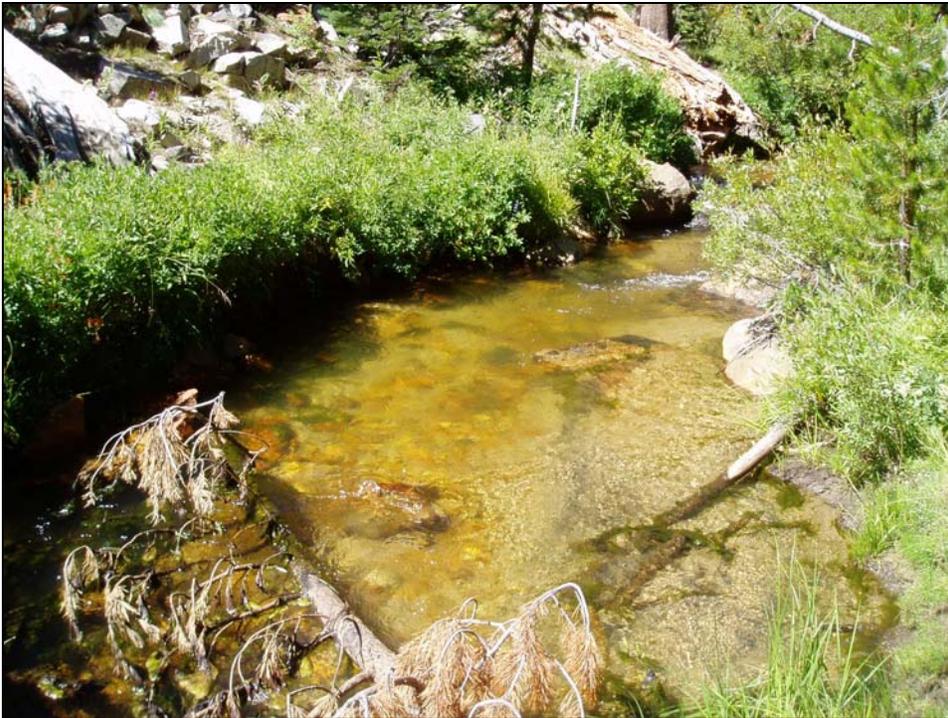
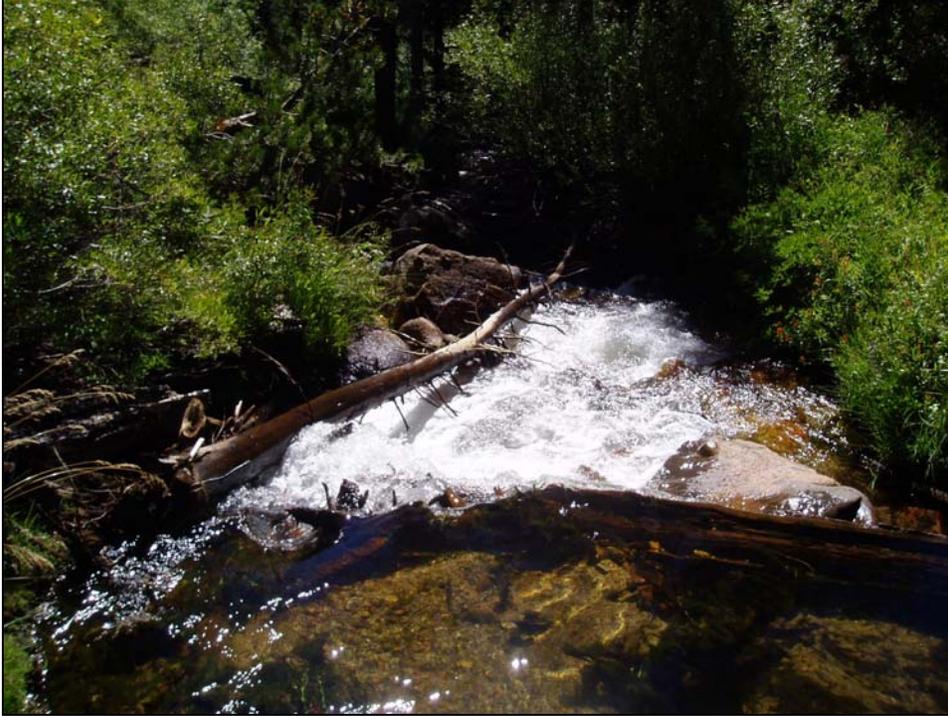
**Site 4:** Willow Creek, Carson Ranger District. Upstream view of creek at break-point where the gradient changes. This site is located at UTM: N: 4300033 & E: 247484, Elev. 8163 feet (2489m).

**Site 4:** Willow Creek, Carson Ranger District. Downstream view of creek at break-point where the gradient changes. Note the descending stream. This site is located at UTM: N: 4300033 & E: 247484, Elev. 8163 feet (2489m).

1. Consider the 1.9 mile section of Willow Creek between Site 4 and Site 21 as potential LCT habitat and consider Willow Creek a high candidate for restoration. The lower section of Willow Creek downstream of Site 1 could contribute towards restoring a metapopulation of LCT in the West Fork Carson River watershed (See 2008 Carson River Summary Report).

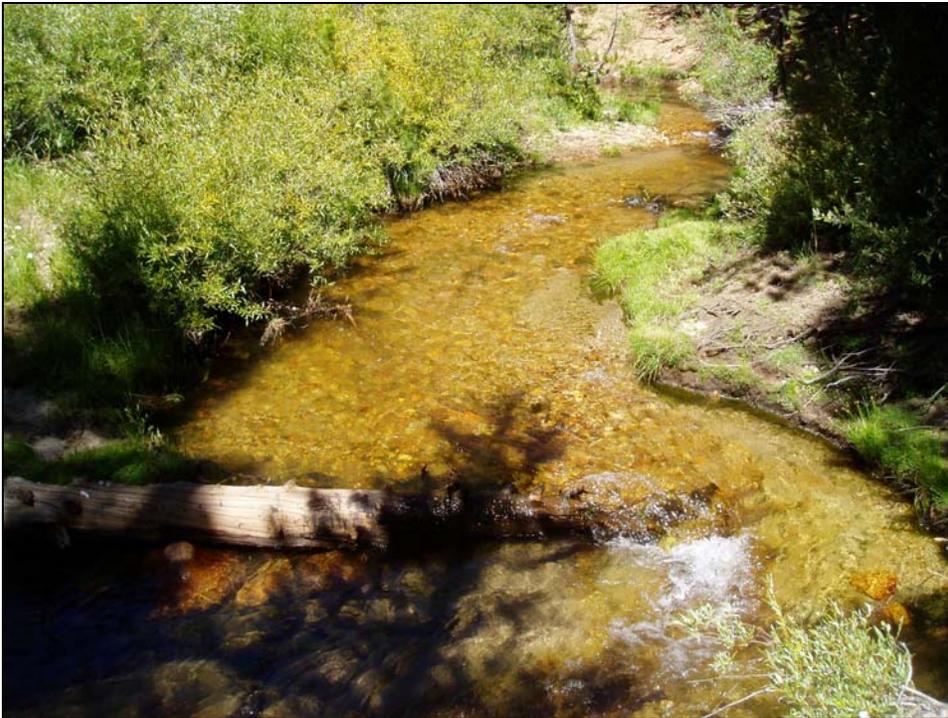
**Site 5:** Willow Creek, Carson Ranger District. Upstream view of Willow Creek. Note the presence of a riffle and large-woody-debris. This site is located at UTM: N: 4300170 & E: 247428, Elev. 8102 feet (2470m).

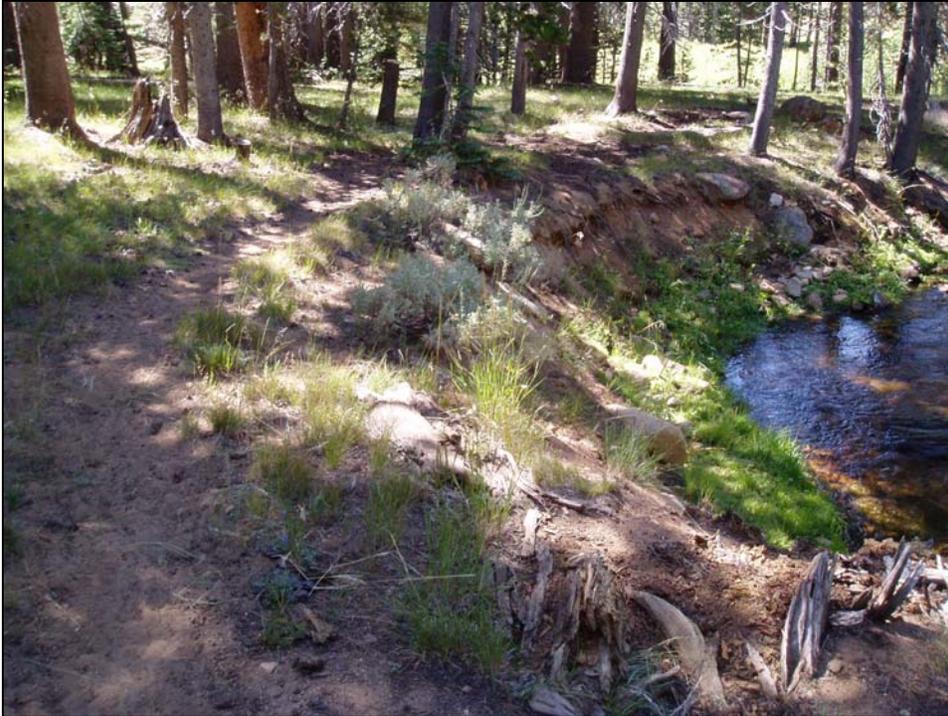
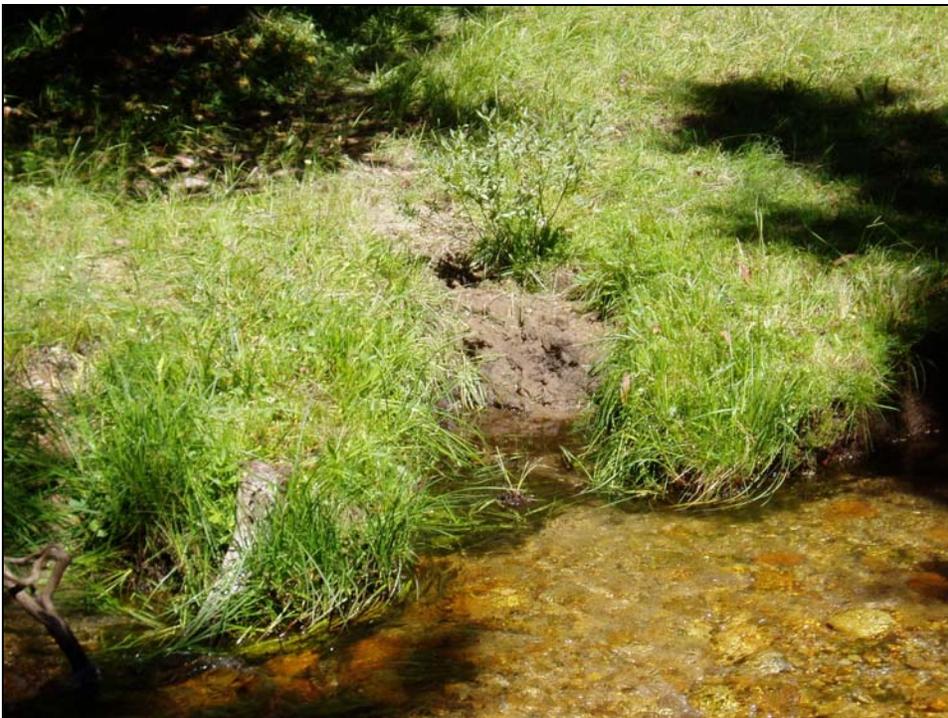
**Site 6:** Willow Creek, Carson Ranger District. Downstream view of trail running along left bank, potentially increasing the rate of erosion. This site is located at UTM: N: 4300228 & E: 247422, Elev. 8079 feet (2463m).

**Site 6:** Willow Creek, Carson Ranger District. Cross-sectional view of trail-stream intersection. This site is located at UTM: N: 4300228 & E: 247422, Elev. 8079 feet (2463m).

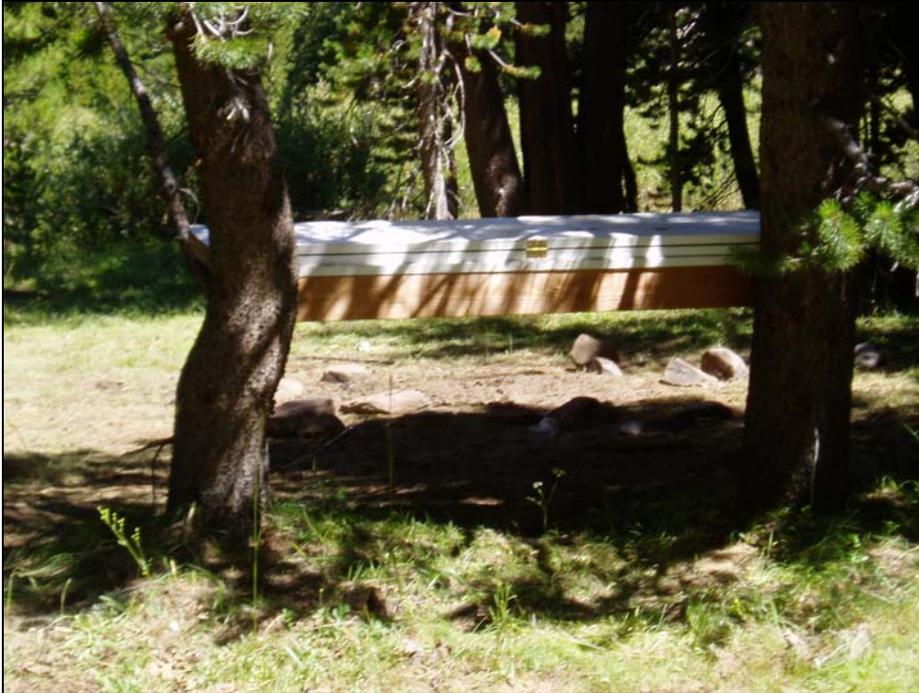
**Site 7:** Willow Creek, Carson Ranger District. Photo shows the outdoor kitchen area of a large campsite located 15m from the stream. The campsite dimensions are roughly 30m x 30m. This site is located at UTM: N: 4300344 & E: 247424, Elev. 8075 feet (2462m).

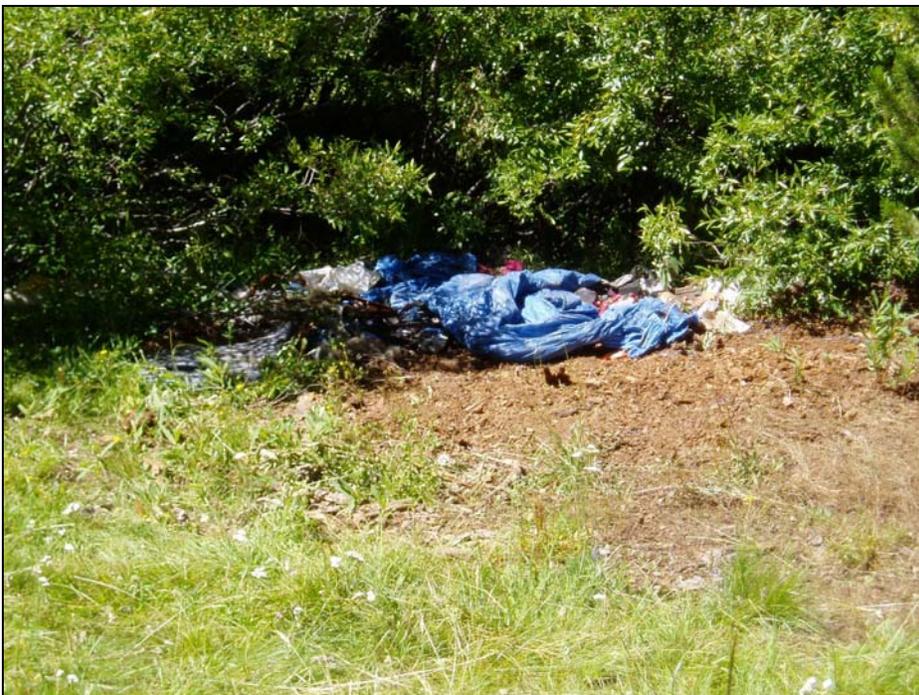
**Site 7:** Willow Creek, Carson Ranger District. Photo shows a trash pile associated with the campsite. This site is located at UTM: N: 4300344 & E: 247424, Elev. 8075 feet (2462m).

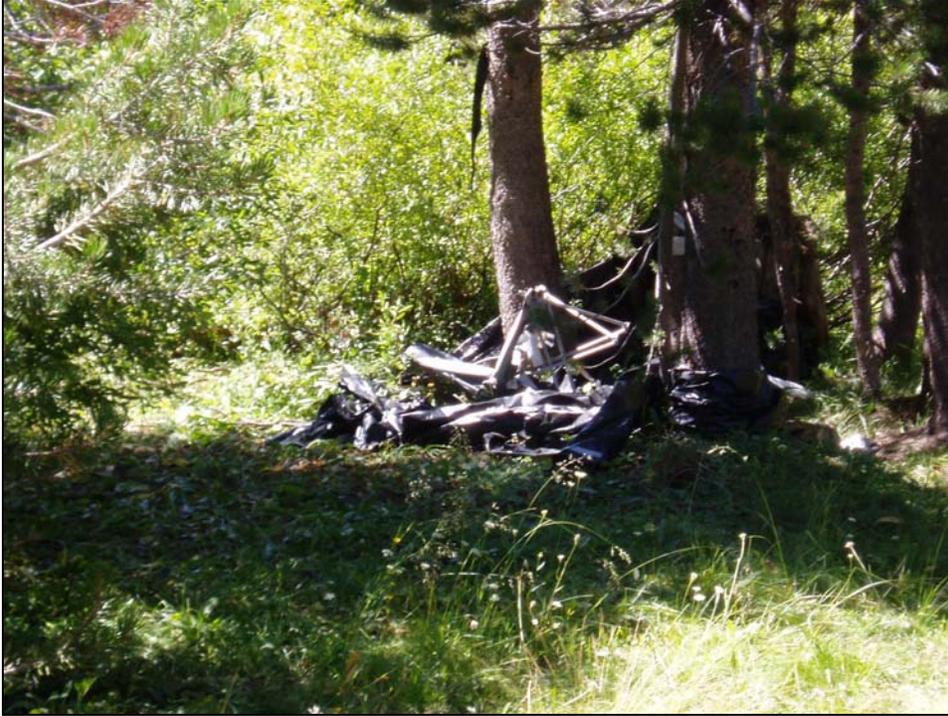
**Site 7:** Willow Creek, Carson Ranger District. The campsite includes a make-shift outhouse, shown collapsed in the photo. This site is located at UTM: N: 4300344 & E: 247424, Elev. 8075 feet (2462m).

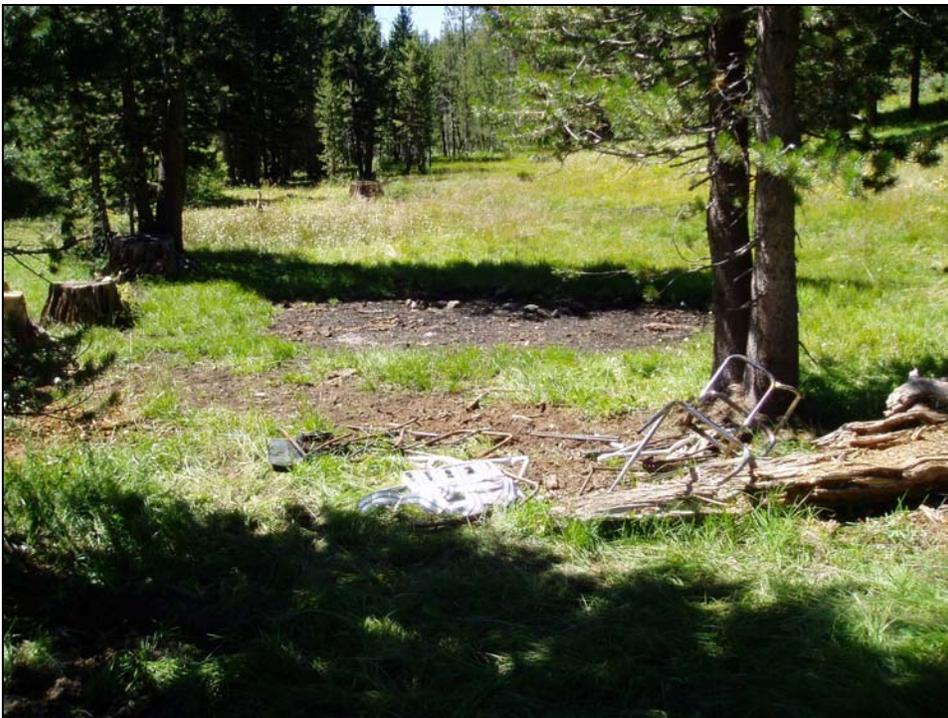
**Site 7:** Willow Creek, Carson Ranger District. Photo shows broken lawn chairs left at the campsite. This site is located at UTM: N: 4300344 & E: 247424, Elev. 8075 feet (2462m).

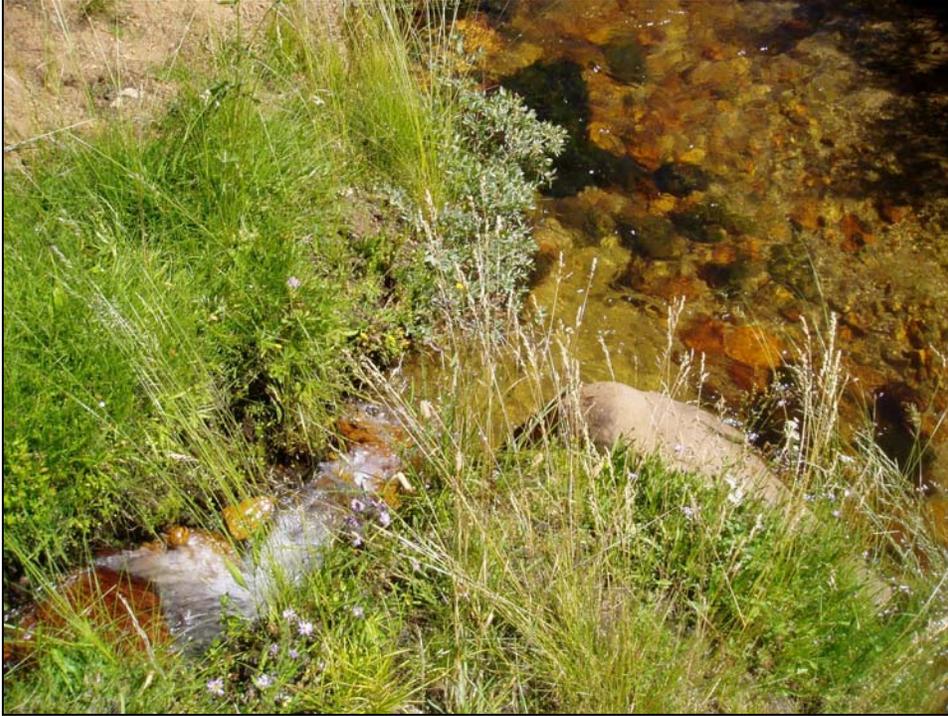
**Site 8:** Willow Creek, Carson Ranger District. A small tributary enters river right and adds 3 percent to the overall stream flow. This site is located at UTM: N: 4300387 & E: 247440, Elev. 8056 feet (2456m).

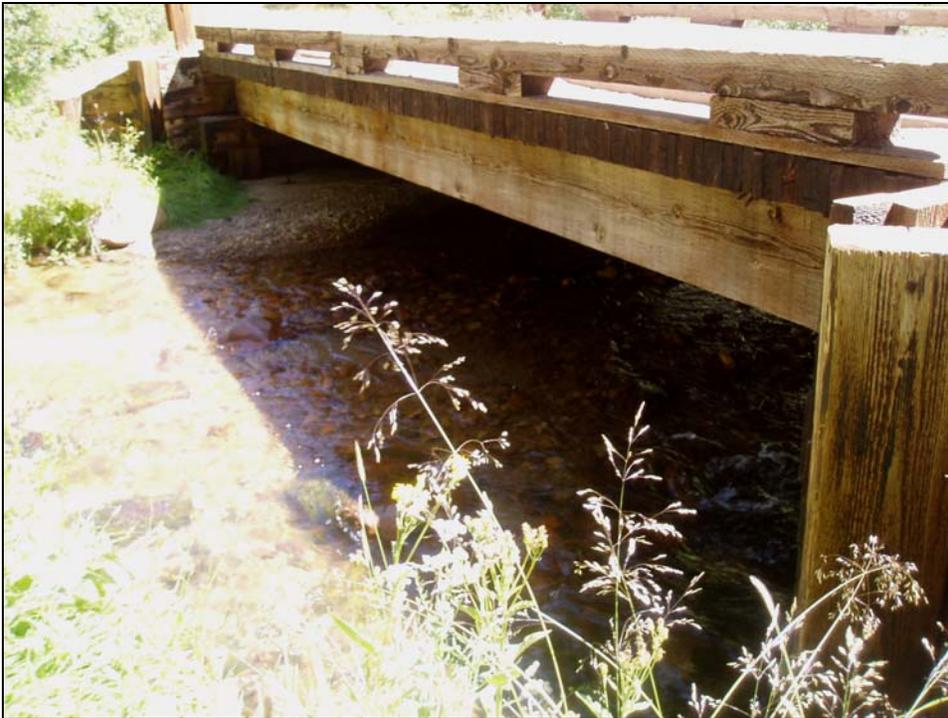
**Site 9:** Willow Creek, Carson Ranger District. Photo shows the point where Forest Service Road 051 crosses Willow Creek. The bridge allows free passage of water and fish. This site is located at UTM: N: 4300614 & E: 247450, Elev. 8102 feet (2470m).

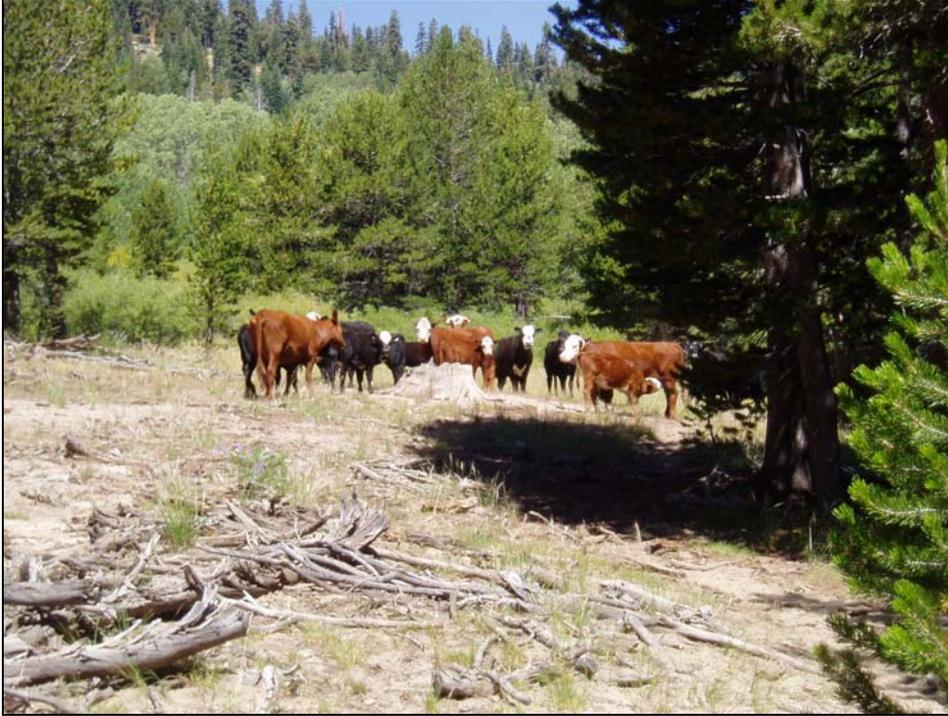
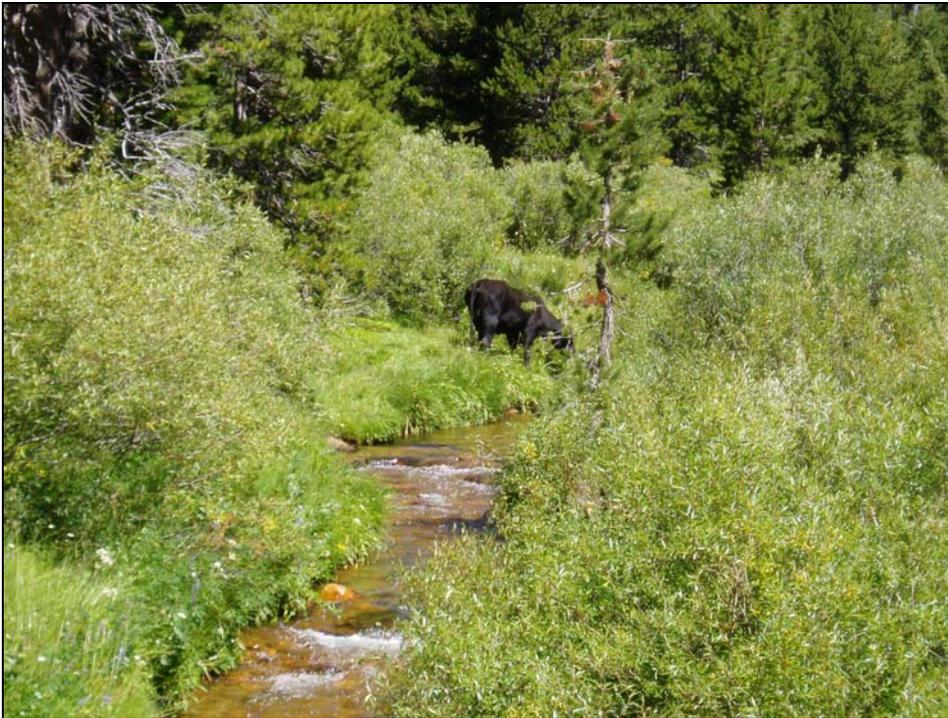
**Site 10:** Willow Creek, Carson Ranger District. These cattle were seen grazing just upstream of the road crossing at Site 9. This site is located at UTM: N: 4300614 & E: 247442, Elev. 8108 feet (2472m).

**Site 10:** Willow Creek, Carson Ranger District. Upstream photo of a cow grazing on the right bank. This site is located at UTM: N: 4300614 & E: 247442, Elev. 8108 feet (2472m).

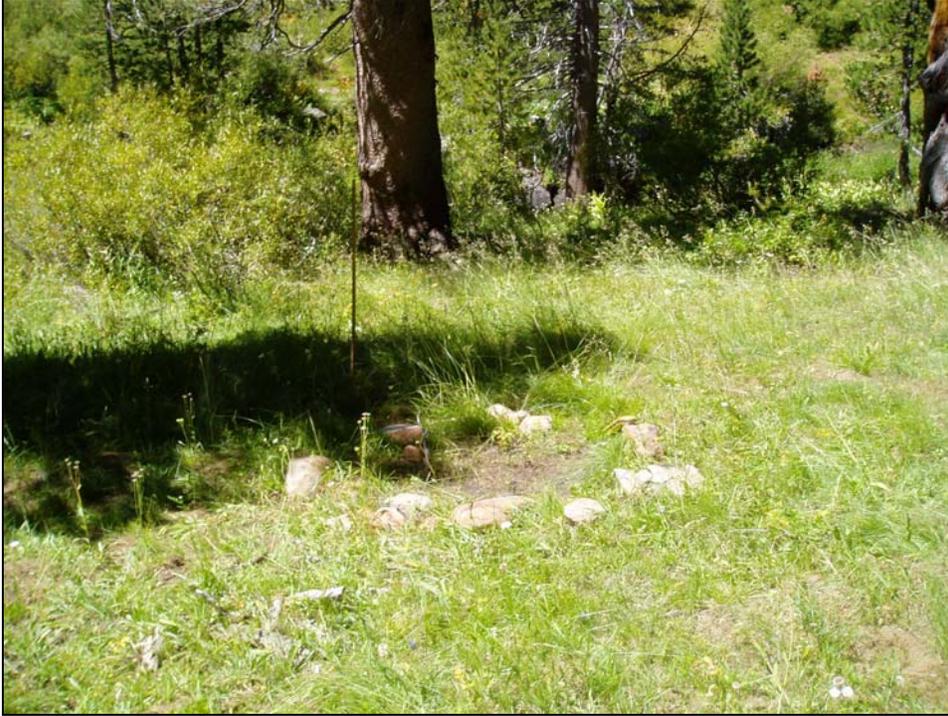
**Site 11:** Willow Creek, Carson Ranger District. Photo shows a campsite with dimensions 10m x 10m, located approximately 20m from river left. This site is located at UTM: N: 4300998 & E: 247512, Elev. 8187 feet (2496m).

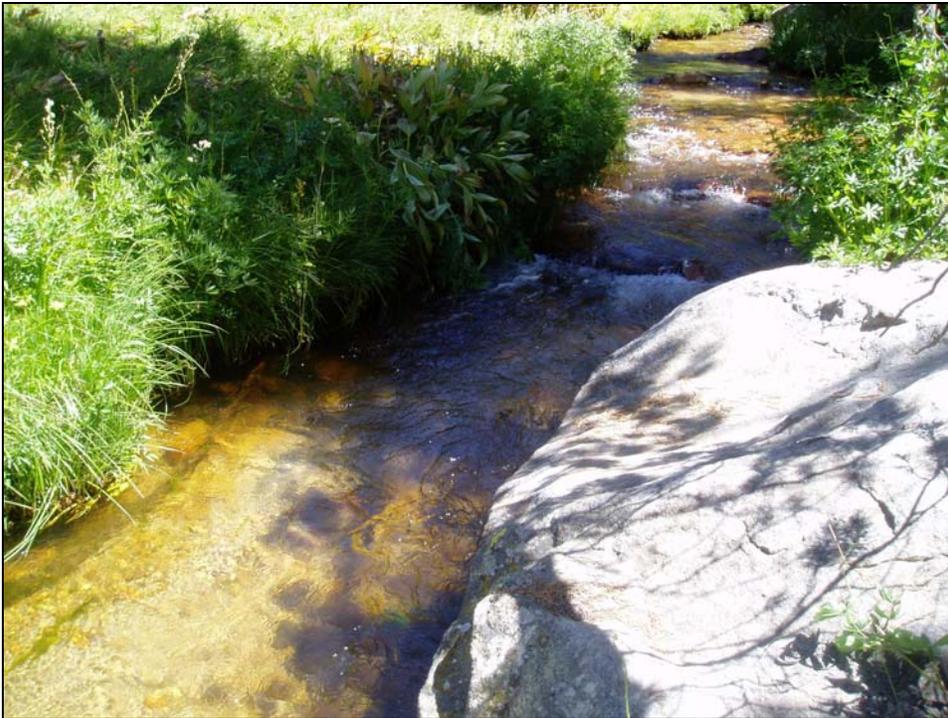
**Site 12:** Willow Creek, Carson Ranger District. Upstream photo of a pool where a 7-9-inch fish was sighted. This site is located at UTM: N: 4301226 & E: 247716, Elev. 8216 feet (2595m).

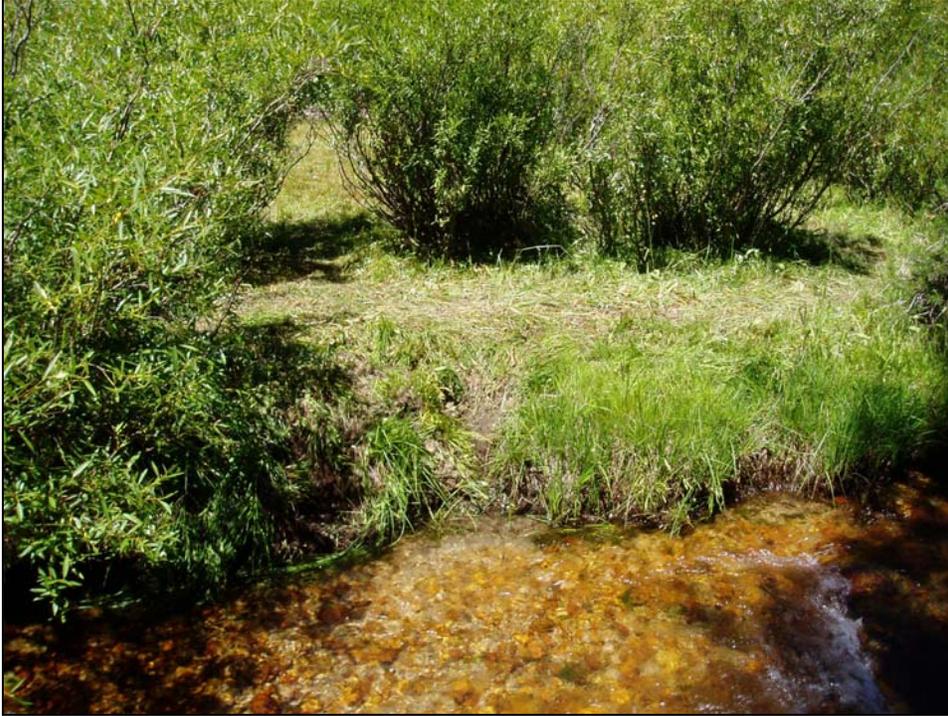
**Site 13:** Willow Creek, Carson Ranger District. Photo shows recent cattle activity in the riparian corridor (i.e. grazing, stream crossings, etc.). This site is located at UTM: N: 4301260 & E: 247794, Elev. 8216 feet (2505m).

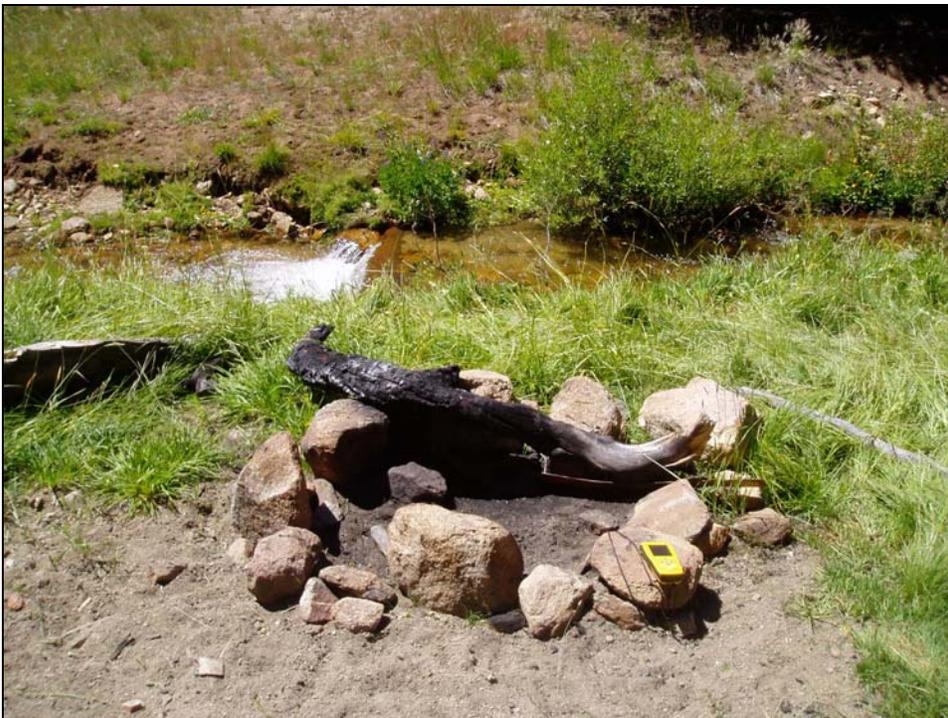
**Site 14:** Willow Creek, Carson Ranger District. Photo of a campsite located 2m from Willow Creek. A road spur allows vehicle access to this point. This site is located at UTM: N: 4301568 & E: 248194.

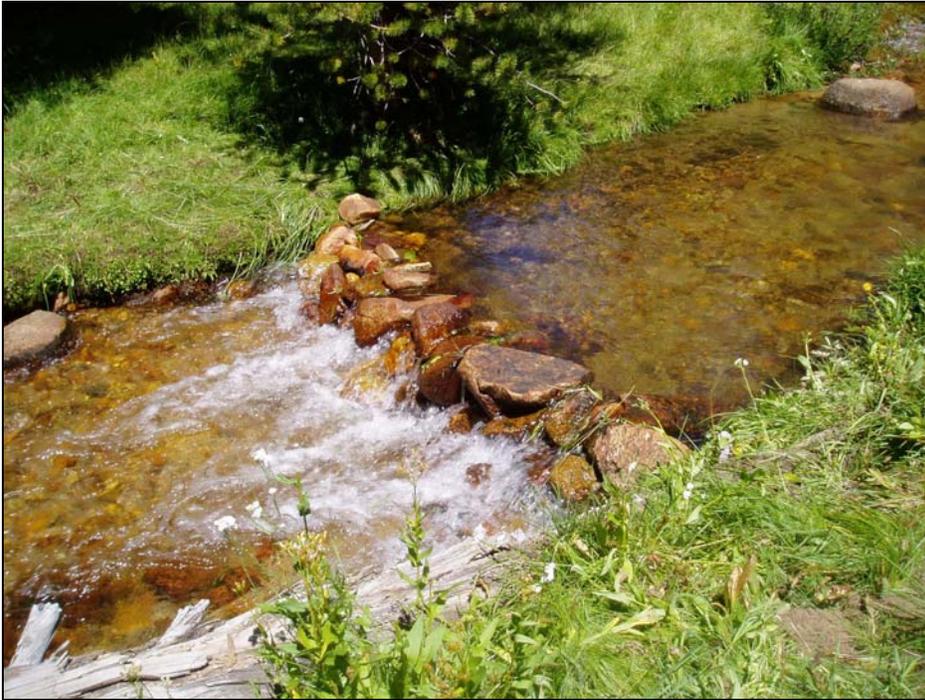
**Site 14:** Willow Creek, Carson Ranger District. Photo of a check-dam created just upstream of the campsite. This site is located at UTM: N: 4301568 & E: 248194.

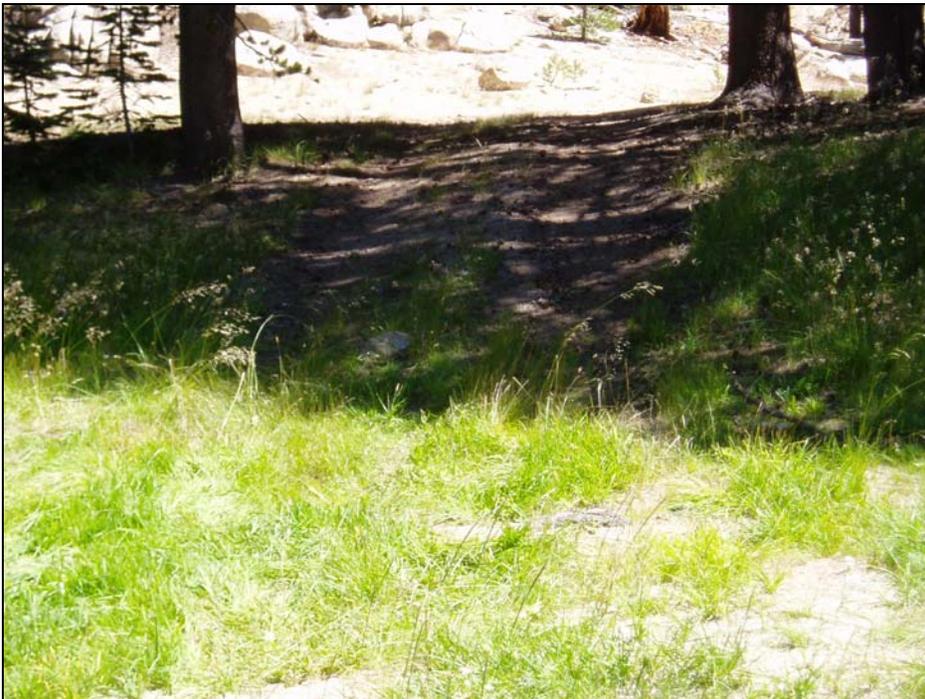
**Site 14:** Willow Creek, Carson Ranger District. Looking up the road spur that allows vehicle access to the banks of Willow Creek. This site is located at UTM: N: 4301568 & E: 248194.

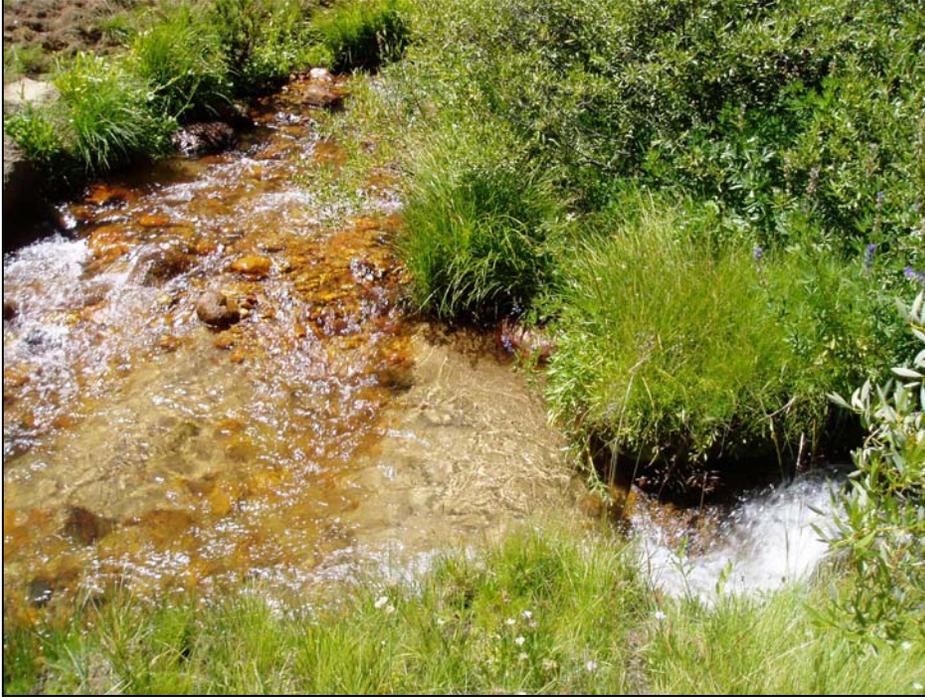
**Site 15:** Willow Creek, Carson Ranger District. Upstream photo of a large tributary entering Willow Creek on river left. The tributary adds 30-35 percent to the total downstream flow in the creek. This site is located at UTM: N: 4301646 & E: 248239.

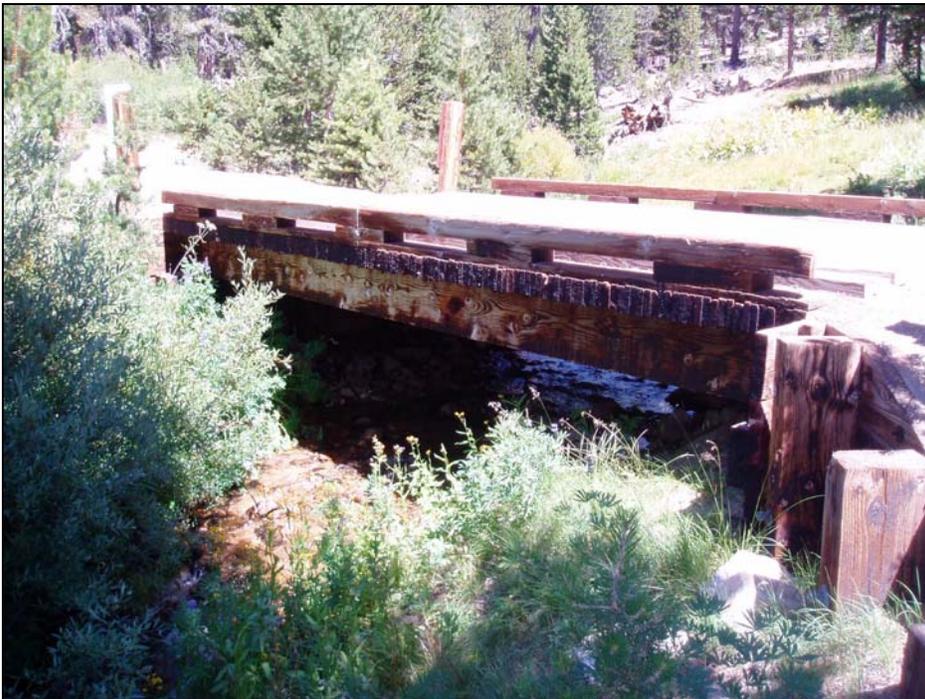
**Site 15:** Tributary to Willow Creek, Carson Ranger District. Upstream photo of bridge where the tributary featured above intersects Forest Service Road 051. This site is located at UTM: N: 4301646 & E: 248239

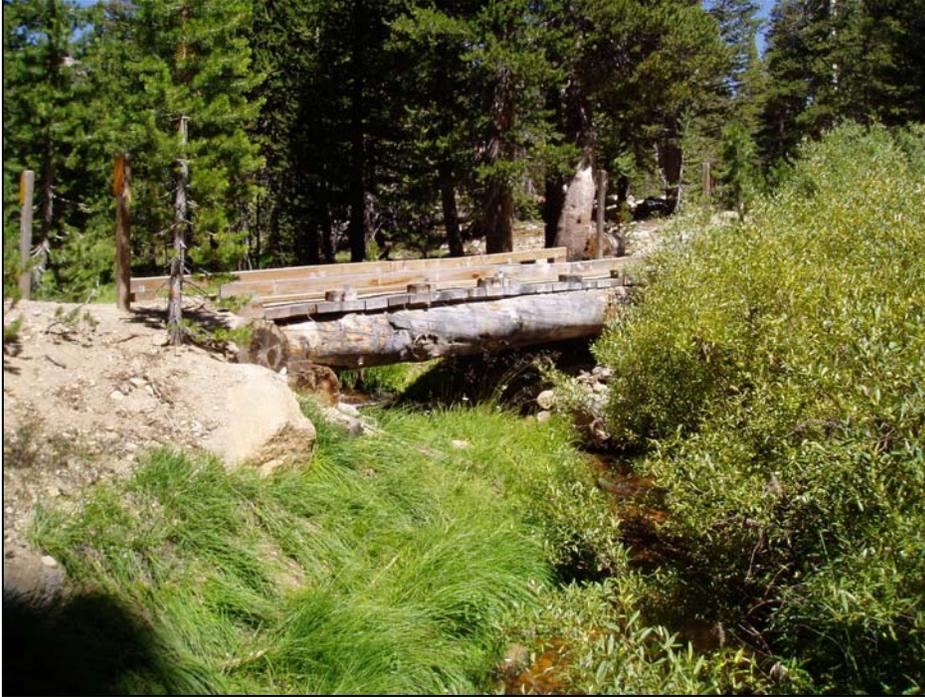
**Site 16:** Willow Creek, Carson Ranger District. Upstream photo of a bridge that crosses over Willow Creek. The trail allows for ATV and foot traffic only. This site is located at UTM: N: 4301721 & E: 248236, Elev. 8282 feet (2525m).
