# **WILLOW CREEK**

## 2006 Stream Habitat Survey Report

Carson Ranger District: Humboldt-Toiyabe National Forest

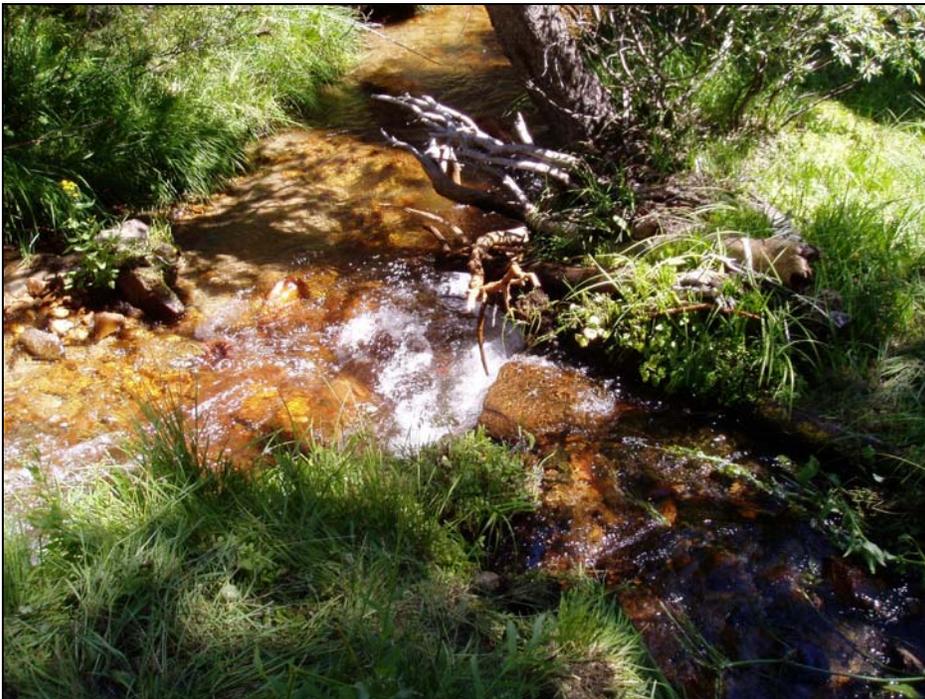
**Site 17:** Willow Creek, Carson Ranger District. Downstream view of a tributary (15% contribution to flow) entering river right. This site is located at UTM: N: 4301715 & E: 248232, Elev. 8282 feet (2525m).

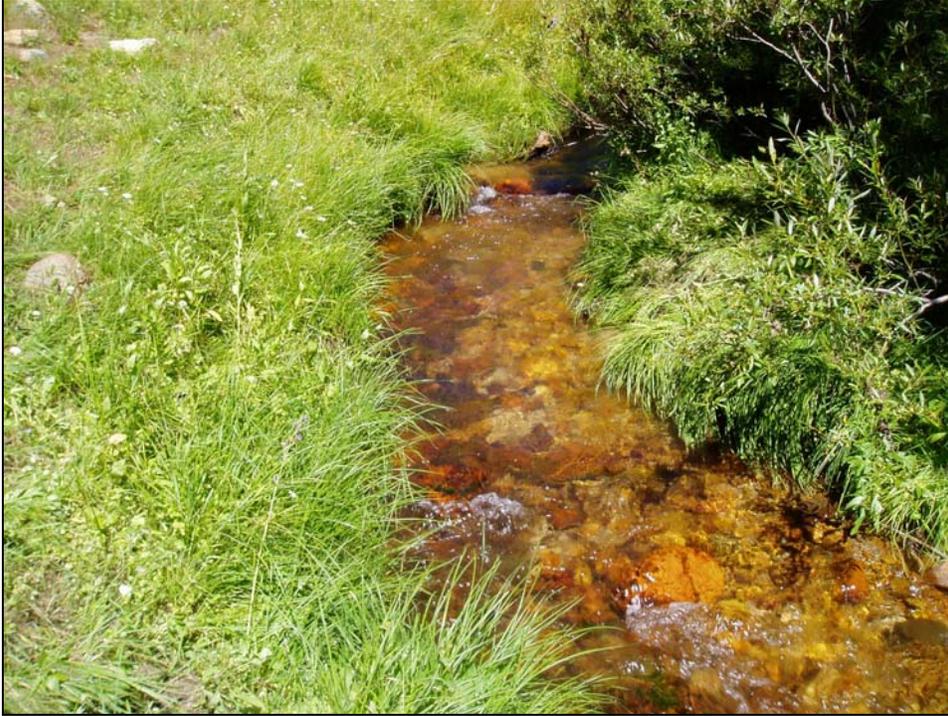
**Site 17:** Willow Creek, Carson Ranger District. Upstream photo of Willow Creek above the confluence. This site is located at UTM: N: 4301715 & E: 248232, Elev. 8282 feet (2525m).

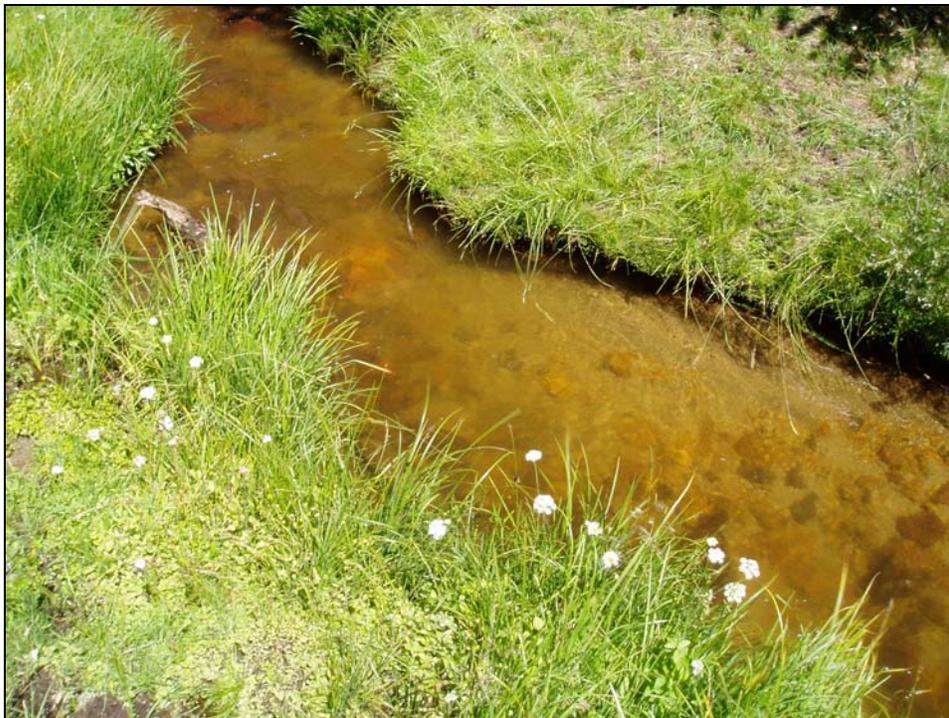
**Site 18:** Willow Creek, Carson Ranger District. Upstream photo of a pool where three fish were sighted. This site is located at UTM: N: 4301920 & E: 248323, Elev. 8374 feet (2553m).

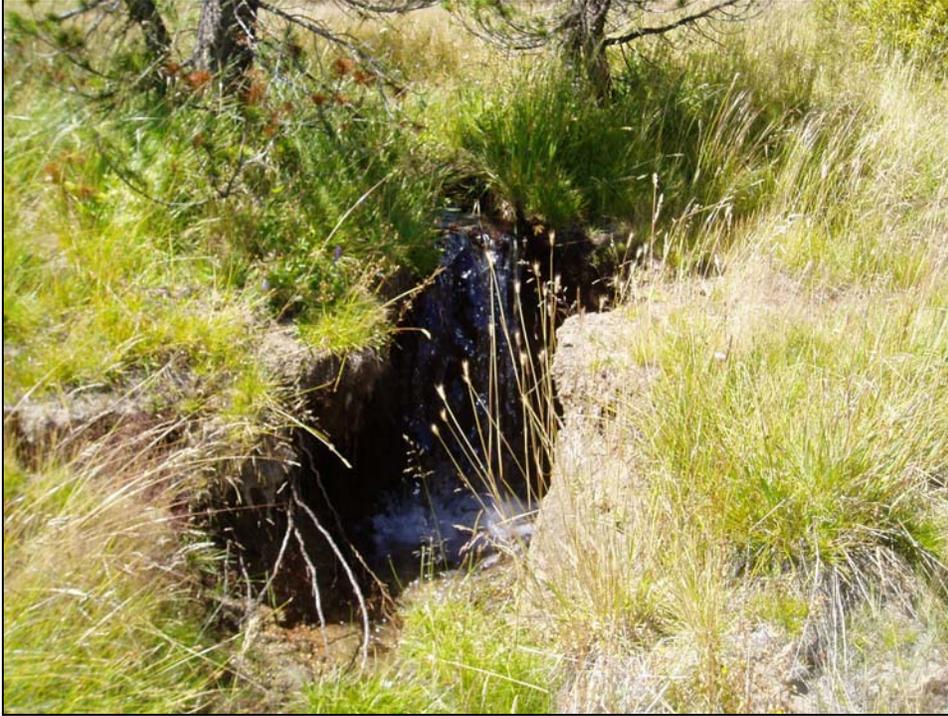
**Site 19:** Willow Creek, Carson Ranger District. Looking up a small trib (4 percent addition) that enters river right. This site is located at UTM: N: 4302215 & E: 248611, Elev. 8380 feet (2555m).

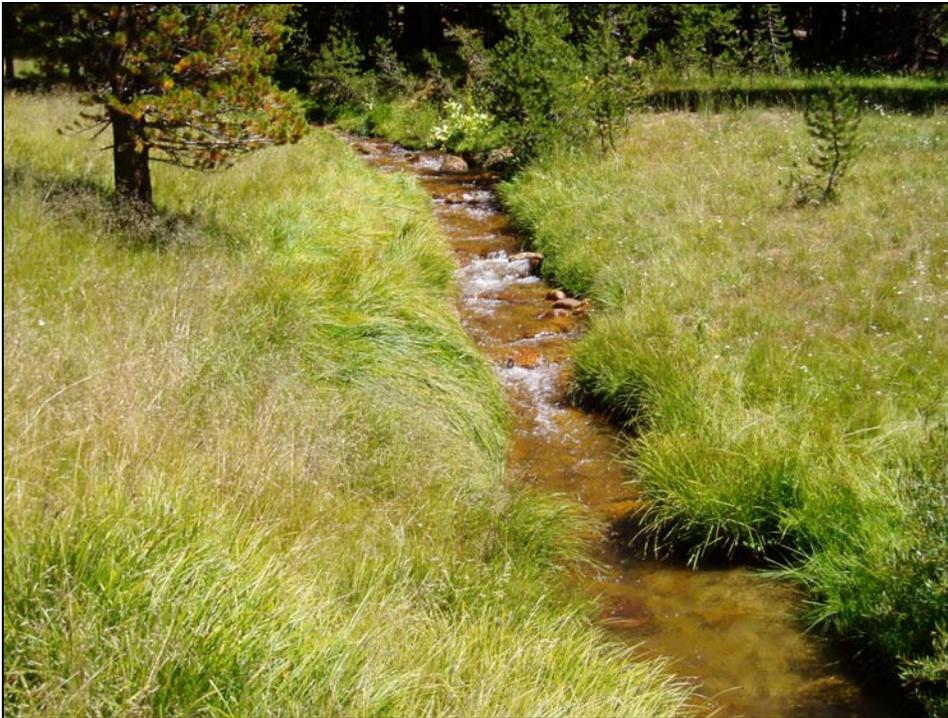
**Site 19:** Willow Creek, Carson Ranger District. Looking up Willow Creek from the confluence noted above. This site is located at UTM: N: 4302215 & E: 248611, Elev. 8380 feet (2555m).

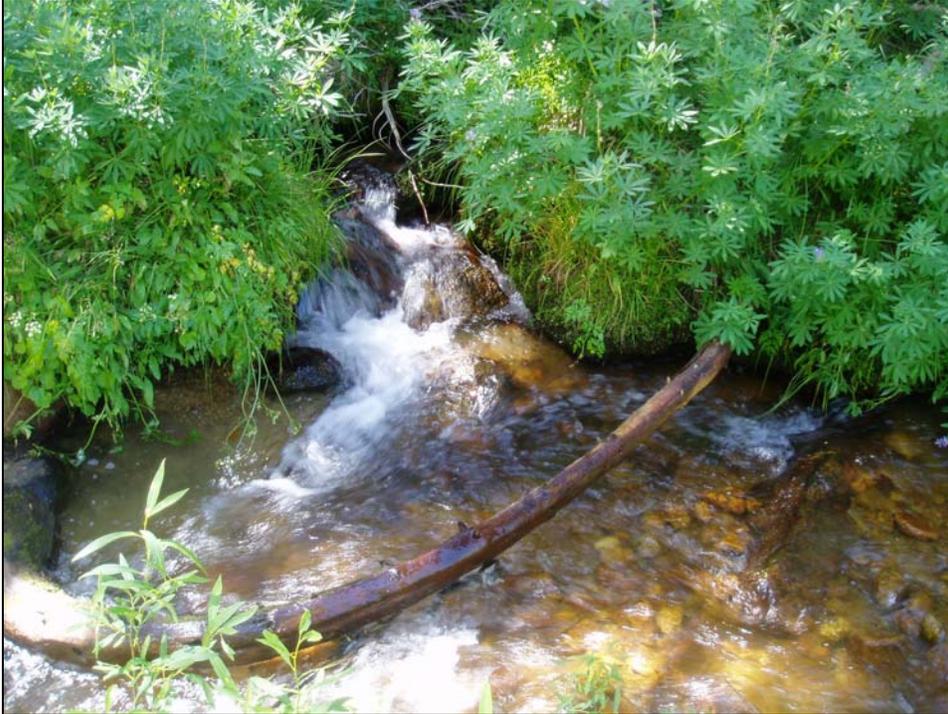
**Site 20:** Willow Creek, Carson Ranger District. Cross-sectional photo of a tributary entering on river right (35% contribution). This site is located at UTM: N: 4302215 & E: 248611, Elev. 8380 feet (2555m).

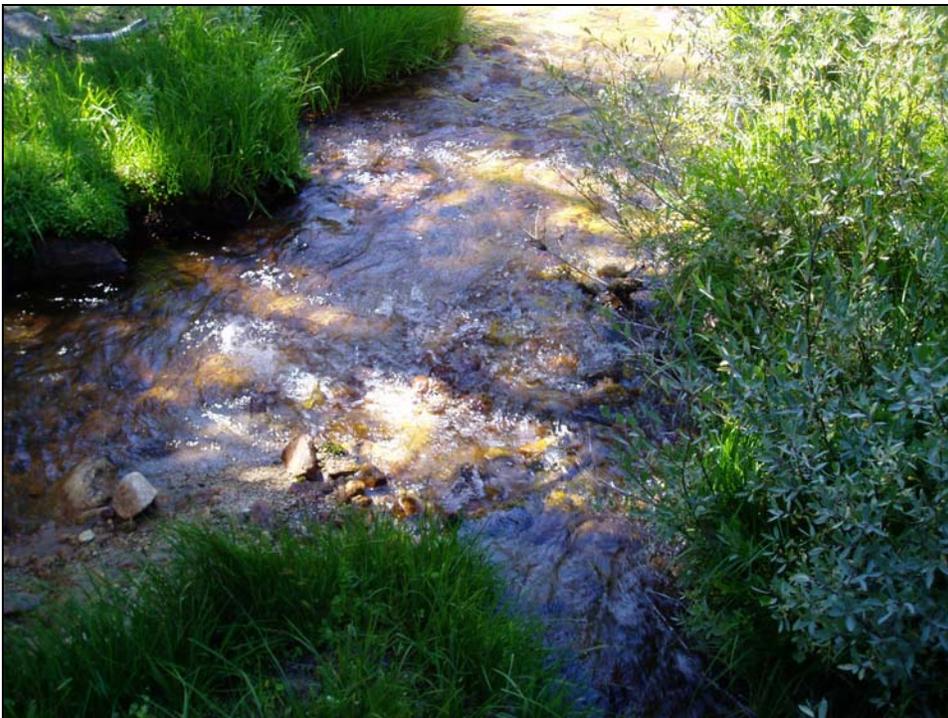
**Site 21:** Willow Creek, Carson Ranger District. Bird's eye view of a tributary contributing roughly 20-30 percent to flow in Willow Creek. This site is located at UTM: N: 4302347 & E: 248881, Elev. 8462 feet (2580m).

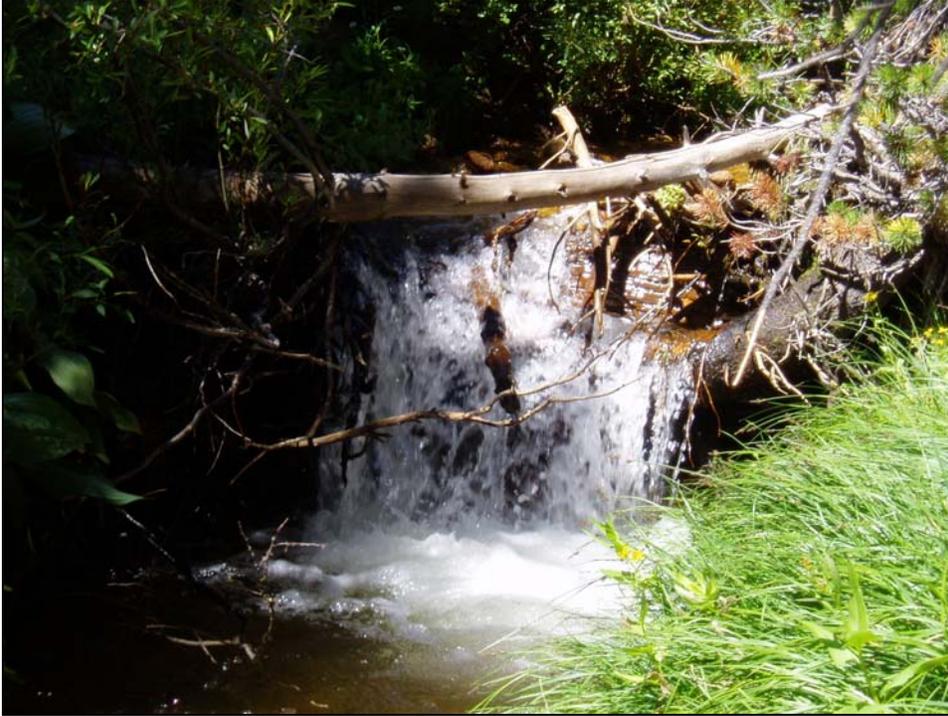
**Site 22:** Willow Creek, Carson Ranger District. Upstream photo of a seasonal fish barrier measuring 3.2 feet high, with a maximum pool depth of 2.1 feet. This site is located at UTM: N: 4302595 & E: 249055, Elev. 8482 feet (2586m).

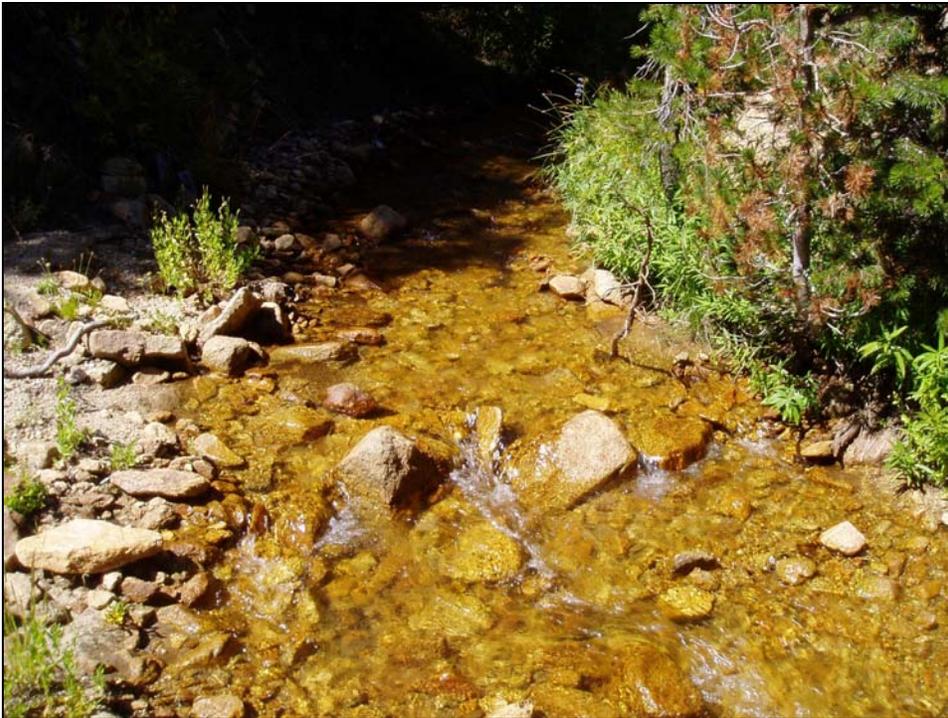
Upstream of Site 21 the stream is reduced in size because tributaries provide a large amount of water to Willow Creek at and below that point (Sites 17, 19, 20, & 21). The minimal flows and small shallow stream are not conducive to sustainable habitat throughout varying hydrologic conditions. Downstream of Site 1 Willow Creek is located on state land. The status and condition of that section is unknown.

**Site 23:** Willow Creek, Carson Ranger District. Upstream photo at the survey end point. Stream flow is likely minimal or non-existent at this location during dry years. This site is located at UTM: N: 4303043 & E: 249501, Elev. 8715 feet (2657m).

2. Consider the section of Willow Creek between Site 1 and Site 4, and the section between Site 21 and Site 23 as having no potential LCT habitat.
3. Discuss with ranchers/livestock managers the possibility of isolating a riparian corridor, and or limiting livestock access points to the creek. Consider cost-share in fencing these buffers.
4. Remove and disassemble all campsites within 100 feet of the stream.
5. Close and decommission all non-designated roads that lead to unwanted campsites and/or allow vehicles to drive onto stream banks.
