WOLF CREEK

2006 Stream Habitat Survey Report

Carson Ranger District: Humboldt-Toiyabe National Forest

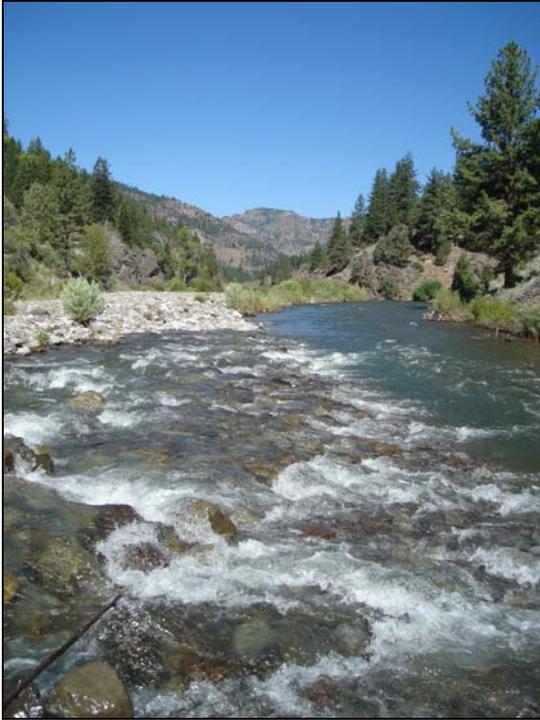
Site 1: Wolf Creek, Carson Ranger District. Downstream photo of the confluence of Wolf Creek (left) and the East Fork Carson River (right). Wolf Creek contributes an average of 30% to the downstream flow in the East Fork. This site is located at UTM: N: 4277190 & E: 265544, Elev. 6038 feet (1841m).

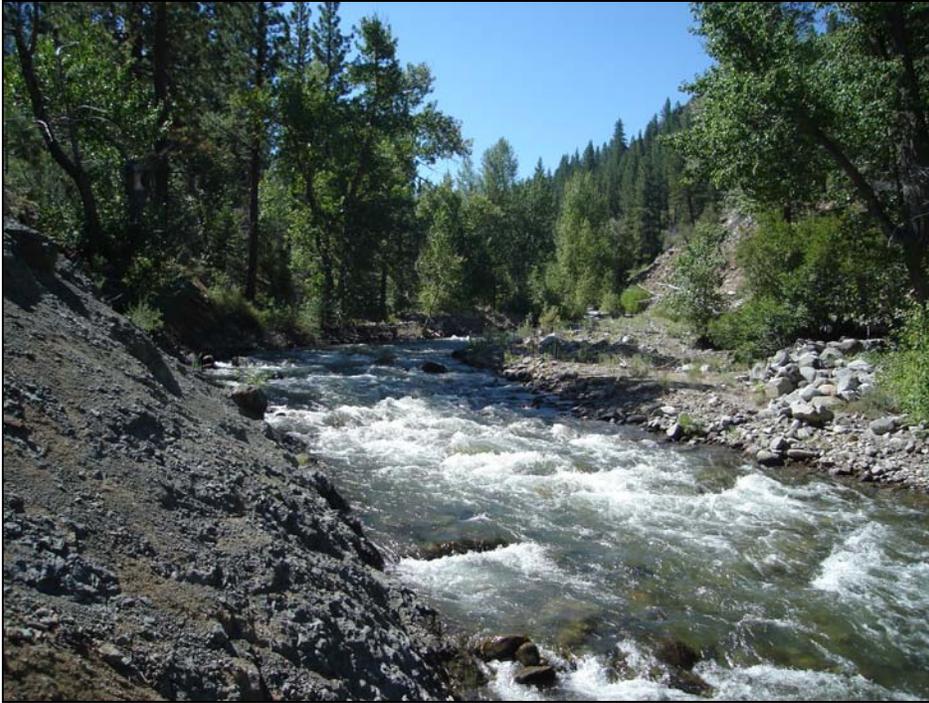
Site 1: Wolf Creek, Carson Ranger District. Upstream photo of Wolf Creek just above the confluence with the East Fork. This site is located at UTM: N: 4277190 & E: 265544, Elev. 6038 feet (1841m).

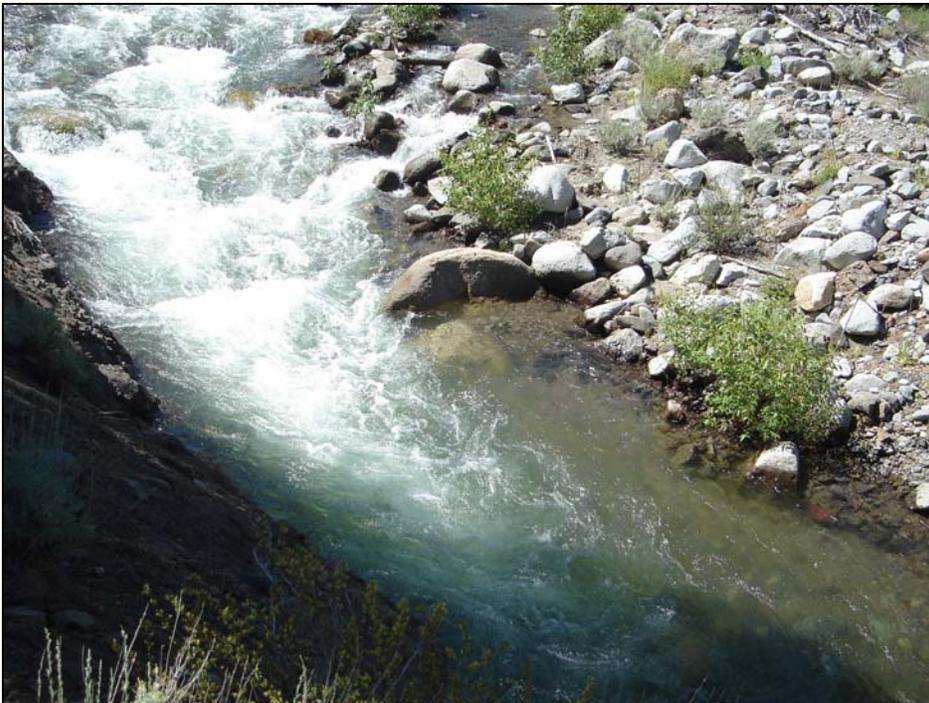
Site 2: Wolf Creek, Carson Ranger District. Upstream photo shows typical cross-section: the outside of the bend is steep bedrock and the inside is a bar composed of cobble/boulder substrate. This site is located at UTM: N: 4277114 & E: 265699, Elev. 6055 feet (1846m).

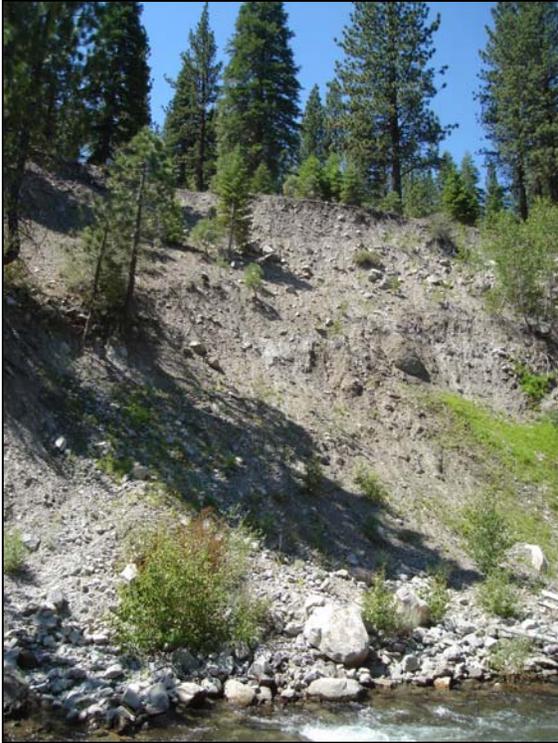
Site 4: Wolf Creek, Carson Ranger District. Photo shows an exposed left bank (80m long & 5-20m tall), subject to erosion. This site is located at UTM: N: 4276252 & E: 265916, Elev. 6183 feet(1885m).

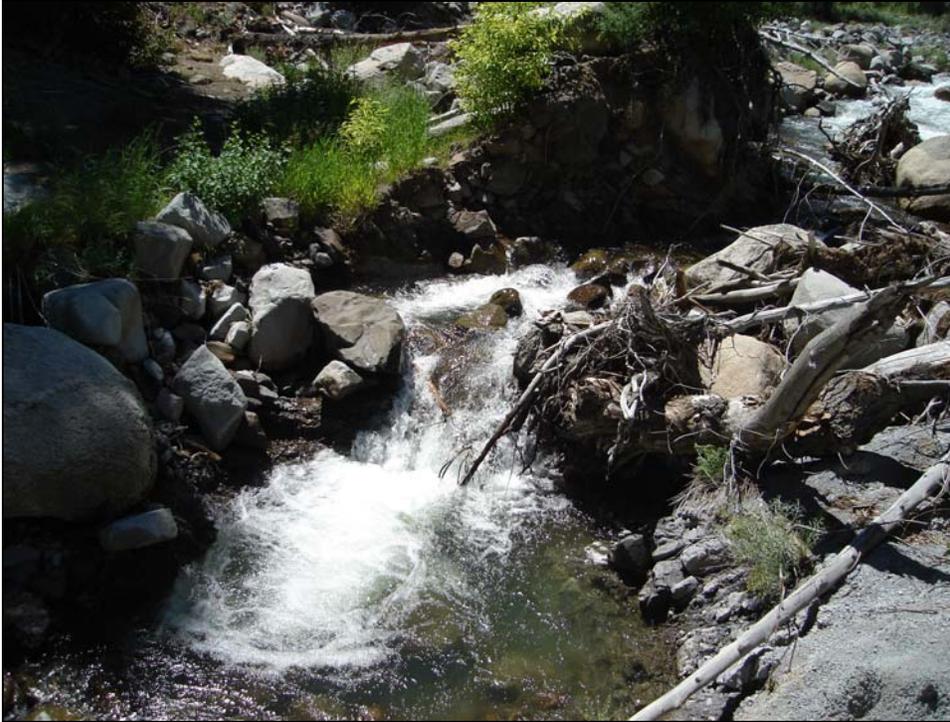
Site 5: Wolf Creek, Carson Ranger District. Photo shows a campsite inside the canyon. The camp is located roughly 15m from right bank. This site is located at UTM: N: 4276266 & E: 265964, Elev. 6219 feet (1896m).

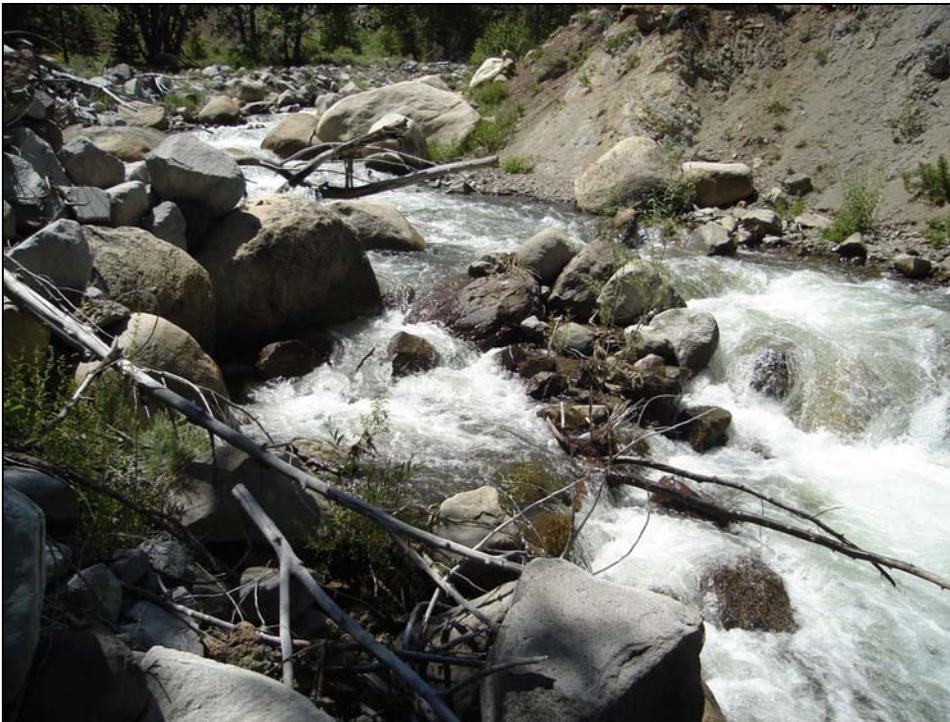
Site 6: Wolf Creek, Carson Ranger District. Upstream photo of the river right braid and a 2.9 foot seasonal fish barrier. The stream divides into two braids, both of which have seasonal barriers. This site is located at UTM: N: 4276203 & E: 265995.

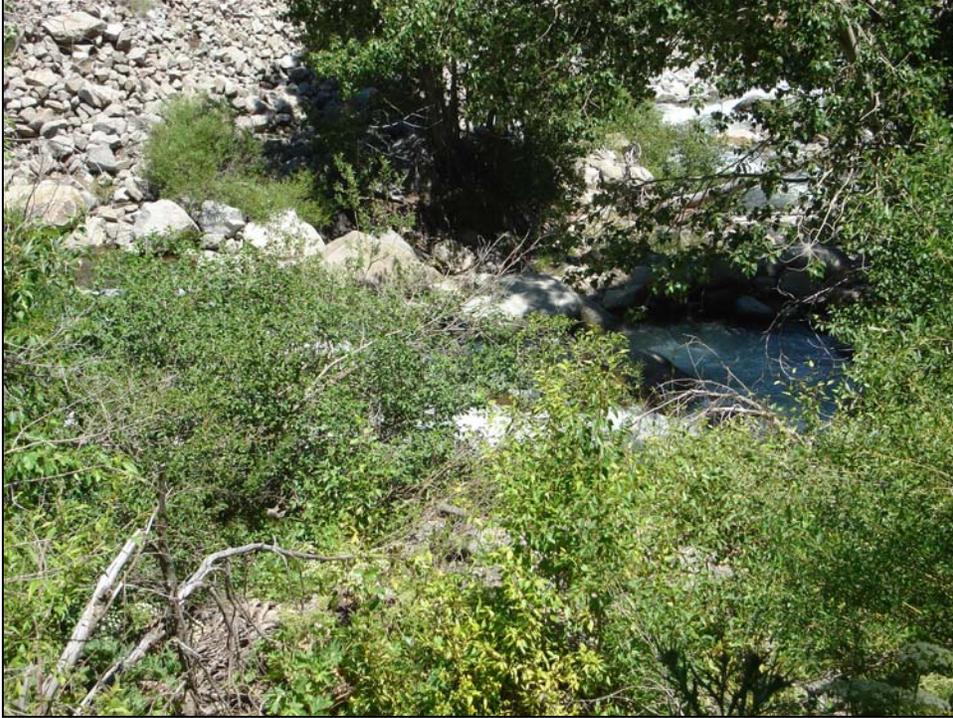
Site 9: Wolf Creek, Carson Ranger District. Viewpoint looking down a small, brushy tributary towards river right (<1% contribution). This site is located at UTM: N: 4275846 & E: 265976, Elev. 6248 feet (1905m).

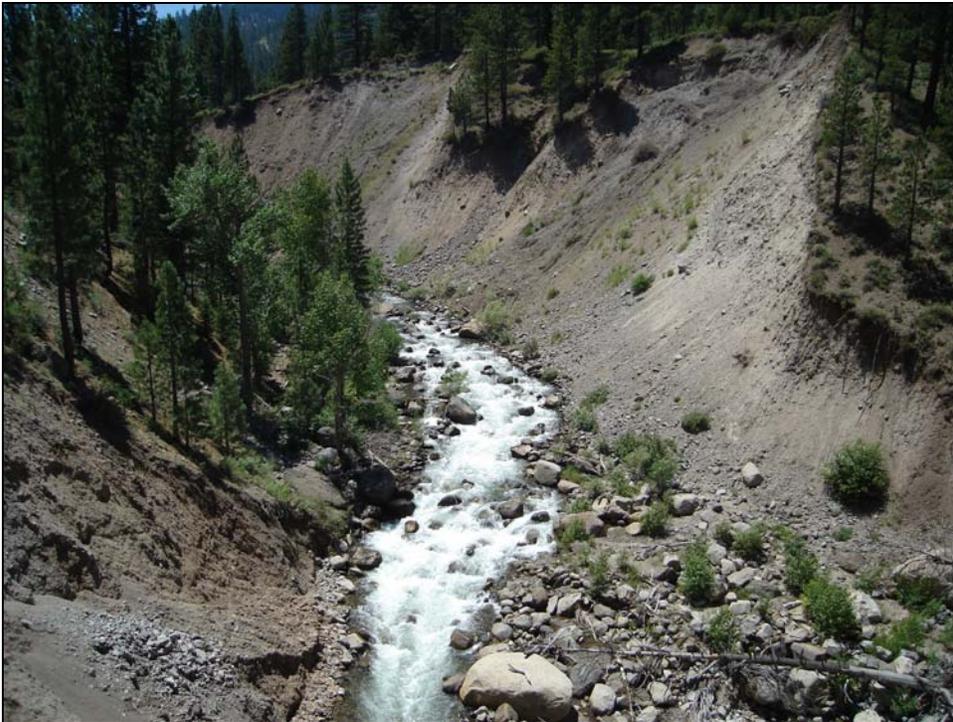
Site 10: Wolf Creek, Carson Ranger District. Upstream photo of an entrenched and moderate gradient Wolf Creek. This site is located at UTM: N: 4275849 & E: 265951, Elev. 6409 feet (1954m) at point of photo.

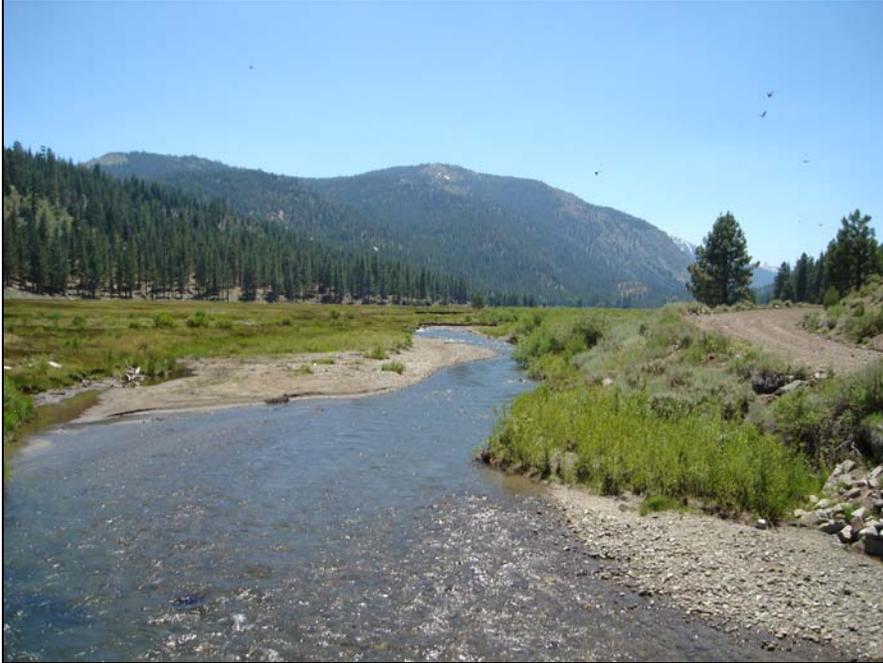
Site 11: Wolf Creek, Carson Ranger District. Upstream photo of Wolf Creek Meadows, taken from a bridge where Forest Service Road 090 crosses the stream. This bridge is located at the downstream boundary line of a private parcel of property. This site is located at UTM: N: 4275694 & E: 265916.

3. Discuss with private landowners the possibility of fencing a riparian corridor along Wolf Creek (Sites 11-12). Explore the possibility of funding/cost-share on fencing in exchange for retiring acreage.

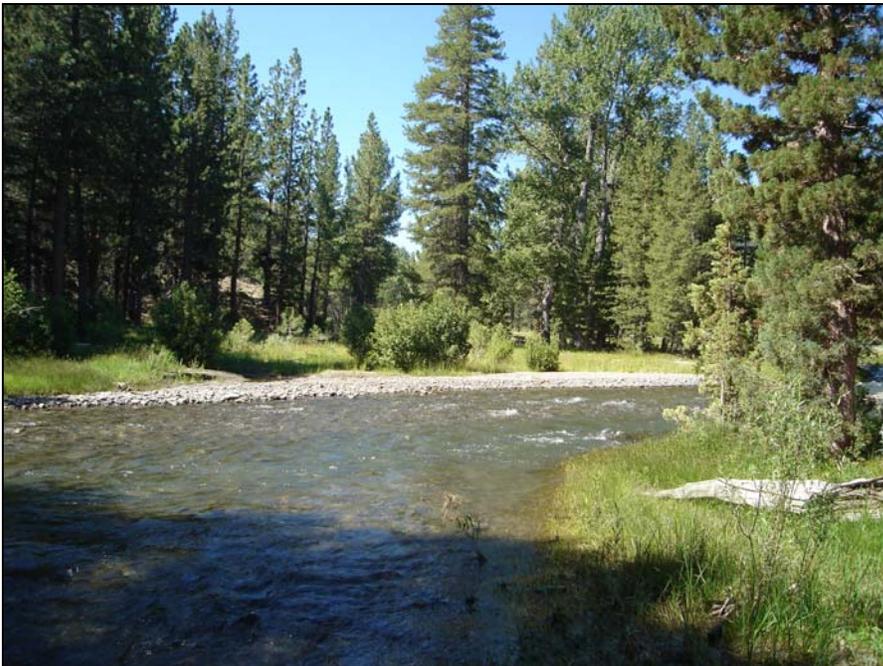
Site 12: Wolf Creek, Carson Ranger District. Upstream view from the upper private property boundary. Sites 11 and 12 are separated by approximately 1.5 miles. This site is located at UTM: N: 4273714 & E: 265705, Elev. 6435 feet (1962m).

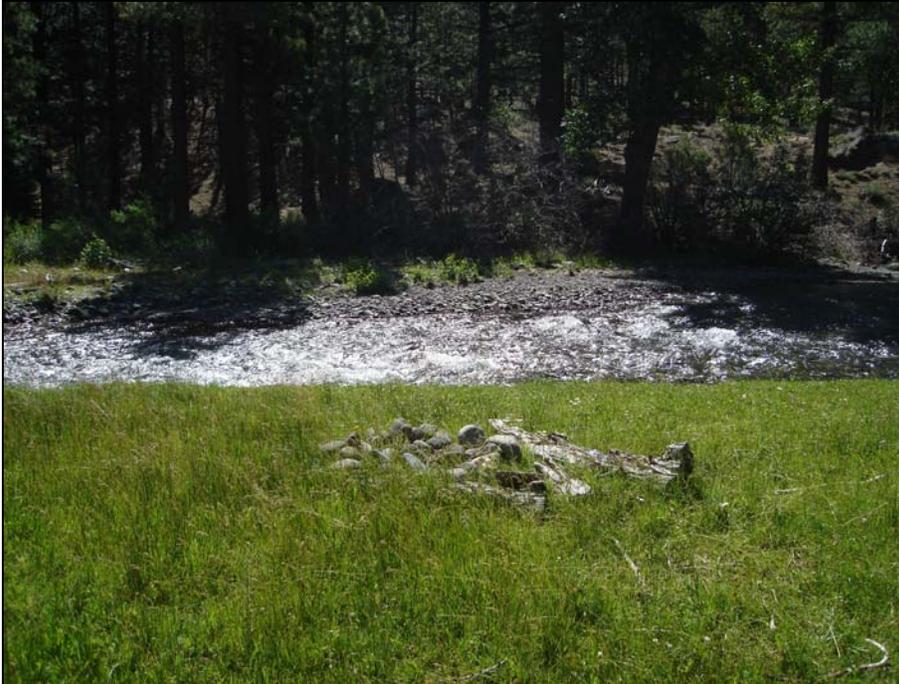
Site 13: Wolf Creek, Carson Ranger District. Photo shows a campsite on the left bank, located about 1m from water. This site is located at UTM: N: 4273641 & E: 265657.

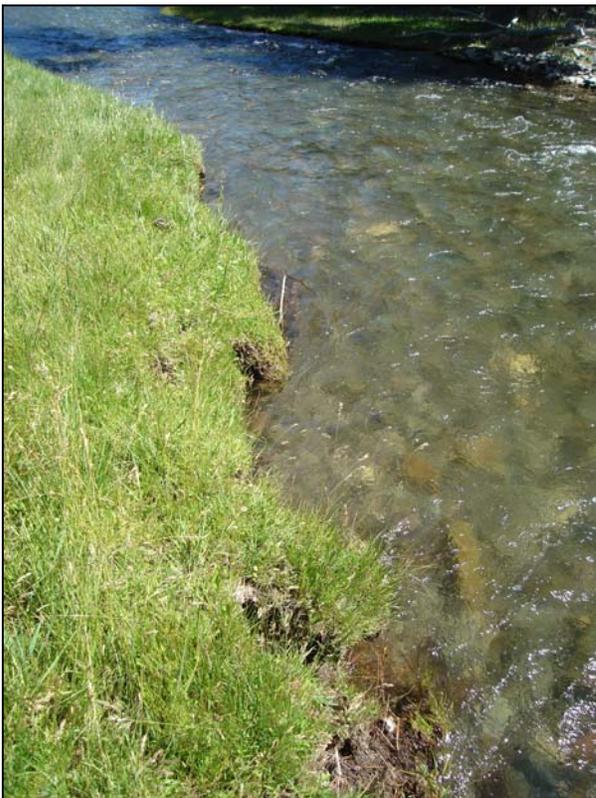
Site 13: Wolf Creek, Carson Ranger District. Downstream photo of a slumping bank near the campsite. Grazing and hooves may expedite the erosion process at this location. This site is located at UTM: N: 4273641 & E: 265657.

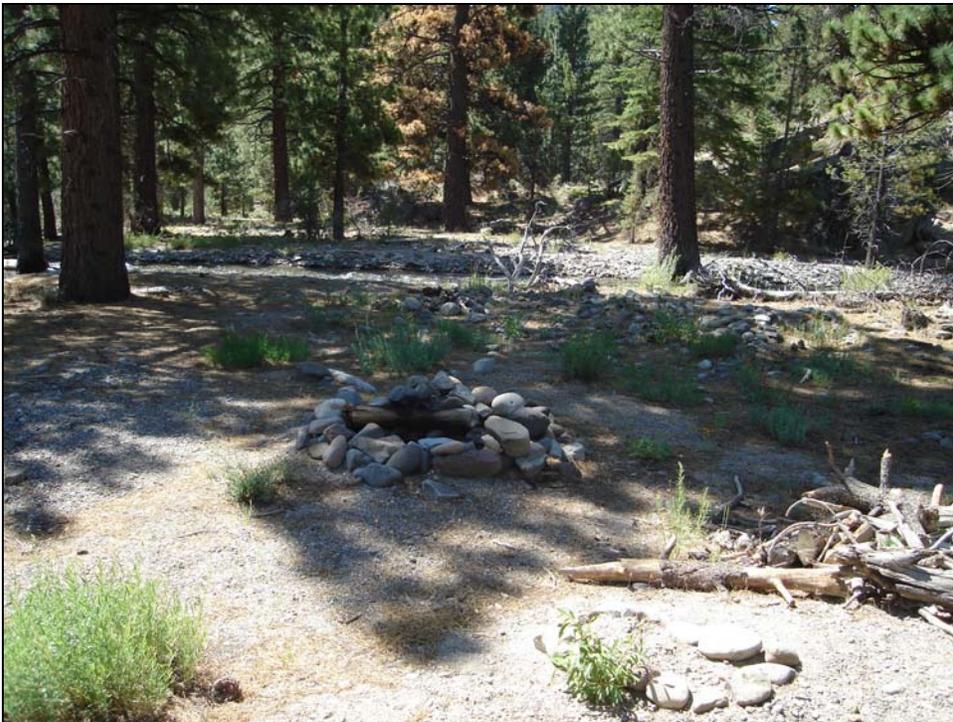
Site 15: Wolf Creek, Carson Ranger District. Photo shows a campsite located 8m from the left bank. This site is located at UTM: N: 4273283 & E: 265412, Elev. 6458 feet (1969m).

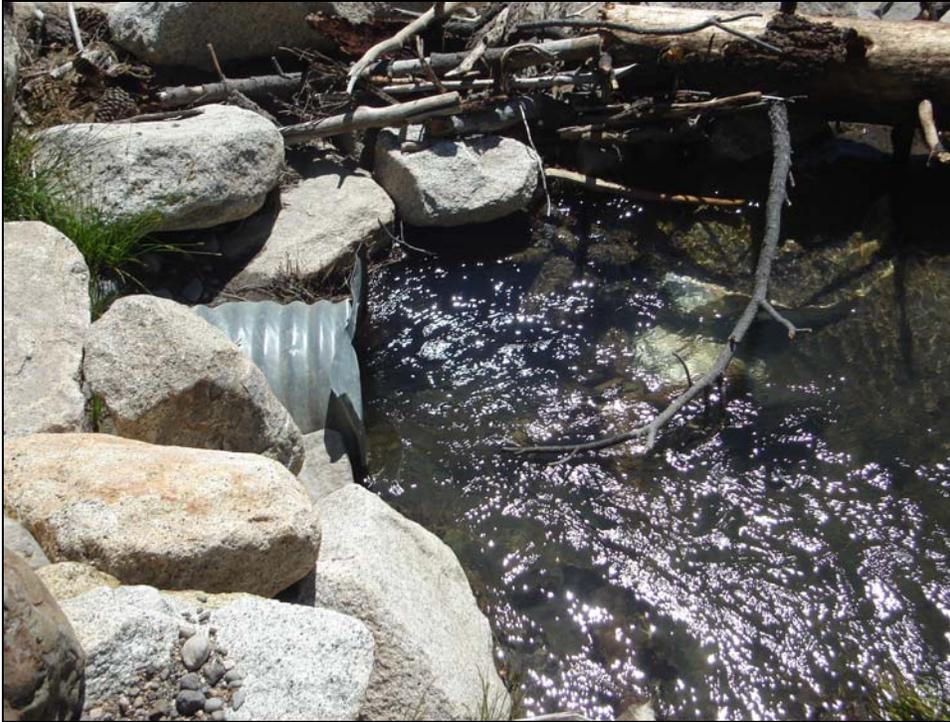
Site 16: Wolf Creek, Carson Ranger District. Bird's eye view of a diversion that takes 4-5% of the flow in the stream out to irrigated pasture. This site is located at UTM: N: 4273267 & E: 265322, Elev. 6514 feet (1986m).

4. Investigate and enhance the effectiveness of the diversion at Site 16 to ensure that the adjudicated quantity of water is diverted, and to ensure that fish are not being terminally recruited into an irrigation canal.

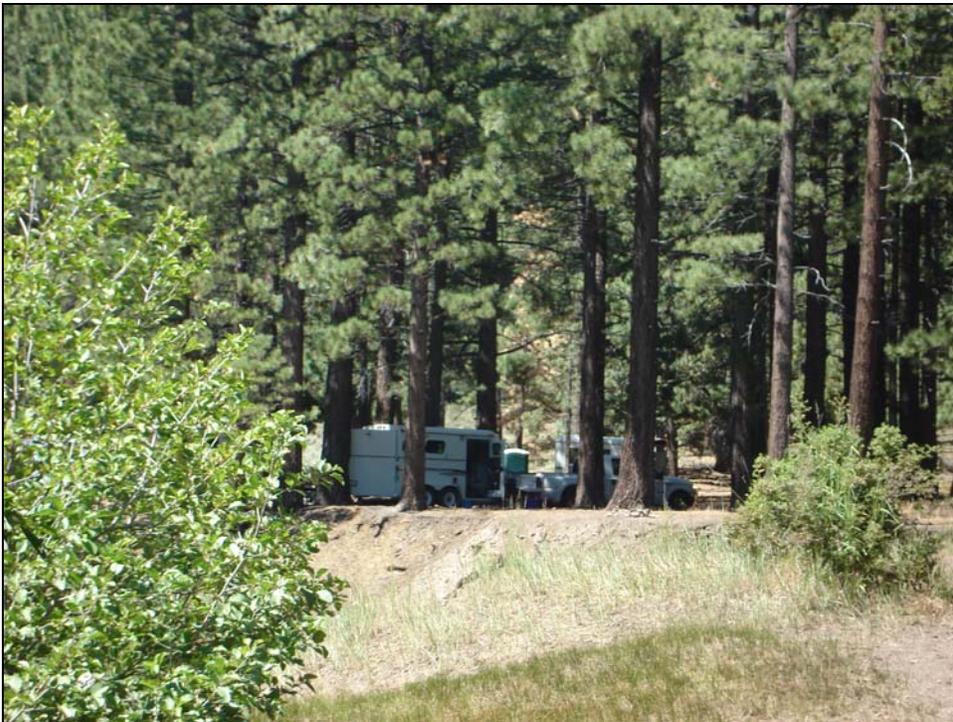
Site 17: Wolf Creek, Carson Ranger District. Photo of a horse trailer parked near the Wolf Creek trailhead. This trailer is one of ten or more parked in the large camp. This site is located at UTM: N: 4273150 & E: 265244, Elev. 6560 feet (2000m).

5. Work with Forest Service personnel to maintain the integrity of both Wolf Creek and the campsite at Site 17. Consider opening more camping space away from the stream in order to close the areas adjacent to the watercourse. Decommission infrequently used campsites in the Wolf Creek watershed and encourage campers to utilize well established sites located at least 100 feet from the stream.

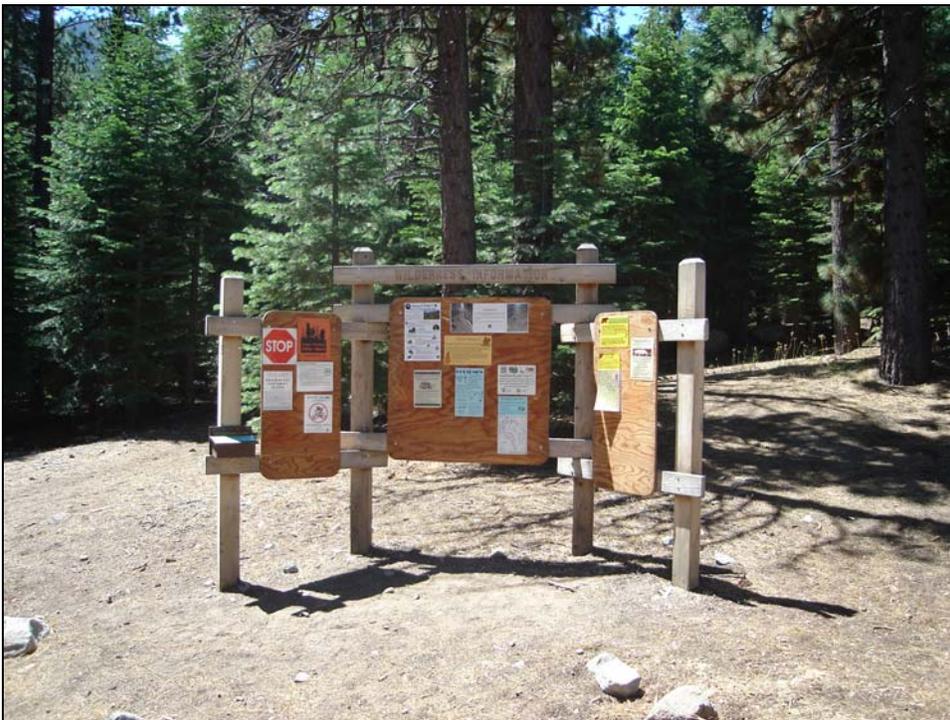
Site 18: Wolf Creek, Carson Ranger District. Photo of an information board near the trailhead. This site is located at UTM: N: 4272938 & E: 265071.

6. Enhance the visibility of Leave-No-Trace principles at trailheads leading into the Carson-Iceberg Wilderness.

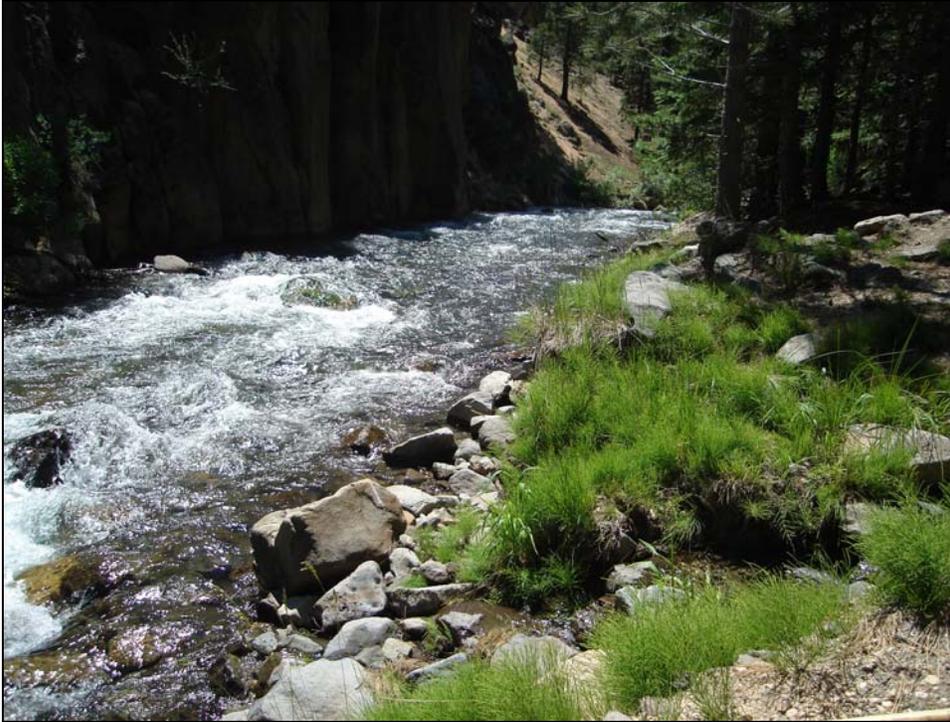
Site 19: Wolf Creek, Carson Ranger District. Upstream photo of confluence of Wolf Creek and a small tributary that enters at the Wilderness boundary line. This site is located at UTM: N: 4272981 & E: 265173.

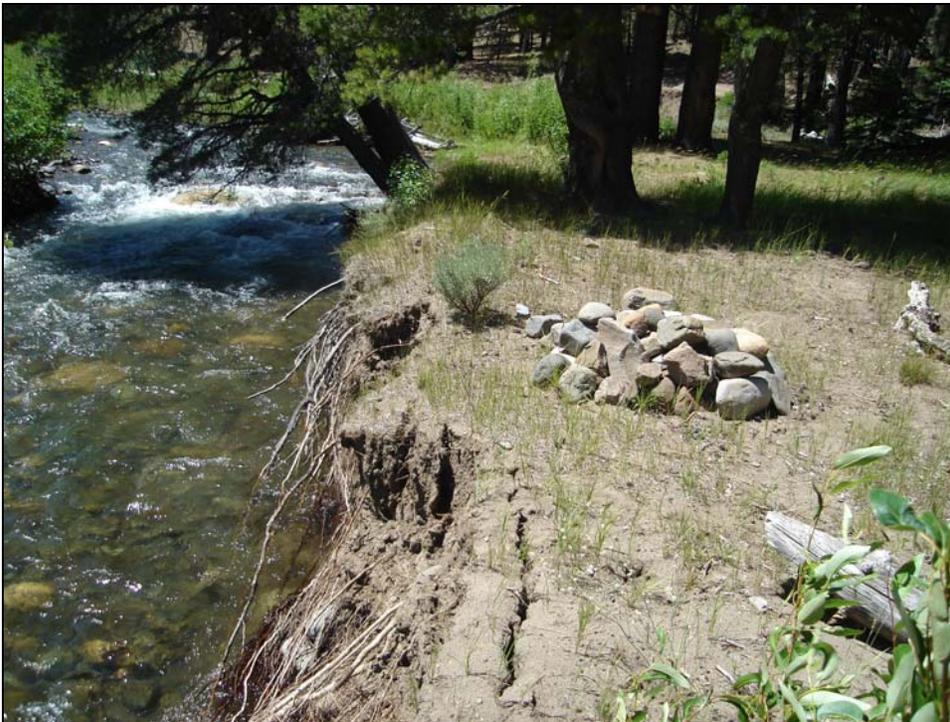
Site 20: Wolf Creek, Carson ranger District. Upstream view of a campsite situated less than 1m from the water. The campsite dimensions are 10m x 20m. Note the cracked bank. This site is located at UTM: N: 4272683 & E: 265175, Elev. 6540 feet (1994m).

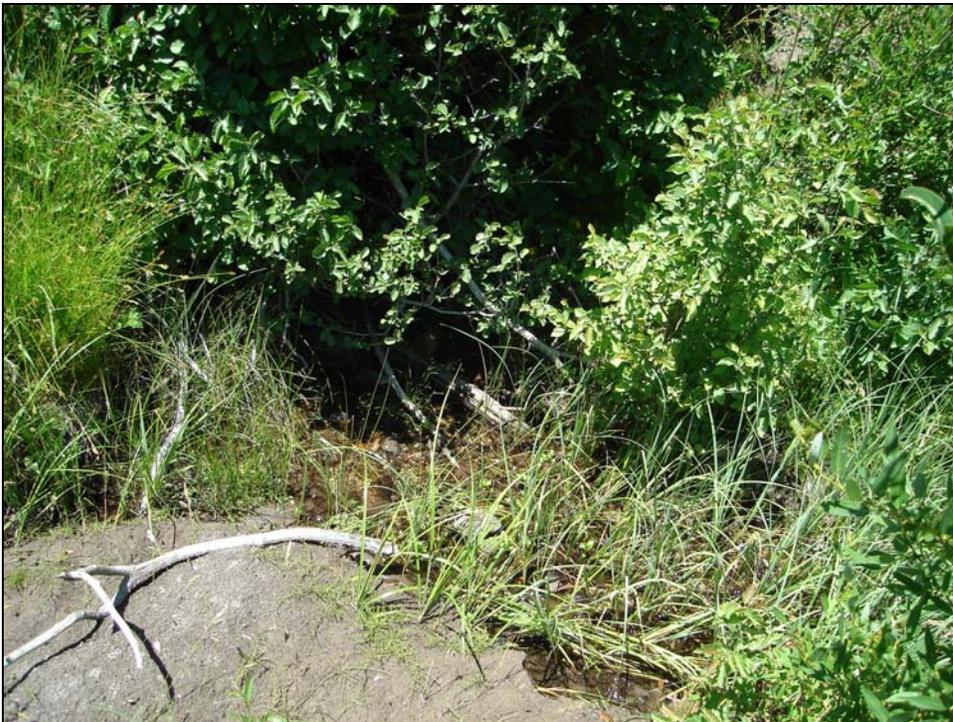
Site 22: Wolf Creek, Carson Ranger District. Photo of a small tributary that enters river left (1% contribution). This site is located at UTM: N: 4271677 & E: 264569, Elev. 6603 feet (2013m).

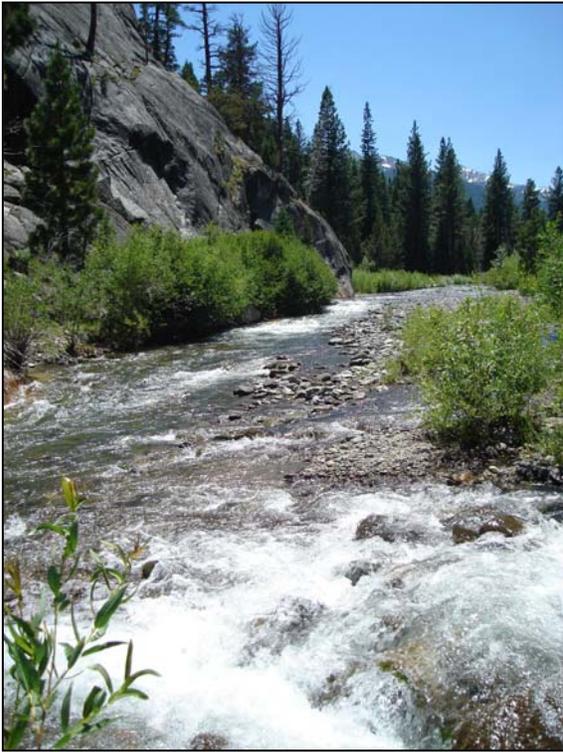
Site 23: Wolf Creek, Carson Ranger District. Looking up Wolf Creek where Dixon Creek enters (photo right), contributing 40% of the total flow. This site is located at UTM: N: 4271319 & E: 264439, Elev. 6652 feet (2028m).

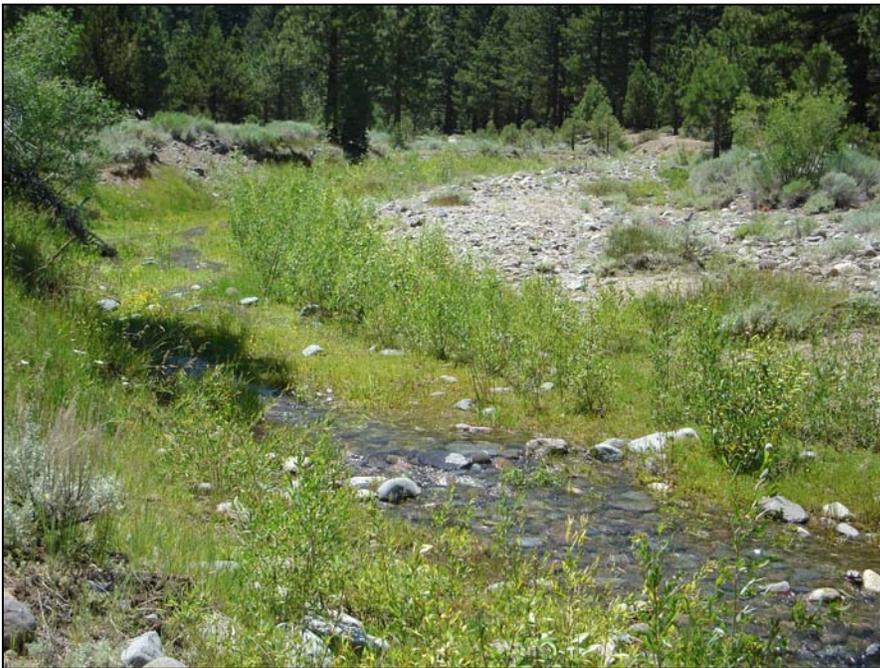
Site 24: Wolf Creek, Carson Ranger District. Looking up an unnamed tributary that enters Wolf Creek on river left (2% contribution). This site is located at UTM: N: 4271202 & E: 264387, Elev. 6649 feet (2027m).

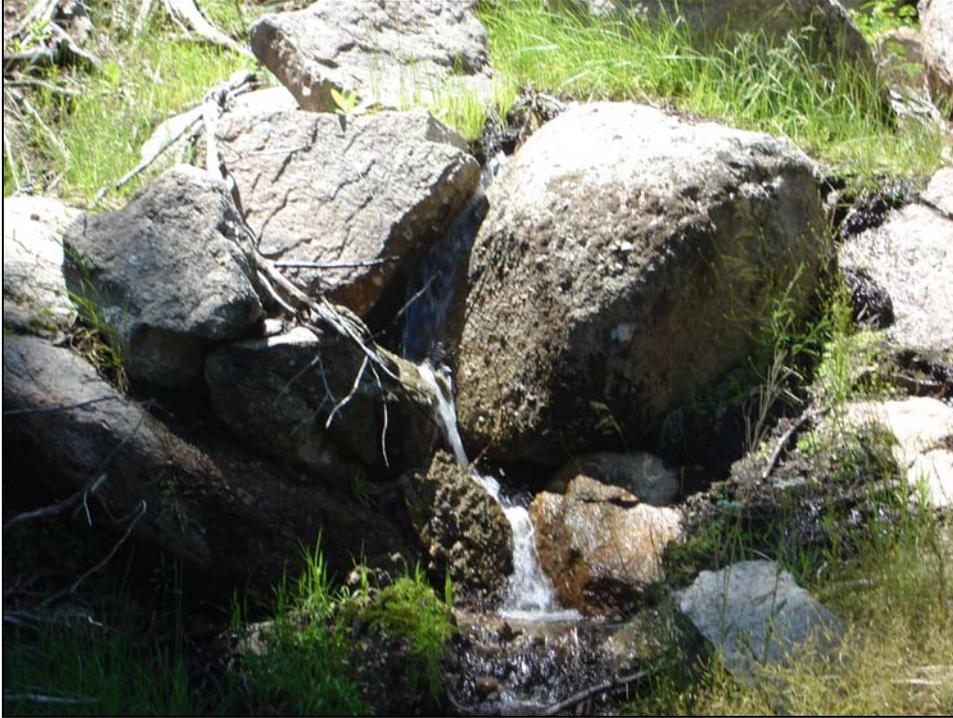
Site 25: Wolf Creek, Carson Ranger District. Photo of a small tributary (1% contribution) that enters river left. This site is located at UTM: N: 4270444 & E: 264089.

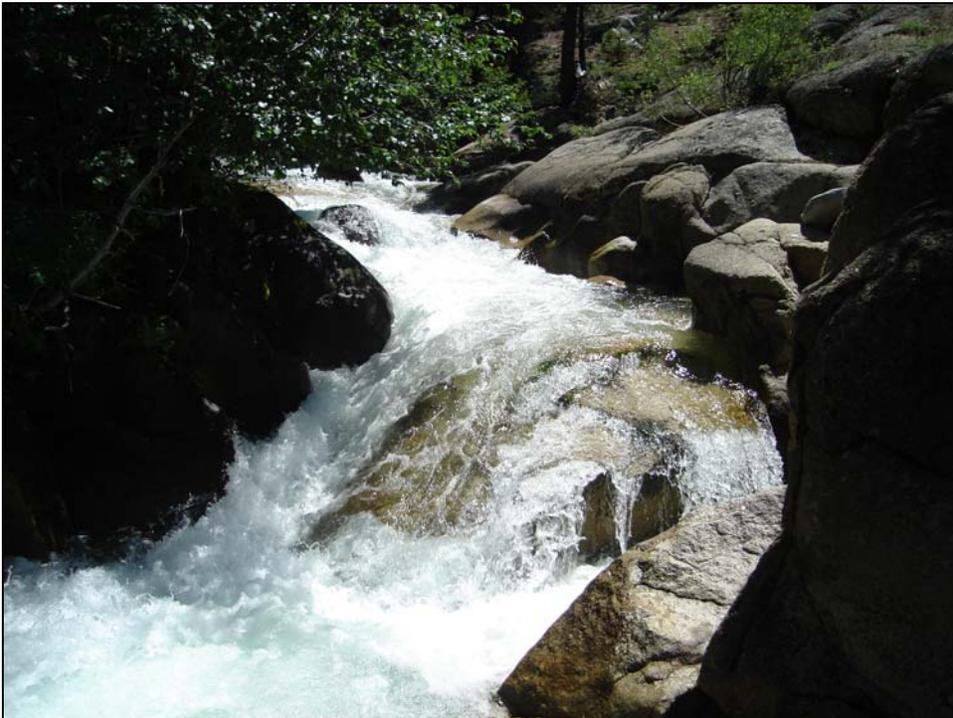
Three of the four recorded permanent fish passage barriers (Sites 26, 40 & Site 42) on Wolf Creek separate the stream into three substantial and continuous sections: Sites 1-26, Sites 26-40, and Sites 42-57. The reach between Site 1 and Site 26 is approximately 6.0 miles long, including the 1.5 river miles flowing through private property. Between Site 26 and Site 40 the stream has a relatively low gradient and total of approximately 2.86 river miles. Wolf Creek Falls (Site 40) is comprised of two parts and has a total vertical height of 50-75 feet. The permanent barrier at Site 42 is a 10-foot waterfall with a maximum pool depth of approximately 5.0 feet. The distance between the waterfalls at Sites 40 and 42 is approximately 0.50 miles. The river mileage between Sites 42-57 is approximately 2.65 miles. Seasonal barriers are found throughout the drainage; however, most of these barriers are concentrated in the upper half of the watershed. Between Sites 1 and 40 two seasonal barriers exist: a 2.4 foot barrier (Site 6) and 3.3 foot barrier (Site 35). The barrier at Site 26, although referenced as a permanent barrier above, this site may actually only prohibit fish passage seasonally. This section of stream offers vegetative cover, habitat complexity, and has a verified capability of inhabiting fish.

Site 26: Wolf Creek, Carson Ranger District. Upstream photo of a permanent fish barrier with height 5.3 feet. This site is located at UTM: N: 4269850 & E: 264273, Elev. 6803 feet (2074m).

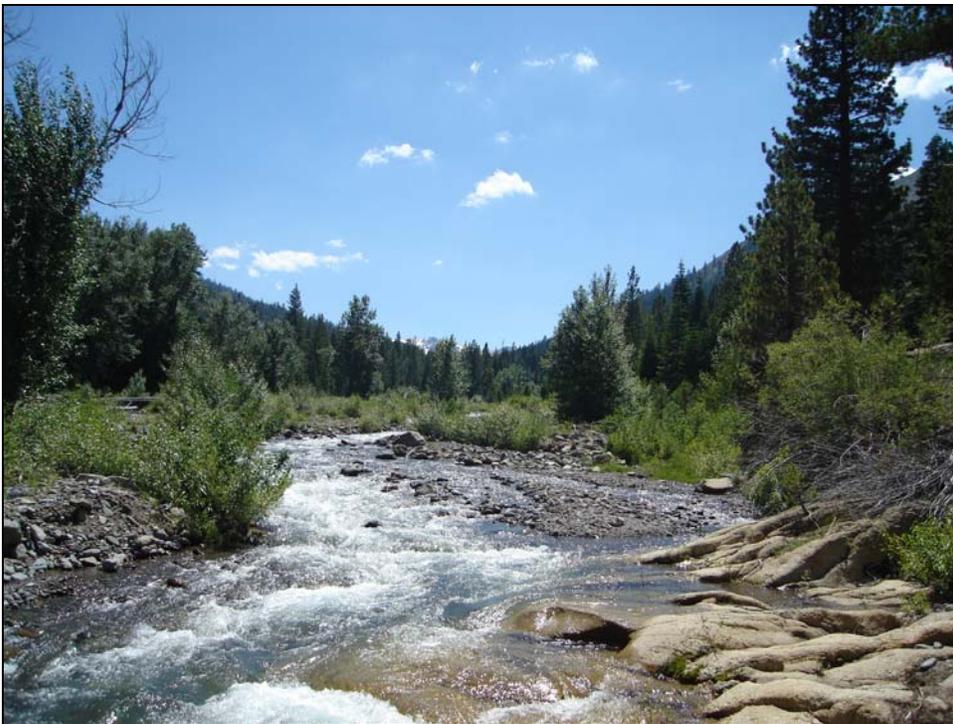
Site 27: Wolf Creek, Carson Ranger District. Upstream photo of creek as it flows through an alluvial valley. This site is located at UTM: N: 4269582 & E: 264200, Elev. 2095m).

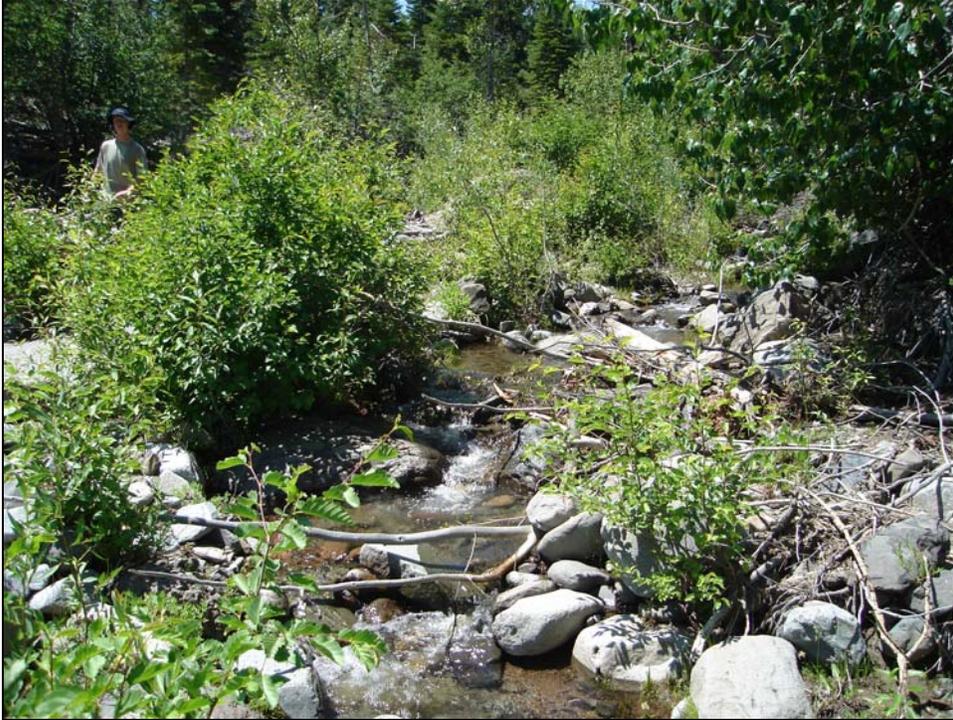
Site 28: Wolf Creek, Carson Ranger District. Photo of a tributary entering on river left (4% contribution). This site is located at UTM: N: 4269024 & E: 263813, Elev. 6891 feet (2101m).

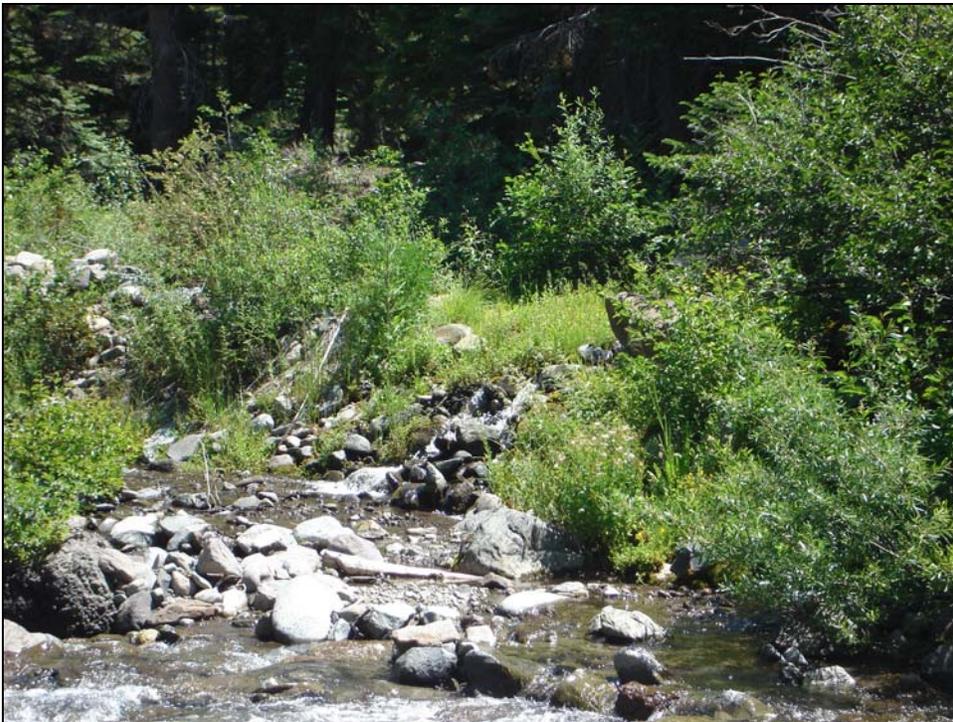
Site 28: Wolf Creek, Carson Ranger District. Photo of a tributary entering on river right (1-2% contribution). This site is located at UTM: N: 4269024 & E: 263813, Elev. 6891 feet (2101m).

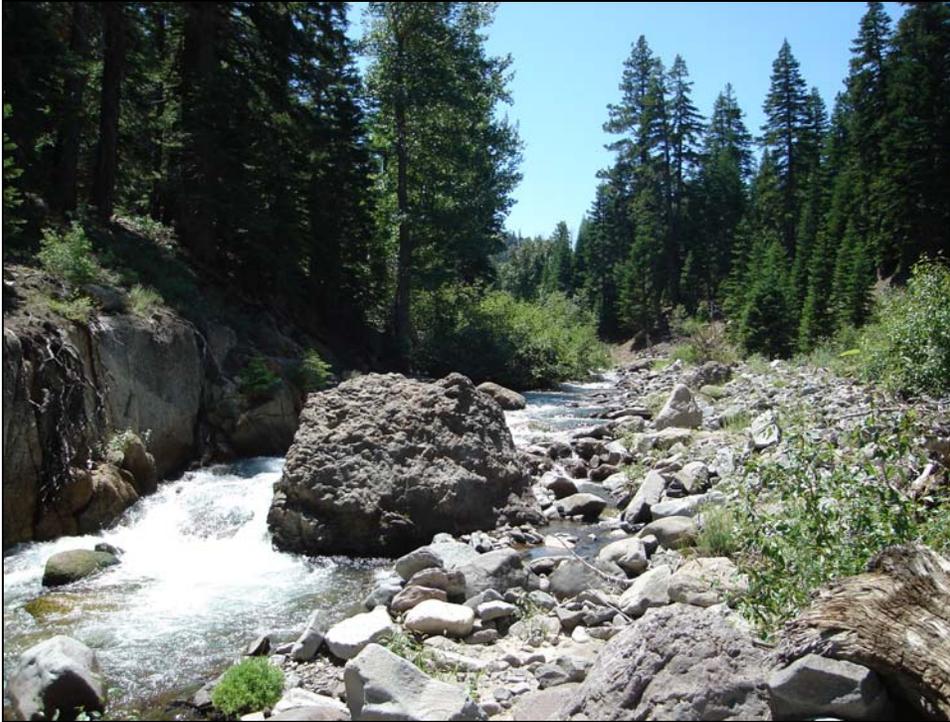
Site 29: Wolf Creek, Carson Ranger District. Upstream view of a moderately steep section of stream. This site is located at UTM: N: 4268306 & E: 263413, Elev. 7088 feet (2161m).

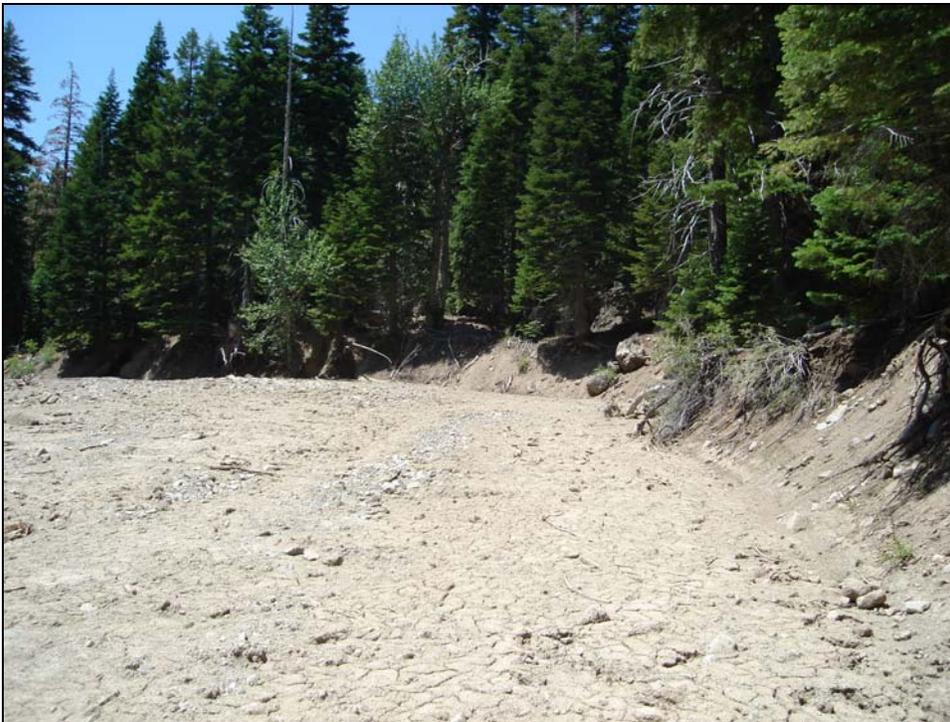
One major landslide event was documented and photographed as Site 30. A naturally occurring mudflow reached the floodplain and left a large debris pile, cutting through the main trail in the process. The photos associated with Sites 30-32 show the evidence of the event. At Site 33 the trail is located directly on an elevated stream bank. Any sort of slumping or further erosion will result in a piece of the trail falling into the channel below.

Site 30: Wolf Creek, Carson Ranger District. Upstream view of a debris bar deposited during a mudslide. The debris area is approximately 50m x 25m, with a depth of up to 3m. This site is located at UTM: N: 4268121 & E: 263276, Elev. 7131 feet (2174m).

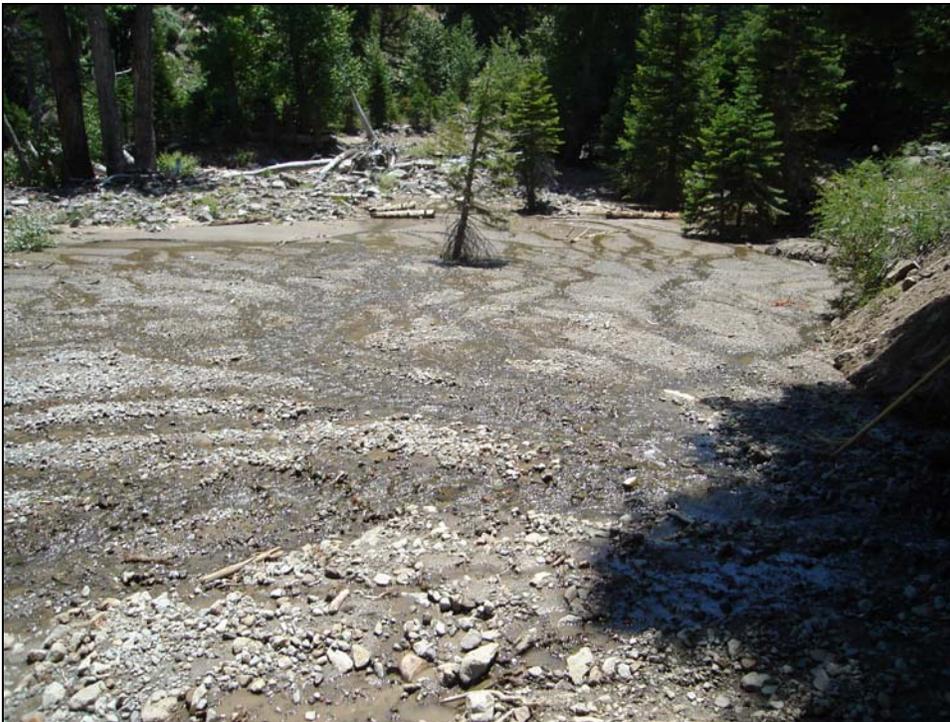
Site 31: Wolf Creek, Carson Ranger District. Photo shows the tributary that was the likely conduit for the mudflow. This site is located at UTM: N: 4268121 & E: 263276, Elev. 7131 feet (2174m).

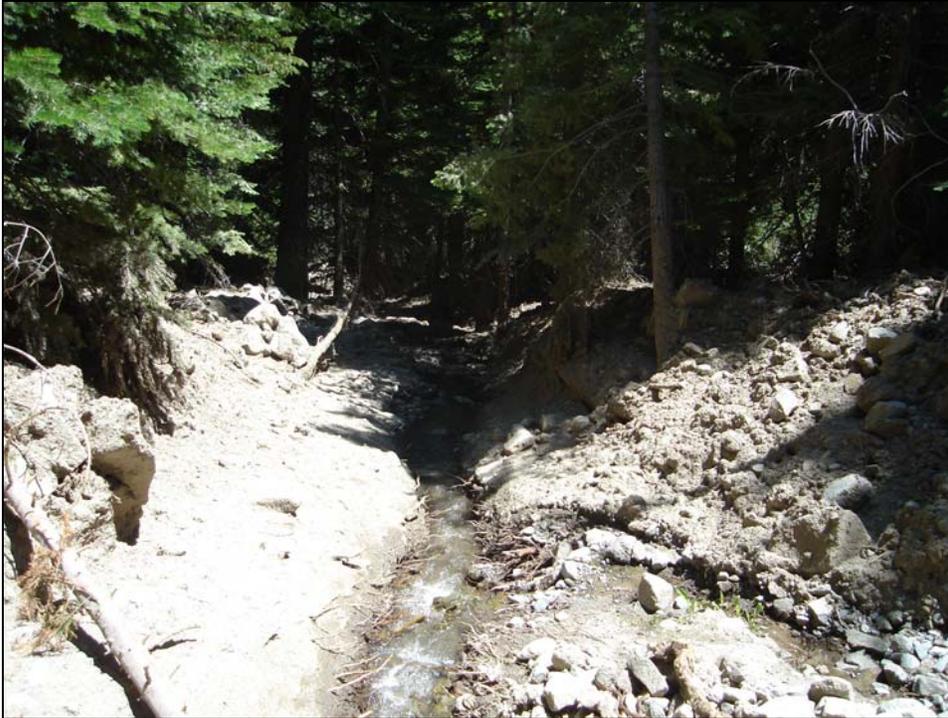
Site 32: Wolf Creek, Carson Ranger District. Looking up the tributary from Site 32 where the Wolf Creek trail intersects the drainage. This site is located at UTM: N: 4268103 & E: 263187.

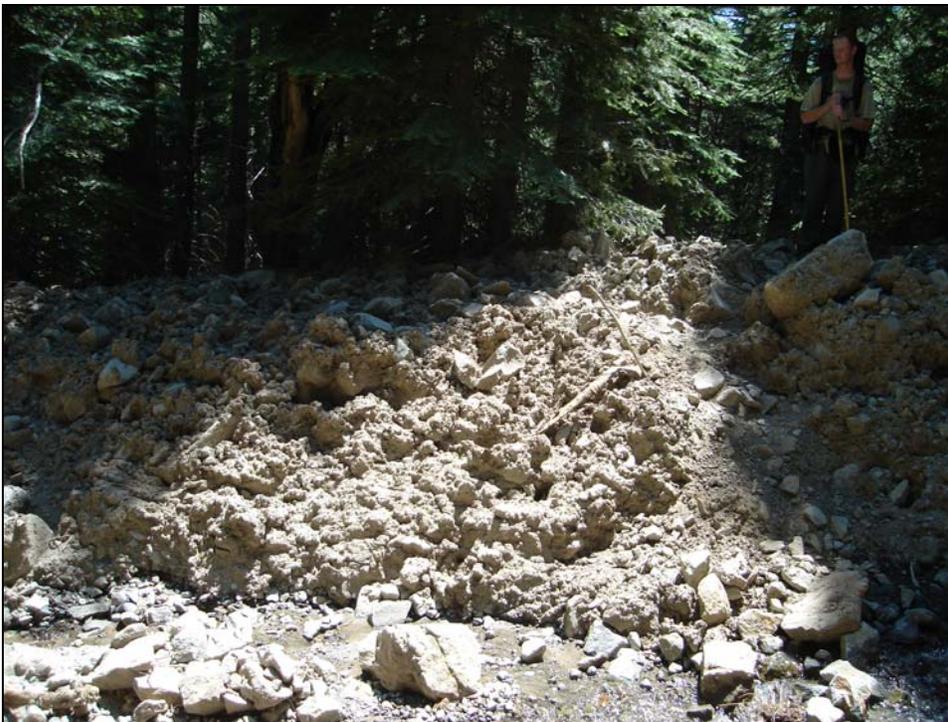
Site 32: Wolf Creek, Carson Ranger District. Viewpoint looking up the trail, where dirt levees have been formed by the debris. This site is located at UTM: N: 4268103 & E: 263187.
