WOLF CREEK

2006 Stream Habitat Survey Report

Carson Ranger District: Humboldt-Toiyabe National Forest

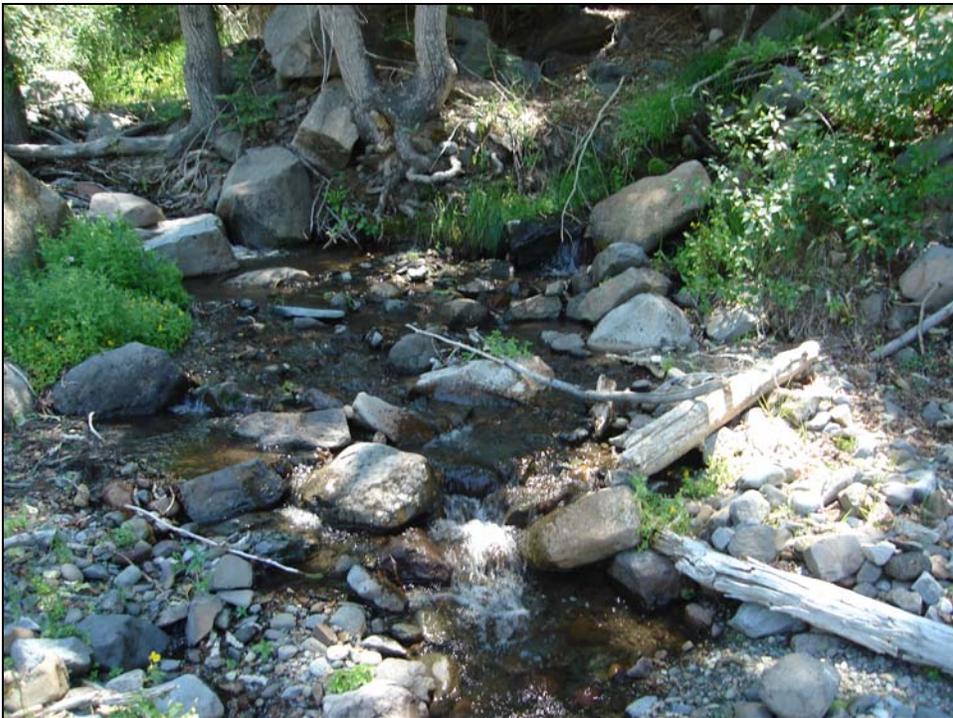
Site 33: Wolf Creek, Carson Ranger District. Photo shows a location where the trail runs along a steep eroding bank. This site is located at UTM: N: 4267838 & E: 263007.

2. Work with trail crews and Forest Service personnel to relocate the trail at Site 33 to a path further away from the high bank. A wash-out appears to be eminent.

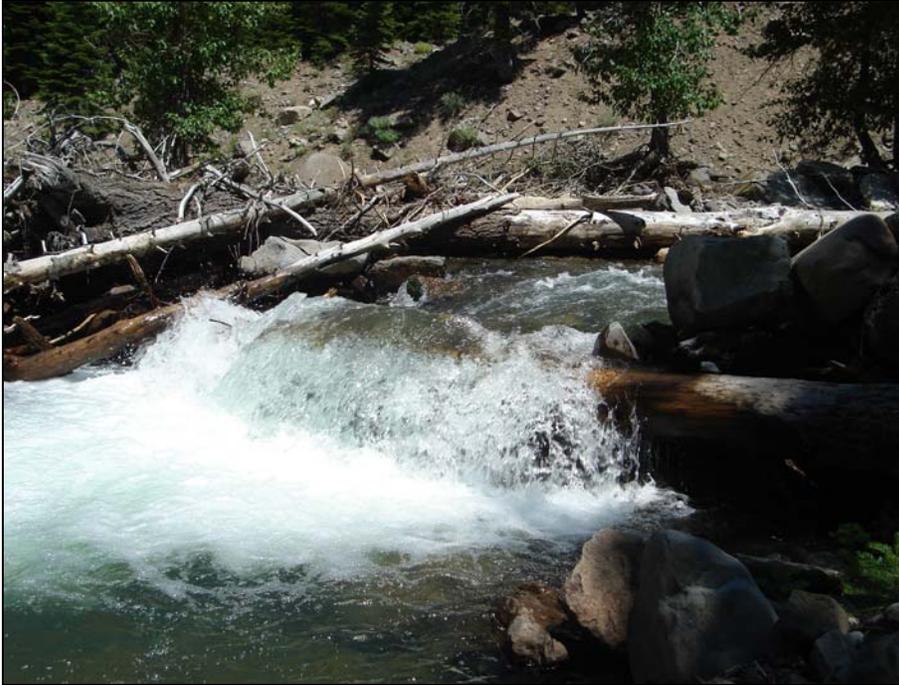
Site 35: Wolf Creek, Carson Ranger District. Upstream photo of a seasonal fish barrier with height 3.3 feet and a maximum pool depth of 5.5-6.0 feet. A salmonid was sighted in the plunge pool. This site is located at UTM: N: 4267723 & E: 263013, Elev. 7206 feet (2197m).

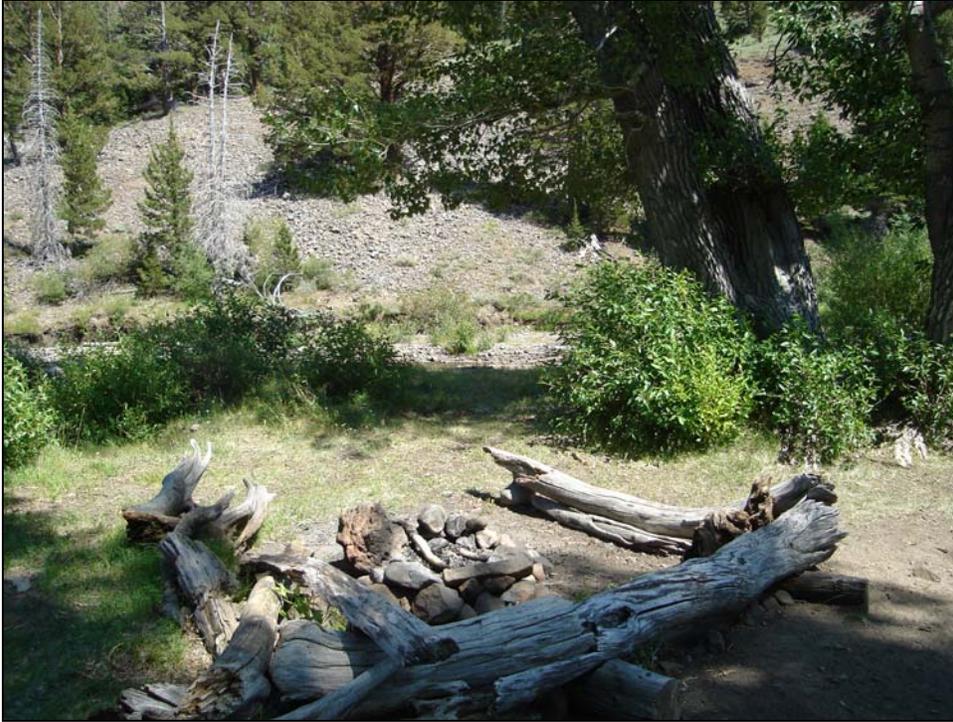
Site 37: Wolf Creek, Carson Ranger District. A campsite is located on river left, approximately 20m from the water. This site is located at UTM: N: 4267377 & E: 262713, Elev. 7272 feet (2217m).

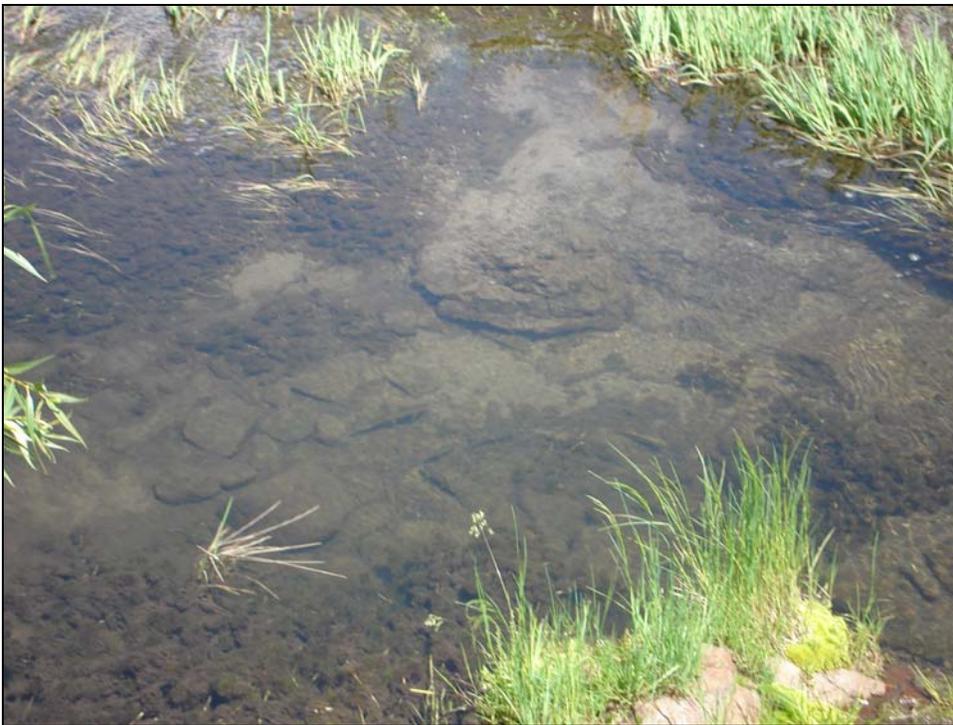
Site 38: Wolf Creek, Carson Ranger District. A small tributary enters Wolf Creek on river left. Photo shows 5 brook trout in the tributary. This site is located at UTM: N: 4267049 & E: 262384, Elev. 7318 feet (2231m).

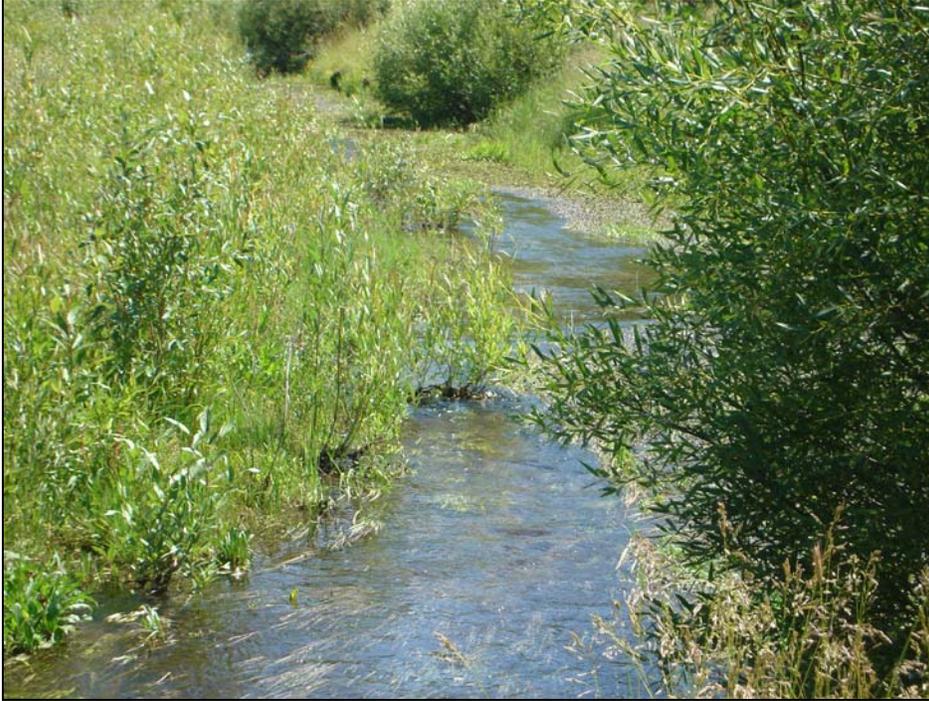
Site 38: Wolf Creek, Carson Ranger District. Upstream photo of a small tributary that enters Wolf Creek on river left. Photo shows 5 brook trout in the tributary. This site is located at UTM: N: 4267049 & E: 262384, Elev. 7318 feet (2231m).

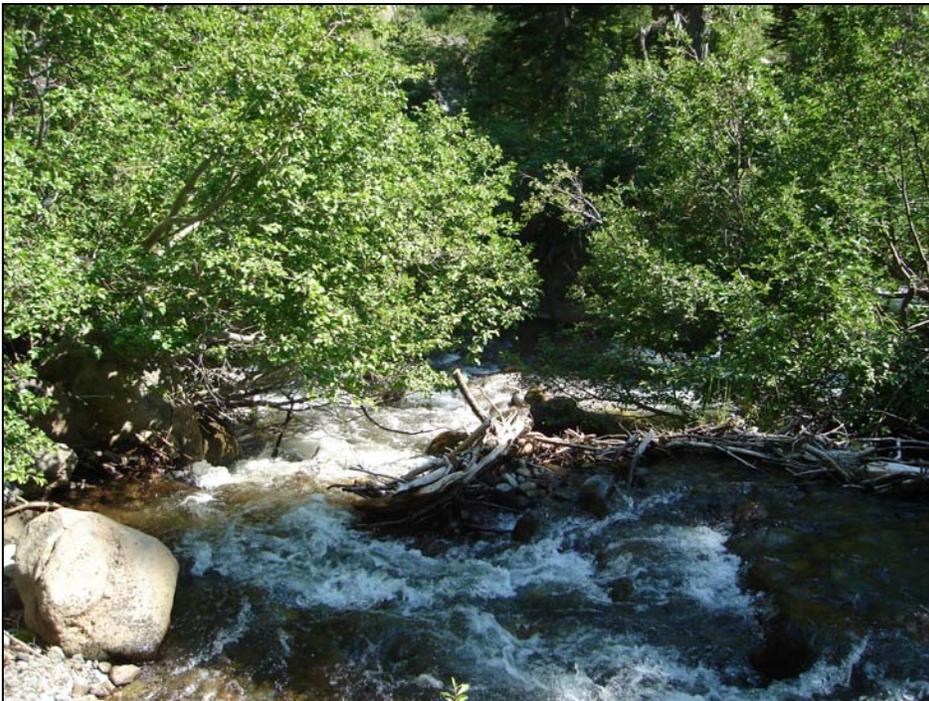
Site 39: Wolf Creek, Carson Ranger District. Viewpoint looking down Bull Canyon Creek at the confluence with Wolf Creek. Bull Canyon adds 30-40 % to the total flow in Wolf Creek. This site is located at UTM: N: 4266579 & E: 262199, Elev. 7429 feet (2265m).

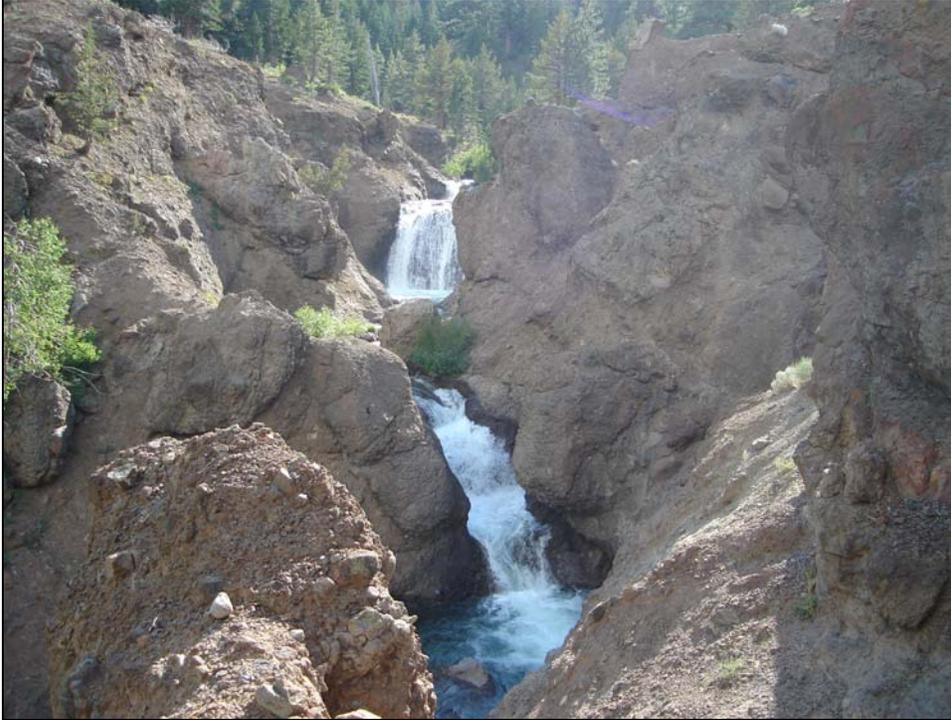
Three of the four recorded permanent fish passage barriers (Sites 26, 40 & Site 42) on Wolf Creek separate the stream into three substantial and continuous sections: Sites 1-26, Sites 26-40, and Sites 42-57. The reach between Site 1 and Site 26 is approximately 6.0 miles long, including the 1.5 river miles flowing through private property. Between Site 26 and Site 40 the stream has a relatively low gradient and total of approximately 2.86 river miles. Wolf Creek Falls (Site 40) is comprised of two parts and has a total vertical height of 50-75 feet. The permanent barrier at Site 42 is a 10-foot waterfall with a maximum pool depth of approximately 5.0 feet. The distance between the waterfalls at Sites 40 and 42 is approximately 0.50 miles. The river mileage between Sites 42-57 is approximately 2.65 miles. Seasonal barriers are found throughout the drainage; however, most of these barriers are concentrated in the upper half of the watershed. Between Sites 1 and 40 two seasonal barriers exist: a 2.4 foot barrier (Site 6) and 3.3 foot barrier (Site 35). The barrier at Site 26, although referenced as a permanent barrier above, this site may actually only prohibit fish passage seasonally. This section of stream offers vegetative cover, habitat complexity, and has a verified capability of inhabiting fish.

Site 40: Wolf Creek, Carson Ranger District. Upstream photo of Wolf Creek Falls. This permanent fish passage barrier has two parts totaling 50-75 vertical feet. This site is located at UTM: N: 4266555 & E: 262075, Elev. 7432 feet (2266m).

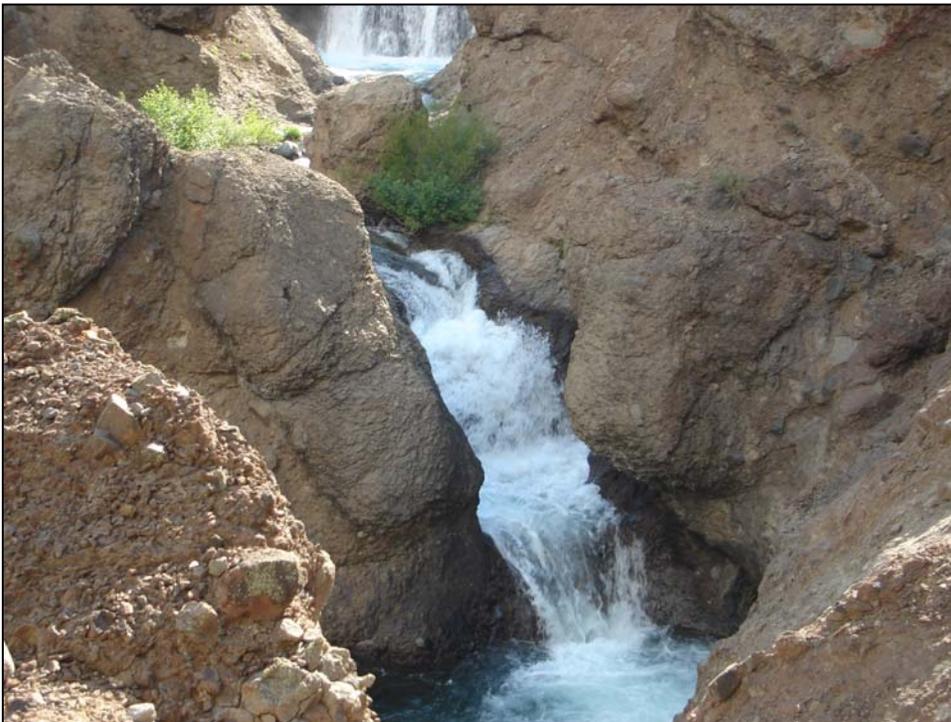
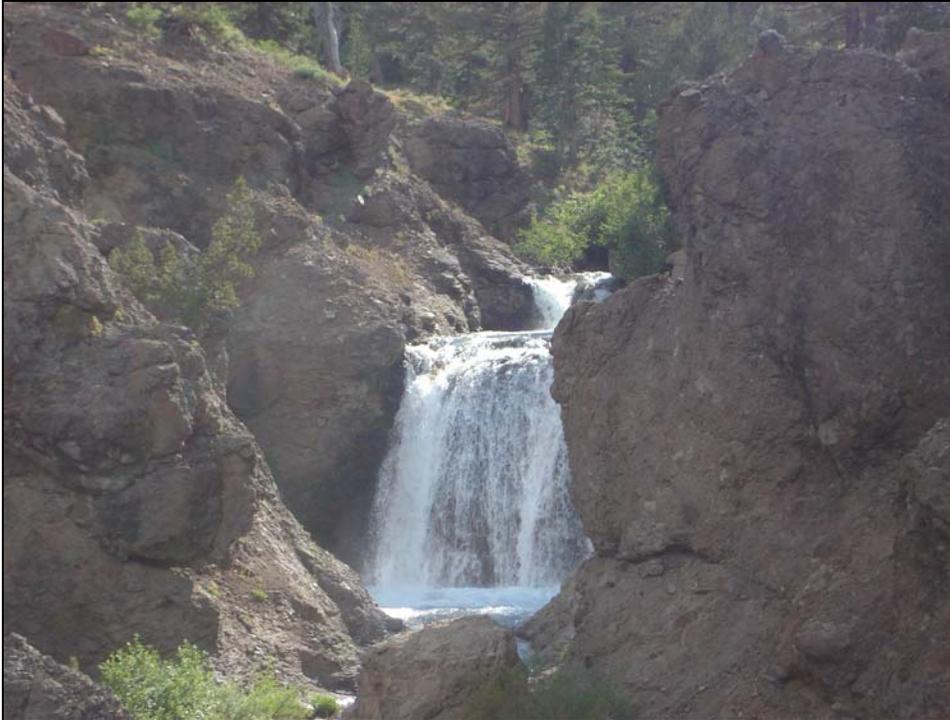
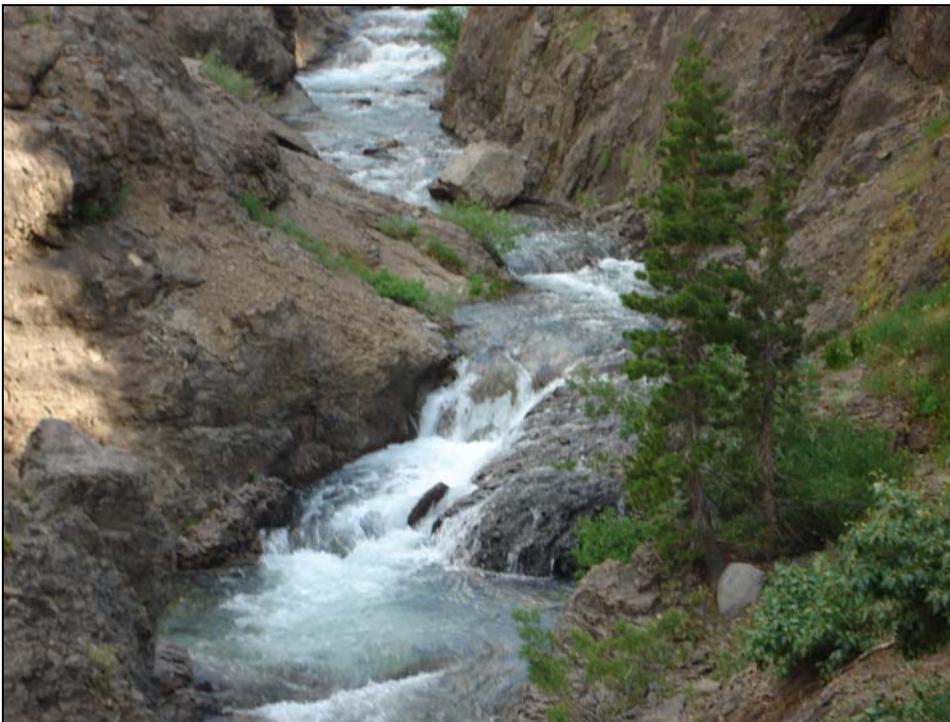
Site 40: Wolf Creek, Carson Ranger District. Upstream photo of Wolf Creek Falls. Zoomed in view of lower Wolf Creek Falls. This site is located at UTM: N: 4266555 & E: 262075, Elev. 7432 feet (2266m).

Site 40: Wolf Creek, Carson Ranger District. Zoomed in view of upper Wolf Creek Falls. This site is located at UTM: N: 4266555 & E: 262075, Elev. 7432 feet (2266m).

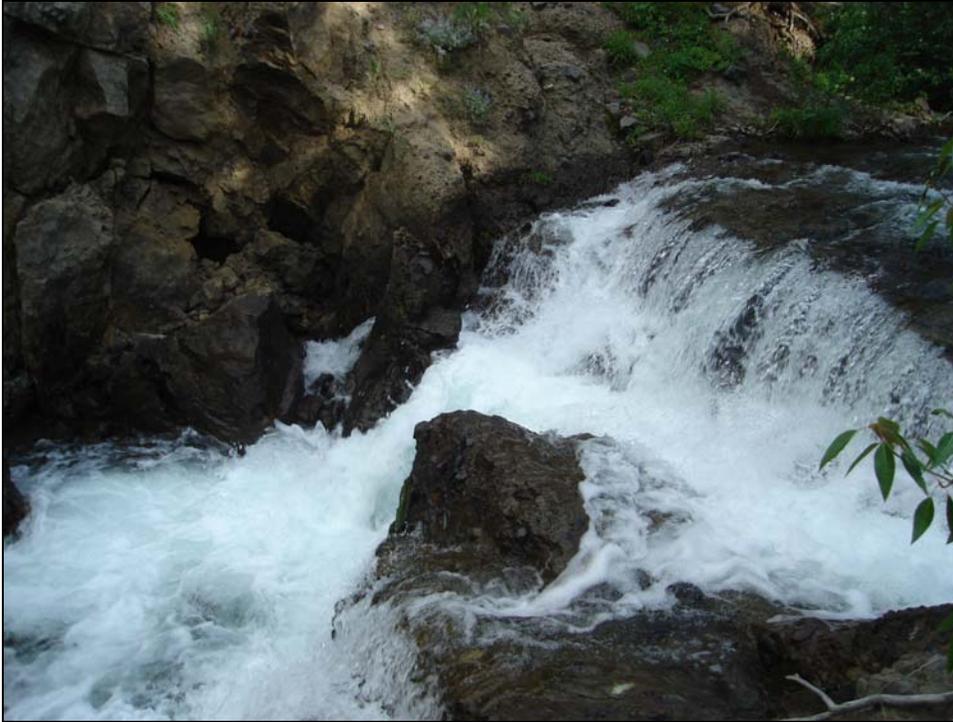
Site 41: Wolf Creek, Carson Ranger District. Upstream photo of a 3.5 foot seasonal barrier with maximum pool depth 1.5 feet. This site is located at UTM: N: 4266487 & E: 261922, Elev. 7426 feet (2264m).

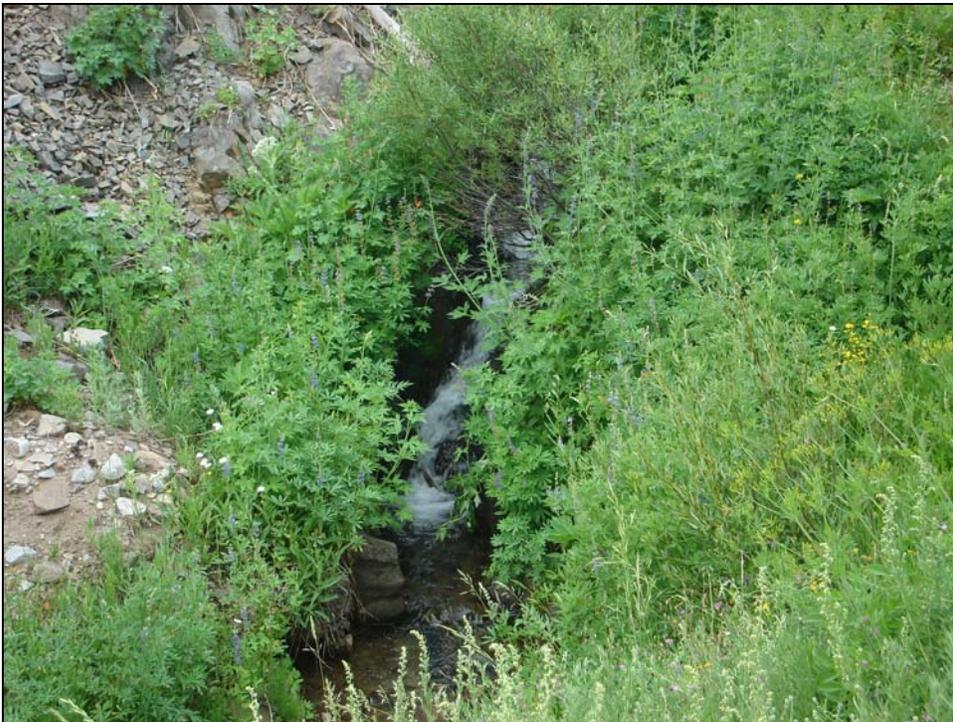
Site 42: Wolf Creek, Carson Ranger District. Side view of a 10-foot permanent fish passage barrier (max. pool depth 5.0 feet). This site is located at UTM: N: 4266898 & E: 261828, Elev. 7432 (2308m).

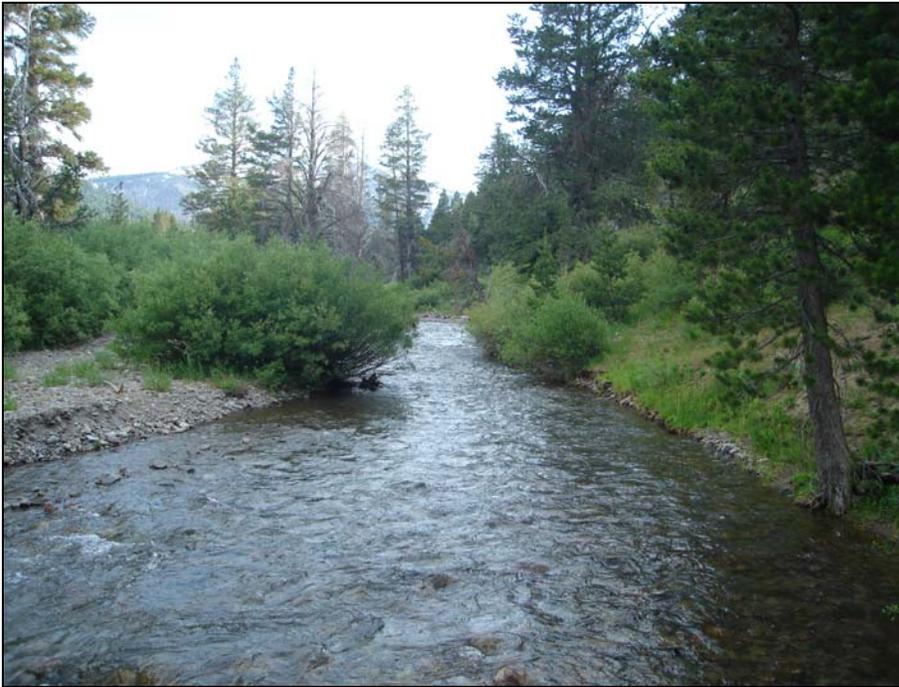
Site 44: Wolf Creek, Carson Ranger District. Upstream photo of Wolf Creek taken from a ford trail crossing. This site is located at UTM: N: 4265141 & E: 261585, Elev. 7810 feet (2381m).

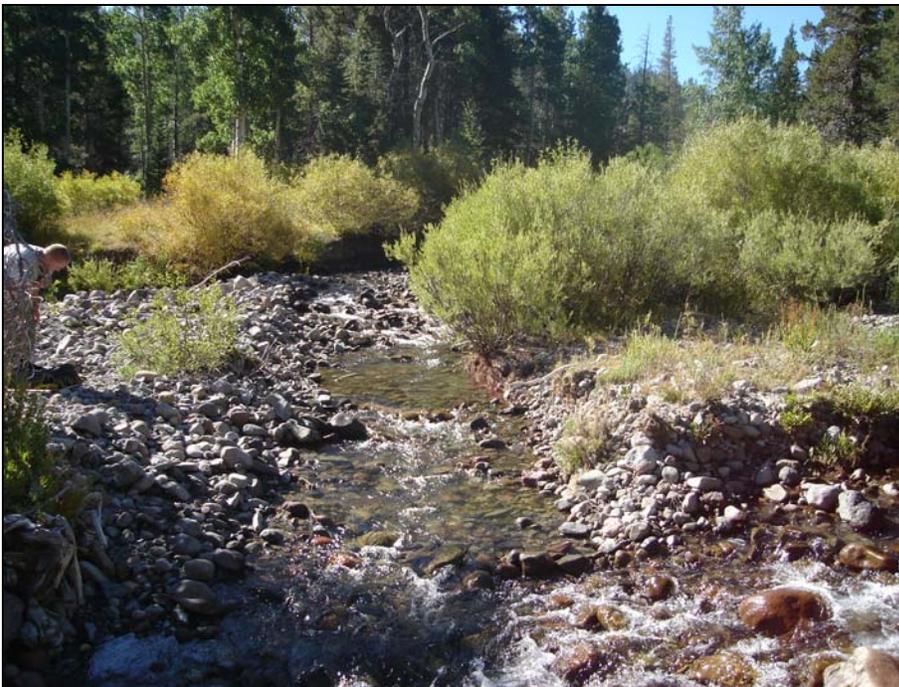
Site 45: Wolf Creek, Carson Ranger District. Upstream view of confluence of Elder Creek (photo right) and Wolf Creek (photo center). Elder Creek and upper Wolf Creek contribute equal portions to the total discharge in Wolf Creek. This site is located at UTM: N: 4264622 & E: 261108, Elev. 7757 feet (2365m).

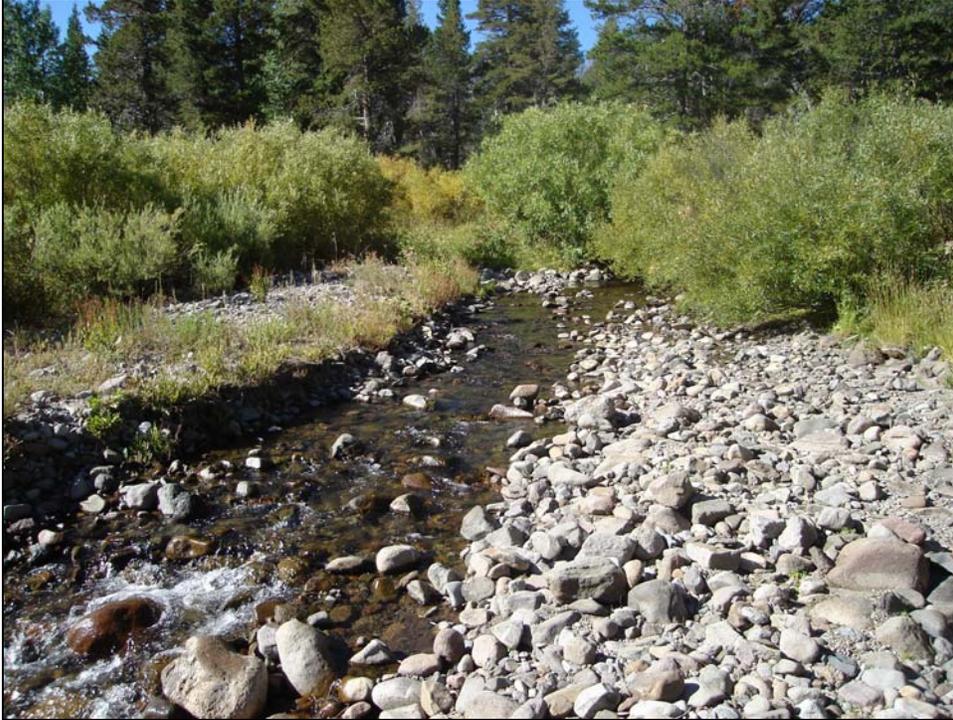
Site 45: Wolf Creek, Carson Ranger District. Upstream photo of Wolf Creek taken above the confluence with Elder. This site is located at UTM: N: 4264622 & E: 261108, Elev. 7757 feet (2365m).

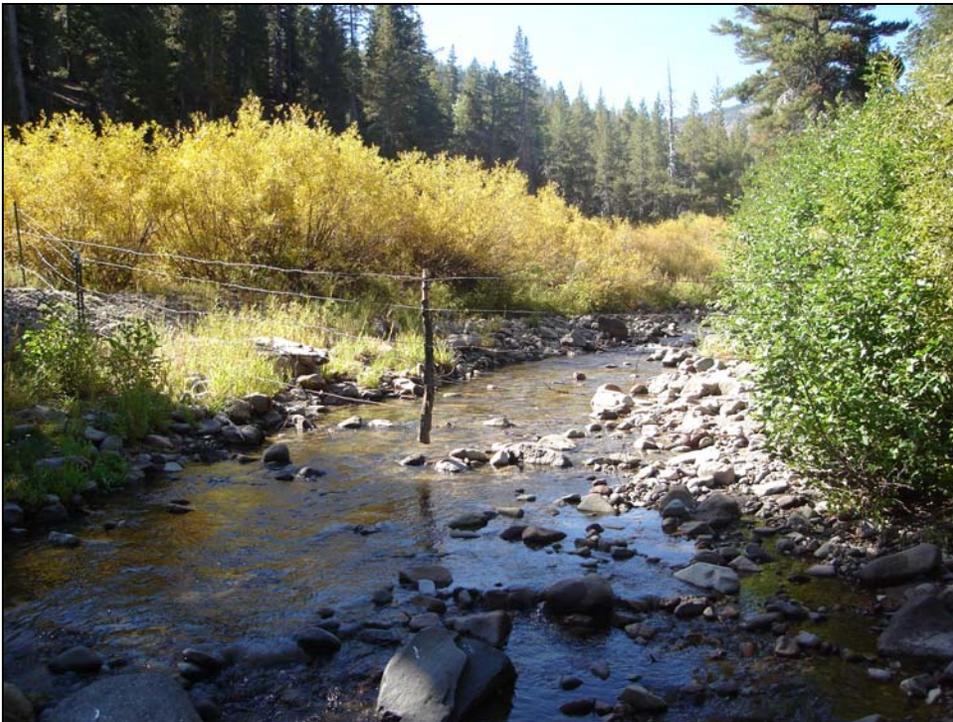
Site 46: Wolf Creek, Carson Ranger District. Upstream view of a barbed-wire fence strung across Wolf Creek. This site is located at UTM: N: 4264336 & E: 261063, Elev. 7823 feet (2385m).

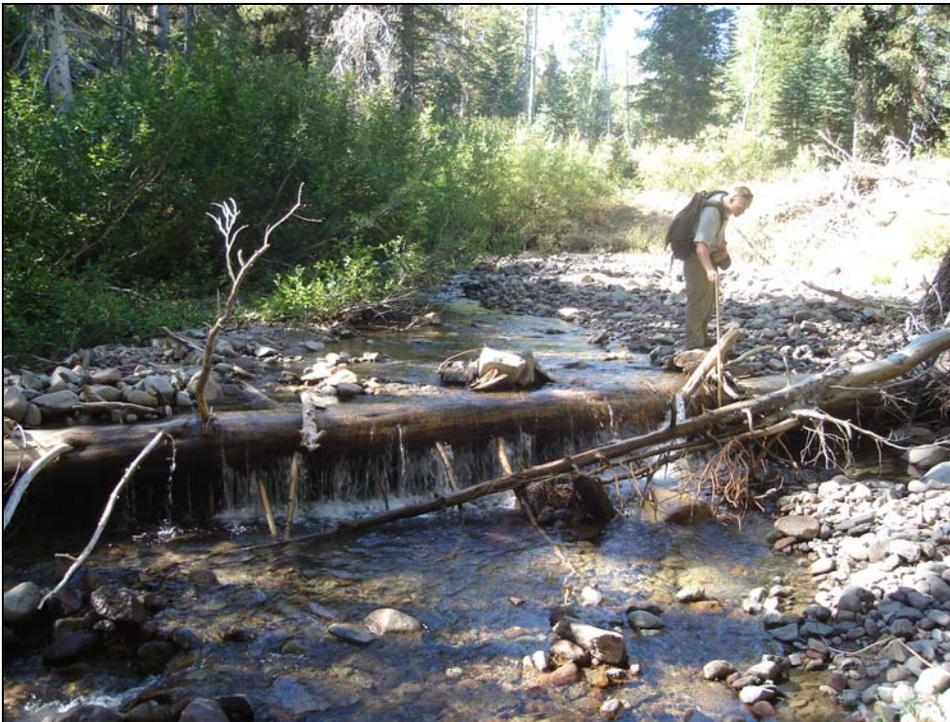
Site 48: Wolf Creek, Carson Ranger District. Upstream photo of a seasonal barrier measuring 2.3 feet high, with a maximum pool depth of 0.9 feet. This site is located at UTM: N: 4264098 & E: 260864, Elev. 2385.

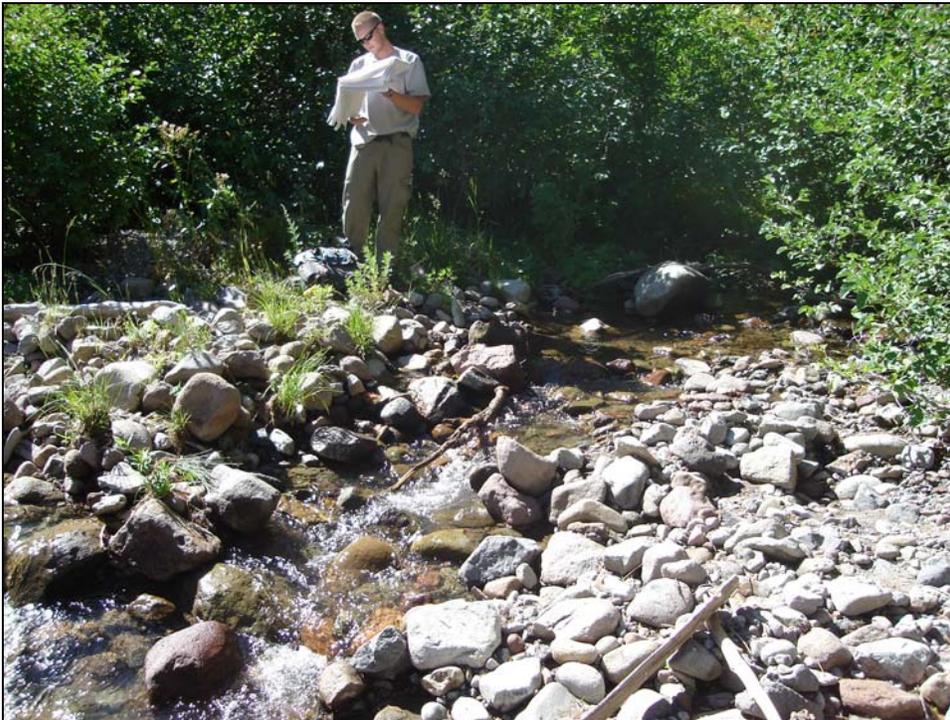
Upstream of Site 42 the seasonal barriers range from 2.0 to 3.7 feet in height, inhibiting but not excluding fish passage. At Site 50 the survey progressed up the drainage that contributed the greatest amount of water at that confluence. The main stem of Wolf Creek provided 40% of the total flow; therefore, the survey progressed up an unnamed

Site 50: Wolf Creek, Carson Ranger District. Upstream photo of the headwater Wolf Creek, which contributes 40% of the flow to the mainstem. The survey proceeded up the headwater branch that contributes 60% of flow to Wolf creek. This site is located at UTM: N: 4263713 & E: 260672, Elev. 7938 feet (2420m).

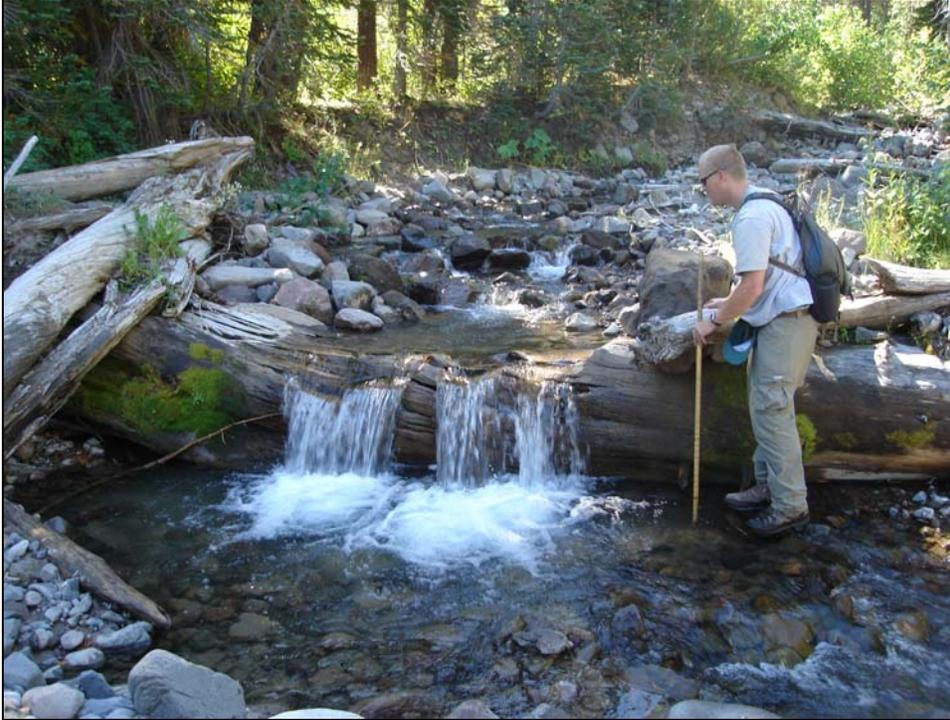
Site 51: Wolf Creek, Carson Ranger District. Upstream photo of a small seasonal fish barrier created by LWD. The barrier height is 2.35 feet and the max. pool depth is 1.7 feet. This site is located at UTM: N: 4263669 & E: 260666, Elev. 7944 feet (2422m).

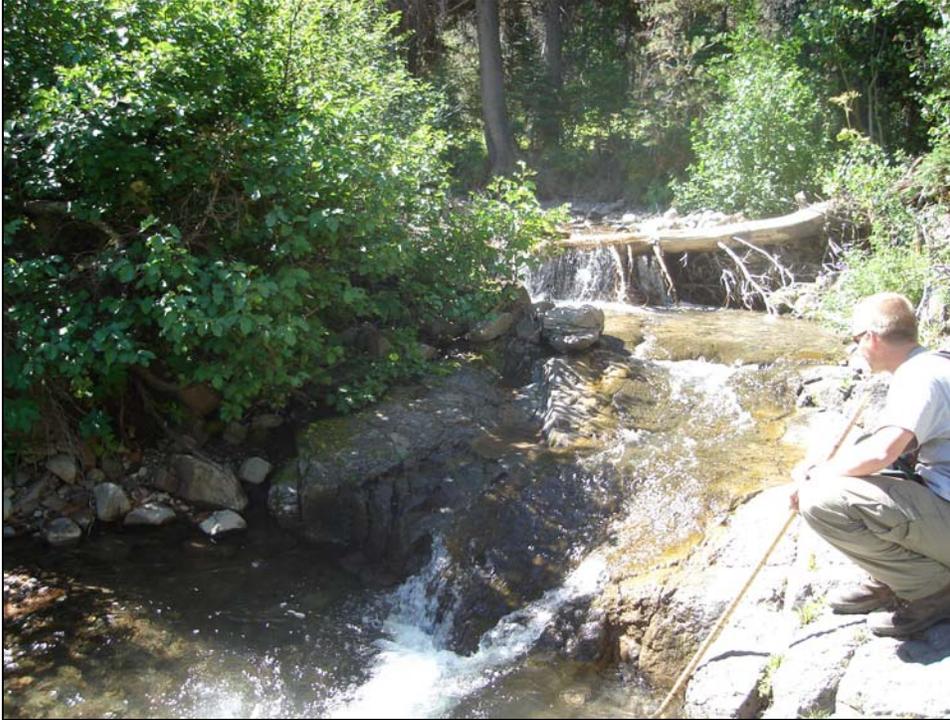
Site 53: Wolf Creek, Carson Ranger District. Upstream photo of a seasonal fish barrier formed by a two-part waterslide with height 2.75 feet and length 12 feet. This site is located at UTM: N: 4263488 & E: 260633, Elev. 7957 feet (2426m).

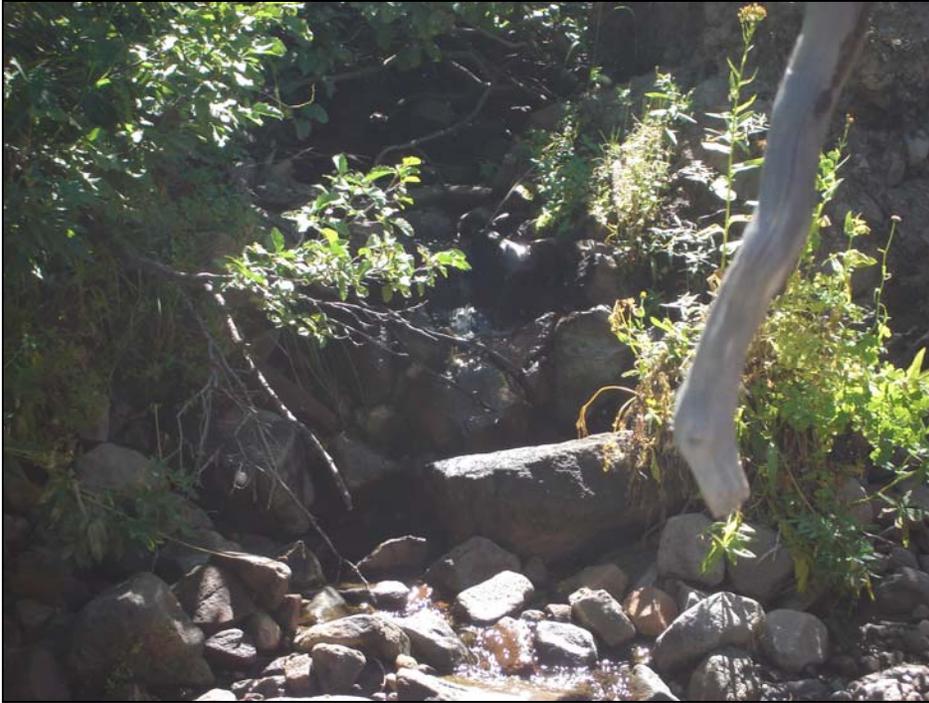
Site 54: Wolf Creek, Carson Ranger District. Upstream photo of a 2.8-foot seasonal barrier (max. pool depth .85 feet). This site is located at UTM: N: 4263186 & E: 260595, Elev.8046 feet (2453m).

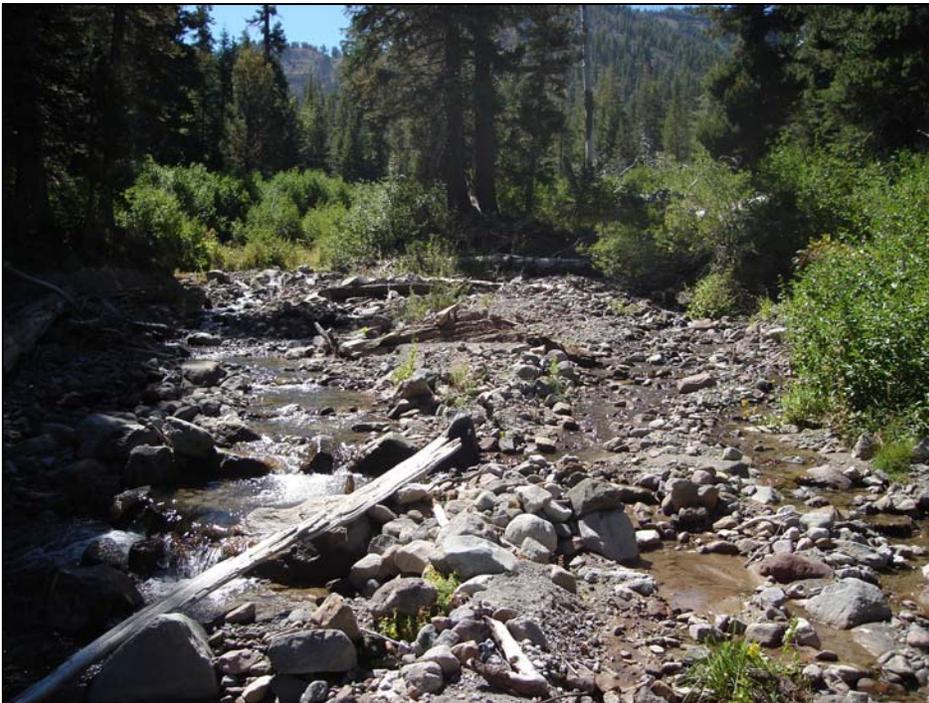
Site 56: Wolf Creek, Carson Ranger District. Upstream photo of confluence of two headwater streams, each of which contributes a nearly equal amount of water. The survey progressed up the branch in (photo right). This point marks the end of LCT habitat. This site is located at UTM: N: 4263070 & E: 260545, Elev. 8098 feet (2469m).

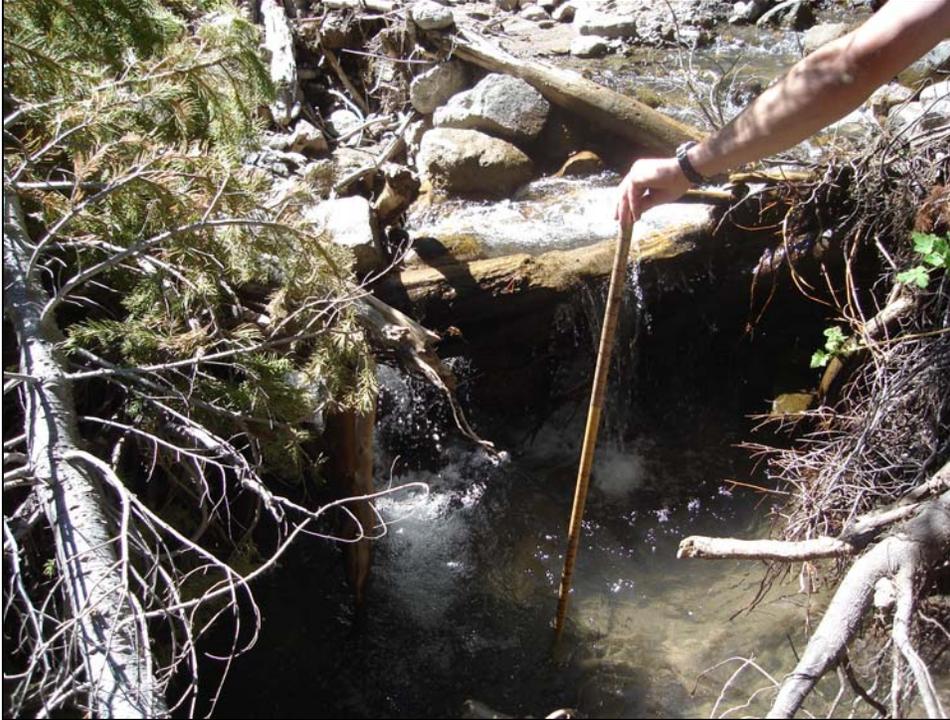
Site 57: Wolf Creek, Carson Ranger District. Upstream view of a seasonal barrier measuring 2.5 feet high with a maximum pool depth of 1.55 feet. This site is located at UTM: N: 4263041 & E: 260525, Elev. 8010 feet (2442m).

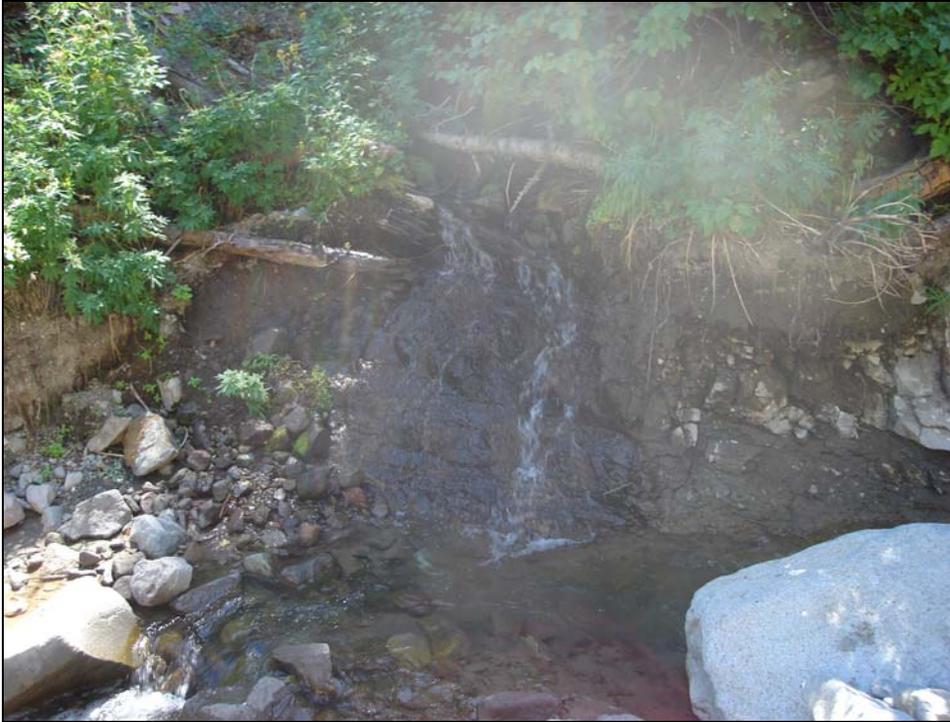
Site 58: Wolf Creek, Carson Ranger District. Upstream view of a seasonal barrier measuring 3.7 feet high with a maximum pool depth of 1.5 feet. This site is located at UTM: N: 4262964 & E: 260401, Elev. 8190 feet (2497m).

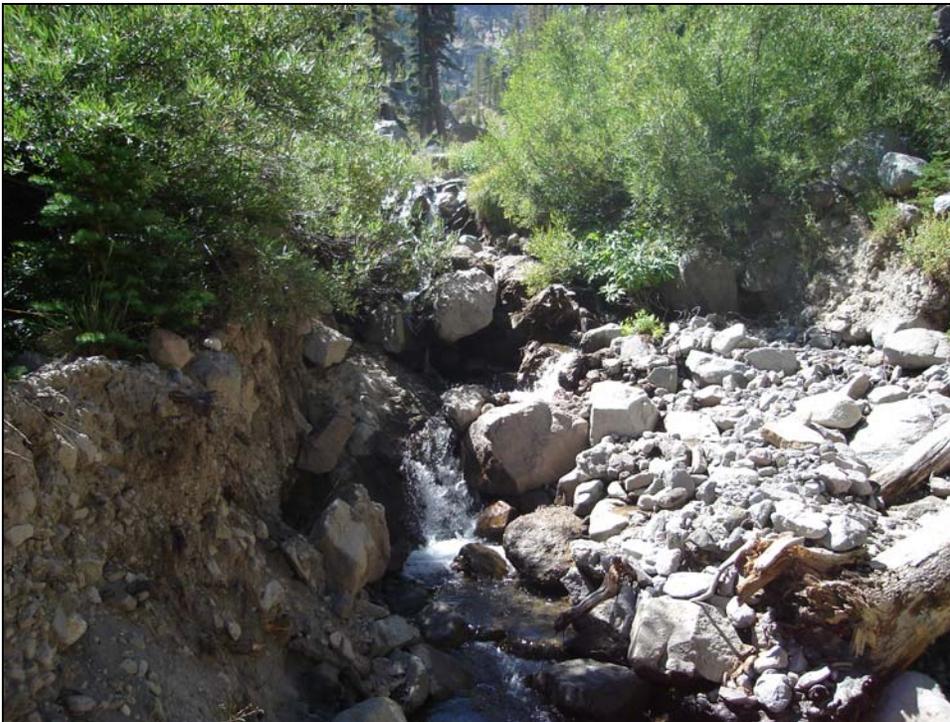
Site 60: Wolf Creek, Carson Ranger District. Upstream photo of a 9.0 foot tall permanent fish barrier (max. pool depth 1.0 foot). This site is located at UTM: N 4262694 & E: 260190, Elev. 8259 feet (2518m).
