Forest Service
Pacific
Southwest
Region

Land Management Plan Monitoring and Evaluation Report

Cleveland National Forest Fiscal Year 2007

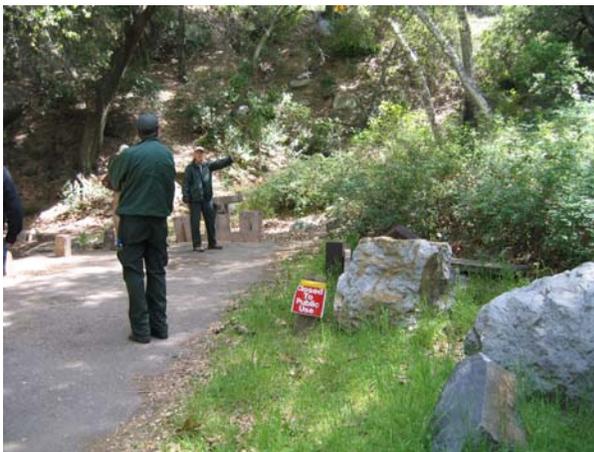
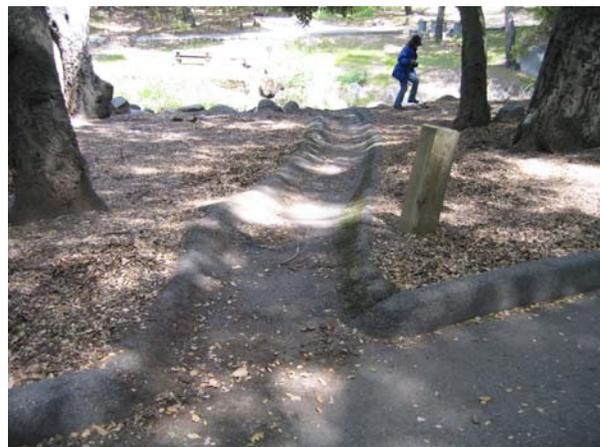
Upper San Juan Campground: On the left, a closed campsite. On the right, road drainage.

Upon entry into the campground, observations were made of a closed campsite filled with and blocked off by boulders. This campsite, in the past, allowed for camping adjacent to a creek. Closing of this campsite protected the RCA. Another site (#8) is located next to a pond formed from road water that drains into the channel. Access to the site requires crossing the water. There is a high potential of contamination and sediment entering the water if this site is allowed to continue.

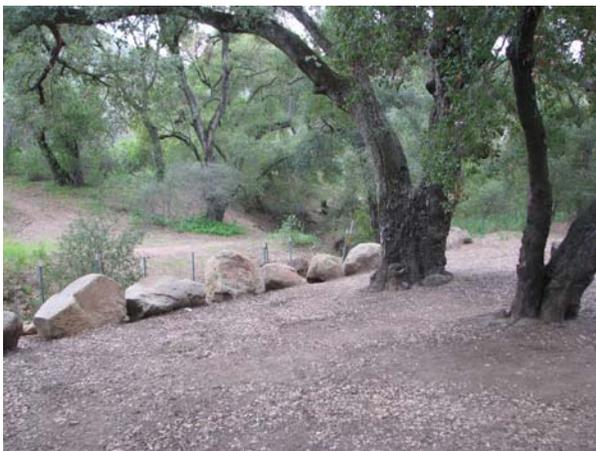
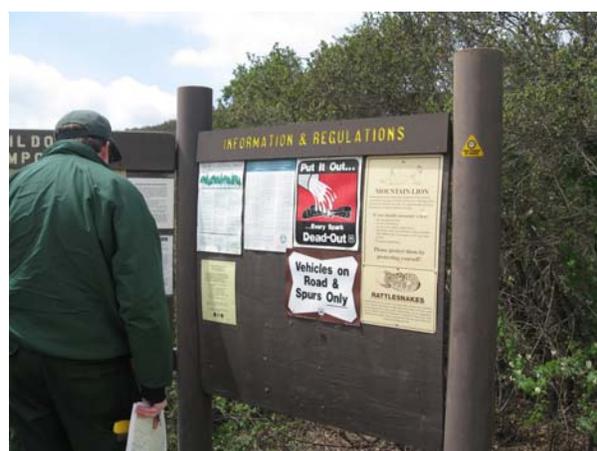
The field survey included visual inspection of toilet facilities, refuse disposal facilities, and the water faucet in the campground as well as the sediment deposition basin in the OHV parking/staging area. The campground is adjacent to an intermittent creek that is tributary to the steelhead trout stream. The nearest campfire pit to the channel is at 55 feet. The trash cans were in good repair and there was little trash on the ground. During the high use time, trash cans have been reported to be overflowing. Previous to this inspection, the campground had access to the creek which led to unauthorized OHV route creation. The CNF recreation staff put fencing and large boulders at the bank of the creek to deny motorized access. Barriers were installed to define sites and to discourage erosion and "parking lot creep," but the level of erosion is still unacceptable in the picnic table area due to lack of vegetation. The campground had 70% bare ground (the BMP calls for less than 10%). As the campground is within the RCA, sediment and runoff are reaching the channel.

Wildomar Campground: (L) barriers protecting riparian values; (R) sign restricting vehicles to roads and spurs.

signs specifying that no dishwashing should be done at the water spigot, or within 100 feet of the creek. Potentially the campfire rings within the RCA (100 feet) would need to be moved. More importantly, the ground should have a mulch cover installed and the cover should not be raked. The entry road had signs of gravel that had been dispersed. More gravel could be added. The degree of sediment produced has the potential to be significant and last more than one season and affect the stream reach. This site was found to not meet BMP effectiveness and implementation protocols, though there are plans to address these issues.

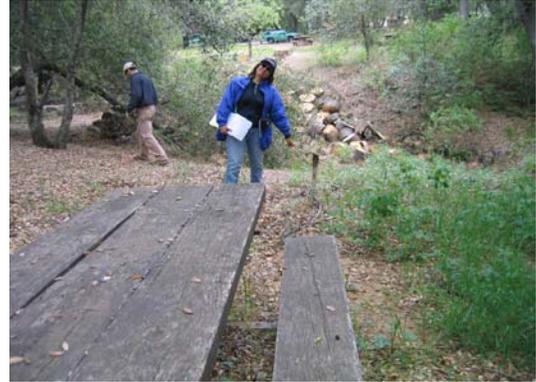
The signage looks good. Tables are old but functional. One barbeque in the rear site across the walkway is deteriorated. This lone picnic site is inconspicuous and probably poorly maintained because only one recreation field staff is trying to cover for multiple vacant recreation jobs and was not aware of its presence. There have not been any recent maintenance projects.

El Cariso Picnic Area (riparian area in background).

- Prepare operations and maintenance (O&M) plan for site.
- Schedule site for O&M including sanding and BBQ in far picnic site
- Work with utility to clean up and educate about RCA.
- Remedy issues surfaced in BMPEP: Remove the tree rounds from the RCA and clean up the burn residue.

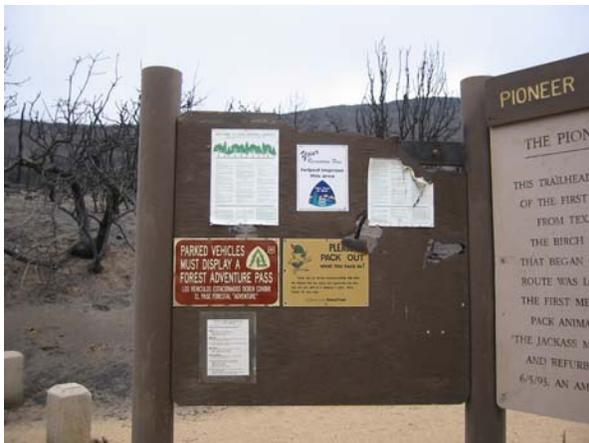
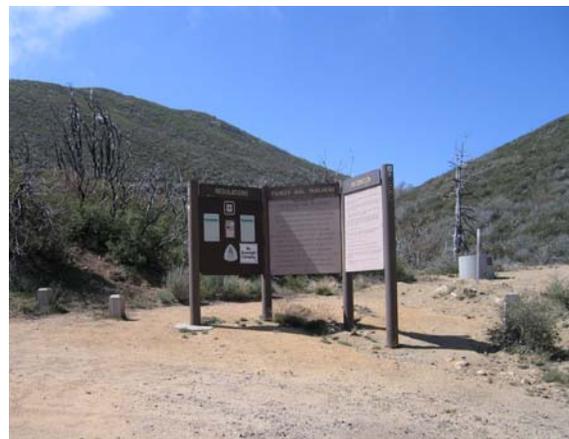
There is no operations and maintenance (O&M) plan for the site. These plans help to institutionalize activities needed to meet service or resources needs. The trailhead structures were destroyed in the Cedar Fire. The reconstruction looks great. The picnic sites and vault toilets are well maintained. The area has fencing to prevent vehicle encroachment. No trail user or resource conflicts were raised.

Pioneer Mail trailhead post-Cedar Fire (L); and today (R).

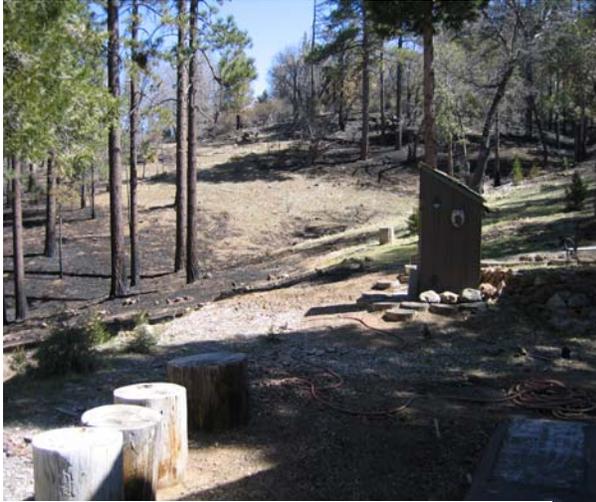
Fuels clearance around cabins has been addressed and is 100 feet. The tract is adjacent to the current Laguna Recreation fuels project, and the 175 ac Wooded Hill fuels project which is currently being reanalyzed. Clearance and removal of hazardous (including bark beetle kill) trees is aided by improvement association that pays half the cost of hazardous tree removal via a Firesafe Council grant. The “Deadwood Gang” assists Laguna Mountain tracts to treat fuels appropriately. Fire personnel are slated to remove black oak mortality and hazard trees along road.

Shows tract after successful prescribed burn; unauthorized cutting of timber is also evident.

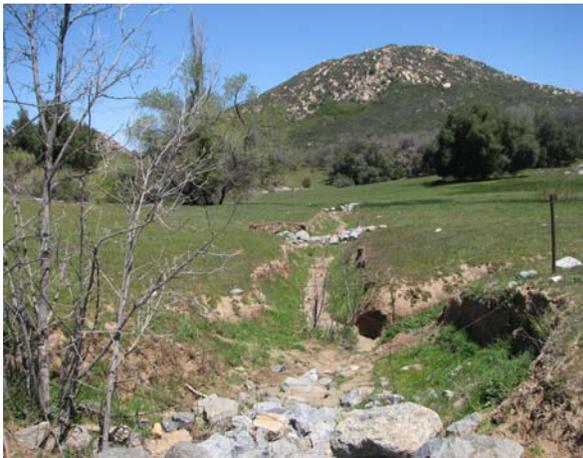
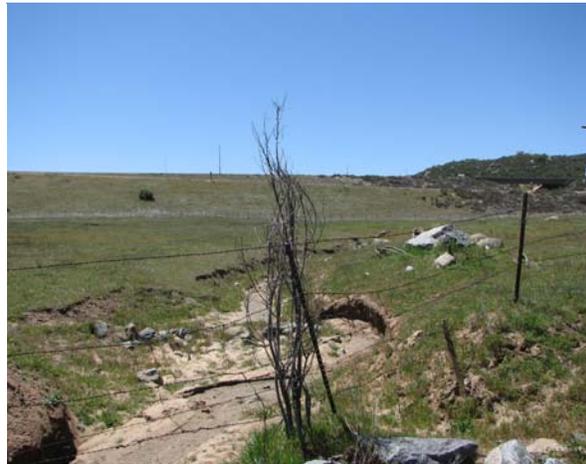
The standards and guidelines groundcover objective of 50% is meeting standards and there is no evidence of rilling or floodplain erosion due to grazing operations. Highway 8 crosses the meadow and CalTrans concentrates water into four specific locations. This channeling of water has caused gullies to cross the meadow and erode the streambank so that it is stable for only 50% to 60% of the reach. CalTrans has installed rock check dams, but the flows of water have bypassed the rock check dams and caused extensive erosion. Until the CalTrans situation is remedied, streambank restoration would have insignificant effect. The erosion primarily caused by CalTrans is significant in quantity, will last more than one season, and affects the stream reach. The sedimentation problems are contained on site due to manmade stock ponds at various points in the meadow which catch and retain sediment.

Guatay allotment (Roberts Ranch). On the right, Highway 8 can be seen in the background.

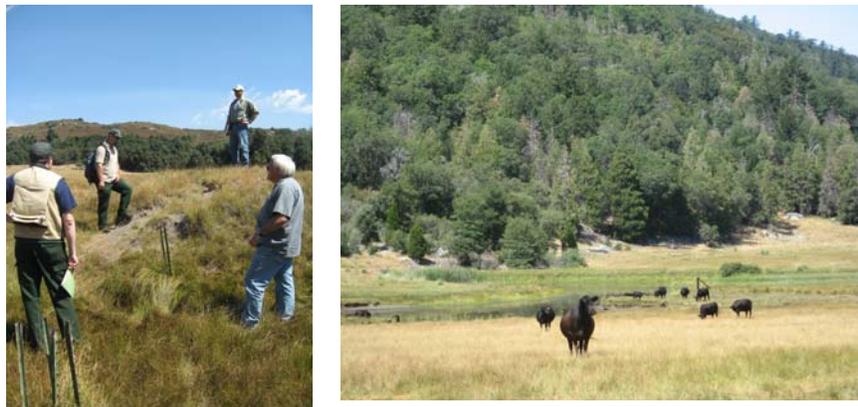
Mendenhall allotment. On left the team reviews stabilization structures.

Near the boundary with the private land, a dam had been built in the 1920s to contain water for the livestock. Water flow below the dam could not be checked as it was on private land. The channel is not an active stream. The base of the channel is predominantly vegetated, preventing sediment from flowing downstream in significant quantities.

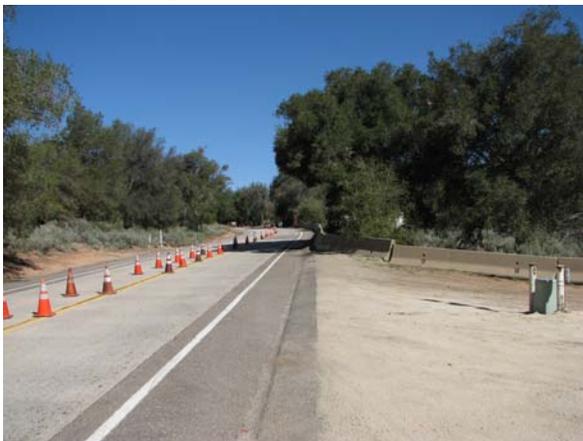
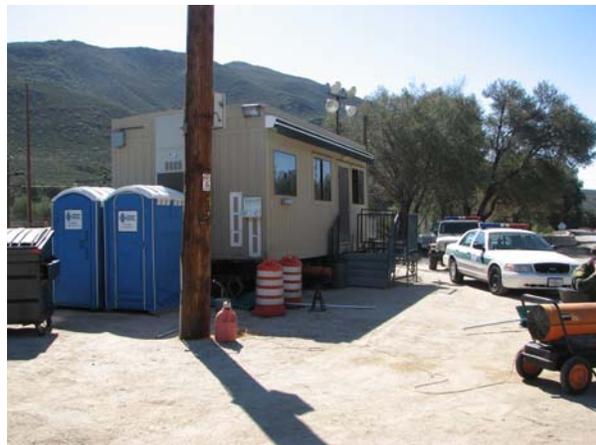
Permit issuance is supported by a decision memo including BA/BE and LMP consistency checklist. K-rails were installed for safety. Construction minimized soils erosion and a toad monitor was present.

US Border Patrol checkpoint.

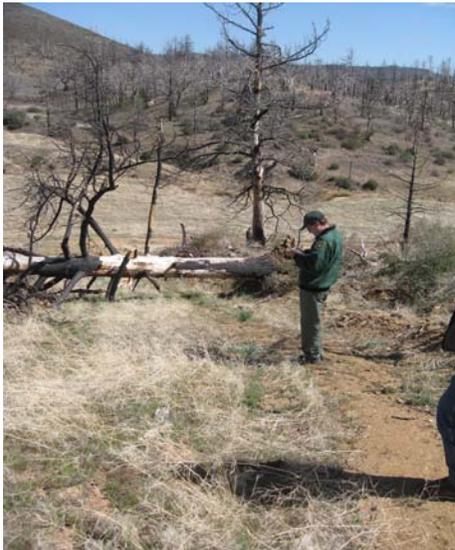
Decommissioned unauthorized route

The road surface showed some rilling was present, but occurred on less than 10% of the road length. The drainage crossing monitored was ephemeral, though the drainage led to a meadow. The road is generally outsloped. In the area of the crossing, there is no evidence of rilling, rutting, or sediment movement. The road is closed seasonally due to snow. In addition, the road is only maintained once every two years, due to budget constraints. Some of the rolling dips are non-functional. Steep slopes have caused much rilling, but there is no sediment movement to the channel due to the large buffer below the road. The problems with the effectiveness of BMPs are minor in nature, short in duration (maintenance scheduled to occur in 2008), and have near stream effects (large buffer).

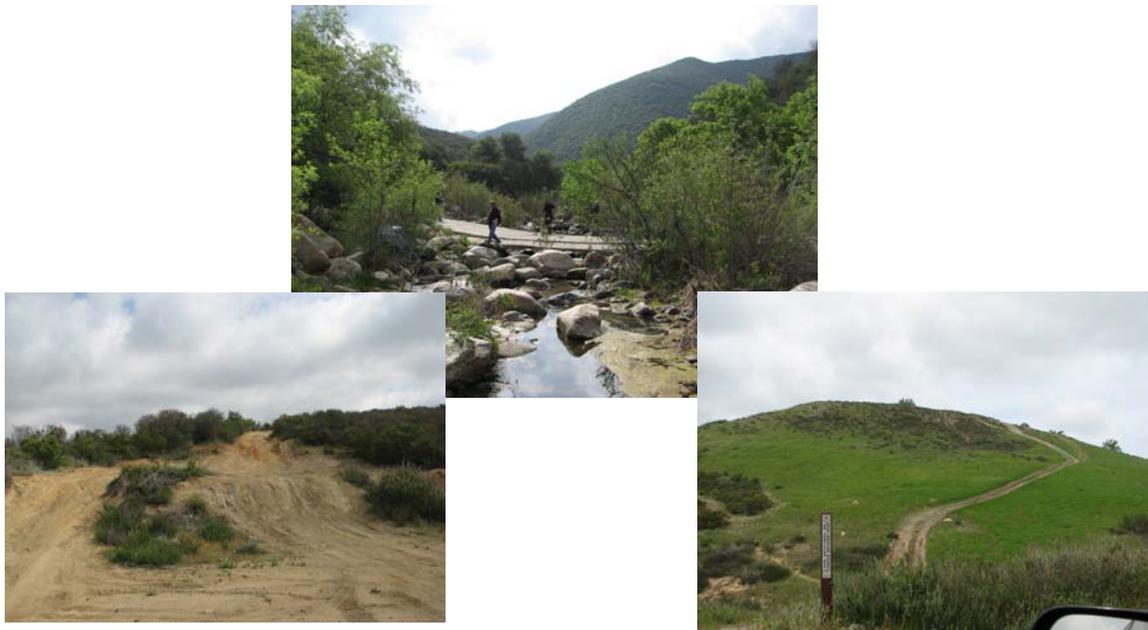
The South Main Divide crossing evaluated is old but in good shape. The road itself is in good condition. The cable along roadside is not an approved guard.

Above, South Main Divide crossing. Below, unauthorized routes off the road.

Unauthorized routes off this road are causing watershed problems. The area near Wildomar and near the Rancho Capistrano community appear to be where management controls are not effective in keeping vehicles on the road, whereas the area closer to Tenaja is better controlled.

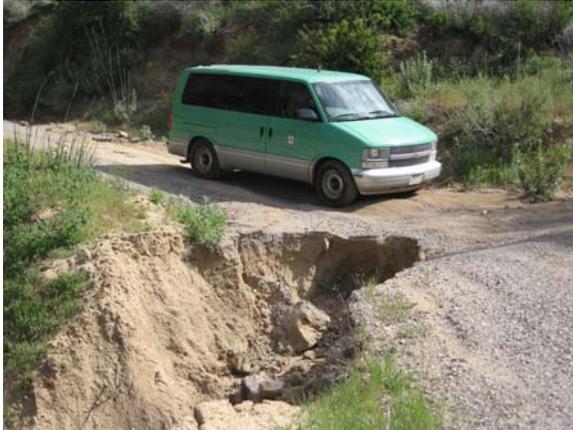
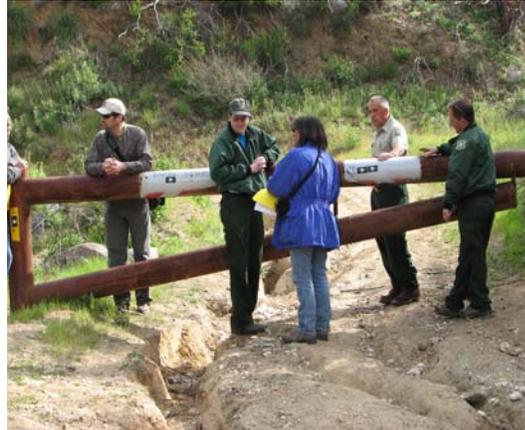
The road maintenance contract included BMPs. The contract notes that where specified, section 204 and CalTrans BMPs apply, but does not spell out details. Details were discussed at prework meeting. Work was done in a dry winter. Drains were cleaned as blading was done. Certain places on this road fail continuously.

Post Witch Fire damage on Lusardi Road. Team discusses consistency with road BMPs and LMP.

The road maintenance COR (road engineer) states that operational controls were implemented during maintenance, but that the road was subsequently damaged by Witch Fire. A low water crossing was inspected along a perennial creek. The maintenance contract was for surface blading and drainage repair and return of watershed function. The contract has language indicating that CalTrans BMPs should be used. This system works sufficiently along with pre-work meetings when the Forest engineering specialist and the contractor are familiar with these BMPs. If a situation arose where the contractor was inexperienced, then there could be a problem. There was evidence of rilling on less than 10% of the road length and when present, the rills did not leave the road surface. There was no evidence that sidecast material was put in the RCA. Road 11S03 has been closed due to the Witch Fire and the subsequent intense storm year. The protocol for closed roads is to check them prior to maintenance being conducted. In the area of the fire, and under the influence of the current storm year, more than 10% of the road had rills greater than 10 feet in length which continued off the road surface. There was also some rutting and delivery of sediment into the streamside buffer area. These deficiencies were further along the road than the stream crossing that was monitored.

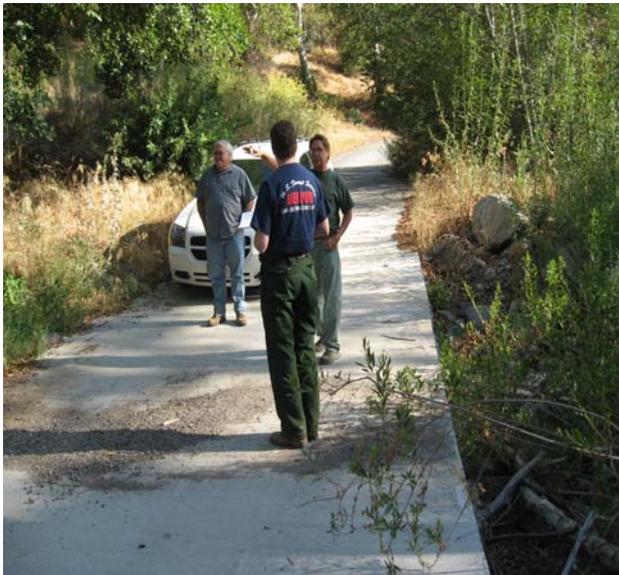
Maple Springs Road wet crossing. The team hydrologist evaluates the inchannel construction.

Road 5S04 (Maple Springs Road) has had five concrete crossings installed; the last installed (2006) was evaluated. Before concrete crossing installation, more intensive ongoing measures such as gravel were necessary to keep the crossings passable for fire engine access. During construction, water was diverted through a pipe to keep the area dry. All excavated material was removed from the area. The project was coordinated with the District biologist. Only the crossing was disturbed, but the District biologist assessed that the habitat was returning, the riparian vegetation was healthy, and the habitat had been improved in the long term. All effectiveness protocols were met.

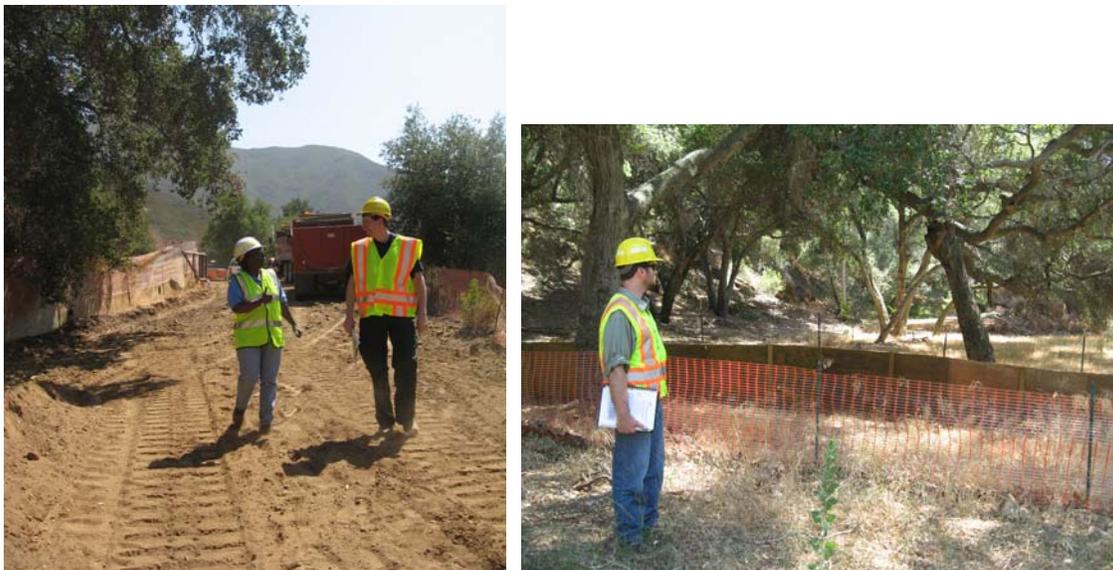
Decommissioning of Lower San Juan Picnic Area to protect riparian habitat.

In acquiring the necessary permits, CalTrans was informed that they would get a “jeopardy” opinion if they did work in the channel due to the presence of species. To avoid the channel, CalTrans has implemented a large number of BMPs, and uses on-site inspectors and ongoing surveys. Two areas were visited on August 28, 2008. The first was the Lower San Juan Picnic Area. In coordination with the Forest, CalTrans is going to close this area to protect species.

Intensive protection measures for arroyo toad were implemented effectively at the picnic area restoration site. The silt fences, slash spreading, fiber rolls, and planned mulching, as well as the constant surveys and inspections are keeping the project from delivering sediment to the riparian areas. In completed areas, there continues to be inspections. As the project is ahead of schedule, the permanent erosion control will not be implemented right away. As such, temporary erosion control measures are being put in place until the end of the project. Interaction with Forest engineering and biology staff continues to monitor the success of this project. The final phase of the project will be restoration of native vegetation now that the picnic tables and road/parking area have been removed. The arroyo toad fence will be left in place until the revegetation project is complete.

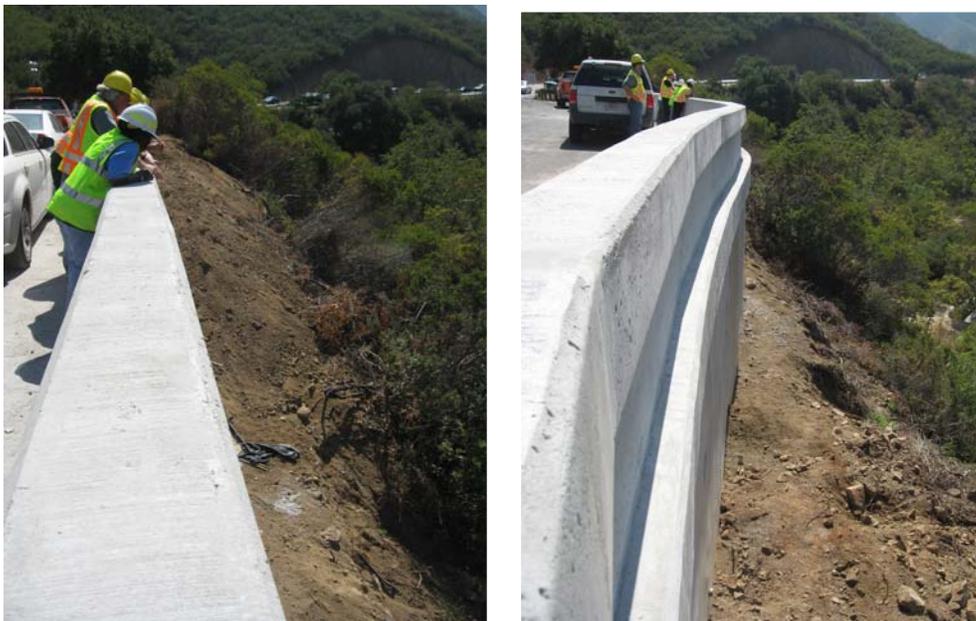
Cal Trans and Forest Service officials review use of best management practices.

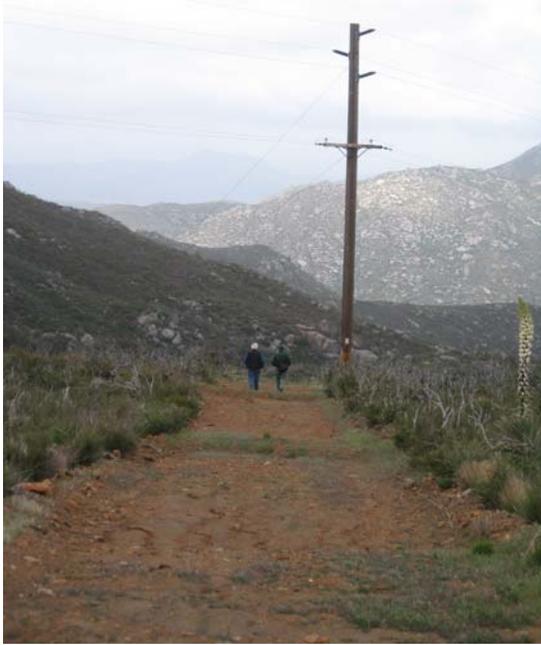
Temporary Road 418606-3 Boulder (07-LMP – Roads - 1)

This is one of two roads associated with the SDG&E Powerlines that were evaluated. Original construction pre-dated NEPA. Because the roads are associated with a special use permit, they are classified as temporary. In both cases, there has been a 50-year right-of-way (ROW) in place. A new master permit is being worked on and the permit is being renewed annually until NEPA is complete. The BE/BA for SDG&E permit renewal as well as section 106 have been completed. Requirements are not implemented yet. Though classified as temporary, these roads are more realistically permanent roads, and should be managed as such.

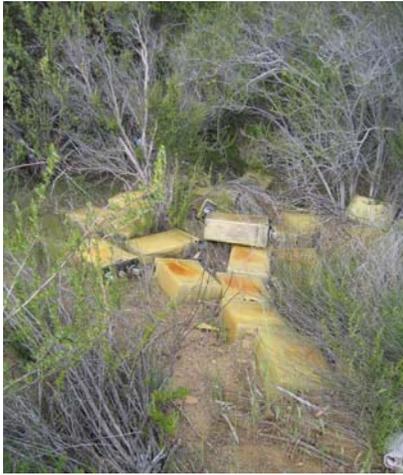
This road was inspected in 2005. As the ROW was put in place 50 years ago, water quality issues were not addressed. These roads weren't designed to allow for adequate movement of water off road surface. There are no functional culverts. The road is rutted and erosion is common on steep road segments. There is litter. Temporary roads are supposed to have closure

provisions; these do not. Maintenance is only done on this road every two years. The steepness of the area and lack of maintenance on the road has caused greater than 200 cubic yards of soil to be displaced through rills and gullies and into an ephemeral drainage. This is a significant issue that will last greater than one season and affect the stream reach if nothing is changed.

The LMP monitoring team discovered what appears to be a number of heavy equipment batteries thrown off the road. This potential hazmat is dumped by pole #Z571337.

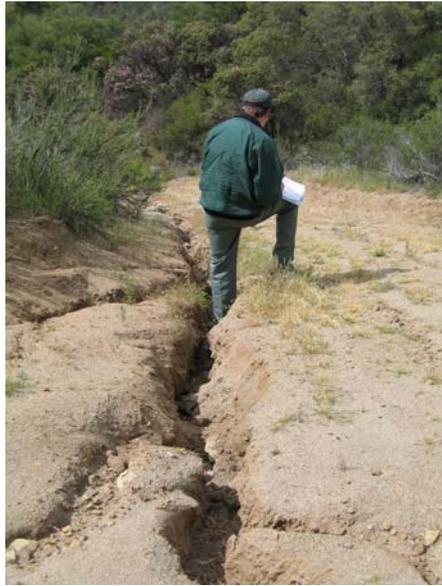
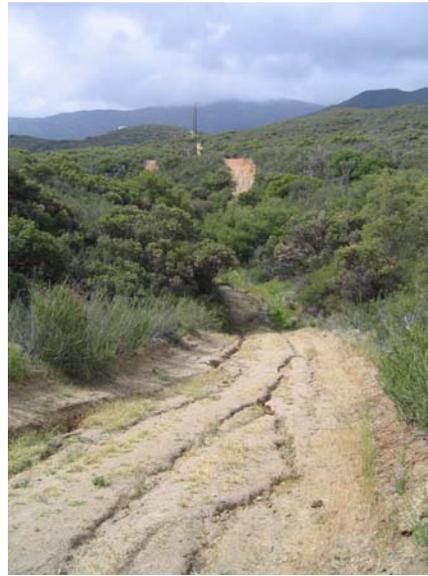
The team evaluates the road for best management practices and notes effects on watershed.

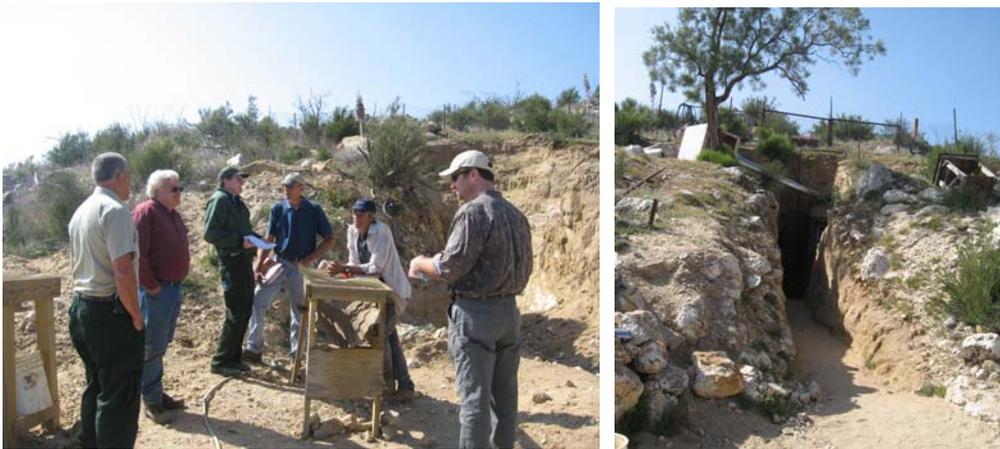
(L) Team listens to operator explaining operations and plans. (R) Mine entrance.

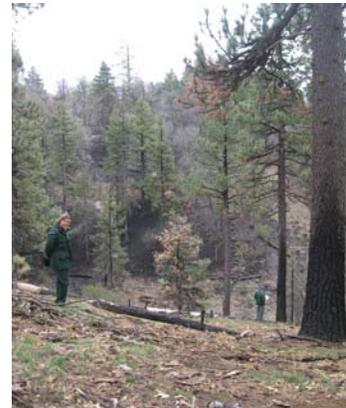
The burn and intensity met the objectives as planned. Ground cover and in some cases lower limbs burned.

Regarding Best Management Practice F25, the monitoring indicated that implementation BMPs were being met. Though there was no hydrology specialist report, the burn plan goal #6 states “conserve or improve long-term soil productivity” as well as consistency with the Forest Plan. One of the supplements of the Forest Plan is the Soil and Water Conservation Protection Policy, which specifies the types of BMPs required on different types of projects including prescribed fire. The burn did meet the prescription. From an effectiveness standpoint, the burn met the BMP objectives of suitable groundcover, lack of hydrophobic soils, and rilling at a rate of less than 1 rill per 100 feet of transect. The burn was backed down into the riparian conservation area (RCA) and there was sufficient regrowth one year later to provide a buffer to the flowing water. The fire management specialists on the ground made sure that the objectives for soil and water protection were being met, such as fuel moisture limitation, time of year for burns, and backing fire into the RCA.

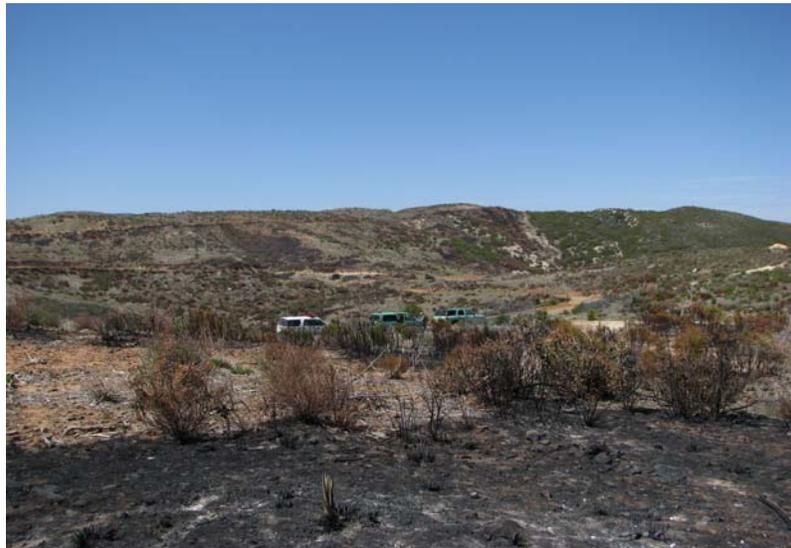
This project on the Aguanga ridge maintains a fuelbreak (type converted vegetation). The intent is to help hold fires from the east and keep such fires from burning into the forested area on Palomar Mountain and into the mountain top community. This type of strategically placed vegetation treatment is consistent with the LMP even though it is not immediately adjacent to the community it protects.

Regarding Best Management Practice F25, the monitoring indicated that implementation BMPs potentially were not being met because the burn plan prescription did not reflect soil and water protection considerations. But the burn did meet the prescription. From an effectiveness standpoint, the burn met the BMP objectives of suitable groundcover, lack of hydrophobic soils, and rilling at a rate of less than 1 rill per 100 feet of transect. There was no evidence of sediment transport to any streamside management zone. The project was on a ridge, far from any flowing water. The burn occurred on just two days before the conditions changed and burning had to be stopped. Though the planning documents did not speak directly to soil and water considerations, the fire management specialists on the ground made sure that the objectives for soil and water protection were being met, such as fuel moisture limitation, time of year for burns, and sufficient buffer left between the burn and drainage channels.

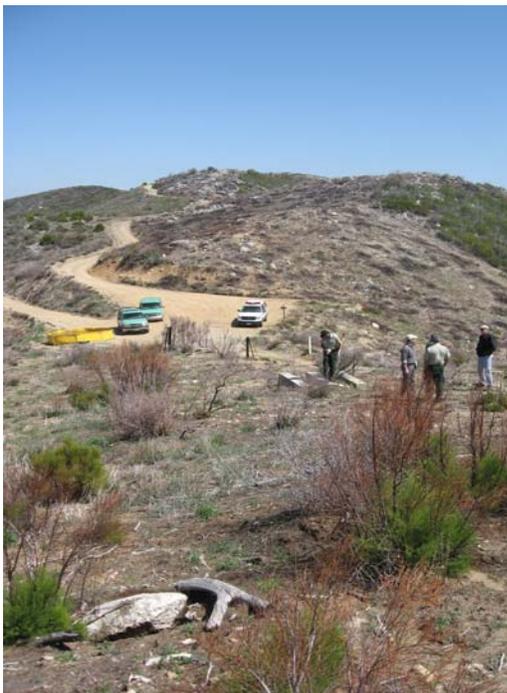
Heritage staff identified/flagged areas in advance. The project used a rubber tracked masticator per ARR. Post-burn monitoring upcoming by heritage staff.

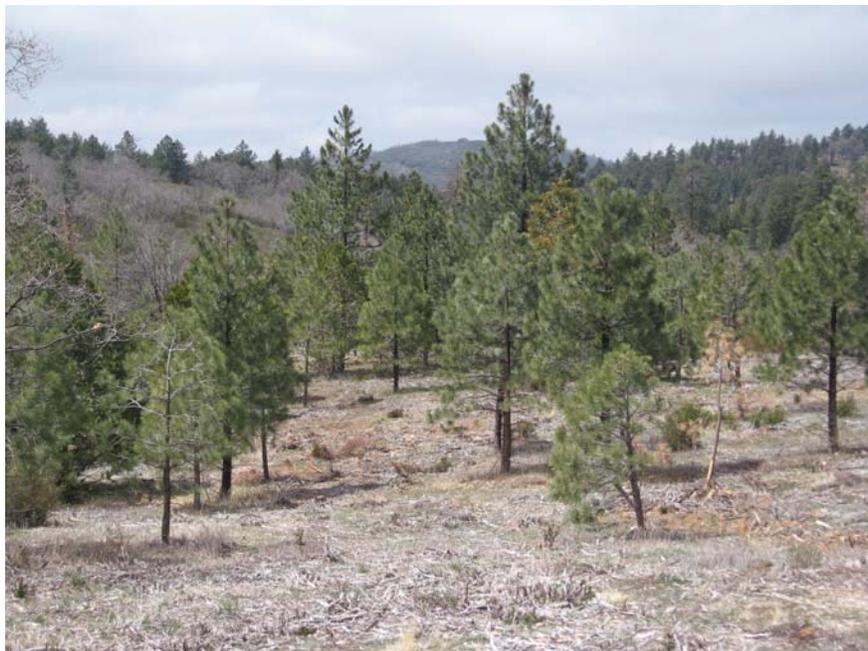
Laguna Mountain mastication

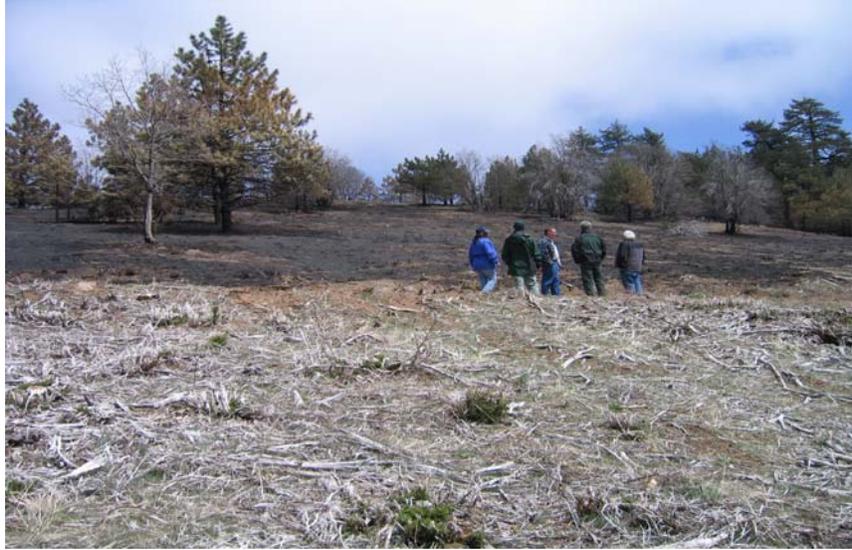
Mastication in foreground; area shown in background was also burned.
