PACFISH/INFISH FIELD REVIEW
Missoula & Helena, Montana

September 2004

FINDINGS

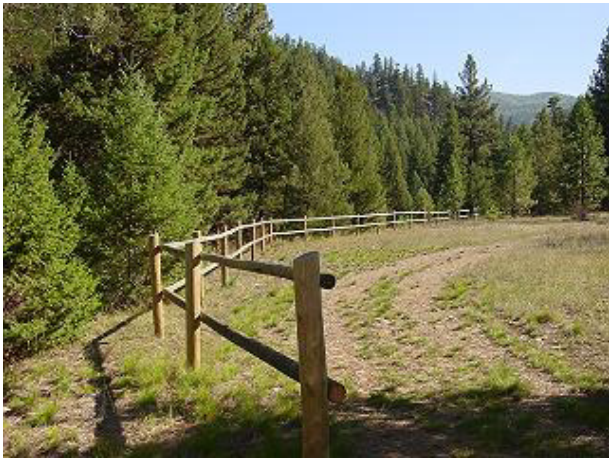
Observations: Fuels treatments (e.g. thinning) were conducted within the RHCA. The RHCA width was not modified, and treatments were implemented to be compliant with Standards and Guidelines. Vegetative treatments were located on a terrace above the river within zones of non-hydric vegetation, and outside of slopes adjacent to the river. Recreation use on those slopes, causing erosion/sedimentation to the river, was controlled using fencing,

as shown in the photo, and by building stepped paths down to the rivers edge. There was a discussion on silvicultural treatments in the RHCA and the application for watershed analysis. A 12,000 acre focused landscape analysis was conducted in this area in conjunction with the project. Field unit is monitoring vegetation and erosion using mainly photo points.

Recommendations: INFISH standards and guides require watershed analysis for salvage cutting in the RHCA's of priority watersheds (TM1a). TM1b is the standard applicable to fuels or silvicultural treatments designed to acquire desired vegetation characteristics, and there is no watershed analysis requirement stated in TM1b. The intent of the project was to be consistent with the INFISH requirement to acquire desired vegetation characteristics that help to attain the RMO's. Obviously monitoring would be required to track attainment of those desired vegetation characteristics and RMOs, as a result of the project through time. Monitoring results could be entered into the Implementation Monitoring (IM) Module database to document the successfulness of the applied Best Management Practices used to move towards Riparian Management Objectives. The IM Module would assist in tracking this management action over time for future evaluation and to assist future field unit experts, not currently in the Field Office, with a better understanding of what the objectives were and what actions were taken.

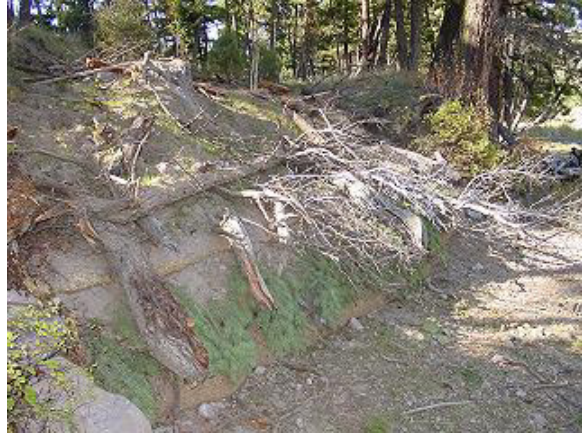
Observations: The old and new boat ramps were treated to control erosion/sedimentation into the river and minimize site disturbance by recreationists. Coir fabric wrap of soil, shown in the photo of a treated boat ramp (at right), was covered with shrub cuttings, a unique approach to stabilizing the streambanks. Vegetative plantings used native species along the disturbed streambanks. There were boulders placed on the road to reduce or prevent access to closed sites.

Recommendations: The use of bank revegetation techniques using fabric wraps and native shrubs is innovative and appears effective. Both sites have been improved and the actions are consistent with the INFISH requirement to adjust practices that prevent attainment of riparian management objectives. The potential for vegetative protection, what kinds and densities of species would be expected along the margins of this river (e.g. desired future conditions), would be a key question addressed in watershed analysis. The watershed analysis for the lower Blackfoot Corridor could have been appended to address this key question during project design. The watershed analysis could also identify the best places to construct a new boat ramp, in lieu of the obvious challenges at the present location. The communications issue with US Fish and Wildlife Service, on this project, appears to be an isolated incident in an otherwise excellent relationship. This field review should serve as a reminder that ESA consultation requires frequent communication between practitioners implementing projects

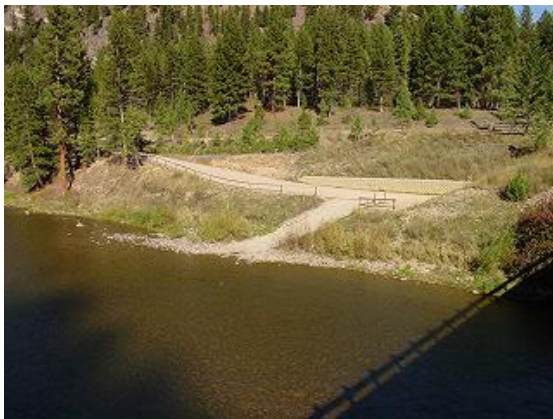
A new boat ramp was constructed and

vegetative protections installed along the previously degraded river banks. These treatments appear to be effective at controlling bank erosion as shown in the photo at left. We had some discussion about the potential for revegetation and vegetative protections along the streambanks of large rivers. It was indicated to the team that this ramp was originally designed with a short, straight approach. This design was concurred with by the US Fish and Wildlife Service in the ESA consultation on the project. Project designs were changed at the time of implementation, constructing a right-angled approach as shown in

the photo, without notifying US Fish and Wildlife Service, or the BLM's Level 1 Team member. Fish and Wildlife Service was subsequently involved in post-project mitigations, including the re-vegetation and bank stabilization work.

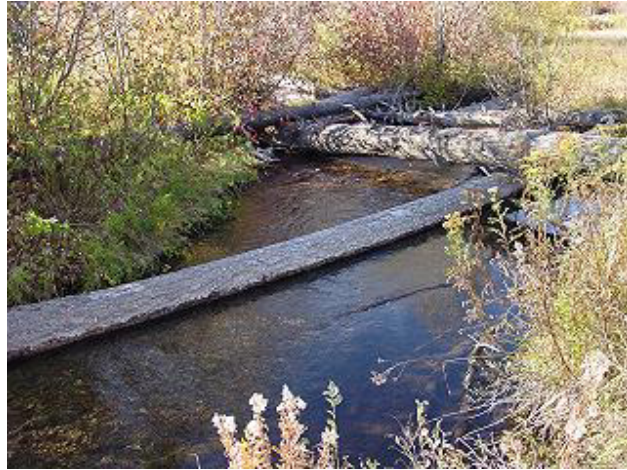
Observation: This degraded stream, with little or no habitat structure, was restored using large woody debris to create pools and graveled spawning areas. Since construction of the project, beaver have added material to the logs, effectively increasing water levels (e.g. damming), and raising the local water table. The rise in water table appears to be expanding the composition of hydric vegetation communities in the floodplain. Redd counts prior to the project indicated little or no spawning in this reach. Post-project monitoring indicated large numbers of cutthroat and rainbow redds. There were 70

logs (pictured at right) installed using horse teams with cable and pulley systems to move the large wood into place. The cost was minimal and the return on the investment appears to be high. How does restoration at this site contribute to achieving the overall conservation strategy for the Blackfoot River bull trout population? Sediment is one of the big problems for the Blackfoot and lower Belmont Creek. At one time bull trout were known to spawn in this reach. Sediment used to fall out in Lower Belmont meadow. When the stream was straightened by the previous landowner, sediment was flushed to the river. The project was then designed to restore the depositional geomorphic condition of the river, and that will improve water quality in the Blackfoot River. The Field Office is monitoring changes in substrate, bed elevation and quantity/quality of habitat features. They have Wolman Pebble Count transects, cross section profiles comparing changes in various features in restored and geomorphically analogous sites, plus pre/post habitat feature evaluations (simple counts of habitat features). Some of the monitoring sites on Belmont Creek have been obliterated by Beaver.

Recommendations: This project appears to be consistent with the INFISH requirement to conduct such projects in a way to promote long-term ecological integrity and contribute to RMO attainment. This project was opportunistic and, designed in the short-term, to acquire, immediate increased habitat productivity and improved water quality in the lower Blackfoot, locally benefiting fish populations. This project will likely also achieve long-term ecological benefits by the natural riparian vegetative restorations. Monitoring should continue to be conducted to evaluate and document both positive short-term and long-term trends and responses to management actions here. The monitoring questions being addressed are: What is the change in pool habitat and spawning substrate through time? What vegetative responses are occurring in the floodplain? In addition to the monitoring already being implemented, we suggest the addition of channel vegetative composition cross sections in the floodplain of this meadow to document changes as water tables rise. We suggest using Al Winward's method for this purpose, as documented in his 2000 publication.

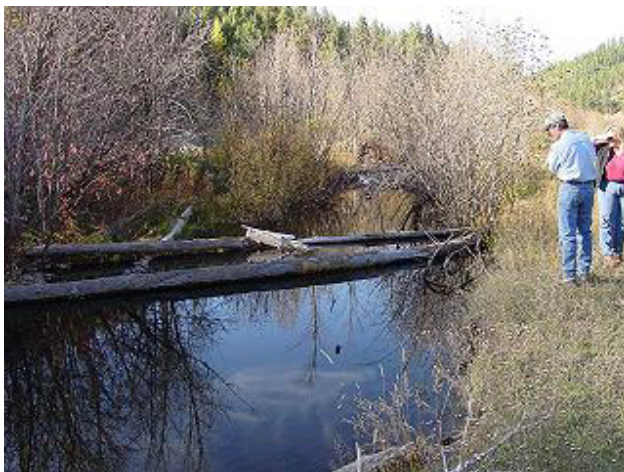
Anything done to improve water quality and habitat quality in streams supporting remaining local populations of bull trout is important for the larger population. Belmont Creek is one of the few streams where there is still connectivity with the main stem Blackfoot River, and therefore supports a fluvial population. Belmont and Gold Creeks are the only 2 in the lower Blackfoot that have fluvial fish. When the Milltown Dam on the Clark's Fork is

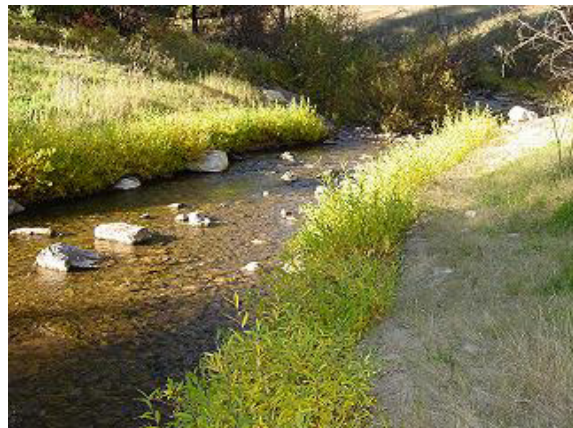
Observation: Cattle were fenced from an area of concentration along Belmont Creek, and the disturbed reach of stream was restored using brush fascine, fabric wrap, and willow cuttings, as shown in the photo at right. Cuttings used were not the dominant vegetative species in this particular reach. The fence crossed a road with raised prism. Because of cultural resources near the old road prism, they did not remove all the old road fill. There were native vegetative plantings on the old stream crossing. Monitoring of vegetation and streambank recovery is being conducted mainly with photo points.

Recommendations: This project is consistent with the INFISH requirement to design restoration projects that promote long-term ecological integrity of ecosystems and contributes to attainment of RMOs. Monitoring should be conducted on all projects designed to attain RMOs. We highly recommend that managers and specialists use the Implementation Monitoring Module to document what was done, where it was done, was it completed as intended, and if not why not, and any measures taken to mitigate the alterations that were made. Once cultural resources have been evaluated, removal of the road fill and re-planting with native vegetation would be an appropriate action within the RHCA. There were concerns about using non-native willow species for planting in the streambank. Vegetative materials used for rehabilitation should match local species to be consistent with INFISH Standard and Guideline WR-1.

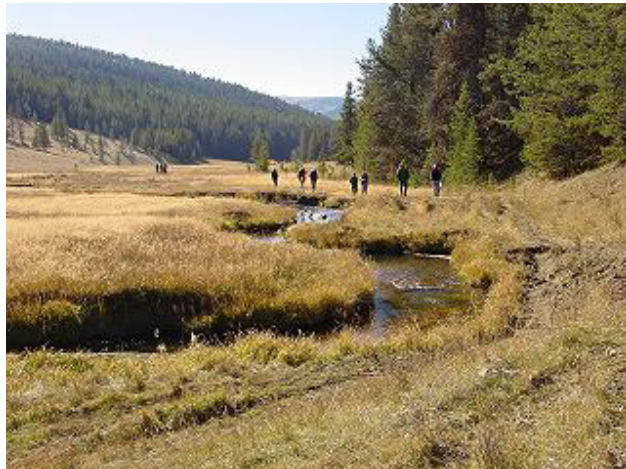
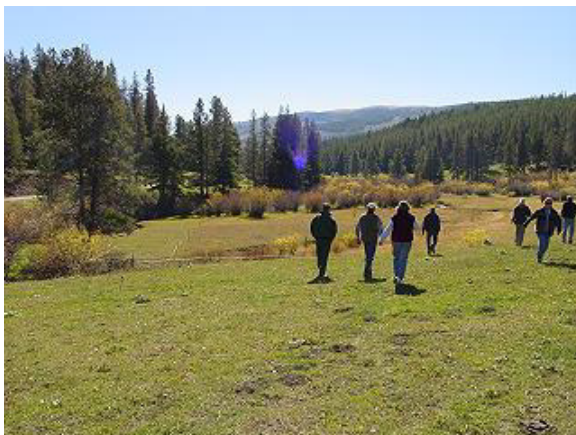
Implementation monitoring initiated in 1999 indicated that the operation was unable to meet terms and conditions of the BO. In 2000 the Forest applied the Helena NF riparian guidelines and bank disturbance transects. Since that time a number of measures have been taken to bring the allotment into compliance. The photo at right is located in the Meadow Creek pasture where many of the measures have been implemented. They include electric fencing exclosures (photo below), numbers and/or season reduced by 20%, off-stream

tank with solar pump, range consultant to work with permittees on the bank disturbance issue, riders to control distribution, and the exclosure in lower Meadow Creek Pasture. There was obvious recovery along the margins of Dog Creek evidenced by colonizing vegetation along the water line, increaser hydric vegetation types in the green line, and some bank stabilization. Most of the current season's disturbance was trailing in the floodplain, with little bank disturbance observed outside of the crossing sites.

Recommendations: The Forest is monitoring using the Implementation Monitoring Module (IM – formerly the IIT module) and to meet requirements of local ESA consultation. As we have observed elsewhere, there may be the perception that the IM Module was intended to be a separate and unique monitoring effort on top of local monitoring requirements. We observed that the Forest splits monitoring attributes up into different locations, perhaps a response to the differing requirements of the IM Module and the local ESA consultation. In fact, all local requirements for stream/riparian monitoring can and should be included as part of IM monitoring and recorded in the IM module. The Module facilitates tracking any indicator associated with land management actions and streams containing listed fish species. All monitoring indicators should be collected at the same designated monitoring area(s) on the stream so that stubble heights, for example, can be calibrated against bank disturbance and woody utilization. IM monitoring has been, and continues to be refined. The Forest would likely benefit by some field-level, hands-on orientation to the IM Module database and recent protocols for selecting the designated monitoring site, as well as methods for monitoring both short- and long-term streamside indicators related to livestock grazing. Forest grazing specialists received training in the IM Module training on October 13th, 2004, but continued refinements, and similar needs of other specialists will necessitate occasional future workshops.

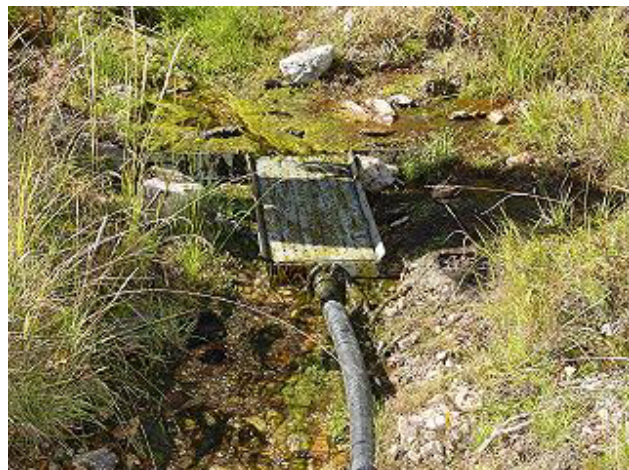
We examined a unique approach to riparian restoration using a “cow-be-gone” (photo at right) to divert water to a trough outside of a permanent exclosure (photo below).
