ABBREVIATED PRELIMINARY ASSESMENT

RAINY MINE AND MILLSITE

Mt. Baker-Snoqualmie National Forest
Snoqualmie Ranger District
King County, WA

September, 2003

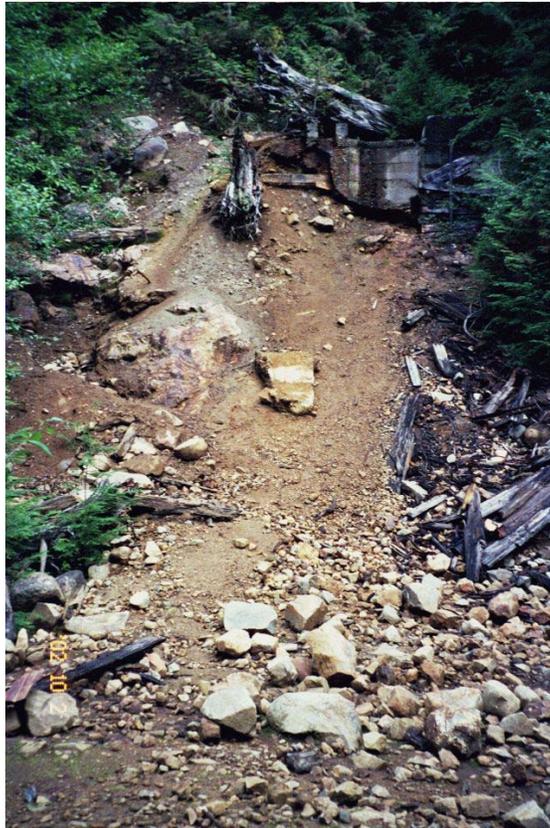
Photo 1. Remains of mill foundation or head house; shaft or collapse feature is behind downed snag at top of picture, view to the northeast (photo by G. Graham, 10/2/2002).

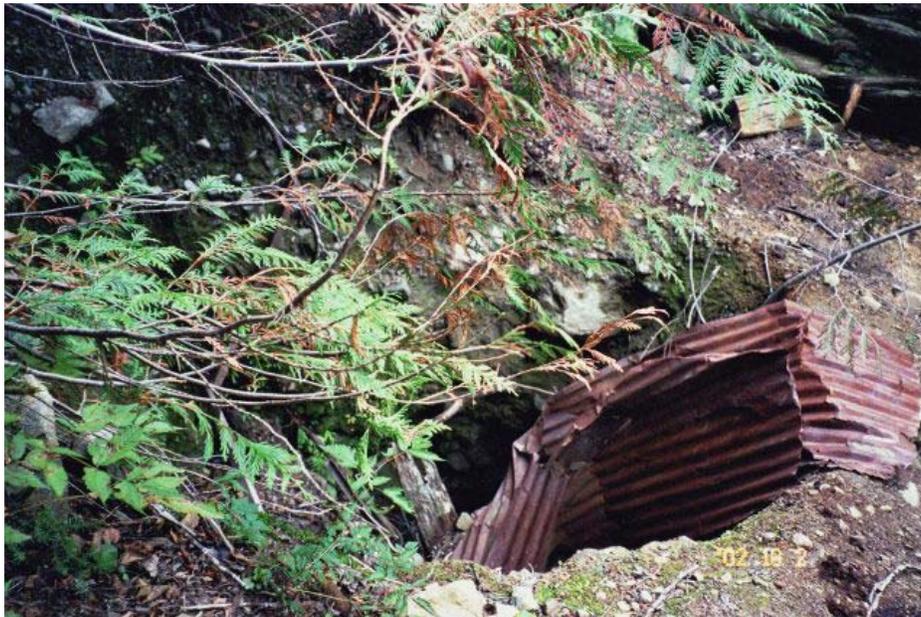
Photo 2. View of shaft or collapse feature mentioned in Photo 1, flooded at depth (photo by G. Graham 10/2/2002).

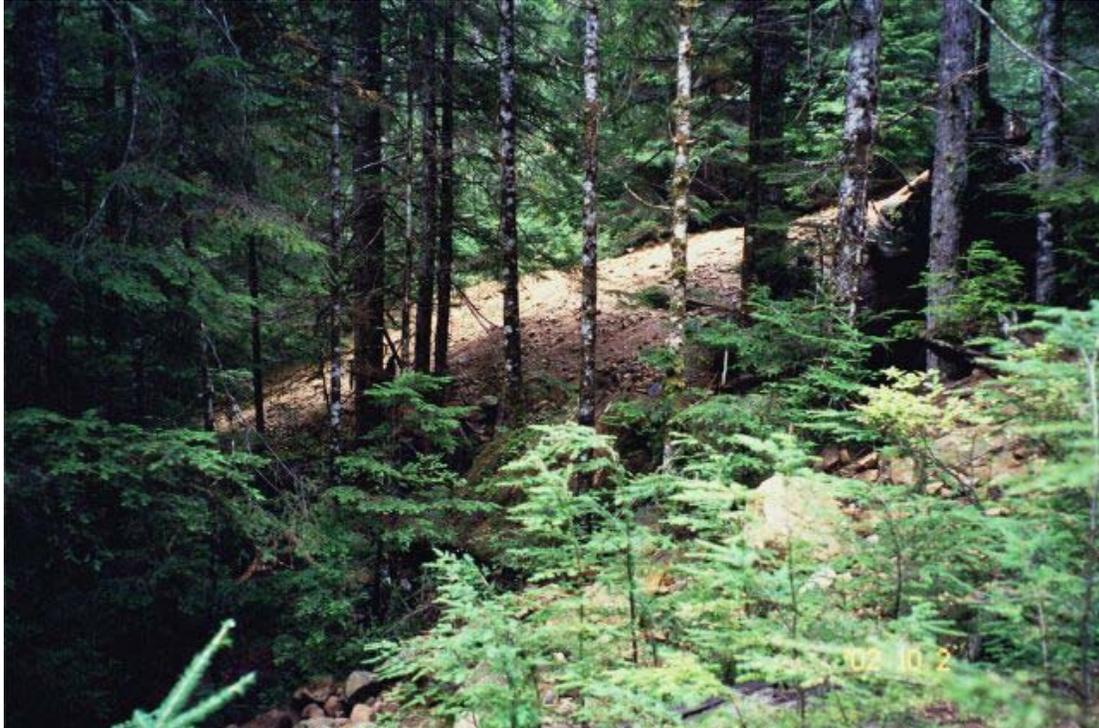
The Site was visited on October 2 and 11, 2002. At that time, water was ponded in the west zone adit behind sloughed material at the portal and numerous seeps were discharging at the base of the waste rock dump in the east zone. These seeps create a marsh-like area characterized by significant precipitation of iron oxide, hydroxide, and/or oxy-hydroxide minerals. After passing through the wetland, these waters discharge to Quartz Creek. No discharge was observed from the caved adit in the east zone but the workings are presumed to be flooded. No water samples were collected as part of this investigation. However, field parameters were obtained using a Hanna Instruments HI-9812 pH-EC-TDS meter, the results of which are outlined below:

The pH measurements indicate a high potential for acid rock drainage from the sulfide-rich waste piles that could adversely affect surface water quality in Quartz Creek.

Photo 3. View of waste rock dumps below remains of mill, multiple seeps are present at the base of the piles, view to the northwest (photo by G. Graham, 10/2/2002).

Based on the In Situ screening of material from the waste rock dumps, bench testing of sediments, the high potential for acid rock drainage, and EPA's APA Checklist (Appendix A), it is recommended that a Site Inspection (SI) be completed. As part of this inspection, a thorough study of the area to determine the extent of contamination is warranted as well as sampling water from pore spaces of the stream gravels immediately above and below the Site. Sampling of the benthic macroinvertebrates are also required. In addition to testing water samples from the pore spaces of the gravels for the presence of metallic elements, water parameters such as pH, conductivity, turbidity, dissolved oxygen, temperature, total dissolved solids, hardness, and oxygen reduction potential are required. The area should be sampled to determine the presence of waste material and tailings, and if present, the potential waste piles and tailings should be sampled at depth and a determination of volumes should be calculated. Acid base accounting (ABA) is required if waste material is present besides what had been observed during this assessment. Sediment samples are to be collected from transects of the stream and preferably at depth and analyzed

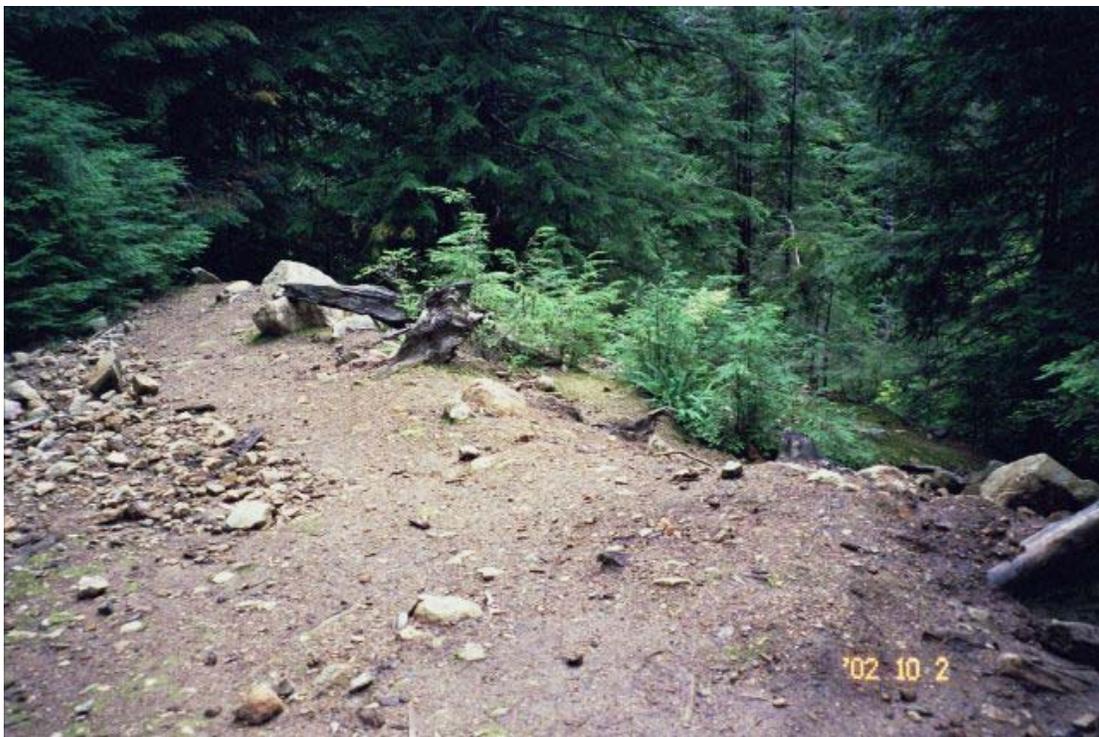
Photo 4. View from top of southeast end of waste rock dump looking towards Quartz Creek, view to the southwest (photo by G. Graham, 10/2/2002).

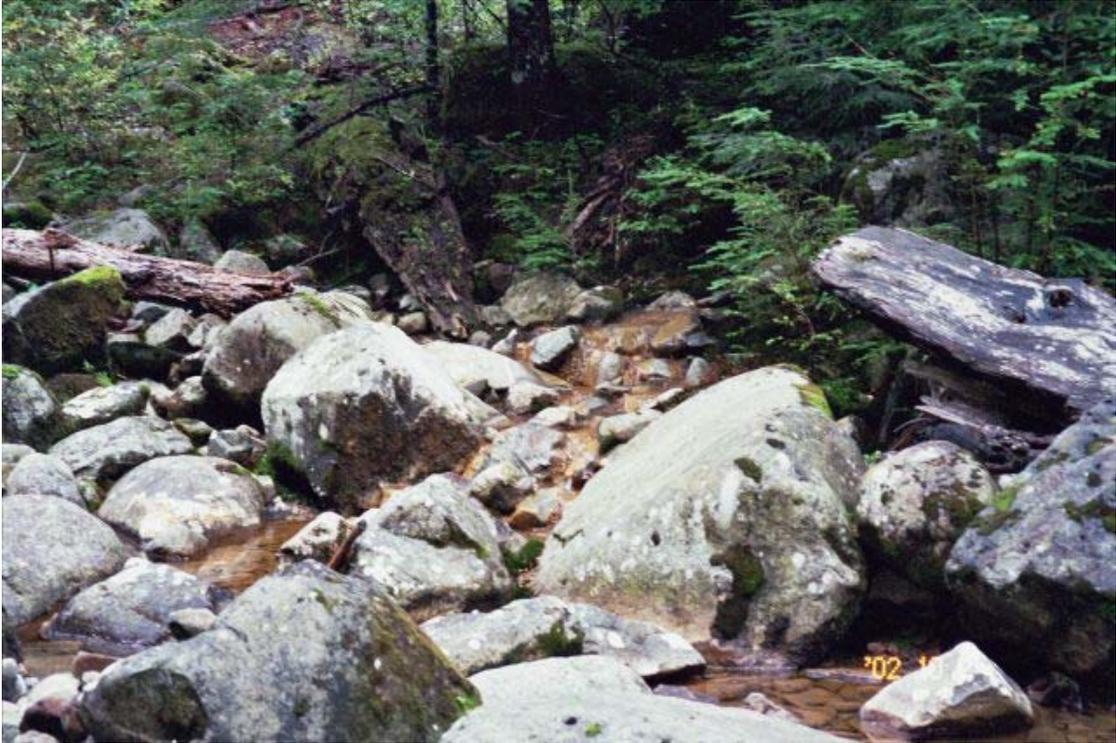
pH measurements at the Site indicate a high potential for acid rock drainage directly to Quartz Creek. Numerous seeps discharge at the base of the sulfide-rich waste rock piles into a wetland with significant iron oxide, hydroxide, and/or oxy-hydroxide precipitation before the effluent enters Quartz Creek.

Photo 5. View of water from seeps at base of waste rock piles discharging directly into Quartz Creek (photo by G. Graham, 10/2/2002).

for total as well as for available metals. Surface water samples are also required for analyses of both total and dissolved metal concentrations in Quartz Creek, Taylor River, and Middle Fork of the Snoqualmie River as well as in any other seeps and/or tributaries that may be present in the vicinity of the Rainy mine and millsite.
