# KIGGINS-NISBET MINE COMPLEX

Mt. Hood National Forest  
Clackamas County, Oregon

## NON-TIME CRITICAL REMOVAL ACTION REPORT

March 5, 2009

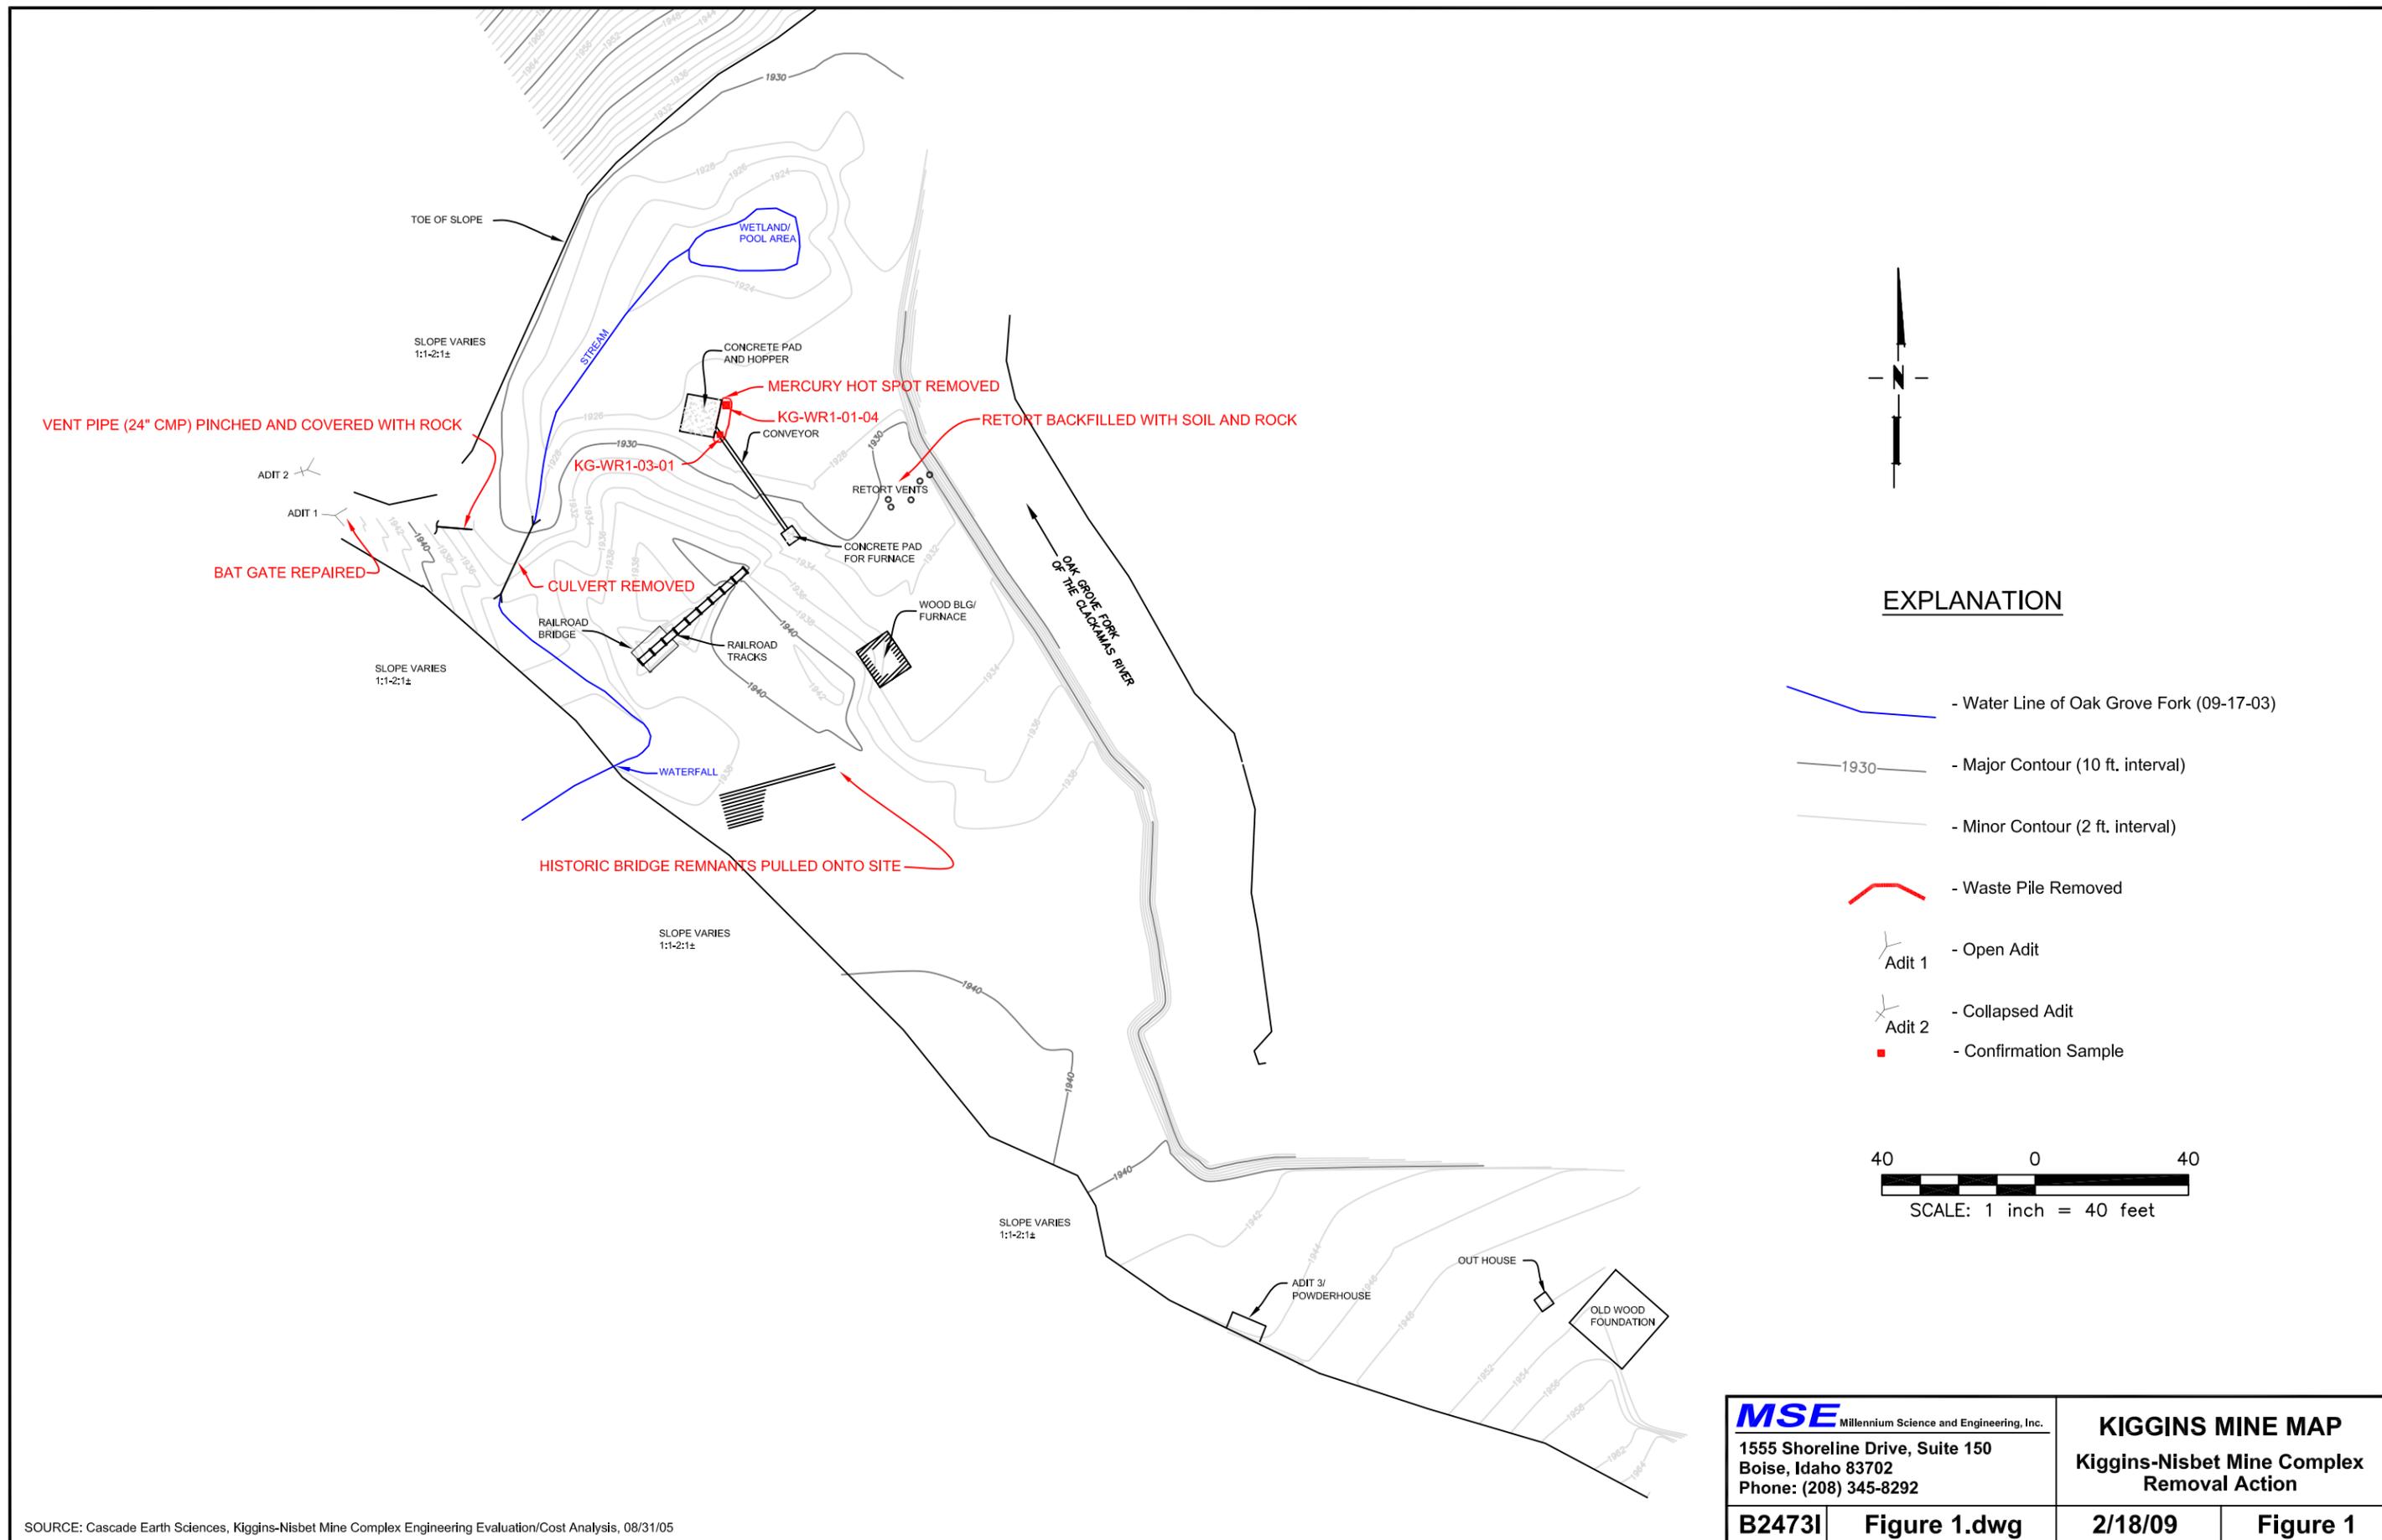
- Site features at the **Kiggins Mine** are shown in Figure 1 and included:
  - Three adits; however, only two were located during the Site Inspection (SI) completed by Cascade Earth Sciences (CES) in 2004.

- Adit 1 has an existing bat gate that was in need of repair.
    - Adit 2 has collapsed about 10 feet into the portal.
    - The third adit is assumed to be collapsed or covered by a landslide.

- An air vent consisting of a 24-inch corrugated metal pipe (CMP) extending downward into the hillside below Adit 1.
  - Waste rock and tailings.
  - Multiple ore beneficiation structures and foundations, including:

- Furnace wooden structure,
    - Concrete pad and conveyor to another concrete pad and large metal hopper,
    - Ore cart rails, and
    - Brick retort and furnace.

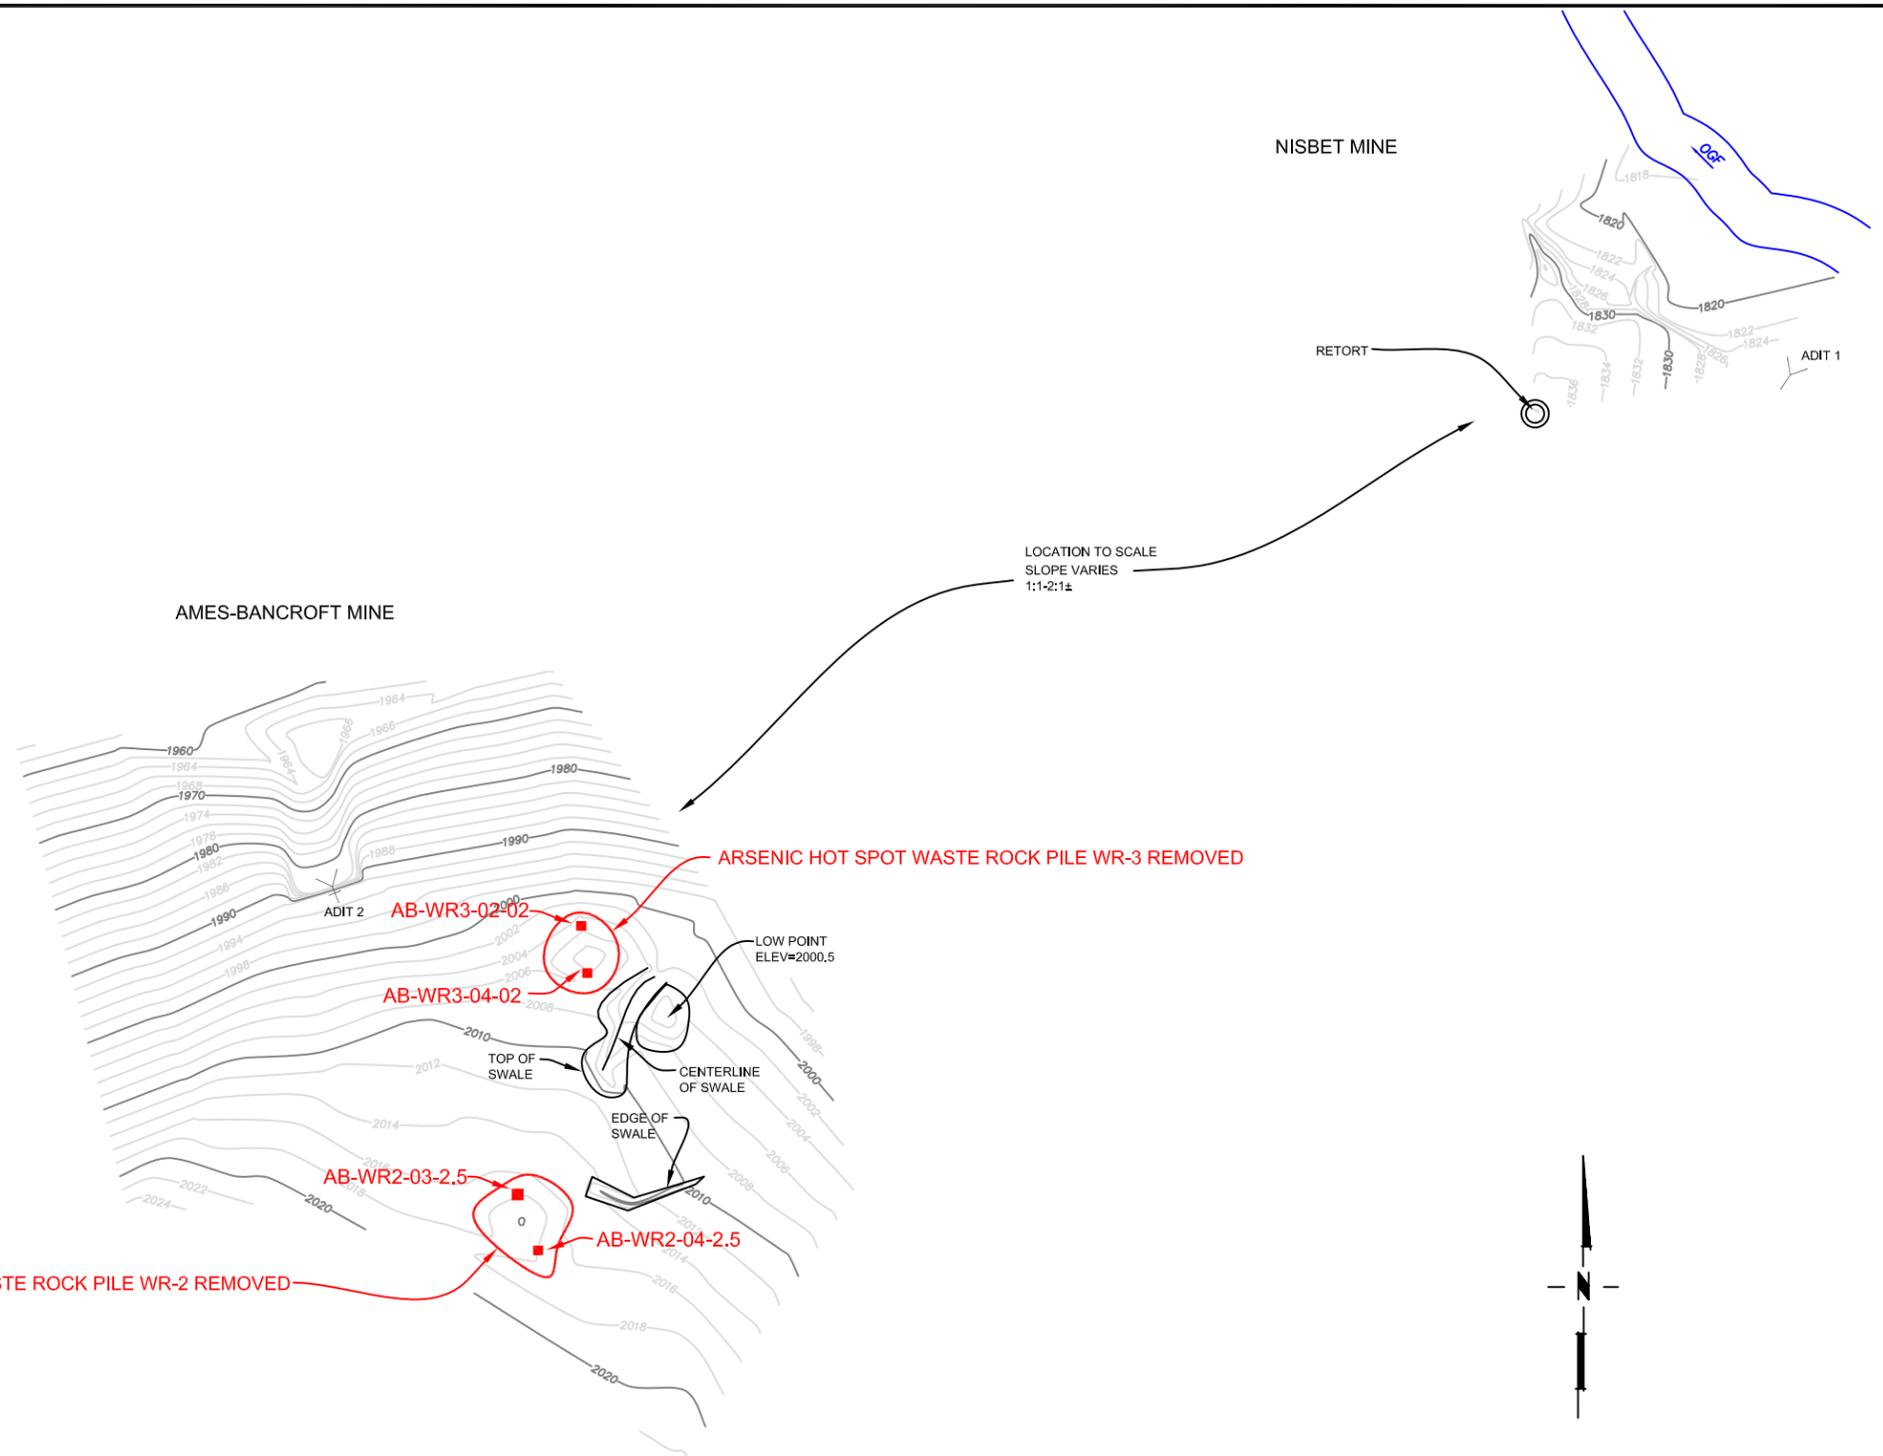
- Site features at the **Ames-Bancroft Mine** are shown in Figure 2 and included:
  - Two waste rock piles, and
  - One collapsed adit.

ARSENIC HOT SPOT WASTE ROCK PILE WR-2 REMOVED

ARSENIC HOT SPOT WASTE ROCK PILE WR-3 REMOVED

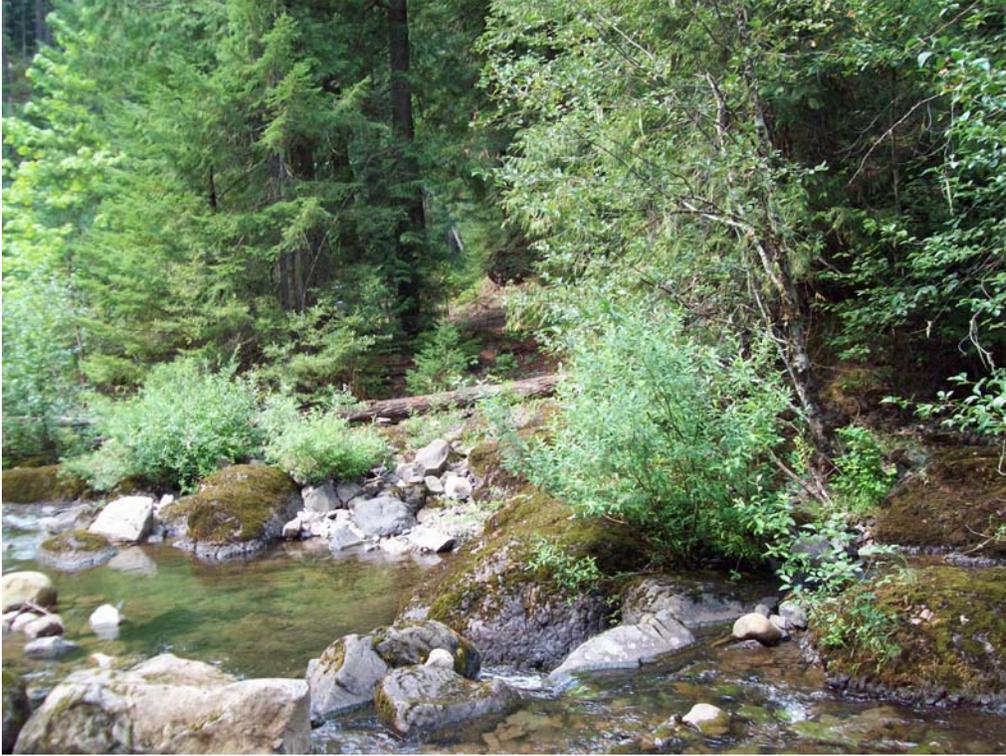
**Photo 1. Oak Grove Fork (OGF) at Kiggins Mine prior to crossing**

- Accessing the Site from Forest Road (FR) 4630 which is about 1,000 feet north of the mine and across the OGF.
    - Equipment accessed the Site by fording the OGF about 100 feet upstream of the dilapidated bridge.

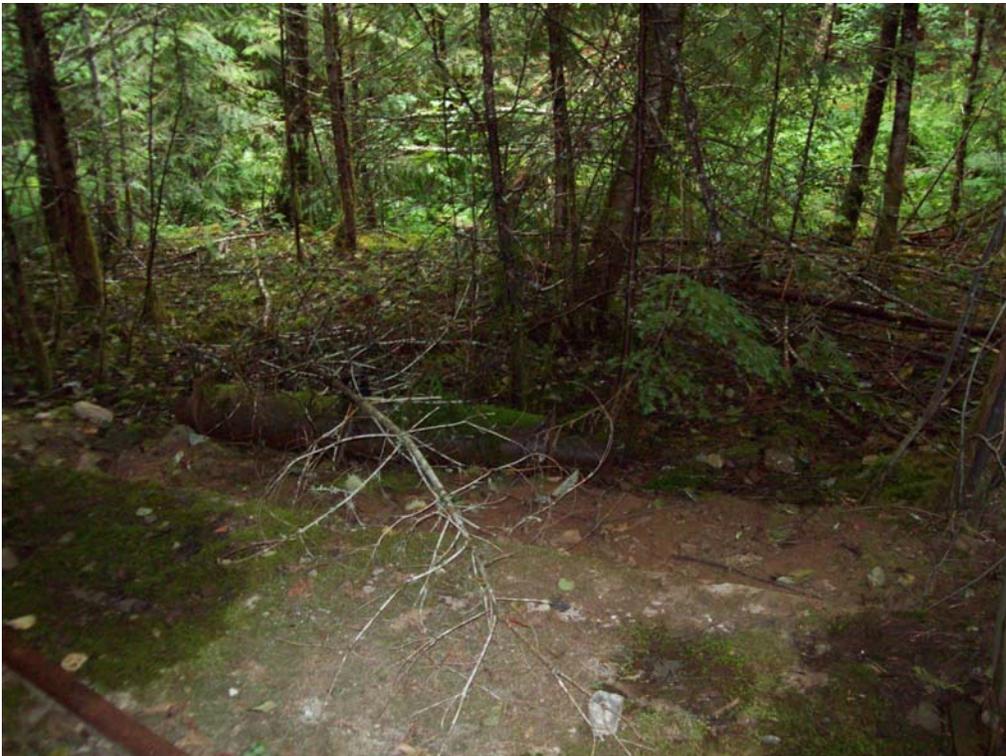
**Photo 8. Mercury hot spot around hopper foundation at Kiggins Mine**

- Excavating the mercury hot spot (~20 bcy) and transporting to the Columbia Ridge RCRA Subtitle C landfill in Arlington, Oregon for disposal.
    - The hot spot consisted of mercury-contaminated soil from around the concrete pad under the large hopper that exceeded the mercury hot spot concentration of 30,248.5 mg/kg.

- At the Kiggins Mine, approximately 20 bcy of mercury-contaminated soil was excavated from around the concrete pad under the large hopper.
- At the Ames-Bancroft Mine, approximately 100 bcy of arsenic-contaminated mine waste was excavated from waste rock piles WR-2 and WR-3.

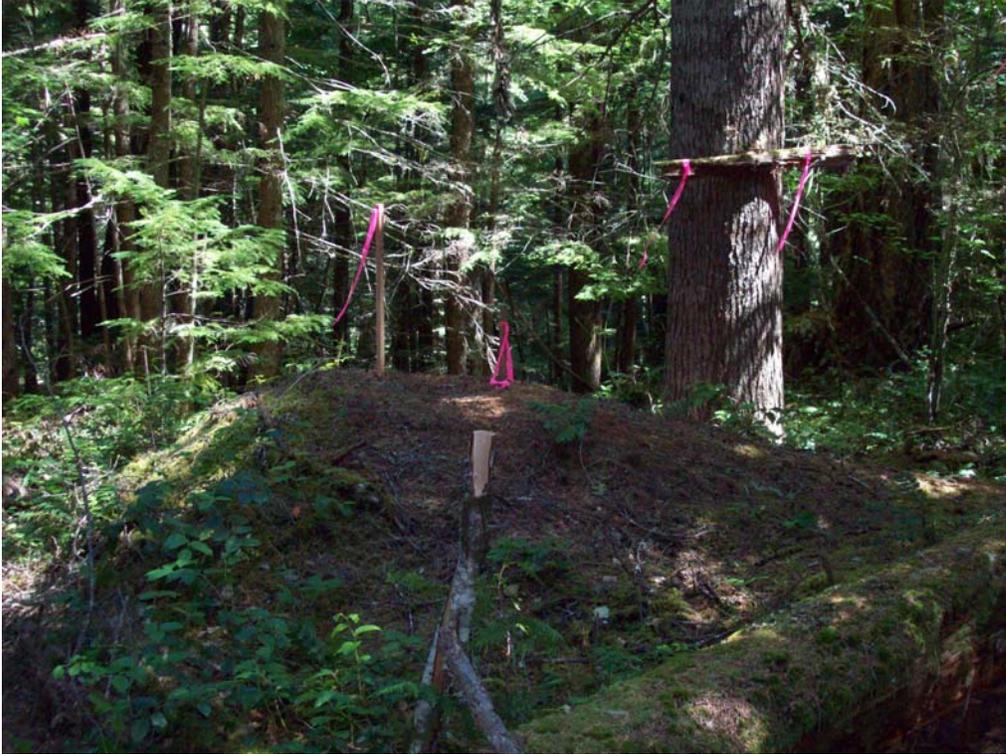
**Photo 17. Ames-Bancroft Mine waste rock pile WR-2 pre-removal**

- The hot spots consisted of two waste rock piles (WR-2 & WR-3) that exceeded the arsenic hot spot concentration established in the EE/CA of 3,500 mg/kg.
