Umatilla National Forest

SECTION U

◆ 2000 Monitoring Report ◆

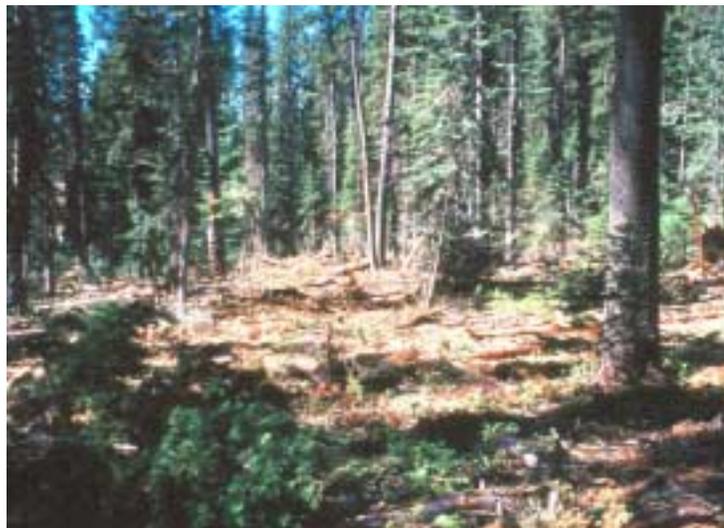
Figure U-1
HARVESTER/FORWARDER TRAIL

The current operations (complete at the time of this visit) indicated an excellent result relative to soil effects with virtually no soil exposed to erosion hazard, and well-spaced harvester trails for maximum utility of the harvester/forwarder system. There was a relatively even slash mat on harvester trails providing good support for the equipment with only a few areas (short 10-20' sections) subject to compaction due to insufficient downed wood or slash. (Figures U-1 and 2).

Detrimental soil impacts were estimated at 1-3%, with compaction being the dominant impact. Soil protection guidelines were met with this operation. Research needs to further pursue the question of soil disturbance in previously undisturbed, natural systems, including recovery rates.

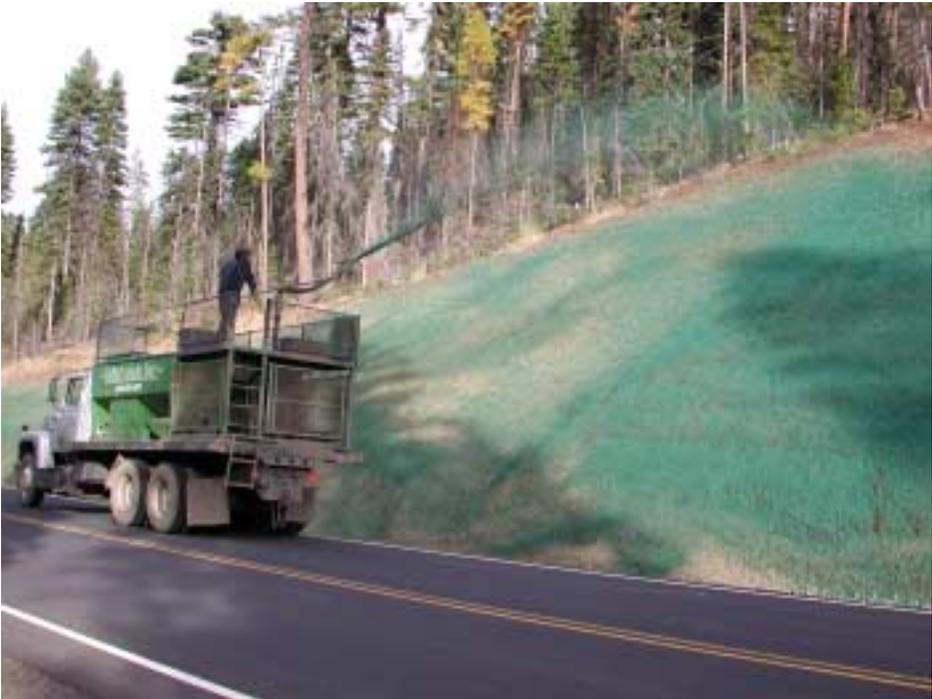
Figure U-3
HYDRO-MULCHING ROADCUT SLOPE ON FOREST ROAD 53

Mitigation measures were identified in the NEPA document. Objectives were to provide stability to cut and fill slopes, increase cover, reduce erosion, increase infiltration, enhance plant diversity, and enhance aesthetic values.

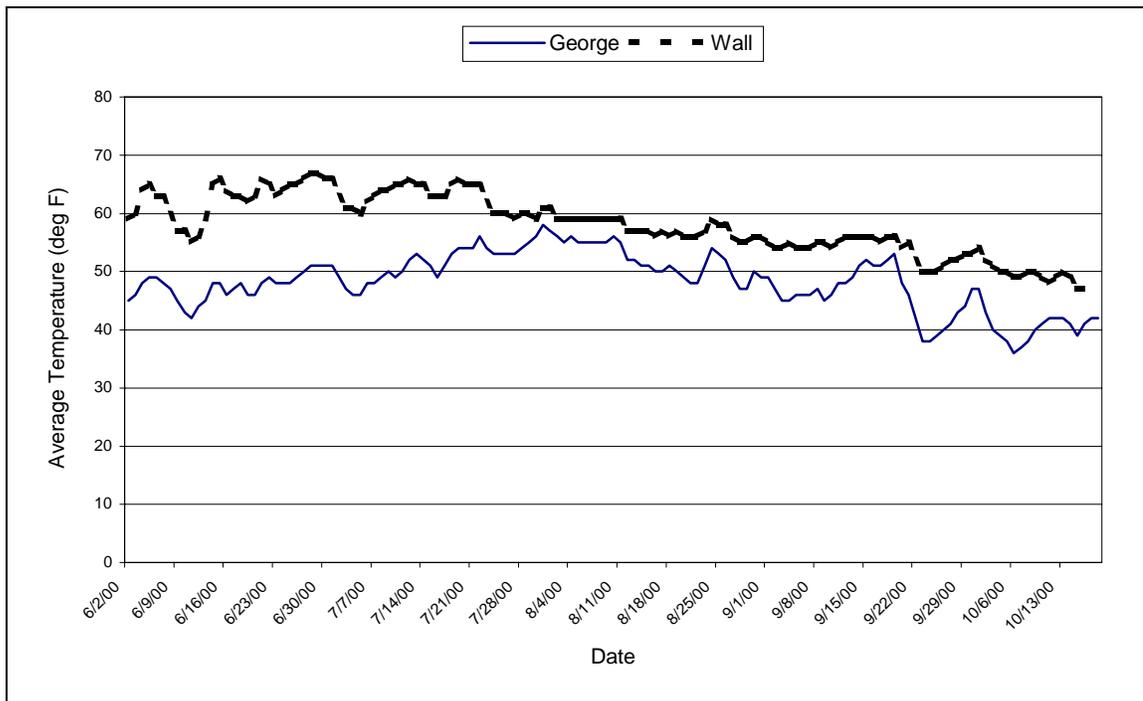
Figure U-4
SUMMER STREAM TEMPERATURES, 2000
(Mean daily temperatures, degrees Fahrenheit)

Water temperatures were measured at 139 locations across the Forest with recording thermographs, devices used for continuous recording of water temperatures. Summer water temperatures reached maximum in mid to late July. Stream temperature conditions varied across the Forest as shown by two examples from the north half of the Forest (George Creek and Tucannon River at Panjab Creek) and two from the south half (Hidaway Creek and Wall Creek) (Figures U-4 and U-5).

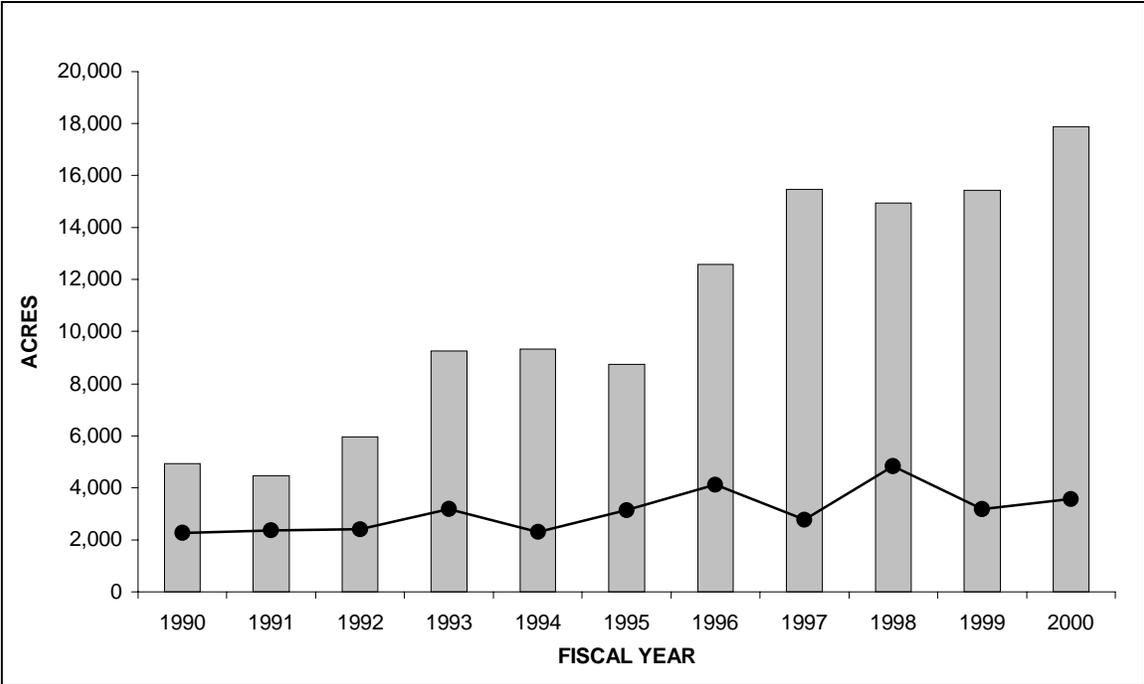
Figure U-6
STOCKING LEVEL CONTROL: ATTAINMENT (line) VERSUS NEED (bars)

Thinning is an active restoration technique affecting small-diameter trees. It can be used to reduce wildfire risk and improve forest health, to develop or protect fish and wildlife habitat, to encourage undergrowth vegetation, to promote late-successional characteristics for biological diversity, and to accomplish a variety of other land management objectives. The Forest Plan did not anticipate many of these uses for stocking-level control and that is probably one reason for the Plan's relatively low projections with respect to release and noncommercial thinning.

- Even though the Forest has exceeded Plan projections (based on the 6-year average) and this average is outside of Plan thresholds, a change is needed to address the backlog of acres needing stocking-control treatment. Funding for these treatments has been lacking for several years and the backlog is increasing. Under the current management scenario it is unlikely the Forest would be able to treat all of the over stocked acres, even if treating all the acres was determined to be desirable. Additional issues to be considered include fish and wildlife habitat needs and ecosystem sustainability. Stand management for stands of noncommercial size needs to be evaluated and adjusted during revision of the Forest Plan.

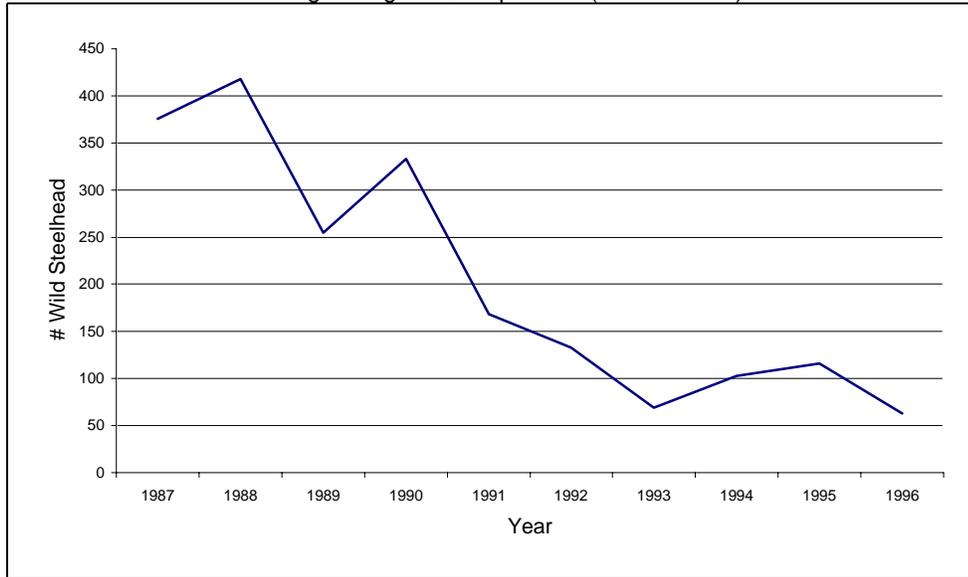
Figure U-7
ESTIMATED WILD STEELHEAD ESCAPEMENT -- TUCANNON RIVER
 Marengo Bridge to Sheep Creek (Schuck 1997)

In the fall of 1997 a permanent adult steelhead and salmon trap was installed at the Tucannon Fish Hatchery by the Washington Department of Fish and Wildlife. The trap was checked daily by hatchery personnel beginning in October 1997 and continuing through June 30, 1998 (WDFW 2000). Fifteen wild steelhead and 60 steelhead of hatchery origin were trapped and passed upstream at Tucannon Fish Hatchery site in the first year of operation.

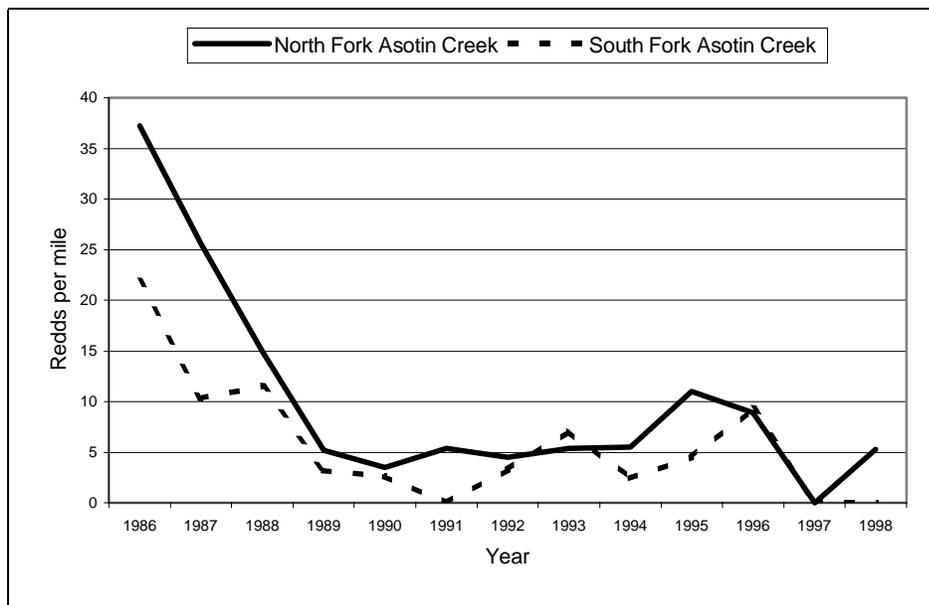
Figure U-8
STEELHEAD SPAWNING GROUND SURVEYS -- REDDS PER MILE
 Asotin Creek Watershed

Asotin Creek supported a run of over 1,000 steelhead from 1954 to 1961 (Schuck, personal communication). The present annual return of between 120 and 170 adults is below the Washington State escapement goal of 225 spawning steelhead. Spawning habitat on the Forest is restricted to approximately 10 miles of the North Fork of Asotin Creek. Other steelhead tributaries with headwaters on the Forest are Charlie Creek, George Creek, and South Fork Asotin Creek. Figure U-8 displays the steelhead spawning survey results by the Washington Department of Fish and Wildlife since 1986 (no date was available for both locations in 1997 and South Fork Asotin Creek in 1998) (Schuck, Viola, and Keller, 1997).

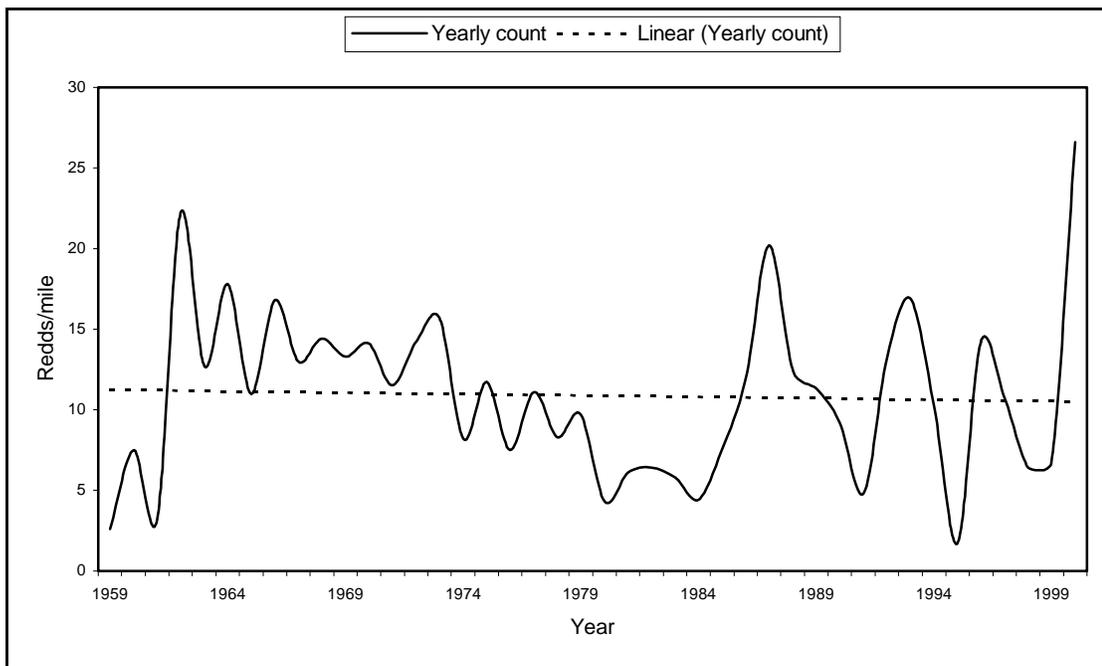
Figure U-9
JOHN DAY RIVER BASIN CHINOOK SALMON REDD COUNTS 1959-2000

The Oregon Department of Fish and Wildlife (ODFW) established spring chinook spawning distribution and abundance index reaches in the John Day River drainage in 1959. The purpose of the monitoring is to document the Chinook spawning trends in the basin. Redds are counted on representative reaches of streams each year. Index reaches on the North Fork John Day River, Granite Creek, Clear Creek, and Wenaha River are on the Umatilla National Forest. Figure U-9 displays the redd count trend, summarized in redds per mile, for the John Day basin with data from the last 41 years. The dotted line indicates the overall trend.

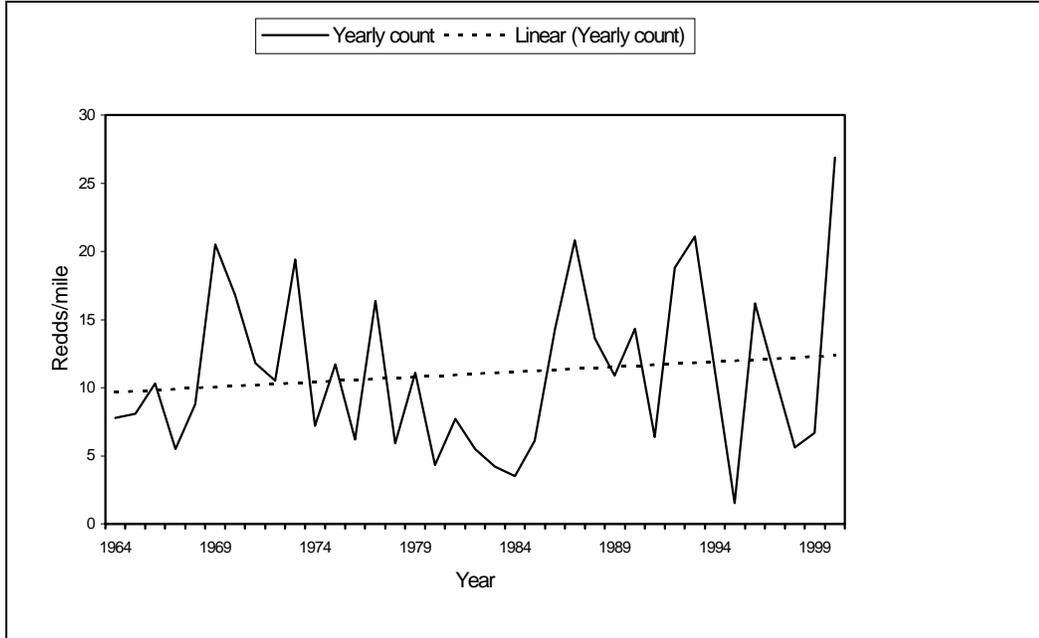
Figure U-10
NORTH FORK JOHN DAY RIVER CHINOOK SALMON REDD COUNTS 1964-2000

The long-term trends for spring chinook redd counts on the North Fork John Day River is slightly up as shown in figure U-10 and down for the Granite Creek system, Figure U-11, which includes both the Granite Creek and Clear Creek index sites.

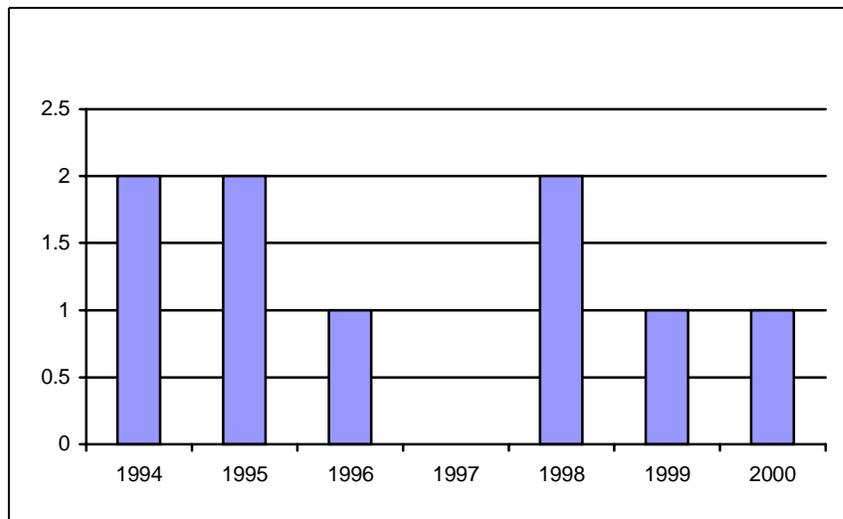
Figure U-12
DRY CREEK EAGLE NEST SITE
 Number of Eaglets Fledged

Monitoring occurred at the Dry Creek bald eagle nest site in fiscal year 2000. However, only one visit occurred by mid summer, because of reduced funding. During the visit, one fledged young eaglet was observed at the nest site. Since 1994, this nest has fledged nine eaglets, for an average of 1.3 eaglets fledged per year, Figure U-12. In 1999, the Heppner Ranger District implemented the Dry Creek site-specific management plan.
