Silver Lake Watershed Assessment

Creating a Healthy Watershed through
Cooperative Watershed Management

February 2003

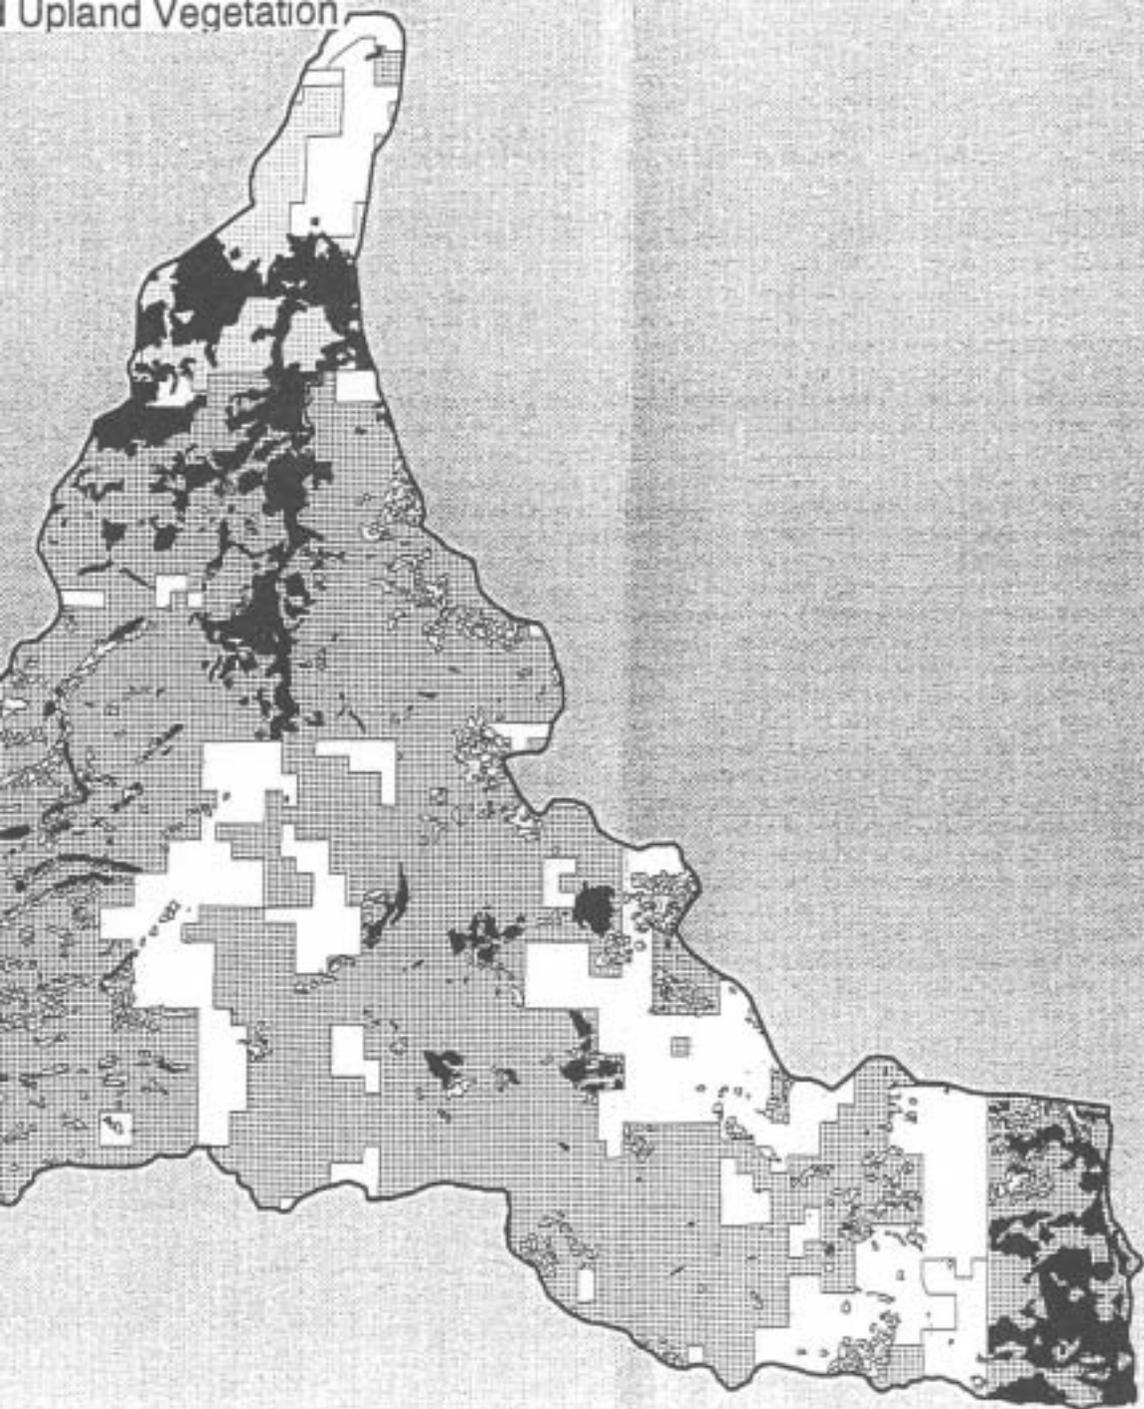
Upland Vegetation

Silver Creek Watershed
(108,278 acres)

Silver Creek Watershed: Within the 108,278 acre watershed, forested lands cover 83,842 acres or approximately 77% of the area. Conifers have encroached into many of the dry and moist meadows and aspen stands within the watershed. Aspen stands or scattered aspen occupy about 3,420 acres, while there are an estimated 6,834 acres of juniper/bitterbrush/bunchgrass or ponderosa pine-juniper/mountain mahogany-bitterbrush-big sagebrush/fescue plant communities, with encroachment of juniper occurring in the drier, deeper-soil pine sites.

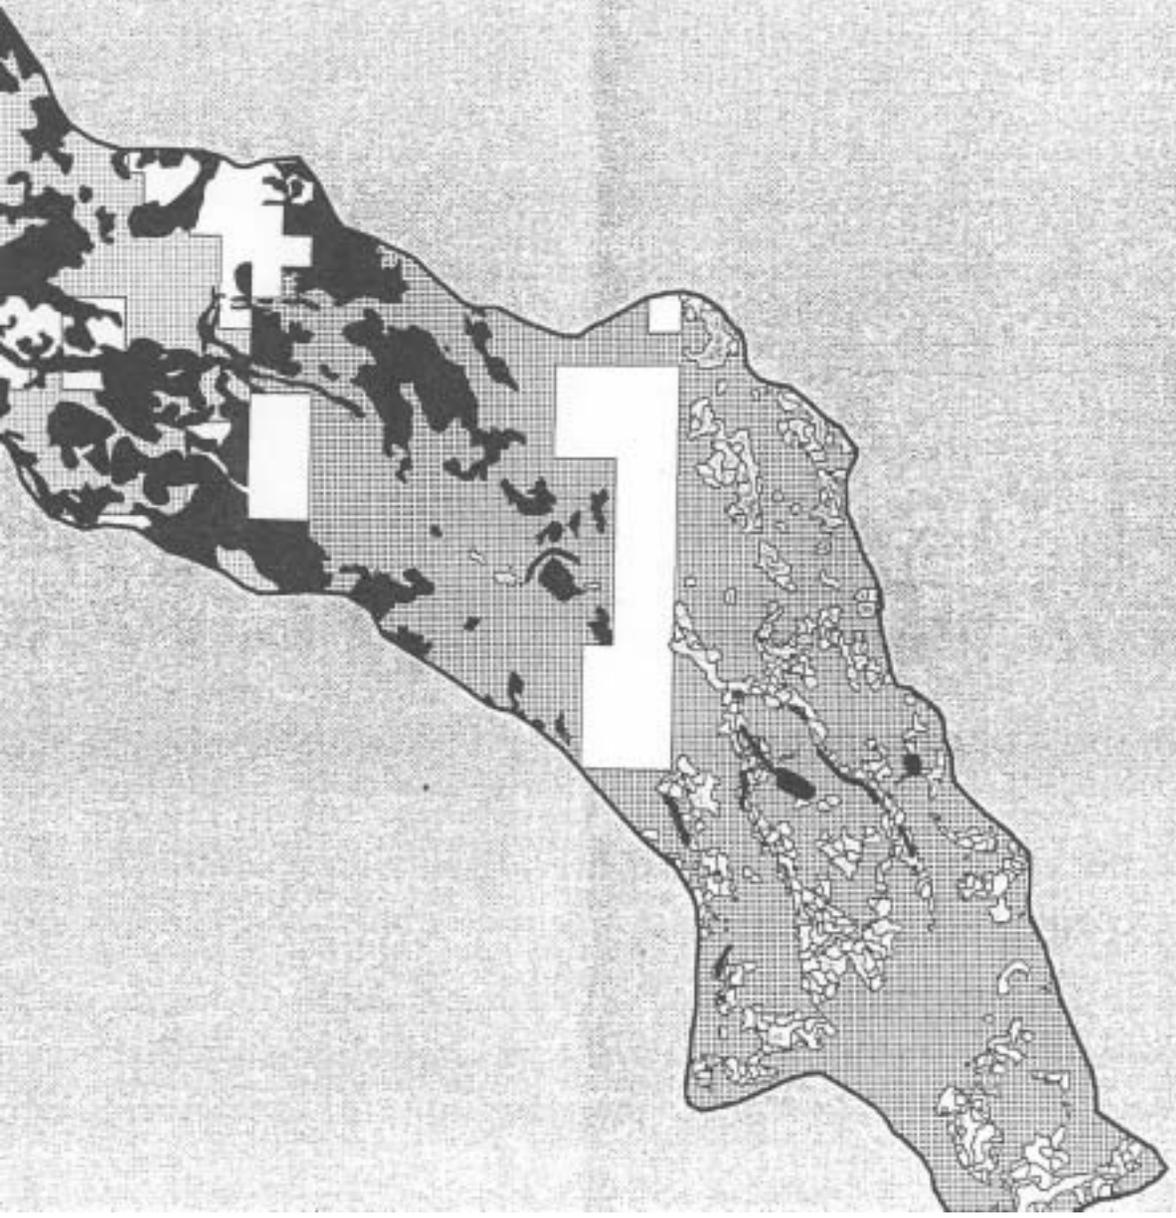
Bridge Creek Watershed
(26,158 acres)

Nineteen percent, or 2,817 acres of the forested areas, have canopy closure that exceeds HRV (refer to Figure 3.2 – Bridge Creek Watershed Upland Vegetation). Much of the private land owned by US Timberlands Services was harvested in the late 1970's and early 1980's and is comprised primarily of ponderosa pine plantations that are in early-to-mid seral (sapling-pole) condition, but are still considered to have forest canopy closures outside the HRV values. A few of the areas, on both private and Forest Service lands where much of the overstory has been removed, are considered hydrologically recovered in terms of their water use and yield because the leaf area is sufficient to return transpiration rates to reference or historic conditions and canopy closure is sufficient to prevent rapid snowmelt. About 17% (2,600 acres) of the forested lands, or 10% of the watershed, consists of forest openings, mainly seedling/sapling sites.

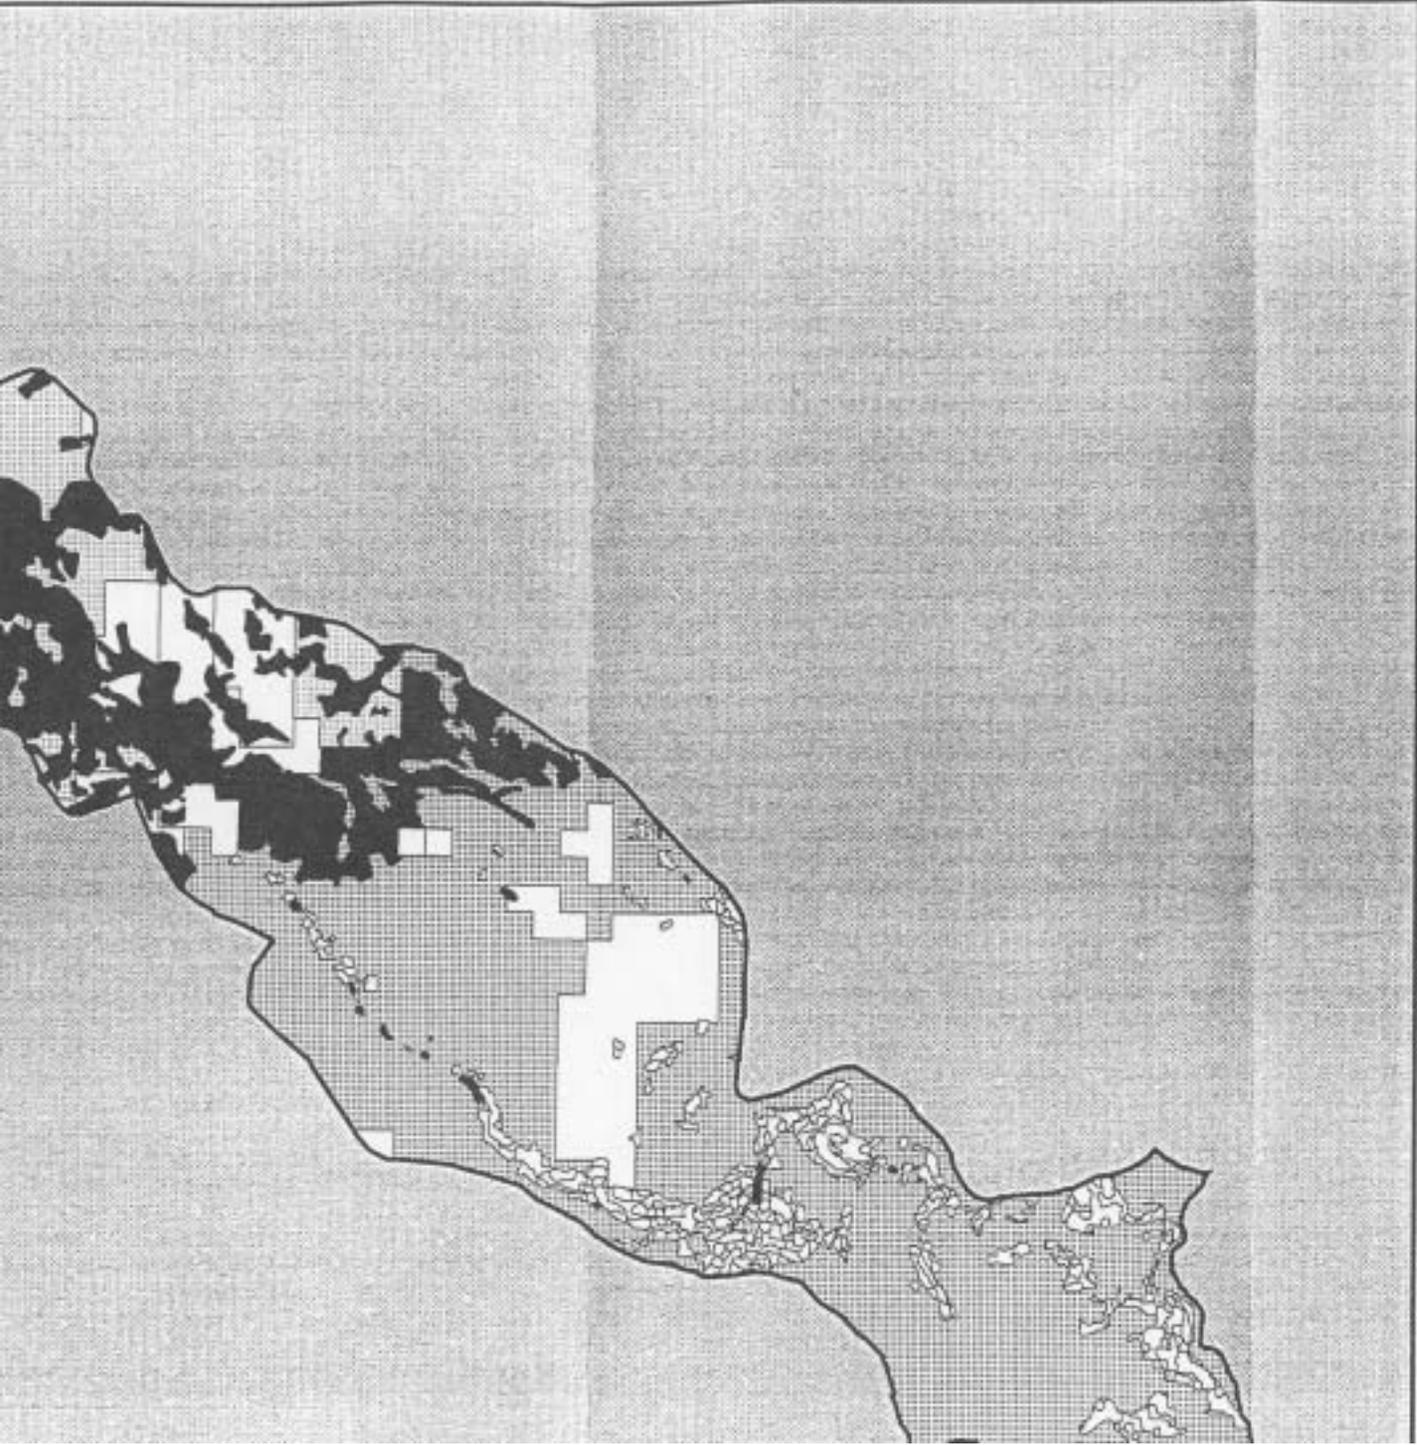
Buck Creek Watershed
(33,244 acres)

Of the forested acres, 15%, or 2,795 acres, have been determined to have canopy closure that exceeds HRV (refer to Figure 3.3 – Buck Creek Watershed Upland Vegetation). Approximately 6% (1,050 acres) of the forested lands, or 3% of the watershed, are in openings, primarily as seedling/sapling sites.

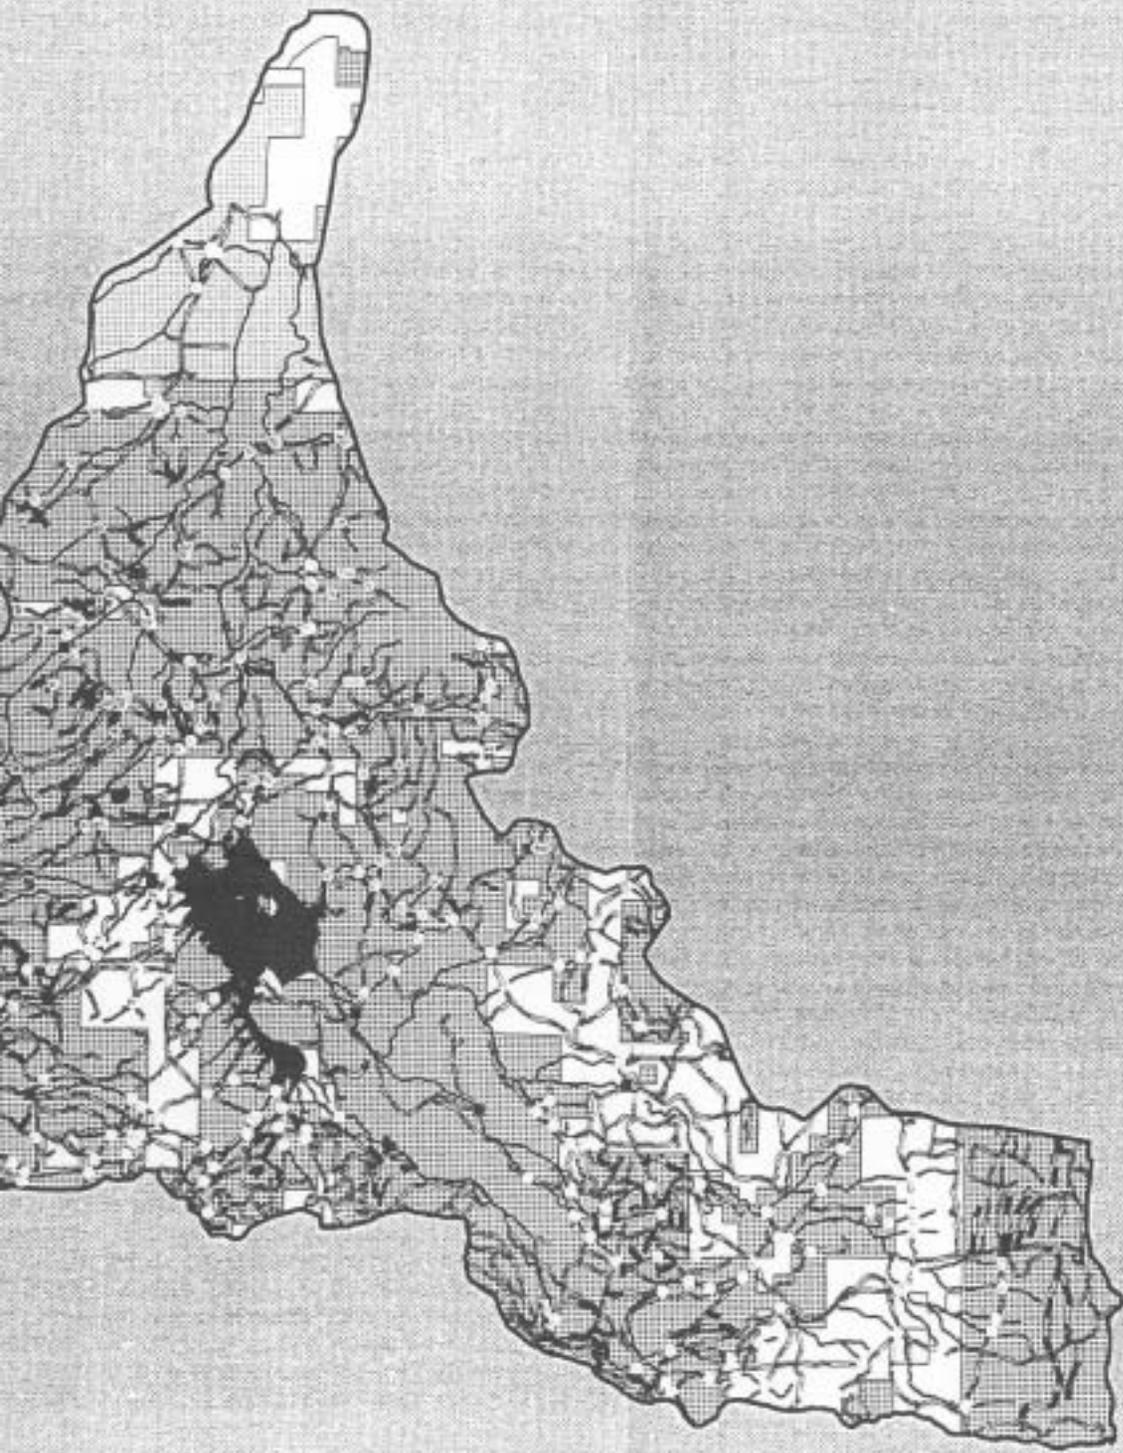
Silver Creek Watershed (108,278 acres)

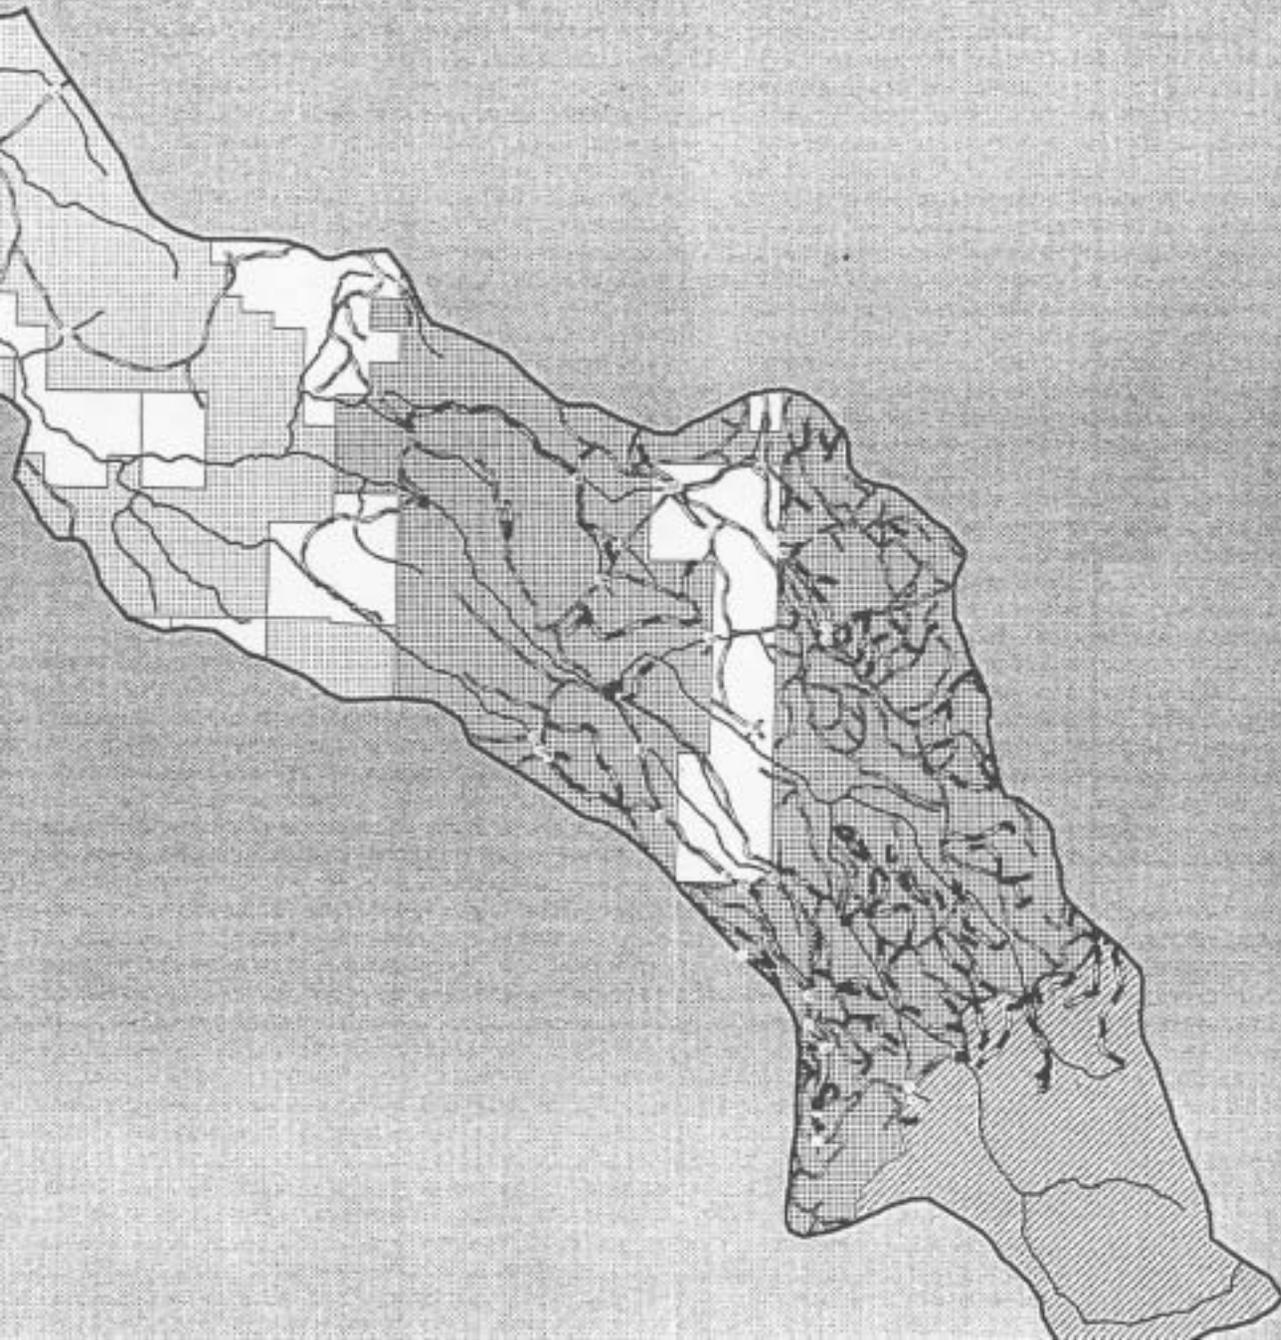
Ridge Creek Watershed
(26,158 acres)

- Culvert, Bridge, or Low Water Crossing
- Surveyed Culvert - Passable
- Surveyed Culvert - Barrier
- ▤ Roads Closed or Obliterated Existing Roads
- ▥ Roads Recommended for Closure or Obliteration
- ▧ Yamsey Mountain Semi-primitive Non-motorized Recreation Area
- ▨ Bureau of Land Management
- ▩ Fremont National Forest Land
- Private Land

Bridge Creek Watershed: In 1995, there were 124 miles of road within this watershed equating to a road density of 3.1 mi/mi². Over the past six years, the Silver Lake Ranger District has decommissioned approximately 11 miles of roads, nearly 9% of the roads within the watershed, in order to reduce road densities and the negative influence of roads on hydrology and water quality. Currently, there are 113 miles of roads within this watershed, which results in a road density of 2.8 mi/mi² (refer to Figure 3.5 – Bridge Creek Watershed Road Locations). Of these roads, twenty miles or 18% are within 300 feet of perennial and intermittent streams. In addition, roads cross channels at 51 locations, sites where direct sediment introduction occurs. Based on the above numbers, the Road Impact Index was calculated to be 0.48. Along with the 66 miles of stream channels, an estimated 68 of the 113 miles of roads are hydrologically integrated with the stream network, thus increasing the drainage network by 103% – using Wemple’s (1994) study results. In addition, the effects of management activities on soil resources has been fairly extensive, a result of past timber harvest activities throughout the watershed. About 35% of the lands within the watershed are mapped as having “high” soil impacts (adverse impacts which occur on more than 20% of the area).

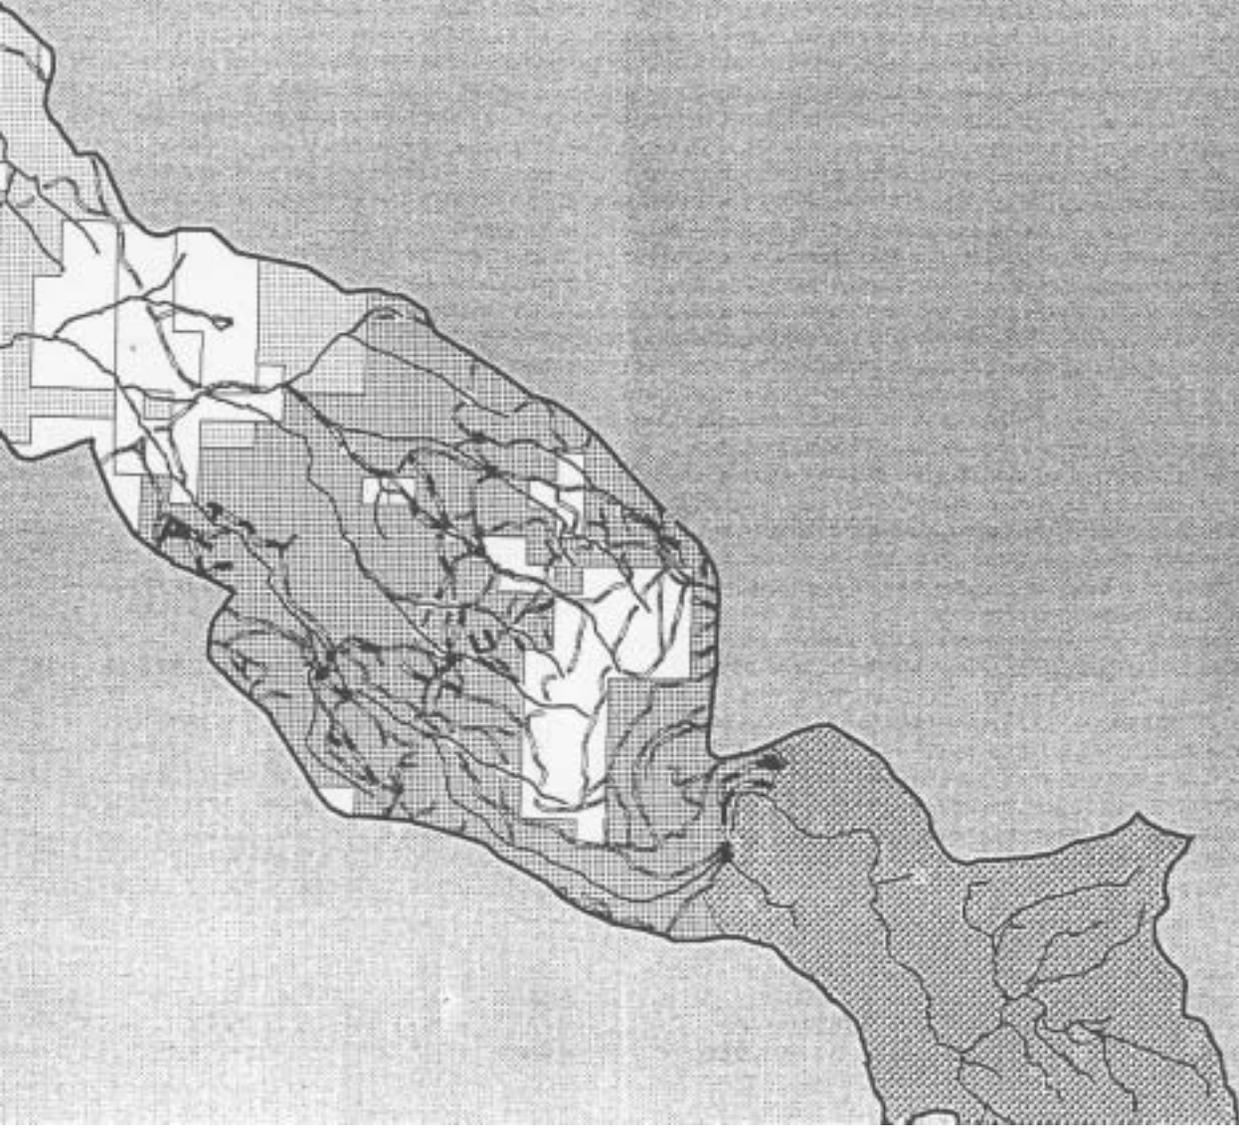
Silver Lake Watershed
(33,244 acres)

- Culvert, Bridge, or Low Water Crossing
- Surveyed Culvert - Passable
- Surveyed Culvert - Barrier
- ▤ Roads Closed or Obliterated Existing Roads
- ▥ Roads Recommended for Closure or Obliteration
- ▧ Yamsey Mountain Semi-primitive Non-motorized Recreation Area
- ▨ Bureau of Land Management
- ▩ Fremont National Forest Land
- Private Land

- *Buck Creek Watershed:* In 1995, there were 101 miles of road within this watershed equating to a road density of 2.0 mi/mi². Over the past six years, the Silver Lake Ranger District has decommissioned over 5 miles or 5% of roads within the watershed in order to reduce road densities and the negative influence of roads on hydrology and water quality. Currently, there are 96 miles of roads within this watershed, leading to a road density of 1.9 mi/mi² (refer to Figure 3.6 – Buck Creek Watershed Road Locations). Of these roads, seventeen miles or 18% are within 300 feet of perennial and intermittent streams. At 50 locations throughout the watershed, roads cross channels, sites where direct sediment introduction occurs. Based on the above numbers, the Road Impact Index was calculated to be 0.32. Along with the 80 miles of stream channels, an estimated 58 of the 96 miles of roads are hydrologically integrated with the stream network, thus increasing the drainage network by 72% – using Wemple’s (1994) study results. In addition, the effects of management activities on soil resources has been fairly extensive, a result of past timber harvest activities throughout the watershed – about 26% of the lands within the watershed are mapped as having “high” soil impacts (adverse impacts which occur on more than 20% of the area).

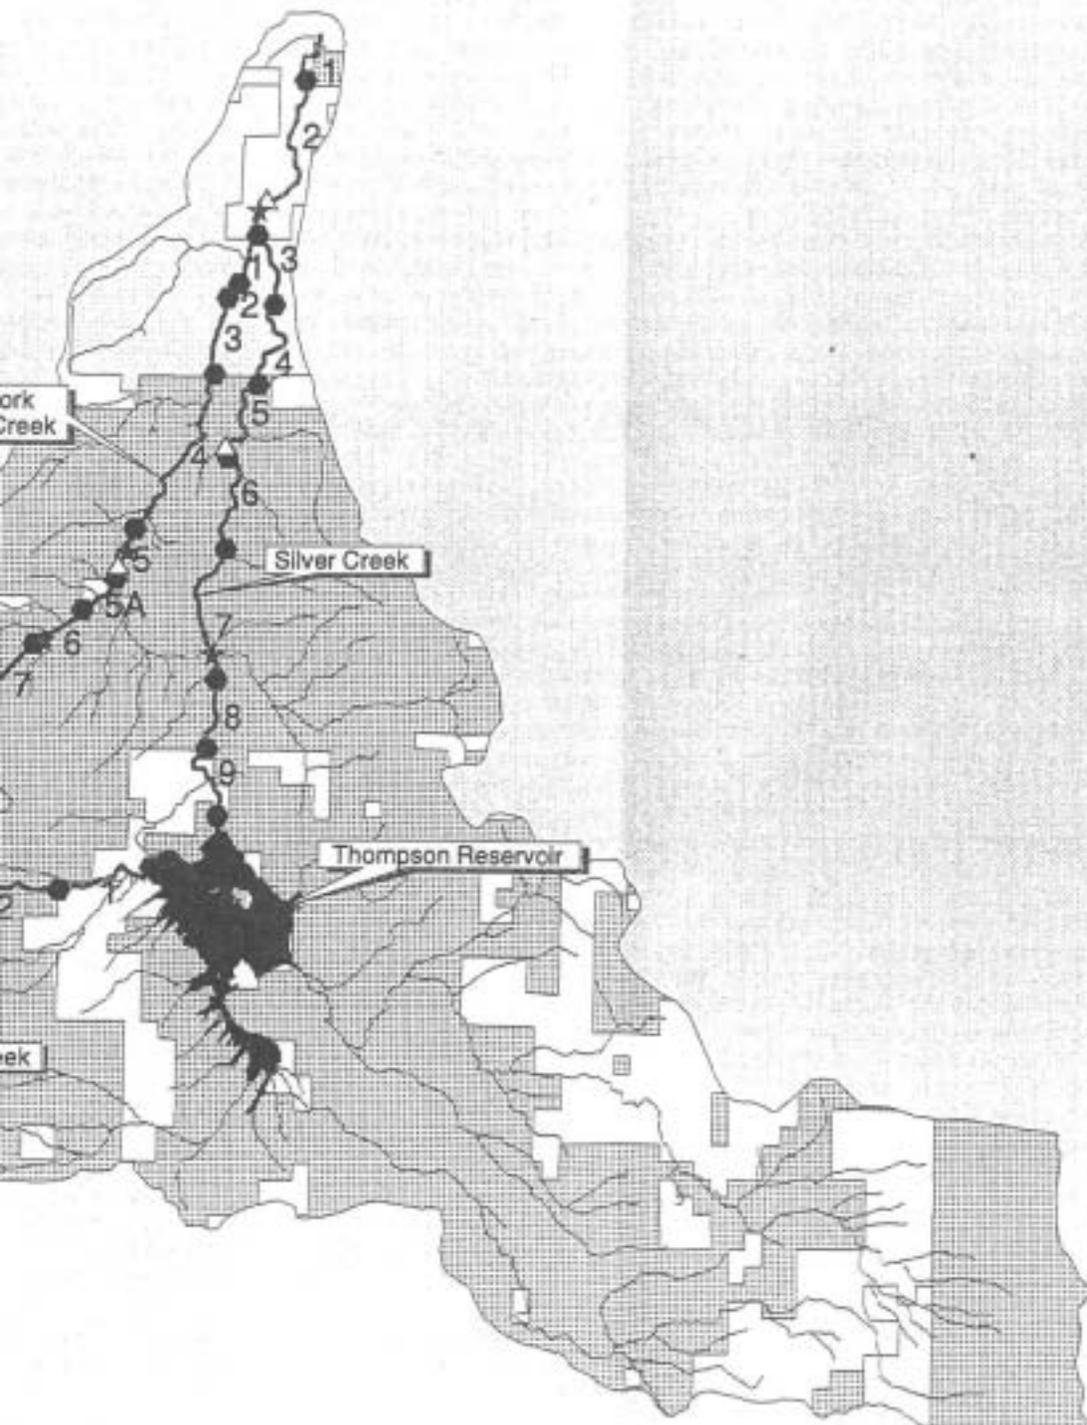
Reach and Monitoring Locations

Silver Creek Watershed (108,278 acres)

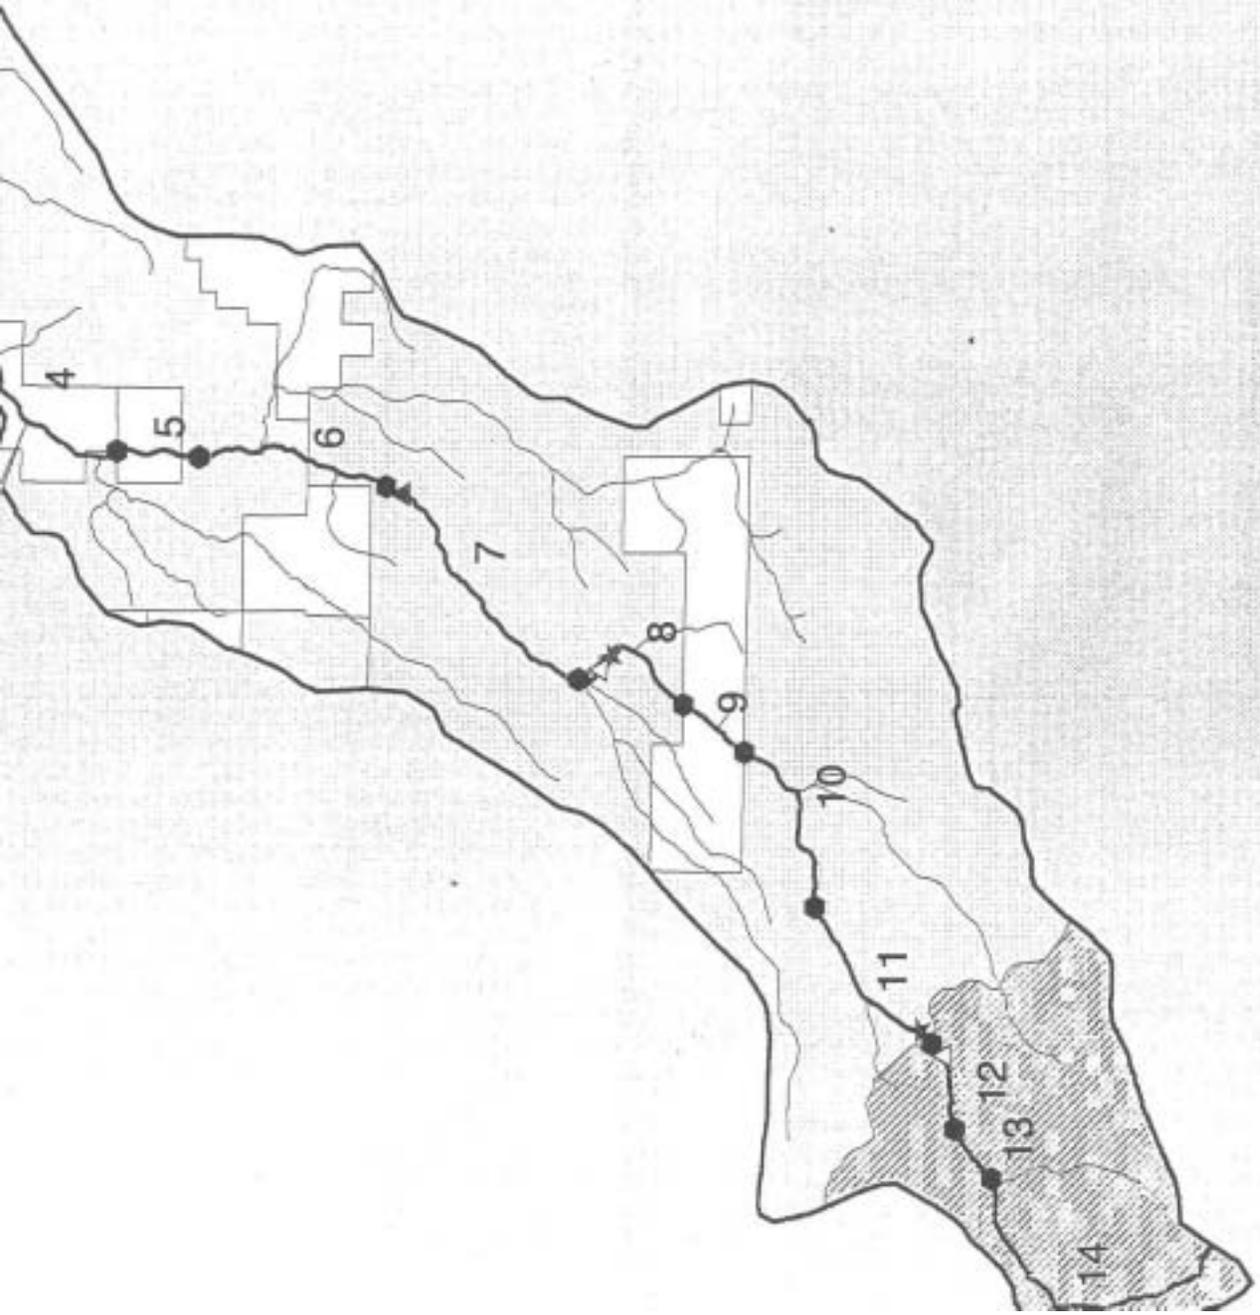
Edge Creek Watershed
(26,158 acres)

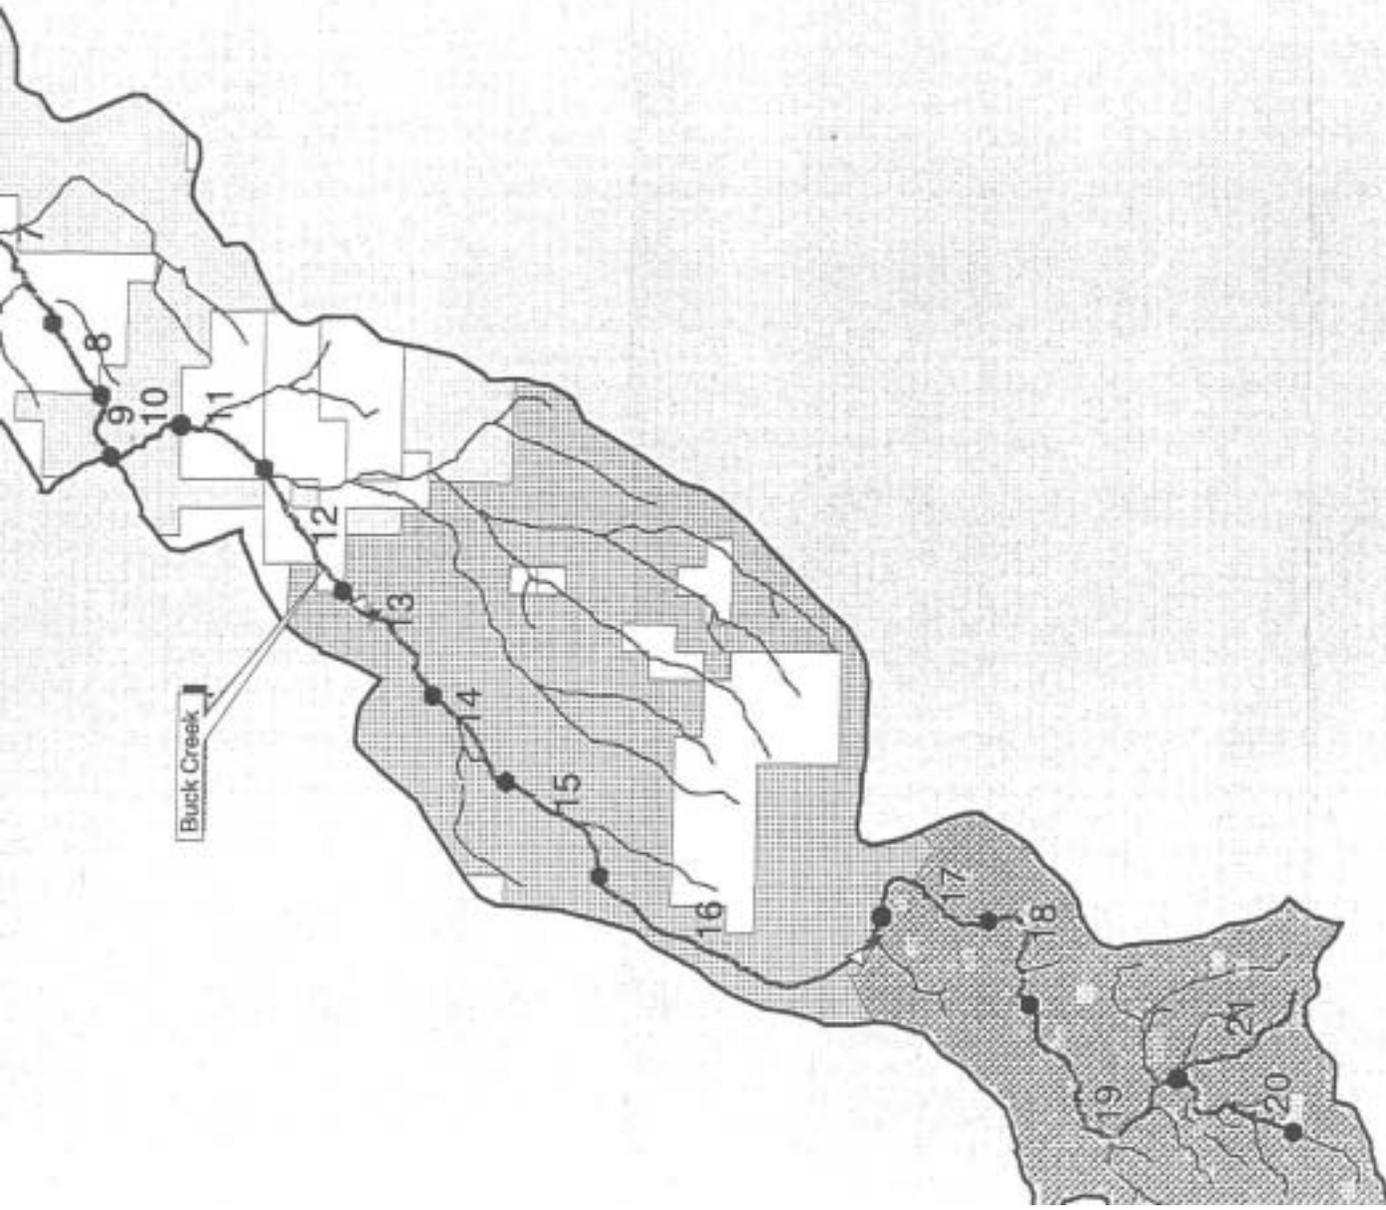
Reach and Monitoring Locations

← Buck Creek Watershed
(33,244 acres)

- Reach Breaks
- △ Temperature Gage Location
- ★ Spawning Gravel Fines Test Location
- ▨ Yamsey Mountain Semi-Primitive Roadless Area
- ▤ Bureau of Land Management
- ▥ Private Land
- ▧ Fremont National Forest Land

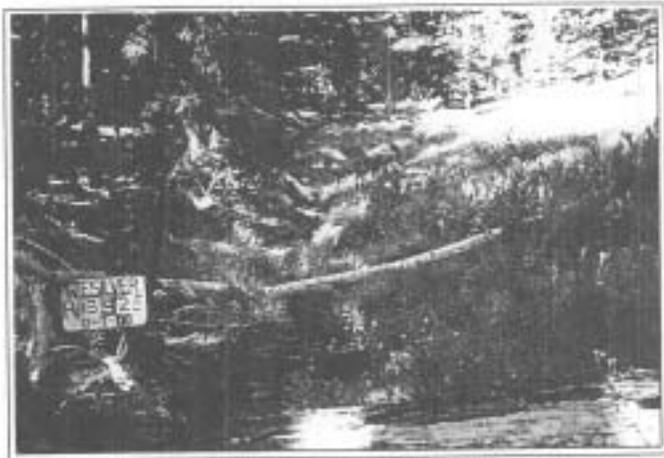
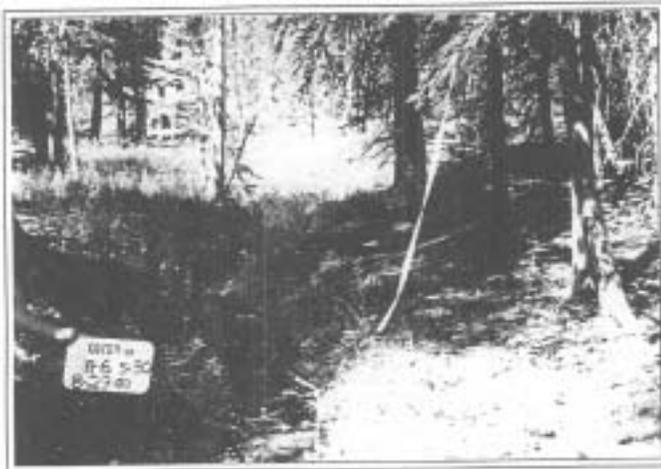
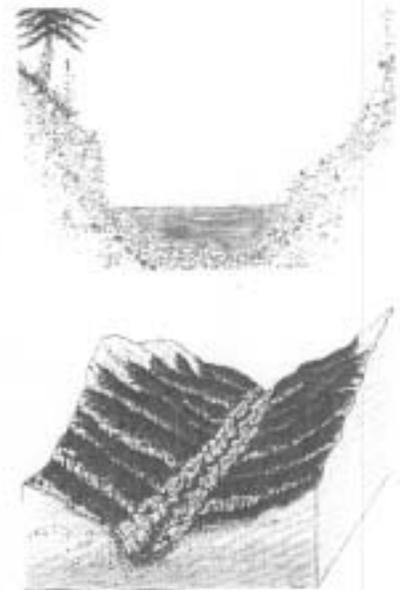
Rosgen A Stream Type

Rosgen A stream types are characterized by steep gradients (between 4 and 10%), with deeply incised channels, and entrenchment ratios <1.4 . They have low width/depth ratios (<12) and low sinuosity (<1.2). Local landform and geology dictates channel stability. The A3 channel types, found in the Silver Lake Watershed, are characterized by a high sensitivity to disturbance, very high stream bank erosion potential, and vegetation having a negligible influence in determining channel stability. Overall, these channels exhibit high sediment supply and transport potential. Large woody debris plays a significant role in determining frequency of step pools which provides fish habitat and overall channel stability.

Delineative Criteria (A3)

- Landform/soils:** Steep narrow depositional slopes typical of glacial moraines and debris slides associated with unconsolidated, heterogenous and non-cohesive materials.
- Channel Materials:** Predominately cobble with a mixture of boulders, gravel and sand.
- Slope Range:** .04 - .10 (A3a+ > .10)
- Entrenchment ratio:** <1.4
- Width/depth Ratio:** <12
- Sinuosity:** <1.2

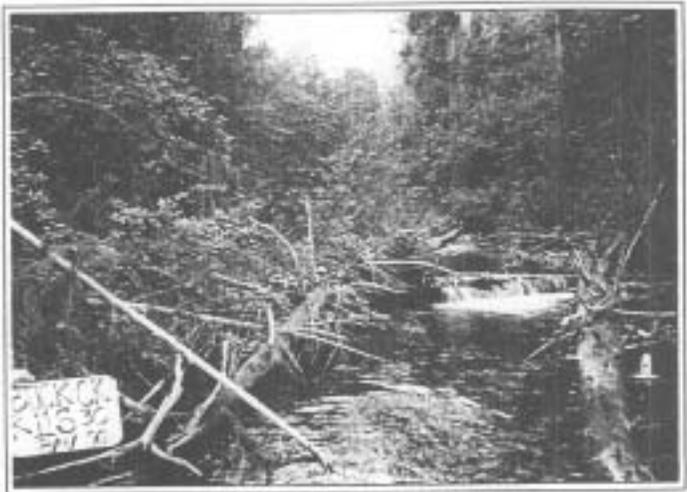
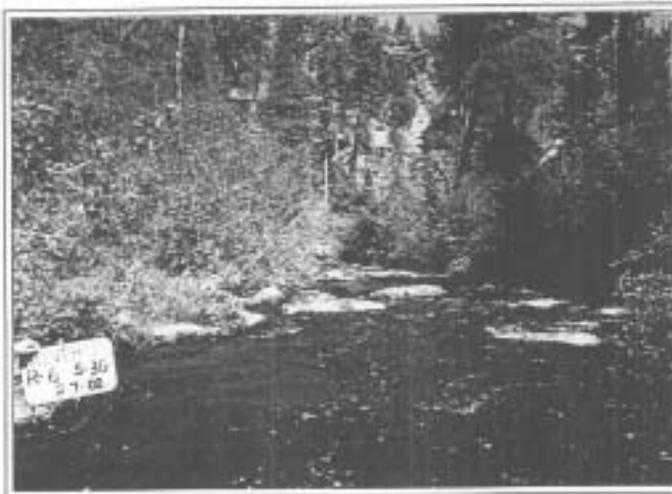
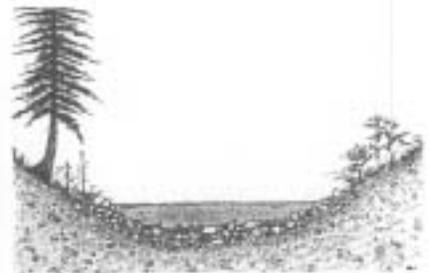
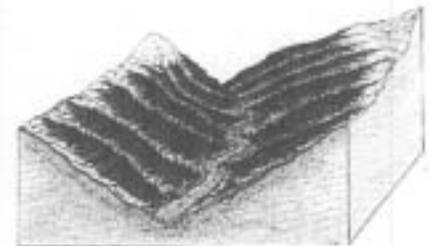
Rosgen B Stream Type

Rosgen B stream types are moderately steep (between 2 and 4%), with rapids and riffles common and scour pools irregularly spaced. These stream types are moderately entrenched (1.4-2.2), with moderate width-to-depth ratios (>12) and sinuosity (>1.2). They are found within "V" type valleys, usually in forested systems, with substrates ranging from gravel (B3) to cobble (B4). Vegetation has a moderate influence in determining channel stability. These channel types are characterized by low to moderate sensitivity to disturbance and low streambank erosion. Fish habitat is often associated with large woody debris which contributes to scour pool formation and cover.

Delineative Criteria (B3)

- Landform/soils:** Narrow, moderately steep colluvial valley with gentle side slopes. Soils are colluvium and/or alluvium. Often in fault line valleys or on well vegetated alluvial fans.
- Channel Materials:** Predominately cobble with lesser amounts of boulders, gravel and sand. Streambanks are stable due to coarse material.
- Slope Range:** .02 - .04 (B3c, <.02)
- Entrenchment Ratio:** 1.4-2.2
- Width/depth Ratio:** > 12
- Sinuosity:** >1.2

The B stream types are usually located in forested reaches and within canyons, areas that are inherently stable. For this reason, forest management activities (such as timber harvest and grazing) have been conducted away from these stream reaches, leaving them relatively unaffected. However, the lack of fire continues to promote higher densities of conifers in riparian areas along B stream types, creating a minor shift in relative species abundance. In addition, many of the E stream types found throughout the watershed are characterized and maintained by late-seral vegetation, resulting from grazing management which appears conducive to late-seral plant composition. As mentioned above, the majority of stream reaches that are not functioning appropriately are the C stream types located along the low gradient meadow reaches of Bridge, Buck and West Fork Silver Creeks. Because these are areas of high forage production, late season grazing practices have altered riparian vegetation. For example, some of these areas have less sedge (more grass) than is desired, and have the potential to produce greater densities of large willow than currently exists; however, cattle graze willow during the late summer because the desirable plant species have lost their palatability and protein contents. An additional factor affecting bank stability within these streams, especially in the lower reaches, might be the increased drainage network associated with roads throughout the watershed, possibly influencing the timing and magnitude of stream flows and their effects on channel scouring.

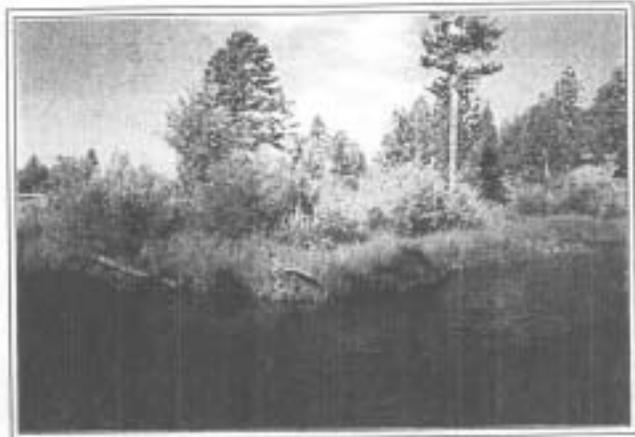
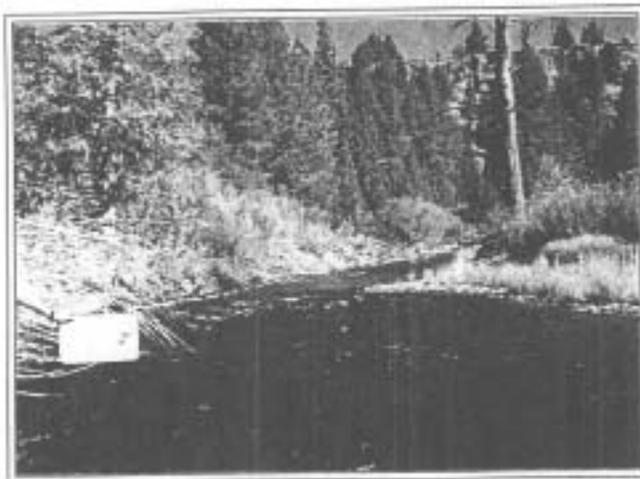
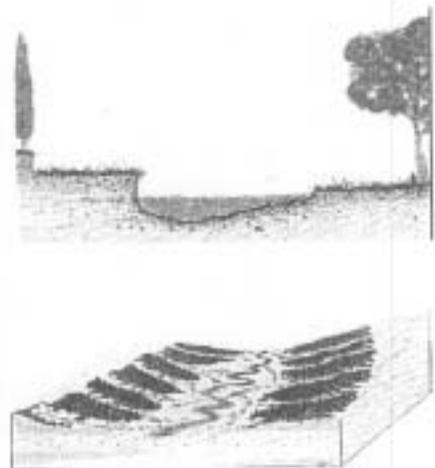
Rosgen C Stream Type

Rosgen C stream types are lower gradient streams which are slightly entrenched (>2.2), have moderate to high (>12) width-to-depth ratios, high sinuosity values (>1.4), and are characterized by riffle/pool sequences. Streams within the watershed are often found in low gradient alluvial valleys with substrates dominated by gravel (C4). Channels have characteristic point bars and broad, well defined floodplains. Vegetation has a very high influence in determining channel stability, and when vegetation is disturbed and removed, these channel types are highly sensitive to both lateral (bank) and vertical (downcutting) erosion. Natural sediment supply is moderate to high except in those areas where stream banks are well vegetated. These streams are highly sensitive to changes in sediment and stream flow.

Delineative Criteria (C4)

Landform/soils: Broad, gentle gradient alluvial valleys and river deltas. Soils are alluvium.

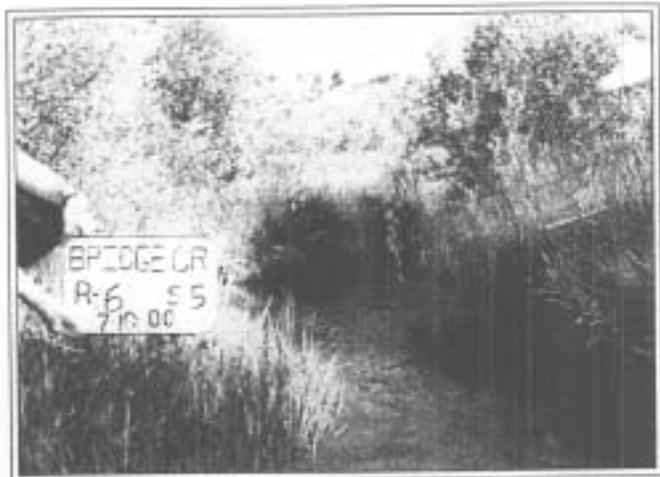
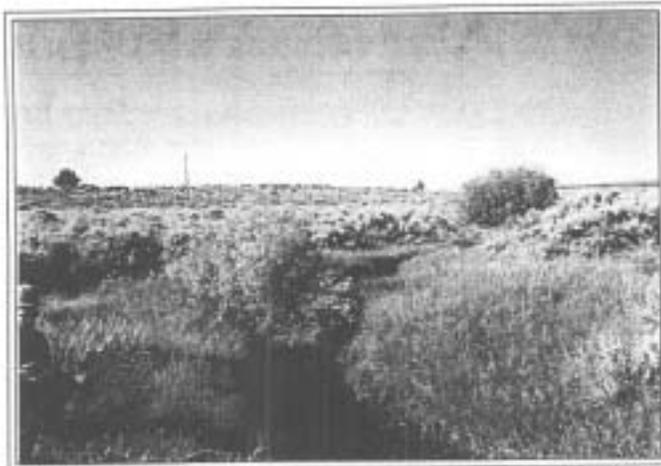
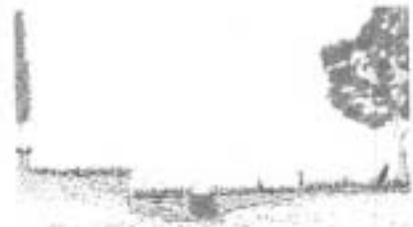
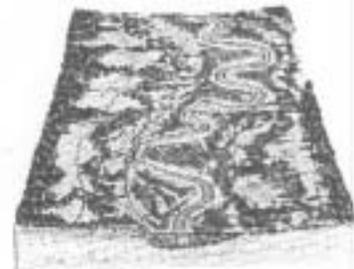
Rosgen E Stream Type

Rosgen E stream types are low-gradient streams (<2%, but can reach 4%) which are slightly entrenched (>2.2) with low width-to-depth ratios (<12), and high sinuosity (>1.5), with riffle/pool sequences and well developed floodplains. In the Silver Lake Watershed, channel substrate is dominated by gravel (E4) and to a lesser degree cobble (E3). Valleys are usually wide and gently sloped. Vegetation has a very high influence on channel stability. When it is lacking, these channel types are highly sensitive to disturbance which may result in increased levels of streambank erosion and downcutting. These streams are highly sensitive to changes in sediment and stream flow. The E stream type provides excellent fish habitat through undercut banks, clean spawning gravels, and numerous deep pools.

Delineative Criteria (E4)

- Landform/soils:** Gentle slopes in broad riverine or lacustrine valleys and river deltas.
- Channel Materials:** Gravel dominated bed with smaller accumulations of sand and occasional cobble. Streambanks composed of sandy/gravel mixture with dense root mat.
- Slope Range:** < 0.02
- Entrenchment ratio:** > 2.2
- Width/depth Ratio:** < 12
- Sinuosity:** > 1.5
