Caribbean National Forest Damage Assessment Report

September 15, 2004 Event

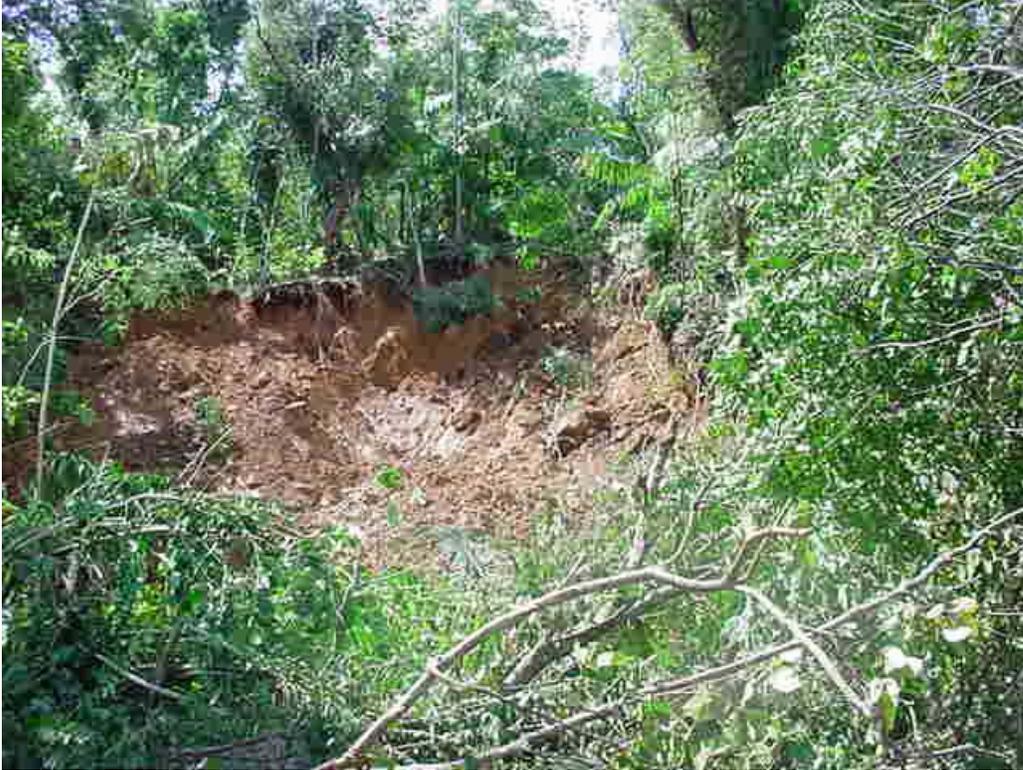
Landslide at PR Road 9966, within Rio Espiritu Santo Watershed.

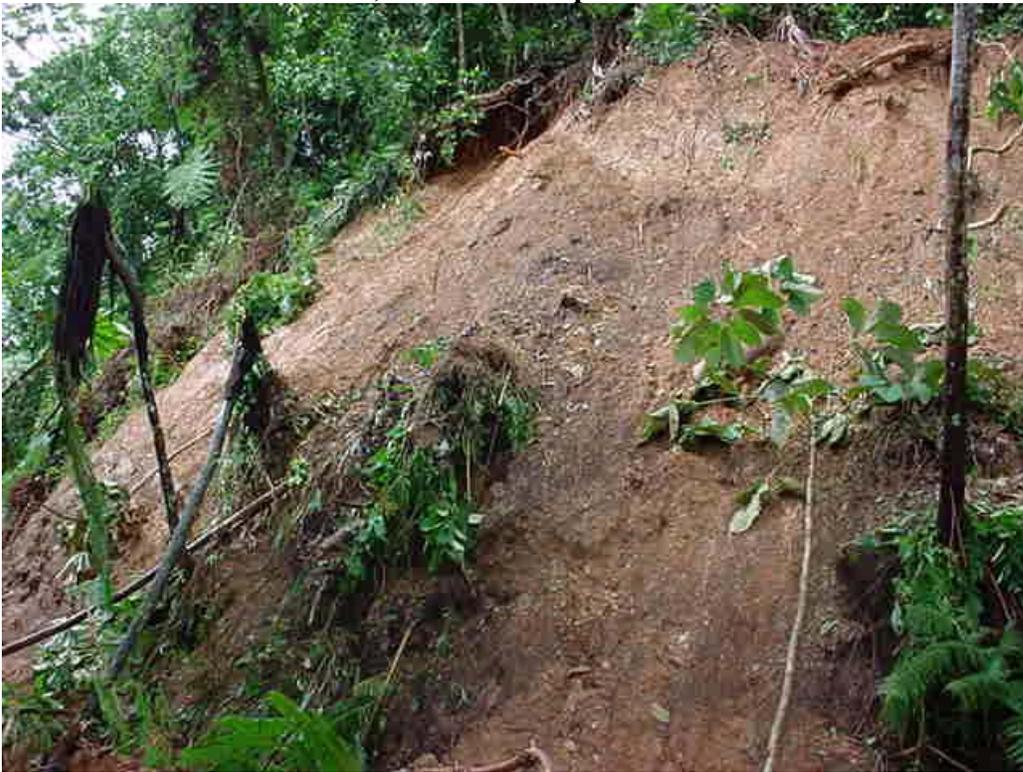
Landslide at 191 North Km. 7.8, within Rio Mameyes Watershed.

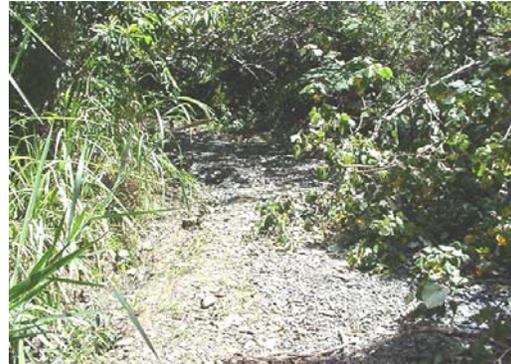
All Forest Service roads (FSR’s, 11.3 miles) suffered the consequences of substantial tree defoliation; bamboo, branches, and limbs falling on or encroaching the traveled way; several downed trees; and small cut bank slides (washouts or small slumps) clogging ditches and culverts. There were no major cut slides blocking the traveled way or embankment failures.

Typical Road Fallen Vegetation

Unit cost to repair above damages is estimated at \$2,500 per mile.

Cost to repair above damages: 11.3 miles x \$2,500/mile = \$28,250

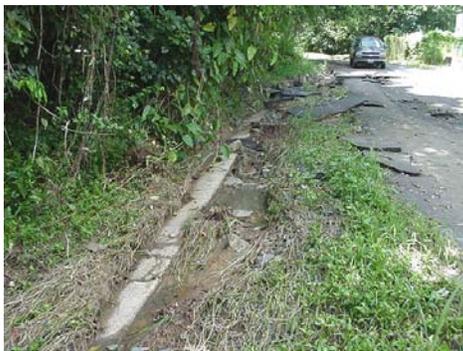
PR 186 - Drainage Damage

PR 186 suffered several drainage structure failures, pavement washouts, sinkholes, and subgrade settlements.

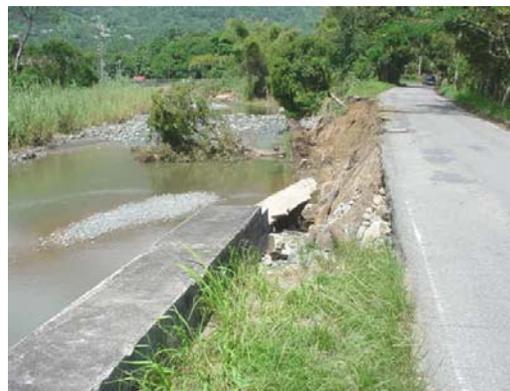
PR 191 south suffered the most damages in the form of drainage structure failures, pavement washouts, fill slides (over 500 LF total at several spots along the road) that will require some form of embankment stabilization or retaining structures, and a major 12-15 ft deep river wall failure (approx 400 LF total on two separate spots).

PR 191 South – River Wall Failure

Forest Highways qualify for Emergency Relief for Federally Owned Roads (ERFO) funds and secondary roads qualify for Emergency relief (ER) funds. The Forest has made a very preliminary estimate of \$750,000 to \$1,000, 000 for repair of damages and has initiated the ERFO/ER consultation process with the Regional Office, Eastern Federal Lands and the PRDOT that would eventually be the recipients of the funds.

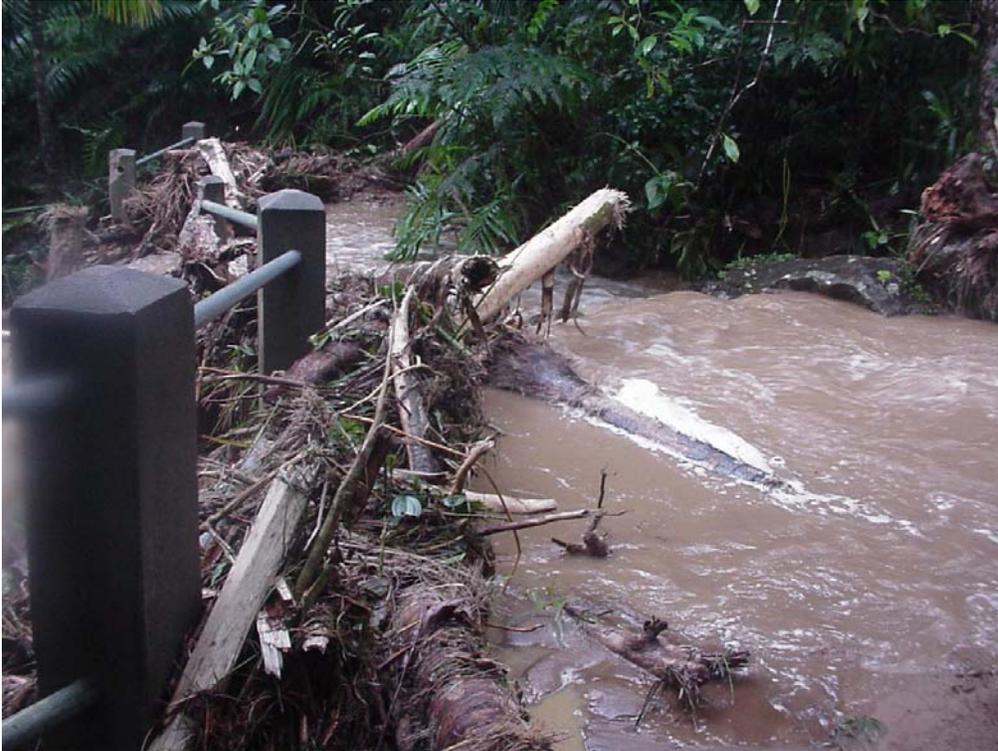
Baño de Oro

The Forest Trail System damage assessment is documented mostly by photos. Extensive vegetation defoliation, significant landslides and soil erosion caused by water runoff was mostly the trial damage caused by Tropical Storm Jeanne. The storm affected several trail structures such as bridges and shelters. Runoff debris and tree blow down damaged bridge supports and railing. Many small landslides and debris along the trails were found and documented with photos. Landslides and debris clogged drainages along the upslope on all trails in the system.

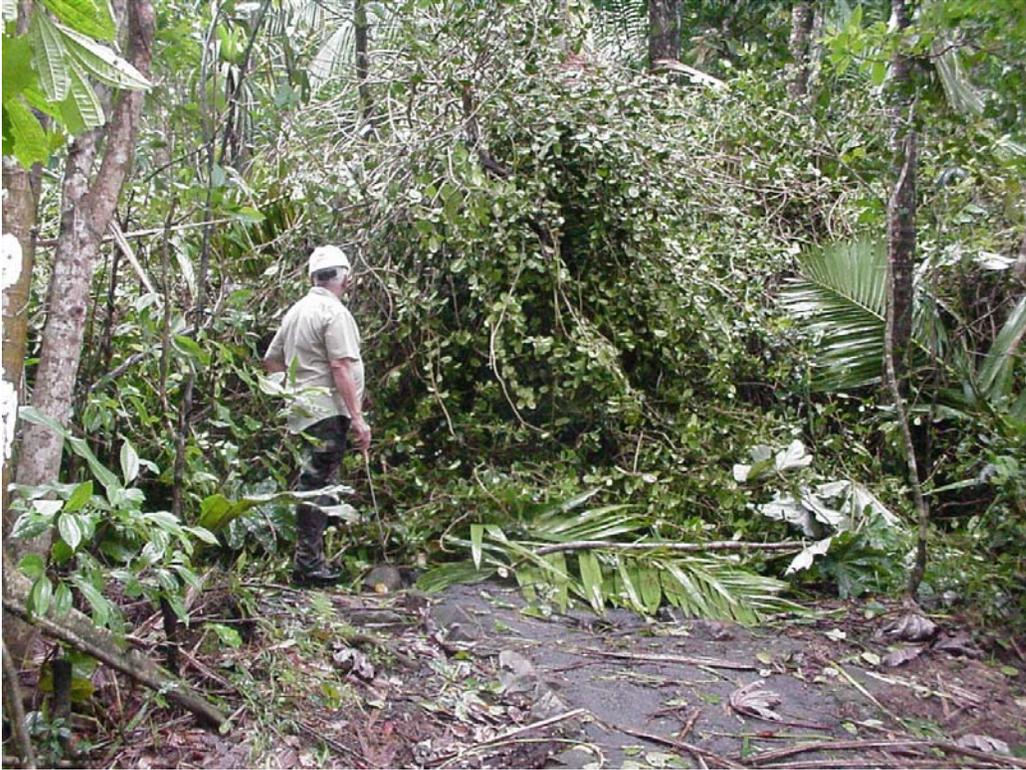
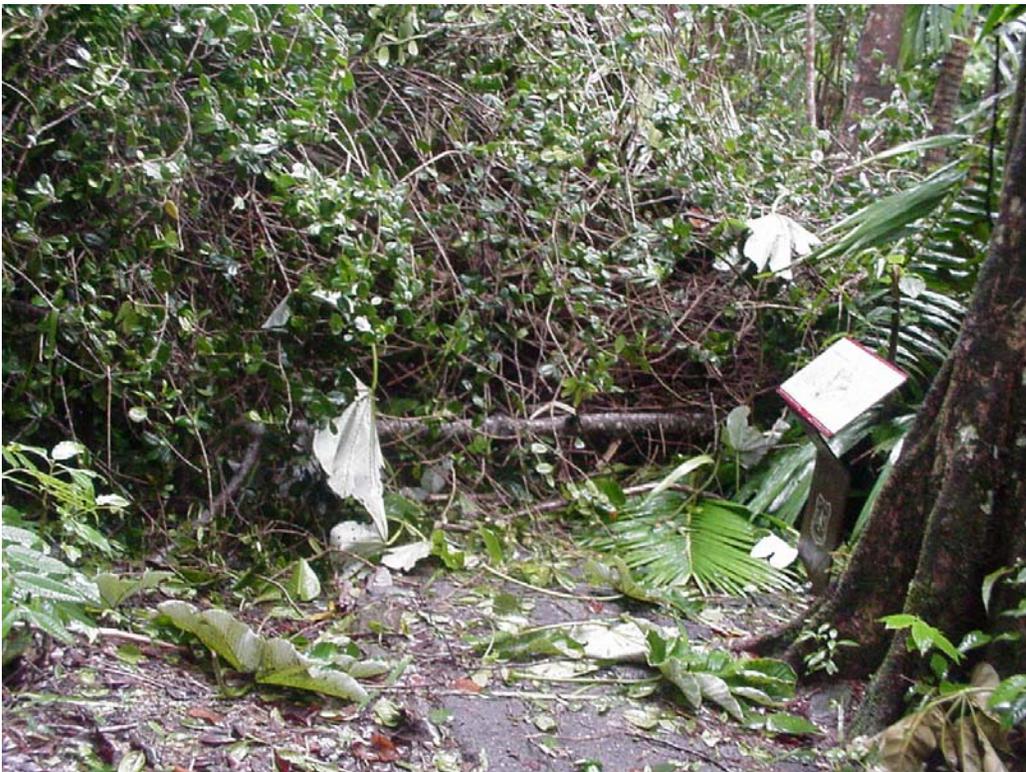
At the Big Tree Trail a panel from the Information Bulletin Board was blown off. The panel was recovered and needs to be installed. Damage to interpretative signs were also reported in Big Tree trail. Significant amount of tree branches and leaf debris was found in the parking area. Following is the initial Trail Damage Assessment Table:
