**Shawnee National Forest  
Hidden Springs Ranger District  
Trails Designation Project Accomplishments  
Months of July - August 2007**

**Trail work accomplished in the Lusk Creek Wilderness under the Trails Designation Project using primitive tools and traditional methods in accordance with the Forest Service National Wilderness Policy:**

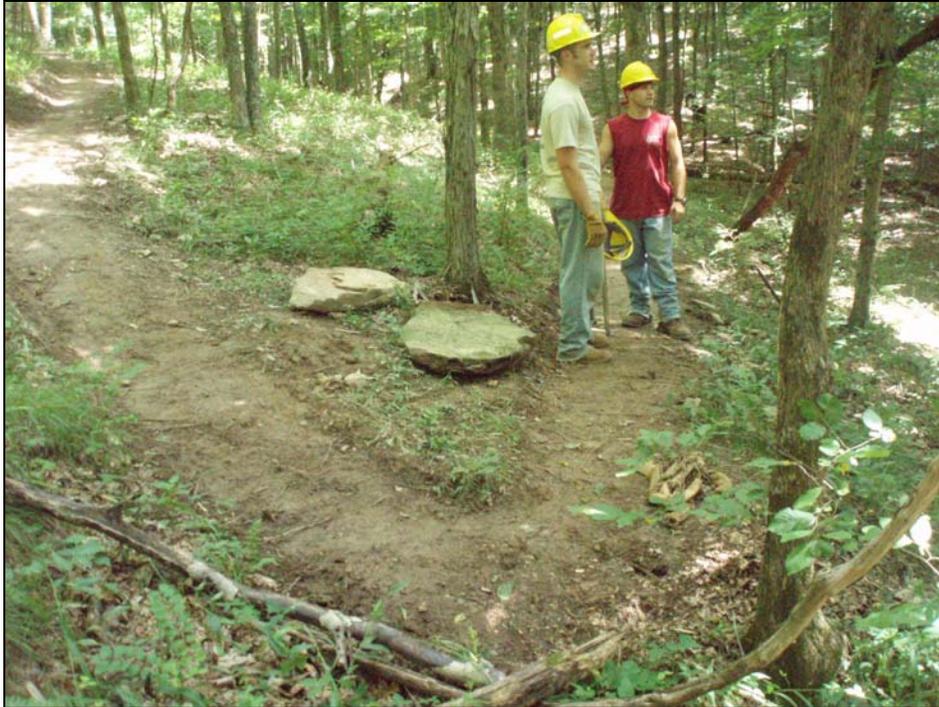
**Figure 1. Before. Switchback on Coyote Club reroute.**

- The trail crew continued to conduct trail work in the Lusk Creek Wilderness throughout the months of July and August. Two primary trail reconstruction projects were the focus during these months. The first project is a continuation of a reroute that begins at the west end of the Natural Bridge landmark. The new reroute continues east looping under the southern boundary of the private property once called the Coyote Club. The reroute, referred to as the Coyote Club Reroute, eventually cuts to the north on a switchback connecting with Trail # 492D south of Secret Canyon. The trail tread for the reroute was initially plowed in and graded earlier this summer by a mule team on loan from the Hoosier National Forest. The trail crew has since used hand tools to build erosion control features and provide detailed rock work in the construction of retaining walls and a switchback (Figures 1 – 4). The 1.5 miles of reroute will be open for use in the fall, and will provide users the opportunity to follow a trail loop that connects with popular natural land marks and stock confinement areas.

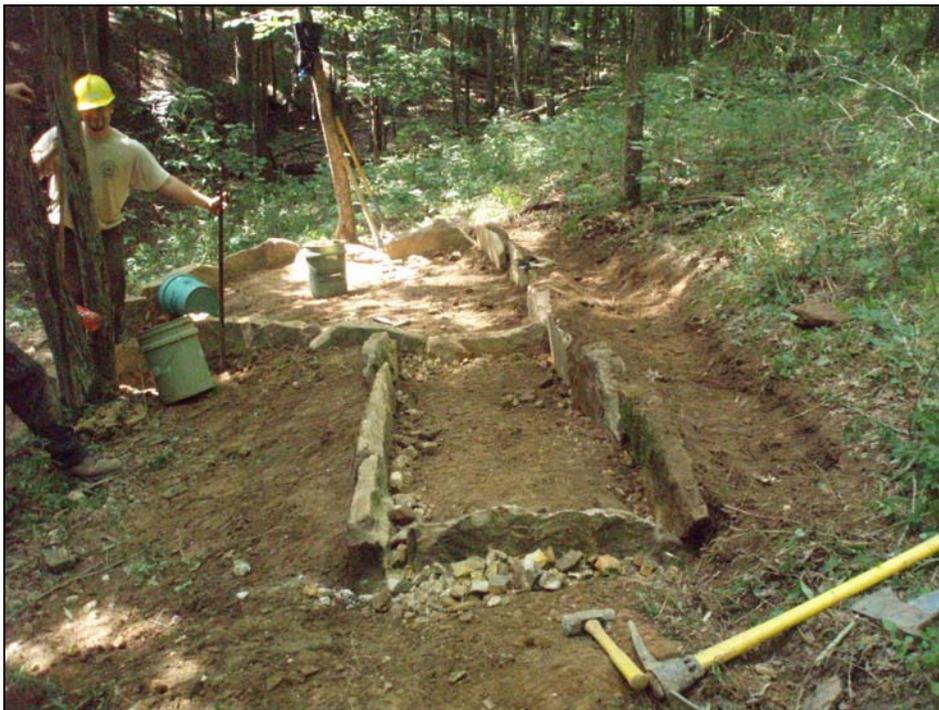
**Figure 2. During. Switchback being reconstructed on the Coyote Club reroute.**

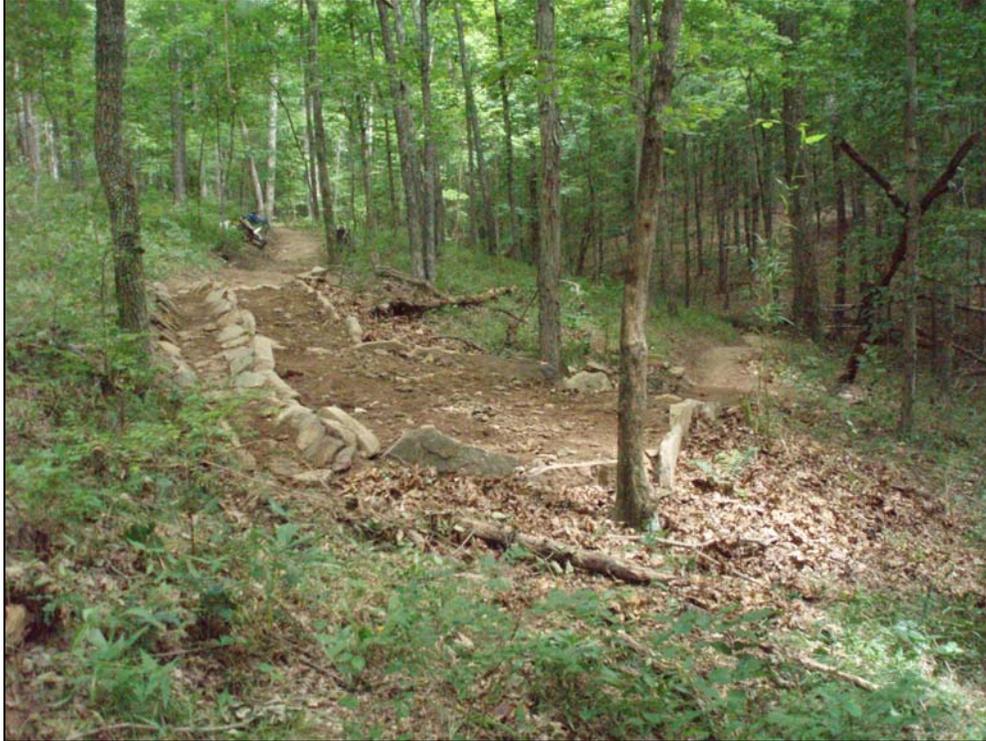
**Figure 3. After. Newly reconstructed switchback on the Coyote Club reroute. Rock steps, retaining wall, and erosion control features added.**

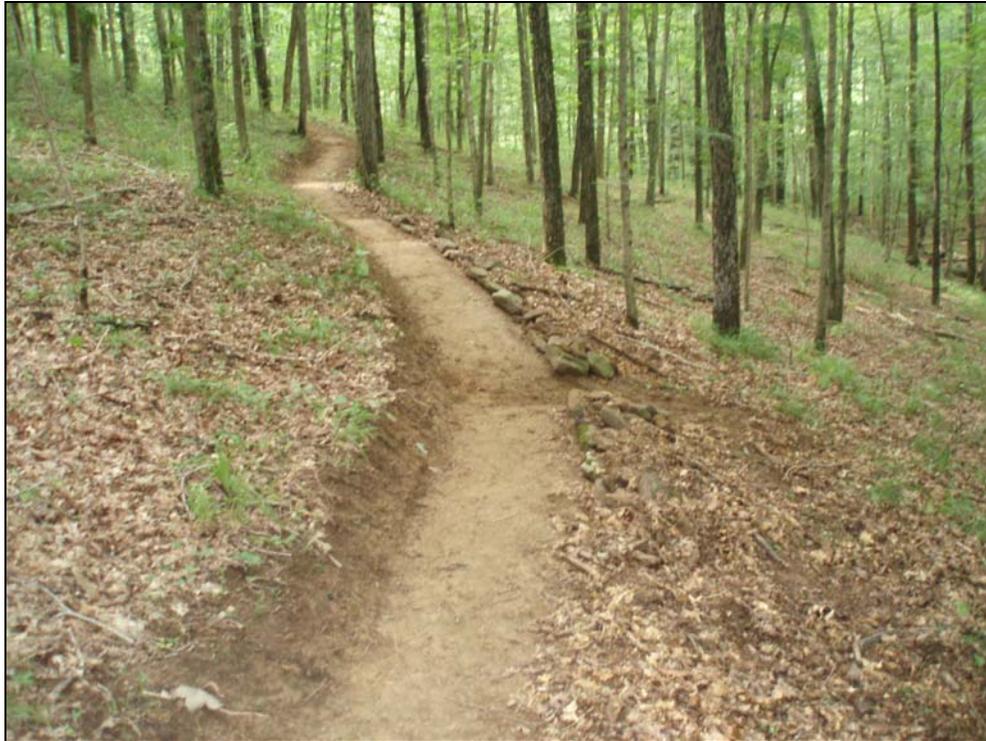
**Figure 4. Completed section of Coyote Club reroute.**

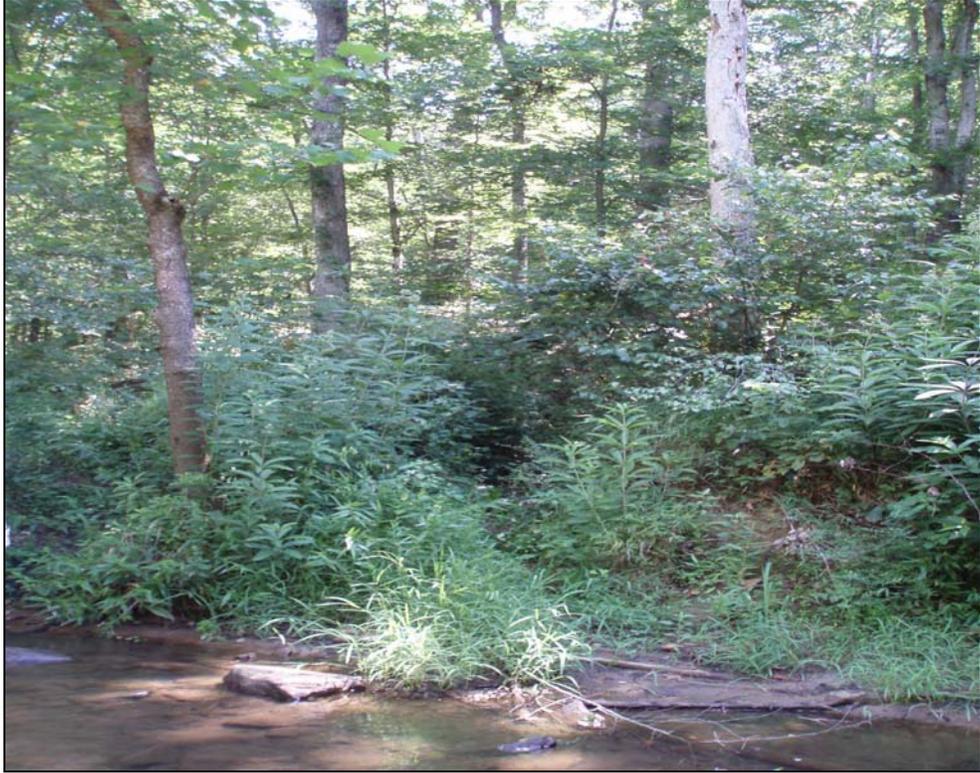
**Figure 5. Previous site of Bowed Tree Creek Crossing, view of east embankment on Lusk Creek. Old crossing was difficult to locate, deeply eroded, dangerous to use, and had the potential to add sedimentation to Lusk Creek.**

- The second project was recently completed in August. The Bowed Tree Creek Crossing on Lusk Creek was slightly relocated and constructed to mitigate resource damage and provide improved recreation opportunities. The old crossing was difficult to locate, deeply eroded, dangerous to use, and had the potential to add sedimentation to Lusk Creek (Figure 5). In preparing the site for the new creek crossing, several uprooted large diameter trees were cleared by hand using a crosscut saw and axes (Figure 6). In addition, seventy-three (73) tons of soil was excavated by shovel from the embankment and uphill slopes and used to fill in deeply eroded ruts in the creek bank (Figures 7 and 8). Also, ninety-eight (98) tons of native sandstone was harvested from the surrounding area and carried by hand to the site in handmade chain baskets where it was used in the construction of steps and retaining walls to withstand seasonal creek flooding (Figures 9 and 10). To complete the crossing, eighteen (18) tons of red rock gravel mixture was hauled to the site by stock animals. A mule team, hired from the local area, hauled the 18 tons of gravel nearly one mile into the wilderness. The gravel was delivered to the wilderness boundary and then loaded by hand into two large gravel bags on each mule. The mules were lead to the crossing and unloaded by hand where the gravel was used to build steps (Figures 11 and 12). In addition to the 18 tons of red rock gravel, 200 feet of 10 – 12 inch diameter cedar logs were hauled by mule from the boundary to the crossing (Figure 13). The logs were used to form the 14 steps necessary to allow equestrians to walk stock animals up and down the creek embankments (Figure 14). The final construction resulted in 186 feet of new creek crossing to include the

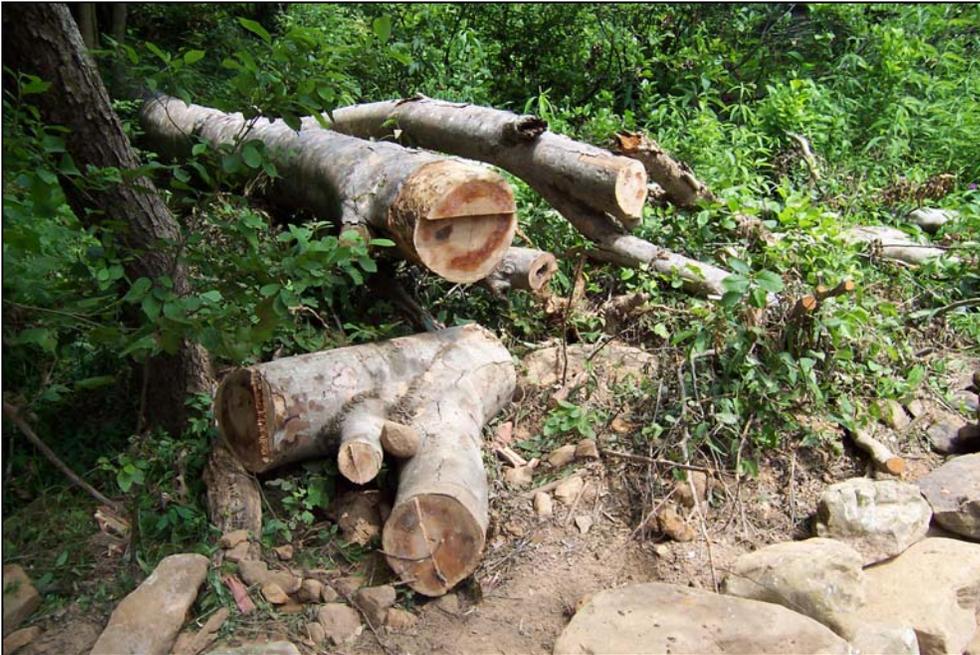
**Figure 6. In preparing the site for the new creek crossing, several uprooted large diameter trees were cleared by hand using a crosscut saw and axes.**

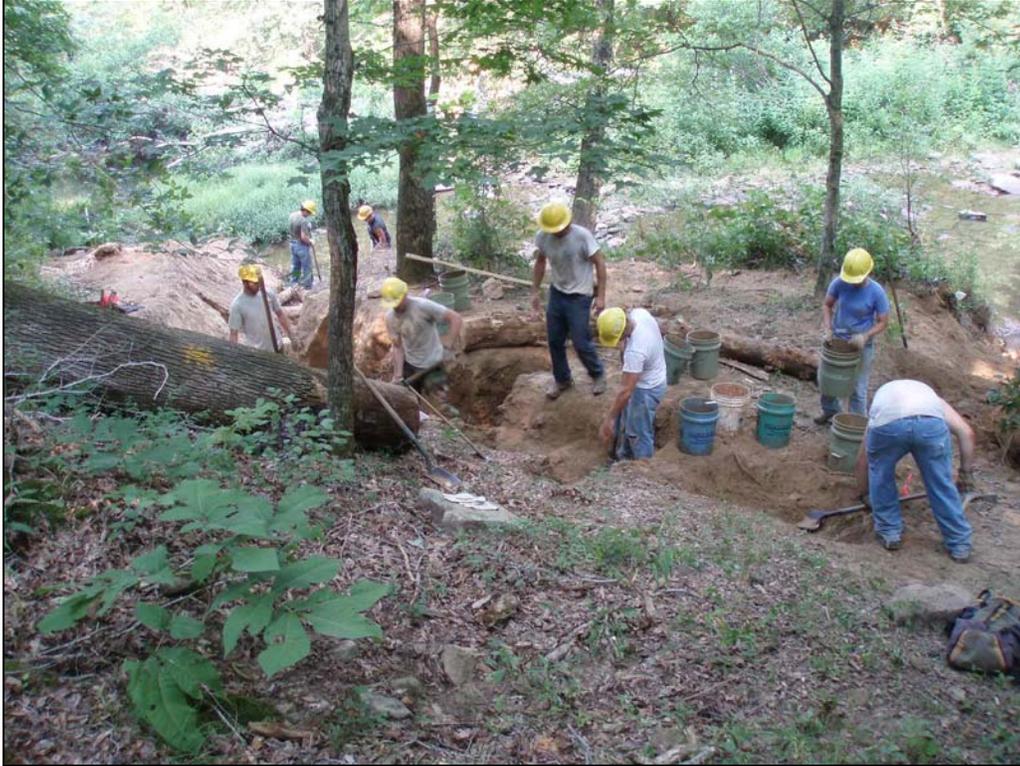
**Figure 7. Seventy-three (73) tons of soil was excavated by shovel from the embankment and uphill slopes and used to fill in deeply eroded ruts in the creek bank.**

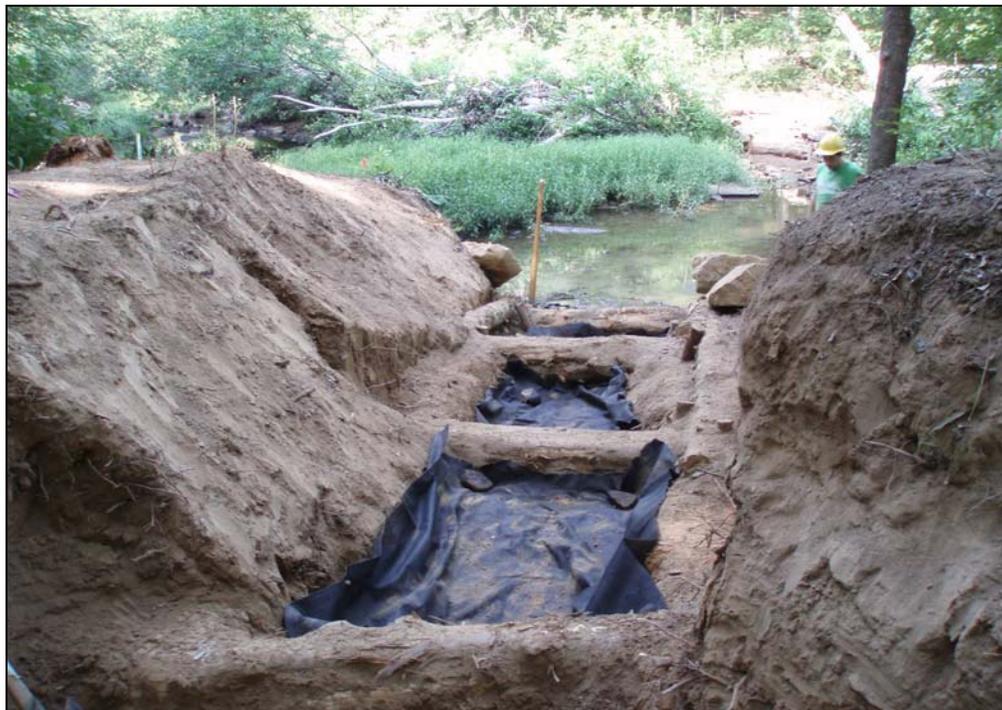
**Figure 8. East embankment of Lusk Creek, soil was excavated to prepare for the installation of steps and retaining wall.**

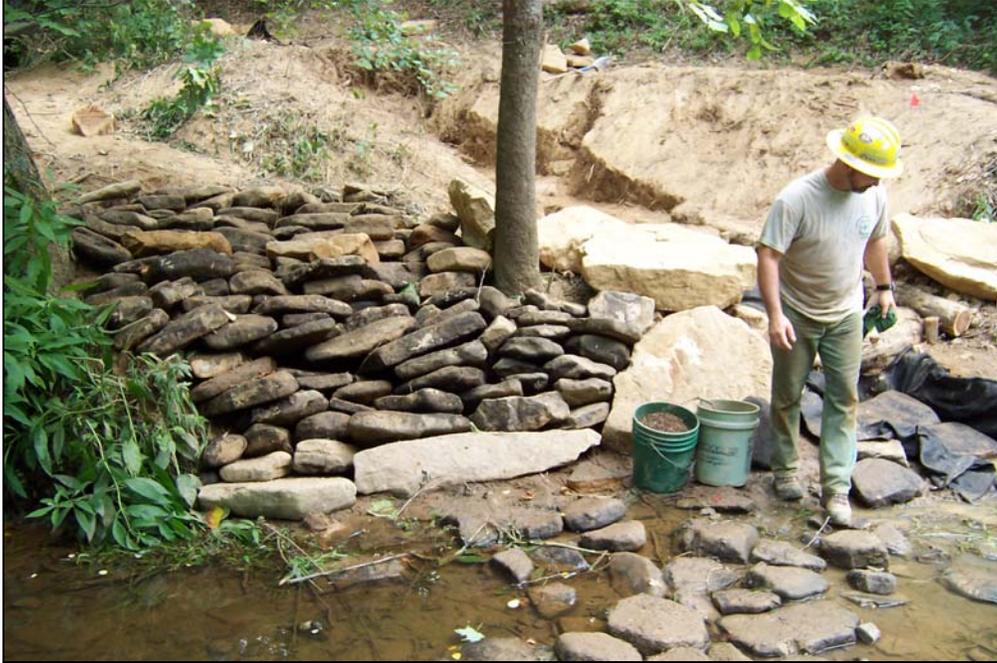
**Figure 9. Ninety-eight (98) tons of native sandstone was harvested from the surrounding area and used in the construction of steps and retaining walls.**

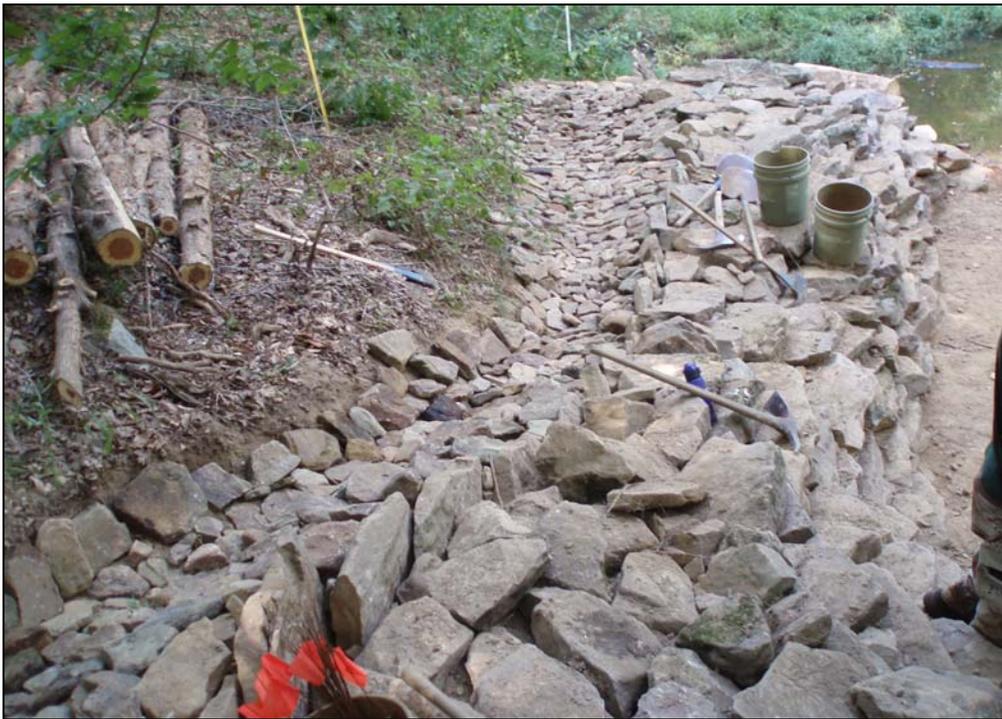
**Figure 10. Native sandstone was used to build retaining walls to withstand seasonal creek flooding and to provide uphill drainage of rainwater runoff.**

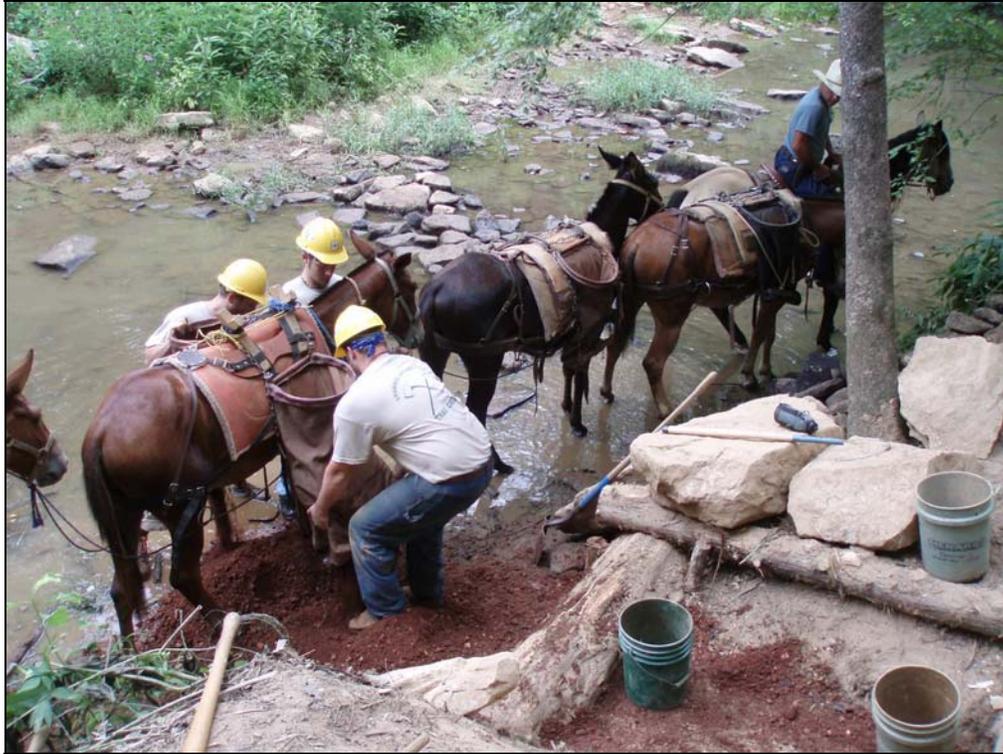
**Figure 11. Eighteen (18) tons of red rock gravel mixture was hauled to the site by stock animals nearly one mile into the wilderness.**

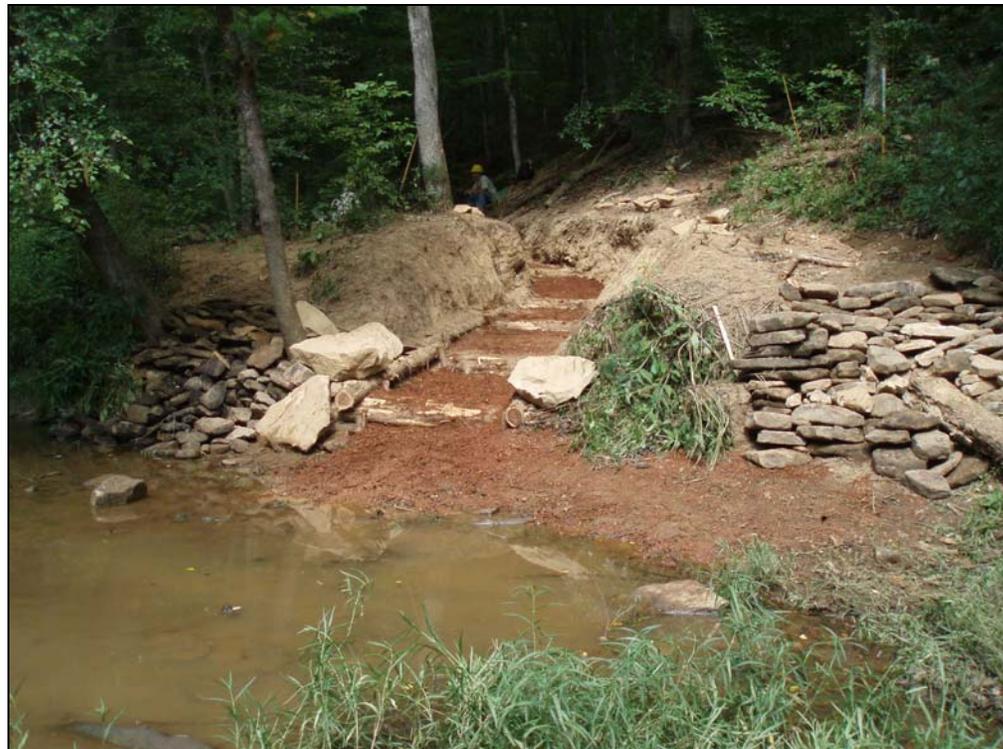
**Figure 12. The red rock gravel mixture is used to build steps that will allow equestrians to safely cross the creek.**

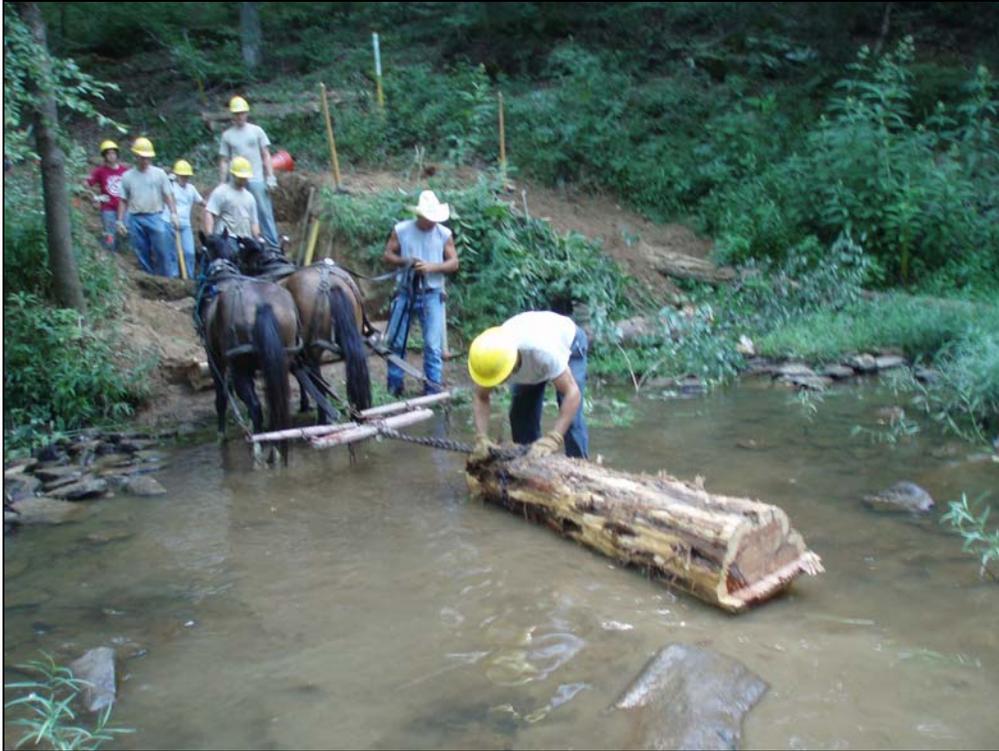
**Figure 13. A total of 200 feet of 10 – 12 inch diameter cedar logs were hauled by mule from the wilderness boundary to the crossing.**

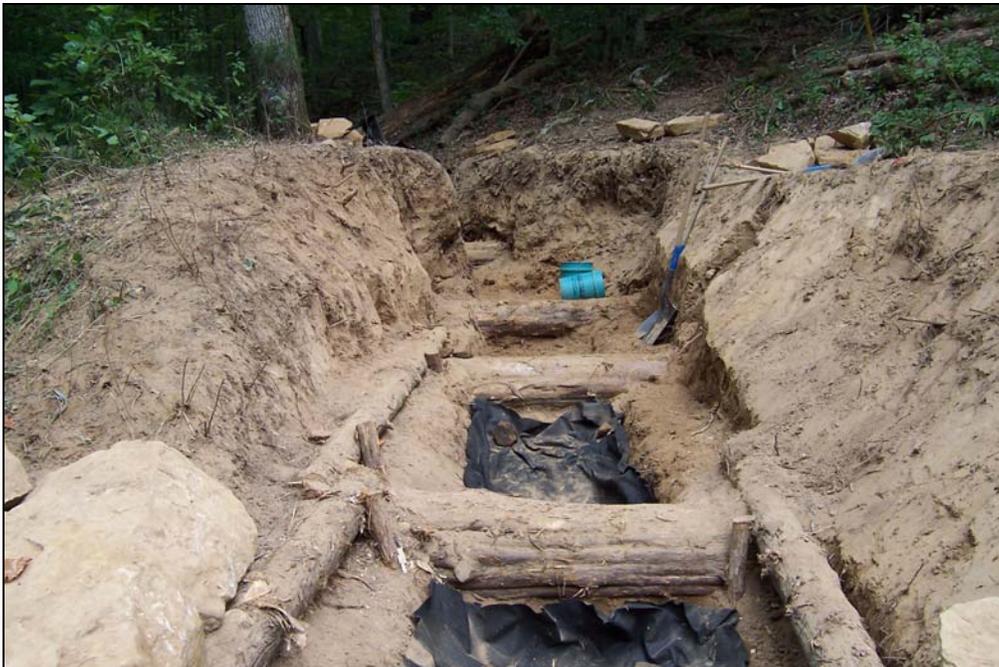
**Figure 14. The logs were used to form the 14 steps necessary to allow equestrians to walk stock animals up and down the creek embankments.**

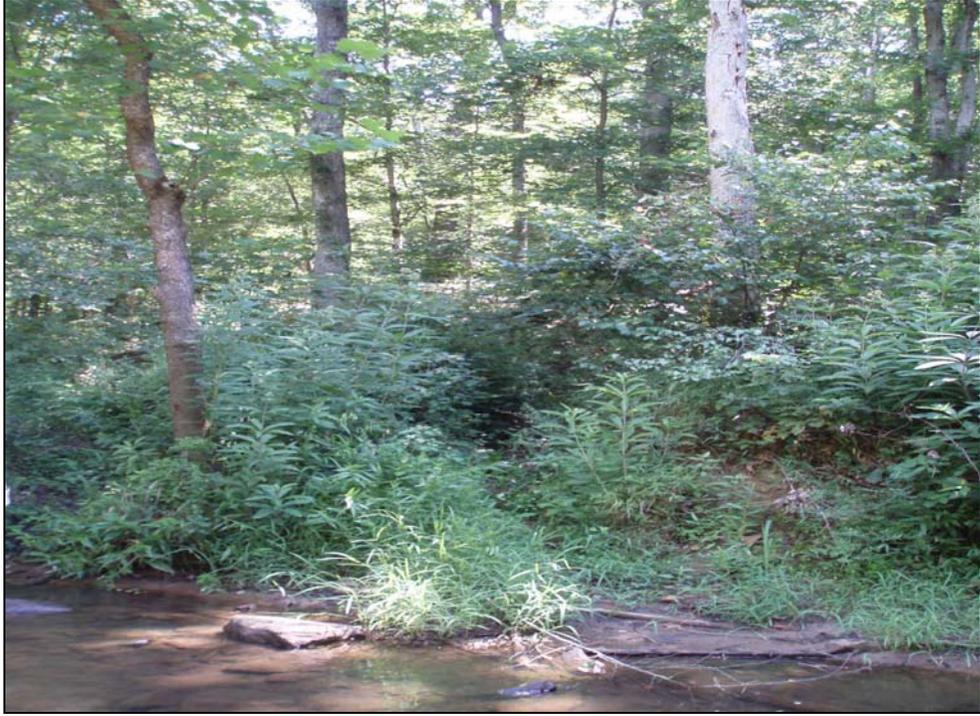
**Figure 15. Before.** Location of creek crossing near Bowed Tree on Lusk Creek before reconstruction of proper crossing. Old crossing was difficult to locate, deeply eroded, dangerous to use, and had the potential to add sedimentation to Lusk Creek.

approach to the creek embankments (Figures 15 and 16). In addition to the Bowed Tree Creek Crossing on Lusk Creek, the trail crew simultaneously completed the much smaller Little Bear Branch Creek Crossing adjacent to Lusk Creek.

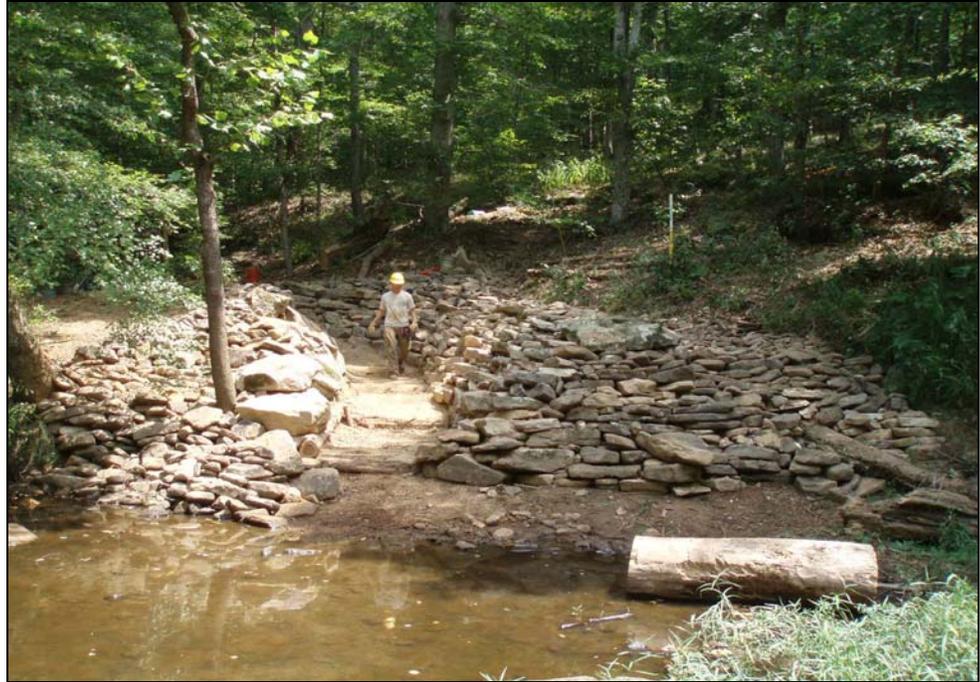
**Figure 16. After.** East embankment of newly reconstructed Bowed Tree Crossing, sandstone retaining walls will withstand seasonal creek flooding. Over time, the sandstone will collect sedimentation between the cracks and allow vegetation to grow resulting in a more naturalized appearance.
