**Shawnee National Forest
Hidden Springs Ranger District
Trails Designation Project Accomplishments
Months of May - August 2008**

The following are highlights of trail work accomplished in early May 2008:

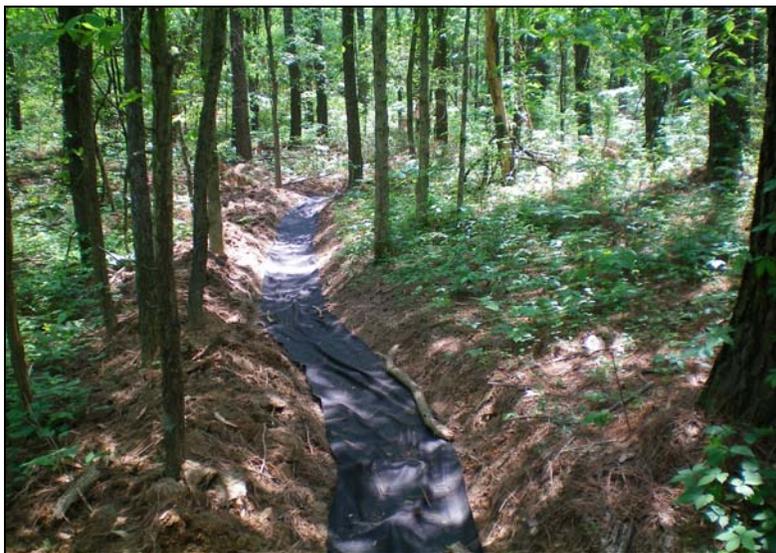
Figure 1. Geotextile fabric lay in a cup trench.

Because of the area's thin, poorly drained soil and lack of natural outslope for drainage, special preparations to the trail tread were necessary before gravel was spread. The preparation involved a cup trench dug in several sections of the re-route, its purpose is to prevent treadway fill (gravel) from dispersing in seasonably wet areas. The trail crew used shovels to dig nearly one half mile of cup trench 24 inches wide by 6 to 8 inches deep. The trench was lined with 600 yards of geotextile fabric. The fabric's felt-like layers made it easy to cut, and its flexibility easy to place on curved trail sections (Figure 1). The purpose of the fabric is to act as a separation between two layers of soil with different particle size distributions. For example, geotextiles are used to prevent trail base materials (gravel) from penetrating into soft underlying subgrade soils, thereby maintaining design thickness and trail tread integrity.

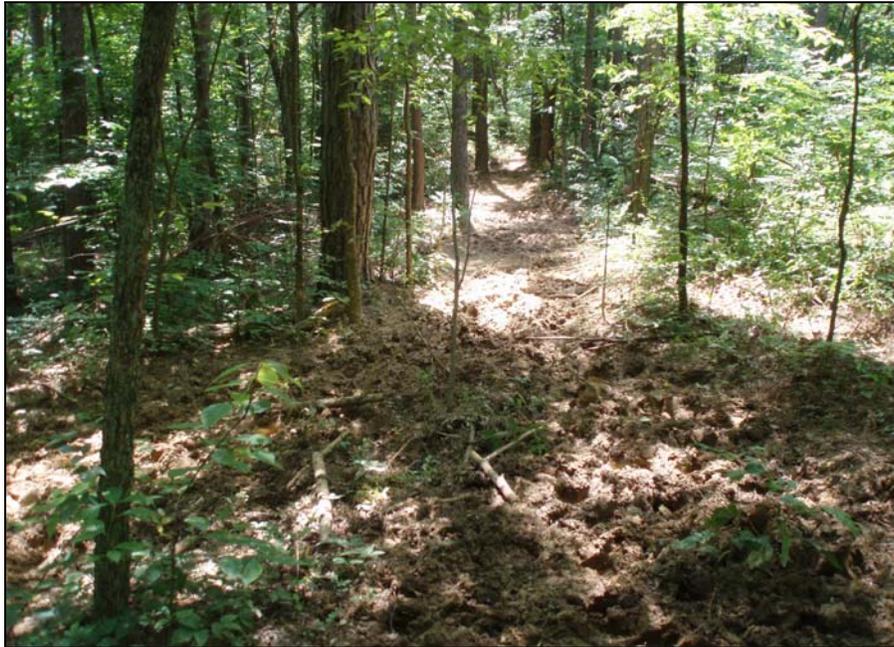
Figure 2. FS Trail 481B – before installation of turnpike.

A twenty-two foot, two directional Y-style turnpike, built of native cedar and pine logs, was installed at the junction of FS Trail 481B and the upper section of FS Trail 483 (Barger Branch Trail). The Y-style turnpike provides traffic from three different directions a smooth transition to access FS Trail 483, or continue in either direction on FS Trail 481B. Turnpikes play a critical role in areas where there is no alternative pathway location by lifting the tread above water-saturated soil carrying the trail across problematic terrain (Figure 2 and 3).

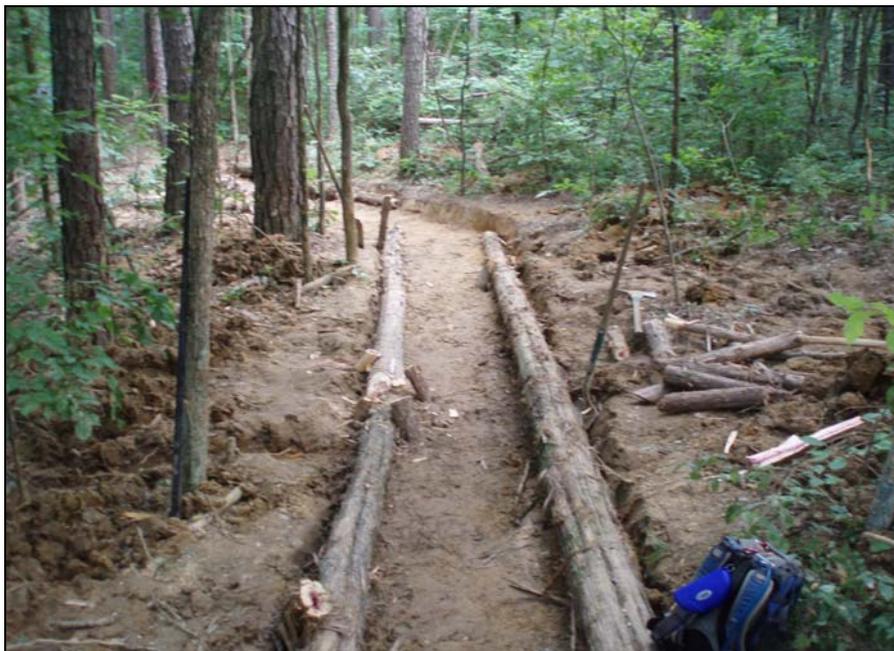
Figure 3. FS Trail 481B – during construction of turnpike.

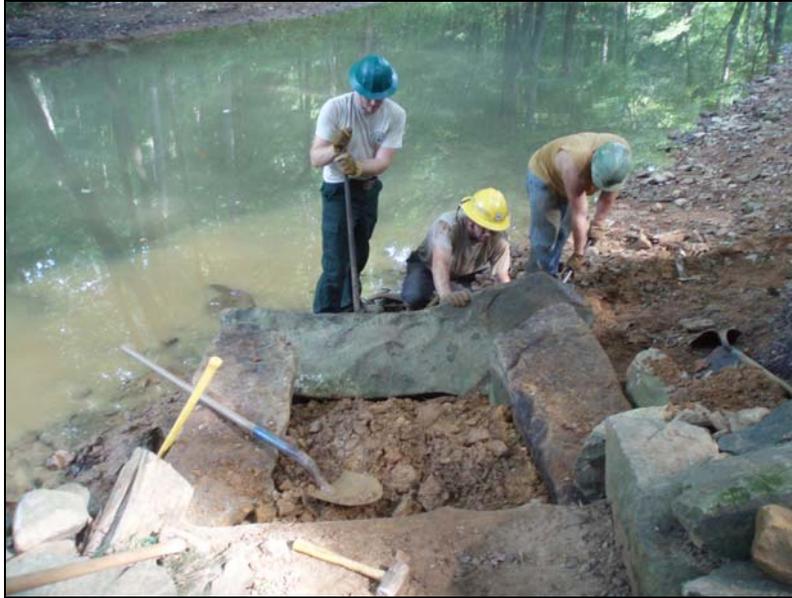
Figure 4. Sandstone rocks form the walls of the new step.

In addition, the trail crew made improvements to the Blanchard Church Creek Crossing on Lusk Creek. Unseasonably strong winter storms caused extensive flooding of Lusk Creek. Overall the Blanchard Church Creek Crossing withstood the flooding; however, the north side of the crossing sustained some erosion at the base of the last step leading to the creek. The constant eddying of water washed out the gravel, causing a three to four foot drop to the creek bed. To correct this, the trail crew built two additional steps, and a retaining wall. Heavy sandstone rocks were used to form the steps and the wall (Figure 4). Once the rocks were in place, the steps were filled in with crushed sandstone and capped with the red-fines gravel (Figure 5).

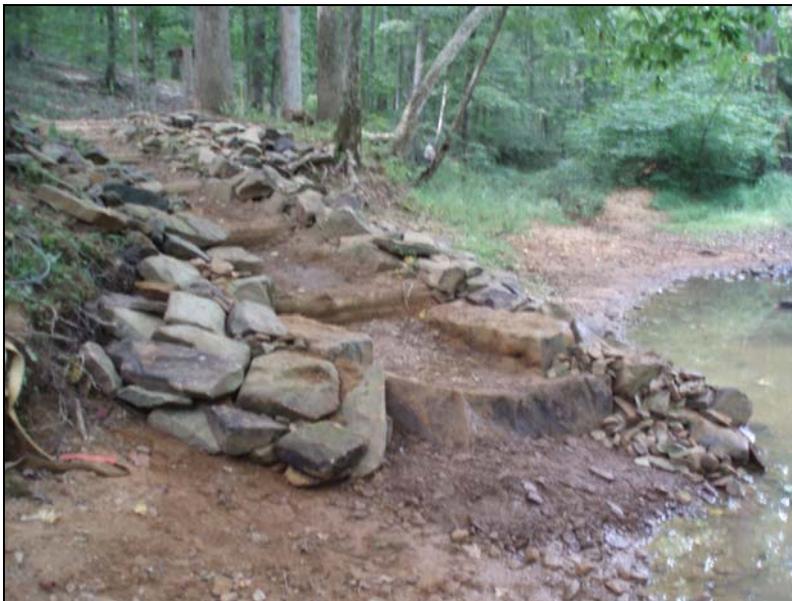
Figure 5. East embankment of Blanchard Church Creek Crossing with two additional steps and a retaining wall.

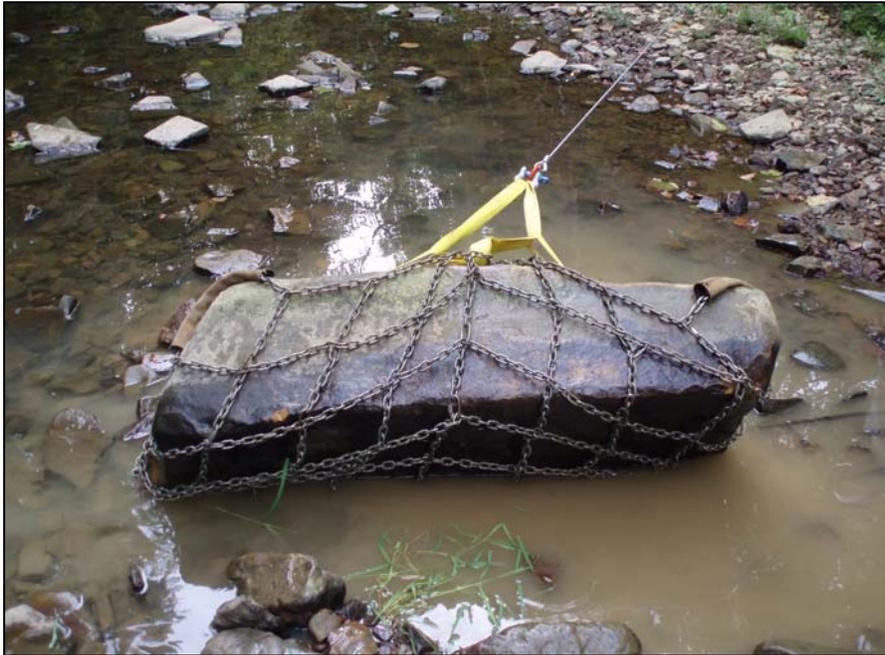
Figure 6. Sandstone rock being moved with a single-line pull.

A new method of rigging grip hoists, called a single-line pull, was employed to move the large sandstone rocks used in the installation of the creek crossing. For this method, a winch was anchored to a large tree by looping a sling around the trunk. Once secured, a cable was stretched out and attached to a loop sling and chain netting wrapped around a large rock (Figure 6). One person could then use the winch to pull the rock across the ground (Figure 7). This method is much safer than the previous method of several persons lifting heavy rocks in a prefab chain-link basket, and carrying it by hand.

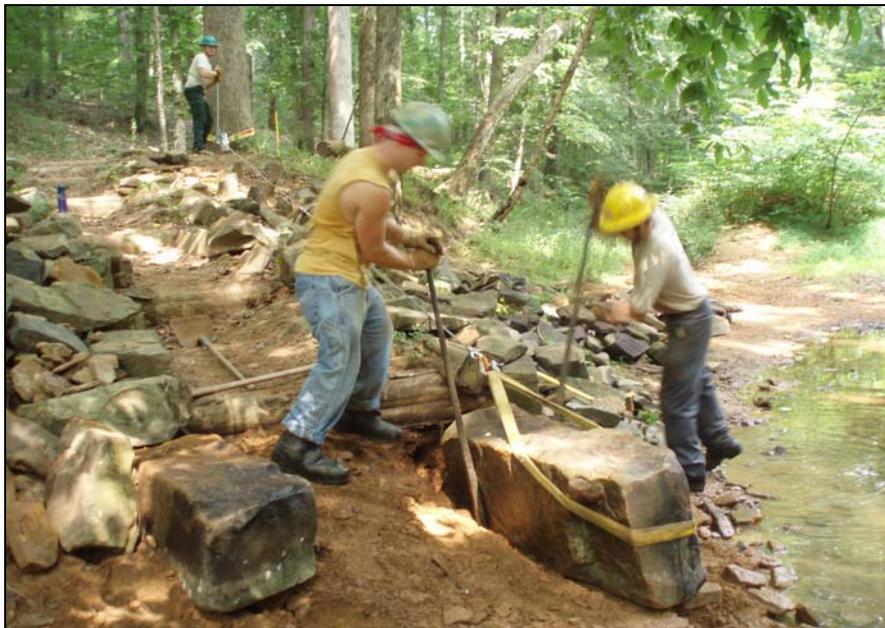
Figure 7. Maneuvering a rock into place with the grip hoist.

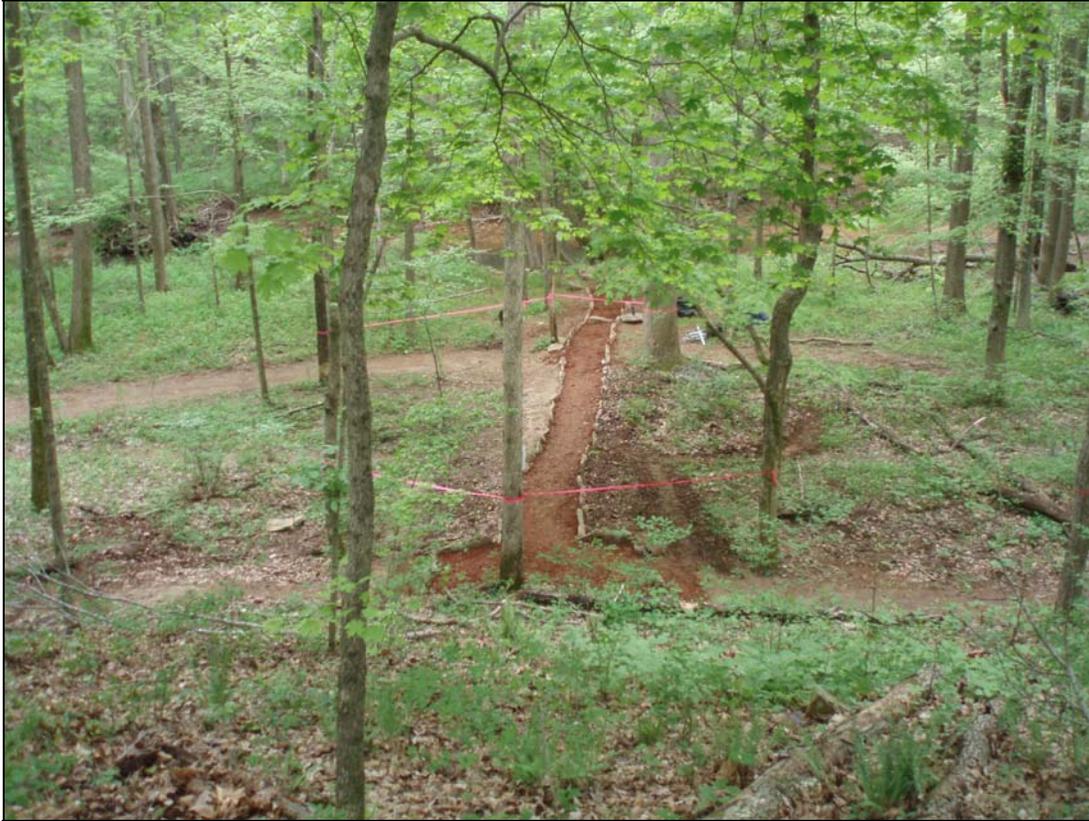
Figure 8. New causeway at the east embankment of the Blanchard Church Creek Crossing on Lusk Creek.

In addition, on FS Trail 457, the trail crew installed a 75-foot causeway/turnpike leading to the Blanchard Church Creek Crossing, located along the east embankment. The original approach was re-routed with the causeway to provide a more sustainable access to the crossing. One hundred thirty-five flat sandstone rocks were carefully selected, and buried two-thirds into the ground to form the walls of the causeway, thereby directing trail traffic to the crossing (Figure 8).

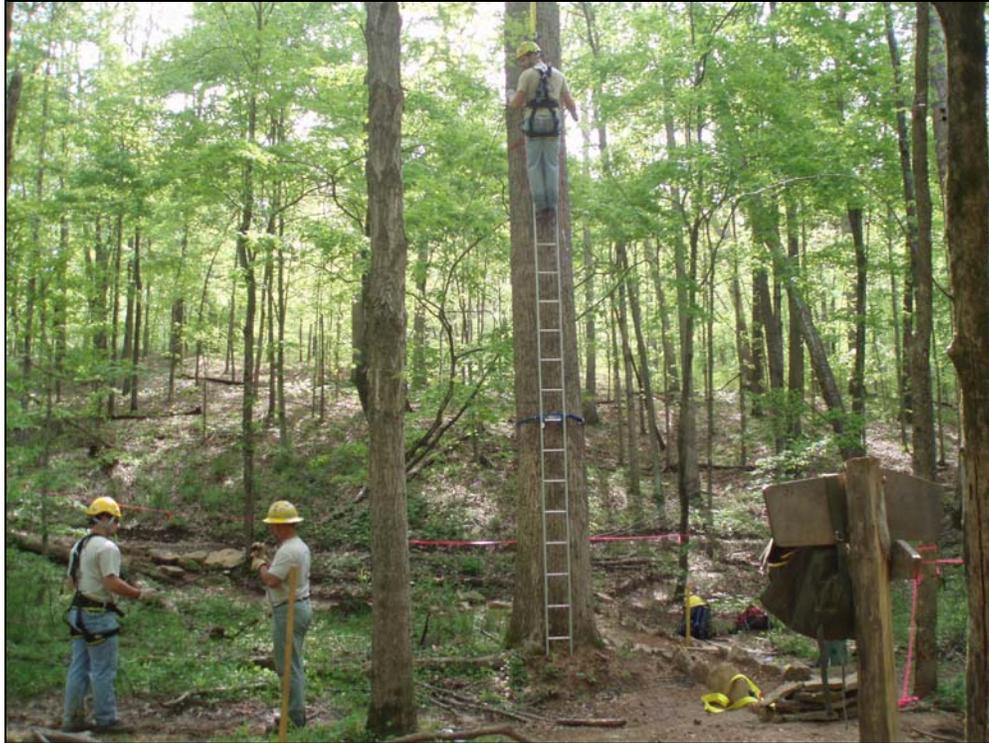
Figure 9. Trail crew members setting up the skyline.

A more advanced winch technique called a skyline was used to move three tons of sandstone gravel, in 5-gallon buckets, over 200-feet. Although a skyline requires additional equipment and setup time, it proved an efficient, less strenuous way to move large quantities of rock. This technique allowed the buckets filled with gravel to be lifted and transported above the ground from quarry to trail along a tensioned wire rope. The wire rope was suspended above the ground by trees, and a system of pulleys (Figures 9 and 10). Once in the causeway, the gravel was used as a base layer, and later capped with the red-fines gravel. The clay consistency of the red-fines gravel compacted and provides an excellent surface for trail traffic.

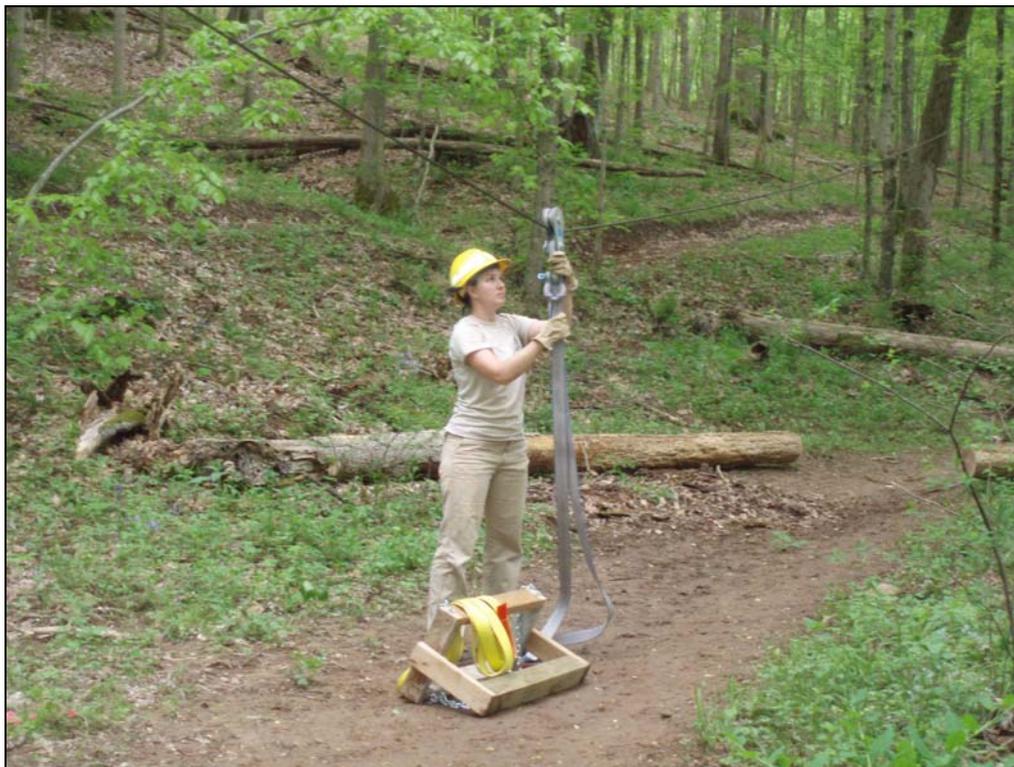
Figure 10. Trail crew member setting up the rock box with a pulley system.

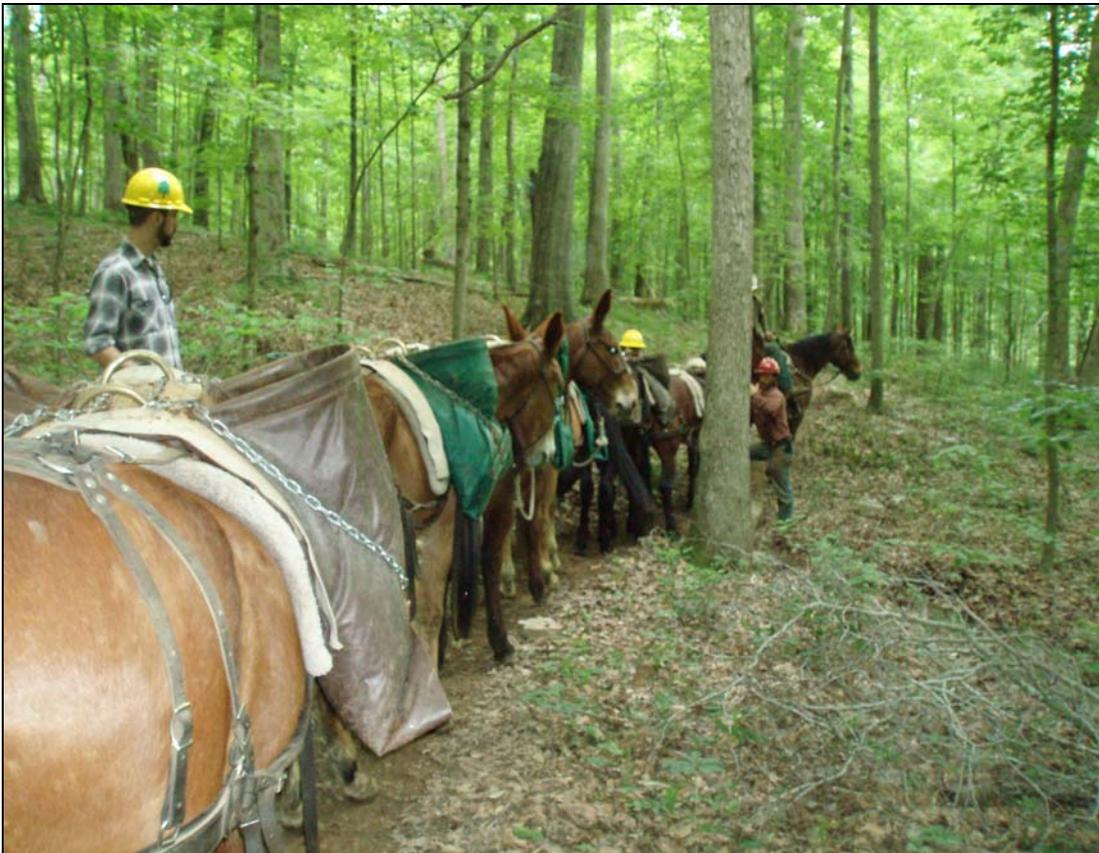
Figure 11. Mule teams were led down the trail to their destination; gravel bags were emptied, and the gravel spread in the trail tread.

Lusk Creek Wilderness - Hauling Gravel with Pack Stock (Bridger-Teton and Hoosier National Forest Detail): During the later part of May, and into early June, the Bridger-Teton National Forest (NF), out of Wyoming, sent a team of eight mules with staff to the Shawnee NF. In addition, a mule team from the Hoosier NF, out of Indiana, with four mules and staff were on Forest during the same time period. This was the second year in a row both mule teams provided gravel hauling for the Shawnee NF trails. This year, the mule teams, while working in concert with the trail crew, hauled 320 tons of gravel, the equivalent of 21 dump truck loads, into the wilderness for use on FS Trail 481B. In addition, 27 students from the Southern Illinois University's Forestry Department volunteered with the trail crew for a day to load mules with gravel. Once transported by gravel hauler to the wilderness boundary, the gravel was shoveled into 5-gallon buckets and loaded by hand into specially designed gravel bags on each mule. Each bucket held approximately 60 pounds of gravel, while each gravel bag held two bucket loads. Tons of gravel were shoveled into buckets, lifted at shoulder height, and poured into specially designed bags on the back of each mule. The mules were lead down the trail, and once at their destination, unloaded and the gravel spread by hand in the trail tread (Figure 11).

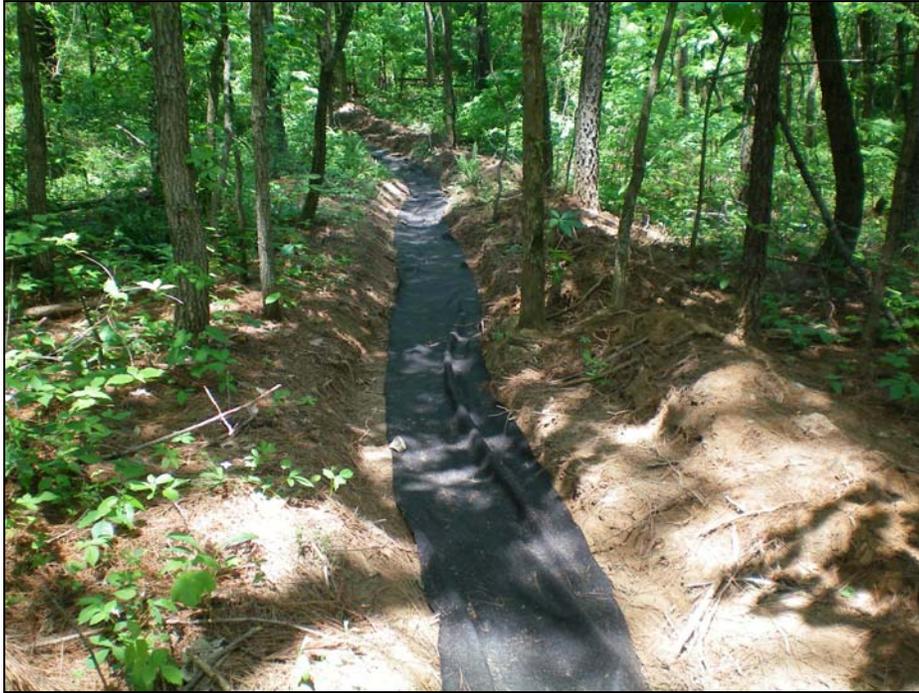
Figure 12. FS Trail 481B – re-route during construction.

Both the Bridger/Teton and the Hoosier mule teams hauled tons of gravel to the new re-routes where it was spread and compacted by hand in the trail tread, and trail features, such as the many turnpikes and cribbed stone steps (Figures 12 and 13).

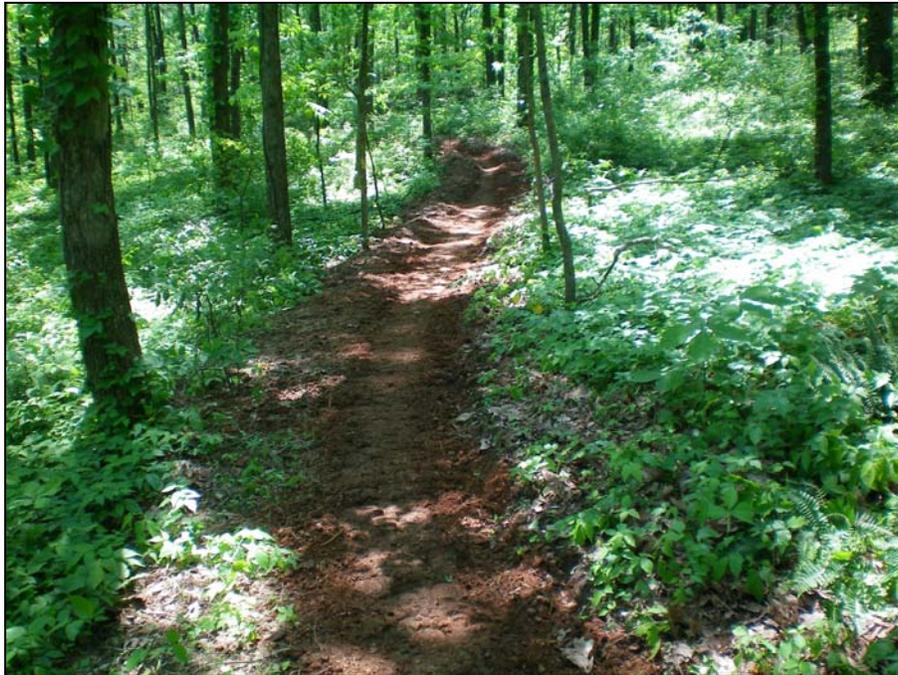
Figure 13. FS Trail 481B – after construction. The red-fines gravel spread in the trail tread allows for all-weather rideability.

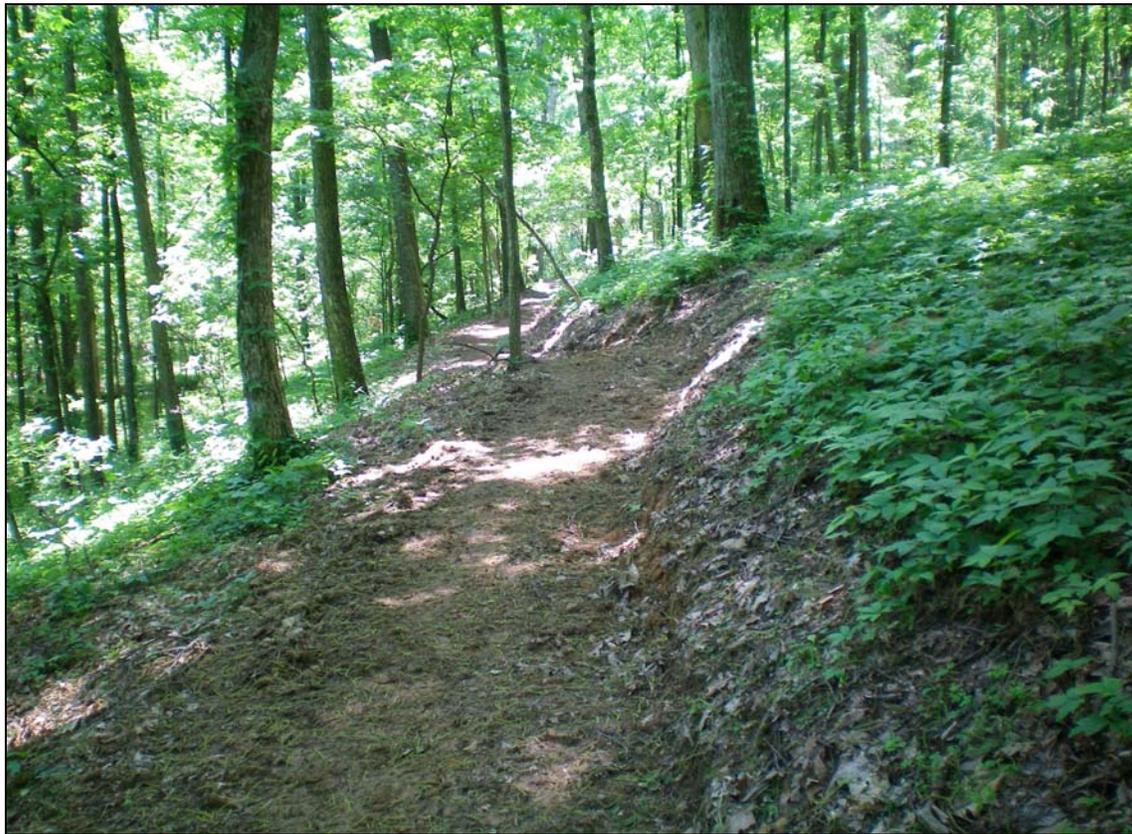
In addition, other sections of the old, user created FS Trail 487B (Wishing Well Trail) ascended long, steep gradients. As a result, gullies formed by erosion were deteriorating the old trail route. The new FS Trail 481B re-route replaces these old, non-designated sections. The re-route continues to cross hills and knolls, and climbs into and out of small hollows; however, its careful design and lay out on the sidehill locations provide a happy medium between the trail's function of gaining elevation, and the tendency of surface water runoff and user traffic to rapidly erode trails on steep grades (Figure 14). The new sidehill locations allow running water to cross the trail, but not run down the treadway at high velocities that aggravate erosion. The variations in the topography also provide the elements of a stimulating and interesting trail design, while subtle turns and undulations in grade steepness offer trail users an appealing and satisfying trail experience.

Figure 14. New sidehill location of FS Trail 481B (Wishing Well Trail).

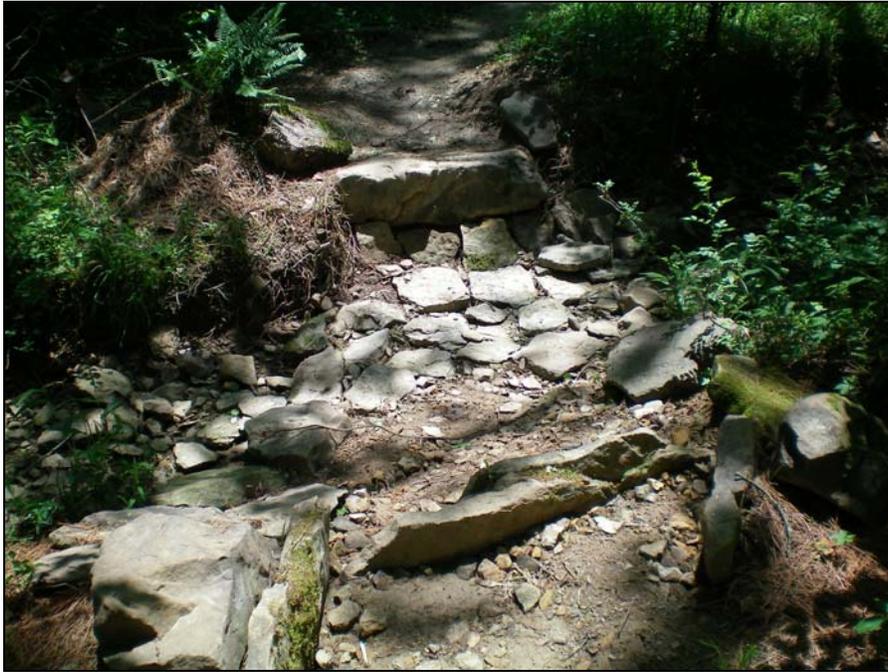
Figure 15. FS Trail 481B. Rock Steps and water bars provide stability for the approaches to the natural drainage crossings.

In areas where FS Trail 481B crossed over natural drainages, the trail crew installed features such as rock steps and water bars to maintain sustainability. A total of nine drainages had rock steps installed on either side of the trails approach to the drainage (Figures 15 and 16).

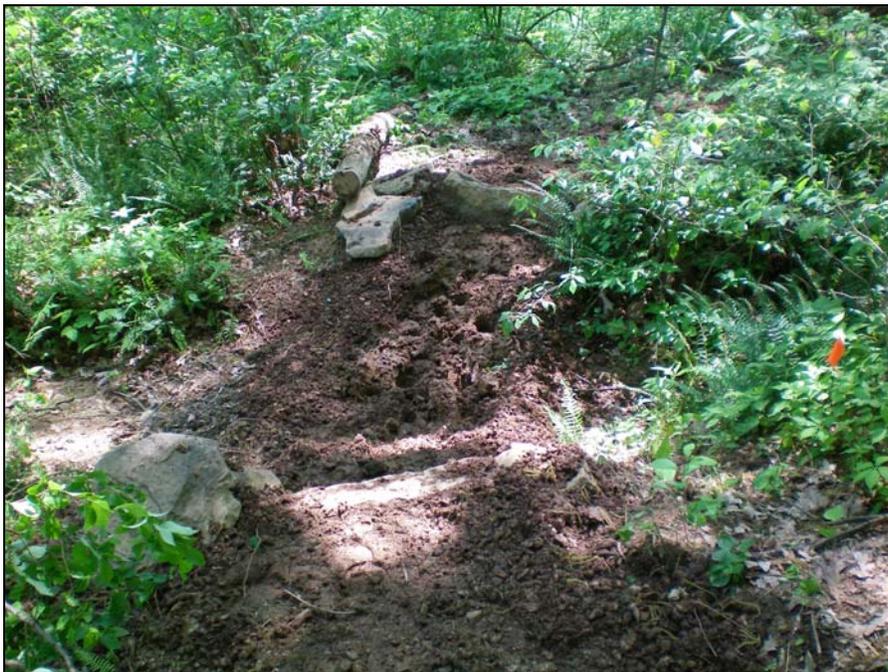
Figure 16. FS Trail 481B. Rock steps and water bars with gravel.

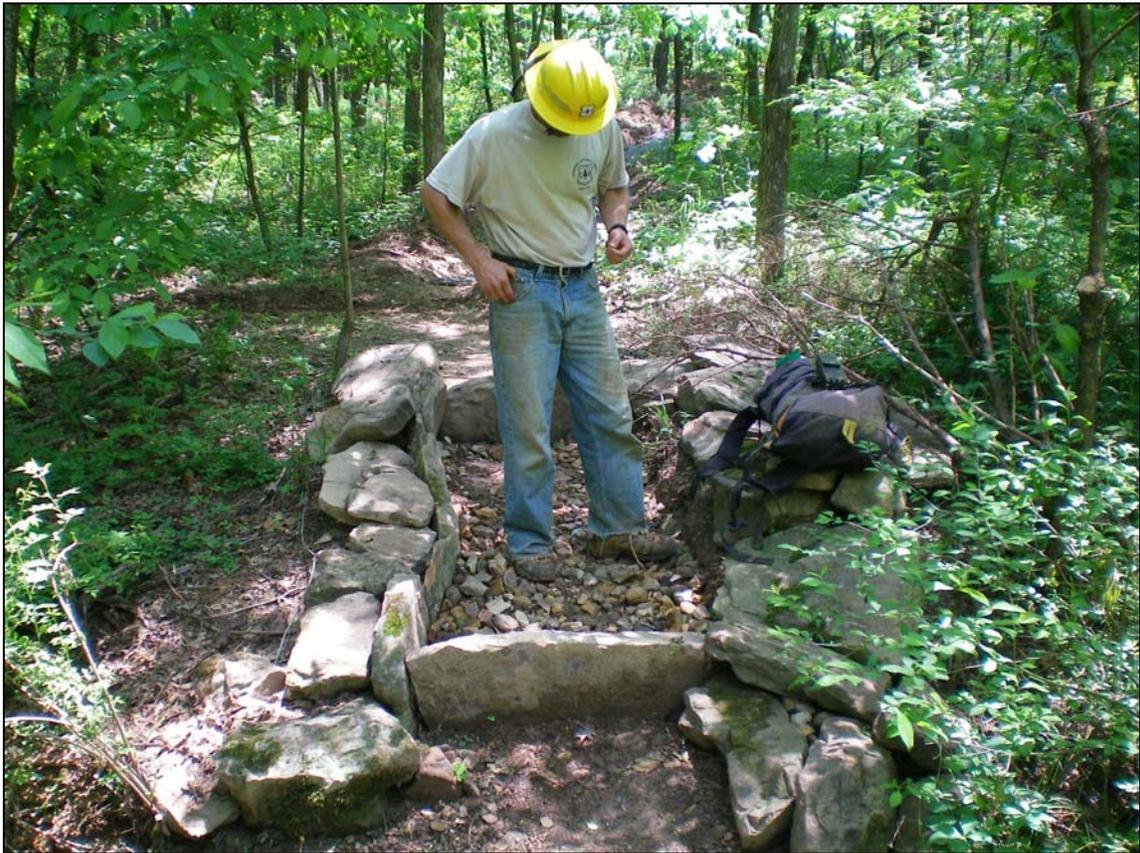
Figure 17. FS Trail 481B. Sandstone rock is used to form the walls of a rock step/platform at a natural drainage, crushed sandstone provides the foundation.

Several tons of native sandstone were used in the construction of the steps and water bars at the drainages. To accommodate stock animals (equestrian trail traffic), each step formed a platform measuring several feet in width and six feet in length. Some drainage locations were the result of natural seepage where the approach required mucking out of mud with shovels. Once the area was prepared, sandstone rock weighting hundreds of pounds were moved into place, and used to form the walls of the platform and provide a solid foundation of the step. Additional sandstone was crushed by hand and used as backfill for the step (Figure 17). The red-fines gravel was hauled in my mule teams and used to cap the crushed sandstone in the platform. The smooth red-fines gravel, with its clay binder, packed tight as a backfill. A great deal of effort and detail went into the installation of the drainage crossing in an effort to provide enhanced trail sustainability.

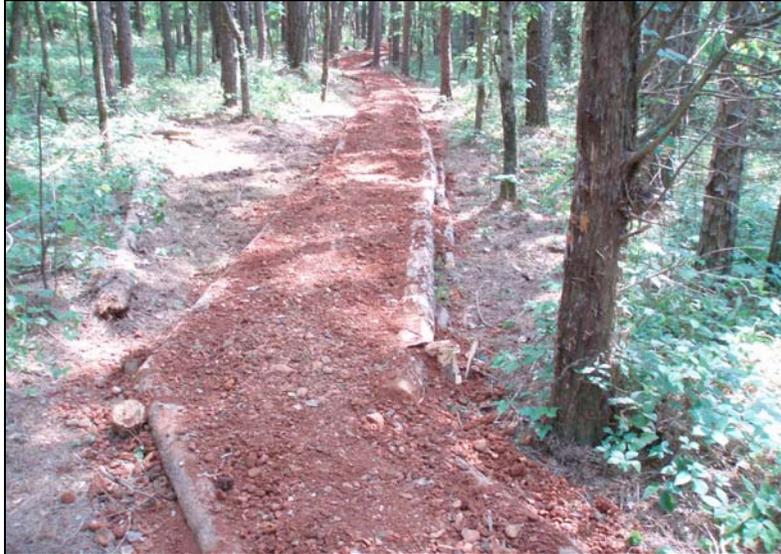
Figure 18. Turnpike installed in areas of water saturated soil.

Lusk Creek Wilderness - During the month of July, the trail crew continued working on trail sections in the Lusk Creek Wilderness. A total of six turnpikes were built in several sections of FS Trail 457 (Coyote Club Trail). The turnpikes play a critical role in areas where there is no alternative pathway location by lifting the tread above water saturated soil, and carrying the trail across problematic terrain (Figure 18).

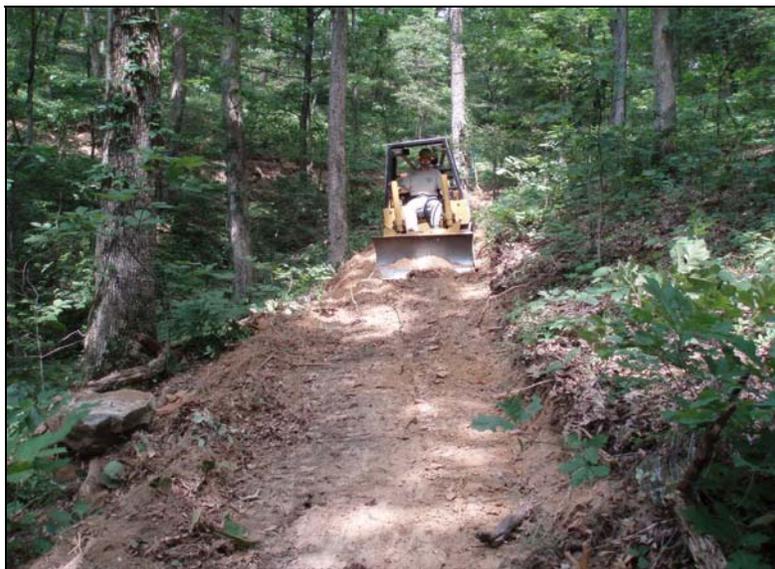
Figure 19. Sweco trail dozer cutting in new trail tread.

Non-designated Wilderness - In addition, mechanized work was conducted outside of non-designated wilderness areas. One and a quarter miles of re-routes on sections of FS Trail 487H were completed. The new re-routes, located immediately north of Frank's Tract, follow the natural contour of the terrain, and like the original sections, loop back to the boundary of the Lusk Creek Wilderness (Figure 19).

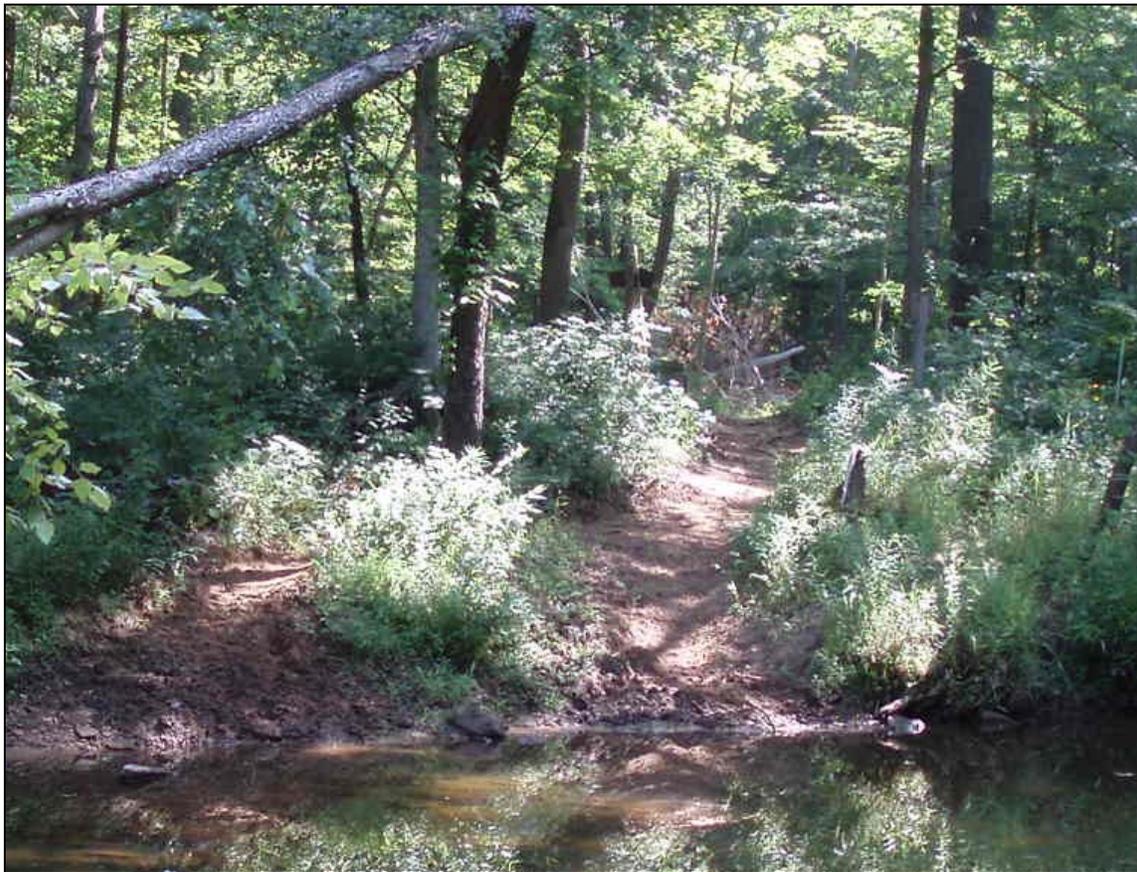
Lusk Creek Wilderness - Because the entire length of Lusk Creek is a designated Zoological Area along both sides of the embankment, a limited number of authorized creek crossings are available for equestrian use. As such, the existing crossings must be able to sustain frequent trail traffic, such as horse and mule use. Some of these crossings were historically user-created and required relocating and proper installation. The Salt Peter Cave Creek Crossing, located northeast of the ride-through-only trail segment opposite Salt Peter Cave, was one such crossing that required construction. The actual site of the user-created crossing was suitable. The approach to the crossing on the south side of Lusk Creek is flat and level, as such, it did not need improvements; however, the north embankment dropped approximately five feet to the creek. Trail traffic was climbing up out of the creek on this embankment at a 40 percent slope. As a result, the old crossing was eroded on the north embankment, and had the potential to add sedimentation to Lusk Creek (Figure 20).

Figure 20. Before construction. Old, user-created Salt Peter Cave Creek Crossing on north embankment of Lusk Creek.

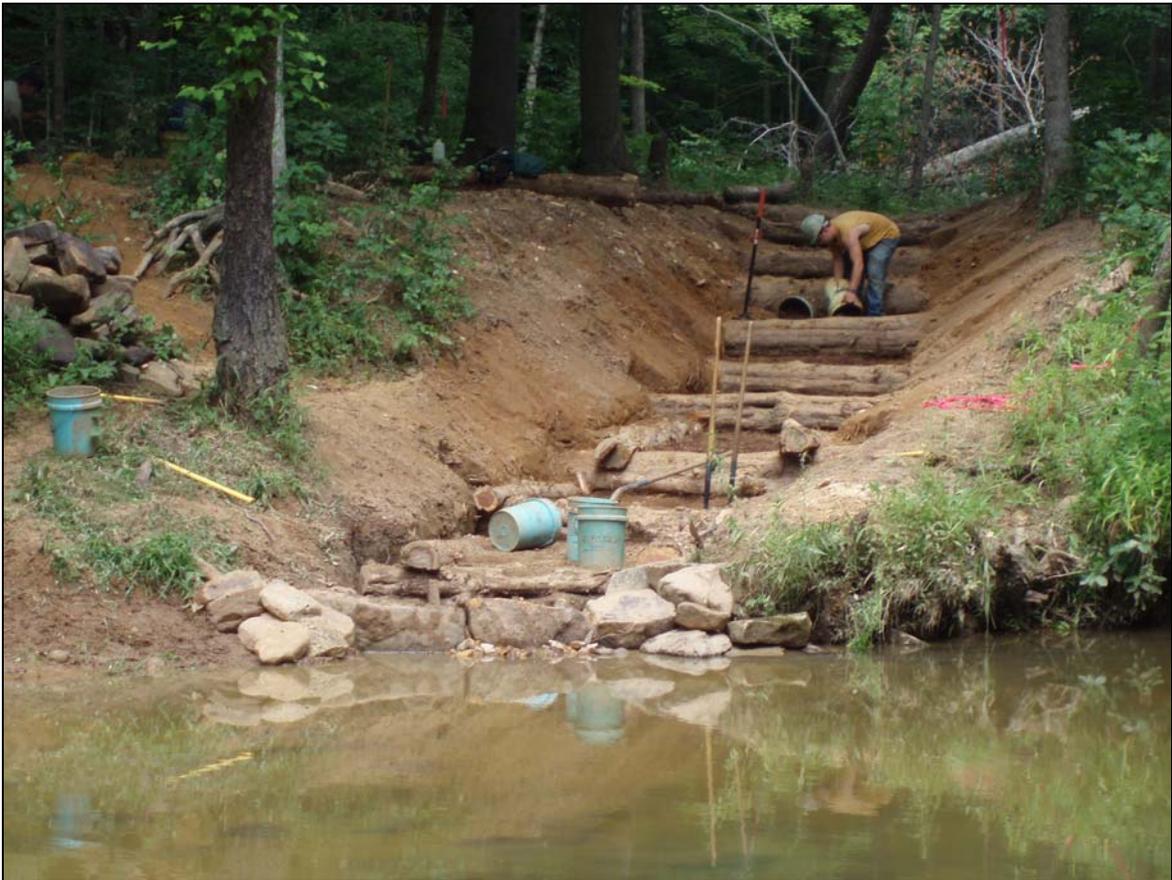
Figure 21. During construction - north embankment of Salt Peter Cave Creek Crossing on Lusk Creek.

Salt Peter Cave Creek Crossing - To prepare the creek crossing for equestrian use, the trail crew used shovels and 5-gallon buckets to excavate tons of soil in order to achieve the desired rise and run (slope). Each step of the crossing was constructed to allow a stock animal's four legs to stand, before advancing to the next step. A total of nine steps were installed, each step built with native cedar and sandstone (Figure 21). The creek crossings, reconstructed during the Trails Designation Project in designated wilderness areas, are an excellent example of what can be accomplished in accordance with Wilderness Principals. The use of native building materials and pack stock, primitive tools to shape timber, and dry stack masonry were all incorporated into the improvements of the Salt Peter Cave Creek Crossing.

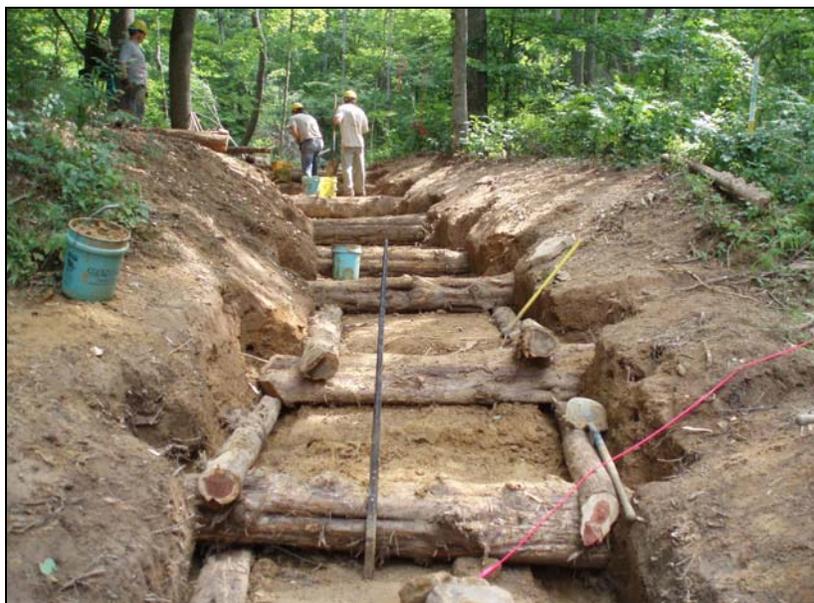
Figure 22. Cedar logs being used to form the steps.

Salt Peter Cave Creek Crossing - Cedar logs were hauled by mules from the wilderness boundary to the site of the crossing. The mule team, hired from the local area, hauled the logs nearly one mile into the wilderness. The logs were used to construct the cribbed walls of the stairway (Figure 22). This rustic timber construction uses the traditional technique of *joinery*, the art of joining pieces of wood with notches rather than nails, screws, or bolts.

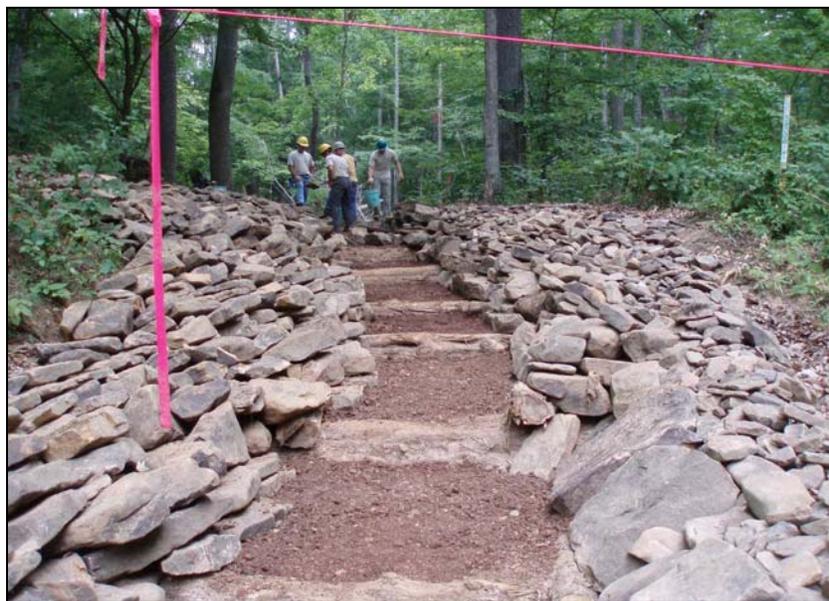
Figure 23. Sandstone rock forms the retaining walls.

To withstand seasonal creek flooding, several tons of native sandstone was used in the construction of steps and retaining walls which play a critical role in stabilizing the crossing (Figure 23). To complete the crossing, over ten tons of red-fines gravel was hauled to the site by mules. The gravel was used as a top surface in the cribbed stair steps making travel more comfortable for hikers and equestrians.

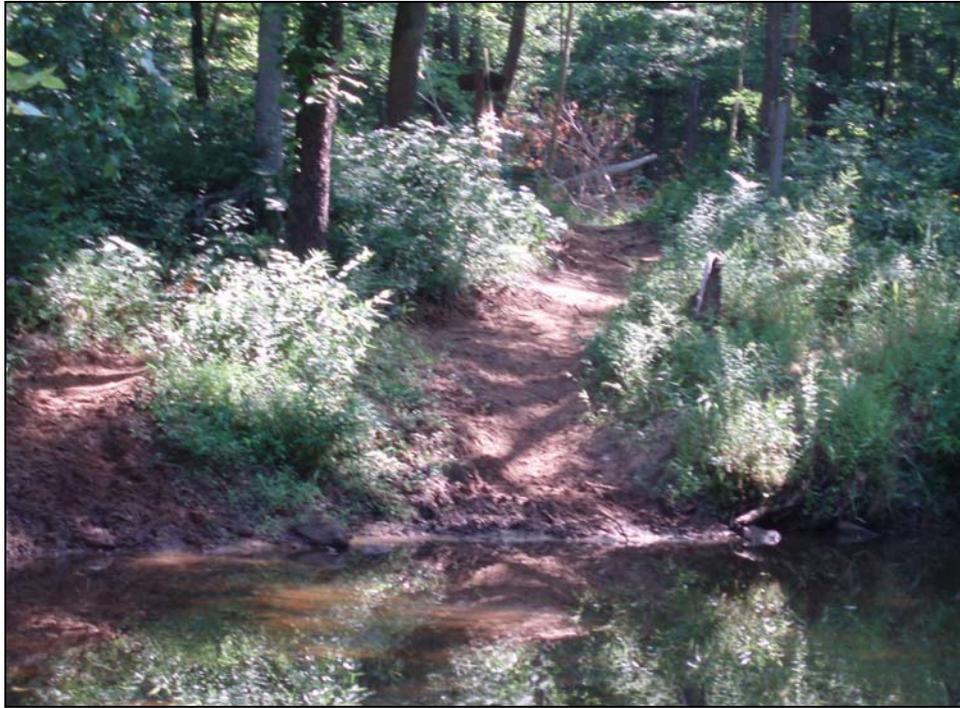
Figure 24. Salt Peter Cave Creek Crossing before construction.

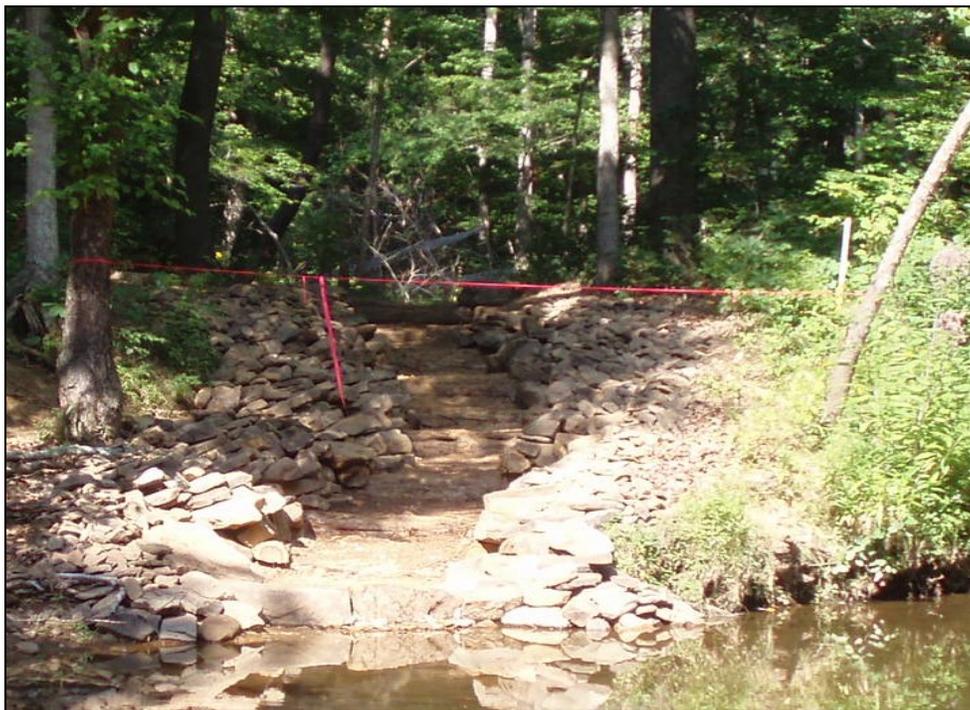
Figure 25. Salt Peter Cave Creek Crossing after construction.

Salt Peter Cave Creek Crossing - Improvements to the north embankment of the Salt Peter Cave Creek Crossing help to mitigate resource damage and provide improved recreational opportunities.
