# **MONITORING REPORT**

## **TRAILS DESIGNATION PROJECT, PHASE ONE October 1, 2006 – September 30, 2007**

### **SHAWNEE NATIONAL FOREST HIDDEN SPRINGS RANGER DISTRICT**

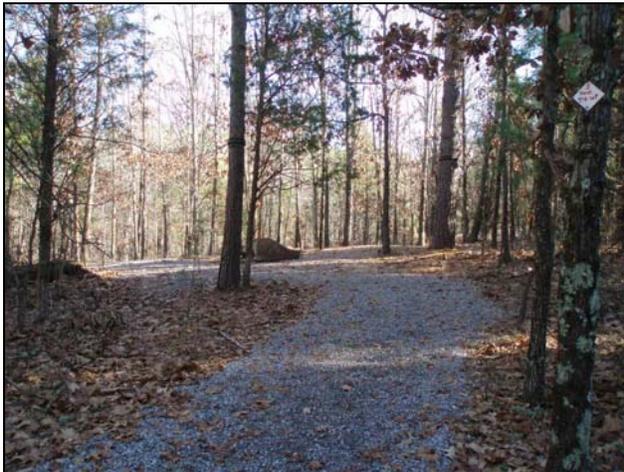
Figure 1. Entrance to reconstructed Jackson Hole stock-confinement area.

**Results:** In its original location, the user-developed Jackson Hole stock-confinement area had no highlines with tie-ups to secure stock, which were simply tied to trees. The area has been relocated to a sustainable and suitable site with gravel spread at the entrance (Figure 1) and within the confinement area to provide wet-weather ridability. Hayes Canyon Horse Campground volunteered assistance during the relocation and provided the new tie-ups made of old horseshoes (Figure 2). The relocated and reconstructed area provides equestrians with a safe and effective means of securing stock while offering protection of natural resources by confining stock to a suitable area.

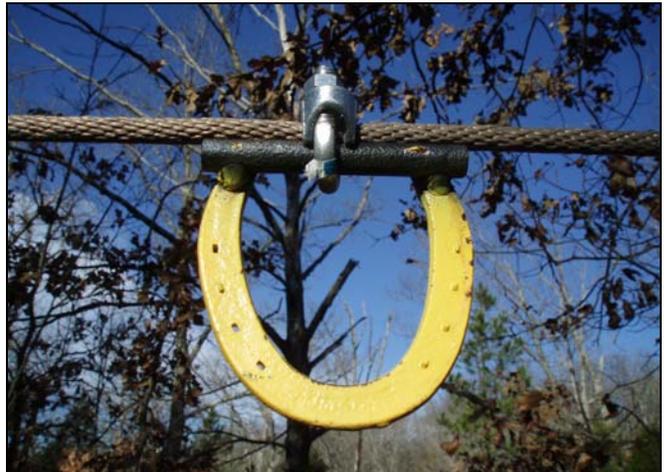
Figure 2. New tie-up on highline at Jackson Hole.

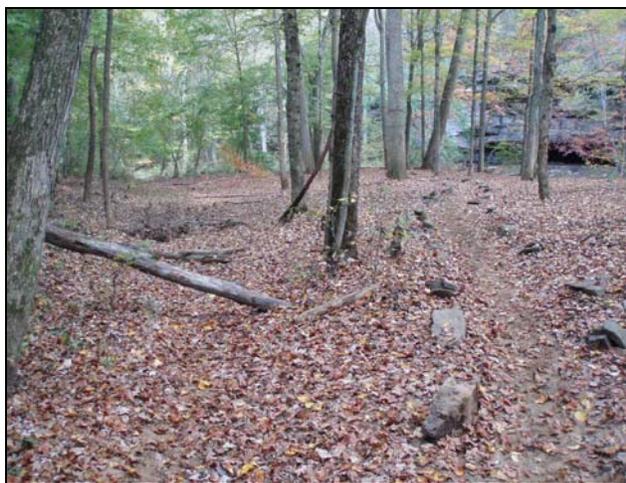
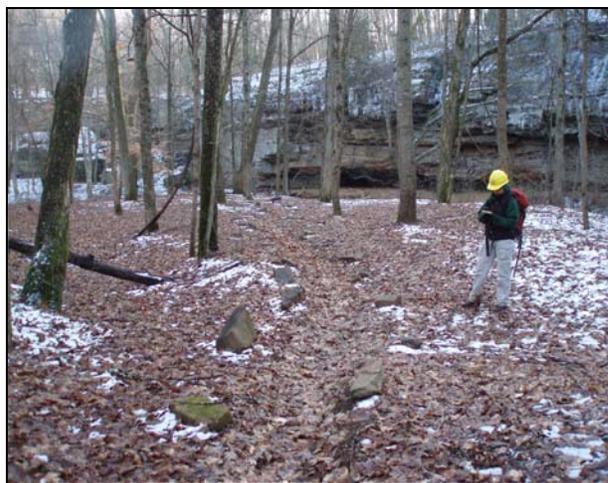
Figure 5. Saltpeter Cave ride-through-only trail, fall 2006.

Figure 6. Saltpeter Cave ride-through-only trail one year later, winter 2007.

There were no observations of equestrians stopping or tying stock to the trees at the ride-through-only trail section opposite Saltpeter Cave (Figures 5 and 6). Monitoring shows evidence (stock hoof imprints) that some stock have strayed from the delineated path (rocks placed along the trail edge) in the ride-through-only section opposite Saltpeter Cave, however, this has caused little impact.

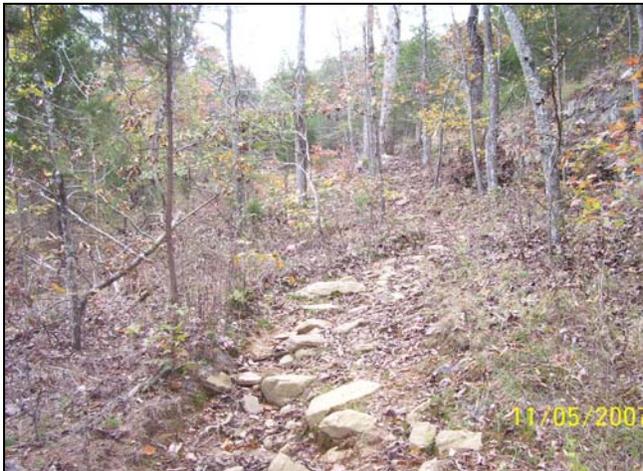
Figure 7. Old, non-designated section of River-to-River Trail closed and re-routed.

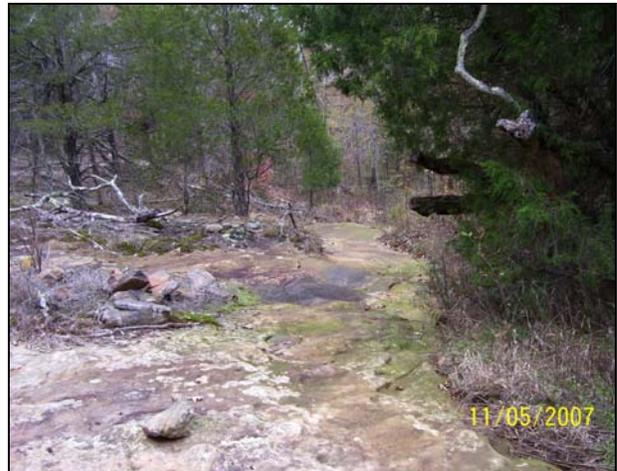
Figure 8. Highly eroded section of non-designated River-to-River Trail closed and re-routed.

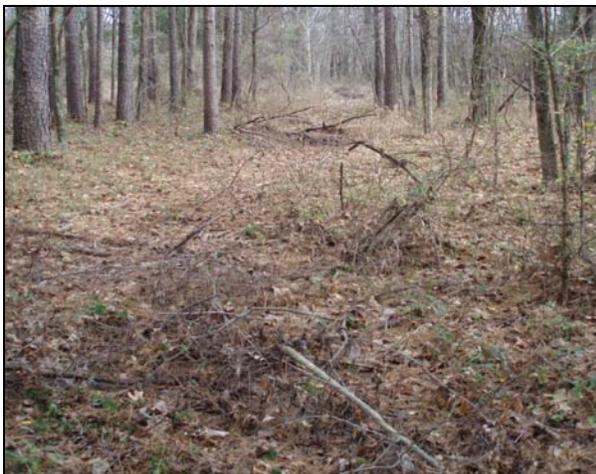
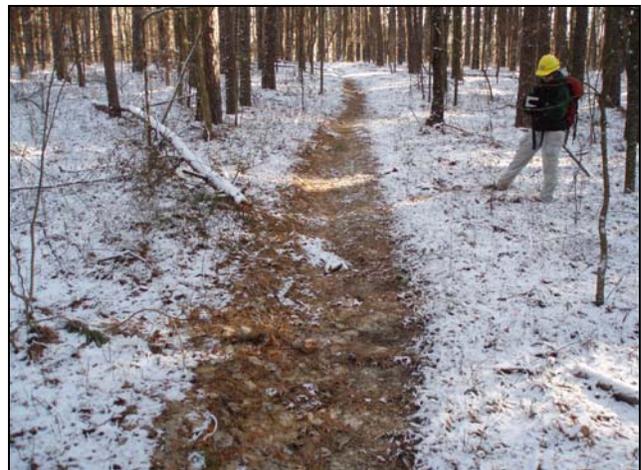
Figure 9. Fall 2006. Section of non-designated, user-developed FT 492A brushed in a year ago.

Figure 10. A different section of FT 492A. The old user-developed route, to left of existing path, was brushed-in and re-routed.

- FT 492A (section off FR 1867 north of New Liberty Church and continuing southwest to Lusk Creek): In 2006, these sections of non-designated trail were brushed in and reported in the Monitoring Report. Continued monitoring in 2007 shows that natural processes have continued to sufficiently reduce the impacts on the brushed-in sections of trail. Users are staying on the designated trail and off the brushed-in, non-designated sections; brush has not been removed (Figures 9 and 10).

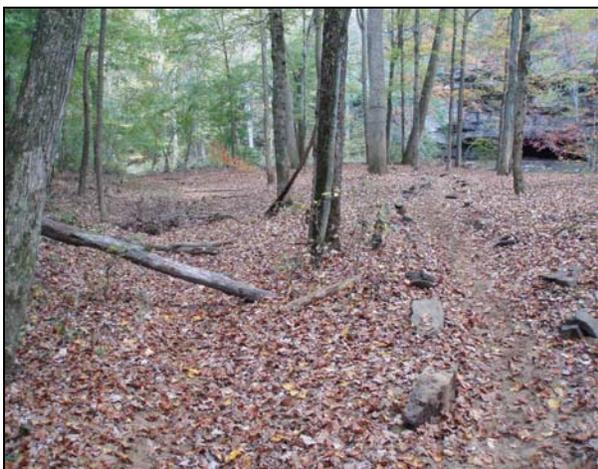
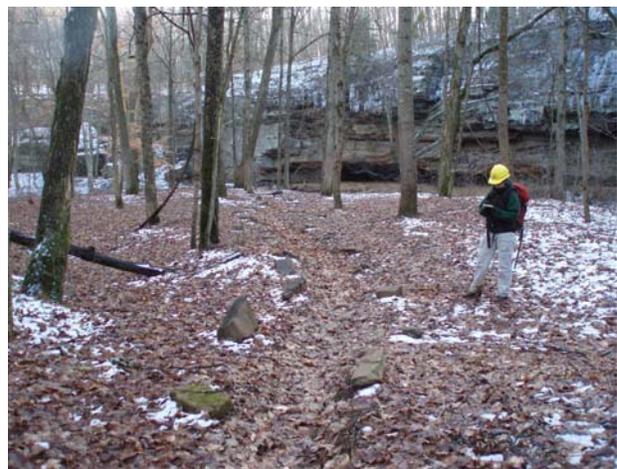
Figure 13. **Early fall 2006.** Old Saltpeter Cave stock-confinement area, highline removed and area converted to ride-through-only.

Figure 14. **Winter 2007.** Old Saltpeter Cave stock-confinement area.

- **Ride-through-only trail (Saltpeter Cave to Natural Bridge):** In 2006, the stock-confinement area opposite Saltpeter Cave was relocated and the original location converted into a ride-through-only trail. Continued monitoring in 2007 shows natural processes continue to reduce the impact on the previous stock-confinement area. Users are primarily staying on the designated trail and are riding through the old confinement area to the Natural Bridge. Some users are meandering off the trail opposite the Saltpeter Cave as it is an open area. However, there is no evidence of equestrians stopping and tying stock to trees. In addition, they have not removed the brush, the signage directing users to ride through the area, or the stones used to delineate the ride-through trail (Figures 13 and 14). Monitoring shows that some equestrians are stopping at Natural Bridge and tying stock to trees, as was reported in 2006.

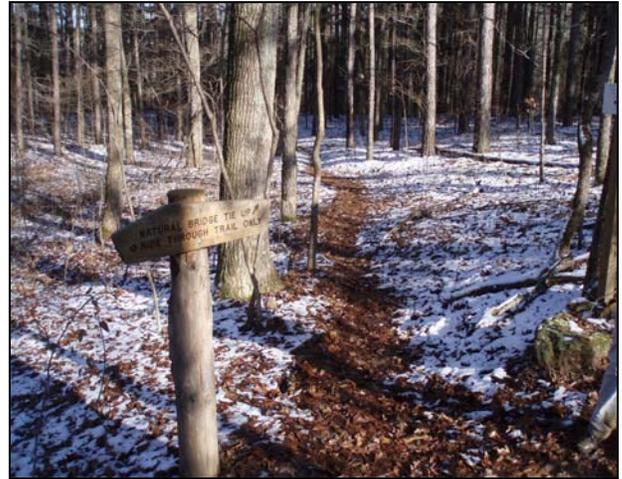
Figure 16. New access trail and sign to confinement area.

the pine plantation, now called the Natural Bridge tie-up. This work involved constructing an access trail for ingress and egress of the confinement area (Figure 16). Originally built to provide space for thirty stock animals, the new stock-confinement area currently offers tie-ups for fifteen stock animals. Additional brushing-in of the ride-through-only trail opposite Saltpeter Cave and trails no longer needed as a result of the completed re-routes between the old and new confinement areas was also accomplished. Users are staying on the designated trail and are staying off the non-designated sections of trail that were brushed in; brush has not been removed.

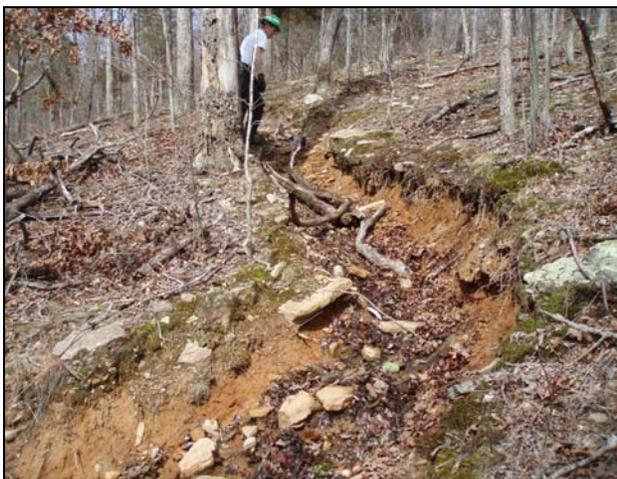
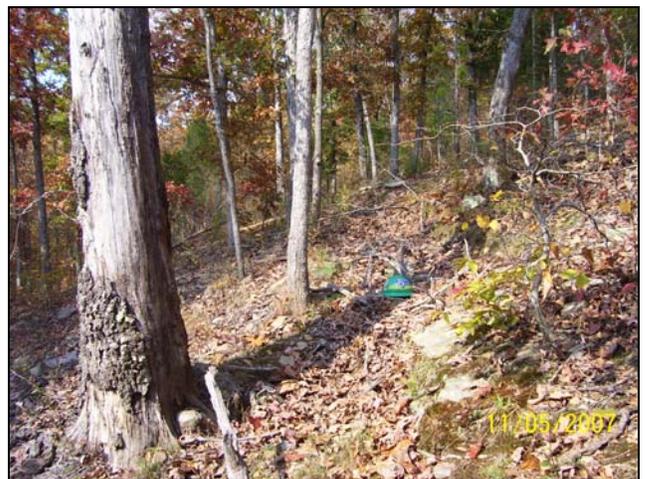
Figure 17. User-developed section of Goat Trail above Little Bear Branch Creek.

Figure 18. Early fall 2007. Same section as on left, one year later.

- FT 001 (River-to-River Trail/Goat Trail, sections above Little Bear Branch Creek): Non-designated trail sections were brushed in at this area shortly after implementation of the project in 2006. Monitoring in 2007 shows that natural processes continue to reduce impacts on the brushed-in sections of non-designated trail (Figures 17-20). Users are staying on the newly constructed re-route; however, some have short-cut the switchback. The short-cut was brushed-in and rock positioned to prevent this from continuing (Figures 21 and 22). This area will be closely monitored to determine if users continue to short-cut.

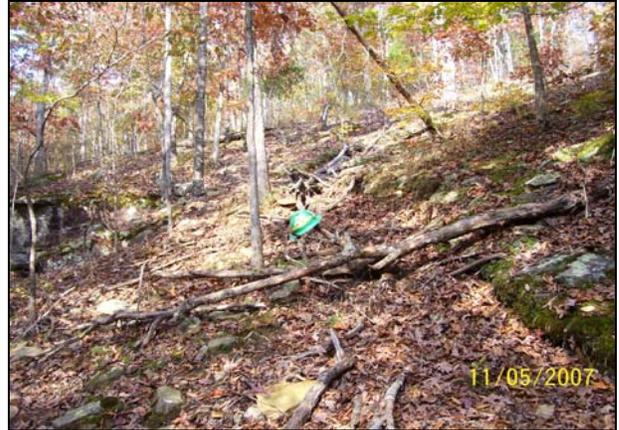
Figure 20. Same section as on left, one year after being brushed in.

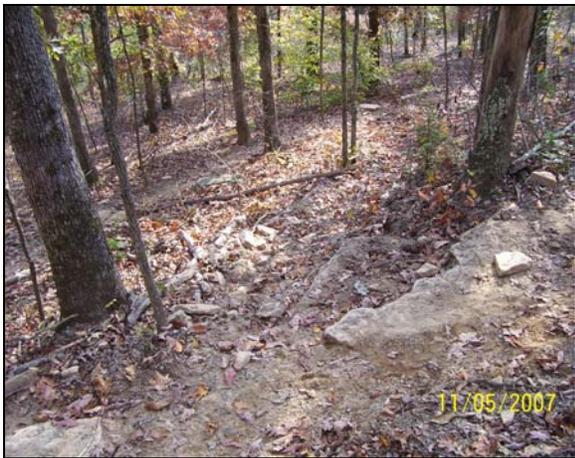
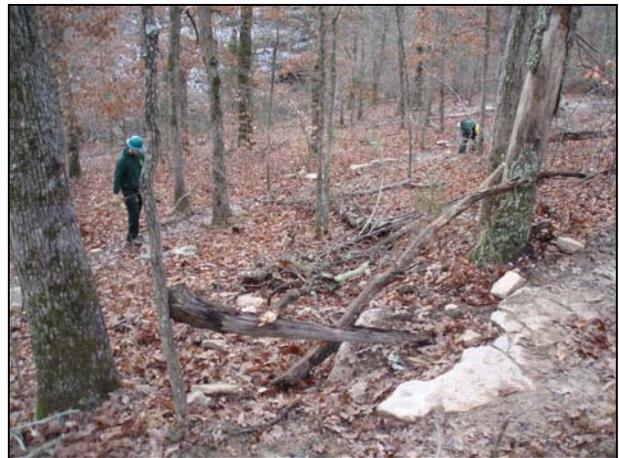
Figure 21. Short-cut on switchback at Goat Trail.

Figure 22. Brush placed in short-cut to keep users on designated trail.

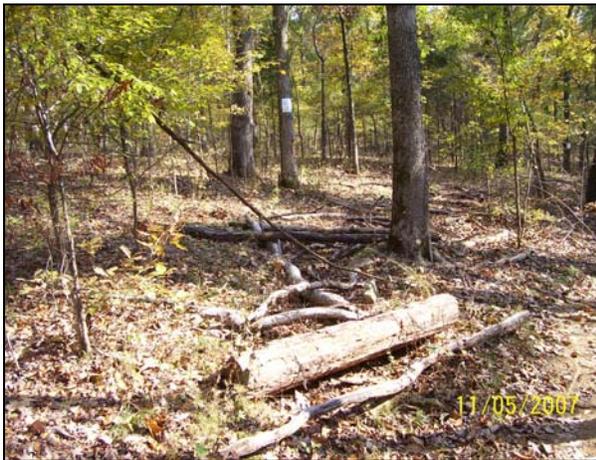
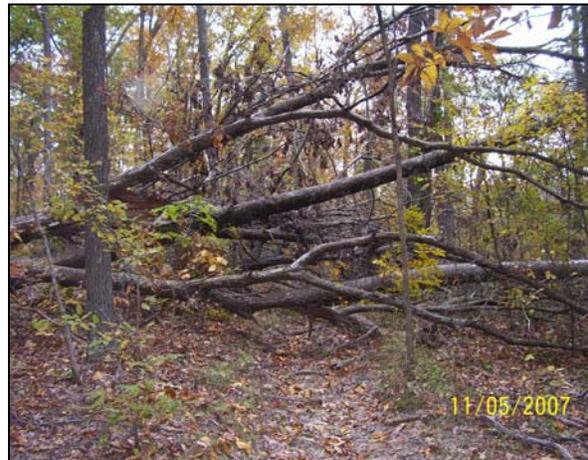
Figure 25. Brushed-in section of old, non-designated River-to-River Trail east of turnpikes.

Figure 26. Fallen trees blown over in recent storms have begun to obscure old trail.

- FT 001 (old, non-designated R-T-R Trail to Guest Farm stream-crossing on Lusk Creek): Throughout 2007, the trail crew worked on a one mile re-route between the River-To-River (R-T-R) Trail and Goat Trail. The re-route replaced a section of R-T-R Trail near the western boundary of the wilderness between the turnpikes and the Guest Farm stream-crossing on Lusk Creek. The trail crew brushed in one hundred feet of the old, non-designated R-T-R Trail east of the turnpikes (Figure 25). Signs were put up to inform users to stay off the brushed in section and inform them of the existing re-route. Brush has not been removed; however, field observations have shown evidence of a single set of hoof prints from stock on the closed section of trail. Also, fallen trees, blown over due to recent storms, have begun to obscure the old trail (Figure 26). Additional gully plugs are needed in some of the worst area of rutting. This area will be monitored to ensure users are staying on the designated trail and off the non-designated sections of trail that were brushed in.

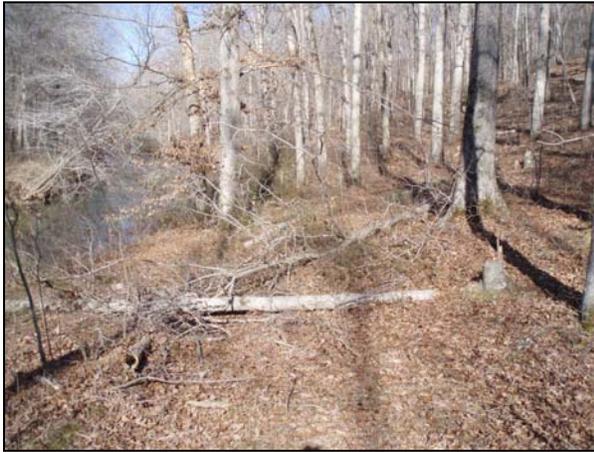
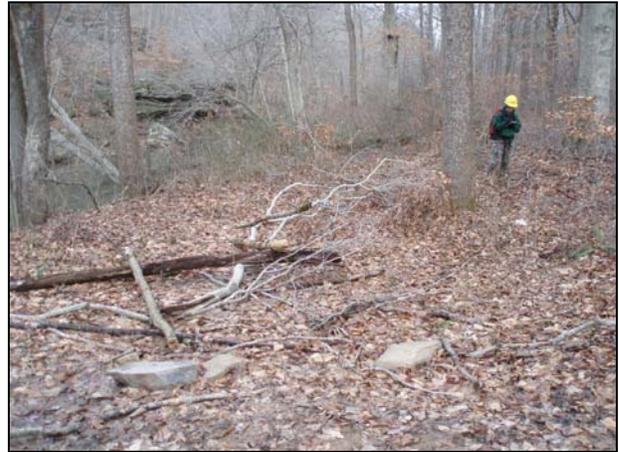
Figure 27. Winter 2006. Section of trail brushed in shortly after building re-route.

Figure 28. Winter 2007. Same trail section as on left, one year later.

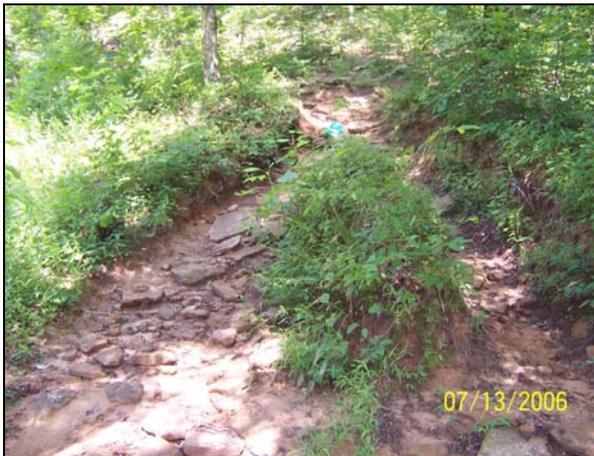
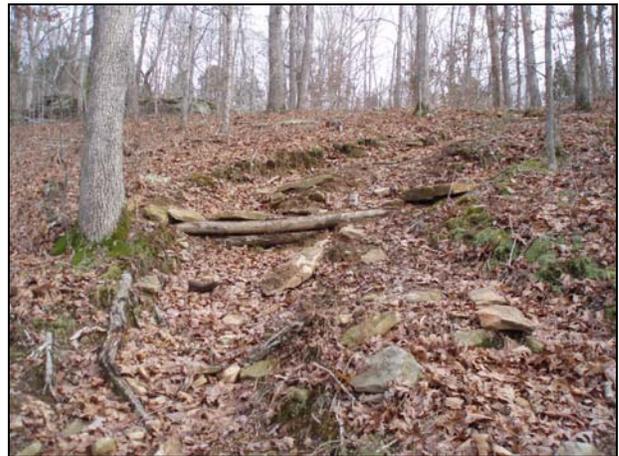
Figure 29. Summer 2006. Rutted, non-designated section of FT 457 before gully plugs installed.

Figure 30. Winter 2007. Gully plugs helping to arrest erosion on old, non-designated section of FT 457.

Gully plugs installed in 2006 are functioning as intended; soil and debris are filling in the ruts (Figures 29 and 30).

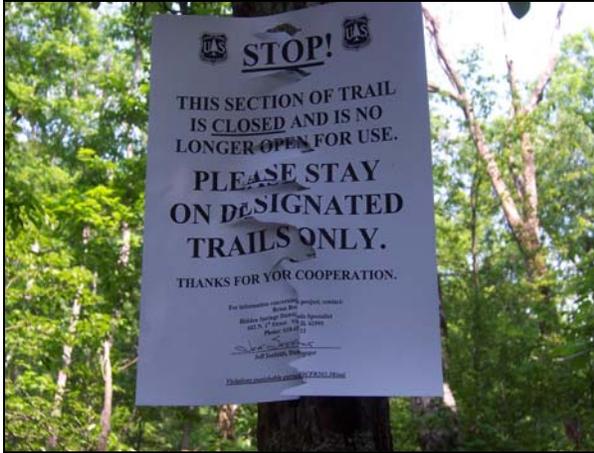
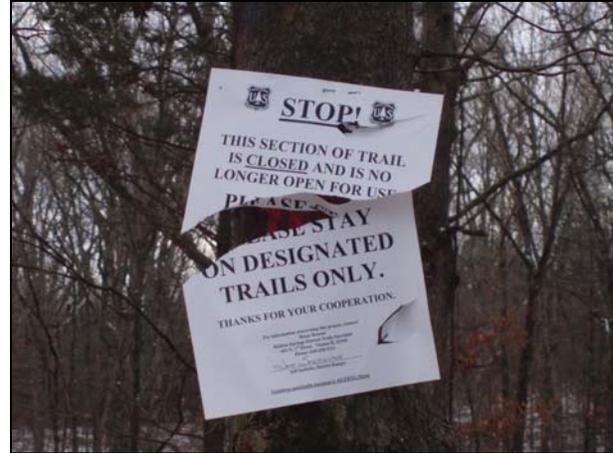
Figure 39. Summer 2007. Torn FS sign in Lusk Creek Wilderness.

Figure 40. Winter 2007. Torn FS sign in Lusk Creek Wilderness.

- Inappropriate use of signs: The inappropriate use of Forest Service signs has been observed in Lusk Creek Wilderness during this reporting period. A small percentage of signs installed on brushed-in sections of trail in Lusk Creek Wilderness were damaged. The signs informed users that a section of trail was closed and to stay on designated trails. Evidence suggests these signs were deliberately torn; some were ripped from the sign post (Figures 39 and 40).

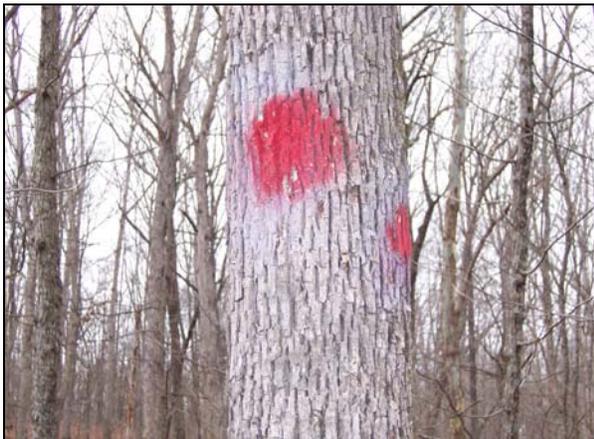
Figure 41. Red spray paint used for unauthorized reassurance markers on trees.

- Monitoring shows that red spray paint continues to be used as unauthorized reassurance markers on trees along some of the trails in Lusk Creek Wilderness (Figure 41). In the past, the trail crew has removed spray paint on trees when observed. Commercial horse camps around Lusk Creek Wilderness have been informed that the use of spray paint in the wilderness is unauthorized. Observation of red spray paint was also recorded in the 2006 TDP Monitoring Report.

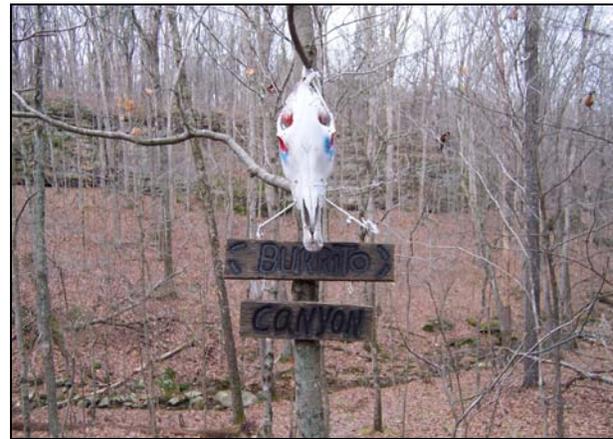
Figure 42. Unauthorized sign in Garden of the Gods Wilderness.

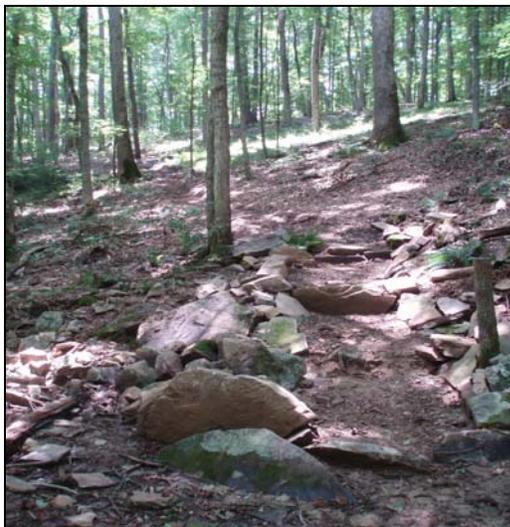
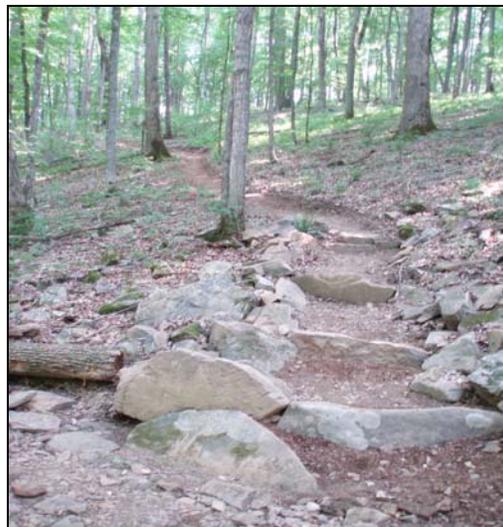
Figure 43. Stone steps at base of Barger Branch Creek.

Figure 44. Same steps as on left after reconstruction.

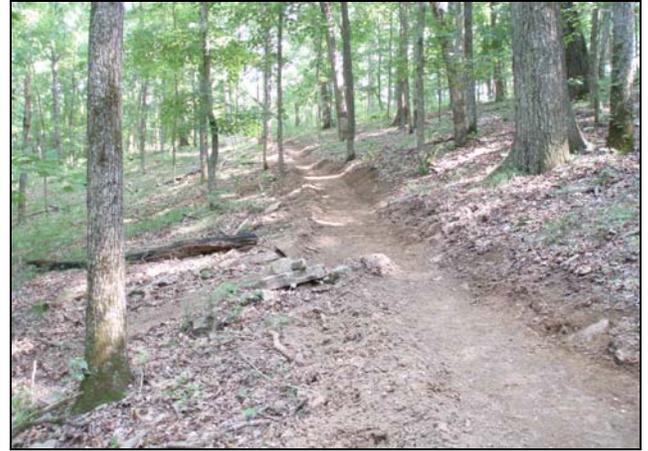
Figure 46. After. FT 481 after reconstruction with new backslope, tread, and drainage features.

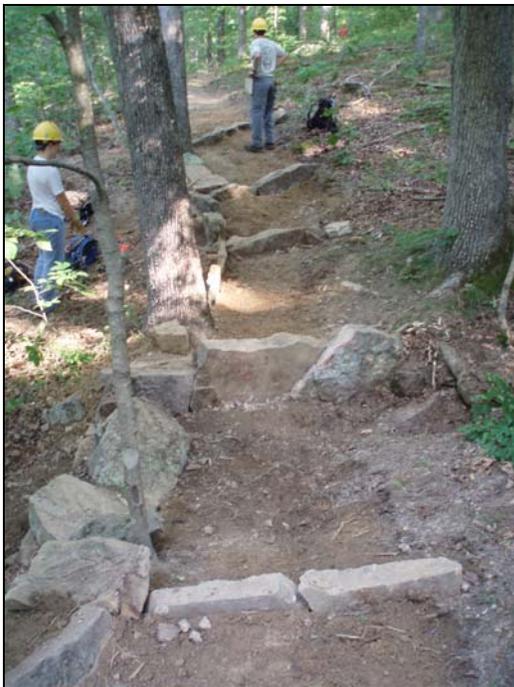
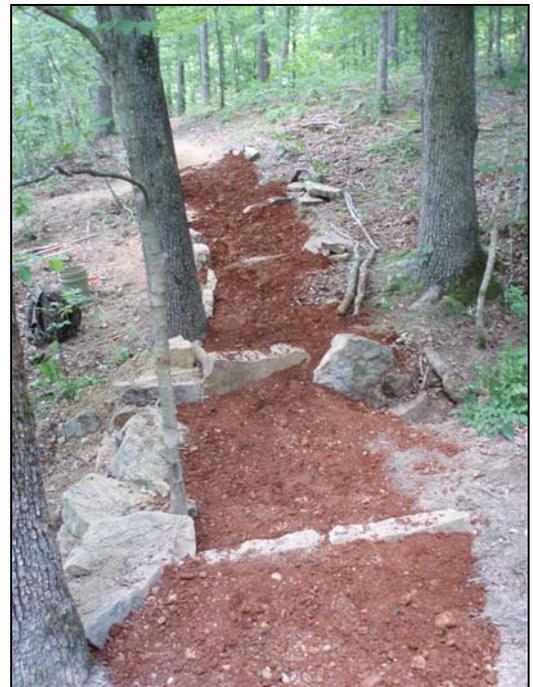
Figure 47. Sandstone used to crib trail-tread.

Figure 48. Reconstructed cribbed tread backfilled with gravel.

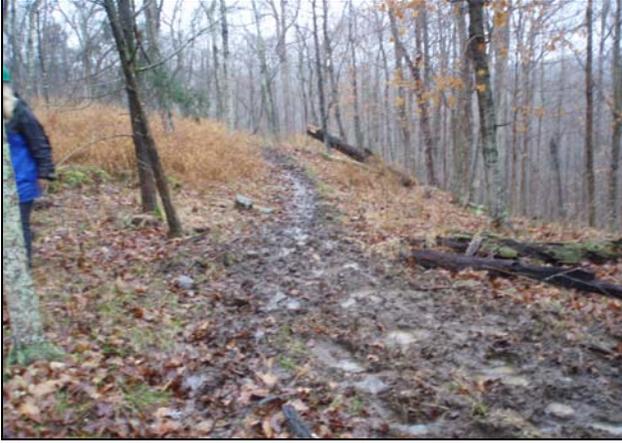
Figure 49. Wet and muddy section of FT 483 (Cactus Trail) over Saltpeter Cave.

- FT 483 (from Cactus Trail south over Saltpeter Cave to Guest Farm crossing on Lusk Creek): In FY2006, this FT over Saltpeter Cave was open for users shortly after the re-route was constructed to Barger Branch Creek. (These sections have not been worked on since TDP implementation). Monitoring in 2006 showed several sections holding surface water and needing maintenance (Figures 49 and 50). In FY2008, this trail may be re-routed or left in place and graveled. This will also be determined for the remainder of the trail, proceeding south towards the junction of the River-to-River Trail, ending just west of the Guest Farm stream-crossing.

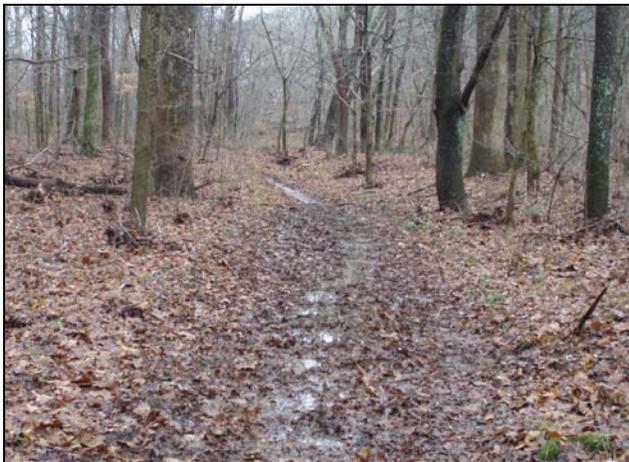
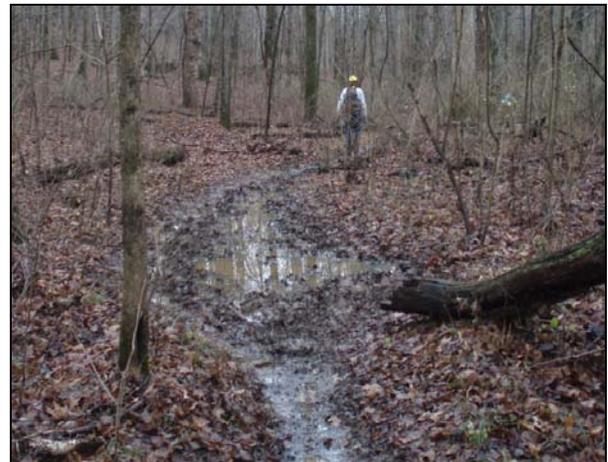
Figure 51. FT 457 was located in flat terrain.

Figure 52. FT 457 needed re-routing.

- FT 457 (from Blanchard Church stream-crossing proceeding south along the east bank of Lusk Creek to the junction with FT 492A). In the 2006 TDP Monitoring Report, this section of trail, located on flat terrain alongside Lusk Creek, had difficulty draining surface water (Figure 51). Several sections were reported as wet and muddy due to rainwater accumulation (Figure 52).

During the 2007 trail season, the trail crew and the Hoosier National Forest mule team plowed and graded the re-route for FT 457 upslope along the natural contour of the terrain (Figures 53 and 54). The re-route will require graveling to ensure wet-weather ridability and is planned for the 2008 trail season.

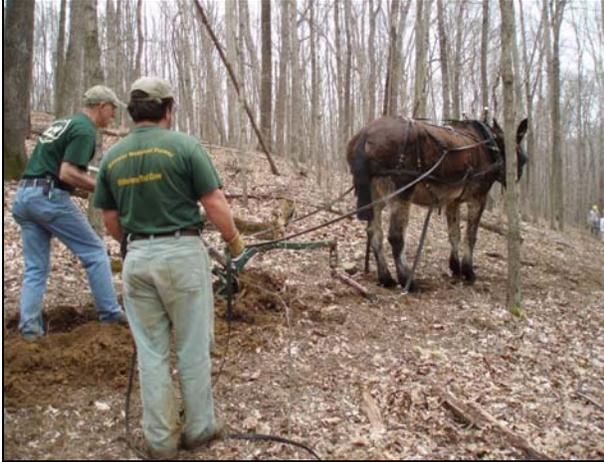
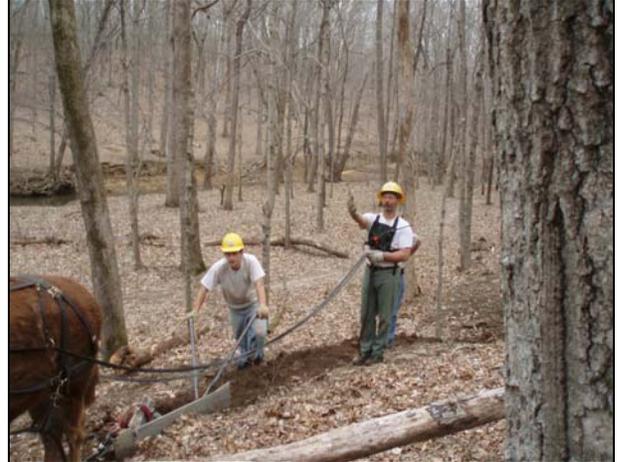
Figure 53. Hoosier National Forest mule team plowing FT 457 re-route above Lusk Creek.

Figure 54. Trail crew using Hoosier National Forest mules to grade FT 457 re-route.

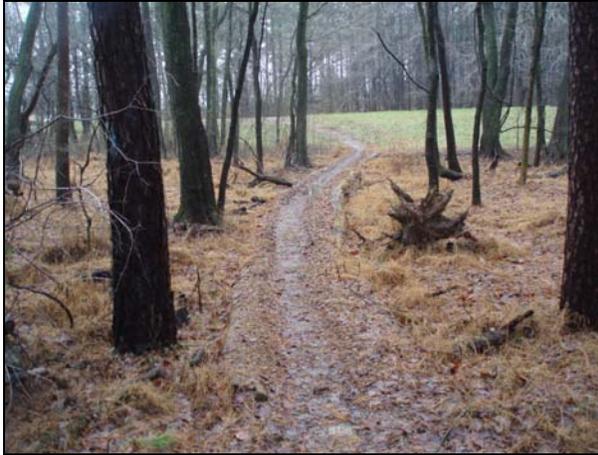
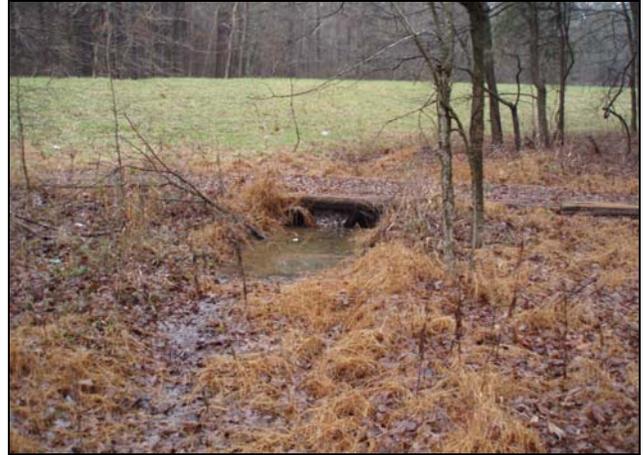
Figure 55. Turnpike on FT 472C continues to provide tread above wet areas.

Figure 56. Culvert on FT 472C continues to provide drainage above a ditch.

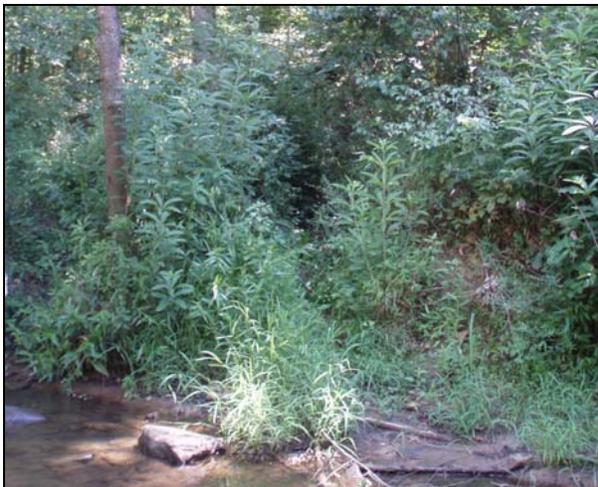
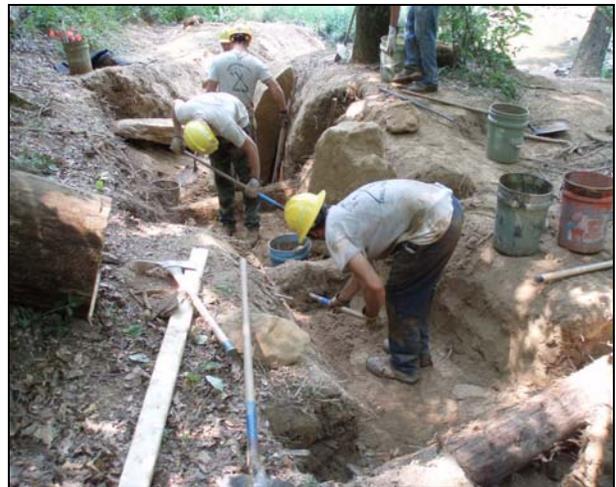
Figure 57. Site of old, user-developed Bowed Tree stream-crossing on Lusk Creek.

Figure 58. Crew members using shovels to excavate steps needed for new stream-crossing.

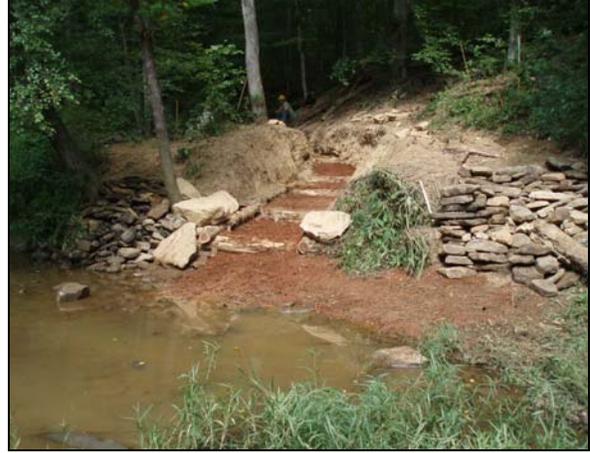
**Figure 60. View of east embankment with retaining walls on either side of stairway where old crossing was located.**

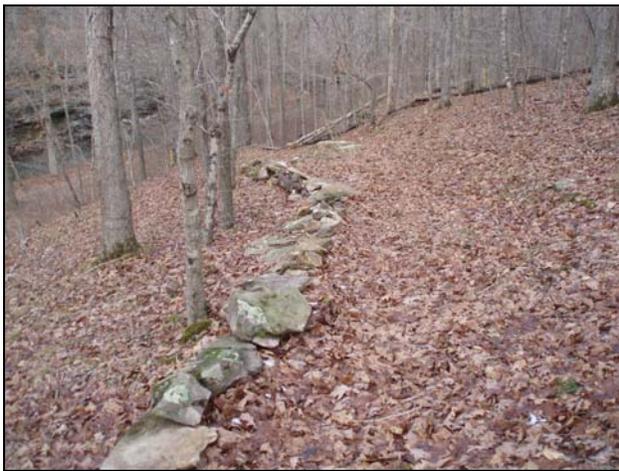
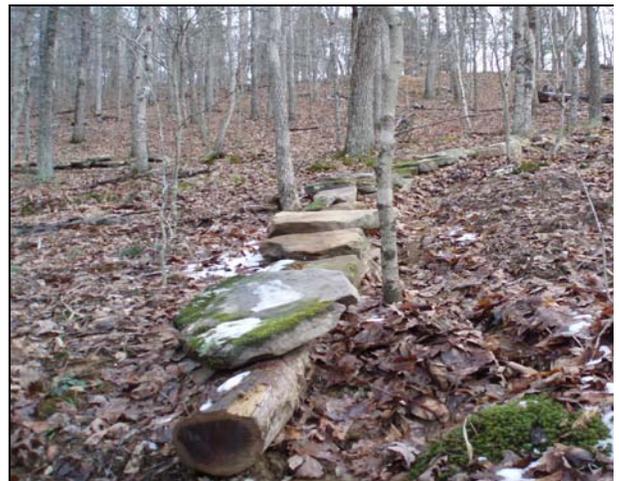
**Figure 61. Sandstone wall used to divert rainwater along old roadbed.**

**Figure 62. Diversion feature along embankment.**

Upon completion of the Bowed Tree stream-crossing, the trail crew installed an erosion-control feature designed to divert rainwater runoff from flowing down the east embankment via an old roadbed located upslope from the crossing (Figure 61). Sandstone and redcedar logs were used to form a diversion wall to redirect and slow surface water, thereby creating sheet flow, as opposed to direct flow (Figure 62). This method is intended to prevent erosion of the embankment and reduce sedimentation into Lusk Creek. Continued monitoring indicates this diversion feature is functioning as planned.

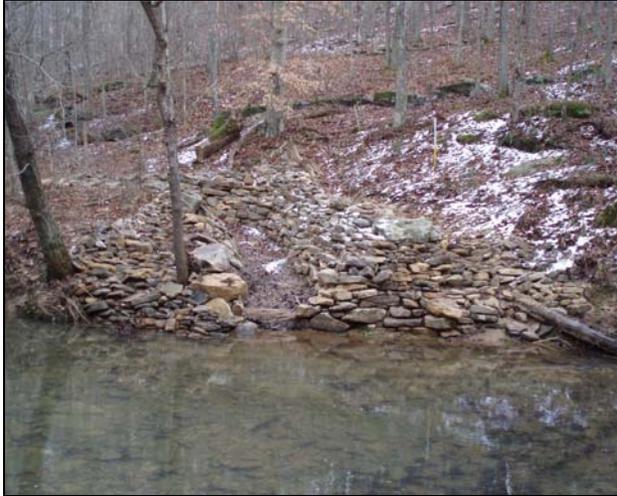
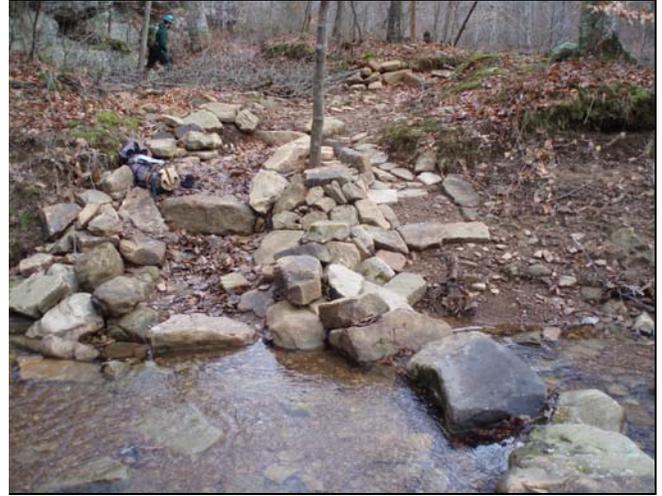
Since construction of the Bowed Tree and Little Bear Branch stream-crossings, heavy rainstorms have resulted in the waters of Lusk Creek and Little Bear Branch Creek raising several feet. Because the gravel used to form the steps of the crossings contain a compacted clay base and sound building materials were used—large sandstone and cedar logs—the crossings easily withstood the rising creek waters (Figures 63 and 64).

Figure 63. Bowed Tree stream-crossing after a winter storm.

Figure 64. Little Bear Branch stream-crossing after a winter storm.

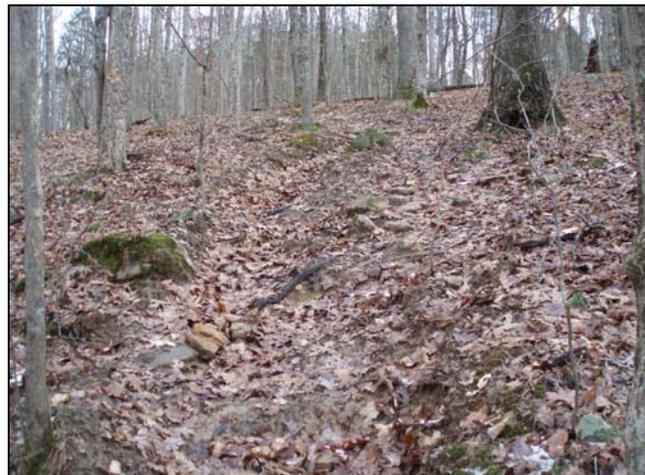
Figure 65. Preexisting ruts on trail section east of Bowed Tree.

In addition, Forest users informed the District of increased equestrian and hiker traffic on a section of interim trail connecting with Bowed Tree stream-crossing to the east. The trail is located up a steep slope and has been used for years. It existed at the time of the old crossing. However, the majority of users choose to cross Lusk Creek upstream at the Guest Farm stream-crossing. There was limited use of this trail until the reconstruction of the Bowed Tree stream-crossing. The majority of users now cross at Bowed Tree. Once users cross to the east embankment, there is currently only one way to continue, upslope. Monitoring shows that there is rutting and erosion of the trail; however, these are preexisting conditions more revealed as a result of increased traffic (Figure 65). The section of trail in question has been scheduled for re-routing in the spring/summer of 2008.

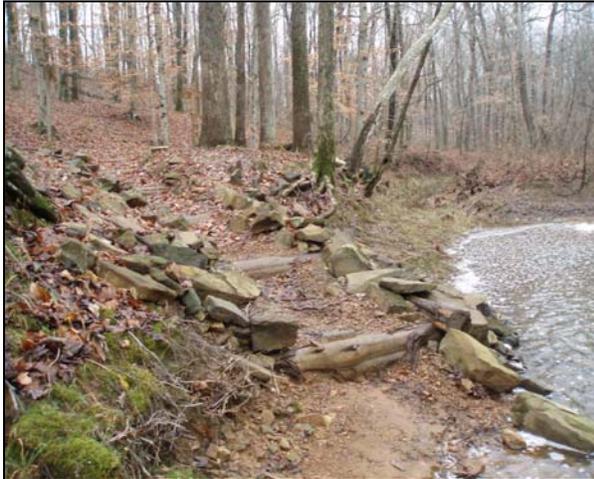
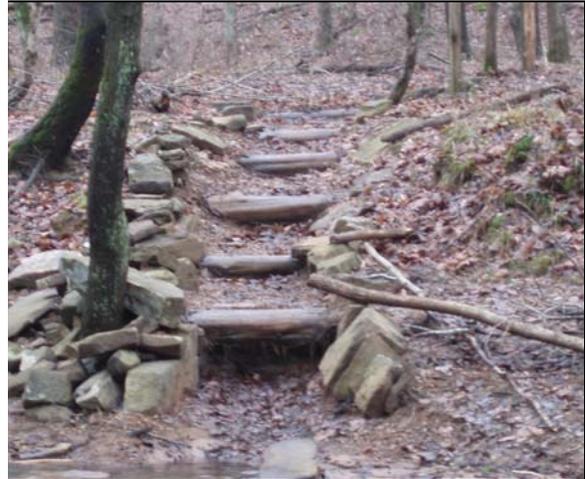
Figure 66. West embankment of Blanchard Church stream-crossing, working as intended.

Figure 67. East embankment, where maintenance is required for lower step.

In 2006, the Blanchard Church stream-crossing on Lusk Creek was relocated and reconstructed. In 2007, monitoring shows that the crossing is functioning as intended (Figure 65); however, maintenance is required for the lower step along the water's edge on the east embankment (Figure 66). An additional step is required to prevent the eddying of water from washing out soil. The trail crew will conduct the needed maintenance in 2008, once the water level drops. Several other stream-crossings in Lusk Creek Wilderness could be reconstructed depending on scheduling priorities.

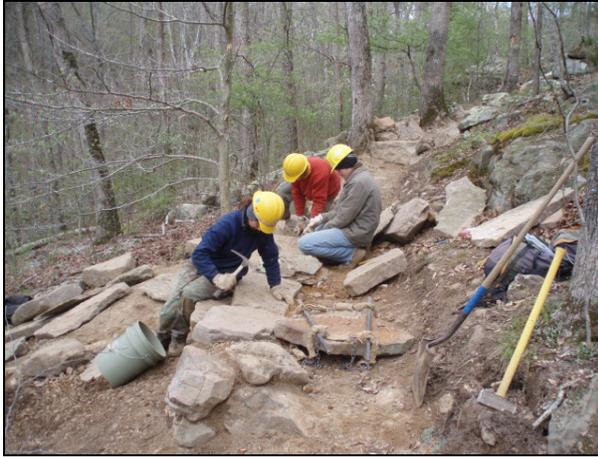
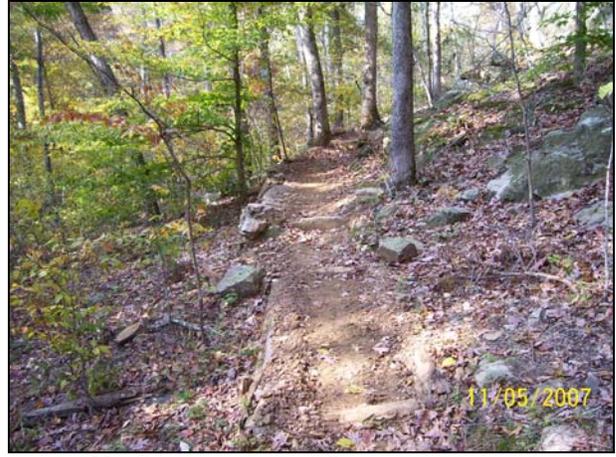
Figure 68. Cribbed retaining wall under construction on Goat Trail, March 2007.

Figure 69. Same section of Goat Trail as on left, eight months later, November 2007.

**Results:** A total of 350 tons of gravel was used in the wilderness to harden miles of trail-tread and provide for the construction of trail features. The gravel used as backfilled in the trail features and placed in the tread was chosen for its rustic brown coloration, which creates a natural appearance. As has been the practice of the trail crew, special attention was taken to naturalize any new re-routes by collecting leaf litter and scattering it along the back slope of new trails. Because of the techniques and natural materials used in building, and the trail crew's attention to detail, over a short period of time the new re-routes and trail features blend well with their natural surroundings (Figures 63 – 70).

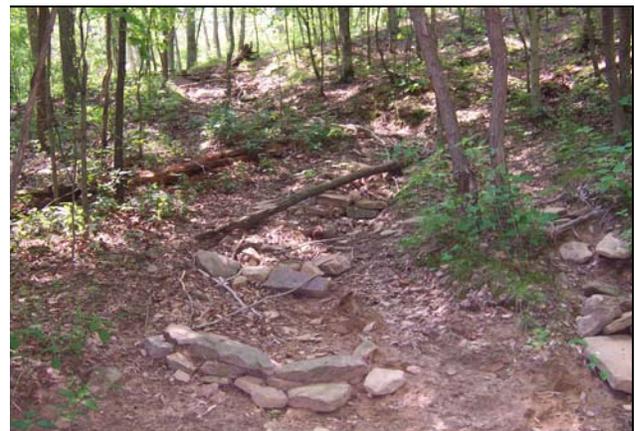
Figure 79. Section of brushed-in trail with sandstone used as gully plugs.
