Early 20th-Century Building Materials: Siding and Roofing

Richa Wilson, Intermountain Regional Architectural Historian
Kathleen Snodgrass, Project Leader

This tech tip is the fourth in a series about innovative building materials developed in the first half of the 20th century and commonly incorporated into Forest Service buildings. The series will help you identify materials by describing their histories, manufacture, and physical characteristics. This series also addresses common problems and provides guidance on maintenance, repair, and replacement.

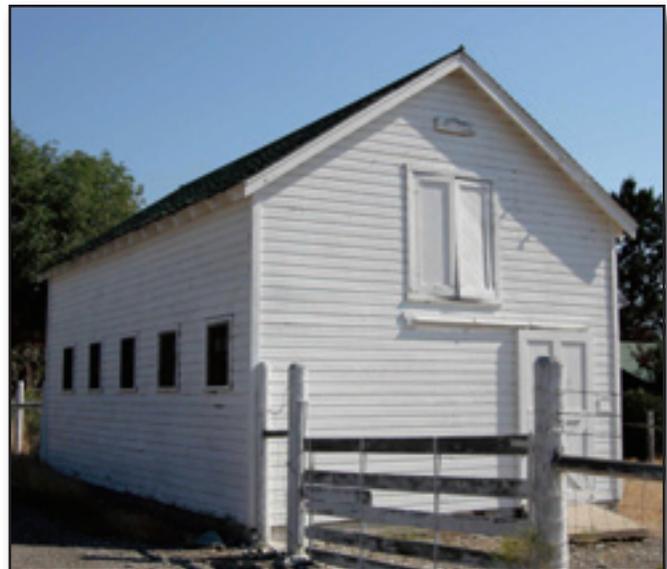
Figure 1—Following national trends, the Forest Service often used wood siding with a variety of profiles on frame buildings in the early 20th century. The drop siding on this barn was one of the most popular choices. The barn was built in 1933 at the Salmon Ranger Station in Salmon, ID (Salmon-Challis National Forest, Intermountain Region).

availability of wood building materials, greatly influenced the exterior appearance of the agency’s first administrative and recreation facilities. Roofs were covered with wood shingles or shakes. Many early Forest Service buildings were constructed from logs. Wood siding with a variety of profiles was the usual cladding on buildings constructed with wood frames (figure 1).

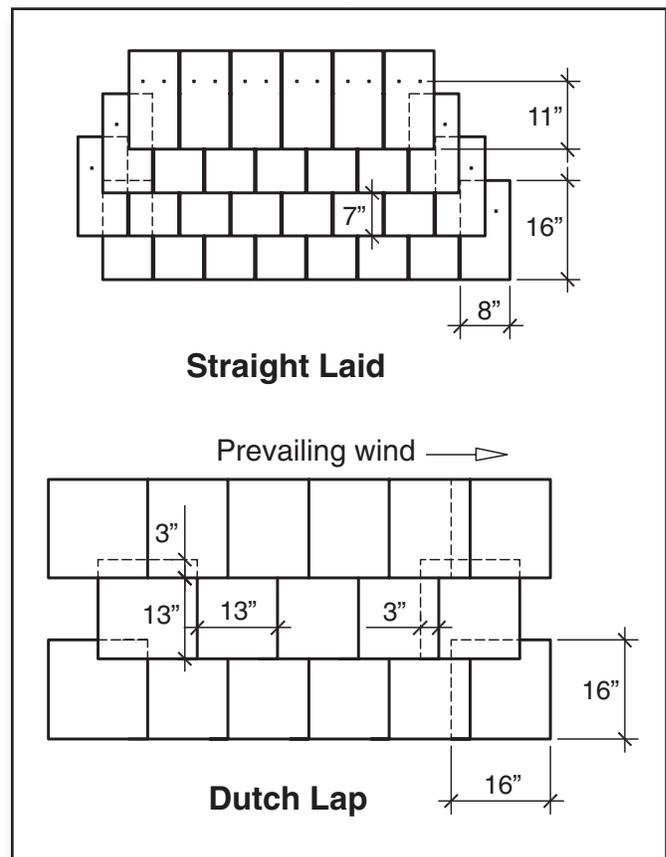
Figure 2—This drawing shows typical sizes, shapes, and installation for American method asphalt shingle roofing.

- American method or "straight" shingles of the 1920s and 1930s were square or rectangular. The shingles were installed to overlap the course below. They could be straight laid, abutting adjacent shingles, or Dutch lap, overlapping adjacent shingles (figure 2).

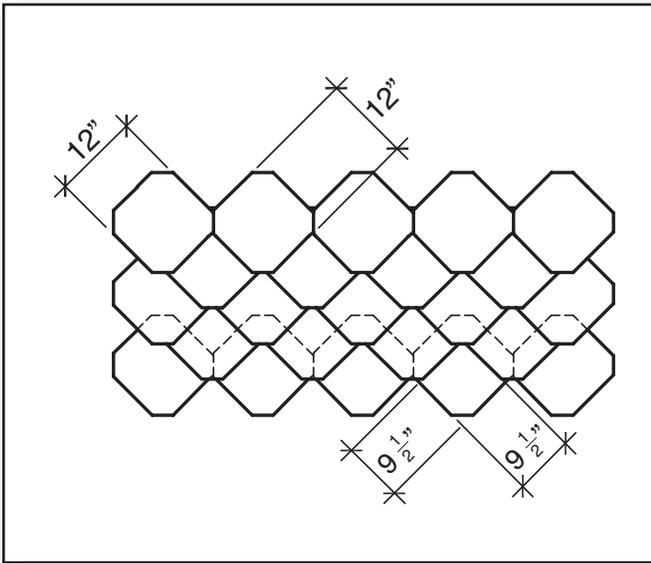
Figure 3—This drawing shows typical sizes, shapes, and installation for French method asphalt shingles.

- French method shingles are shaped like diamonds or hexagons in an attempt to imitate slate roofs of French chateaux. Historically, they were so large (12 by 12 inches and 16 by 16 inches were standard sizes) that they required storm anchors (hooks to hold the edges down during high winds). Because they had little overlap on their edges, French method shingles provided only one layer of roofing. This was acceptable when they were installed over existing roofing, but not in new construction as the French method provided only minimal protection of the roof deck (figure 3).

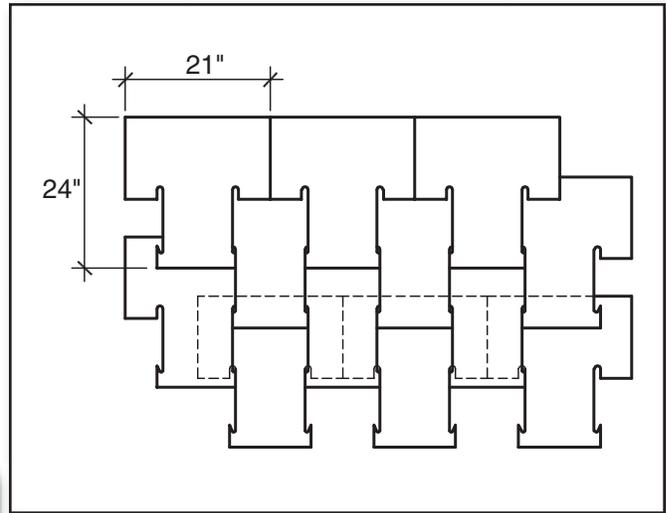
Figure 4—This drawing shows typical sizes, shapes, and installation for interlocking asphalt shingles.

- Interlocking shingles, whether installed in strips or as individual shingles, have high wind resistance and protect the roof decking better than other types. They were available by the late 1920s and were popular during the 1930s and 1940s. The complex shapes had ears, catches, and slits that interconnected with the shingle course below to create a basket weave pattern. Interlocking shingles worked well on the rolled eaves of cottage style houses (1930s and 1940s), where they evoked thatched roofs (figure 4).

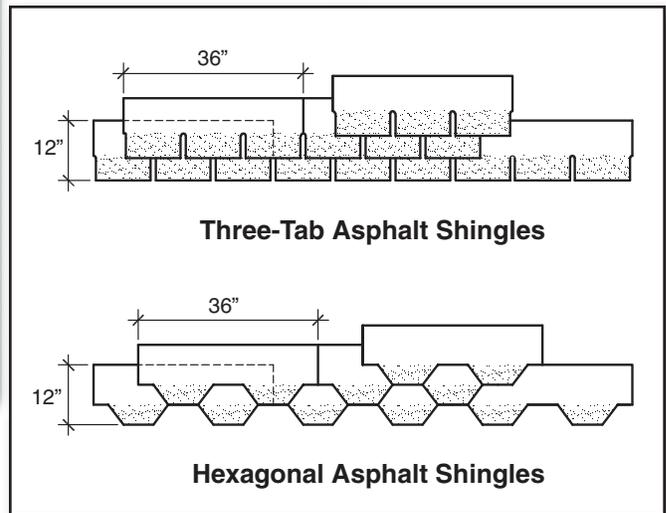
Figure 5—This drawing shows typical sizes, shapes, and installation for tab-style asphalt shingles.

Individual shingles fell out of favor as more companies produced strip shingles, with or without tabs. Tab shingles have cutouts that minimize buckling and mimic the appearance of individual shingles. By 1935, most major manufacturers were producing 12- by 36-inch tab shingles (figure 5) that looked similar to those manufactured today.

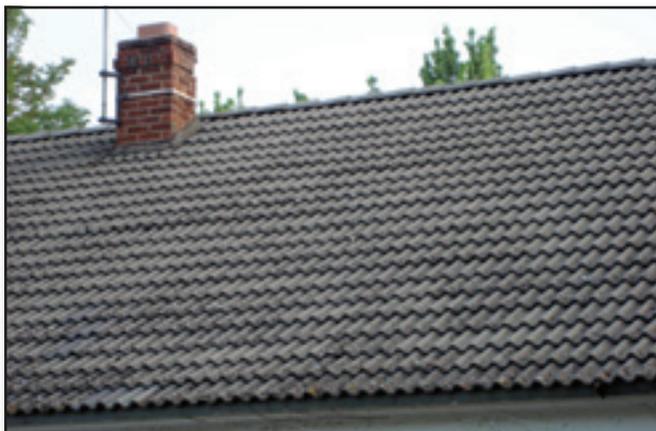
Figure 6—Asbestos-cement roofing tiles were popular on period revival styles such as the Mission and Spanish Eclectic styles, which were most common in the Southwest and Florida.

Like their asphalt counterparts, asbestos-cement shingles were characterized by a variety of shapes (square, rectangular, diamond, chamfered, scalloped, and ogee) and method of installation (American, French, or interlocking). Asbestos-cement roofing tiles shaped to imitate clay tiles found on French and Spanish-style buildings were also produced (figure 6).

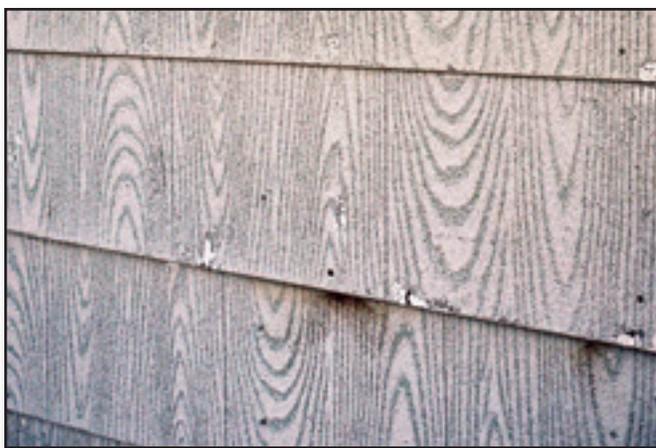
Figure 7—The wood-grain pattern on these asbestos siding shingles makes them look similar to wood shingles when viewed from a distance.

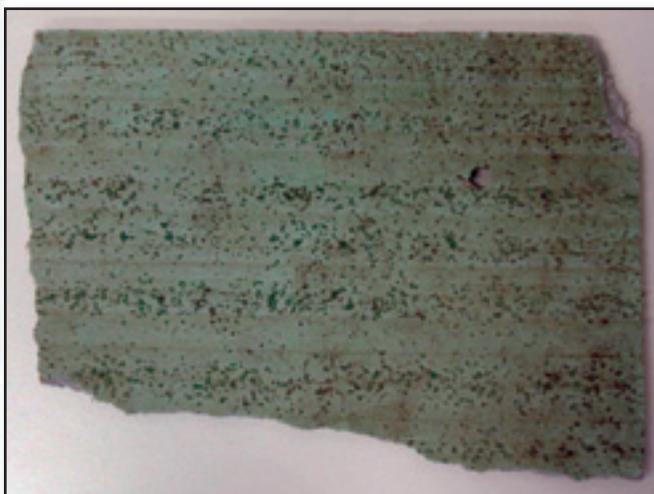
Figure 8—The pigment granules pressed into the surface during manufacturing are clearly visible on this broken piece of asbestos siding.

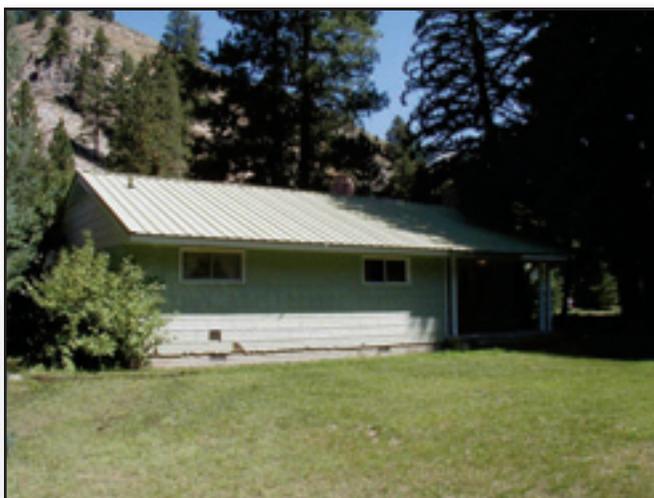
Figure 9—The broken piece of siding shown in figure 8 is from this 1957 house at the Shake Creek Guard Station on the Sawtooth National Forest, ID (Intermountain Region).

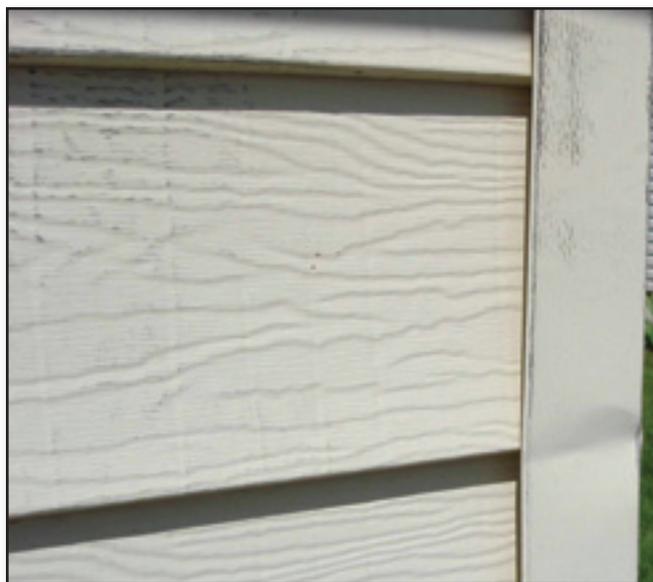
Figure 10—The corner of this house in Soda Springs, ID (Caribou-Targhee National Forest, Intermountain Region), is covered in steel siding that has been battered and bent over the years.

Vinyl and metal siding are similar in appearance, but sound very different when lightly tapped. Once you have identified the siding as metal, use a magnet to determine whether it is aluminum or steel. Aluminum siding is not magnetic. Steel siding (figure 10) is magnetic.

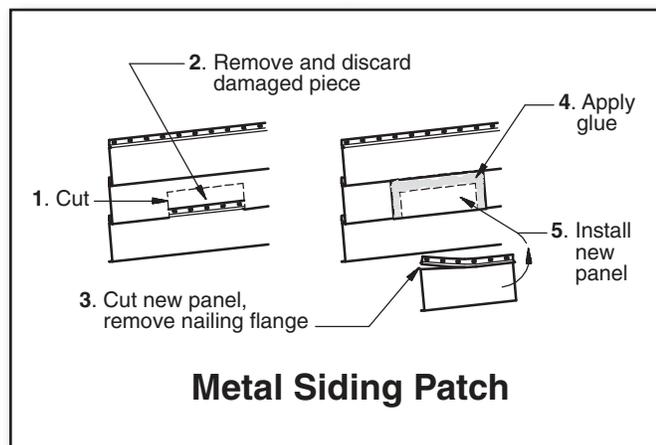
Figure 11—This drawing shows how to patch metal siding using polyurethane caulk or clear silicone sealant to glue the patch in place.

If the damaged area is large, consider patching it with new siding that matches the existing siding (figure 11). Mark vertical lines on either side of the damaged area. Cut across the center between these two lines and down the lines with a utility knife or tin snips. Remove and discard the lower half. Cut a patch panel from the new material so it will overlap the removed section by 2 inches on each side. Cut the nailing flange from the patch. Coat the overlapping area with polyurethane caulk or clear silicone sealant. Press the new panel over the damaged area so that it adheres to the caulk or sealant.
