Southwest Crown of the Continent GRAIP Roads Assessment

Center Horse and Morrell/Trail Project Area,
Poorman Creek, and Cold Creek
Lolo, Helena, and Flathead National Forests, Montana

August 15, 2014

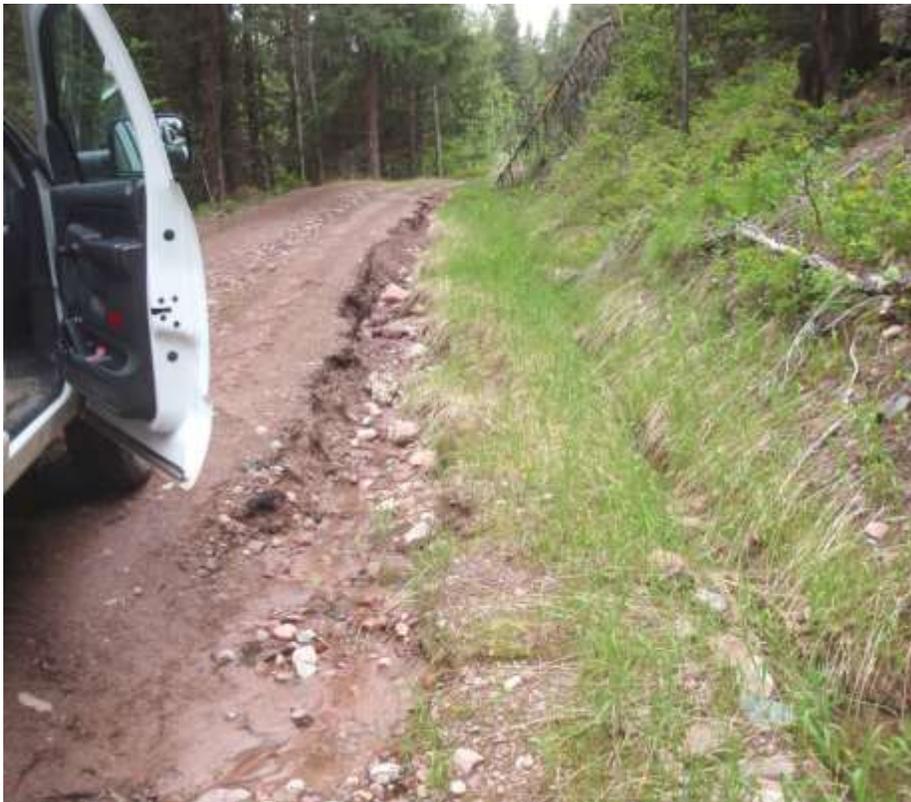
Figure 43. Spring Creek diversion that delivered 41 Mg of sediment to the stream.

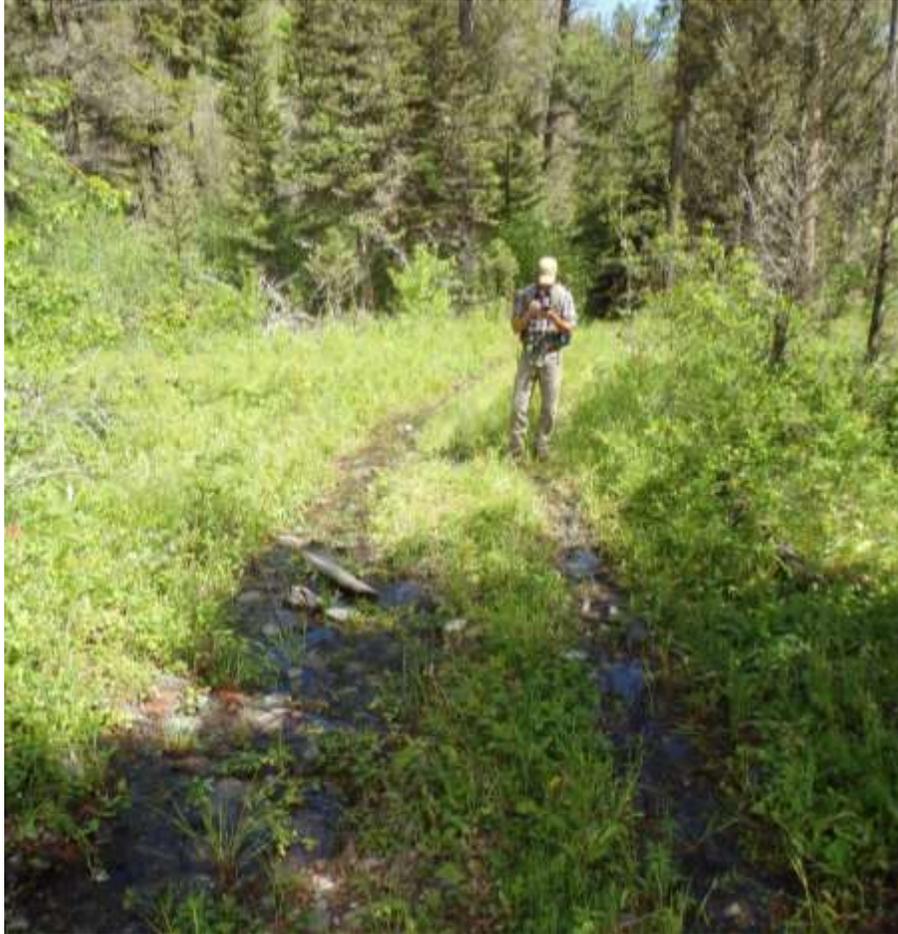
Figure 46. Stream diversion at a natural ford in the western portion of the Poorman Creek area. No major erosion was observed.
