Field Indicators of Inlet Controlled Road Stream Crossing Capacity

Sam A. Flanagan

Michael J. Furniss

**San Dimas Technology and Development Center
San Dimas, California**

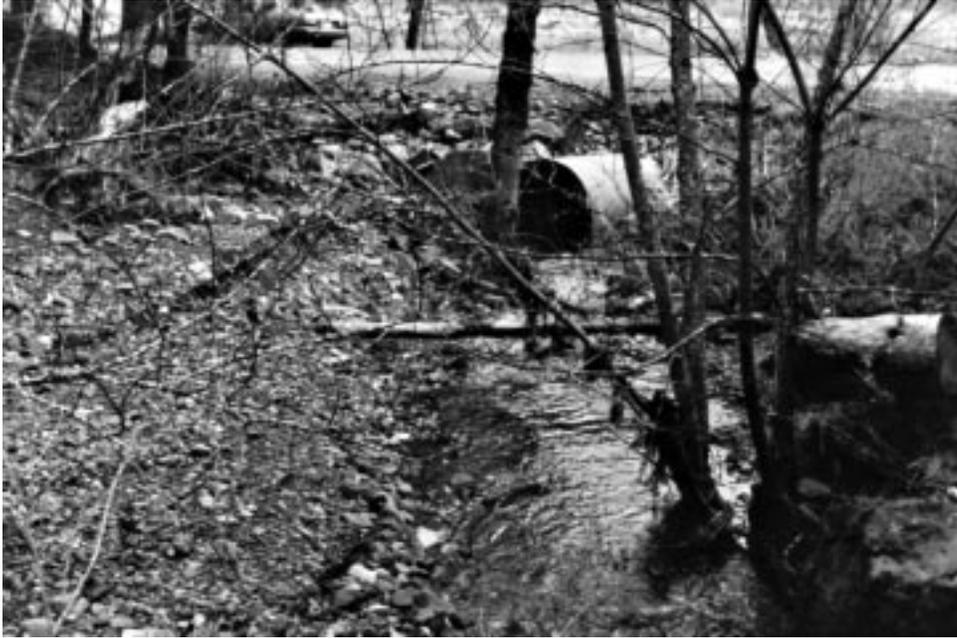
Figure 1—When compared with the bed width, the zone of average annual bedload transport, this culvert is undersized. Hydraulic calculations show this pipe unable to pass a 10-year design discharge. Also note terrace development. Such physical features often coexist and provide evidence for inadequately sized culverts.

Channels develop their particular form in response to their long-term regime of water, debris, and sediment. Channel dimensions are thus a good indicator of the range of water, debris and sediment yields in the channel. Stream bed width—the zone of annual scour—(Lisle 1986) is a readily observable feature for most low-order channels. Traditionally, bankfull or active-channel width has been used for assessing channel dimensions (Keller and Tally

Plugging of culverts by woody debris is common in woodland settings; however, traditional analysis techniques do not address debris passage. Small culverts on relatively wide stream channels are at a greater risk of plugging with floating wood than culverts that do not restrict the channel width. The role of channel width in controlling the size of fluvially transported debris is well documented (Keller and Swanson 1979, Bilby 1985, Robison and Beschta 1990). Often, the diameter of the culvert is less than the stream bed width. For example, a survey of 140 road stream crossings in the North Fork Eel River watershed in Northern California revealed that 9 percent of the culverts had a diameter less than half the stream bed width. This width constriction is a favorable place for the accumulation of woody debris. As culvert diameter increases, longer pieces of woody debris are required to initiate culvert plugging (Flanagan, in review). Thus, the ratio of culvert diameter to stream bed width provides one indication of plugging potential in woodland settings (figure 1).

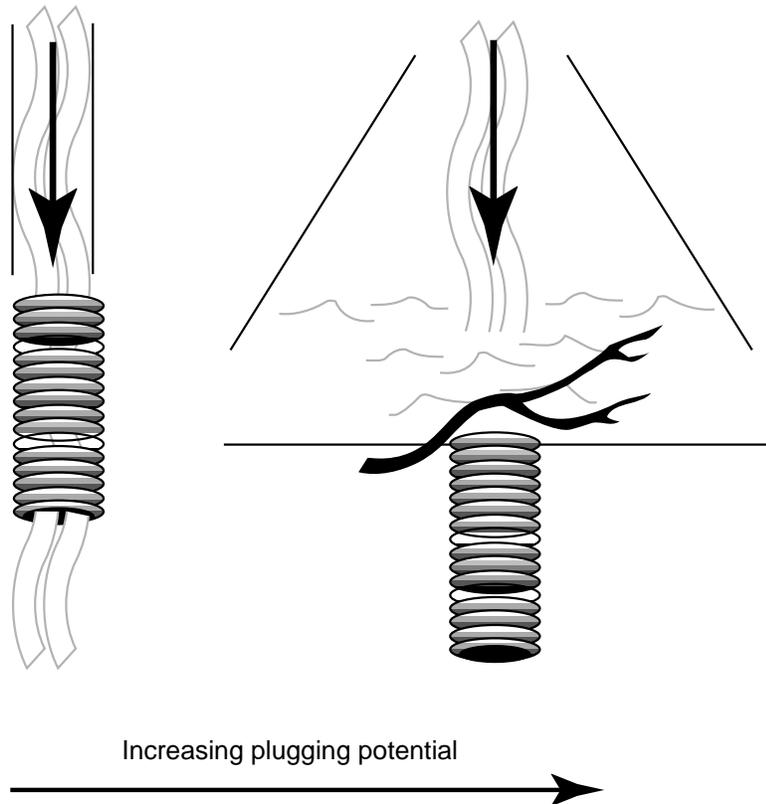
Figure 2—Inlet basin plan view. Inlet basins that maintain the natural channel configuration promote debris transport and passage through the culvert. Where the flow is allowed to spread laterally, debris can accumulate and increase the chance of plugging. Furthermore, debris rotation is promoted in the turbulent eddies of the widening flow. Similarly, where the channel abruptly changes direction, wood lodgment is enhanced. This is a common scenario for cross drains.

Debris plugging is more likely where channel confinement decreases and channel width increases towards the inlet. During peak flows, the water spreads laterally promoting debris rotation and accumulation in the turbulent eddies of the widening flow (figure 2). Pieces oriented perpendicular to the inlet most often become lodged across the inlet thus initiating plugging. Normann et al. (1985) suggest straight, narrow channel approaches promote debris passage.

Similarly, high angle channel approaches promote plugging by debris (Garland 1983 and Piehl et al. 1988). Wood in transport, oriented parallel to the channel, is unable to rotate when it approaches the inlet due to forward momentum and/or lack of rotational space (figure 2).

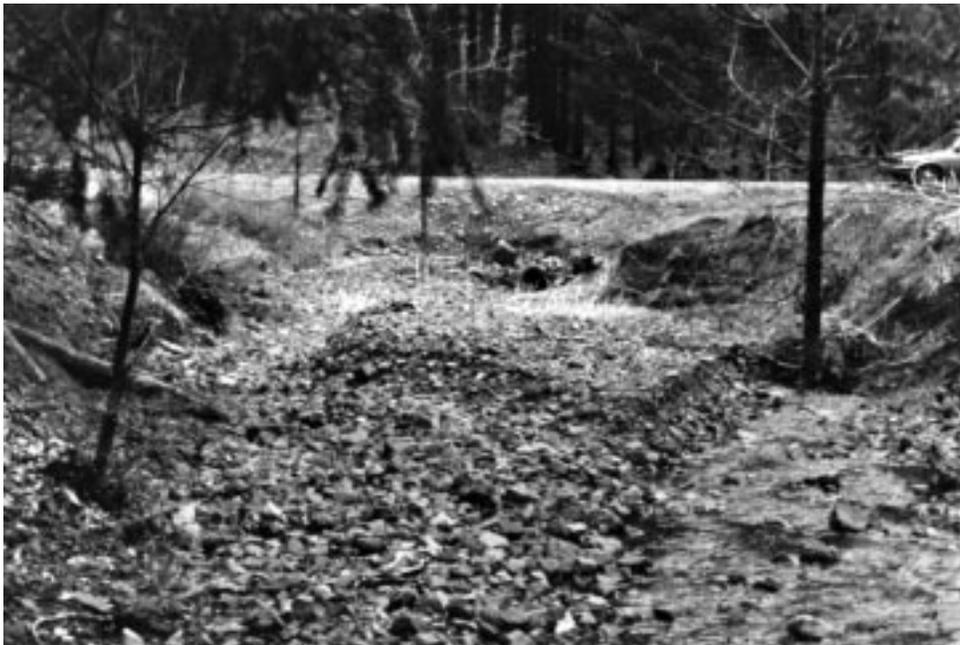
Figure 3—Terraces upstream of the culvert inlet indicate past ponded conditions. Channel dimensions and hydraulic capacity of this culvert should be checked.

Crossings with a history of ponding water due to insufficient culvert capacity often produce terraces upstream of the inlet (figure 3). Sediment is deposited during ponded conditions. Terrace elevations can provide a clue to the magnitude of peak flows. Debris torrents that are slowed or stopped by the fill prisms also leave similar, but typically larger, undulating terraces. Terrace surfaces that project to near the road surface suggest peak flows have overtopped the fill. Terraces are rapidly colonized by vegetation and may require close examination of the inlet basin.

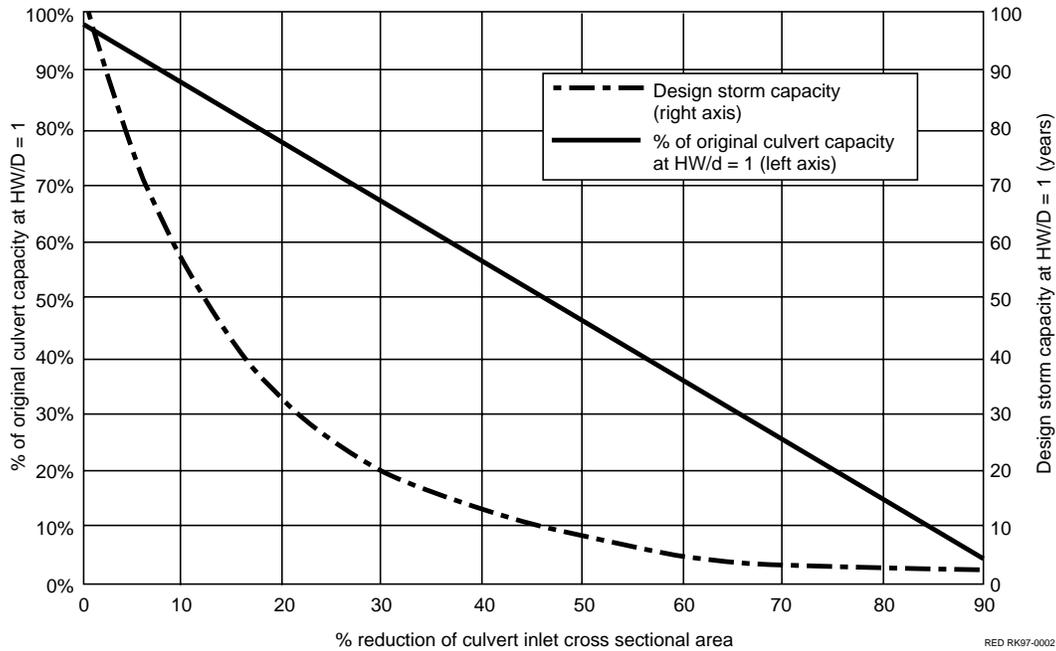
Figure 4—The percentage of cross sectional area reduced by crushing or partial plugging of the inlet is nearly equal to the percent of hydraulic capacity reduced (solid line). However, these reductions in capacity translate to large reductions in design storm capacity (dashed line). In this example from northwest California, a culvert originally sized for the 100 year design storm at HW/d=1 can only pass the 25-year storm with a 25 percent reduction in cross sectional area.

Culverts with a history of plugging may have crushed or dented inlets from repeated excavation by heavy equipment. A crushed or plugged inlet will have an effective diameter corresponding to the degree of damage or plugging. For inlet-controlled culverts, reductions in the inlet cross sectional area result in a loss of hydraulic capacity. However, when expressed as a design storm capacity, reductions in inlet cross sectional area substantially reduce the design storm capacity of the pipe (figure 4). The percent reduction in inlet cross sectional area should be included in more detailed pipe capacity calculations. In the absence of maintenance, plugging is cumulative. The reduced aperture created by the plug promotes further plugging.
