# FORESTER C-2000— DEMONSTRATION PROJECT

**Anne Fischer, PE, Civil Engineer**  
**Tim Pasqual, Forester C-2000 Operator**  
*Coronado National Forest*

**James R. Bassel, PE, Civil Engineer**  
*San Dimas Technology & Development Center*

November 1996

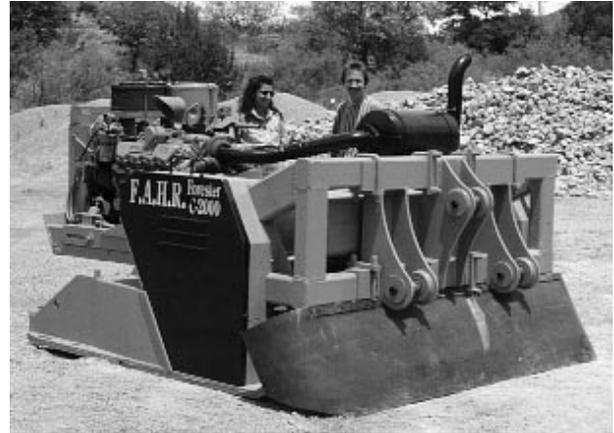
Figure 1.  
Forester C-2000 before attachment to front end loader.

The Forester C-2000, developed by FAHR Industries, Saint-Jacques, New Brunswick, Canada, mounts on the front of a CAT 950F front end loader (see figure 1). The crusher is powered by a CAT 3208, 255 horsepower, diesel engine and consists of eight hammers bolted through a solid steel rotor. The rotor spins in the direction that is opposite the travel of the loader. Rocks are crushed between the rotating hammers and steel anvils bolted to the top of the crusher box (see figure 2). A heavy duty chain drape hangs in front of the box keeping rocks in line for the crusher rather than the rocks being pushed out as the loader moves forward. When the rock material is crushed small enough to fit through the spaces between the hammers and the anvils, the crushed material passes out the back under a flexible belting screen into a new windrow (see figure 3).

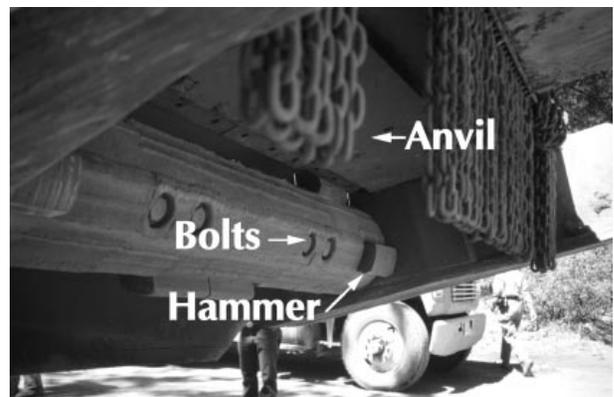
Figure 2.  
Crushing mechanism of Forester C-2000.

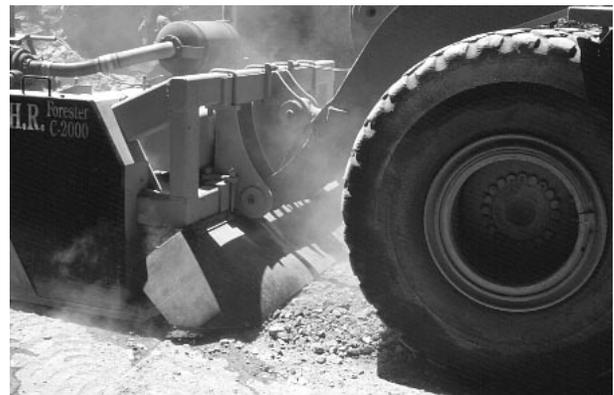
Figure 3.  
Crushed material exiting Forester C-2000.

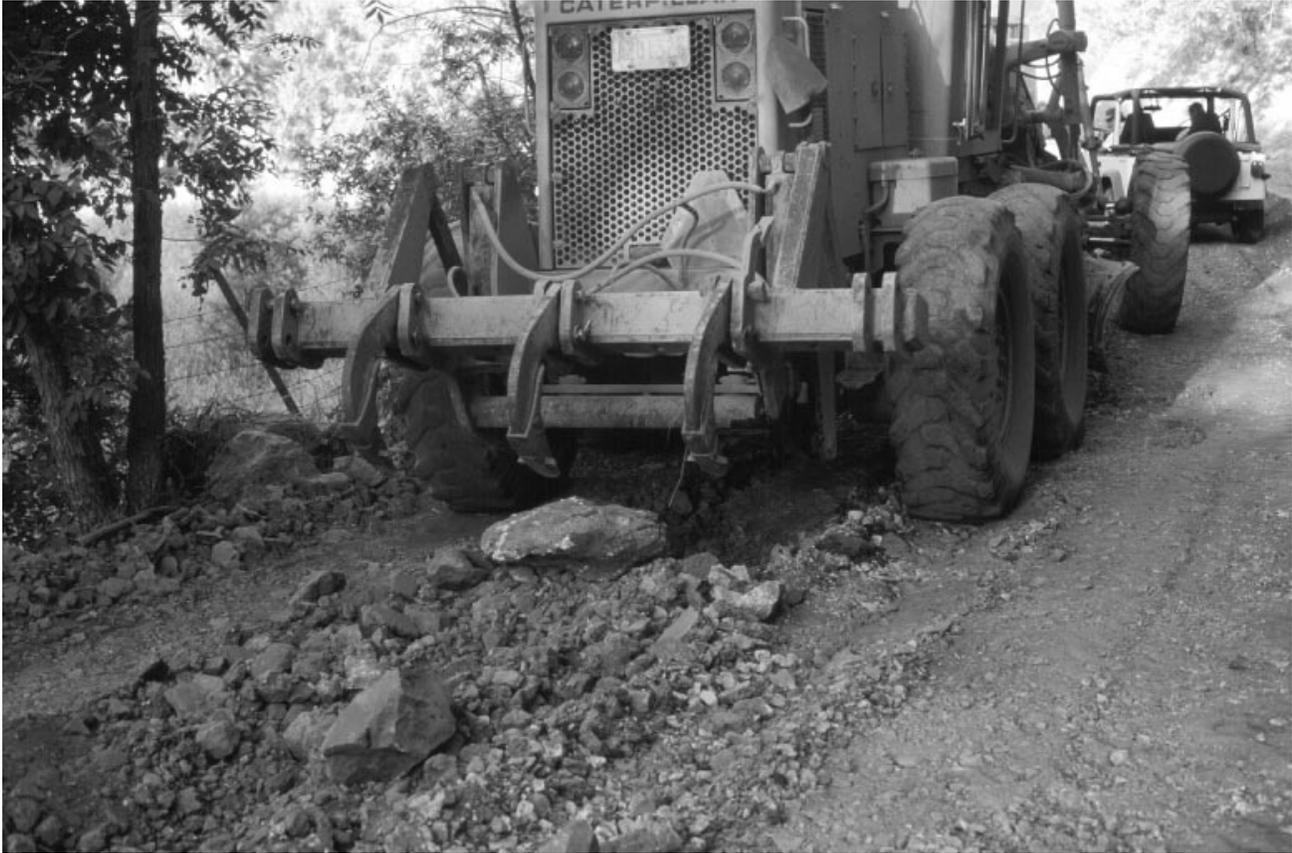
Figure 4. Grader ripping the road surface.

The crushing operation began with the motor grader ripping the road surface (see figure 4). The ripped material, along with loose rock on the shoulders and ditches, is windrowed. The size of the windrow affects the crusher's performance. An overly large windrow clogs the crusher and stalls the crusher engine, and a small windrow produces insufficient crushed material. The optimal windrow size is 5 feet wide by 1 foot high. The water truck wets the windrow for dust abatement before the crusher processes the material (see figure 5). The crusher's production rate depends on the size of windrow, the quantity and size of rock, and the road alignment. Finally, the second grader spreads the crushed material on the roadway, watering as needed.

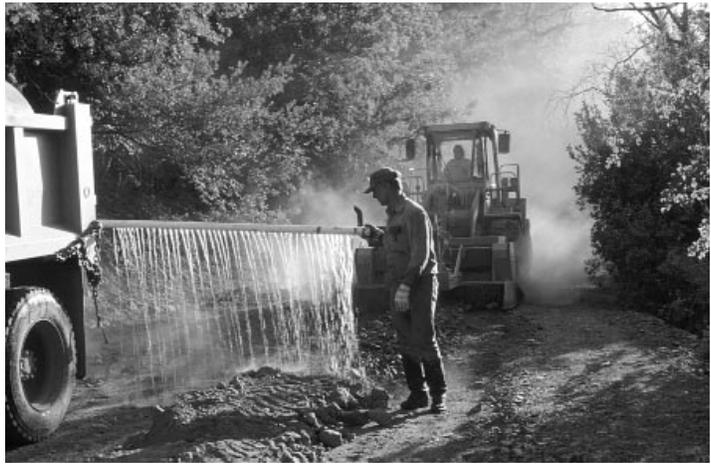
Figure 5. Watering windrow prior to crushing.

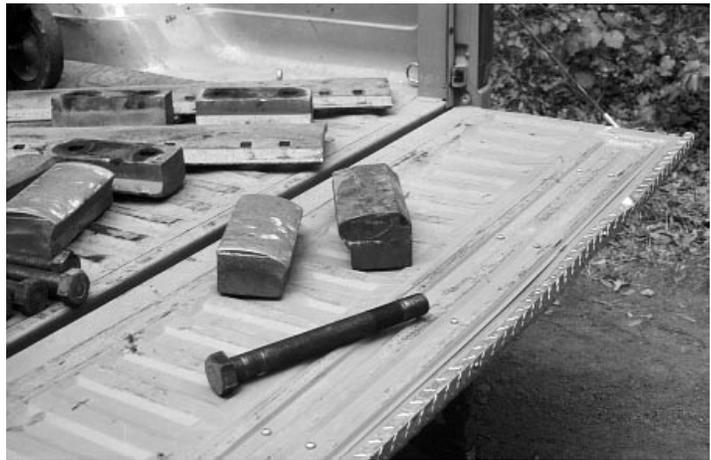
Figure 6. Attachment bolts and worn hammers.

Hammers last for 6 to 8 operational hours and then must be replaced (see figure 6). Under normal operating conditions this task must be done daily and takes about 30 minutes. Anvils, depending on wear, usually need to be changed once a week; this process takes about two hours. The crusher must be greased several times a day. The air filter is cleaned once a day and replaced when necessary.

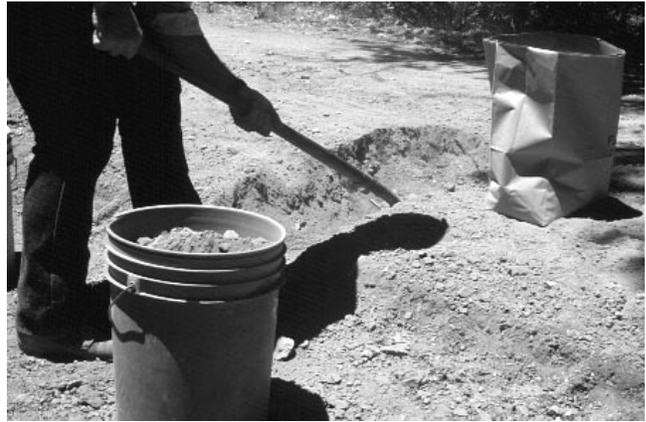
Figure 7. Samples being taken for analysis.

Tests were taken at three random locations during the crushing operations. A Tucson firm collected samples of material from both in front of and behind the crusher. For the 'before' sample, all rocks larger than 4 inches were discarded; the Contracting Officer's Representative (COR) noted that some discarded rocks were as large as 10 inches by 10 inches. The 'after' sample included all crushed rocks. The oversized rocks that were discarded in the 'before' sample were crushed and included in the 'after' sample (see figure 7). The samples were taken from wherever work was being done that particular day; consequently, the areas sampled were not representative of areas that contained a significant number of the larger rocks. It is highly recommended that further testing be conducted since the number of tests (three) are not enough to be truly representational of the materials found on more than 29 miles of road. These results are to be viewed as preliminary and somewhat indicative of the results one could expect. See table 4.

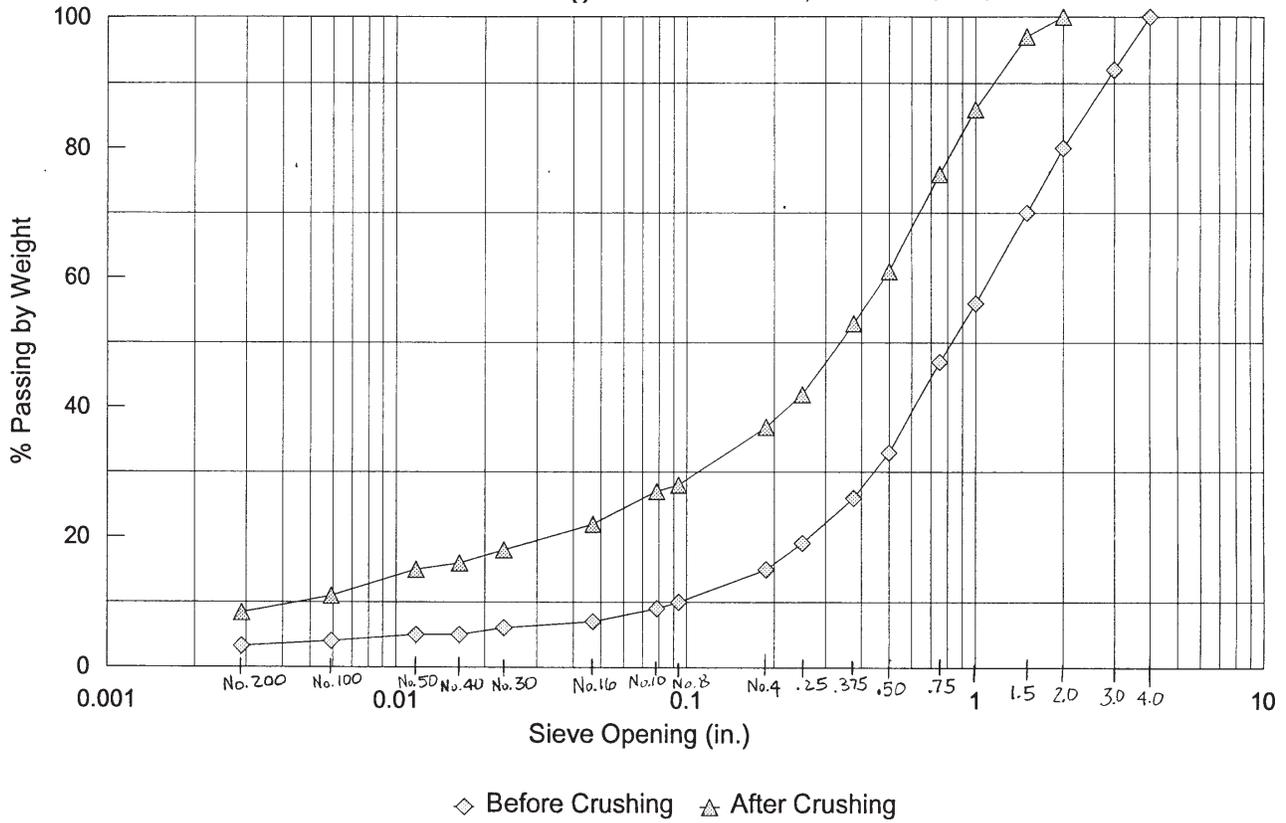
**Forester C-2000—Coronado NF (Chiricahua Mountains)  
400' Below 1st Bridge on Road #42, Date: 6/20/95**

Site 1—400 foot below 1st bridge on Road #42, 6/20/95

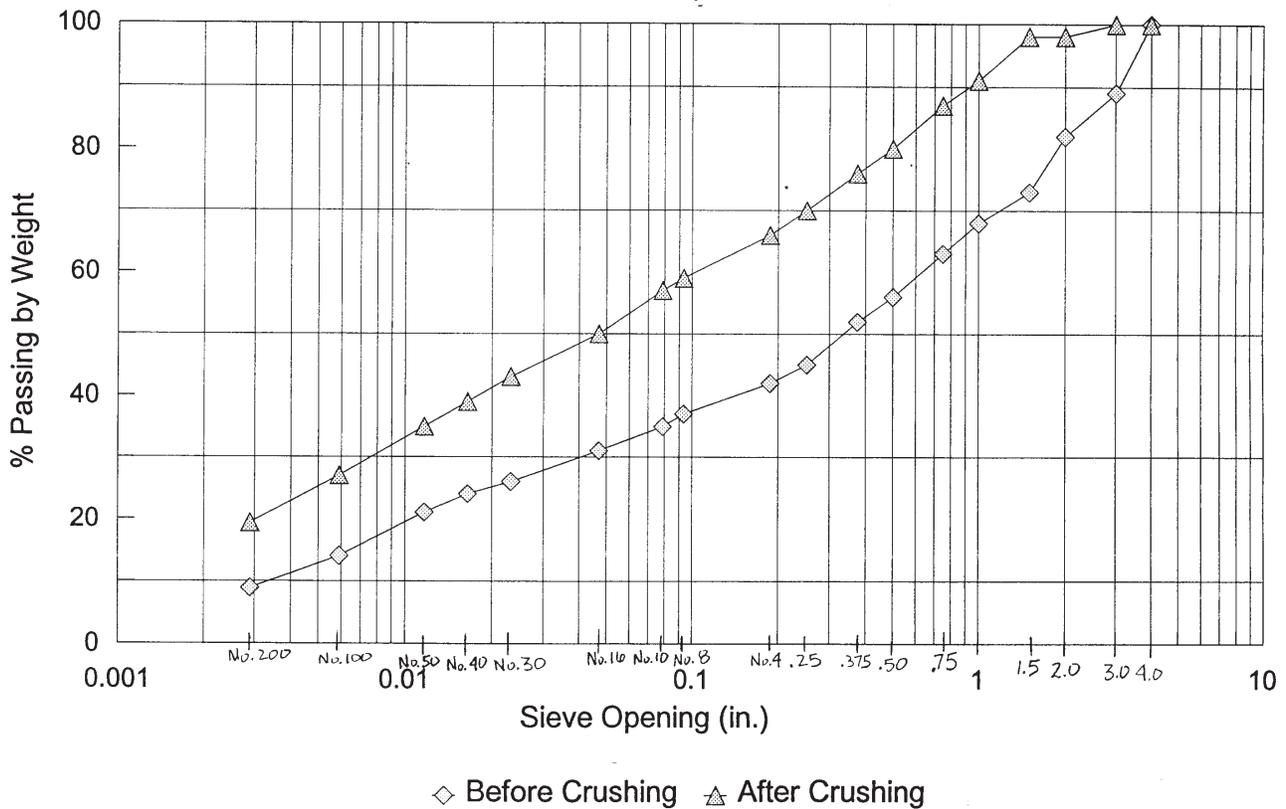
**Forester C-2000—Coronado NF (Chiricahua Mountains)  
Road #42 (1 Mile E. of Pinery Cabin), Date: 6/28/95**

Site 2—Road #42, 1 mile East of Pinery Cabin, 6/28/95

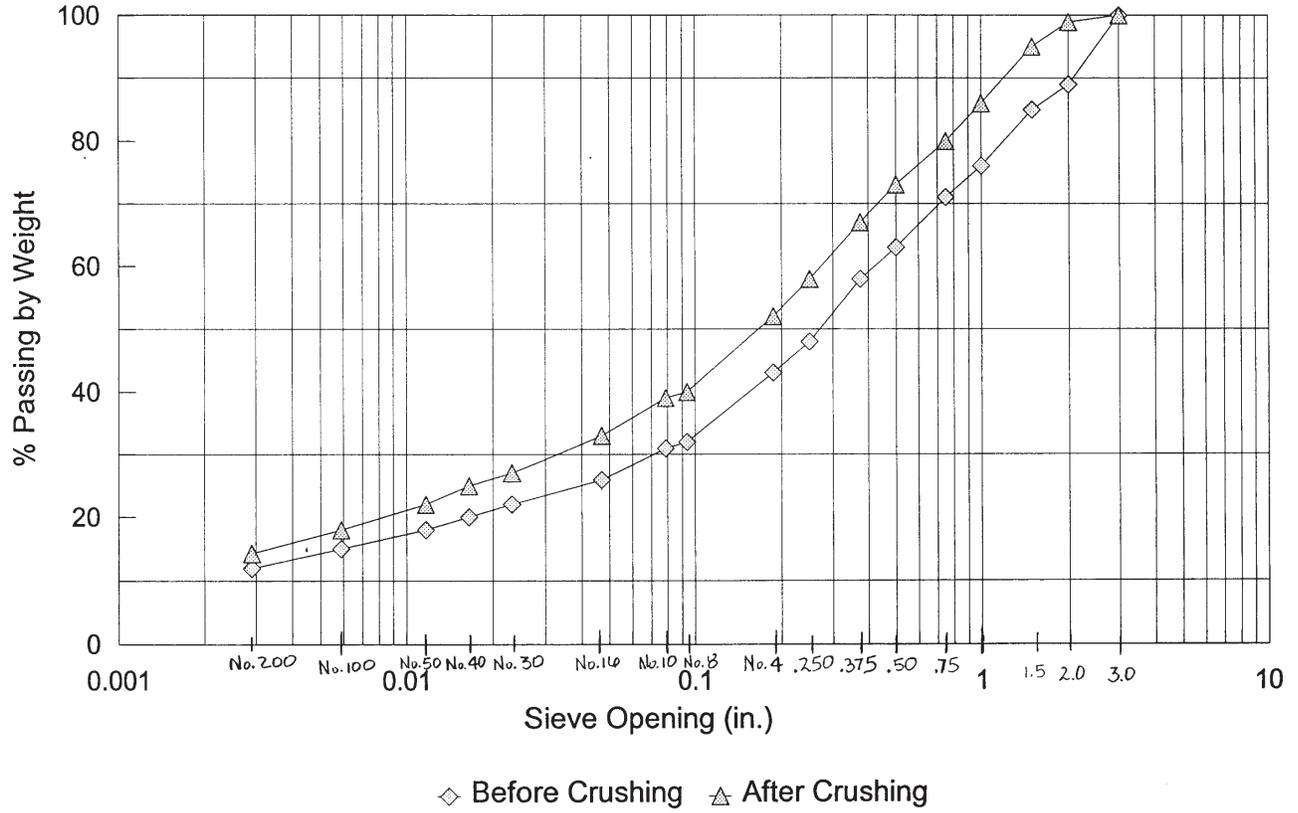
**Forester C-2000—Coronado NF (Chiricahua Mountains)  
3 Mile Below Cazier Bridge Cave Creek, Road #42, Date: 7/11/95**

Site 3—3 miles below Cazier Bridge, Cave Creek, Road #42, 7/1/95

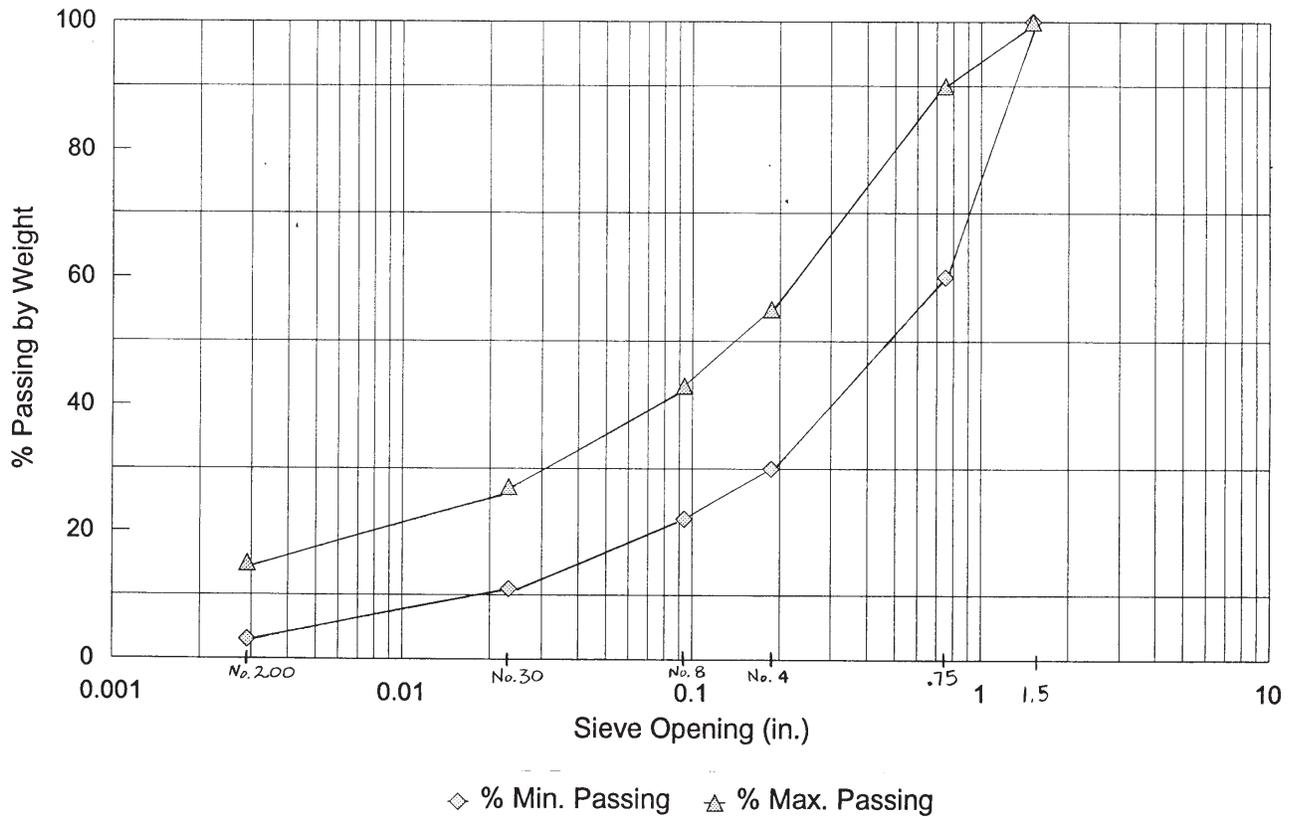
**USDA FOREST SERVICE  
Crushed Aggregate Grading Requirements**

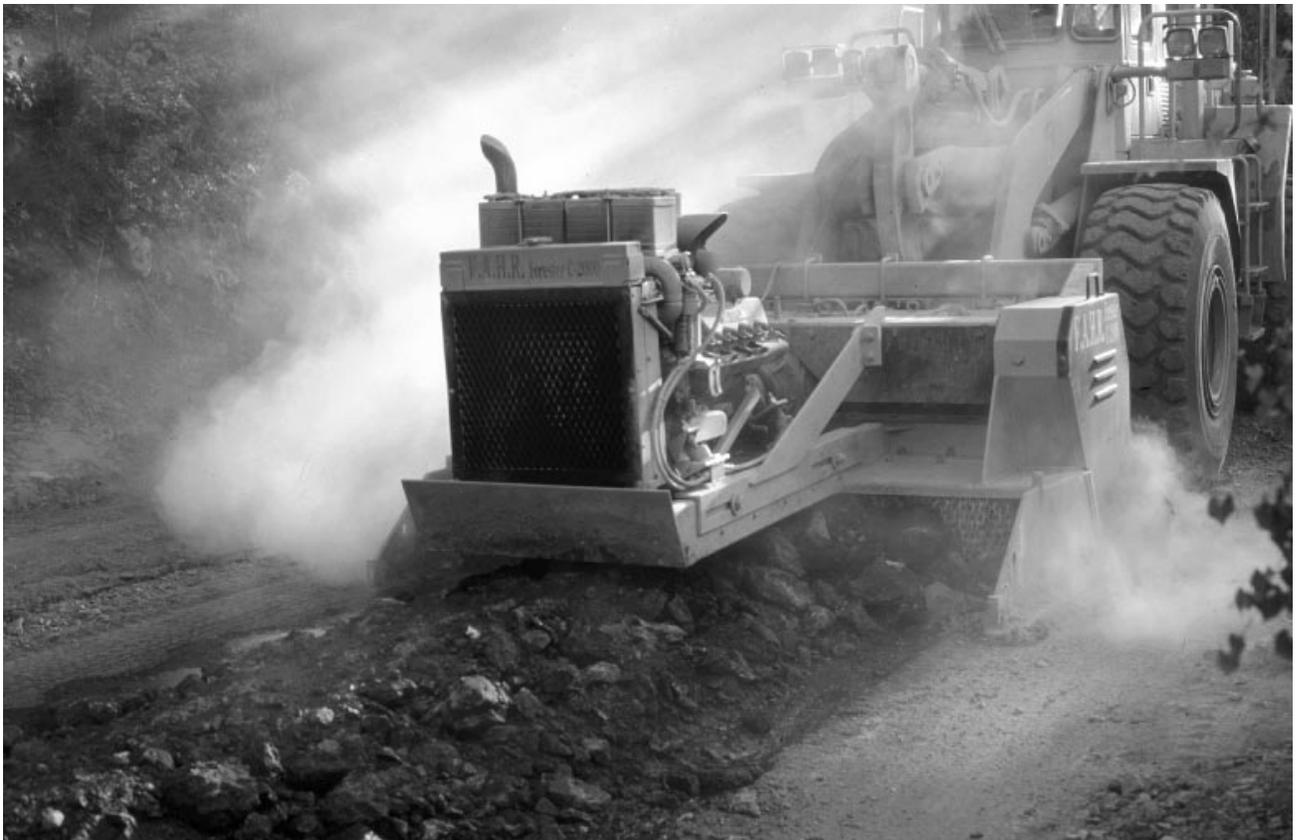
*Figure 8. Forester C-2000 grinding through windrow.*

The demonstration project using the Forester C-2000 proved to be a success considering the types of rock encountered at the test sites. (See figure 8) The 29 miles of road resurfaced with the Forester should remain in relatively good condition with only a minimal amount of additional work required.
