Case Study 1 Red Clover Rock Ford

Northeastern California. Plumas National Forest. An unnamed tributary to Red Clover Creek in McReynolds Valley, 5 miles north of Lake Davis, CA. Forest Road 25N05, Station 82+10 (Red Clover Timber Sale).

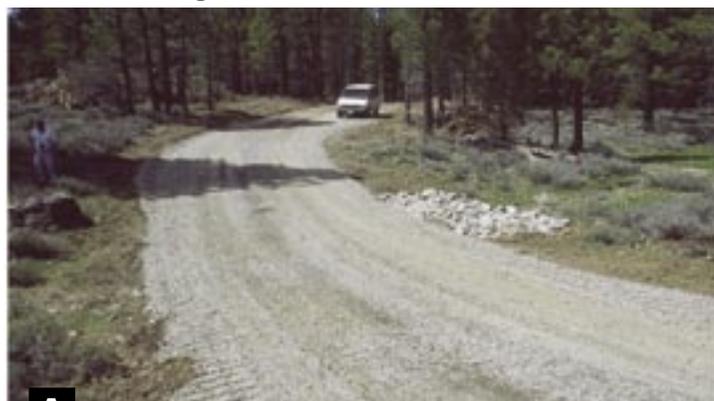
A

Figures A1a and A1b. Red Clover rock dip. Figure A1a. Flow is from left to right across the dip. Figure A1b. View is upstream.

This ford was constructed in 2001 as a simple rock-armored ford across an unnamed ephemeral draw on a road constructed to access a timber sale. The ford is a simple, elongated rolling dip with a riprap-reinforced subgrade with aggregate surfacing and a riprap-armored outlet (figures A1A and A1B). The road is 12 feet wide and the armored portion of the ford is 30 feet long. The entire roadway surface through the dip is approximately 120 feet long. The structure is relatively new, and to date it has only been through moderate runoff events. This design is the “standard” simple, rock ford.

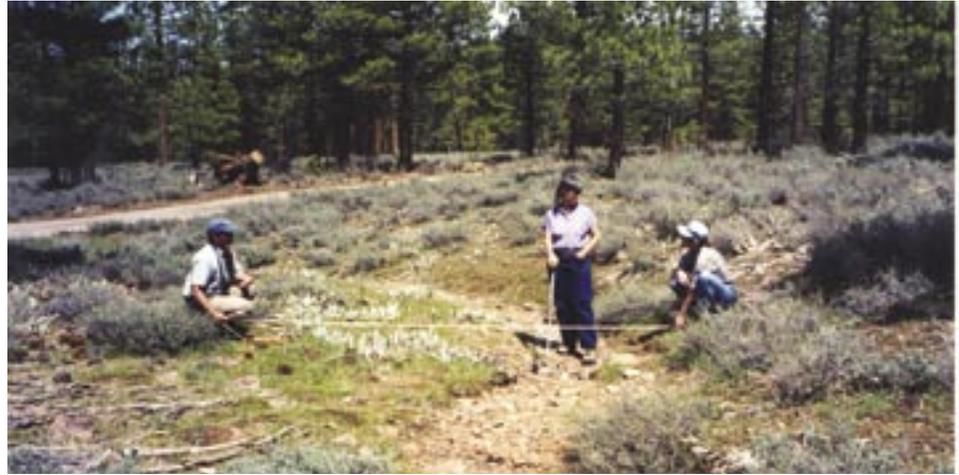
Figure A2. Measuring bankfull channel dimensions on the ephemeral channel upstream of dip.

Channel Description: The channel is only slightly entrenched with banks that are relatively flat and stable except for local scour at some bends (figure A2). Bank vegetation is coniferous trees, shrubs, and grasses. The channel varies from 4 to 10 feet wide near the site and channel slope is about 3 percent. The substrate is a poorly graded mixture of clayey sands, some gravels, and occasional volcanic rocks.
