**Case Study 4. Forest Road 732 Jersey Barrier Fords**

**Location** Northern Arizona. Prescott National Forest. Verde Ranger District. Cienega Creek. Forest Road 732, Squaw Peak Road.

**Crossing Description** These crossings are unvented fords on an ephemeral channel that transports up to boulder-sized rock during floods. Jersey barriers and large riprap support the downstream edge of the road. The jersey barriers also function to trap sediment and prevent channel downcutting occurring due to land use in the area.

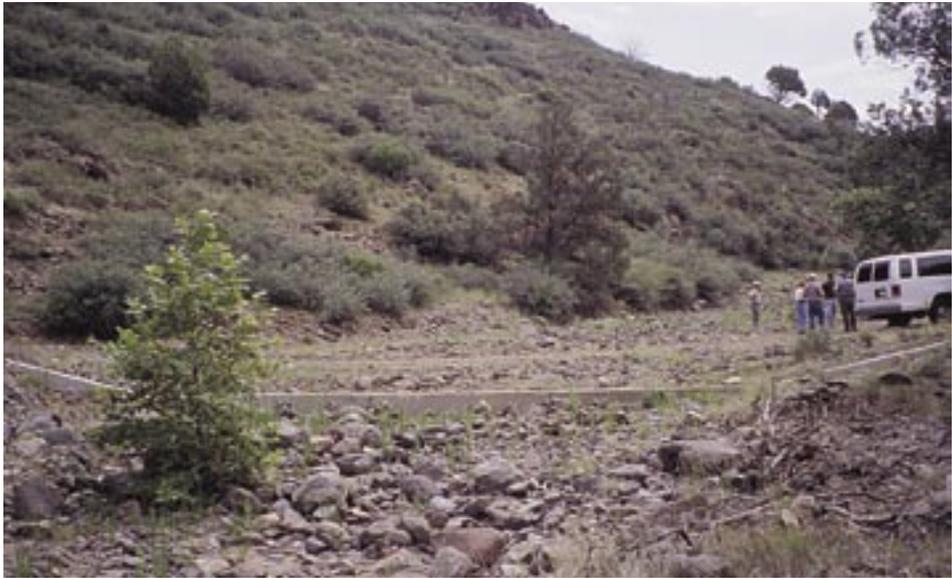
Figure A16. Jersey barrier ford, FR 732.

**Why Were These Structures Selected?** Channels in this area flood 4 to 5 times each year during summer thunderstorms and are dry the rest of the time, making unvented fords feasible structures. Jersey barriers act as a retaining structure, providing support for the road. They also work to control channel downcutting. These structures are simple, easy, and inexpensive to construct with road maintenance equipment, and they have low maintenance requirements.

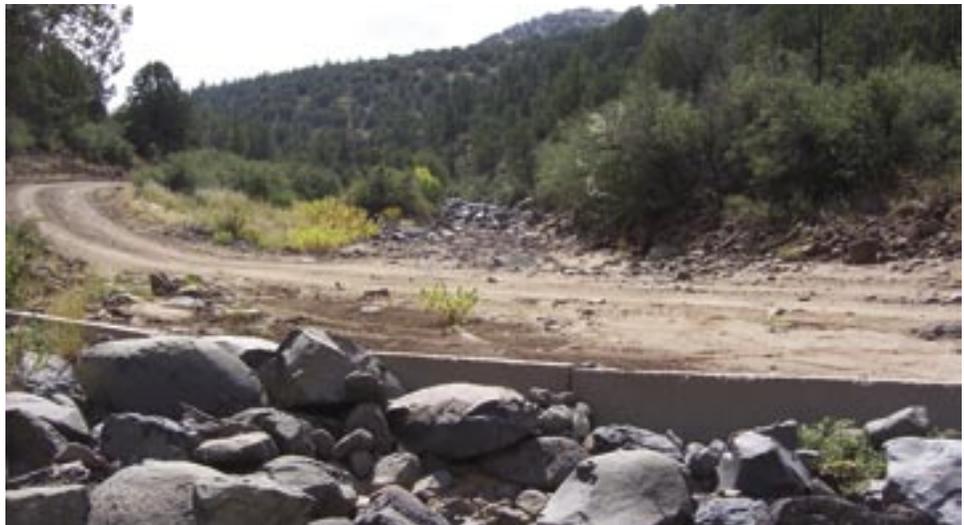
Figure A17. Looking upstream across another jersey barrier ford on FR 732. Sloped road approaches prevent diversion and large rock is placed downstream to prevent scour.

The fords are backfilled with native rock material and large riprap is usually placed downstream to prevent scour (figure A17). Experience has shown that the downstream edge of the jersey barriers should be protected from scour by gabions or an engineered riprap fill (figure A18c) unless the channel is highly resistant to erosion.

**Bank stabilization and approaches:** Road approaches slope down into the crossing to prevent diversion down the road.

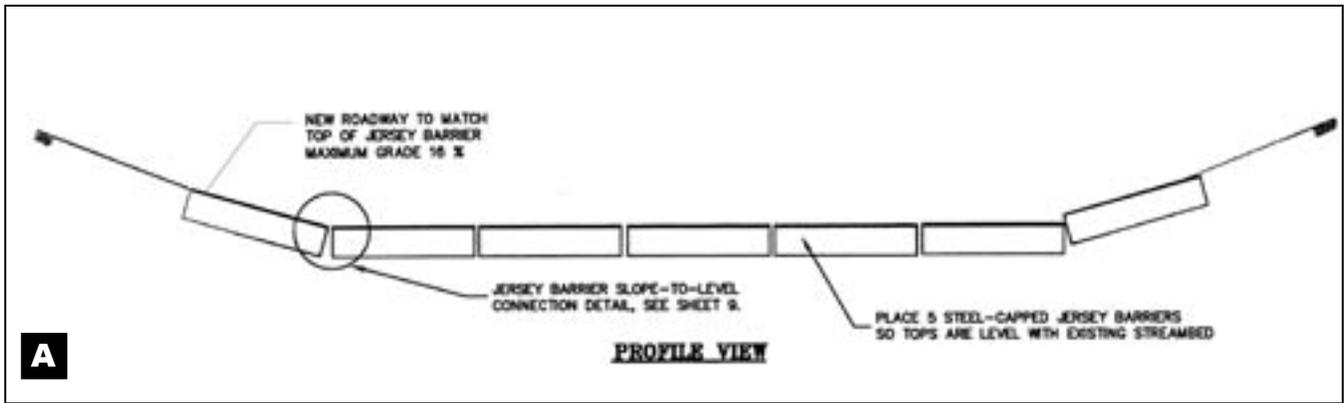
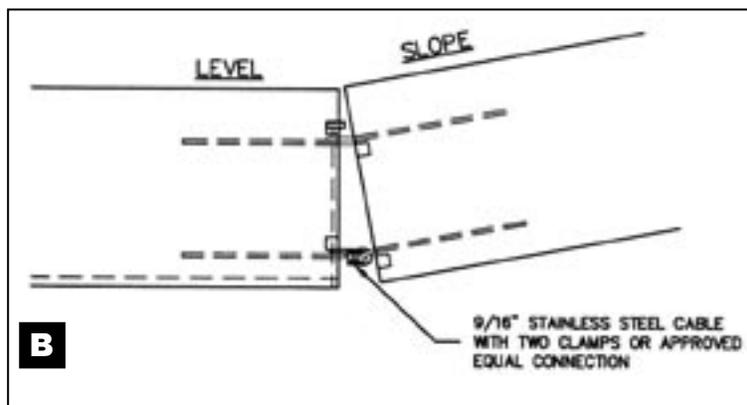
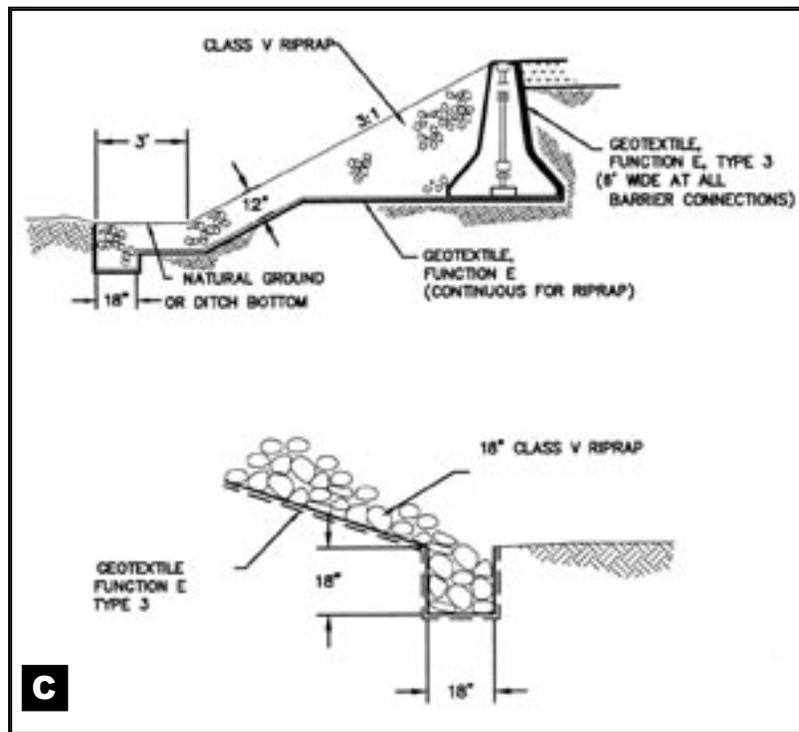
Figures A18a, b, and c. Typical jersey-barrier installations from the Tonto National Forest. (a) profile view (channel cross section view); (b) jersey barrier connections detail; (c) riprap fill detail.

**Structure:** Jersey barriers (usually seen on freeway medians) act as a retaining structure supporting the roadway. Barriers are set to mimic channel width and shape (figure 18a) and the ends of the structure (at channel edges/road approaches) should extend above the elevation of the largest expected flood. Figure 18b shows how they can be connected.

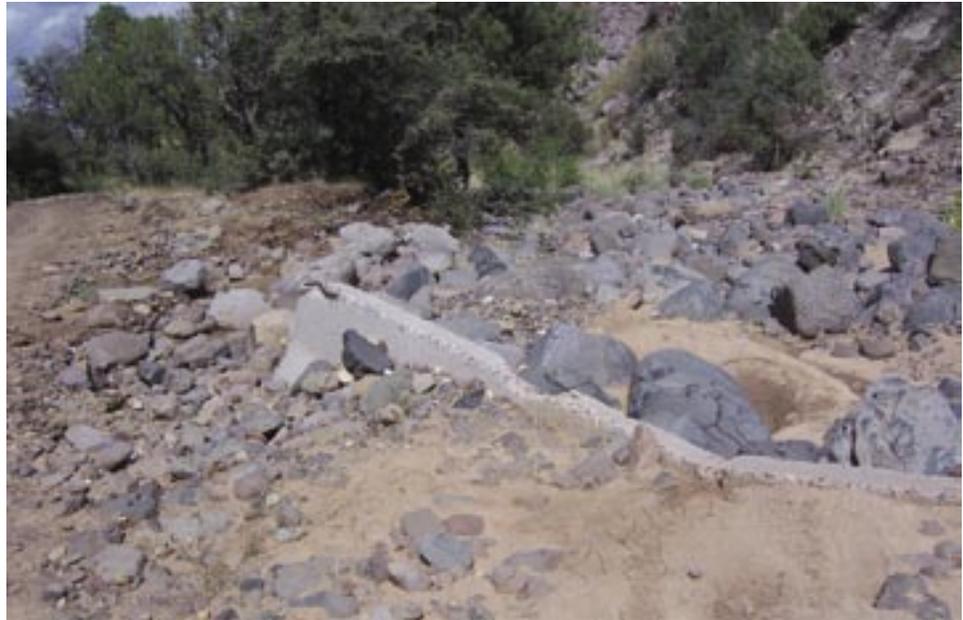
Figure A19. High flows have outflanked one of the ford structures.

No significant flood events have occurred since these structures were installed in 1993, and no maintenance has been done. Some of the structures are now showing the need for repair. For example, in figure A19 the jersey barriers were not extended high enough to control high flows, and water has gone around the ends of the barriers. Part of the reason for this could also be that sediment has been deposited and revegetated upstream of the crossings.

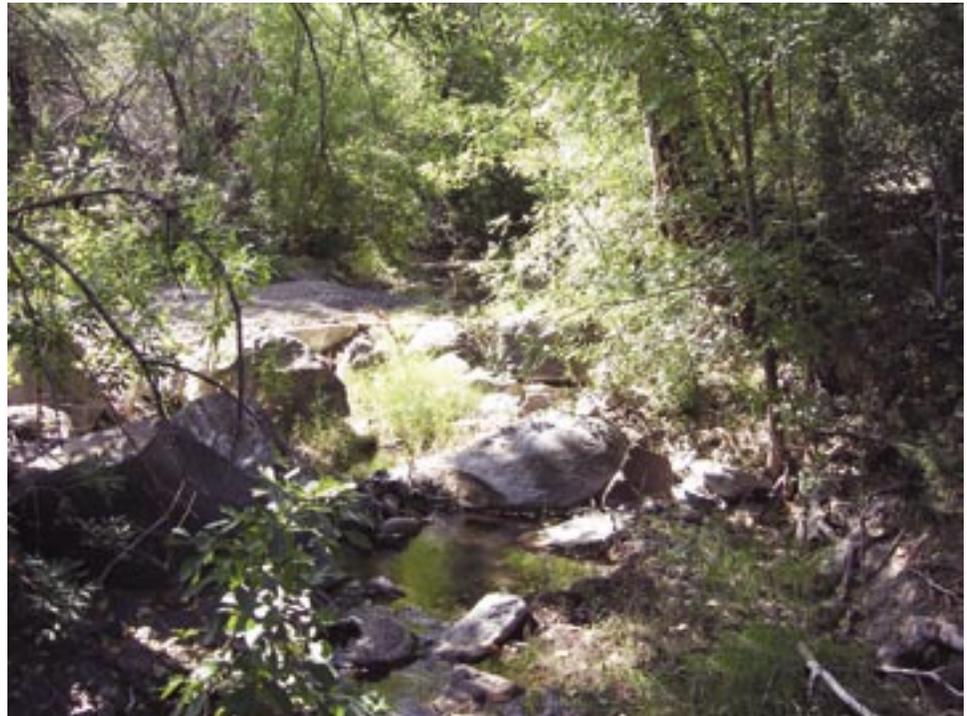
Figure A20. Jersey barrier ford on FR 136 has helped control channel downcutting and restore the riparian area in Copper Canyon. Photo is looking upstream at the ford.

The Prescott National Forest has used the same design on crossings in the Copper Canyon drainage (FR 136). Concentrated runoff from Interstate 17 drains directly into the canyon, and was accelerating channel downcutting. In 1991, Jersey barrier fords were installed in a series at several stream crossings that had been unarmored natural fords. The fords have worked well to retain sediment and foster the growth of riparian vegetation (figure A20). They are working both as stream crossing structures and as riparian improvements.

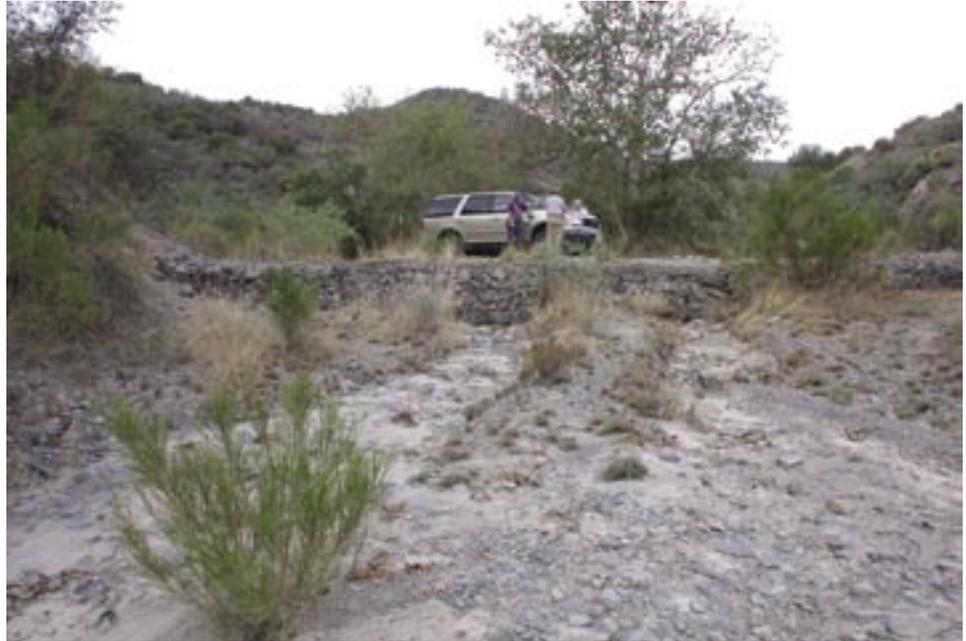
Figure A21. This jersey barrier-gabion ford on the 7-Springs Road on the Tonto replaced a bridge washed out in a flood.

The Tonto National Forest, just south of the Prescott, also uses jersey barrier fords, sometimes adding gabion basket energy dissipators to control downstream scour (figure A21). Jersey barrier fords generally create a downstream drop, and require scour protection to avoid being undermined. When they fail, it is often because of downstream degradation or outflanking when floodwaters rise above the protected approaches. Upstream aggradation can exacerbate problems with outflanking, and care is required to create enough sag and armor the approaches high enough to avoid it.
