Case Study 7. Woodrock Guard Station Geoweb Ford

Crossing Description

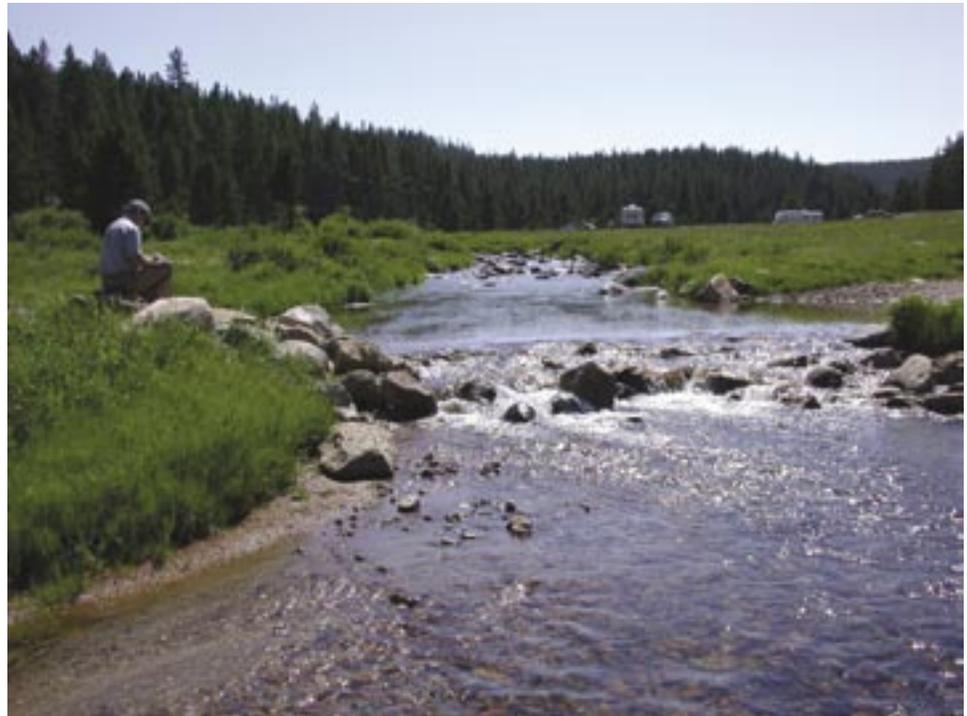
Figure A35. A boulder cascade was constructed at the downstream edge of the ford to control scour caused by placing the Geoweb very slightly above streambed elevation.

The intent was to set the surface of the filled Geoweb cells at the level of the finished streambed, matching stream slope. However, this is very difficult to do without diverting streamflow. The downstream edge of the Geoweb protruded an inch or two, so a rock energy dissipator was placed there. Scour occurred despite this, and in 1999 a larger boulder cascade control was constructed. This support structure creates a berm that backs water up on the crossing so that vehicles drive through deeper water than would otherwise be necessary.

There have been no major floods since the Geoweb was installed. As noted above, scour due to the fact that the Geoweb did not perfectly match stream grade necessitated construction of a boulder weir that now backwaters the ford. Erosion and consolidation of the approaches required the addition of rock, but compaction continued, and the crossing shape could not maintain itself. The boulder weir helps to retain the gravel surfacing necessary to protect the surface, but in many places, tire action appears to spin the gravel out of the top of the cells allowing the material to degrade (figure A39).

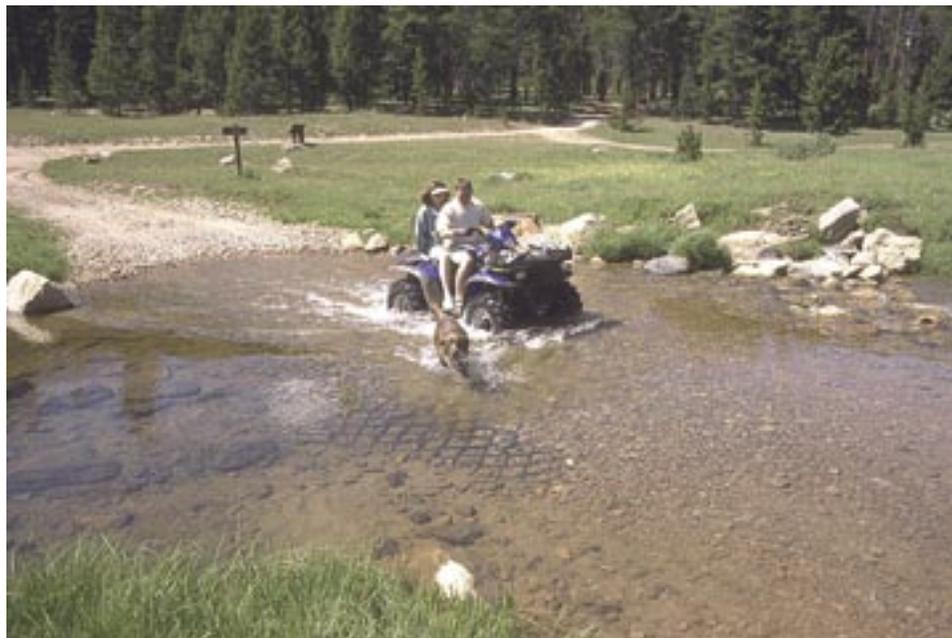
Figure A36. Ford is used by vehicles ranging from ATV's to motor homes.

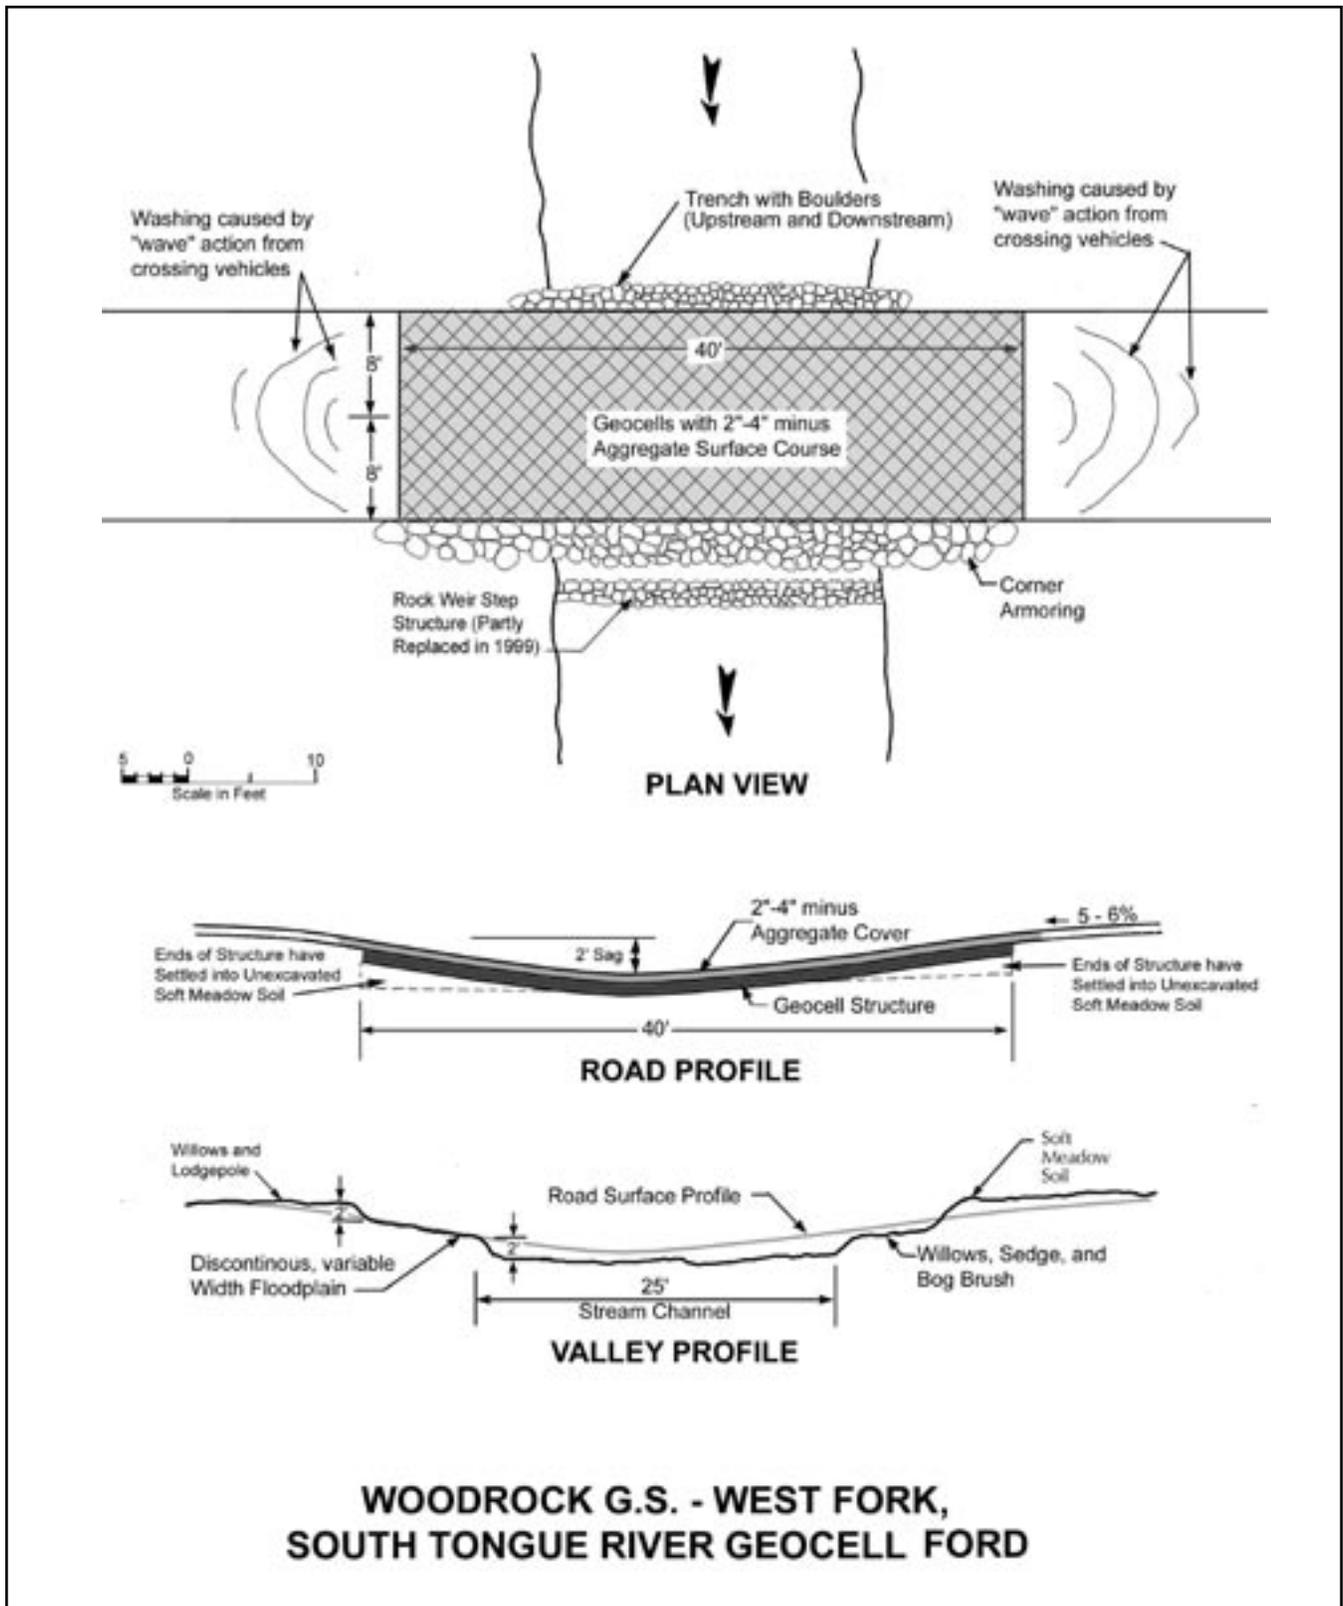
Figure A37. Plan view with valley and road profiles.

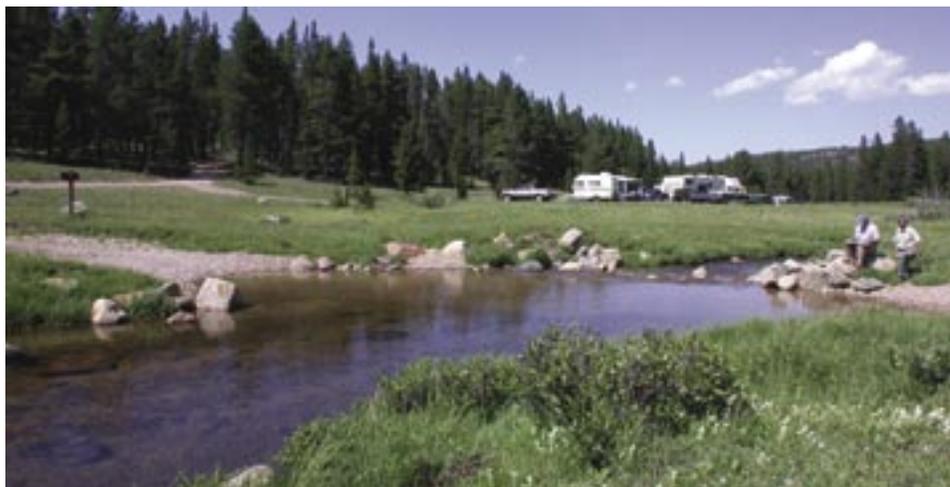
The original intent was to install the Geoweb to the elevation of the 100-year flood. As can be seen in figure A38, although the Geoweb originally extended higher, it has settled under traffic loads and probably does not fully cover the bankfull cross section. The stream widens out substantially at the crossing.

Figure A38. Soil compression on the approaches to the ford causes the stream to widen and lowers the elevation of the ends of the Geoweb mat. Currently the geocell mat protects only part of the crossing during high flows.

Bank stabilization and approaches: The road approaches slope into the crossing at about 5 to 6 percent. Even though 10 cubic yards of rock have been added to the approaches to raise the road grade, figure A38 shows that it is substantially wider than the natural channel. Riprap is placed downstream where the approaches cut into the streambanks.

Geocell fords are attractive for low-traffic and light-vehicle uses because they are inexpensive and quick to install. However, they require the same attention to foundation leveling and compaction as heavier structures do. In this case, construction without diverting the stream may have been responsible for the difficulty with matching stream slope, which then required building a downstream weir and backwatering the structure. The risk of losing the crossing shape because of traffic compressing the soft flood-plain soils also was not recognized. Those soils should have been compacted or overexcavated and replaced with firm material.

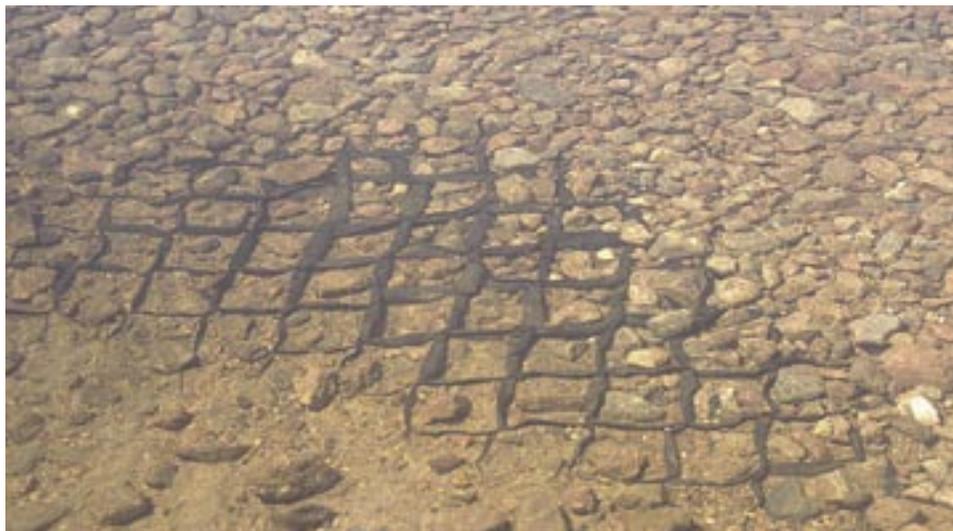
Figure A39. Geoweb exposed, probably by tire action.

The final elevation of the geocells plus cover material is critical to the design. Initially the site should be overexcavated to the depth of the cells plus the anticipated depth of cover aggregate. Four to 6 inches of coarse, clean cover aggregate is recommended. Since this material will likely be removed during high flows, some cover aggregate will periodically have to be replaced.

Carefully weigh the speed and economy of installation against the drawbacks specific to this structure type. The geocells are damaged by traffic if not protected by a layer of gravel, and after high flows the gravel surfacing will need maintenance or replacement (see also figure A41 below). Generally, this design is not preferred for streams that experience high velocity flows or substantial traffic volume. The forest plans to replace this structure with one that will keep vehicles out of the water.

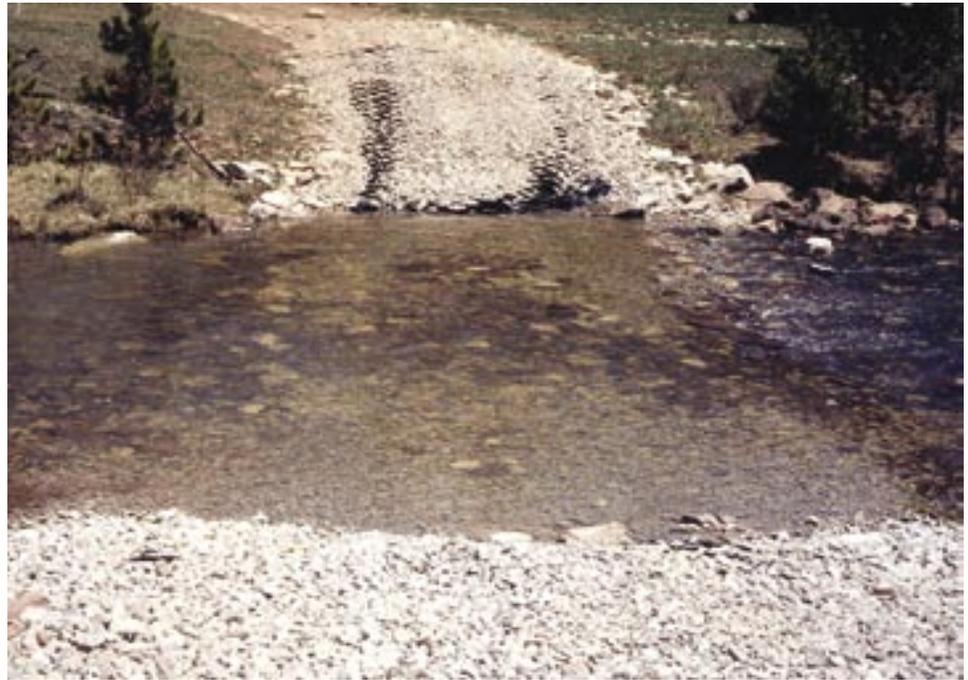
The Ashley National Forest has a successful temporary geocell (similar to Geoweb) installation on Little Brush Creek (figure A40). The material used for this ford is called "TerraCell". The mats are 8-foot by 20-foot by 6-inches deep. Two mats were installed lengthwise across the stream.

The native (darker red) cobbles and gravels deposited on the crossing in figure A40 show the structure provides free downstream passage for debris and bed material. There is no reason to believe the ford would block fish and other aquatic species at the site going upstream. The forest is satisfied with the ford as a temporary crossing.

Figure A40. Little Brush Creek geocell ford in June 2002.

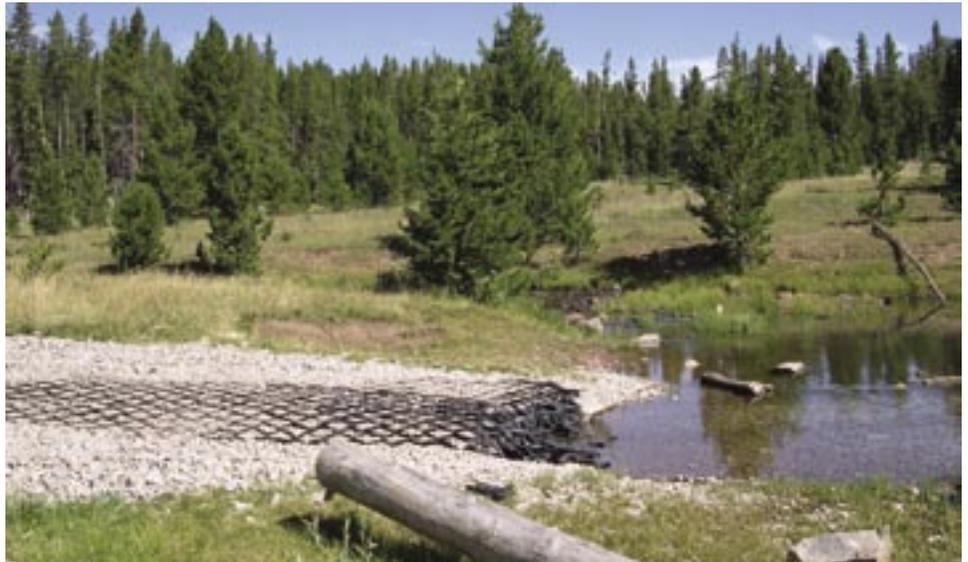
The crossing accesses a road planned for storage within a few years, so the structure needed to last only 3 to 5 years. Traffic is mostly administrative and recreational, and is primarily 4-wheel-drive vehicles such as light duty trucks, all-terrain vehicles, and sports utility vehicles. As the photo shows, after only one year, some of the 4-inch minus surfacing had been lost from the geocells on one side of the structure, and the material was deteriorating. Rock was added during the summer of 2002. Nonetheless, in 2004 the site was in a similar condition (figure A41). More material has eroded out from the geocells on one side of the ford and the channel has widened locally.

Figure A41. Looking upstream at erosion of one side of the ford in August 2004, 3 years after construction. Probably tire action and high flows have combined to pluck material out of the cells or undermine them. The ford is still intact and the geocells are covered by native bed material in the active channel.
