Technology &
Development
Program

2500 Watershed & Air Mgmt
August 2002
0225 1202—SDTDC

Riparian Protection and Restoration: Road Design Techniques

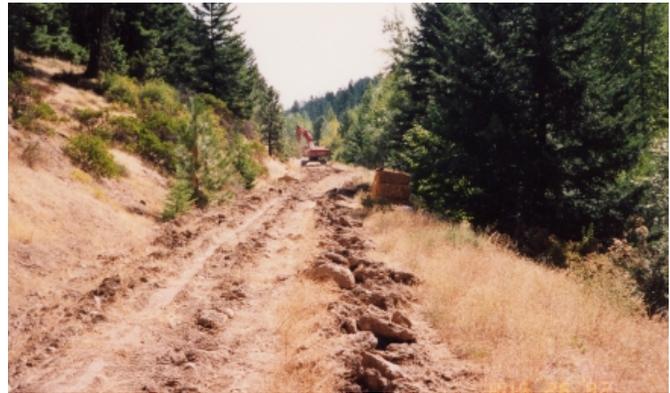
Figure 1—The berm blocking the road was removed to allow fertilizer and bales of mulching straw to be placed every tenth of a mile.

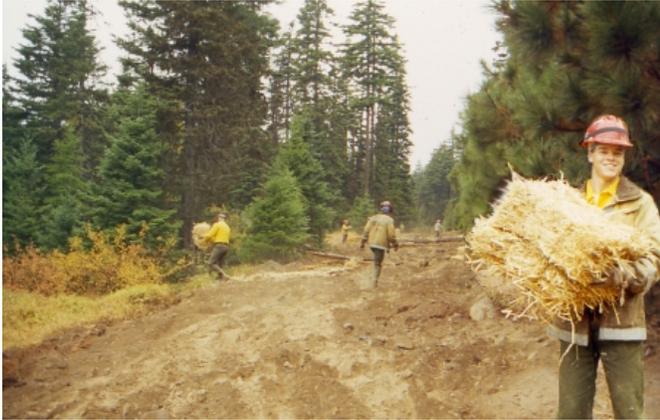
Figure 3—The district project crews seeded and broadcasted fertilizer and mulch (straw).

4. The Link-Belt 4300 excavator pulled back the road fill material from the end of the road and completed the project at the upper portion of the road. Large boulders and shrubs disguised the entrance to the obliterated road.
5. The district project crew seeded and broadcasted fertilizer and mulch (straw) to prevent erosion (figure 3).

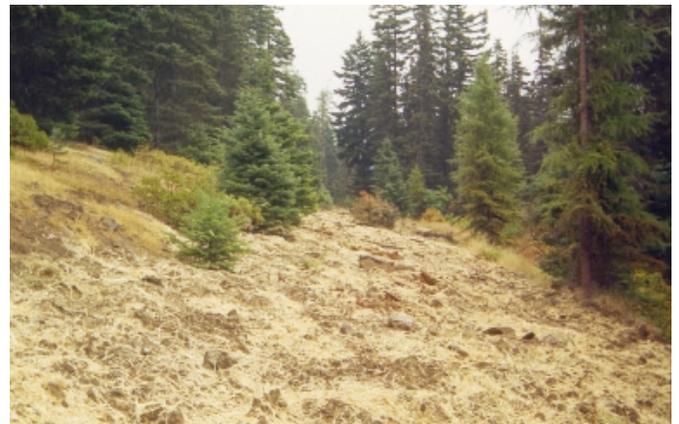
Figure 4—The district project crew hauled in seed and used it with fertilizer and mulch that was already onsite.

Results—Grass with mulch proved to be the fastest and cheapest method for controlling erosion, the primary objective of the Rail Hollow Road Project. Seeding was prescribed rather than using native plants to regenerate the area. The seeding mixture allows for good root development for erosion control, but still gives native vegetation an opportunity to reestablish itself (figure 4).

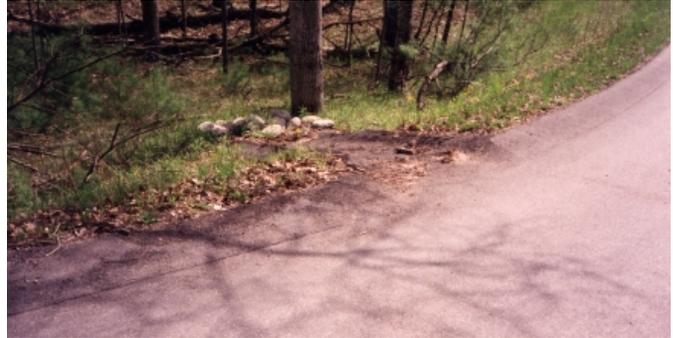
Figure 6—Curbing and drainage structures channel runoff flows off the roadway and into fields or sediment beds.

water into drainage structures. The drainage structures allow runoff to flow off the roadway, away from the river, and into fields or sediment beds (figure 6). Researchers estimate that this upgrade eliminates 50 tons of sediment per year. The upgraded road has also restored degraded salmonid habitat for approximately 4 mi downstream.

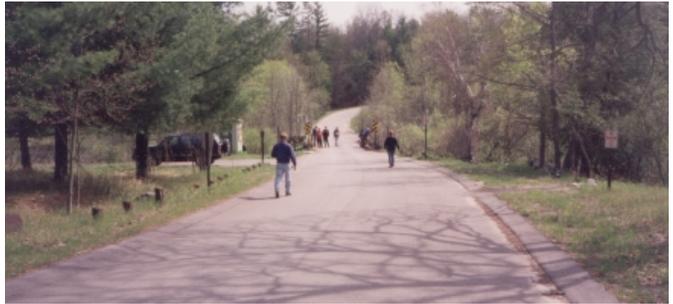
Figure 7—Another positive result of paving is a barrier-free parking area near the bridge that provides fishing opportunities for physically challenged individuals.

As a result of this upgrade, the USDA Forest Service was able to construct a designated barrier-free parking area near the bridge that provides fishing opportunities for physically challenged individuals (figure 7).

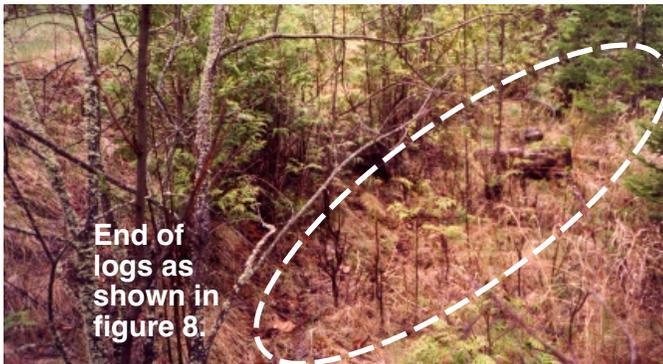
Figure 9—Log corduroy (selected area) was used for cross drainage on this road.

If log corduroy is used for cross drainage, geotextile material should be applied above and below the corduroy (figure 9). If log corduroy is not used, other cross-drainage structures should be considered.

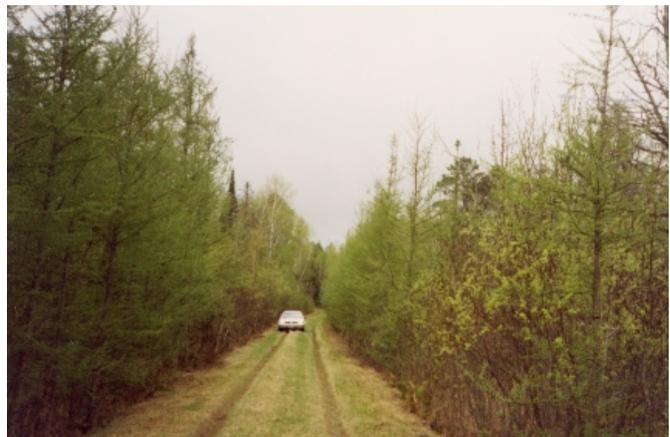
Figure 10—This road still maintains a free flow of water through the roadbed while providing a stable road surface.

Results—In most cases this technique works well. The site shown is 20 years old and is still maintaining the free flow of water through the roadbed while providing a stable road surface (figure 10).

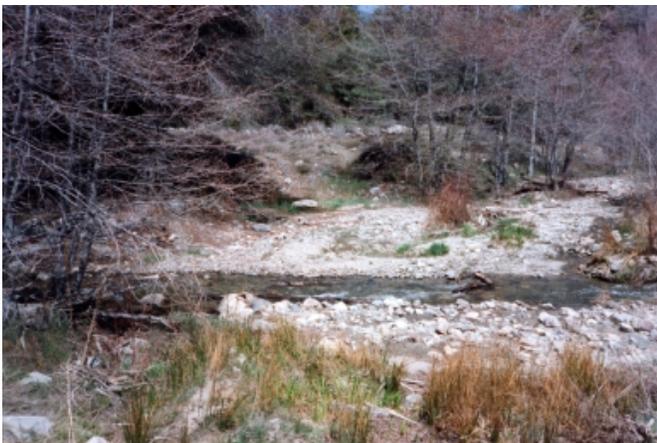
Figure 11—One of the natural river crossings (roadbed in background) that agitates sediment in the stream.

Problem—One 3-mi segment of this road has four natural river crossings with no previous approaches or riverbed improvements. Assistant Forest Engineer Bill Crane said, "Vehicles passed through the river agitating the river with road grime and sediments. The water crossings are a problem for engineering because of maintenance and damage to the resources which result in poor fish habitat." The following problems were identified at the crossings (figure 11).

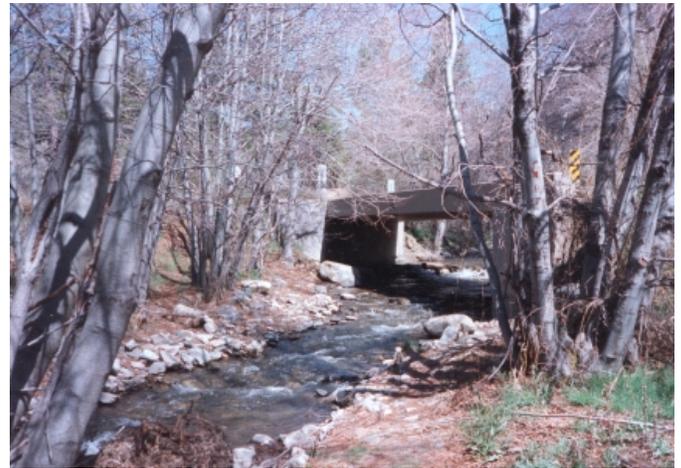
Figure 12—Four precast, 40-ft concrete, single-lane bridges were constructed to replace the natural water crossings and improve aquatic life.

Solution—The USDA Forest Service replaced the natural river crossings with four precast concrete, single-lane bridges that are designed to improve aquatic life (figure 12). The bridges keep vehicles out of the river, with less maintenance required on the ap-

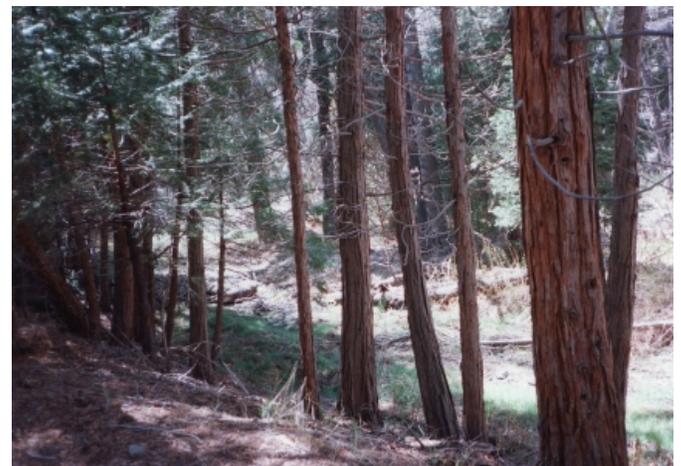
Figure 13—The reestablishment of native vegetation hid all evidence of the original water crossing into the meadow.

To relocate the approach out of the meadow, the planner located the bridge a short distance downstream from the river crossing. The old approach was blocked with multiple 4-ft-high dirt mounds and the remainder of the approach was scarified and raked and left unseeded, allowing the native vegetation to reestablish itself (figure 13).

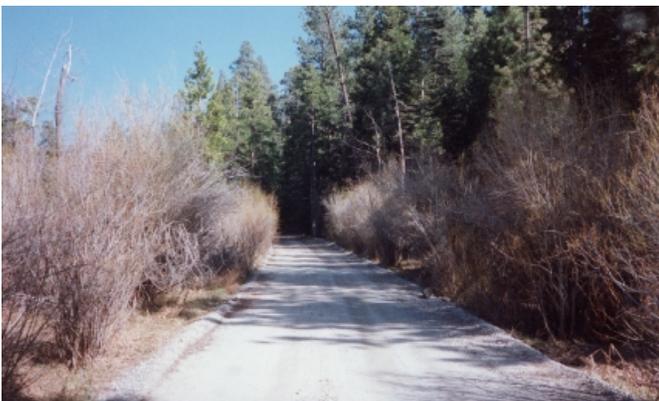
Figure 15—The roadbed was rebuilt using nonwoven geotextile, coarse drain rock, and 3/4-in surfacing aggregate to make a dry road surface.

For the subsurface drain, the forest road crew excavated 12 in below the road surface. A nonwoven geotextile served as the bottom layer, with 6 in of coarse drain rock above the layer of geotextile, and another geotextile layer on top of the rock. The road crew finished with a 6-in layer of 3/4-in aggregate surfacing (figure 14). The finished french drain is shown in figure 15.

The under-the-road drain dried the roadway's surface, while allowing the meadow groundwater to flow freely under the road. This is an excellent example of keeping a riparian area intact. The traffic has a good aggregate surface and the functional integrity of the meadow was not destroyed (figure 15).

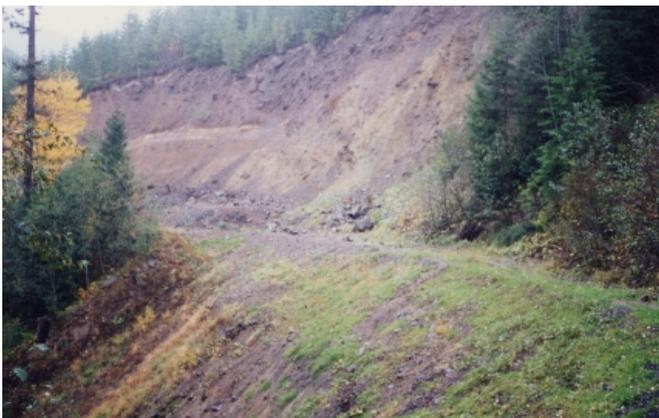
Figure 16—The largest slide on the Greenwater River Road removed 300 ft of roadbed in the inner gorge.

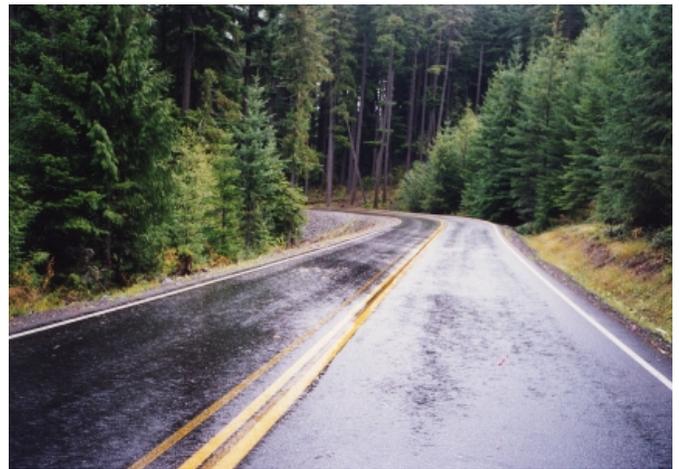
Figure 17—The newly relocated Greenwater River Road.

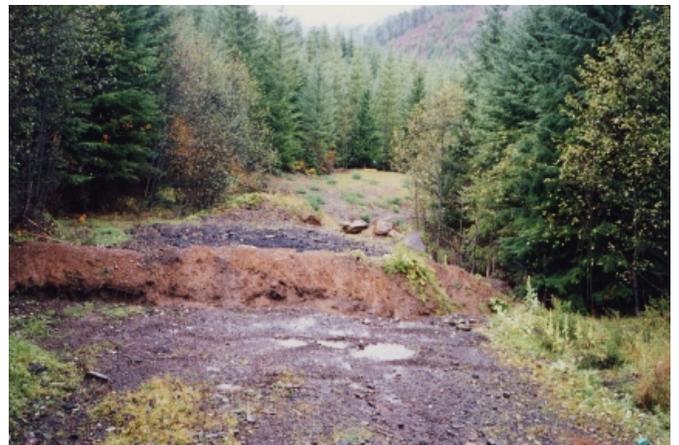
Figure 18—By blocking the two entrances, pulling all culverts, and seeding and mulching the roadbed and sideslopes, the upper road closure affected only 2.9 mi of the existing road.

Only 2.9 mi of the old existing road was closed. It was abandoned by blocking the upper entrance, pulling all culverts, and seeding and mulching the roadbed and sideslopes (figure 18). While removing the culverts, the crew ensured that the trench matched the slope and width of the original ground to maintain the identical stream hydrology.

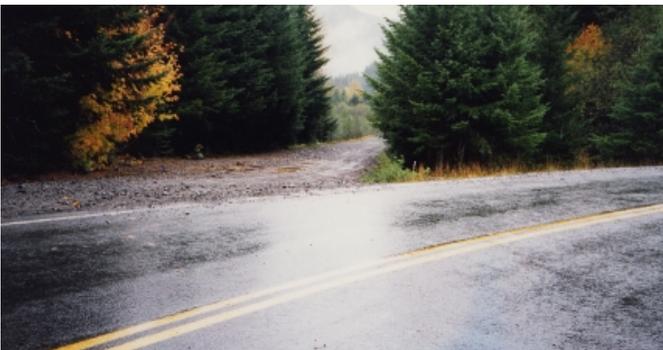
Figure 19—The beginning of the road relocation. The old road (to the left) goes to a dispersed campground.

The following summer, the crew came back, dug deep trenches, and made a larger berm, which proved successful. Researchers discovered that it is important, after initial closure of entrances, to follow up soon afterward to ensure that blockages are intact. The road's lower end was not closed because it was used to access dispersed camping (figure 19).

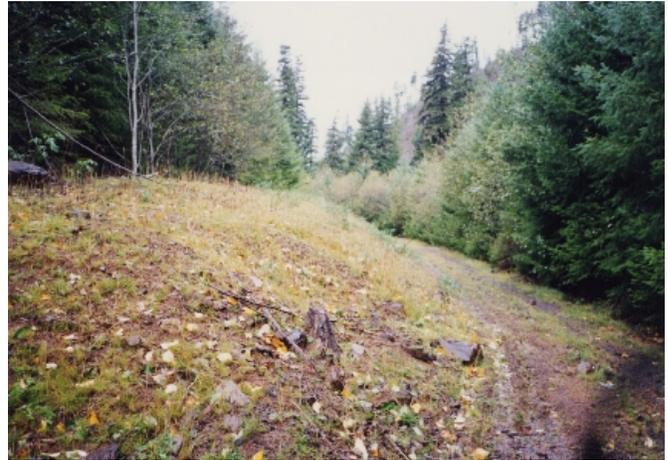
Figure 20—Native vegetation has started to grow back after two growing seasons.

Seed and mulch treatment placed on the rehabilitated roadbed was successful (figure 20). After two growing seasons, no evidence of erosion remains and native vegetation is growing. The culvert removal sites are functioning with no signs of erosion.

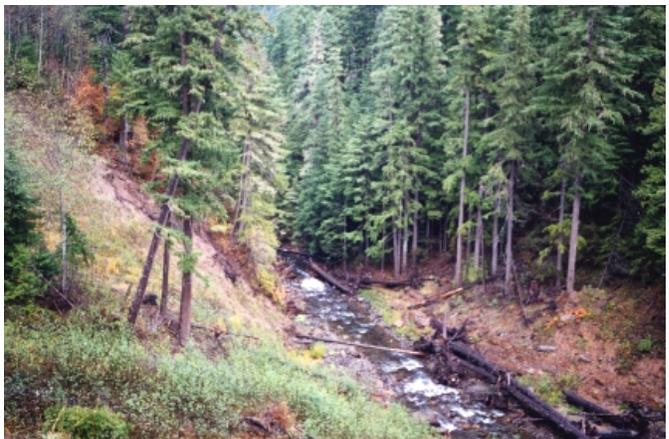
Figure 21—The river below the landslide. The removal of the road from the inner gorge provided an opportunity for riparian restoration.

The road, removed from the inner gorge, reestablished the riparian area (figure 21). Removing a log stringer bridge from over the river allowed a larger amount of bedload movement in the river during high flows and flood events. Culverts that impede fish passage are being removed and other improvements continue. A plan to reconnect the stream channel to its original channel and restore the riverbanks is in the design stage.

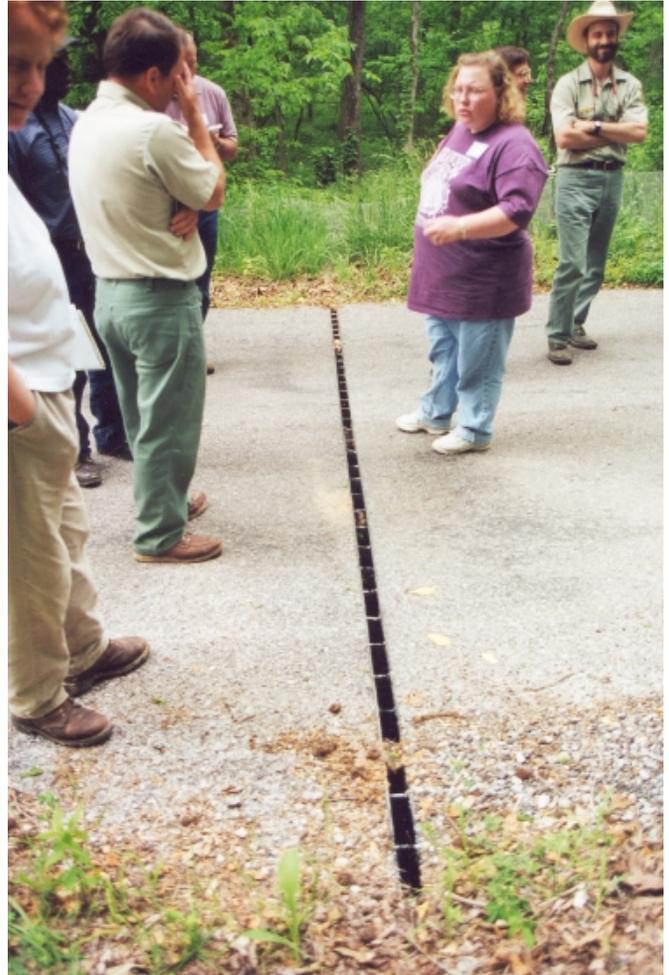
Figure 22—Closeup view of the slot in the roadbed.

According to Cynthia Morris, Shawnee National Forest, three crossings were installed during the road resurfacing at locations where there was evidence of heavy snake activity. The installations are similar to an 18-in culvert with a 12-in extended slot. The culvert was installed under the road and the slots were placed on top. The slots penetrate the roadbed, allowing sunlight and air to enter the culvert used by the reptiles (figure

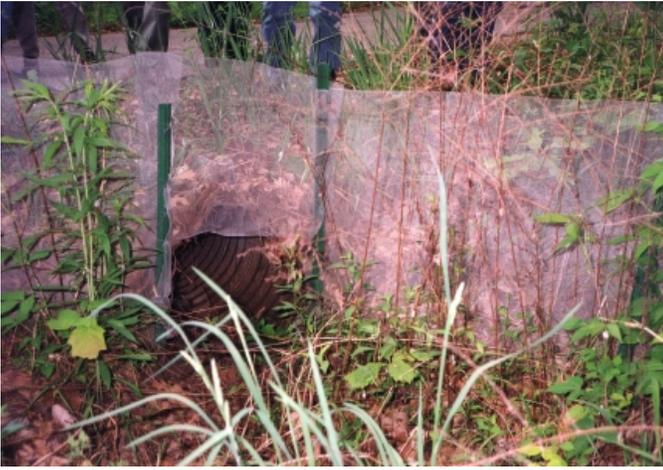
Figure 23—A culvert was installed under the road with plastic webbing to guide the reptiles into the culvert.

22). Plastic webbing was installed for 50 ft along the side of the roadbed to funnel the reptiles into the crossing (figures 23 and 24).

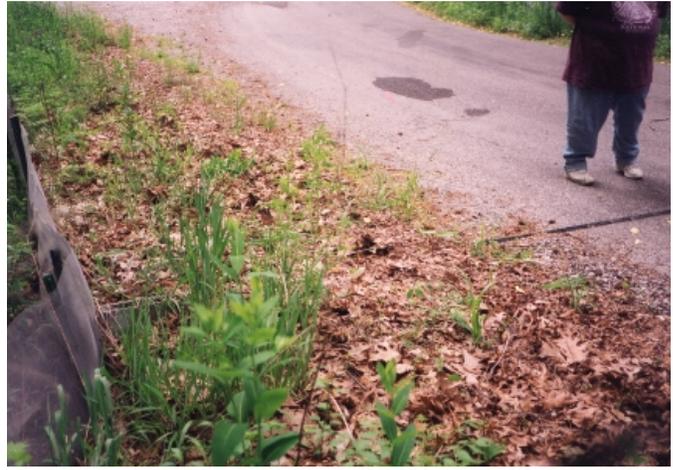
Figure 24—Plastic webbing and slot as viewed from the road.
