2400—Timber
December 1992
9224 1206—SDTDC

Detection of Foreign Objects in Logs —Demonstration Test

**1E01E76
Foreign Object Detection**

December 1992

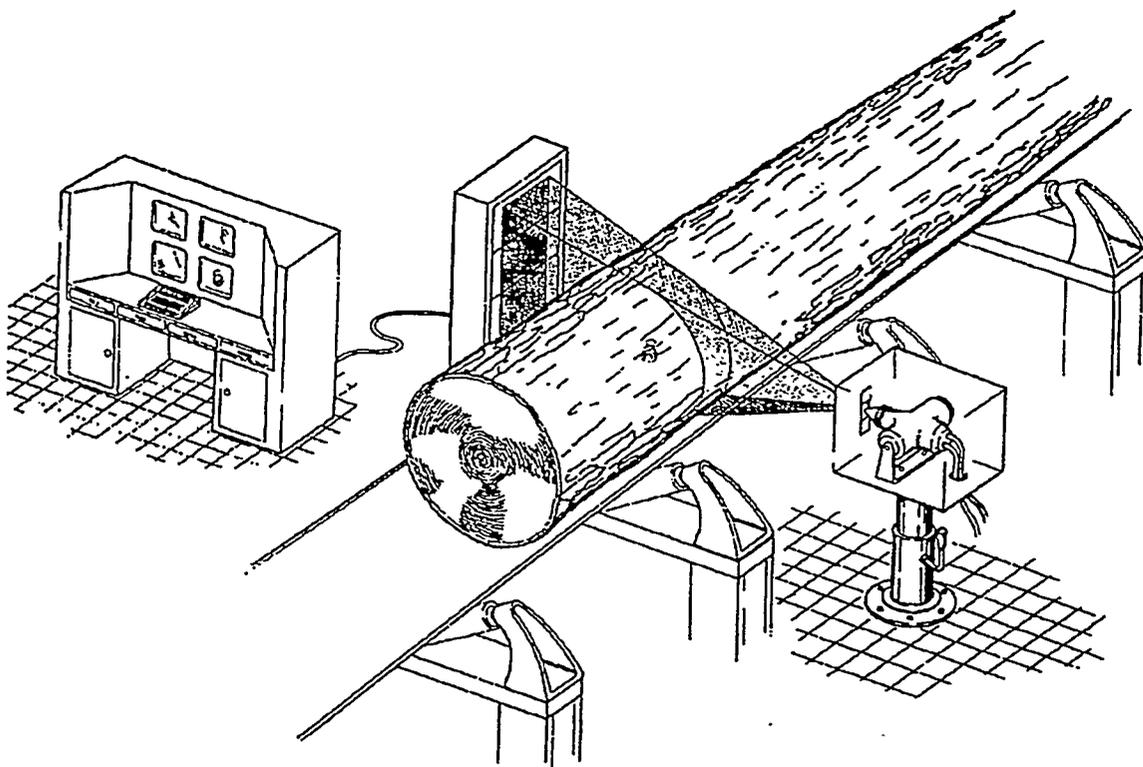
X-ray, sonar, and radar techniques. These proved unsuccessful in the field (fig. 1) due to the lack of power and image enhancement. Faced with these limitations, the Technology Committee changed the project objective to determine the feasibility of detecting foreign objects in logs at the mill site, rather than in standing trees.

Figure 1. Semiportable X-ray system.

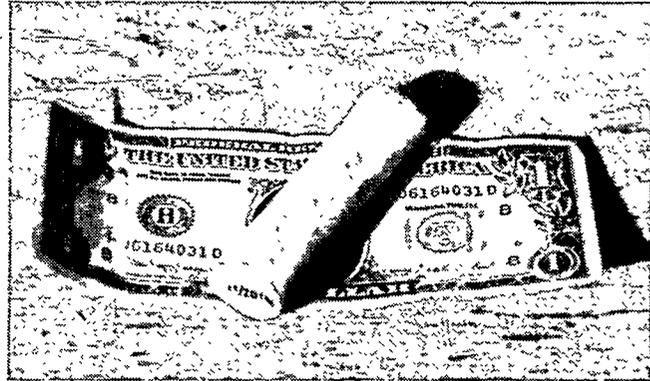
7. A *ceramic spike* (fig. 4), retrieved from a law enforcement case on the Siuslaw National Forest, Oreg., was inserted 6-1/2 feet from the base, into a hole 9-inches deep and 1 inch in diameter. This hole was not backfilled.

Figure 4. Ceramic spike used in tests.

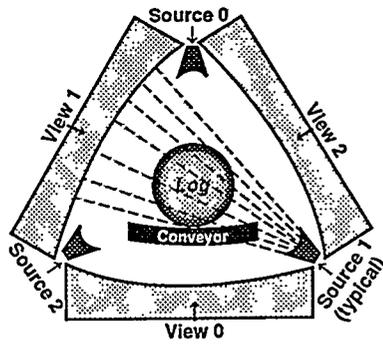
A scanner containing three X-ray sources, each capable of up to 420 kilowatts (kW) of power was utilized to examine the test logs. Each source was aligned on the radial axis of the test log, equally spaced at 120 degrees, and located on a 8.7-foot radius circle (fig. 6). With each X-ray source creating an image, three views of each log are observed immediately after the run on a black-and-white monitor (fig. 7). With the conveyor moving a log at 120 feet per minute through the scanner, data were recorded every 0.1575 inch.

Figure 6. Scanner uses three X-ray sources to provide three views.

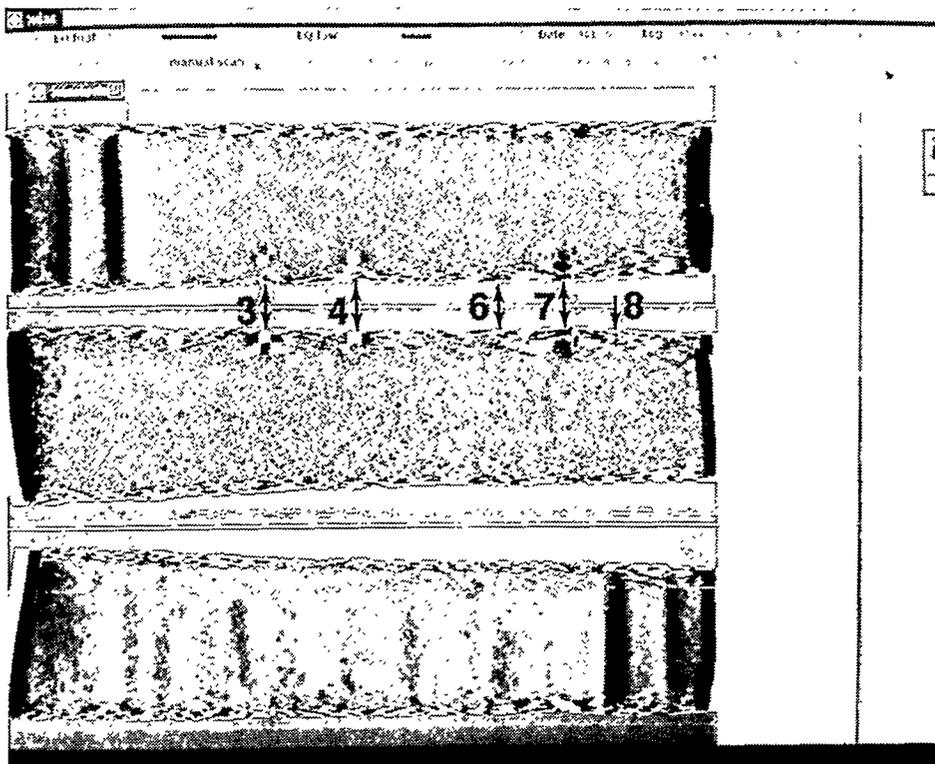
VIII. A large Douglas Fir log (log roll) traveling through the scanner under conditions identical to the Cedar and Hemlock logs above.

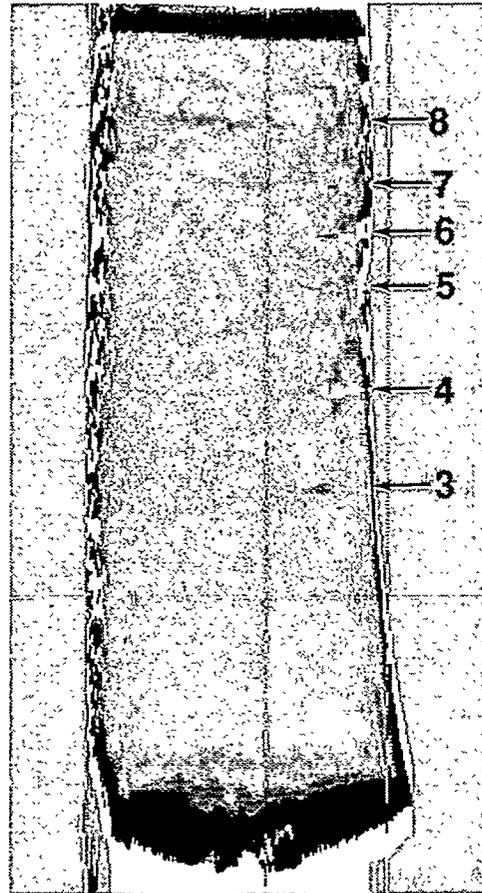
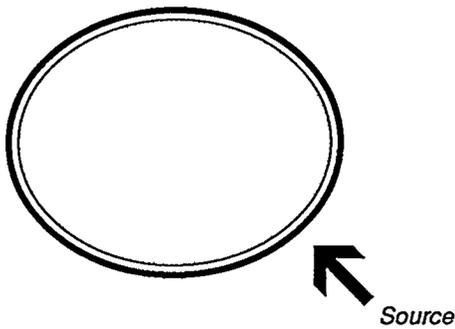
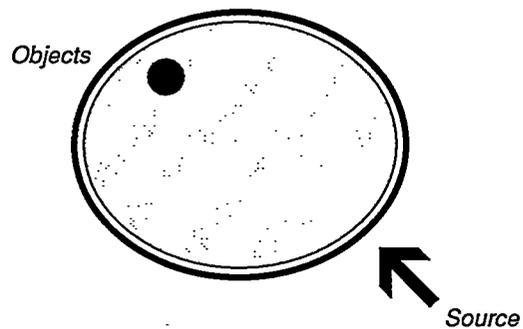
Print No I. View 0 of Log No 1 (36" diameter Douglas Fir) before inserting foreign objects.

Print No II. The same log with the objects in place.

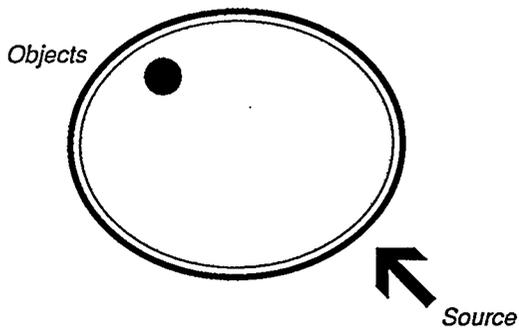
Print No III. Same log at lower conveyor speed.

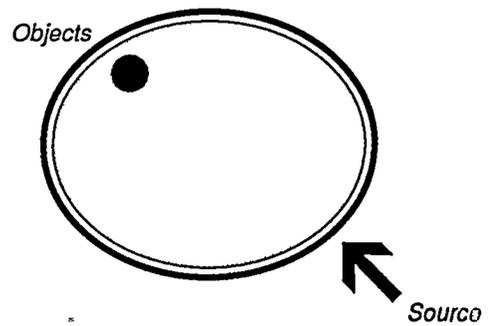
Print No IV. Same log with reduced power.

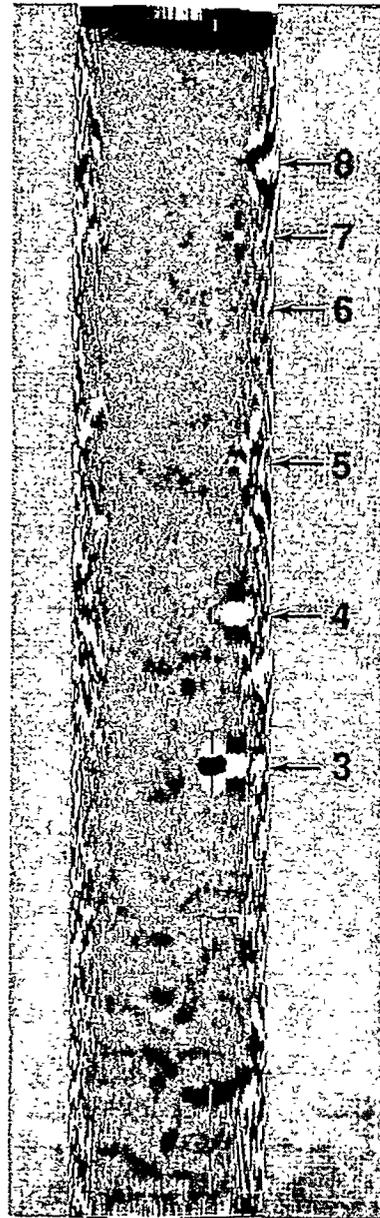
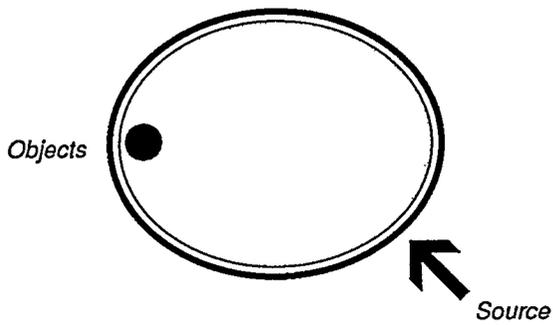
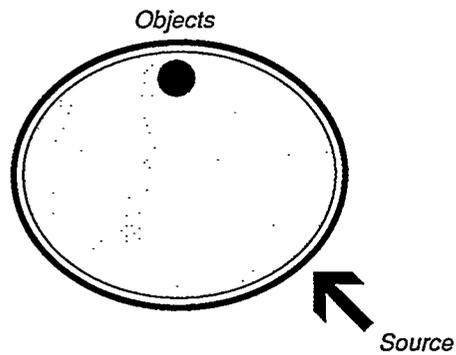
Print No V. Log #1 (same as Print No. III) except log has been rotated 90°.

Print No VI. Log #2 was less dense than Log #1 and had 4 times the moisture.

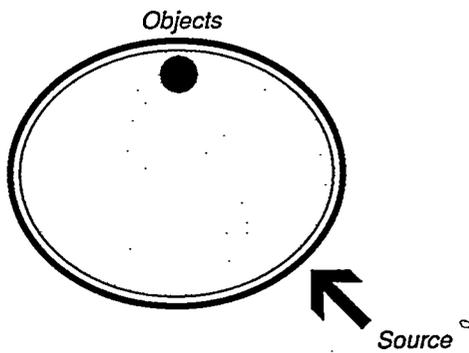
Print No VII. Log #3 had lower density than log #1 and 2 times as much moisture.

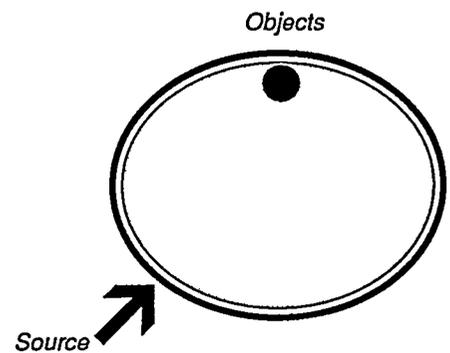
Print No VIII. Log #4 has larger diameter and 44% more moisture than log #1.

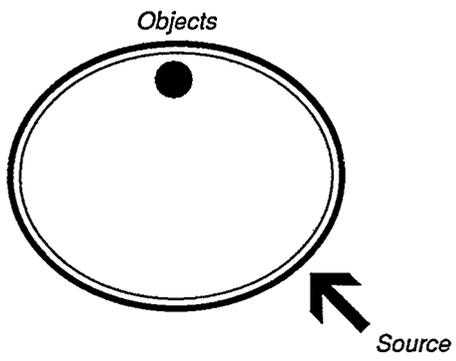
Print No IX. Log #4 shown from a different view.
