Gratings with Geotextile as Wetland Crossing

Lola E. Mason, Civil Engineer

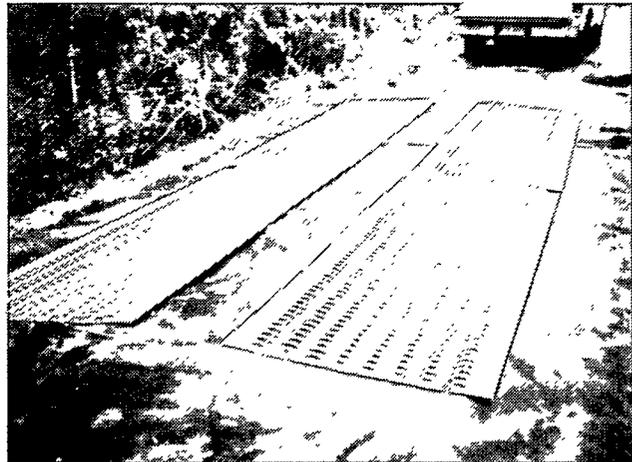
Figure 2. Deck span safety grating.

Grating was chosen due to it being unique to this use and readily available. Two types were chosen—figure 1: 4-pound expanded metal grating; figure 2: deck span safety grating (also called "heavy-duty steel grip strut® safety grating"). Nothing was known by the manufacturer concerning the performance of grating as a road surfacing material.

The *deck span safety grating* is made of 10-gauge, pregalvanized sheet metal that is 3 by 10 feet by 1-5/16 inches. The edges are left flat; the standard is bent into a channel. An eight-diamond design, with an opening that is 3-7/8 by 1-1/4 inches, is punched

into the steel. The punched areas have serrated edges, which make an excellent surface for traction. This grating is very heavy and considered much stiffer and stronger than the first type.

5. The pickup would drive to each wet spot for the grating to be unloaded (fig. 2).

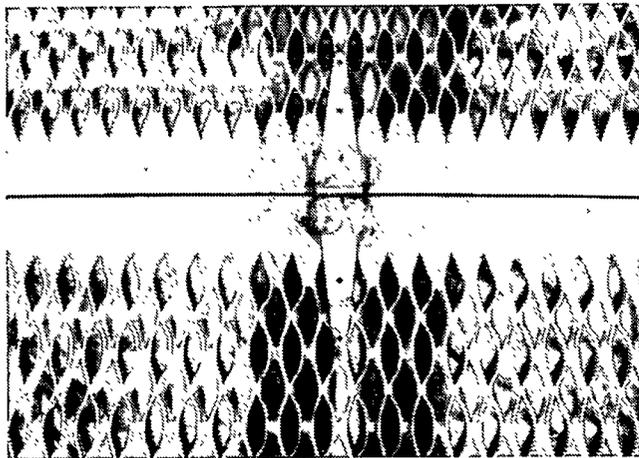
Figure 3. Wing hinge connection.

Prior to placement of the grating, some of the deck span safety grating was connected together to reduce the amount of “cold press.” Cold press is the slow deformation (bowing) of the sheet metal so that the ends curve up instead of laying flat. Cold pressing does not harm the grating, but it would necessitate flipping over the grating occasionally. It is unlikely that log truck drivers would stop to flip the grating over, making it necessary to decrease the amount of the bowing. Connecting the grating was also considered a means of reducing the installation time. Wing hinges were used to connect two sets of the heavy duty safety grating (fig. 3). One set was connected along the width edge, the other was connected along the length edge.

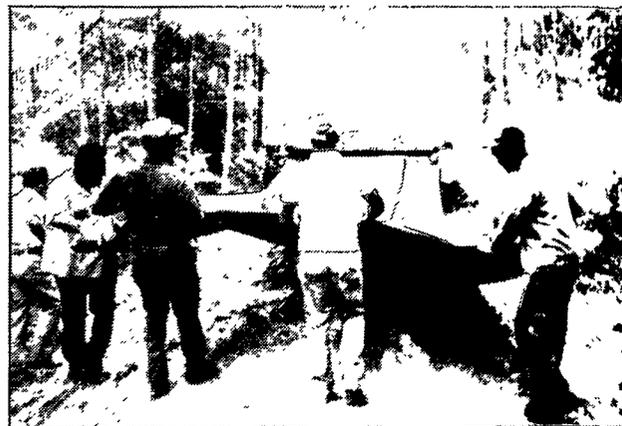
Figure 5. Steps 1 to 3—placing geotextile.

1. The road surface would be bladed or hand shoveled fairly smooth, removing deep wheel ruts (fig. 5).
2. A pickup truck would drive over the road carrying the roll of geotextile (fig. 5)
3. People behind the truck would hold one end of the geotextile at the beginning of each wet area and cut it off at the end of the wet area (fig. 5).
