7300–Facilities
October 2011
1173–2831P–MTDC

Buying Time: Mothballing Forest Service Facilities

**8E82L87 Guide To Temporary Closure
October 2011**

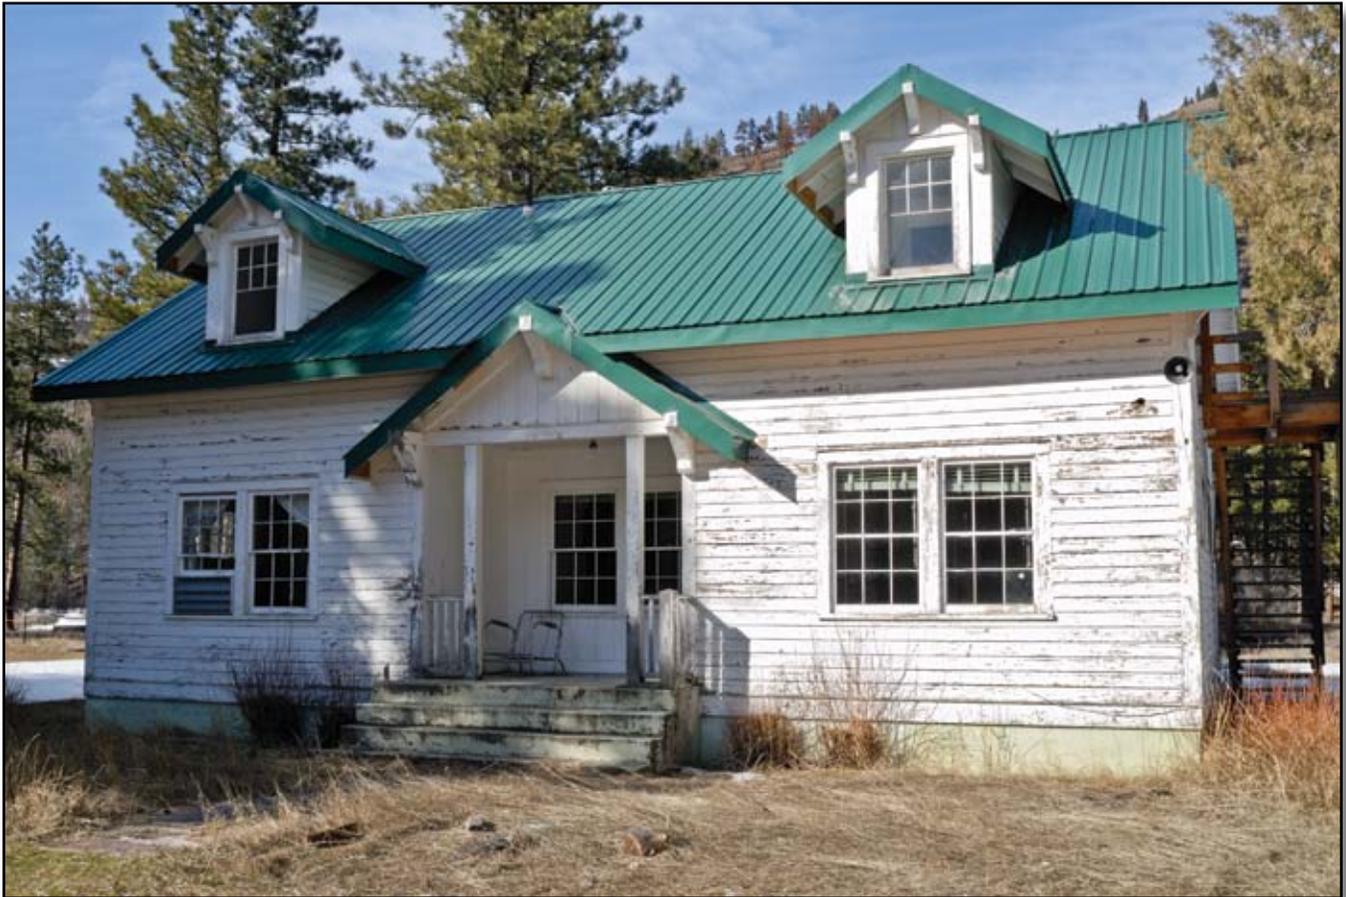
Figure 1—The Bonita Work Center bunkhouse, Lolo National Forest, MT, is mothballed.

Uncertainties about the future need for unused Forest Service buildings may encourage facility managers to hold onto structures that are not currently needed. Buildings that are not needed now, but might be needed in a few years should be “mothballed”—prepared so that they will not deteriorate. Mothballing buys time and maintains options for the buildings and their improvements (figure 1).

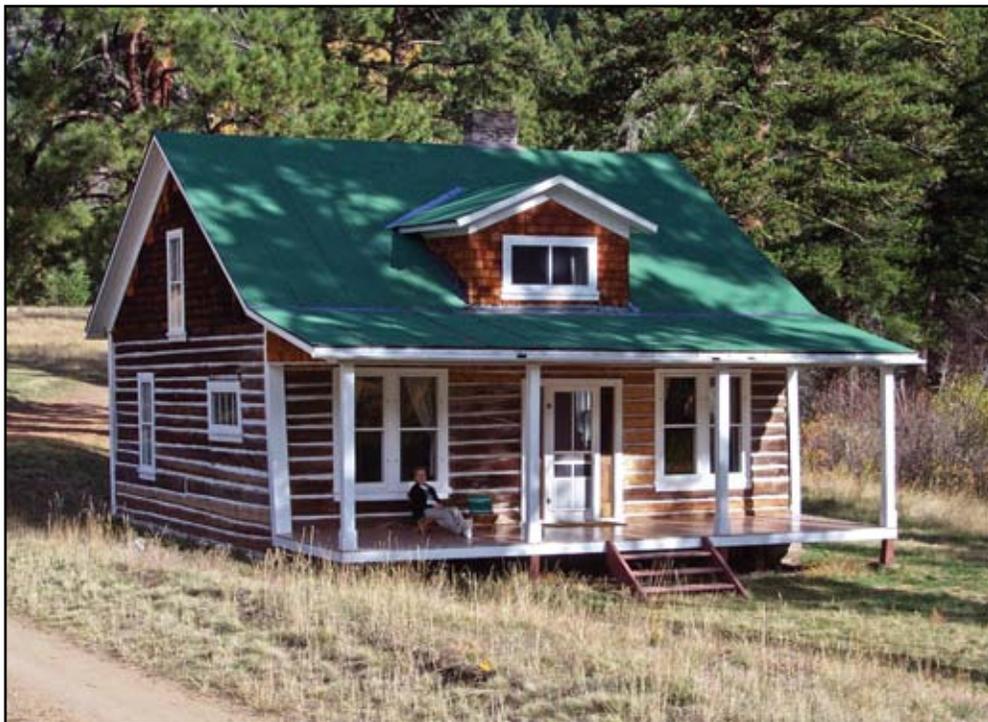
Figure 2—Hogback Homestead Cabin for rent at Rock Creek, MT, Lolo National Forest.

The best way to keep a building from deteriorating is to keep it occupied. Options for keeping the facility occupied include leasing the building to an agency or organization other than the U.S. Department of Agriculture, Forest Service. In certain situations, a facility may be rented as a recreational cabin under the Federal Lands Recreation Enhancement Act (figure 2).

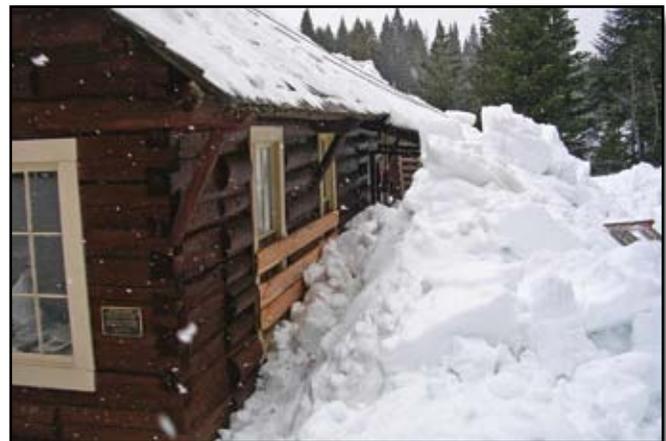
Figure 4—The Moose Creek Cookhouse on the Moose Creek Ranger District, Nez Perce National Forest, ID, relieved of a heavy snow load.

Stabilization of certain features may be needed before mothballing to slow deterioration of the building. "If either the roof or the foundation is in poor condition, you will need to stabilize it in some fashion before you can mothball the building" (Matthew 2009). Stabilization of the roof should take into account its structural ability to sustain snow loads in northern climates (figure 4). Structural stabilization should focus on bracing at the ridge and midpoints, particularly if the roof is sagging.

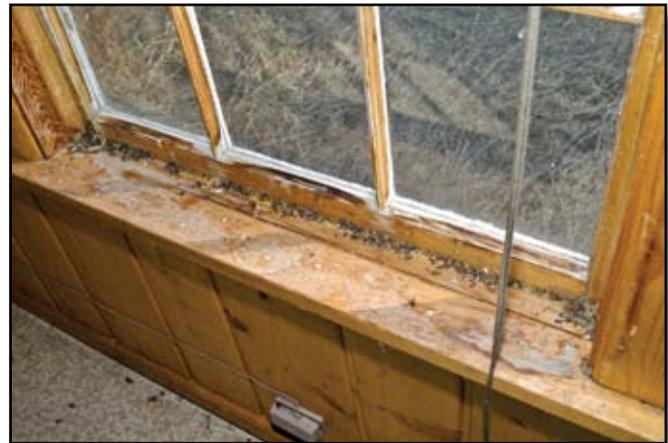
Figure 5—Insect infestations that have not been controlled before mothballing can quickly become apparent on windowsills and floors.

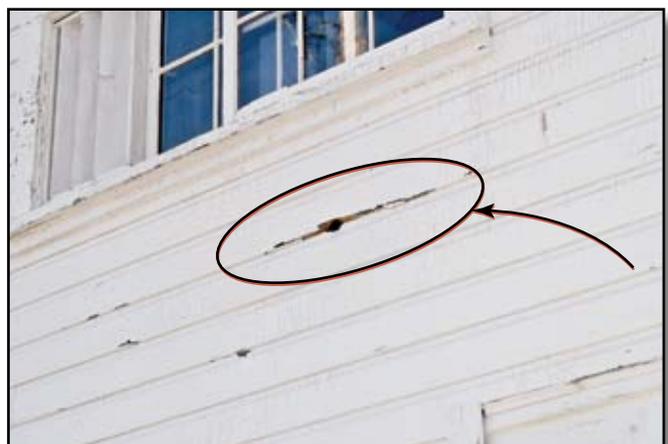
Figure 6—Birds or other animals can peck or chew the exterior of buildings, damaging a building that has been mothballed.

Even if animals or insects are kept out of a building, they can still cause extensive damage to the exterior. Birds and animals peck and chew surfaces on buildings, causing damage and sometimes creating new entry points for other animals and insects (figure 6), particularly if buildings are unoccupied.

Several approaches can be used to discourage this type of damage. MTDC has identified a habanero pepper coating that can protect Forest Service buildings, signs, wiring and fencing from damage by porcupines, horses, rodents, and possibly woodpeckers (Snodgrass 2005).

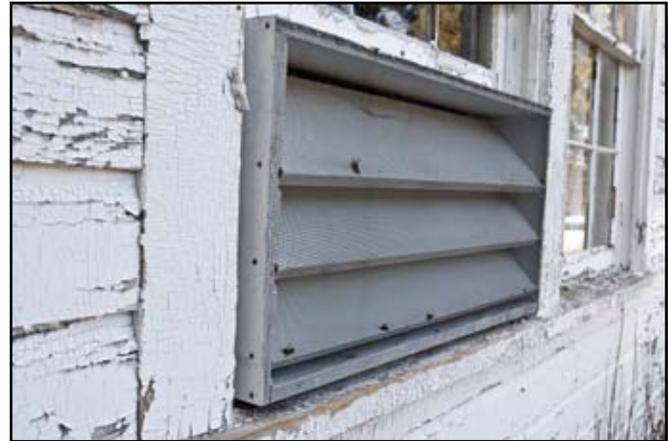
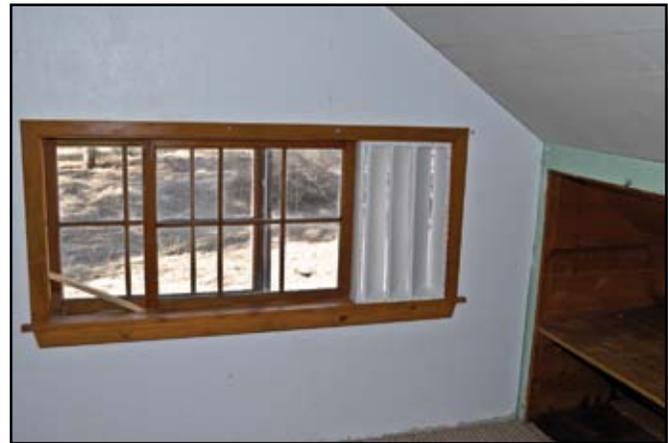
Figure 7a—Louvered window ventilation inserts on the Bonita Work Center bunkhouse, Lolo National Forest, MT (outside view).

Figure 7b—Louvered window ventilation inserts on the Bonita Work Center bunkhouse, Lolo National Forest, MT (inside view).

The ventilation system should be designed so that air can enter at ground level and leave at roof level. Cross ventilation in the attic as well as louvered window inserts can help achieve this type of air exchange (figures 7a and 7b).

Louvers should be constructed so that wind and weather can't enter. As a general rule, if the angles of the louvers are such that you cannot look through them, snow and rain are less likely to blow in. Also, in humid areas such as the Southeast, louvered window vents should be made of treated material to prevent deterioration.

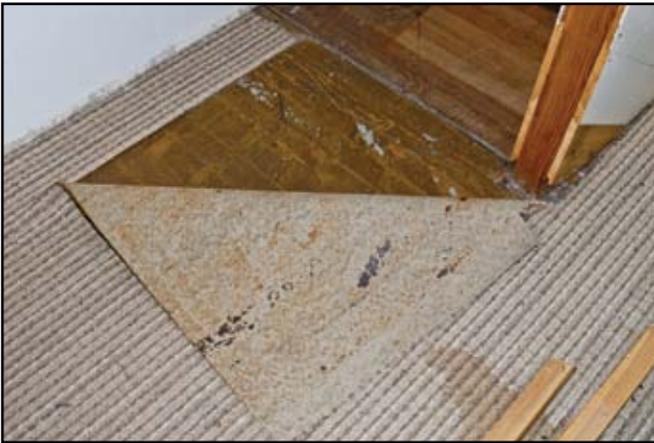
Figure 8—Pulling back carpets from floors can encourage airflow in the building.

At the least, fitted floor coverings should be rolled back from external walls (figure 8). Also any garbage, furniture, or other equipment should be removed. Keeping cupboards and drawers open also helps improve airflow (figure 9).

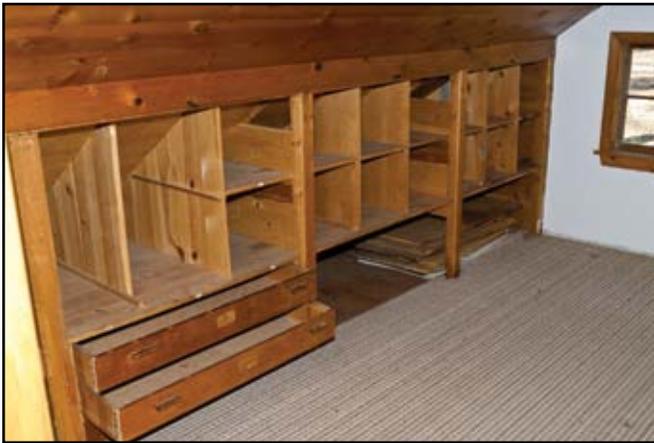
Figure 9—Leaving drawers and cupboards open can encourage airflow in the building.

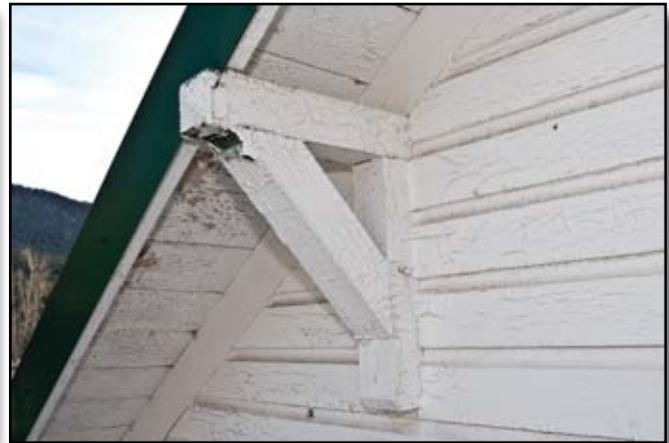
Figure 10—Damaged and flaking lead paint on the Bonita Work Center bunkhouse, Lolo National Forest, MT (outside view).

Older buildings may have lead-based paint. For example, lead-based paint was deteriorating at the Bonita Work Center bunkhouse (figure 10) when the bunkhouse was mothballed. In such cases, the facility manager's task should be to remove and secure the old paint and to repaint the structure. The tech tip "Lead-Based Paint: Planning Your Paint Removal

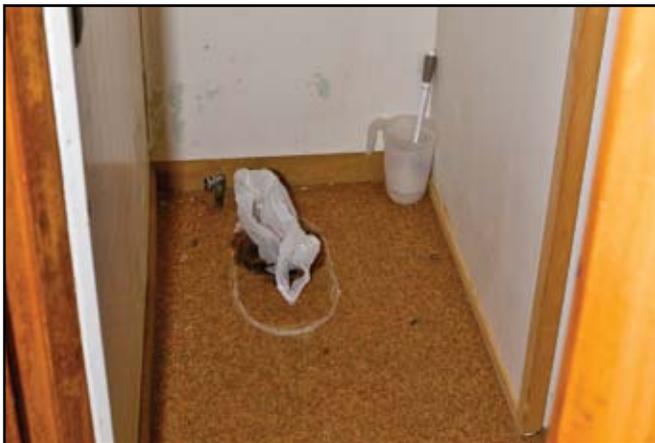
Figure 11—Toilets were removed from bathroom stalls and the drains were plugged in the Bonita Work Center bunkhouse, Lolo National Forest, MT.

If plumbing fixtures are not going to be kept in service, turn off the water supply and drain the pipes, toilets, water heaters, and any other water reservoirs. Disconnecting taps and plugging the plumbing to sinks and other fixtures are good practices. Removing toilets and plugging up the drains will discourage anyone from using them (figure 11).
