Appendix E—Log Building Origins and Styles

Plan and Form

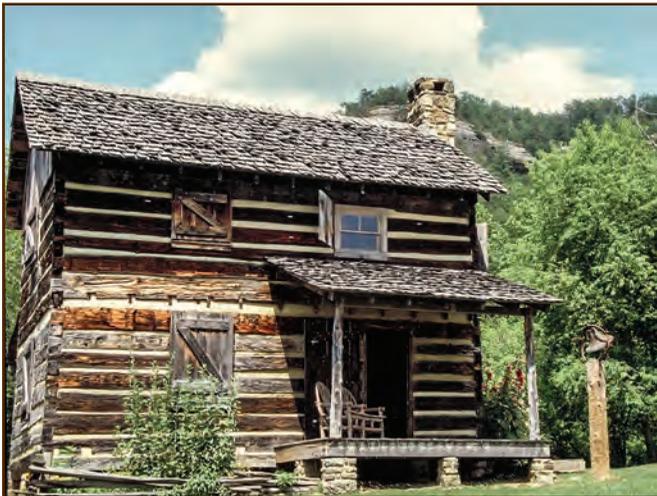
Figure E1—The two-story Gladie pioneer cabin, built around 1900, was restored as part of the Gladie Visitor Center pioneer homestead interpretive site in Kentucky (Daniel Boone National Forest, Southern Region). The builders constructed it of large diameter, hewn hardwood logs with half-dovetail notching and set it on elevated piers. It has a moderate pitch, hand-split shake roof, two full stories, and a stone fireplace on one end. The front and back doors are located under shed-roof porches on the long sides of the building.

As they moved westward, European-American settlers successfully adapted log construction techniques to regional materials, climates, and terrains (figures E1 and E2). The floor plan and shape of log buildings constructed in the 1700s and early 1800s sometimes can provide clues to the ethnic origin or route of migration of the original inhabitant or builder. Because the settlers often borrowed and copied techniques used successfully by their neighbors, don't infer too much about the ethnic origins of a cabin's builders from the way they constructed the cabin.

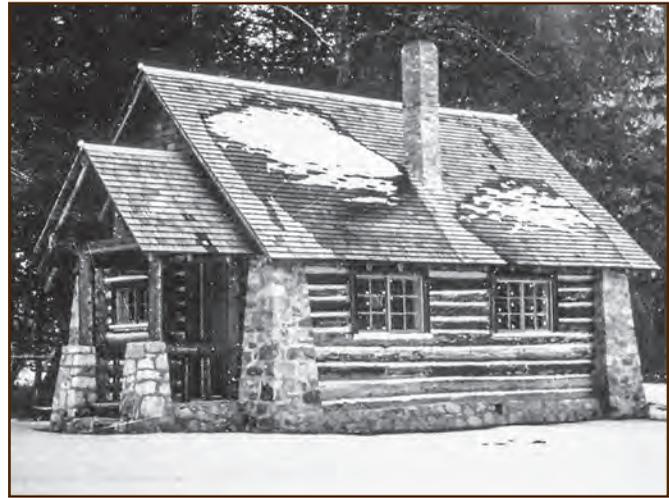
Figure E2—The builder of this cabin at the mouth of Big Timber Creek Canyon on the Big Timber Ranger District in Montana (Gallatin National Forest, Northern Region) used a stone foundation with massive, battered stone corners and porch piers, and moderate diameter, round, softwood log walls. The cabin has a steep cedar shingled roof and a rock chimney for a wood stove near the center of the building. The entry is on the gable end under a gabled porch. It was sold and removed from the site in the early 1980s.

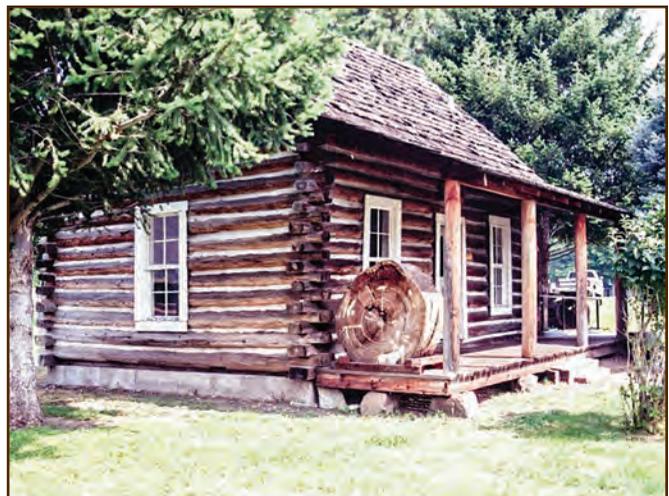
Figure E3—The original one-and-a-half-story Slate Creek Ranger Station, built in 1909 on a tributary of the Salmon River in central Idaho, is a single pen style cabin. It has a single room on the ground floor that served as an office and kitchen. The inhabitants used space under the rafters, accessed by a steep stairway, for sleeping. It was moved several miles from its original location after a new ranger station site was acquired in the late 1950s. The cabin is now used to interpret the life of early forest rangers of the Nez Perce National Forest in the Northern Region.

The basic unit of each of these types is the one-room enclosure formed by four log walls joined at their corners, called a single pen or crib (figure E3). People sometimes divided the single pen by interior partitions or enlarged them by adding another log pen. The typically mid-Atlantic “continental”

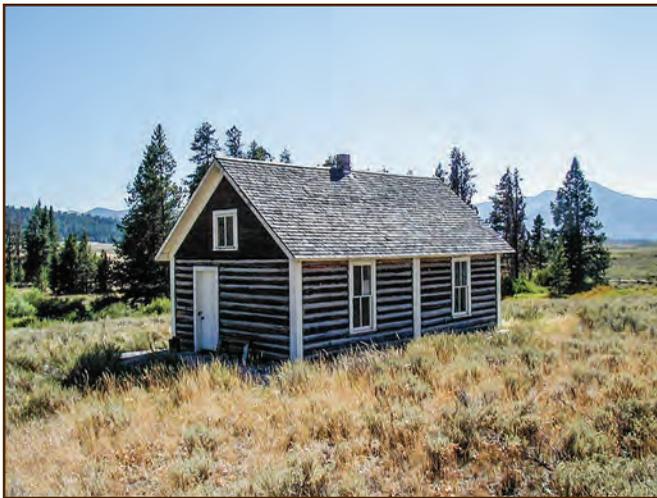
Figure E4—Builders constructed the saddlebag style Pole Creek Ranger Station in 1905 with post corners, posts at the junction of the two pens, and small diameter log infill walls. The characteristic central chimney serves a wood stove, rather than a fireplace. The cabin is located in southeastern Idaho's Sawtooth National Recreation Area in the Intermountain Region.

The saddlebag, or double pen plan (figure E4), was composed of two side-by-side log pens that usually shared a central chimney. Saddlebag buildings often resulted from adding a second pen onto the chimney end wall of a single pen.

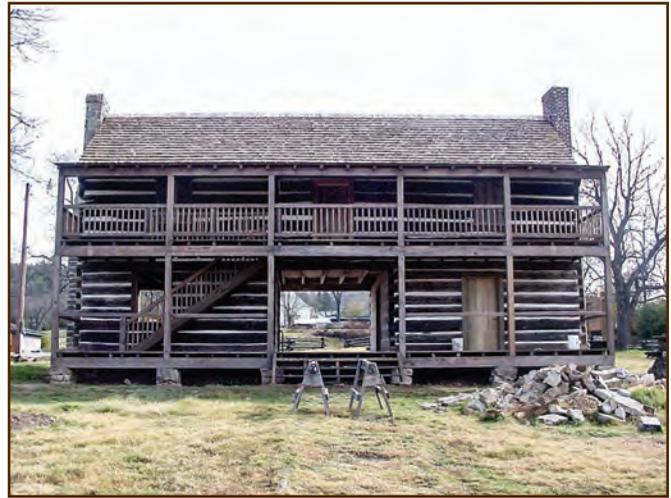
Figure E5—Builders constructed the two-story, dogtrot style Wolf House of hand-hewn yellow pine logs in 1829 on Wolf family land as a county courthouse. It is the oldest public structure, and possibly the oldest standing building, in Arkansas. It has served many purposes over the years. The building, restored from 1999 to 2002, now serves as a museum. It is located across the White River from the Southern Region's Ozark-St. Francis National Forest Sylamore District in the town of Norfolk.

The dogtrot plan (figure E5) had two pens separated by an open passageway (sometimes enclosed later), all covered by a continuous roof. People built variations of dogtrot buildings in many parts of the country, although the style sometimes is considered typically southern because its covered passageway provided air circulation and shelter from the heat.

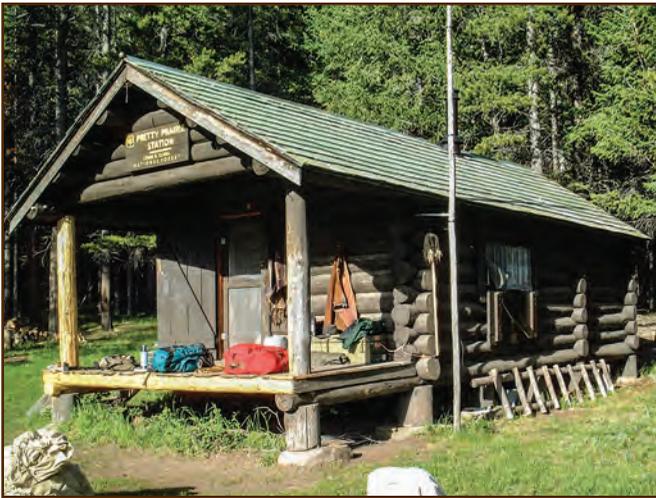
Figure E6—The Pretty Prairie Station, built in Montana in 1924 on the Lewis and Clark National Forest in the Northern Region, is a classic Rocky Mountain style double pen log cabin.

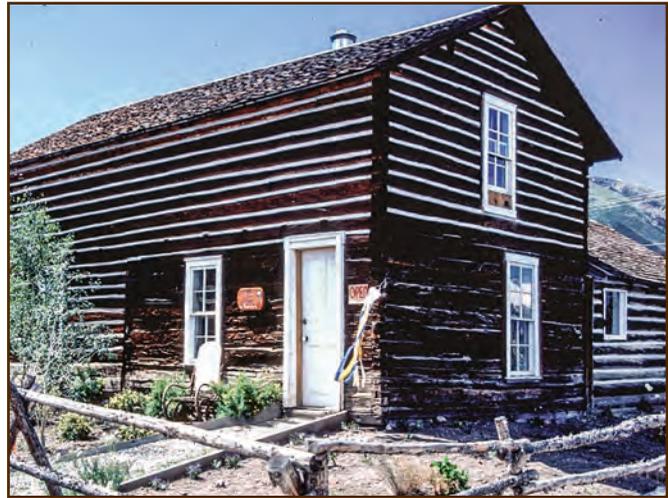
Figure E7—This substantial building in Frisco, CO, began as a small log cabin. Over time, the owners constructed a two-story addition above and beside the original cabin and added a wing behind it.

story to a single-story hewn-log house (figure E7). They accomplished the addition by removing the roof and gables, constructing a second floor, laying additional courses of logs, and building a new roof, or reassembling the old one. Sometimes, each generation of owners expanded a log building by adding on new log pens or masonry or wood frame extensions. They often added a rear “ell” or infill construction to link a formerly freestanding outbuilding, such as a kitchen, to the main house. Such a layering of alterations is part of the evolution of many log buildings.

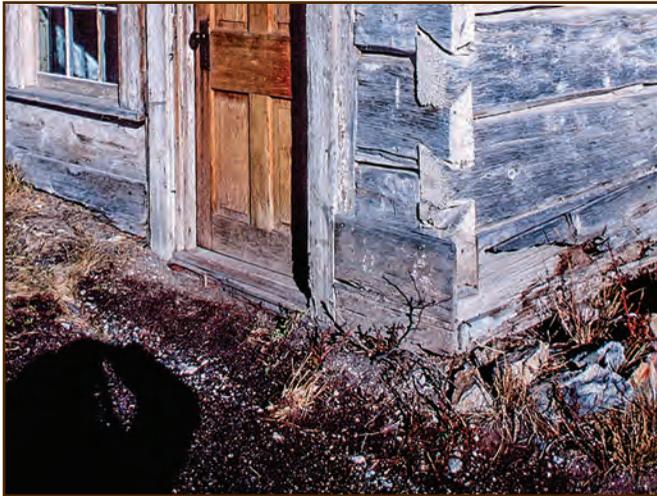
Figure E8—The builders constructed this cabin directly on the ground. The lowest logs of the cabin are rotting because the ground holds moisture against the logs, which enables fungi to invade the wood.

Most builders set their log cabins on foundations of some sort. To save time, some builders set their cabins on bare dirt. Cabins set directly on the ground usually had dirt floors and were intended as temporary shelters. Logs rot much more quickly when in contact with soil (figure E8) than when supported above the ground.

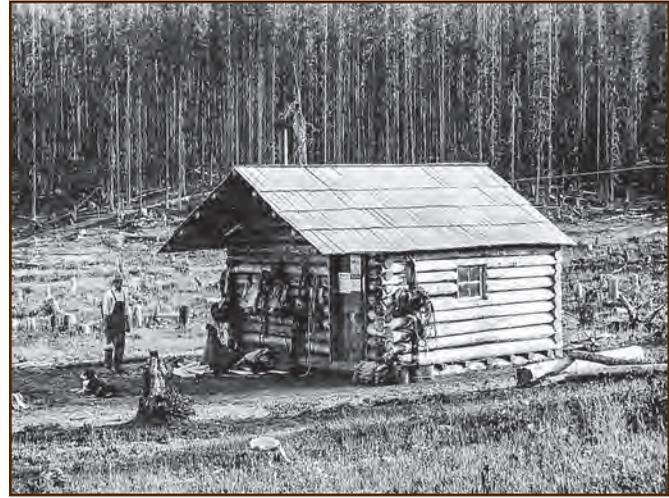
Figure E9—The log sleepers that support the Clearwater Springs Ranger Station cabin are clearly visible under the log floor joists in this photo. The builders constructed the cabin in 1913 and used it as a summer station in the Blue Mountains (Pomeroy Ranger District, Umatilla National Forest, Pacific Northwest Region).

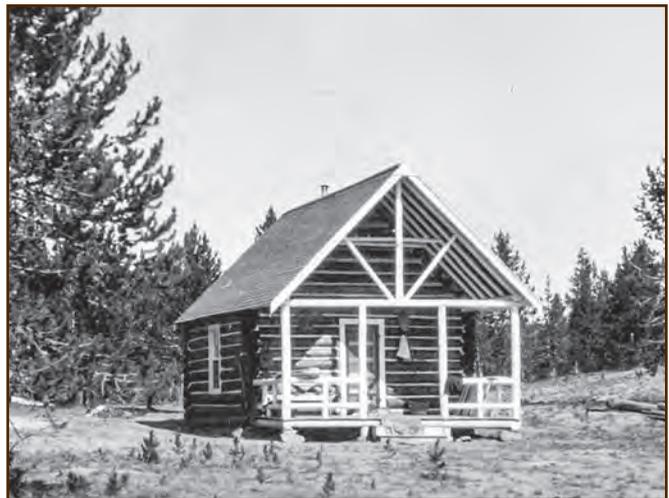
Figure E10—The builders constructed the assistant ranger's house at the Landmark Ranger Station on rock piers in 1936. The Landmark Ranger Station now is a seasonal-use guard station on the Cascade Ranger District in central Idaho (Boise National Forest, Intermountain Region).

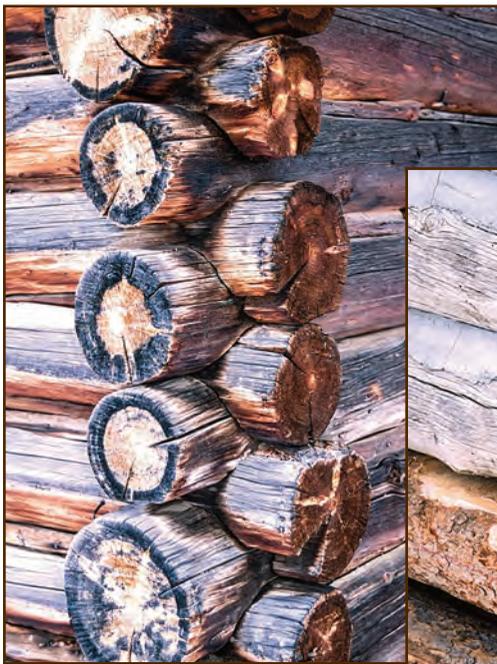
Figure E11—A saddle-notched cabin corner.

Builders used several corner-notching techniques throughout the country. Simple saddle notching (figure E11), which demands minimal time and hewing skill, may be the most common. "V" or steeple notching (figure E12) also

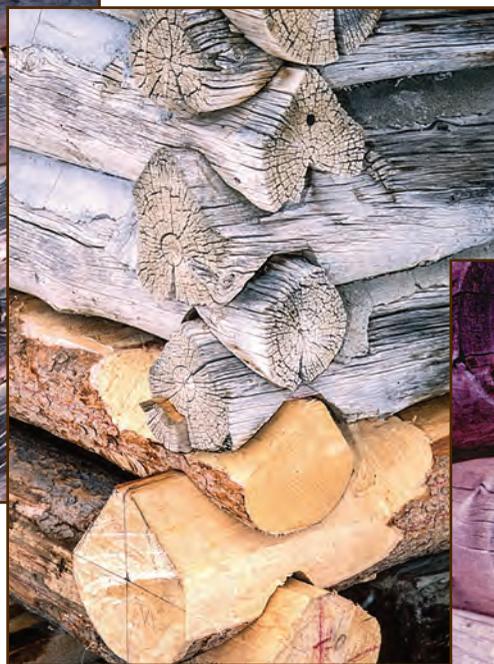
Figure E12—A steeple- or V-notched, cabin corner.

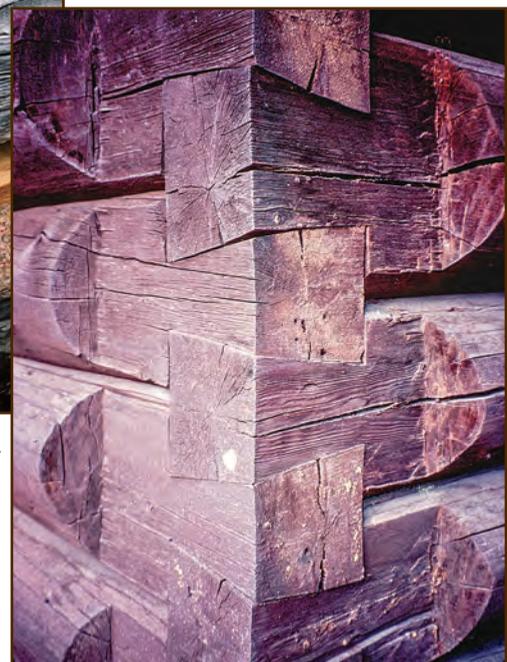
Figure E13—A full-dovetail-notched cabin corner.

is common. Full dovetail notching (figure E13) is one of the sturdiest notching techniques, but also is the most time-consuming to accomplish and requires a high level of craftsmanship. Half dovetail notching (figure E14) is more common because it provides nearly as secure a joint as full dovetail but is easier to craft. Square notching (figure E15) was secured with pegs or spikes because the logs did not interlock. A variation of square notching, called step and lock notching (figure E16), provided some stability. Historically, builders seldom used butt and pass corners. These corners require evenly sized or milled logs stacked in level rows, which alternately butt against and protrude past the perpendicular log, and must be fastened using pegs or spikes.

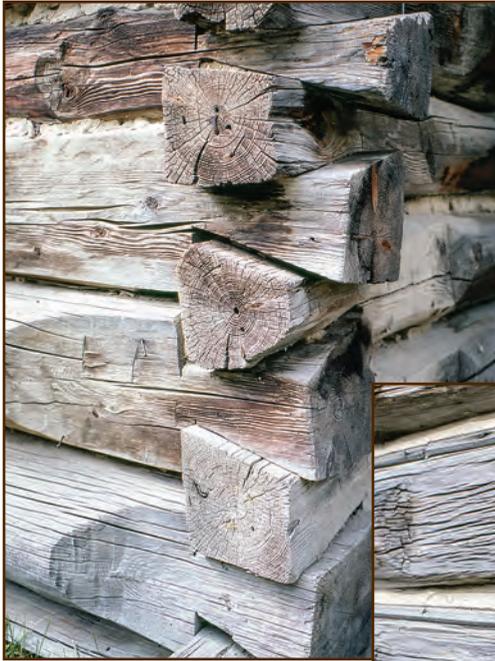
Figure E14—A half-dovetail-notched cabin corner.

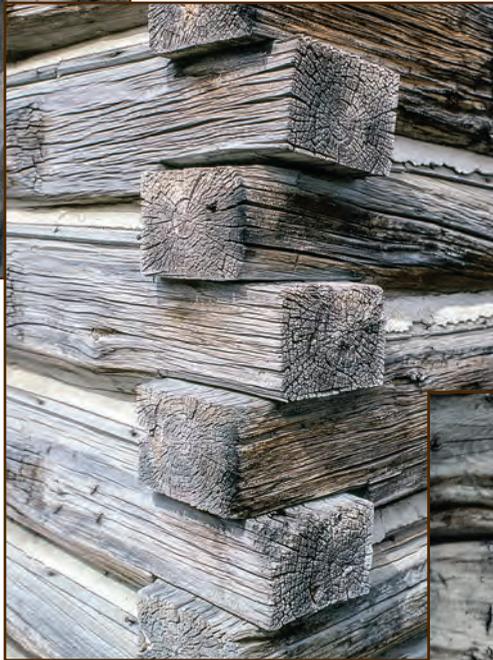
Figure E15—A square-notched cabin corner.

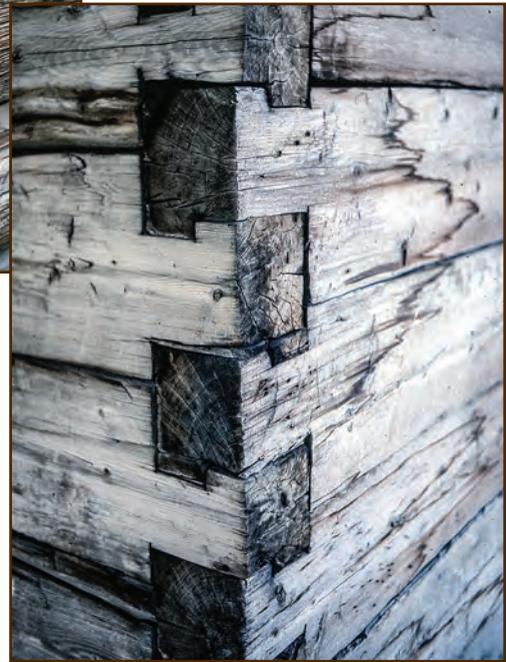
Figure E16—A step-and-lock-notched cabin corner.

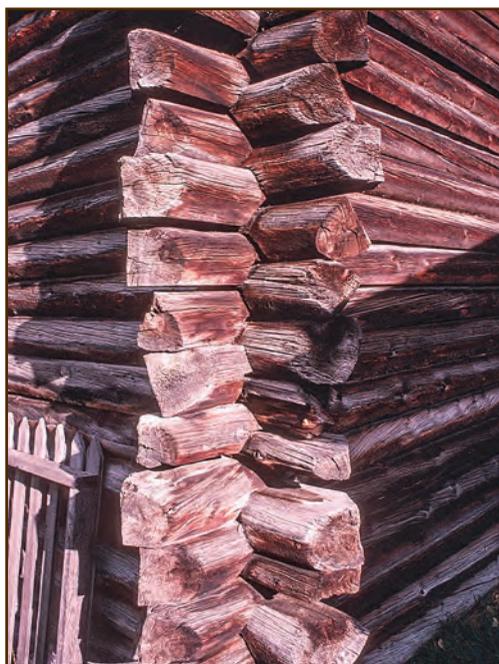
Figure E17—Irregular, wedge-shaped crown ends that extend beyond the corner notches.

Some of the earliest eastern cabins and most 19th-century western cabins (particularly those with saddle notching) had an extended log end or crown (figure E17) beyond the corner notches. The builders sometimes left the crown ends ragged, but often shaped them. Chopper-cut crown ends were wedge-shaped and oriented horizontally, vertically, alternately horizontally and vertically, or randomly (figure E18). The builders sometimes gave crown ends a conical or beaver-chewed shape. Rustic style structures, in particular, had pronounced or exaggerated crowns that people sometimes cut progressively shorter toward the top of the wall, creating a buttress effect at the corners of the building (figure E19). Builders frequently sawed ends evenly for a “Lincoln Log” look (figure E20). Builders seldom used extended crowns on buildings with dovetail or square notching and, of course, couldn’t use them on buildings with corner posts or boards.

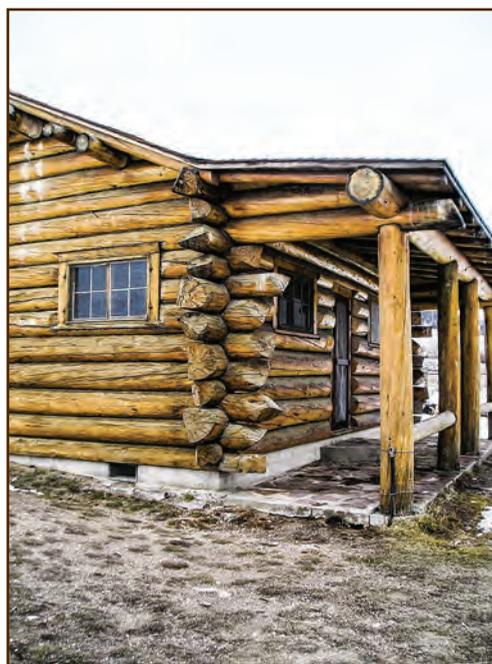
Figure E18—The random length and orientation chopper-cut crown ends extend beyond the corner notches on the Horse Prairie Guard Station (Beaverhead-Deerlodge National Forest, Northern Region).

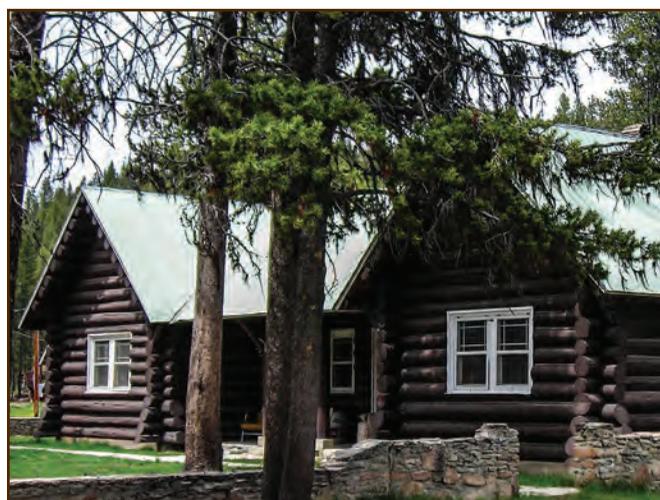
Figure E19—The crown ends of the logs at the corners of the rustic style Elk Creek Ranger Station Office are sawn longer near the ground for a buttress effect. The 1934 office is now a work station of the Lowman Ranger District (Boise National Forest, Intermountain Region) in southwestern Idaho.

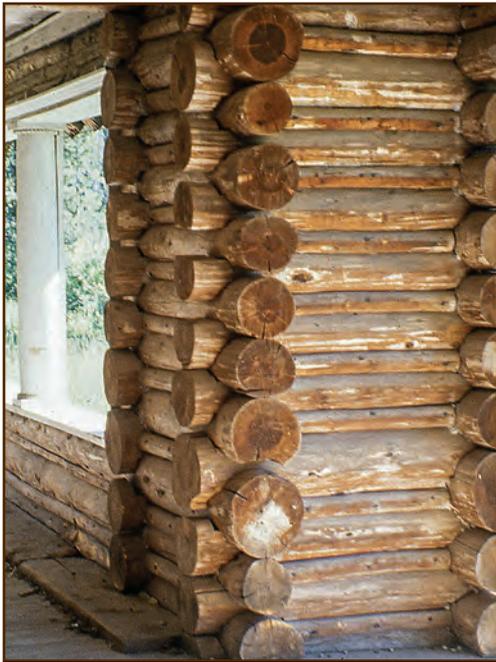
Figure E20—The evenly sawn crown ends impart a “Lincoln Log” look to the porch of the 1907 Upper Mesa Falls Lodge. This two-story log structure with a veranda was closed in the 1930s. It reopened after the Targhee National Forest (Intermountain Region) partnered with the Idaho Department of Parks and Recreation to renovate the building in 1993.

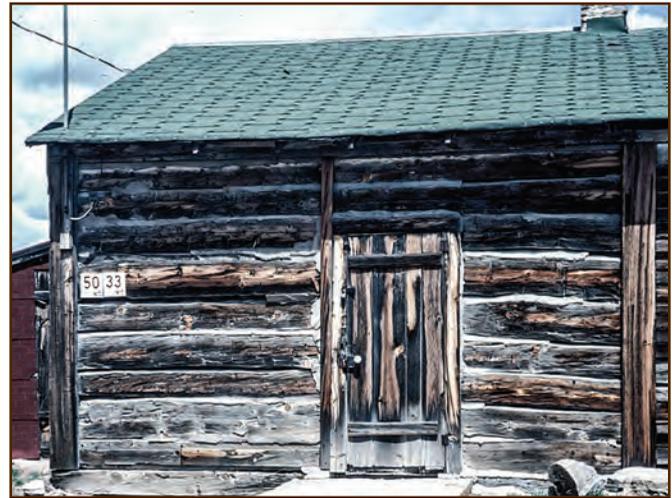
Figure E21—The stage stop in Virginia Dale, CO, has a post and beam structure with stacked log infill walls. The original roof was cedar shingles.

Some post and beam-supported buildings had stacked logs as infill walls between the posts (figure E21). Usually, builders pegged or nailed the log ends into the corner posts.

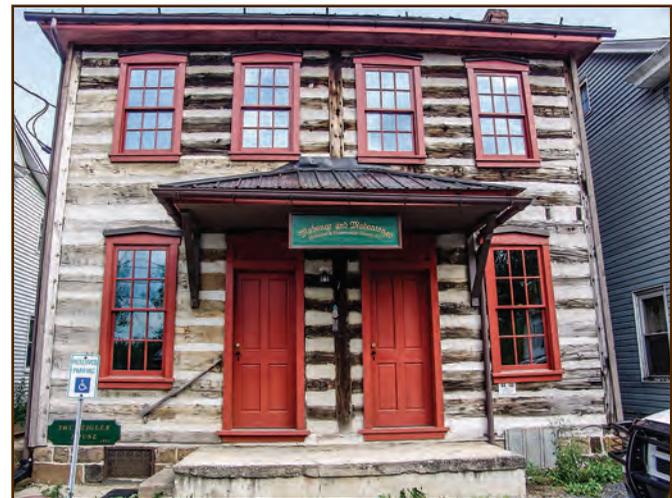
Figure E22—The builders drove pegs through the corner posts into tenons of each wall log on the 1843 Zeigler House in Dalmatia, PA.

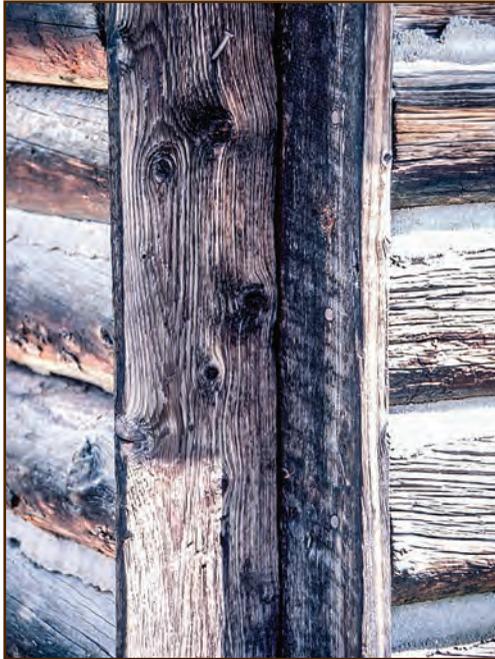
Figure E23—The nails are visible where the builder nailed this hog trough board corner to the stacked log walls.

When the builders were in a hurry and not concerned about making the building last a long time, they sometimes used spikes, nails, or pegs to attach logs to vertical corner planks. This corner-fastening method is called hog trough (figure E23).

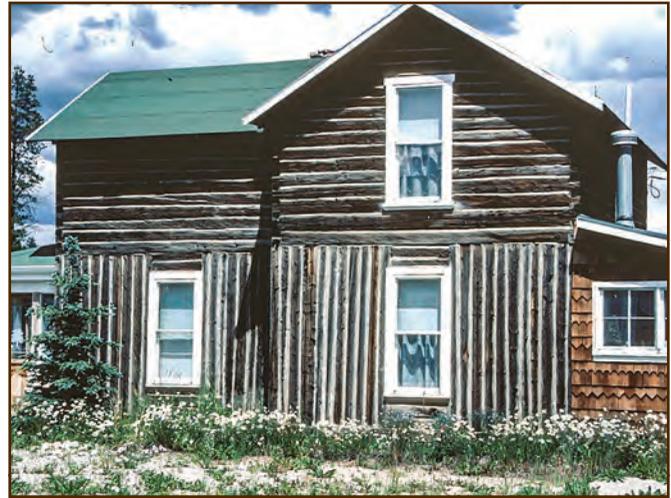
Figure E24—The builders constructed the first floor of this home in Frisco, CO, using stockade style log construction, except at the windows, where they stacked the logs horizontally.

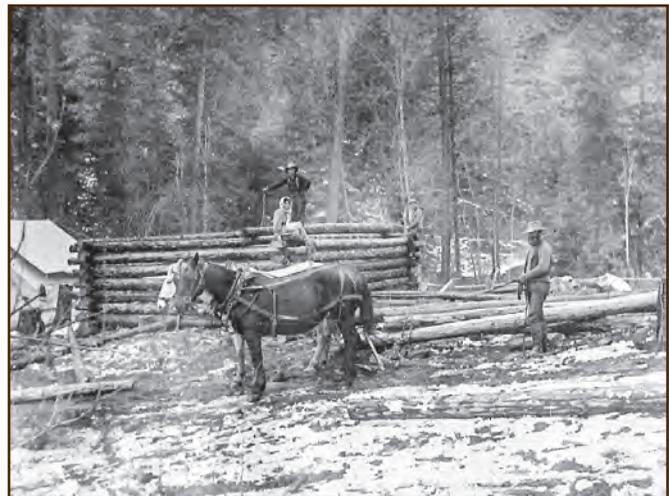
Figure E25—Builders used a team of horses to drag logs to the location where they constructed the original Slate Creek Ranger Station (Nez Perce National Forest, Northern Region) in 1909.

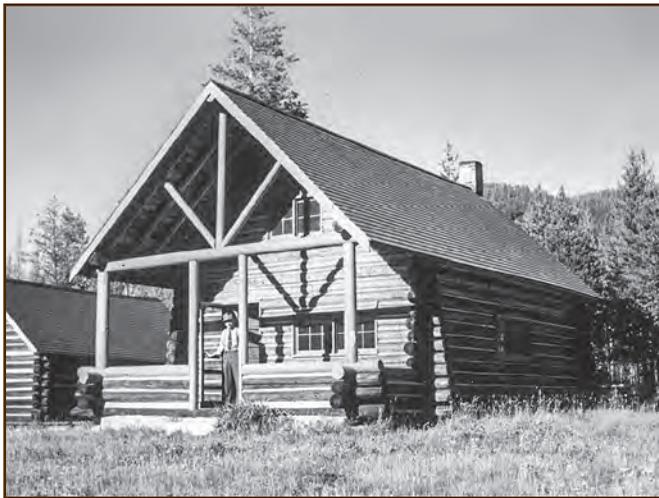
Figure E26—The builders constructed the Stolle Meadows Guard Station on the Cascade Ranger District (Boise National Forest, Intermountain Region) in central Idaho using round logs carefully selected for similar size and little taper.

Most builders constructed cabins of round logs (figure E26), but they sometimes sawed logs into thick planks, or used a broadaxe or adz to hew one or more sides of the logs flat (figure E27). Similarly, most builders used round logs for roof framing and floor joists, but sometimes hewed or sawed them from larger logs.

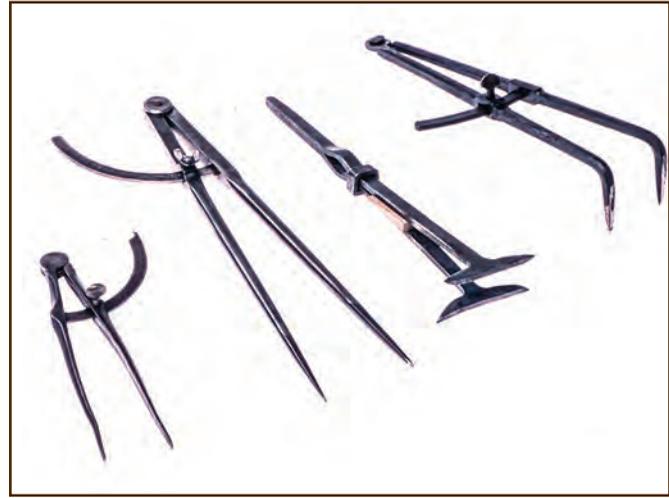
Figure E28—An assortment of older log scribes.

Builders found log dogs handy to keep logs in place while working on them. They used an axe, hatchet, or saw to make notches. Sometimes they used a log scribe (figure E28) to mark the notch and a chisel to make the cuts more precise. To

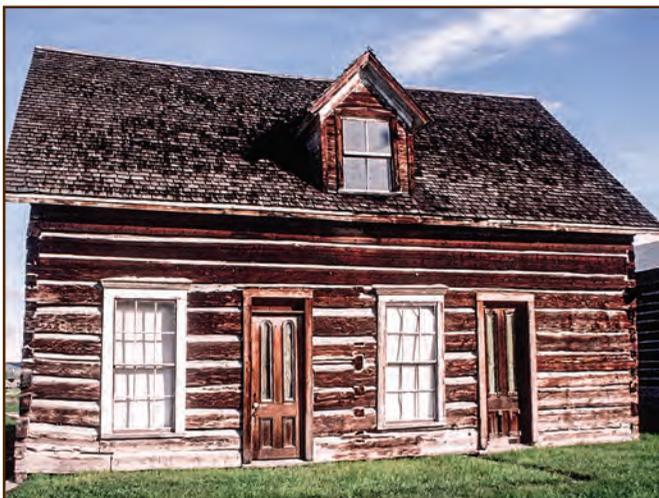
Figure E27—The builders constructed the Switzer House in Nevada City, MT, using hewn logs. This building is one of just a few log duplexes ever built.

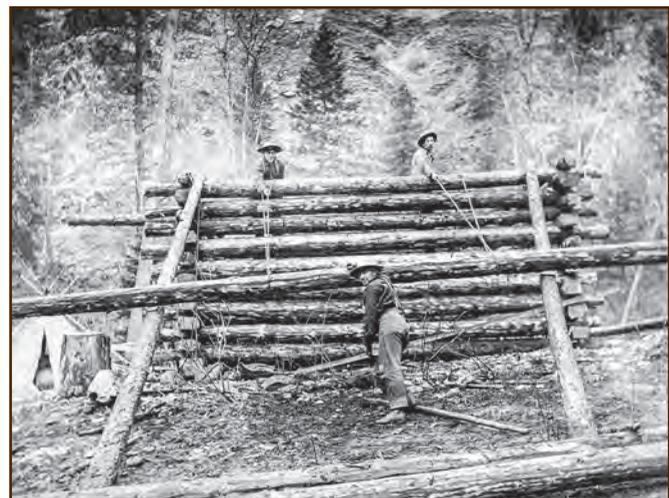
Figure E29—This crew of three men used ropes and skid logs to raise the logs into place on the upper portions of the walls of the Slate Creek Ranger Station (Nez Perce National Forest, Northern Region) during construction in 1909.

Using skid poles and ropes, only a few people are necessary to raise logs into position (figure E29). Although people usually notched the logs at the top and bottom of windows and doors as they set them, they usually sawed out the rest of the logs for these openings after setting all the logs into place.

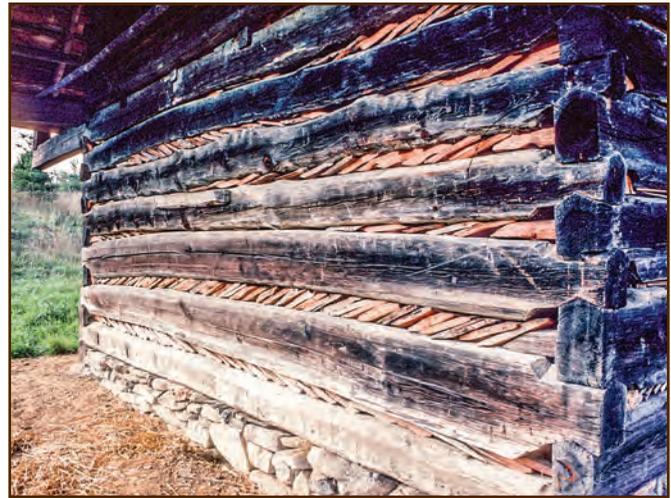
Figure E30—The builders used slate as chinking between the logs on this cabin. They laid the pieces of slate on wood blocking to angle them toward the outside of the building to help shed rain.

If the gaps between the logs were large, chinking could be a two-part system. First, the builder stuffed a dry, bulky, rigid blocking, such as wood slabs or stones (figure E30), into the joint. Next, the builder used soft packing filler, such as oakum (figure E31), moss, clay, fabric, newspaper, or dried animal dung, to fill the cracks between the blocking. Sometimes the builder tacked nails in on the lower log to hold the blocking or filler in place before applying the daubing to cover both the chinking and the nails.

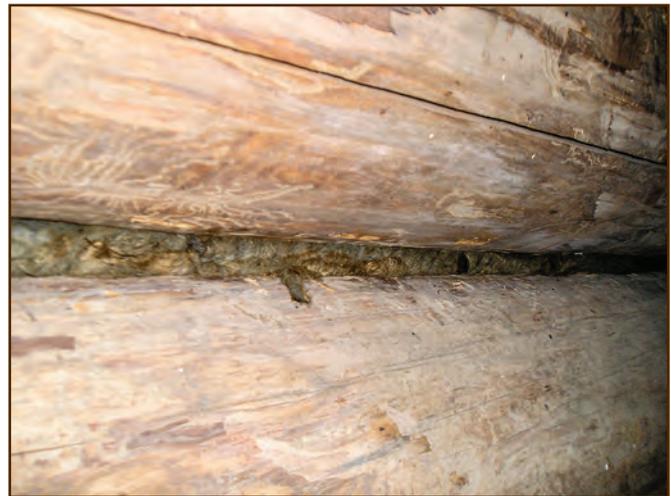
Figure E31—The builders used oakum for chinking on the office/cookhouse building at the Moose Creek Wilderness Station (Nez Perce National Forest, Northern Region), built in 1921.

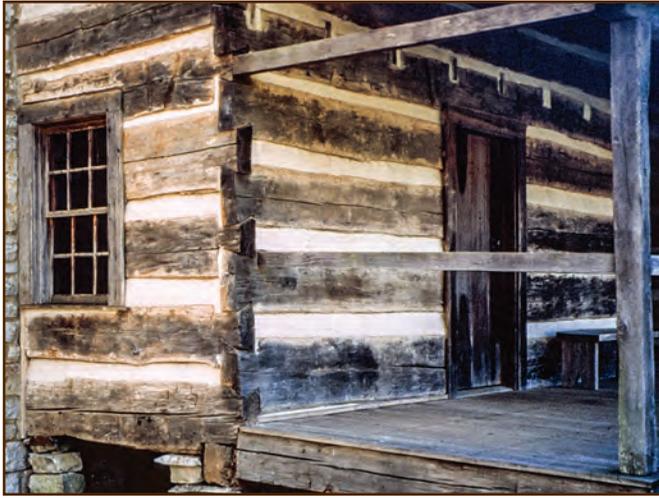
Figure E32—The builders sloped the finely crafted daubing on this hewn log home to shed rain and protect the tops of the logs.

Daubing, which completes the system, is the outer finish layer (figure E32). Daubing traditionally was a wet-troweled mixture of some combination of sand, clay, and lime (figure E33) and, after 1900, sometimes included Portland cement in addition to or completely replacing the lime. Builders often sloped daubing to protect the tops of logs and shed rain.

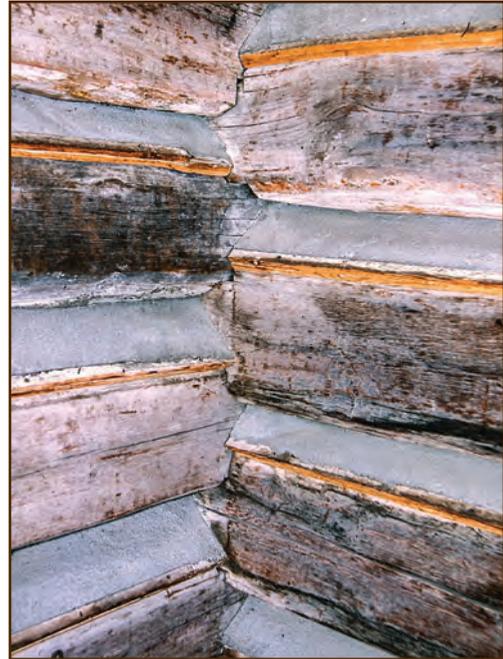
Figure E34—The builders used small pieces of wood trim as edging for the sloped daubing on this hewn log cabin. Preservation crewmembers replaced some of the edging (brighter colored wood) when they repaired the daubing.

Sometimes builders used narrow wood strips as an edging for the daubing (figure E34). Occasionally, they used more inventive methods, such as wire tacked to the logs, as reinforcement for the daubing (figure E35). Builders often used nails only partially driven into the logs as a sort of reinforcement to help keep the daubing in place.

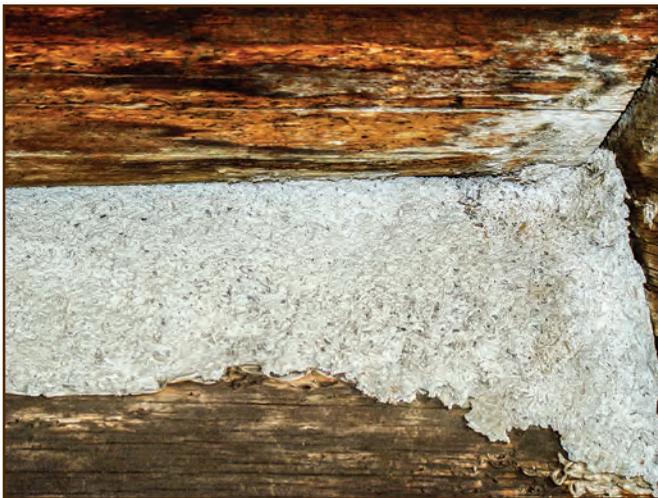
Figure E33—The daubing on this cabin in Sunlight Basin in Wyoming has an unusual texture. It probably was made using local limestone or sand that contained the fossilized remains of small sea creatures. The cabin originally was part of a homestead ranch, but now is part of a Wyoming Game and Fish field station.

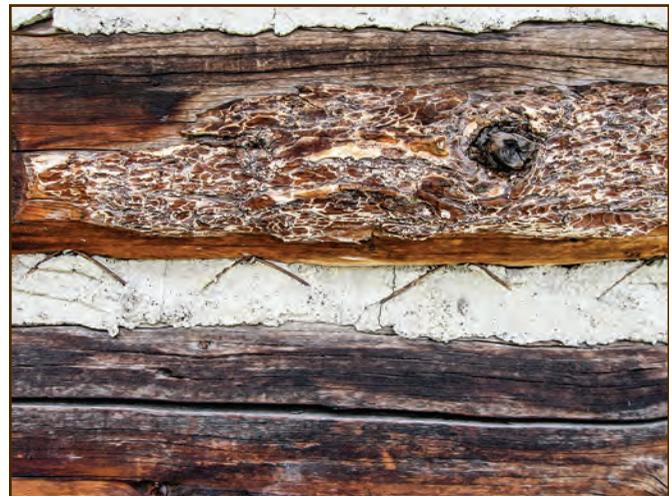
Figure E35—The builders tacked smooth wire to the logs in a zig-zag pattern to provide reinforcing for the daubing on the Fritz Cabin (Dubois Ranger District, Caribou-Targhee National Forest, Intermountain Region).

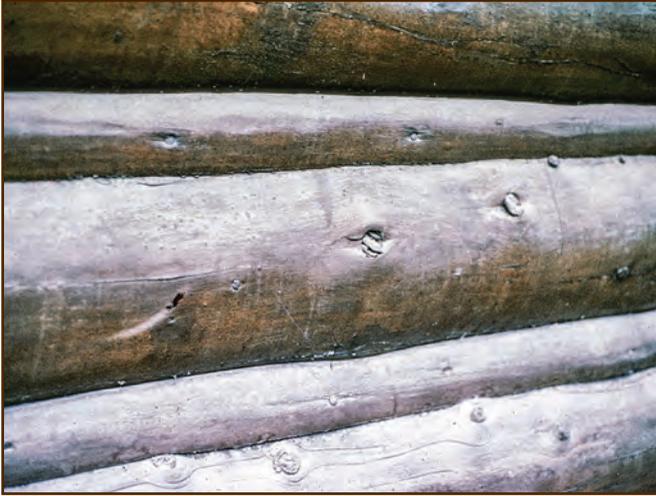
Figure E36—The builders used carefully shaped and fitted quartersawn poles instead of daubing on this cabin.

On some cabins, builders used wood strips or split log poles to cover the gaps between logs (figure E36). They daubed some cabins using tar instead of a mortar-like mix, creating a black line between logs (figure E37) rather than a white line.

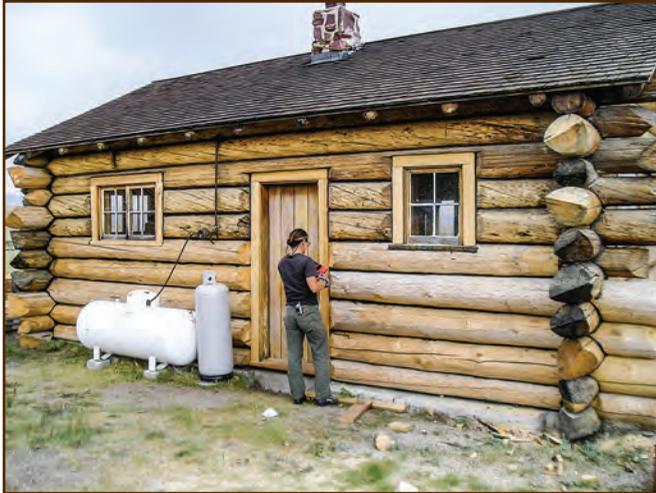
Figure E37—The tar daubing on the 1935 Horse Prairie Guard Station (Beaverhead-Deerlodge National Forest, Northern Region), a fairly common daubing material choice in the Northern Region during that time period, has the effect of accenting the joints between logs.

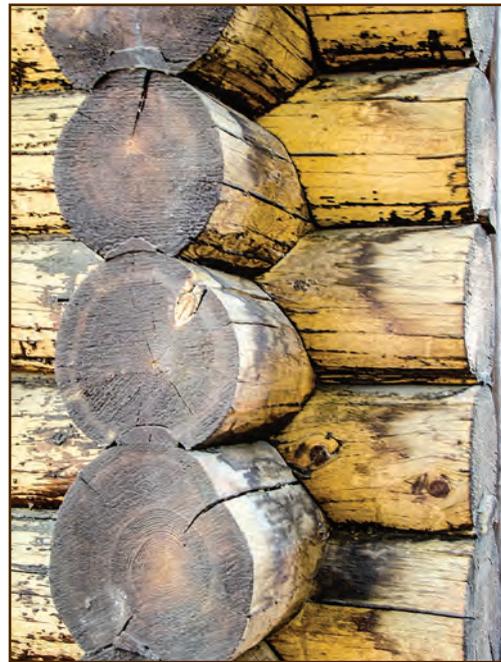
Figure E38—The builders coped the logs of this workshop, providing a tight fit between the logs. They used small wood inserts to more completely seal the space between logs at the crown ends, but daubing was not necessary. The workshop originally was a small barn built in 1936 on the Crandall Ranger Station (Shoshone National Forest, Rocky Mountain Region).

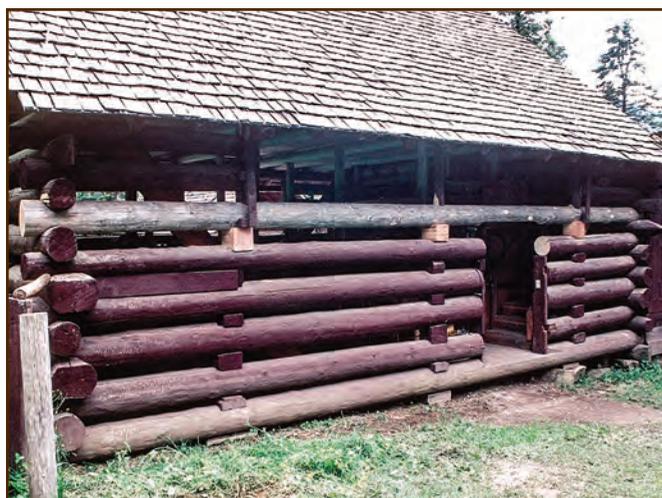
Figure E39—The builders intentionally spaced the logs of this barn to provide ventilation at the Moose Creek Wilderness Station (Nez Perce National Forest, Northern Region) in north central Idaho.

To provide ventilation, people constructed some log buildings with intentional gaps between logs and didn't use chinking or daubing. Corncribs, barns (figure E39), and other storage buildings often have intentional gaps between the logs.

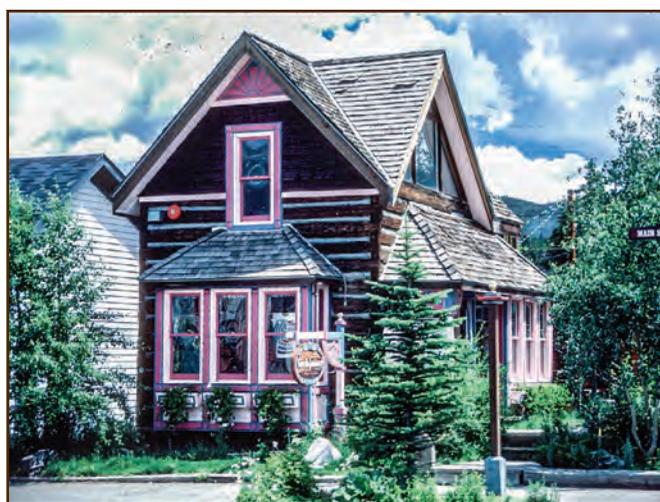
Figure E40—The owner added frame window bays and trim to this log home in Breckenridge, CO, to achieve a Queen Anne style.

Siding and trim could disguise the cabin's simple construction beneath Georgian, Federal, and other architectural styles (figure E40). To harmonize the whole, owners frequently covered—or recovered—log houses with siding when they erected an addition, especially if the addition was wood frame construction. Owners gave some log buildings, especially those used as businesses, framed and sided fronts (figure E41), usually with an extended height that hid the gable end of the roof (called a false front), to make the building appear more imposing and conform to current styles.

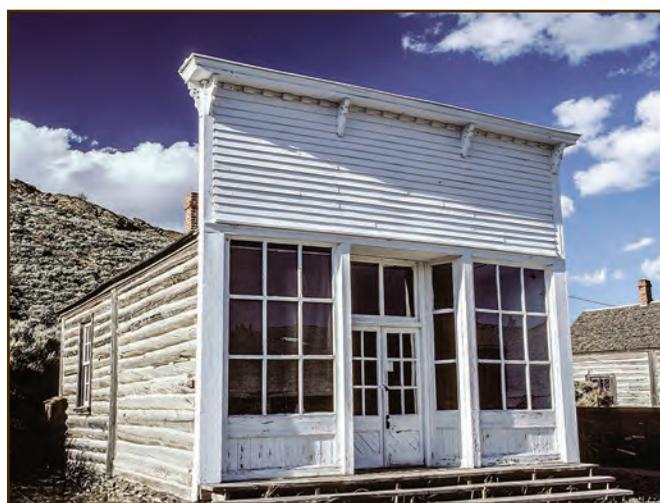
Figure E41—The owner added a false front consisting mainly of windows and clapboard siding to this log building in South Pass City, WY, to make it look more substantial and prosperous. *Photo © Andrew Gulliford; used with permission.*

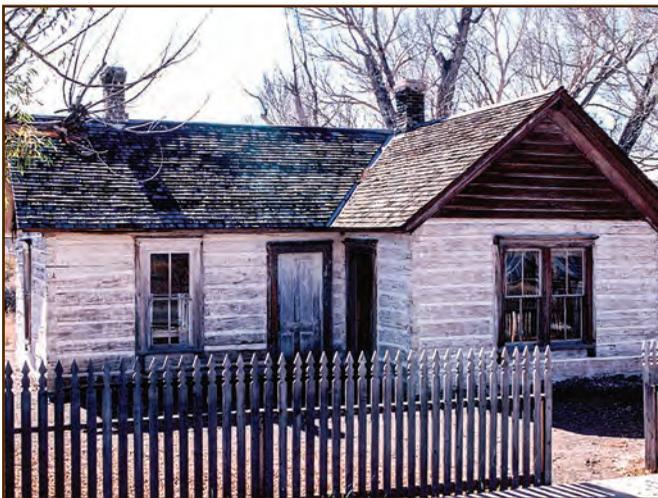
Figure E42—The logs of the Ryburn House at Bannack State Park in Montana are whitewashed. The L-shaped building has a cross gable roof.

In some instances, owners whitewashed the surface of the logs on the outside (figure E42) or the inside of the cabin. Whitewash is a very low-cost type of paint made from slaked lime (calcium hydroxide), chalk (whiting), and sometimes coloring agents or other additives. Whitewash discourages insects and seals hairline cracks in the daubing and between the daubing and logs. Whitewash is not a very durable paint; like daubing, it must periodically be reapplied.

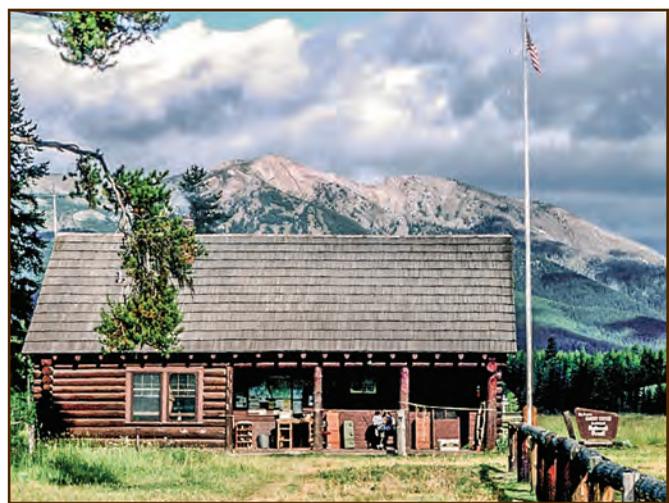
Figure E43—The Big Prairie Ranger Station in northwest Montana (Flathead National Forest, Northern Region) has a simple gable roof covered with cedar shakes.

Although simple gables (figure E43) are the most common roof shape for log cabins, the shapes of log building roofs are as diverse as those for any other kind of building. Cross

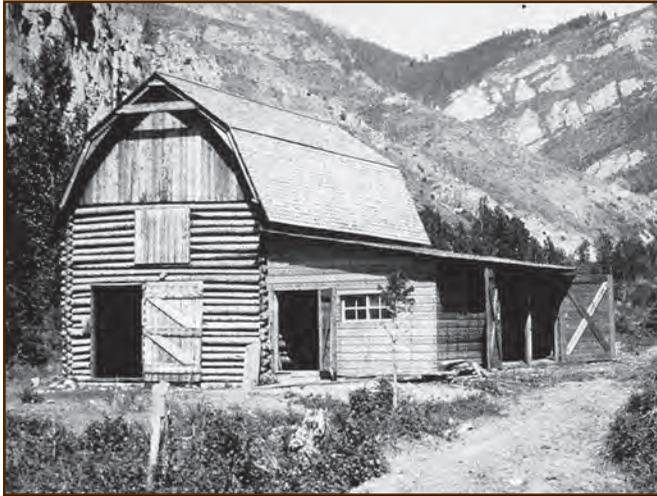
Figure E44—This barn at Shennago Creek Ranger Station (Gallatin National Forest, Northern Region) in Montana has a gambrel roof with a shed roof extension on one side.

gables (see figure E42), gambrels (figure E44), jerkin head (or clipped gable) (figure E45), hip (figure E46), shed, and pyramid (figure E47) roofs all can be found on log buildings.

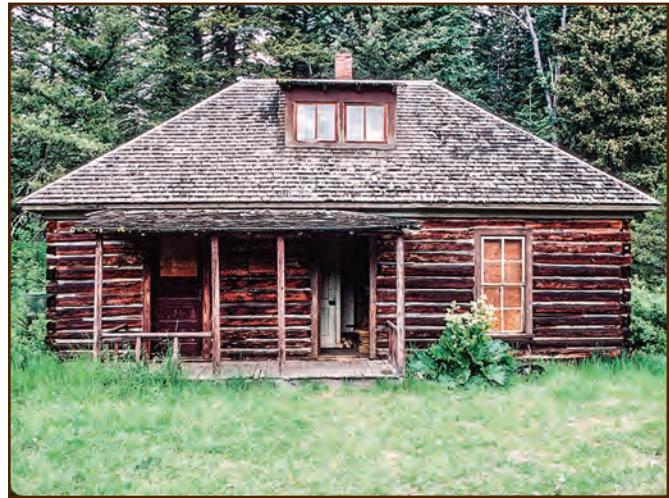
Figure E46—The Big Creek cabin (Gallatin National Forest, Northern Region) in Montana has a hip roof (and a broken window that was later repaired).

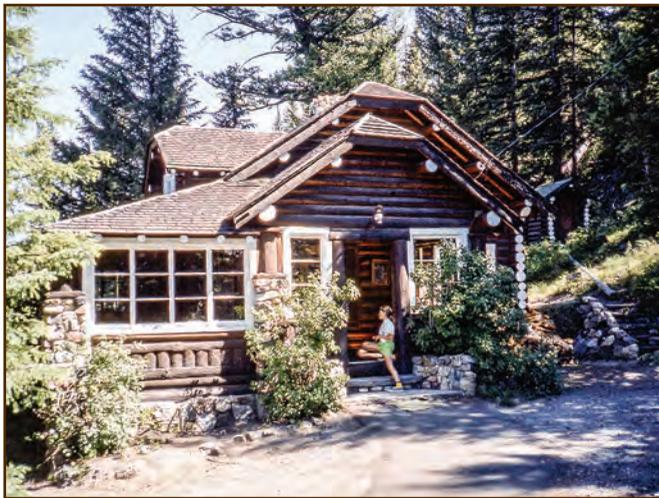
Figure E45—The Johnny Sack Cabin at Big Springs in southeast Idaho has a jerkin head (or clipped gable) style roof. The owner constructed it in the early 1930s on land leased from the Forest Service. It now serves as a visitor information center jointly managed by the Caribou-Targhee National Forest (Intermountain Region), Fremont County Parks and Recreation, and the Island Park Historical Society.

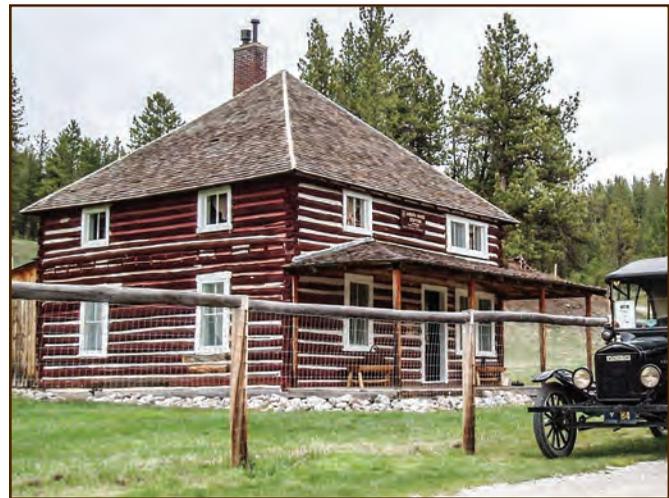
Figure E47—The two-story Judith Ranger Station (Lewis and Clark National Forest, Northern Region) in central Montana has a pyramidal roof covered with cedar shingles.

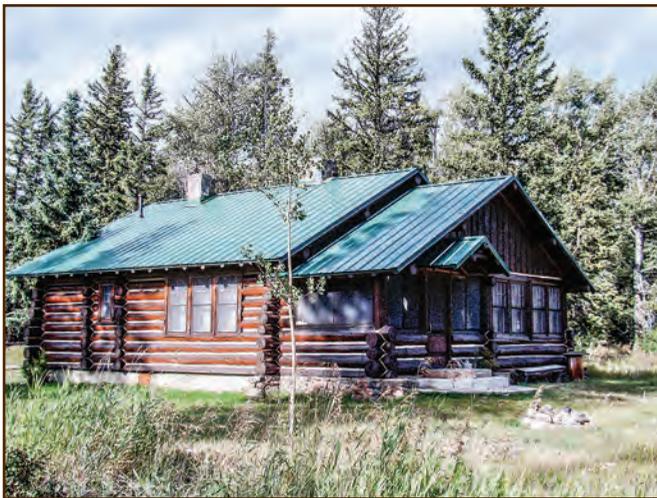
Figure E48—The owner replaced the original roofing on this log cabin in Sunlight Basin in Wyoming with ribbed metal roofing at some point during its history. Replacing historic roofing materials with modern materials usually is not recommended. The cabin originally was part of a homestead ranch that operated as a dude ranch during much of the early and mid 20th century. It now is part of a Wyoming Game and Fish field station.

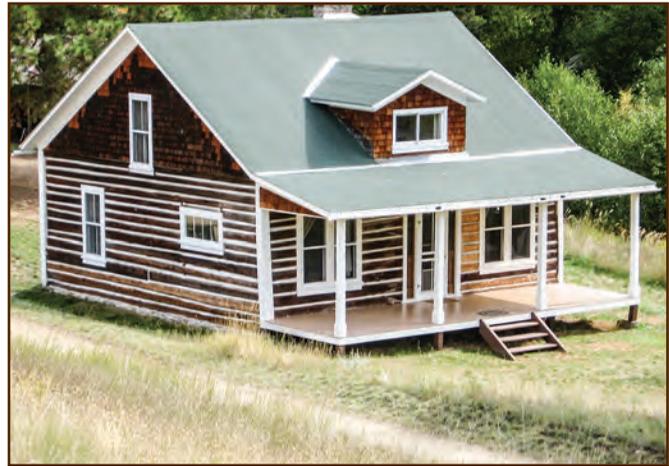
Figure E49—The Hogback cabin (Lolo National Forest, Northern Region) has unusual vertically applied asphalt rolled roofing. This photo shows new roofing that is identical to the original roofing.

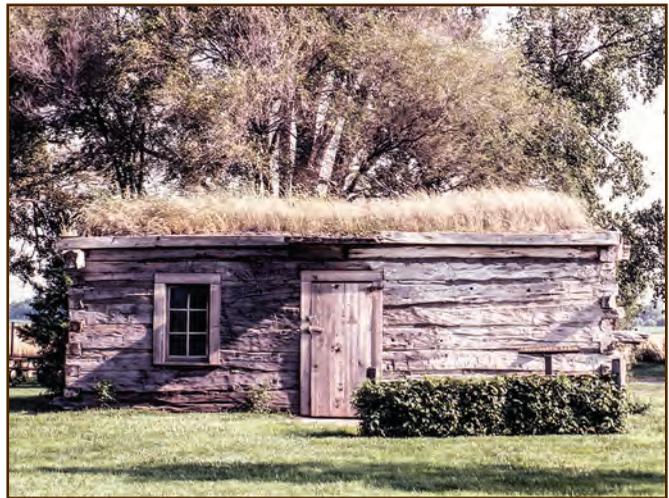
Figure E50—This log cabin at Fort McPherson in Nebraska has a sod roof. “Buffalo” Bill Cody built the cabin for his family while he served as a scout for the U.S. Army’s 5th Cavalry; they moved there in 1870. Photo © Andrew Gulliford; used with permission.

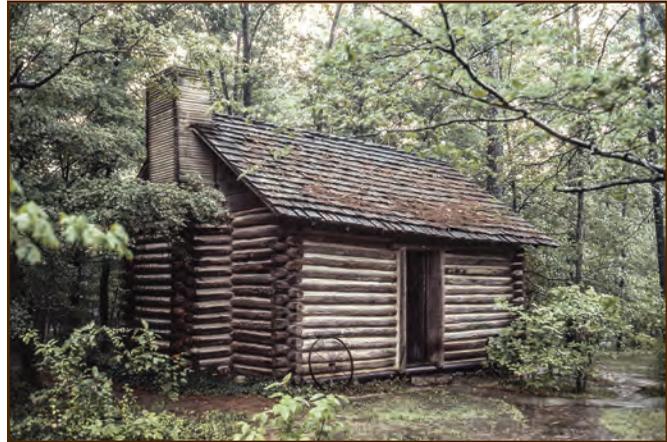
Figure E52—This small cabin, built shortly after the Civil War, was the original structure for the school that eventually became Berry College in Rome, GA. The log exterior surface of the fireplace and flue is unusual. *Photo © Andrew Gulliford; used with permission.*

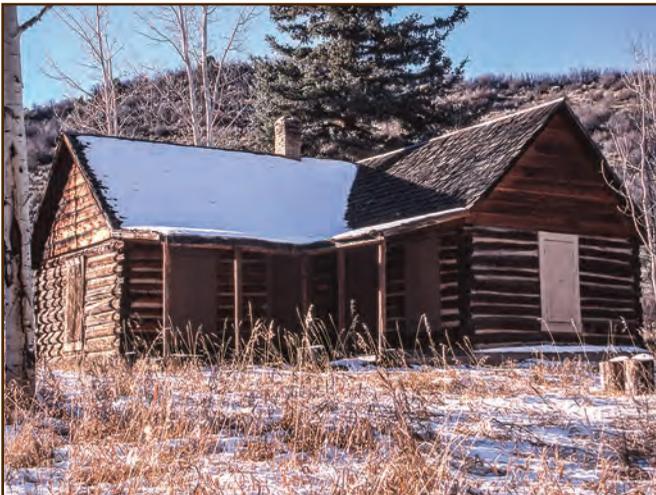
Figure E51—Ranger James Cayton built the Cayton Ranger Station in 1909 as a combination house and office. The house had an internal chimney. Cayton was one of the original 75 Forest Service rangers. *Photo © Andrew Gulliford; used with permission.*
