5100 Fire
September 1997
9751-2817-MTDC

Surviving Fire Entrapments

Comparing Conditions Inside Vehicles and Fire Shelters

September 1997
7E62P87—Vehicle Entrapment

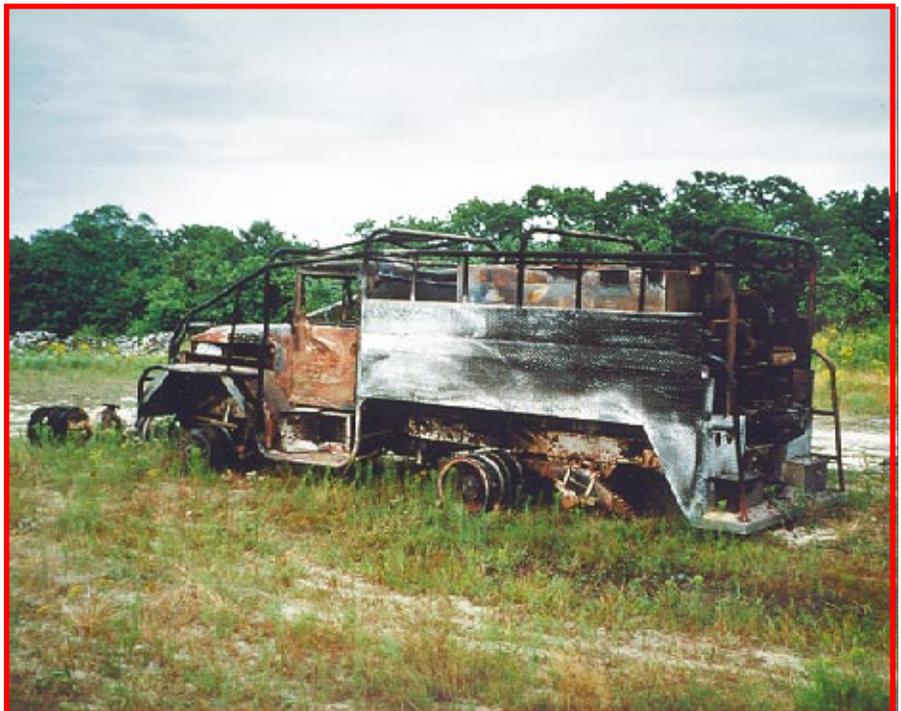
Figure 1—This engine burned during the 1995 fires on Long Island. Although many engines were destroyed, all firefighters escaped without injuries.

◆ In 1995, many engines were destroyed by a fast-moving timber fire on Long Island, NY. All firefighters abandoned their engines and survived (Figures 1 and 2).

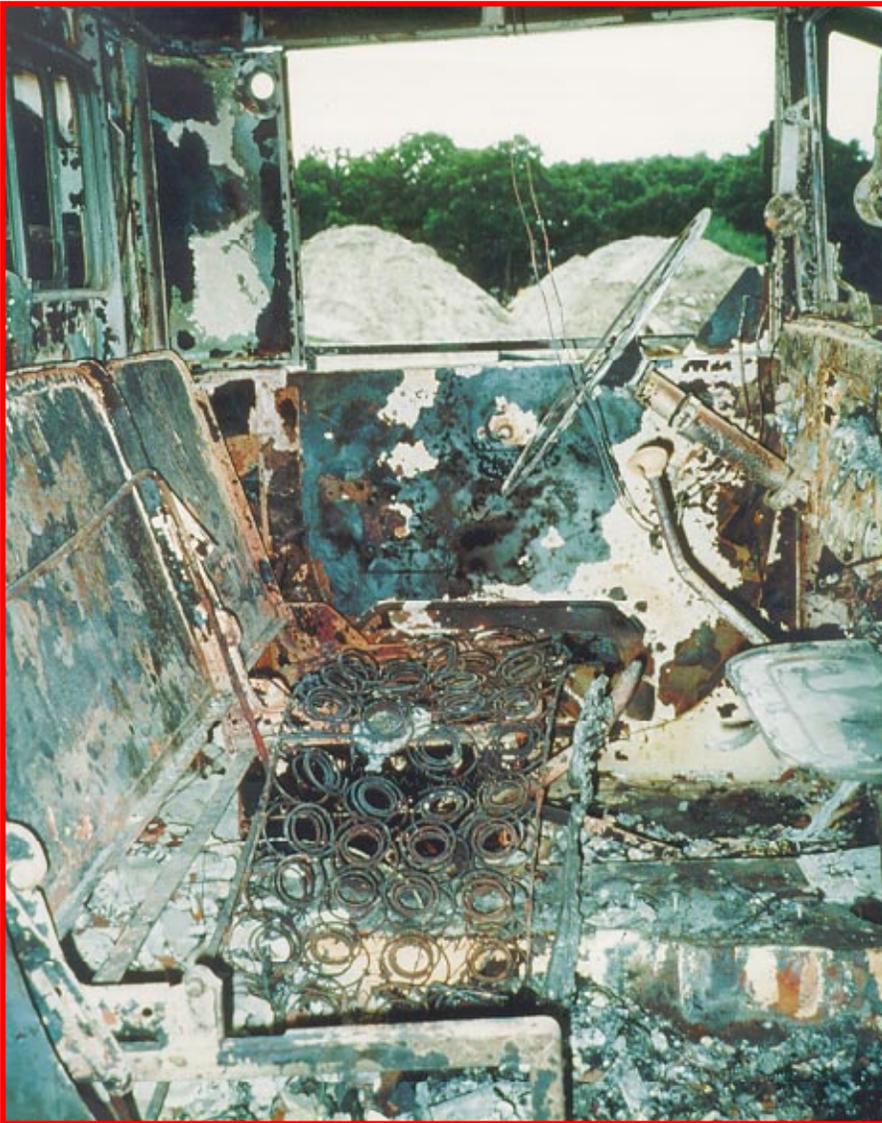
Figure 2—The cab interior of the same engine burned during the 1995 fires on Long Island.

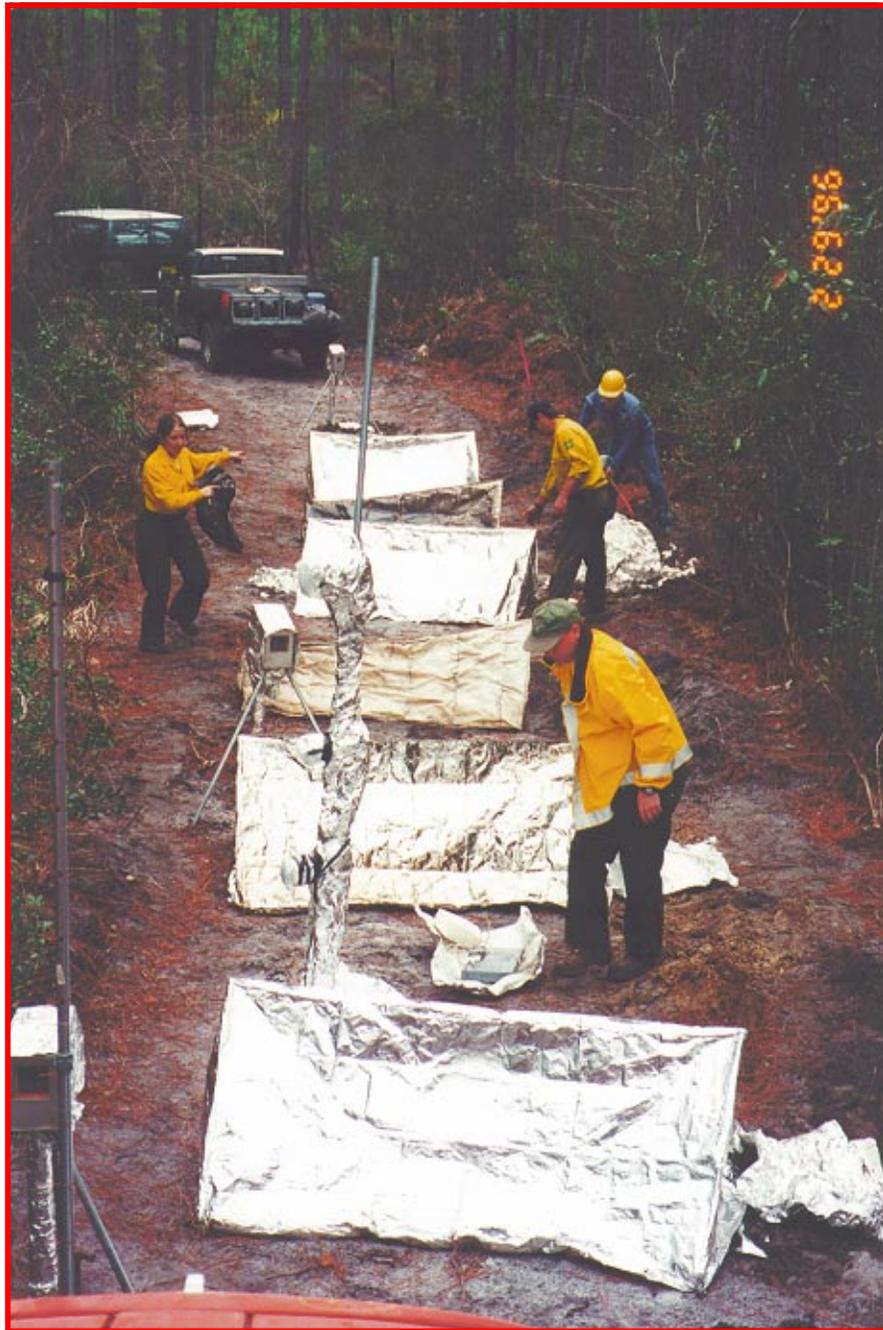
Figure 4—Several types of fire shelters were tested, including the standard Forest Service fire shelter and prototypes from MTDC and a private firm.

Fire shelters, both the Forest Service's standard model and a stainless steel prototype, were erected in front of or behind an engine, using tent framing to keep them erect. Weights along the inside edge of the shelter simulated a firefighter holding the edges to keep them from rising during the burnover. These shelters were adjacent to the fuels, rather than in a preferable deployment site as far from the oncoming fire as possible. This ensured that the data gathered were fully comparable to that obtained from the engines.

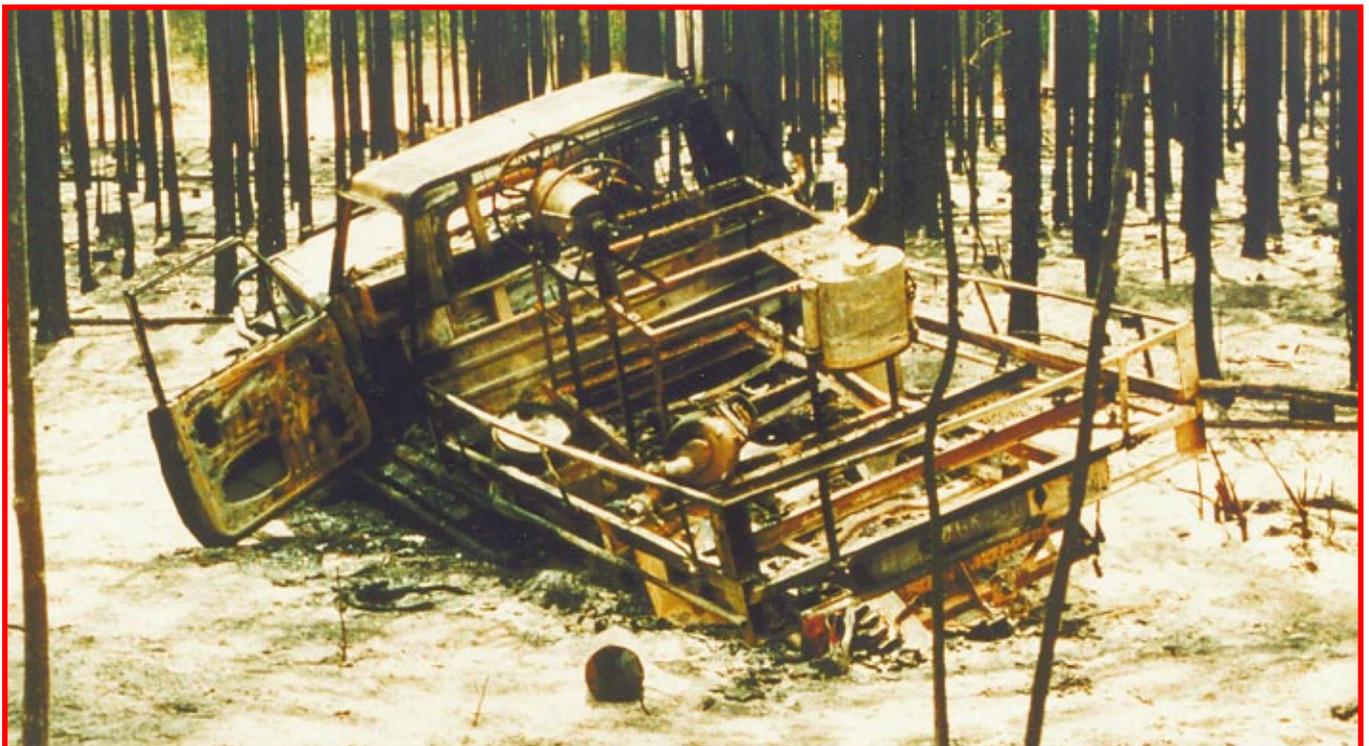
Figure 5—This engine burned during the 1990 Toolara Fire in Australia. Three firefighters were trapped, one of whom was badly burned when he ran for safety. The other two men stayed in the vehicle, spraying themselves with water until the tires caught fire. Then they too ran for safety.

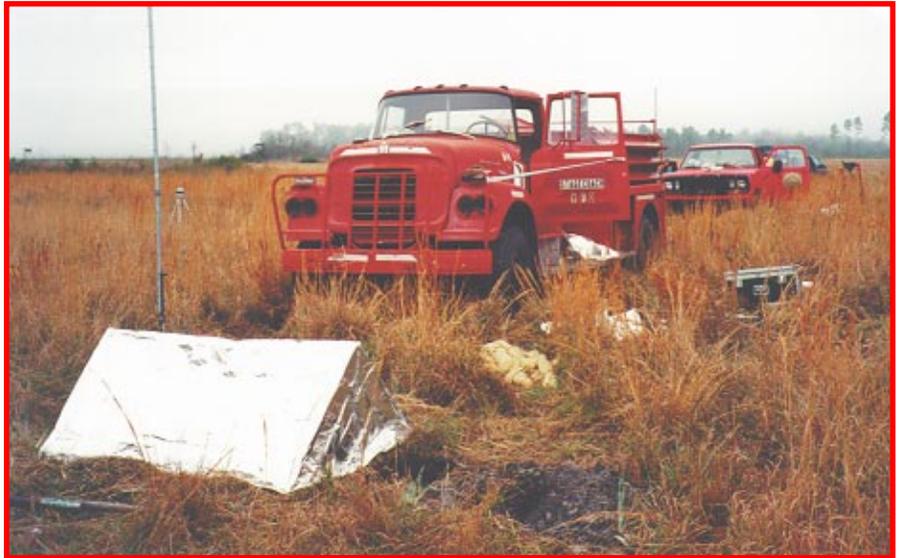
Figure 6—Cooperators provided vehicles used in the tests, such as this engine and pickup provided by the Florida Division of Forestry.

The availability of engines that could be destroyed when subjecting them to the full effects of direct flame was critically important. In response to requests over the Internet, personal contacts, and inter-agency contacts throughout the wildland fire community, surplus engines were identified at the Florida Division of Forestry, Los Angeles County Fire Department, and the Montana Department of Natural Resources and Conservation. These engines enabled MTDC to fully implement the test plan as designed, with the engines and fire shelters exposed to a flaming front of fire for varying durations in a variety of fuel types.

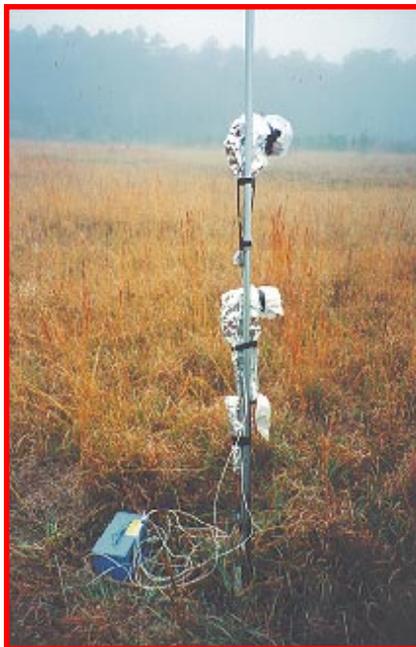
Figure 8—Radiometers on these poles measured radiant heat flux.

Instrumentation on the sites included two poles 9 feet (3 m) tall outfitted with thermocouples every 6 inches (15 cm). Data were recorded on Campbell Scientific data loggers, providing vertical temperature profiles on the burnover site. Radiometers were placed at the front or rear bumpers of the engines and on poles (Figure 8) to measure radiant heat flux. In the passenger side

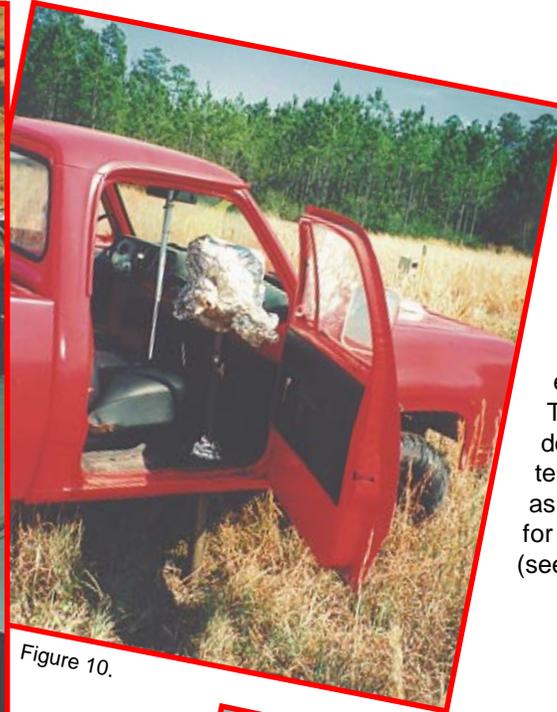
Figure 10.

Figures 9 and 10—Gas collection devices sampled gases inside vehicle cabs. Instrumentation was buried inside ammunition boxes so that it would survive the fire.

Both the engines and fire shelters had gas collection devices (Figures 9 and 10) placed inside to measure gases that could be harmful or fatal to an entrapped firefighter. The breakdown of materials inside the engine cab, such as the volatilization of petroleum-based plastics and sound-deadening materials inside the door panels, were a special concern, as was the off-gassing of the fire shelter adhesive that bonds the aluminum foil to the glass cloth. Detailed documentation of the gas collection system used on these burns—and on the gases collected—can be found in Appendix B.

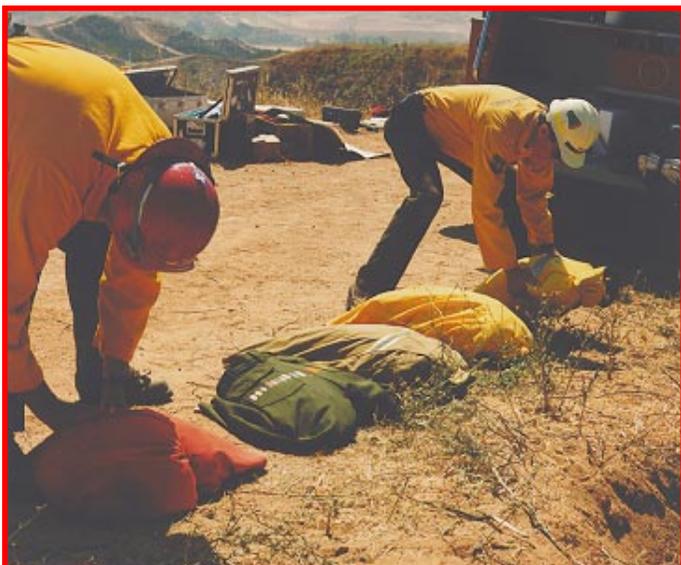
Figure 11—Personal protective clothing was laid out to observe the fire's effects on it.

Personal protective clothing (Figure 11), equipment, and other items commonly used by wildland firefighters were laid out near the fire shelters to visually evaluate their protective value during an entrapment. Items included the standard Forest Service Nomex shirt and trousers; leather firefighter gloves; hardhat; military-issue flight suit; and various outer garments such as brush coats, FR coveralls from Canada and Australia, and shirts from various cooperators. Clothing was tested as though it were on a firefighter. Five-gallon water bladders were filled with water and covered with 100% cotton undershirts. The shirts and jackets (or flightsuits) were placed over the undershirt. The bladder filled out the garments and simulated a heat sink, not unlike that of the human body. While some of these items were not instrumented, we felt visual observation of damage would offer valuable lessons for firefighter training. Specialized fireproof video photography equipment (Figure 12) was developed to take closeup shots of the

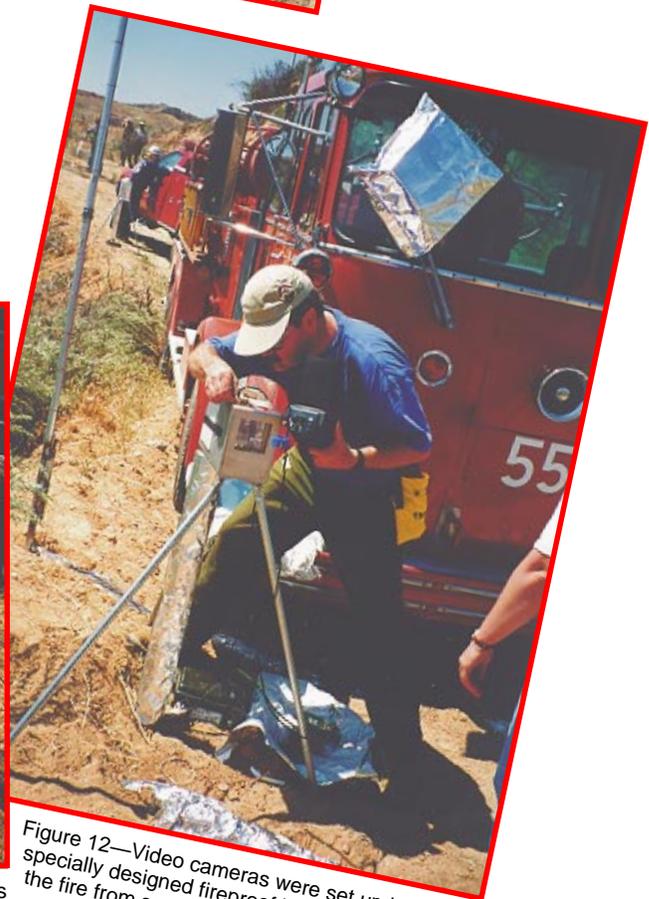
Figure 12—Video cameras were set up inside specially designed fireproof boxes to observe the fire from several vantage points.

fire's effects on the engines and shelters. These boxes were designed to withstand temperatures as high as 2300 °F (1260 °C) for extended periods (see Appendix C).
