## Discussion

Mangan, Richard. 1997. Surviving fire entrapments: comparing conditions inside vehicles and fire shelters. Tech. Rep. 9751-2817-MTDC. Missoula, MT: U.S. Department of Agriculture, Forest Service, Missoula Technology and Development Center. 37 electronic p.

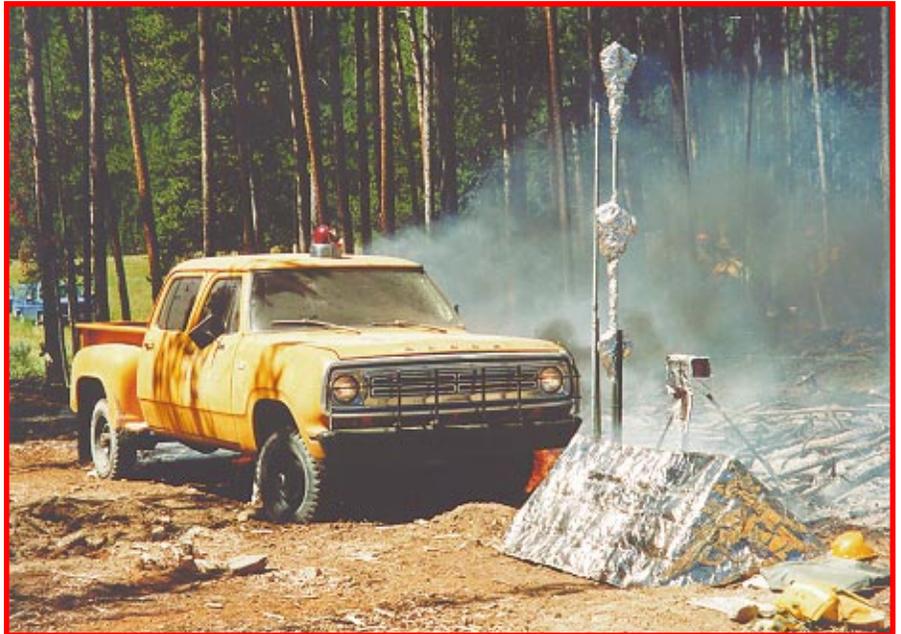
Figure 25—Even after a fire has passed, a vehicle retains heat, acting as a "heat sink."

- ◆ Heat from the passage of the fire front appears to be retained in the vehicles longer than in the fire shelter or other items of PPE, indicating that the metal in an engine may act as a "heat sink" (Figure 25).

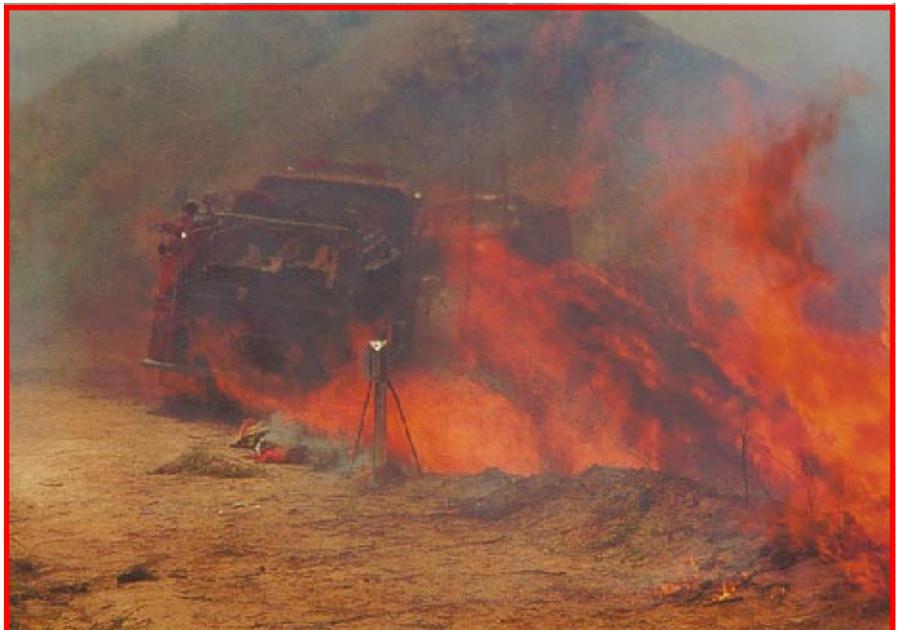
Figure 26—When a fire comes up a steep sideslope, it appears to go over and under the engine, creating an eddy on the back side that draws heat and flame.

- ◆ When fire comes up a steep side-slope, it appears to go over the top of an engine *and* under the chassis, creating an eddy on the back side that draws heat and flame (Figure 26). A firefighter taking shelter behind an engine parked on a steep slope would not be protected from heat or flame. This effect was demonstrated in October 1996 when a engine was burned over during the Calabasas Incident in southern California.

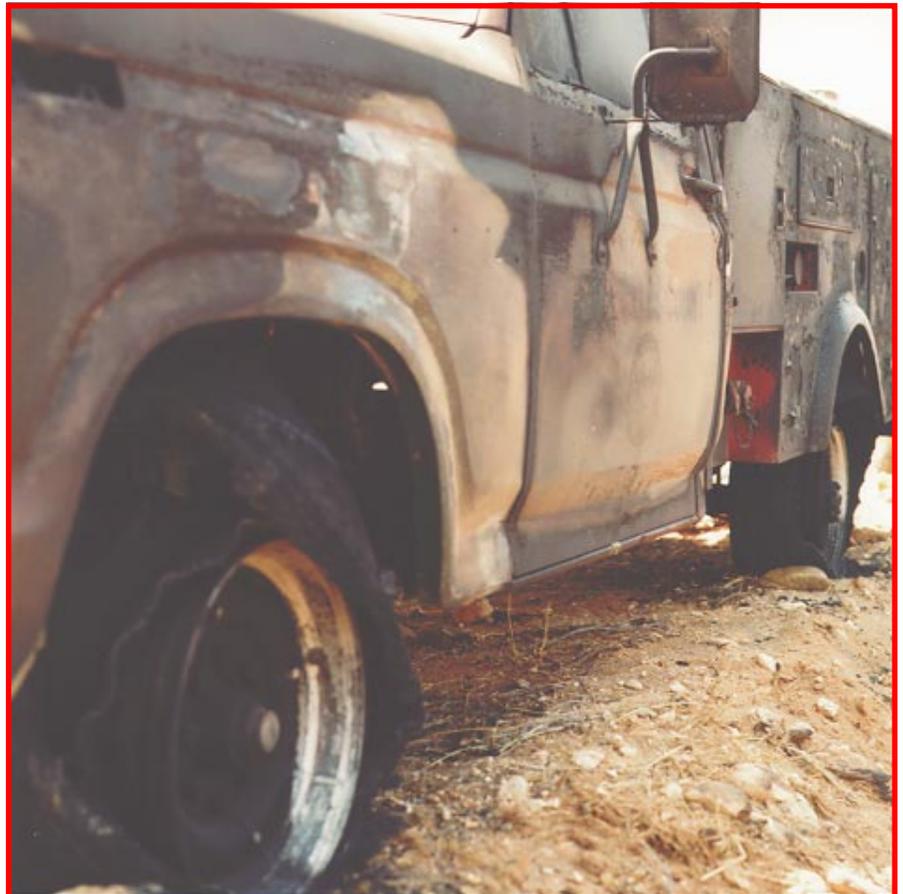
Figures 27 and 28—Items on an engine's exterior may catch fire during moderate-intensity, short-duration fires.

◆ During the moderate-intensity, short-duration exposure of the Los Angeles County tests, exterior components of the engines either caught fire or experienced some melting (Figures 27 and 28). Under higher intensity or longer duration exposures, the engine could catch fire and continue burning when conditions outside would be harmful to a firefighter attempting to leave the engine.

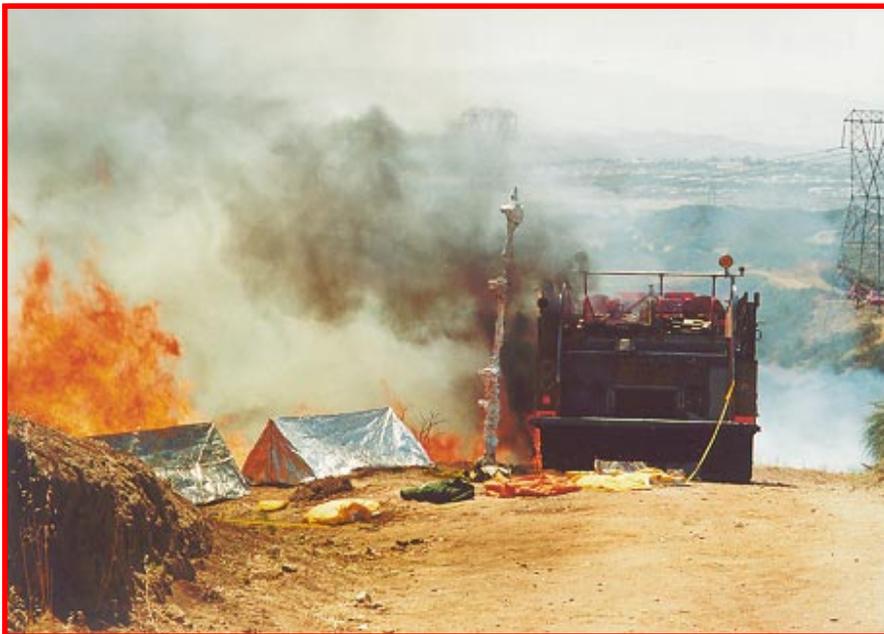
Figure 29—Even though the engine is on fire, the shelters and personal protective clothing are undamaged.

◆ Observation of the exposed PPE indicated that under experienced radiant heat loads, the protective characteristics of the clothing and personal protective equipment appear to offer adequate levels of protection (Figure 29) for an entrapped firefighter who has neither a shelter nor an engine for protection.
