Final Report on Fish Passage Construction at the East 182nd Street Dam, Bronx River

January 2015

Final Report on Fish Passage Construction at the East 182nd Street Dam, Bronx River January 2015

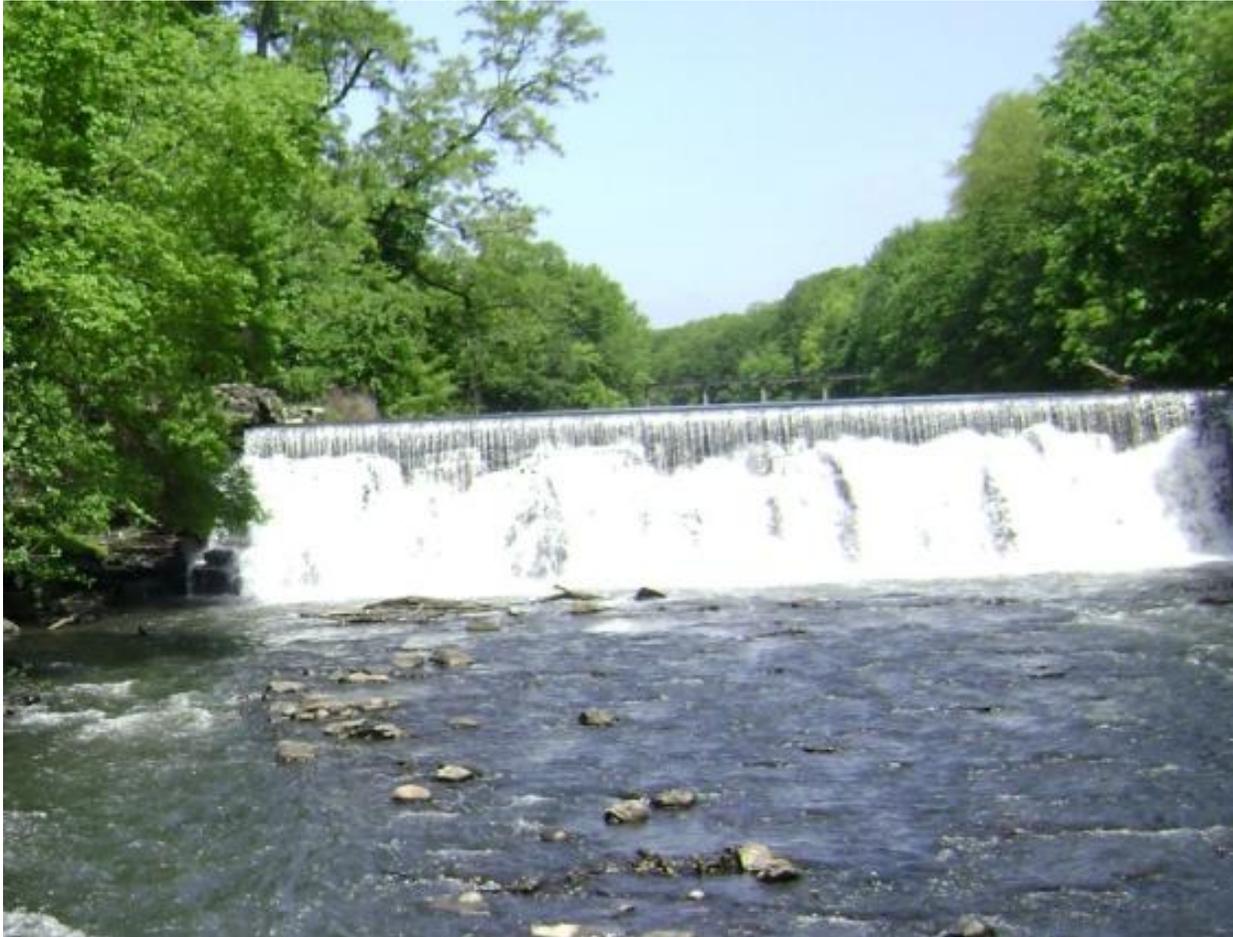
The East 182nd Street Dam is a stone masonry dam, which once had a smooth face, but was transformed with boulders in the 1910s to generate a cascading, waterfall-like appearance. It has a smooth, concrete-top spillway where the water cascades over the dam (Photo 1), which may have been last updated in the 1950s, when the last repair work was done on the abutments of the dam. This dam has a low level intake system which at the time of design was defunct but is meant to lower the water level of the impoundment as a flood precautionary measure.

Photo 1: Dam Spillway looking north before fish passage construction.

In addition to fish passage installation, this project was required by the New York State Department of Environmental Conservation (NYSDEC) Dam Safety Office to upgrade the dam to address dam safety issues. There was evidence of dam leakage on both sides of the dam, in the abutments and retaining walls, or non-overflow sections of the dam. Designs were developed to address the existing leakage and to either repair or remove the dam's defunct low level intake system.

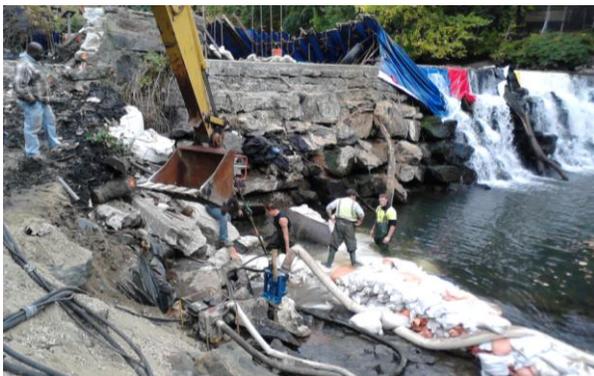
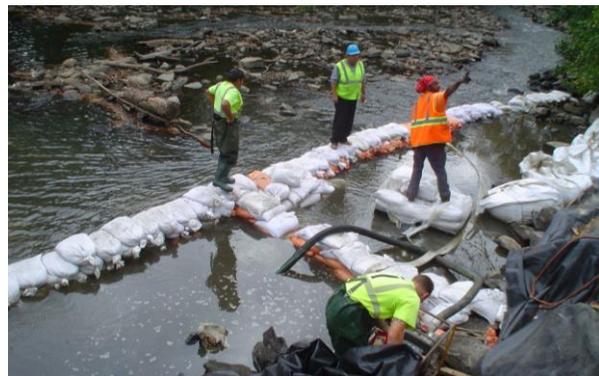
The river was dewatered directly downstream of the dam to accommodate installation of the entrance of the fishway (Photos 2a, 2b) in October 2013. This area was dewatered using sandbags. The contractor was unsuccessful at their first attempt in dewatering this area in an attempt to cover a larger section of the river than needed. They moved the sandbags closer to the bank and were able to dewater a smaller section of the river. A coffer dam was used on the upstream side of the dam for water control during construction in October 2013. The coffer dam was installed beneath the river across approximately half of the dam's spillway (Photos 3a, 3b). Once the coffer dam was in place, the remaining water was pumped out of the upstream area behind the dam.

Photo 2a: Downstream dewatering looking north.

Photo 2b: Downstream dewatering looking east.

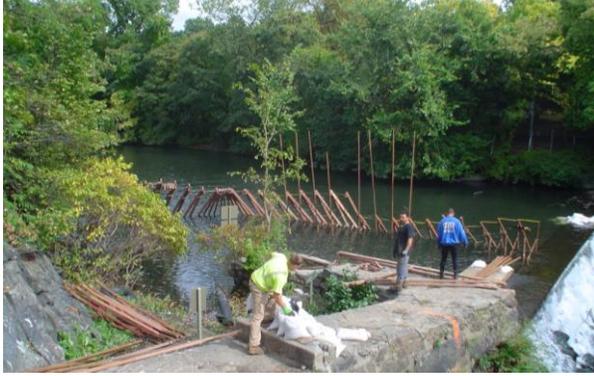
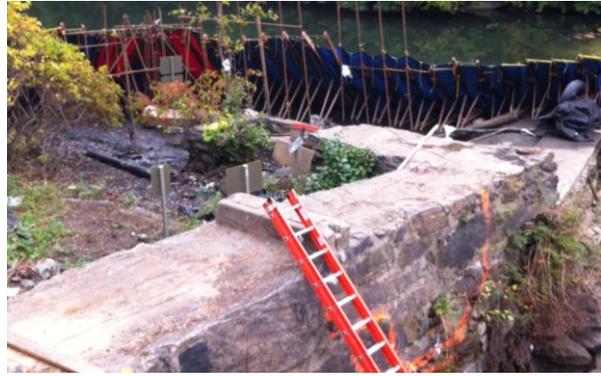
Photo 3a: Installation of the coffer dam on the upstream side of the dam.

Photo 3b: Installed coffer dam on the upstream side of the dam.

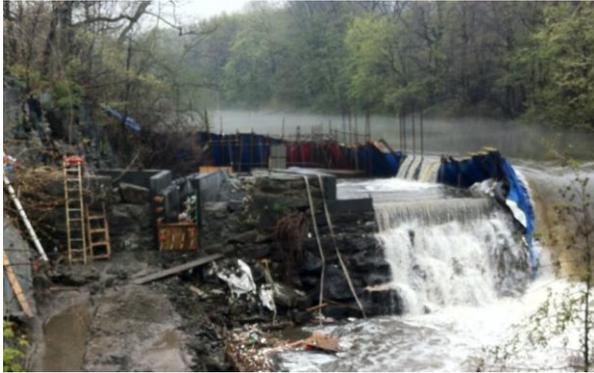
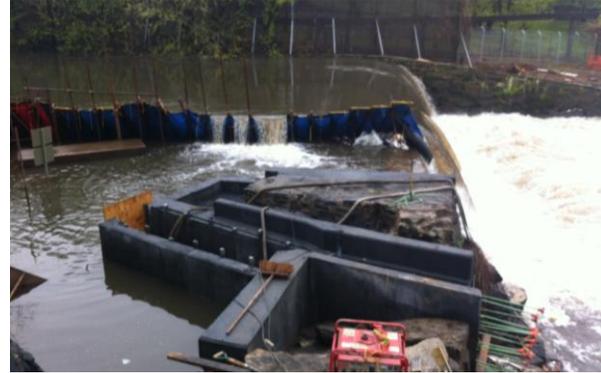
The coffer dam was breached on May 1, 2014, after an approximately five inch rain event (Photos 4a, 4b). The flow associated with this rain was approximately 1700 cfs (cubic feet per second) according to the USGS gauge at the New York Botanical Garden, approximately one mile north of the site (Figure 2). Fortunately, this happened the day after concrete work was completed on the upstream side of the dam.

Photo 4a: May 1, 2014 coffer dam breach facing north.

Photo 4b: May 1, 2014 coffer dam breach facing east.

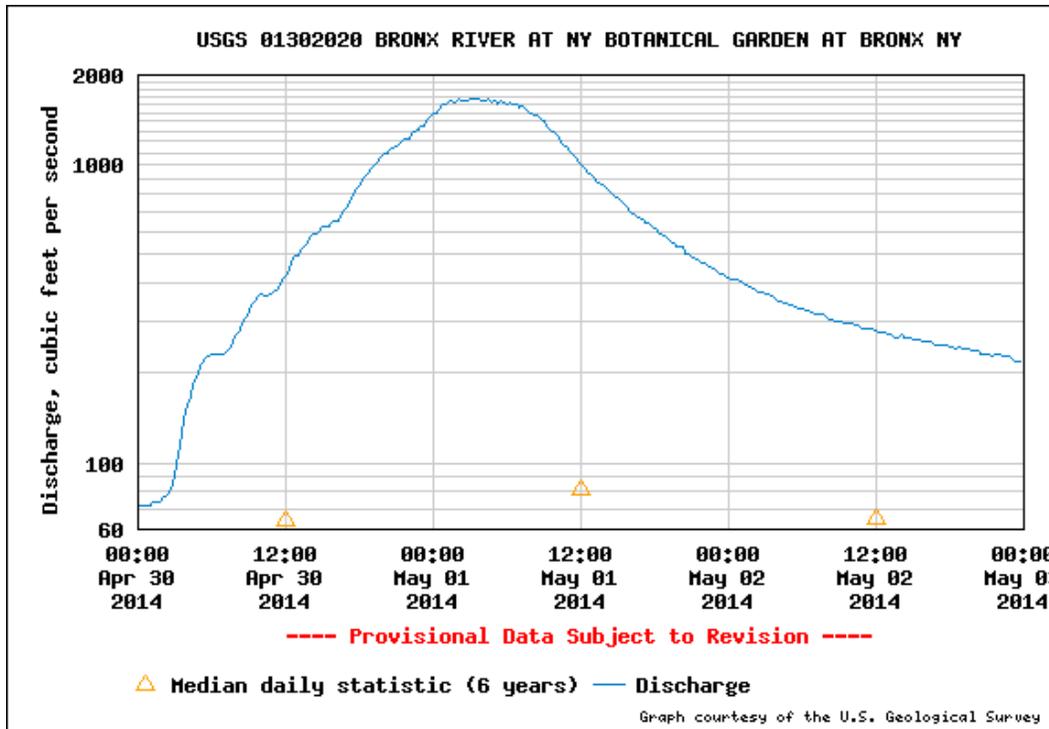
Figure 2: May 1, 2014 rain event created a 1700 CFS flow on the Bronx River, breaching the coffer dam at the construction site.

This area of the dam did not leak when the coffer dam was breached during the May 1, 2014 rain event (see Photos 4a, 4b and 5 in previous section). This indicated that the origin of the dam leak was from an area farther east in the spillway and not directly behind the western portion of the dam through which the water was visibly flowing. Jim MacBroom stated that it is common that stone masonry dams leak, especially ones as old as the East 182nd Street Dam and that it is not always obvious where the leak originates.

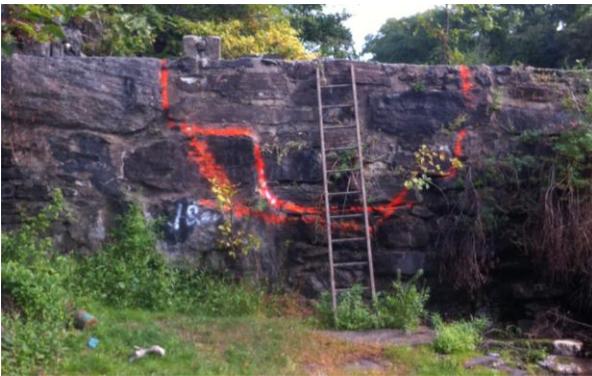
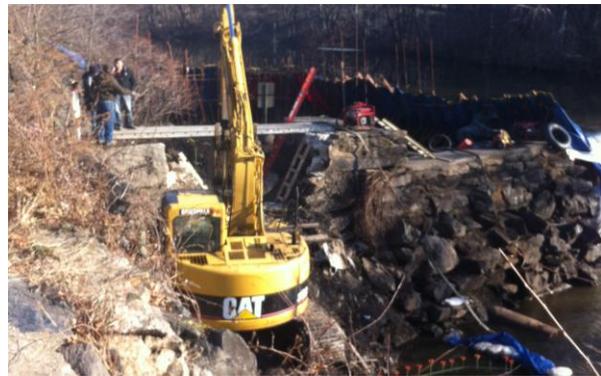
Photo 6a: Section removed from dam outlined in orange paint.

Photo 6b: Dam section being removed and looking north.

As described in earlier sections, the River Park Fish Passage is composed of concrete and metal components. A temporary earthen ramp was built just downstream and to the west of the dam for heavy machinery to access the non-overflow section of the dam where the fish passage would be built. In order to install the fish passage, sections of the western portion of the non-overflow sections of the dam were removed (Photos 6a, 6b). All of the sections of the Alaskan SteepPass aluminum fish way were encased in reinforced concrete that was poured into plywood forms (Photos 7a-7e). The steeppass was installed in July 2014. Weir boards were used to keep water from flowing through the fish passage during construction; the same weir boards will be used to close the fish passage when river herring are not migrating. A flow test was conducted on July 14, 2014 and water flowed through the fish passage for the first time (Photo 8).

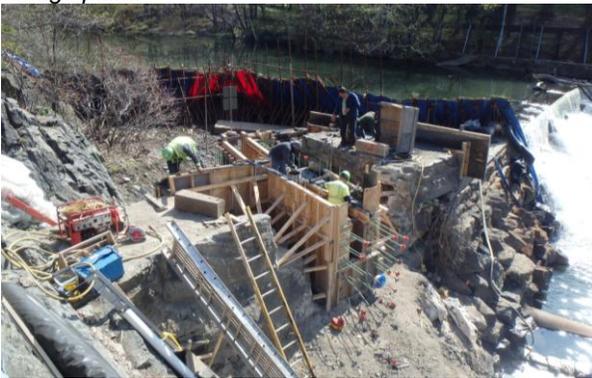
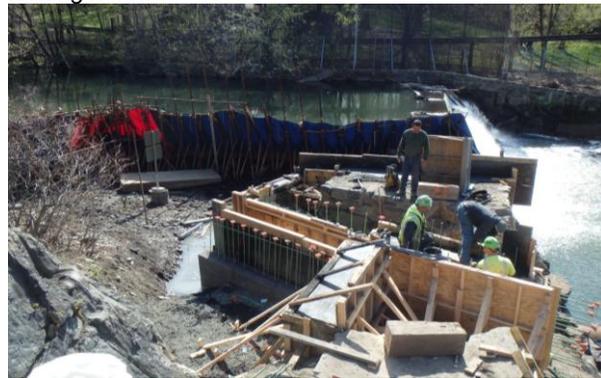
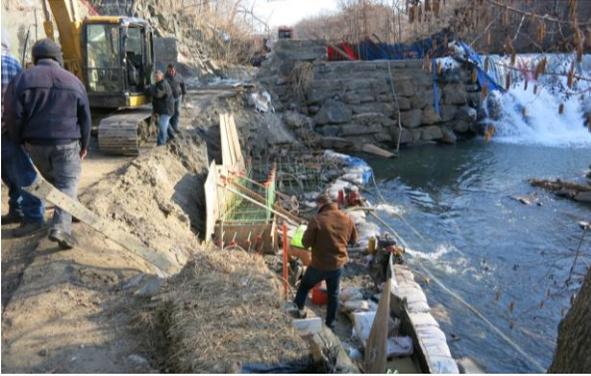
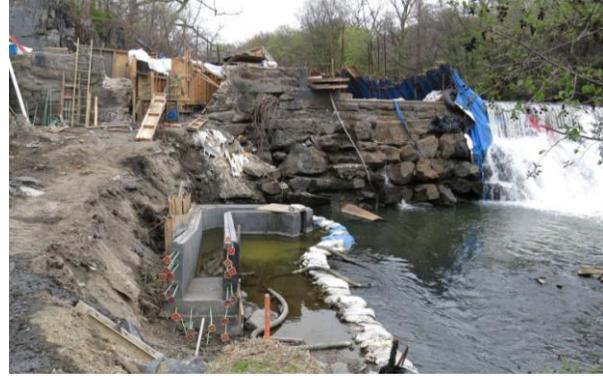
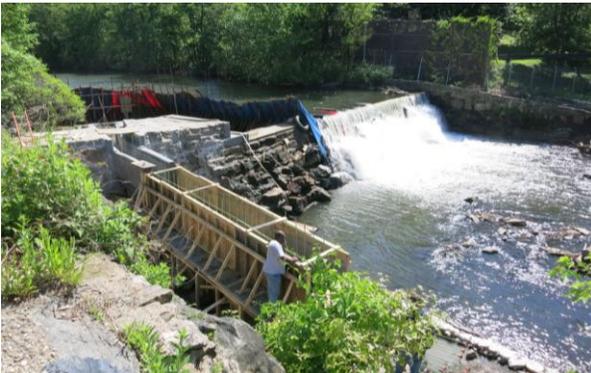
Photo 7a: Upstream reinforced concrete and forms.

Photo 7b: Upstream reinforced concrete and forms.

Photo 7c: Downstream reinforced concrete and forms.

Photo 7d: Downstream reinforced concrete and forms.

Photo 7e: Downstream reinforced concrete and forms.

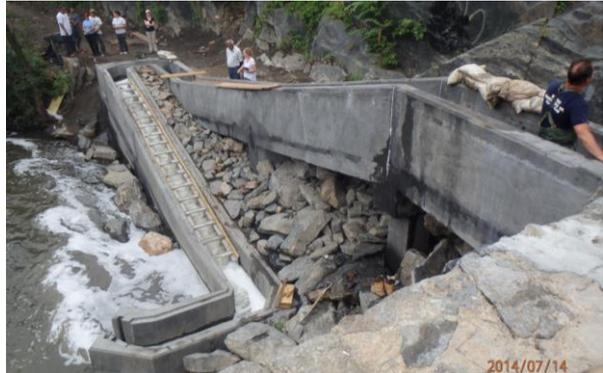
Photo 8: Fish passage open test.

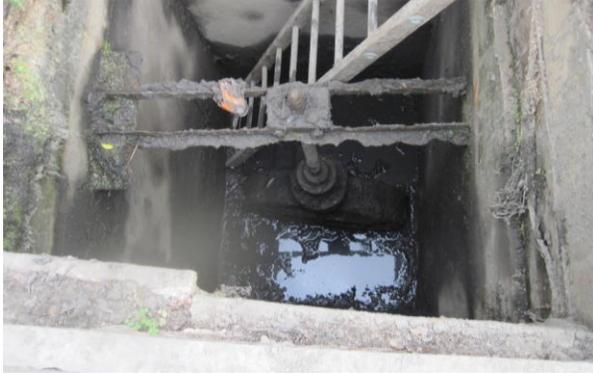
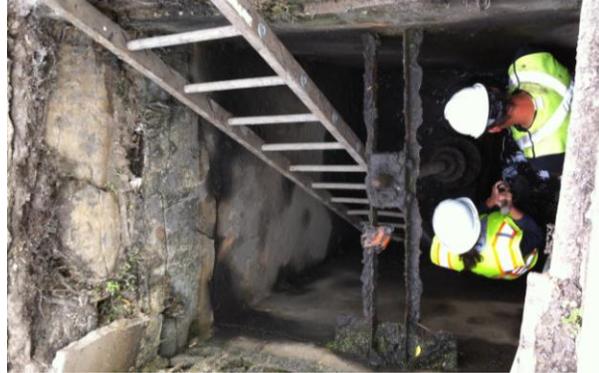
The design plans called for rehabilitation of the low level intake system of the dam. The function of the low level intake is to lower the water level of the impoundment (area of ponded water upstream of the dam) as a flood precautionary measure. The elements of the low level intake system include a 36" intake pipe on the upstream side of the dam that conveys water into a concrete water chamber. Within the water chamber there is a steel gate that can open and close the 36" intake pipe and an output pipe (which is at a lower elevation than the intake pipe) that conveys water from the water chamber to the downstream side of the dam.

The dam's low level intake system differed from the 1958 plans on which the designs were based. After the upstream side of the dam was dewatered, the contractor discovered that rather than having a functioning gate to open and close the intake pipe within the water chamber, there was a concrete floor that sealed the gate within the water chamber (Photo 9a). Site inspections were performed with engineers from NYC Parks, MMI and NYSDEC's Dam Safety Office and alternatives for addressing the issue were proposed (Photo 9b). It was determined that the sediment load behind the dam was so high that even if the low level intake system functioned, it would not be able to significantly lower the water level of the impoundment. The contractor attempted to locate the intake pipe in the impoundment but was unable find it to due to the high sediment load. MMI revised the plans to decommission the low level intake system. This caused significant delays; multiple meetings and conference calls were held with NRG staff and the design consultant, to revise the design.

Photo 9a: Defunct low level intake water chamber.

Photo: 9b Inspection of low level intake water chamber.

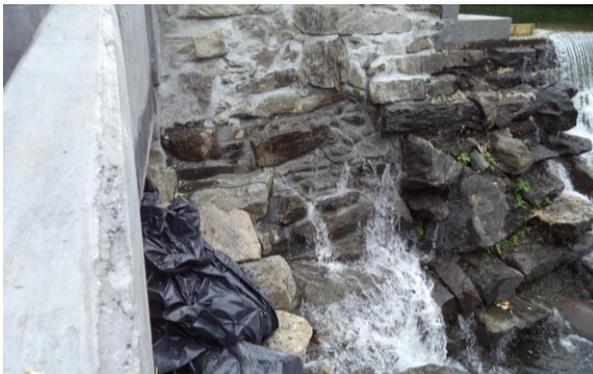
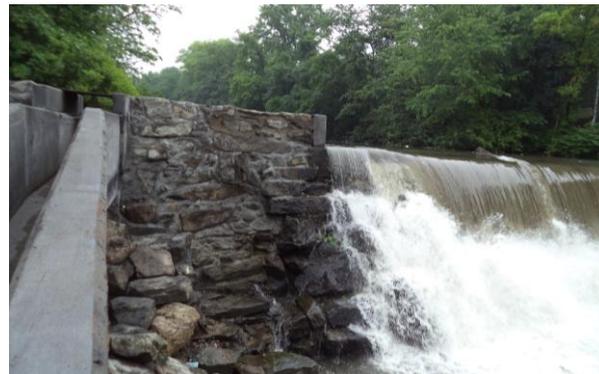
Immediately following the removal of the coffer dam on May 28, 2014, water was observed flowing through the mortar between the existing and newly placed boulders in the western portion of the non-overflow section of the dam (which leaked prior to construction) (Photo 10a). NRG immediately notified the NYSDEC Dam Safety Office who performed a site inspection shortly thereafter. NRG also performed site visits with Jim MacBroom and other design engineers at MMI and came up with approaches to addressing the leakage.

Photo 10a: Dam leakage immediately after coffer dam removal on May 28, 2014.

Photo 10b: Dam leakage 12 days after coffer dam removal on June 9, 2014.

NRG proposed monitoring the dam and reporting any changes in condition to the NYSDEC Dam Safety Office. The dam leakage has been variable but has decreased since the coffer dam was removed (Photo 10b). As of January 2015, there is little to no leakage.

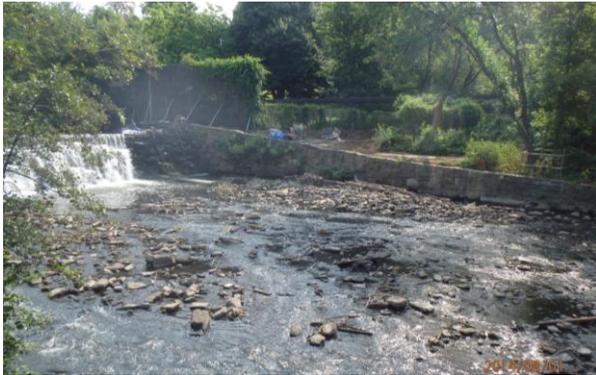
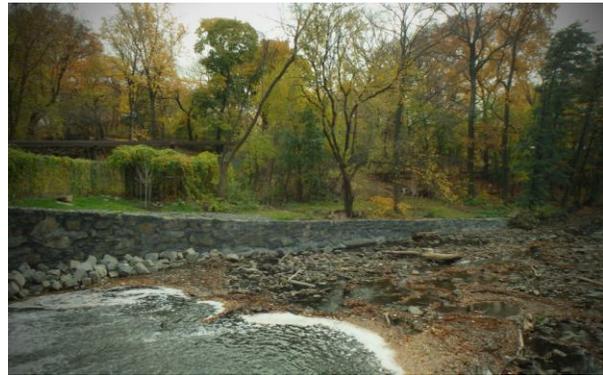
Photo 11a: East side retaining wall during construction.

Photo 11b: Repaired east side retaining wall with boulder reinforcement.

The NYSDEC Dam Safety Office required repairs to the retaining wall on the east side of the dam at the Bronx Zoo. The plans were designed in house by the NYC Parks Capital Projects Design Team and included leak repair, wall reinforcement and re-anchoring of the fencing around the Zoo's monorail (Photos 11a, 11b).

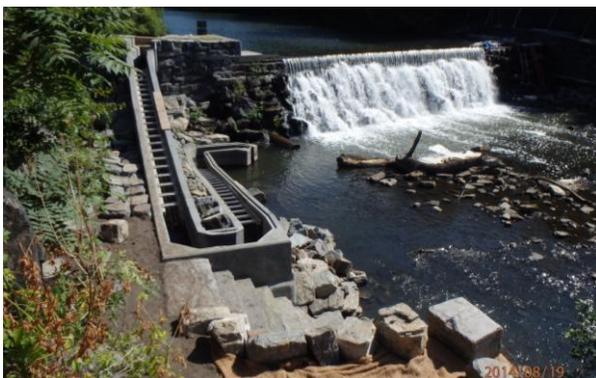
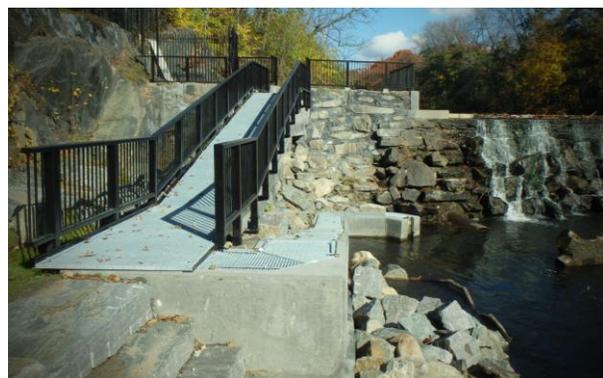
Photo 12a: Steps for canoe portage.

Photo 12b: Grating and railing on canoe portage.

As a National Water Trail, the Bronx River Blueway is open to recreational kayakers and canoeists year round. To ensure safety of paddlers, the East 182nd Street Dam canoe portage was closed during construction from March 2013 to December 2014. An improved canoe portage was incorporated into the construction of the fish passage. Grating and railing was placed over the concrete structure and granite steps were installed to lead paddlers down to the river (Photos 12a, 12b). After further review, the Bronx River Alliance determined that the height of the fish passage on the upstream side of the dam where paddlers exit their boats was too tall. They are currently seeking funding to install a step to accommodate paddlers.

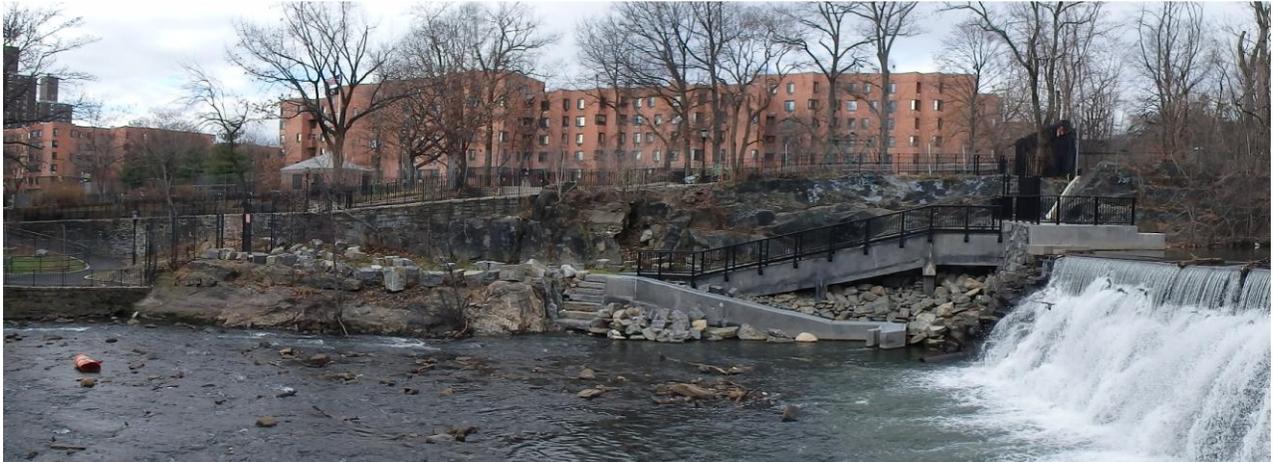
side was restored with riparian vegetation tolerant of shallow soils and potentially drought-like conditions; the dominant species planted here were bear oak (*Quercus ilicifolia*), Virginia creeper (*Parthenocissus quinquefolia*) and meadowsweet (*Spirea latifolia*) (Photo 13, Figure 3, Appendix). The east side of the dam was replanted to establish a riparian forest; the dominant species planted here were red maple (*Acer rubrum*), swamp white oak (*Quercus bicolor*) and red oak (*Quercus rubra*) and seeded with native understory vegetation.

Photo 13: Planted area just south of the fish passage.

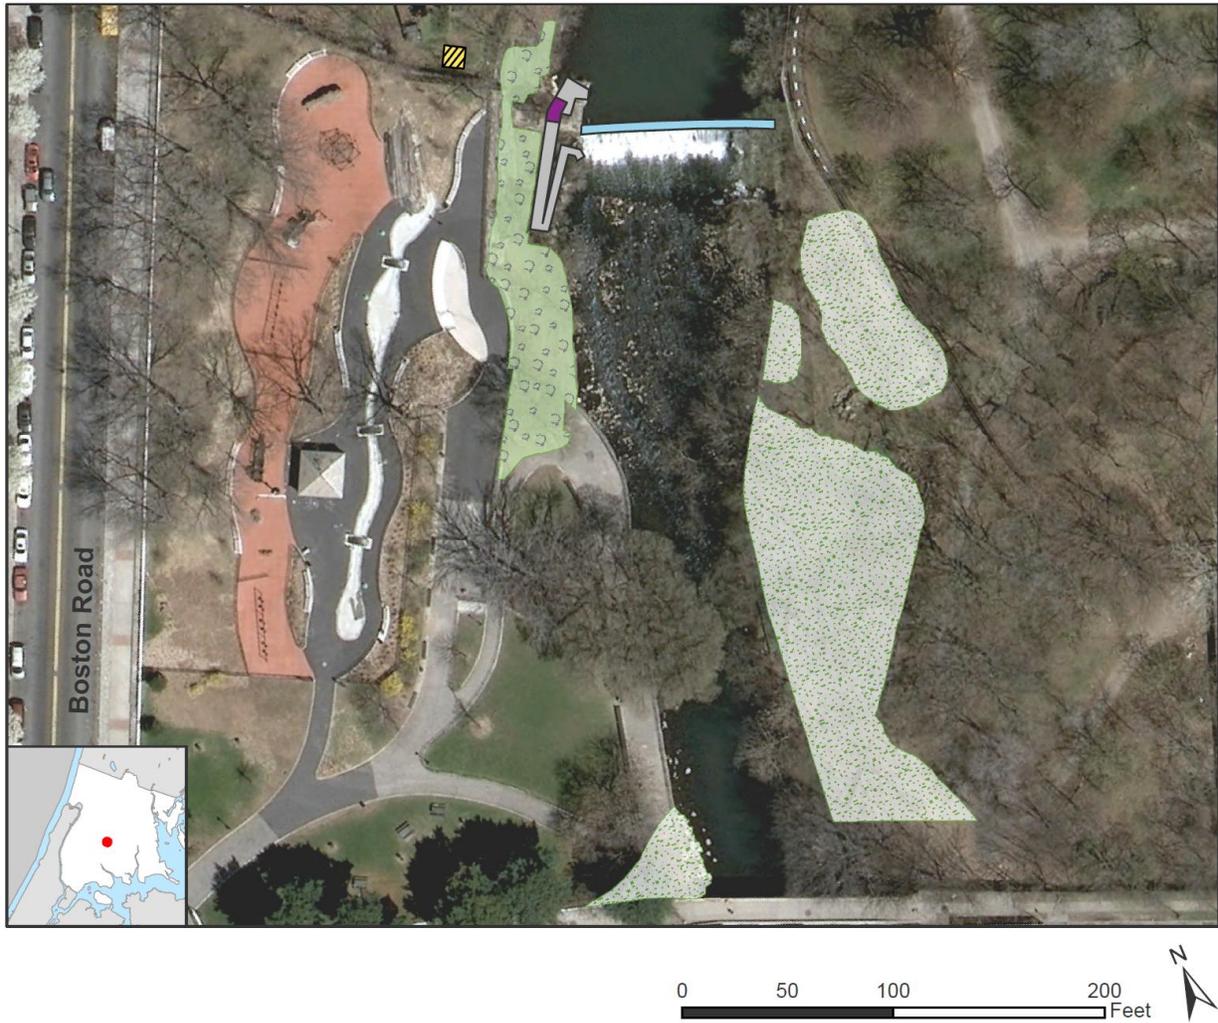
Figure 3: River Park Fish Passage and planted areas.
