Halfway Ranger Station Historic District  
**Historic Structure Report**

Compiled and written by William Clayton, Lee Johnson, Erin Potter, Walt Okstad  
Heritage Resources Program  
Superior National Forest  
8901 Grand Avenue Place  
Duluth, MN 55808

December 2006

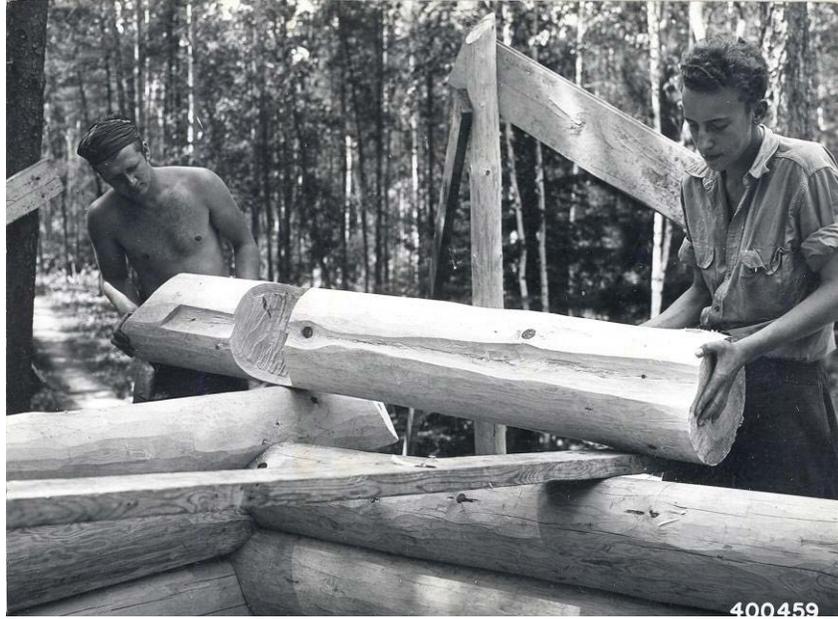
In Northern Minnesota, CCC development projects (conducted between 1933 and 1942) included soil conservation, riparian rehabilitation, fish stocking, fire suppression, tree replanting, road improvement, and the construction of recreation and administrative facilities. Figure 3 shows CCC boys fitting logs during construction of the La Croix Guard Station. This is the same type of log construction used on Halfway Ranger Station buildings.

**Figure 3. CCC boys fitting logs at La Croix Guard Station ca. 1940.  
Photo courtesy of Superior National Forest.**

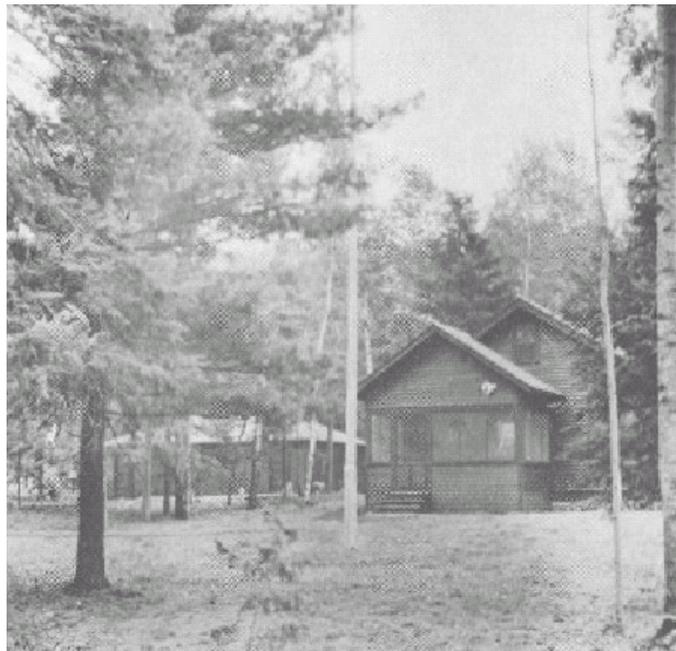
**Figure 5. LSFES bachelor's quarters/office ca. 1934 (Photo source: Rudolf 1985: 218).**

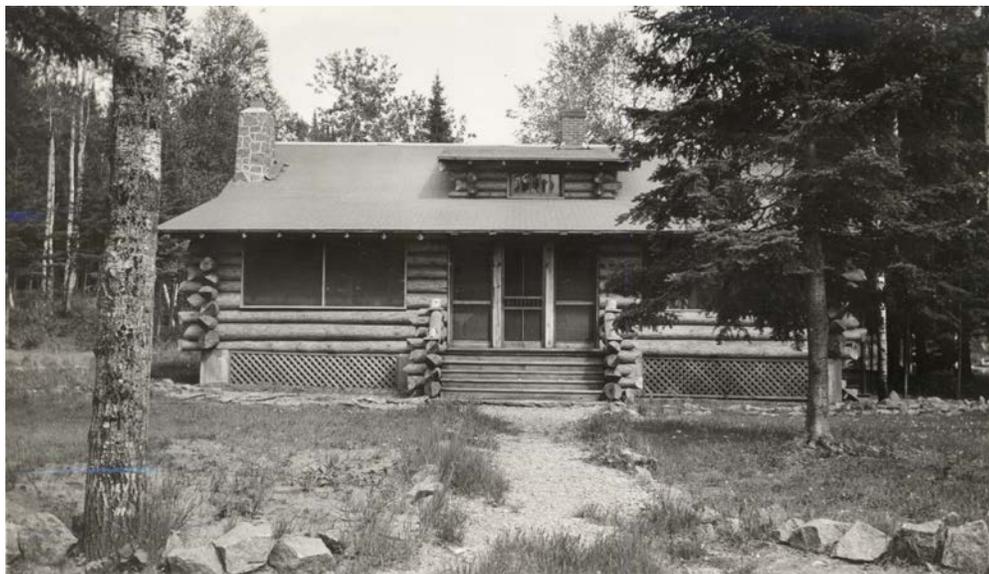
The Ranger Dwelling (see Figure 7) is a single-story side-gabled, residential dwelling that is approximately 38' x 38' and once served as a living quarters for the district ranger and family members. The building also possesses a finished attic. Built with notable deviations from Region 9 building Plan #48 for Ranger Dwellings, the building was designed with a square massed floor plan, which included a full-length porch extending out approximately 7-8 feet from the front entrance façade-wall. A low-angle shed roof that extends directly from the eave-line of the principal roof to form a continuous or “extended” roof covers the porch. The floor plan is oriented on the landscape so that the front entrance façade-wall faces to the west. The center axis of the building is roughly perpendicular to the east shoreline of the South Kawishiwi River.

**Figure 7. Front view of the Ranger Dwelling in 1934. Exposure was taken from the west. Photo courtesy of Superior National Forest.**

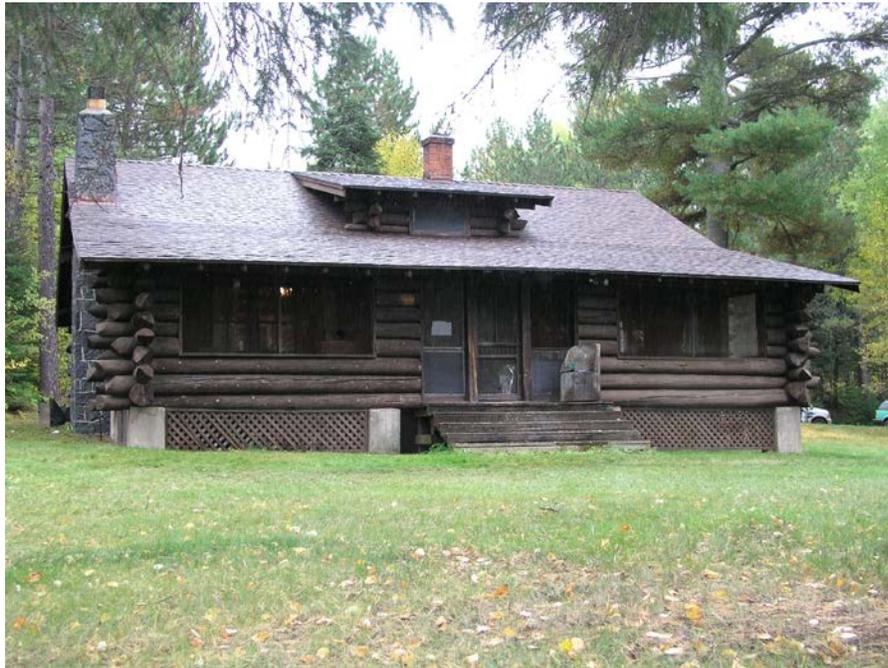
The Ranger Dwelling was constructed on a full-sized, poured concrete basement with at least a 6' wall depth below grade. The outer wall of the porch rests on three large poured concrete footings that are approximately 3' x 3' square. The walls are constructed with peeled round logs prepared from locally available pine and aspen logs (Dunn 1997) that were laid with alternating butt and tip ends and connected by means of a standard saddle-notch. In keeping with the rustic style, log ends were intentionally cut to run proud of the wall intersection and finished off by shaping the ends to chisel-edge point. In order to facilitate a tight, weatherproof, chink-less fit, the logs were prepared by shaping a groove or flute along the entire length of the bottom of each log to promote a tighter fit between logs without having to scribe them. The roof of the Ranger Dwelling was constructed with purlins made of logs of small diameter, relative to the wall logs, and covered over with 1" thick dimensional lumber for sheathing. The original roof covering appears, from photographic evidence, to have consisted of standard asphalt shingles, which have been replaced several times over the years. Figure 8 shows the current building front elevation.

**Figure 8. Front view of the Ranger Dwelling in 2006. Exposure was taken from the west-northwest. Note removal of stair log railing. Photo courtesy of Superior National Forest.**

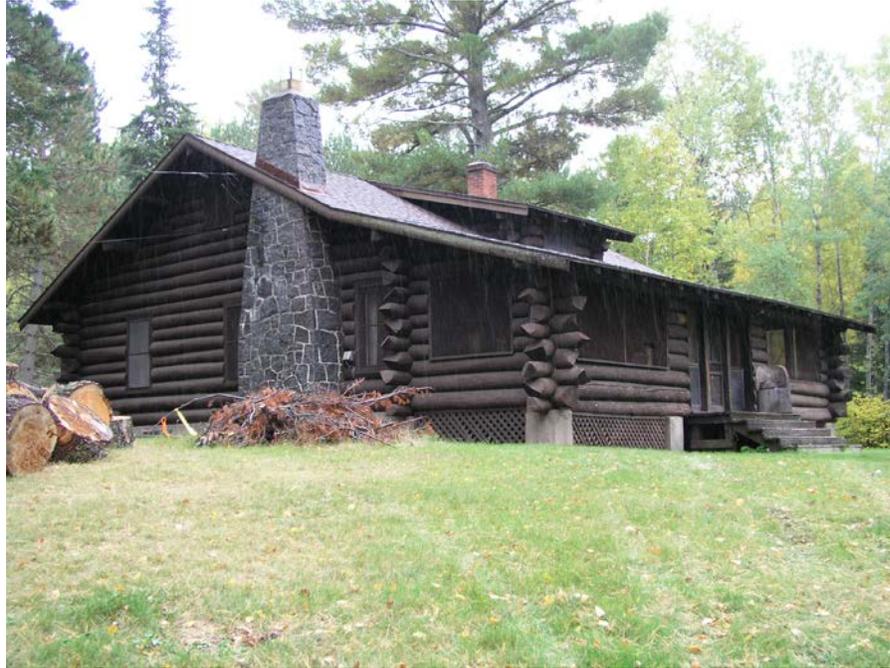
including the most recent one witnessed by the Heritage Resources Staff during a photographic survey trip in the fall of 2006. The most significant change to the overall architecture consists of the removal of the log railing wall on the front entrance stoop, which can be seen in a 1934 photo (see Figure 7) of the front elevation. The timing of this particular change is unknown but was probably completed when the present version of the front stoop was constructed (see Figure 9).

**Figure 9. Corner view of the Ranger Dwelling in 2006. Exposure was taken from the north-northwest. Photo courtesy of Superior National Forest.**

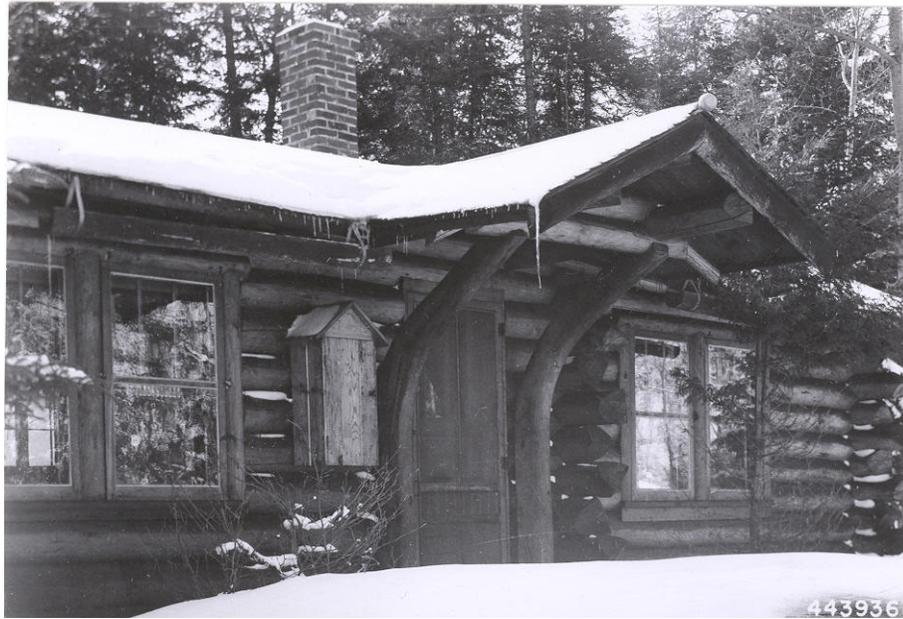
**Figure 10.** Front view of the District Office building in 1947. View is from the north-northwest. Note the curved log brackets supporting the porch roof and hanging half-log gutters. Photo courtesy of Superior National Forest.

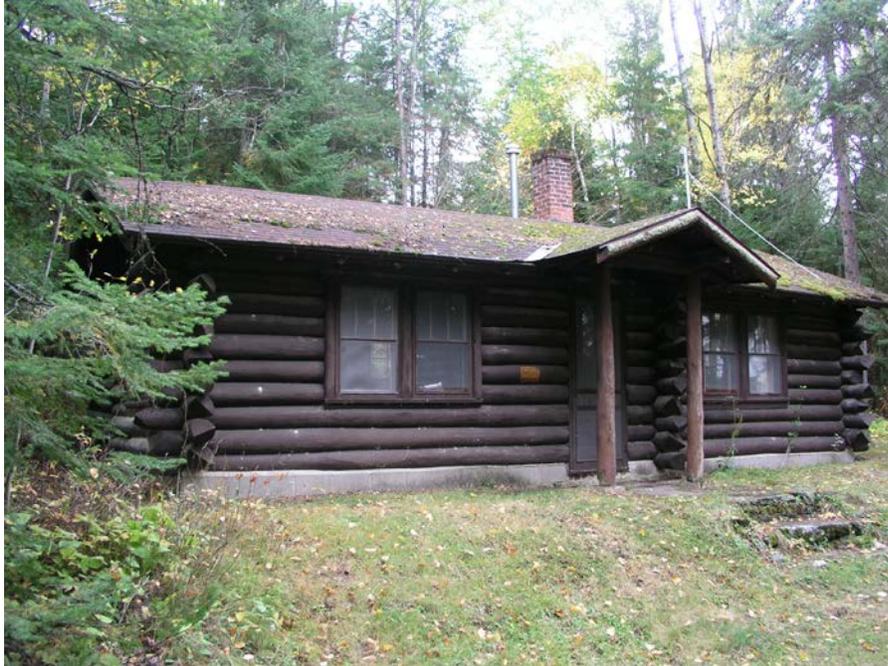
**Figure 71. Office building 2006. Photo courtesy of Superior National Forest.**

Another significant and striking pre-1947 alteration was the complete replacement of the original support posts for the stoop roof. These posts consisted of two unusually bent logs that originally flanked the front entrance door. Each log was connected to the wall in some, yet, unknown fashion and angled up, from the midway point of the door, to meet with a central support log in the stoop roof. The rationale and date of this particular change is unknown but it did take place sometime after 1947. It is probable that the change was made because of some structural failure detected in the posts, possibly caused by dry rot or powder-post beetle infestation.

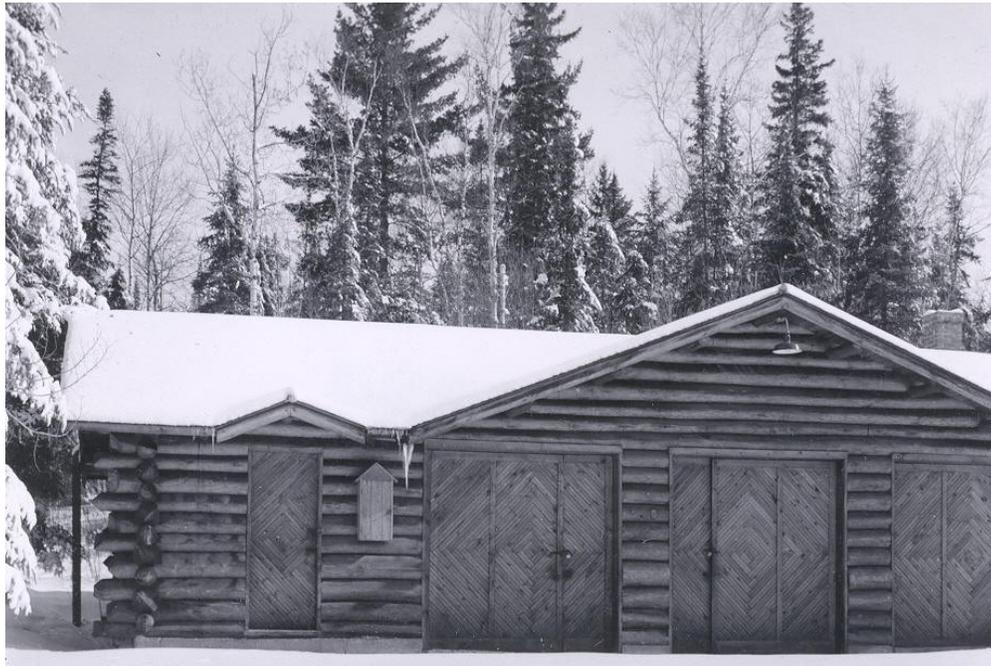
**Figure 12.** View of the left side of the Warehouse in 1947. Taken from the south. Photo courtesy of Superior National Forest.

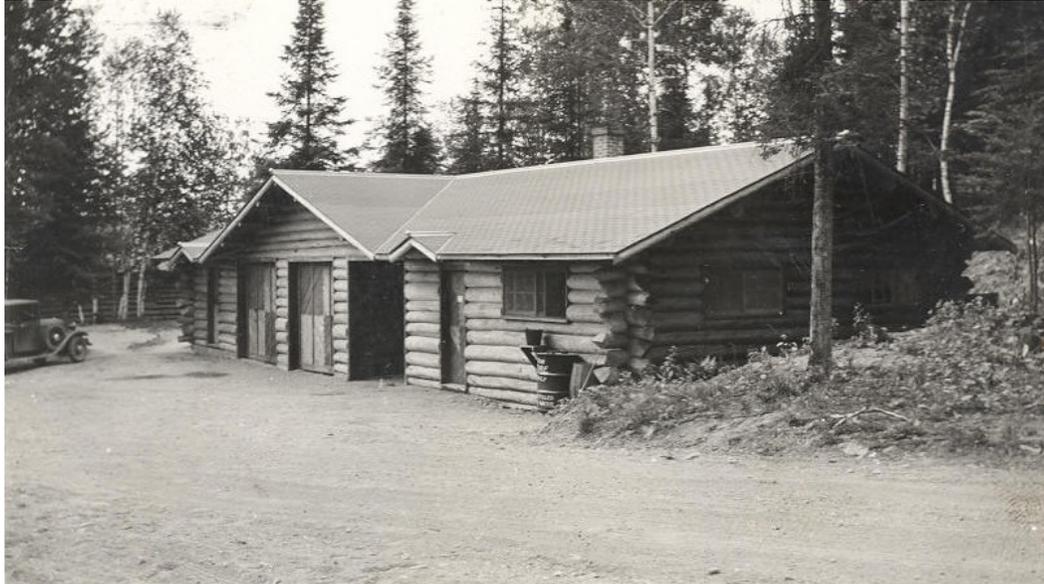
**Figure 13. View of the Warehouse in 1934. Taken from the southeast. Photo courtesy of Superior National Forest.**

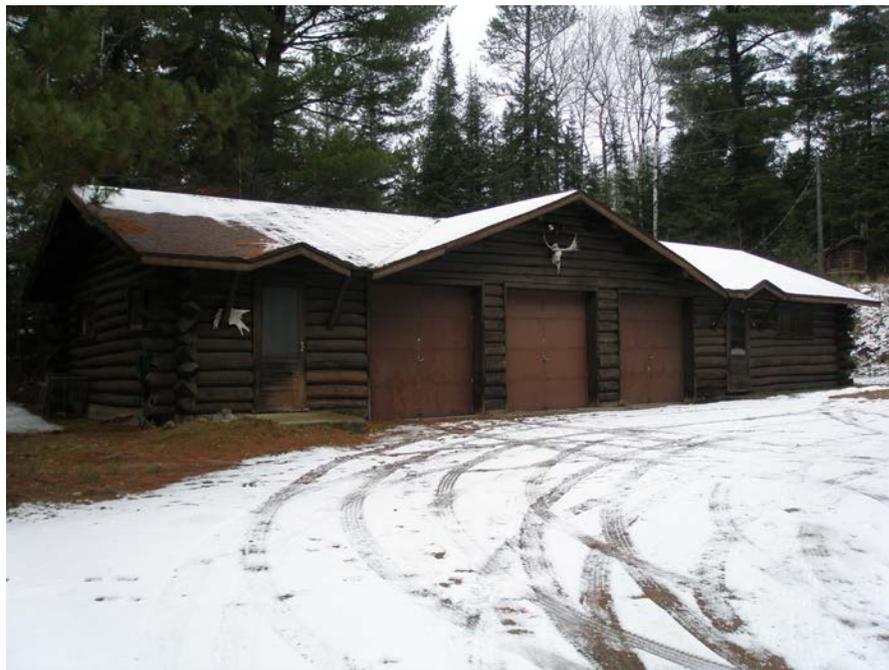
Alterations to the original construction of the Warehouse Building consist of the replacement of all the exterior doors, the removal of the metal ridge cap on all the gable ridges, and the addition of supporting brackets to both the small eave dormers (see Figure 15). As shown in Figure 12, the original door construction consisted of a board-and-batten structure covered on the exterior side by wainscoting, set in a diamond shape pattern. Surviving examples of this door type hang on the front entrance of the Oil House, the front entrance of the Outhouse, the first Cellar door, and a variation on the front entrance of the Boat House. The date of these alterations is presently unknown. The Warehouse has experienced some structural degradation from powder post beetle infestation.

**Figure 15. View of the Warehouse in 2006. Taken from the southwest. Note original herring-bone doors have been replaced. Photo courtesy of Superior National Forest.**

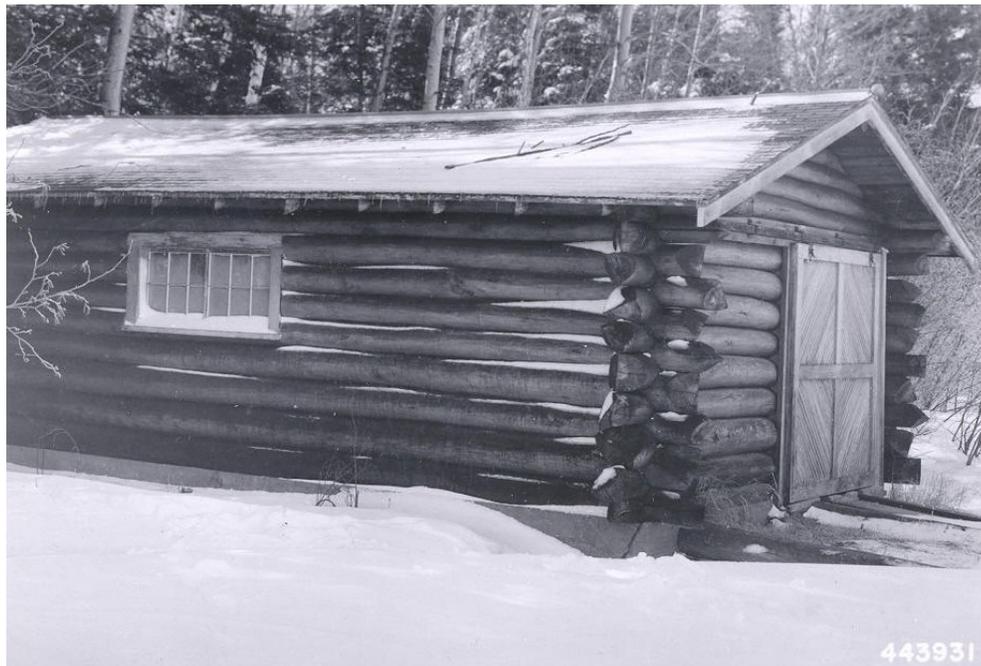
The Boat house has experienced very few alterations except the removal of the original boat ramp consisting of iron rails and a dock, and some structural degradation from powder post beetle infestation. Figures 16 and 17 show these changes.

**Figure 16. Boat House ca. 1947. Note rails in front of door to haul boats from water. Photo courtesy Superior National Forest.**

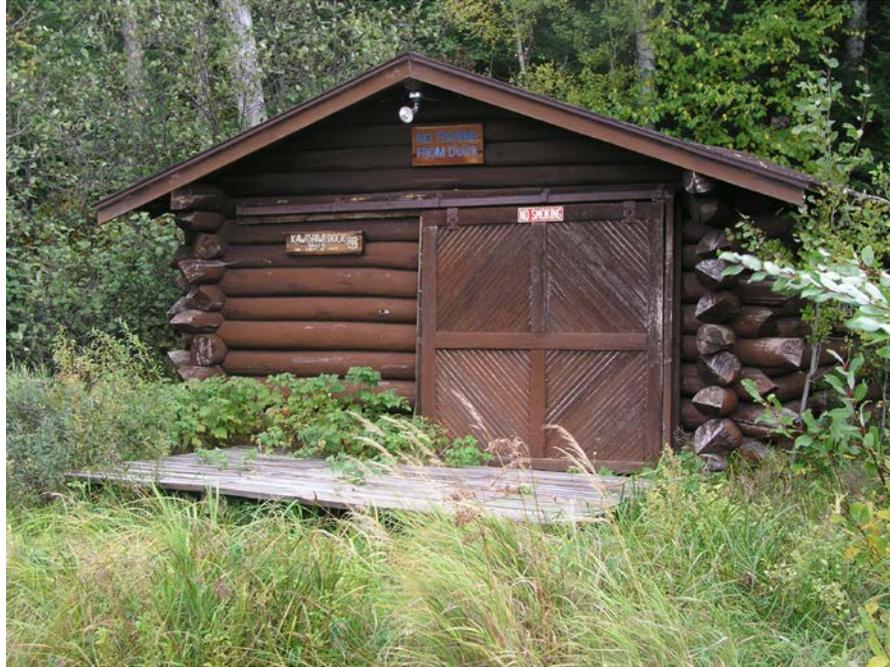
**Figure 17. Current Boat House 2006. Note newer dock and absence of rails.**  
Photo courtesy of Superior National Forest.

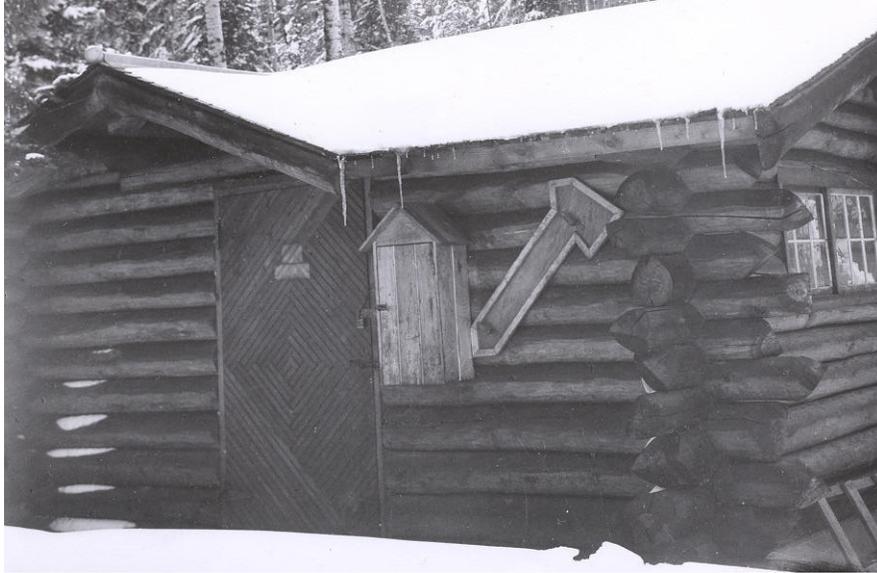
Figure 18. Oil house 1947. Photo courtesy of Superior National Forest.

The Oil House has experienced very few alterations except the removal of the original windows and some structural degradation from powder post beetle infestation (see Figures 18 and 19).

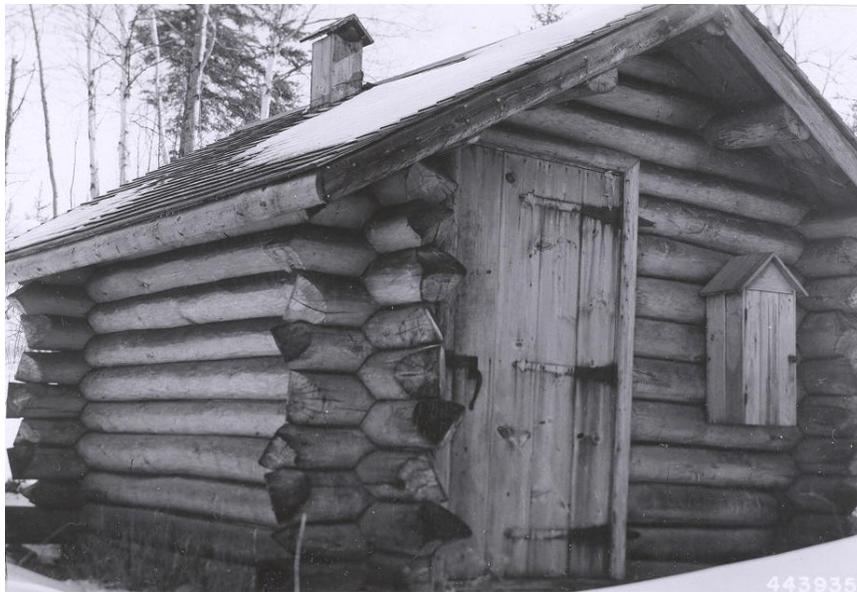
The Pump House has experienced very few alterations, with the exception of slight structural degradation from powder post beetle infestation. Figures 20 and 21 show the pump house historically and today.

**Figure 20. Pump house 1947. Note fire box attached. Photo courtesy of Superior National Forest.**

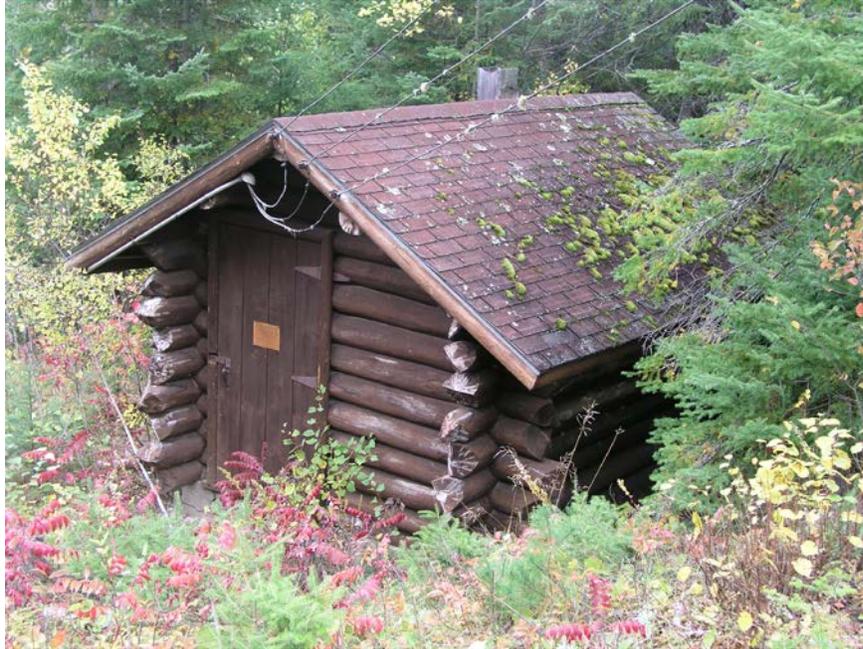
**Figure 81. Pump house 2006. Little has changed, except removal of fire box. White streaks on building are a result of powder post beetle infestation. Photo courtesy of Superior National Forest.**

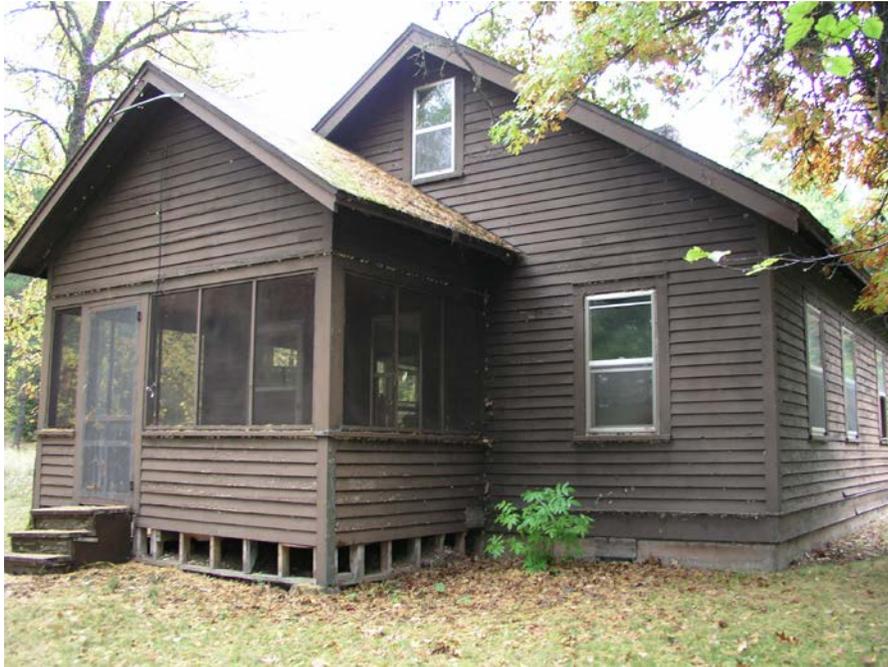
**Figure 22. LSFES Office/Dwelling building 2006. Note modern aluminum window inserts. Photo courtesy of Superior National Forest.**

Based on limited information, the LSFES Dwelling appears to have been relatively unaltered since its construction. The few notable alterations, based on photographic evidence, include the addition of aluminum inserts on all the windows and the replacement of the original doors. Interior changes are undocumented at this time.

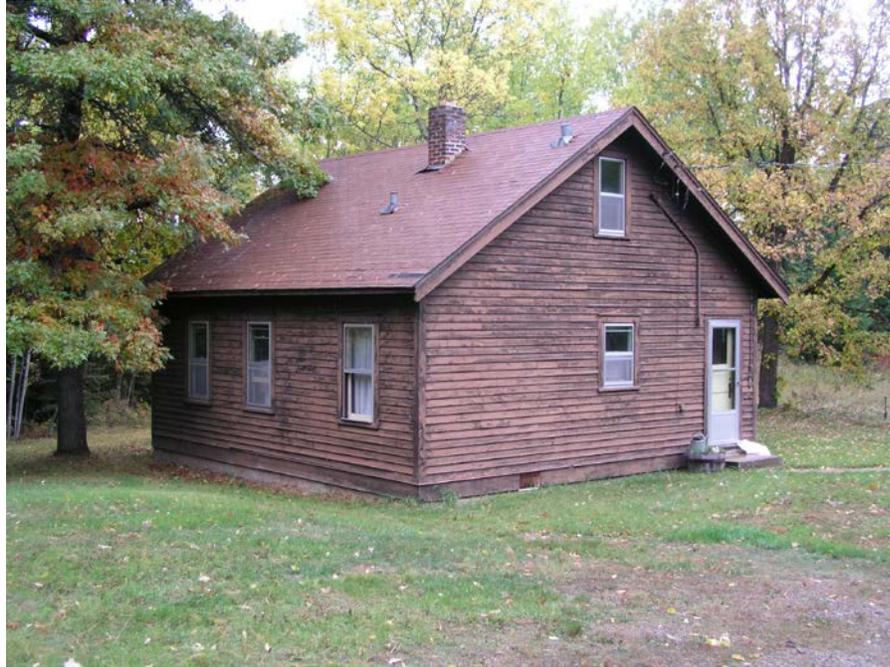
**Figure 23. Back side of LSFES Office/Dwelling 2006. Photo courtesy of Superior National Forest.**

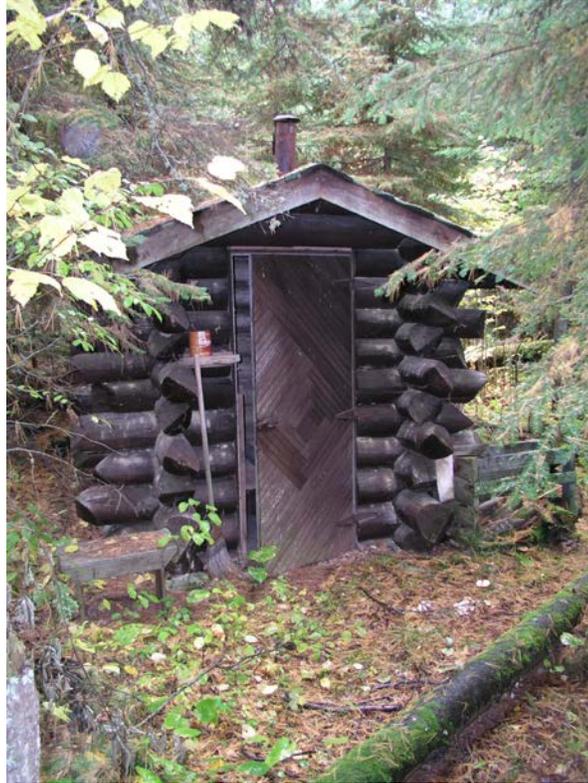
Figure 24. Outhouse 2006, front elevation. Note recurrence of diamond pattern door. Photo courtesy of Superior National Forest.

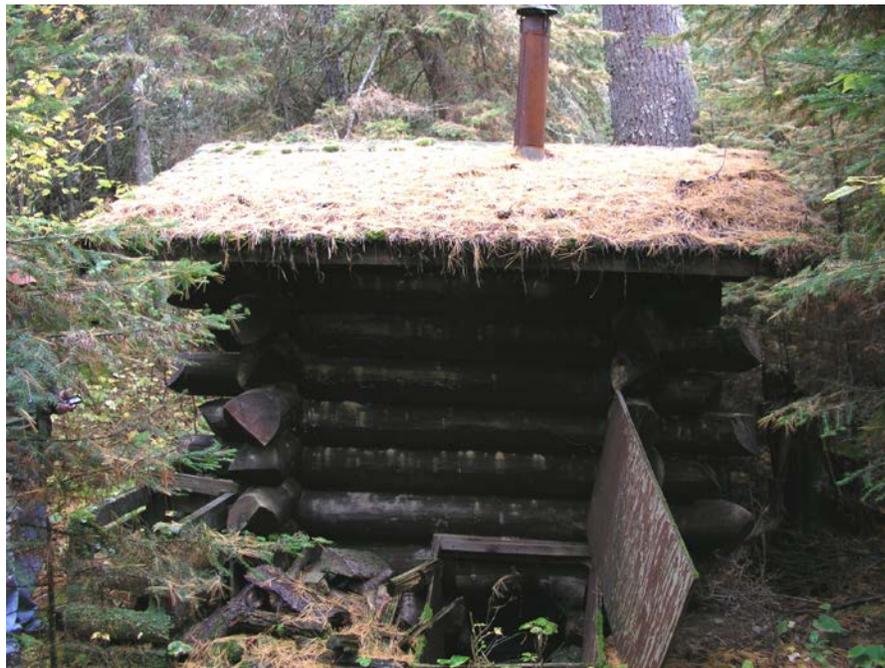
Figure 25. Outhouse 2006. Note powder post beetle infestation, heavy roof duff, and sauna stove pipe. Photo courtesy of Superior National Forest.

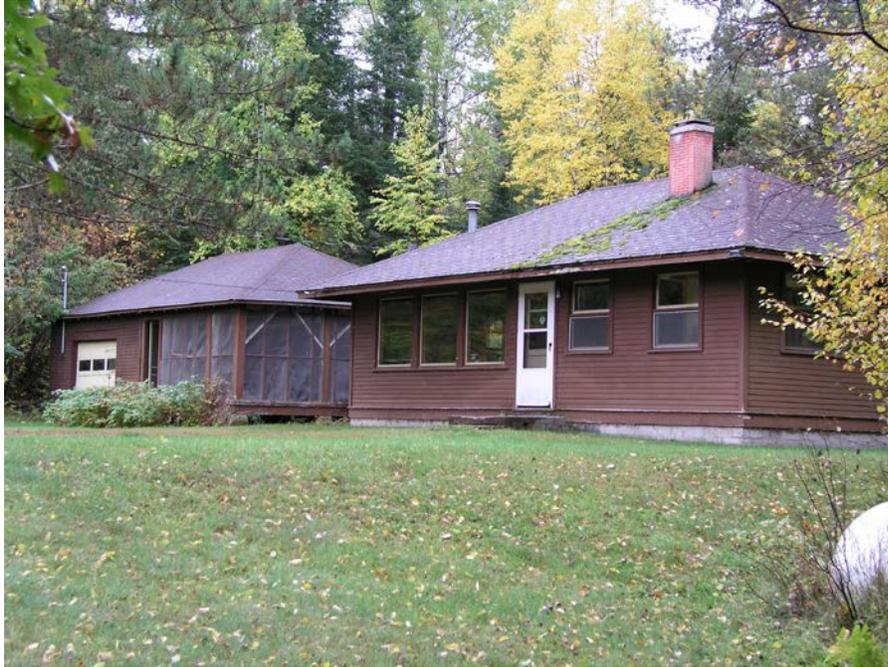
Based on limited information, the LSFES Insectory appears to have been relatively unaltered since its construction.

Figure 26 shows the insectory/garage and laboratory buildings as they exist today.

**Figure 26. Insectory (left) and Laboratory (right) buildings 2006. Photo courtesy of Superior National Forest.**

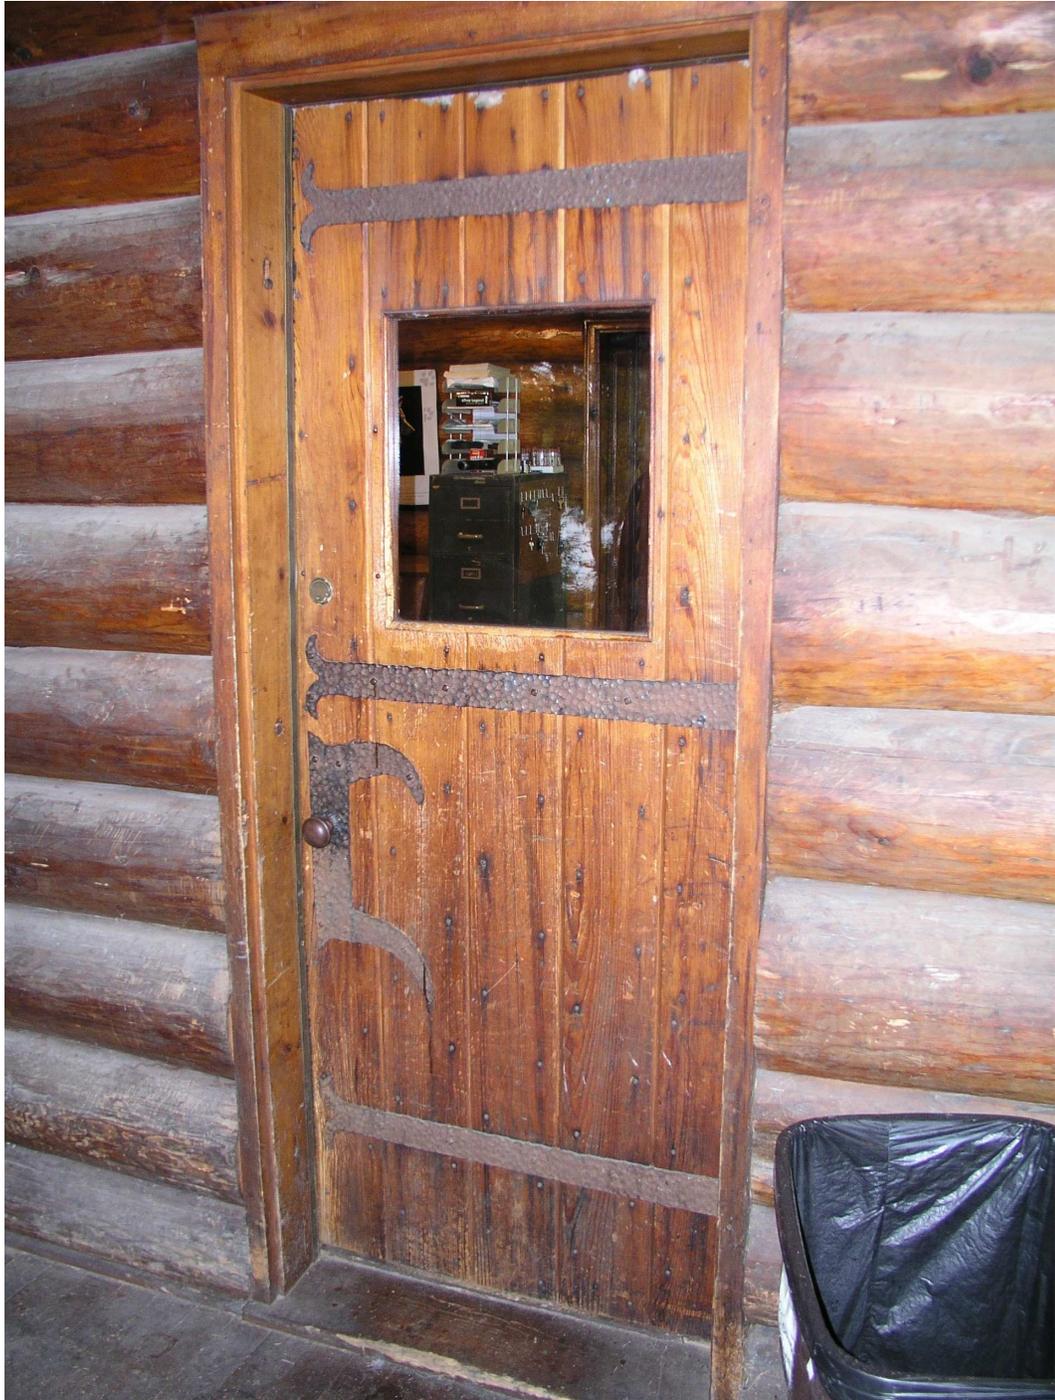
**Photo 1. View of the front door of the Ranger Dwelling. Note the hand-forged hinges and door-knob plate.**

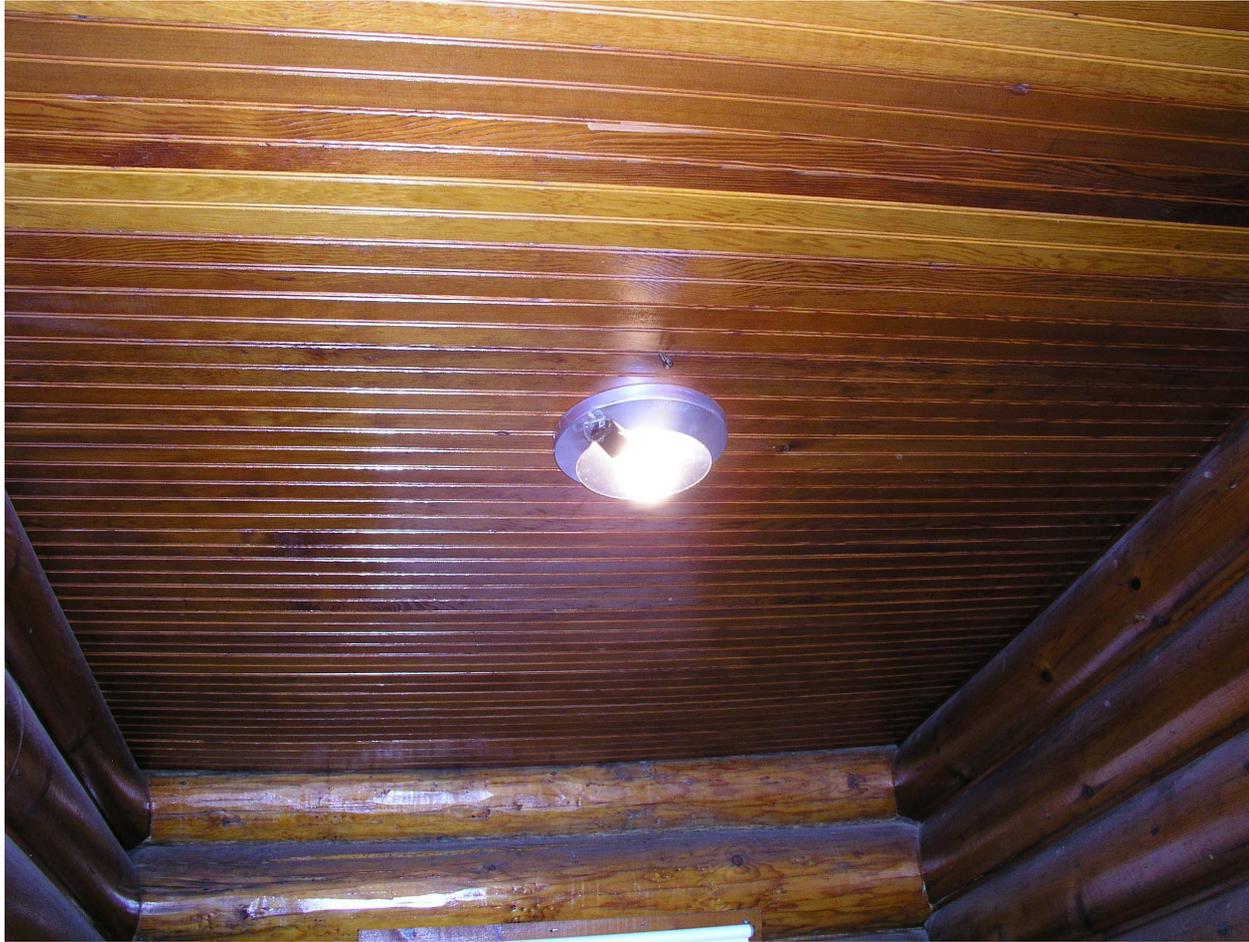
Photo 6. View of the wainscoting used to finish the ceilings of the Ranger Dwelling.

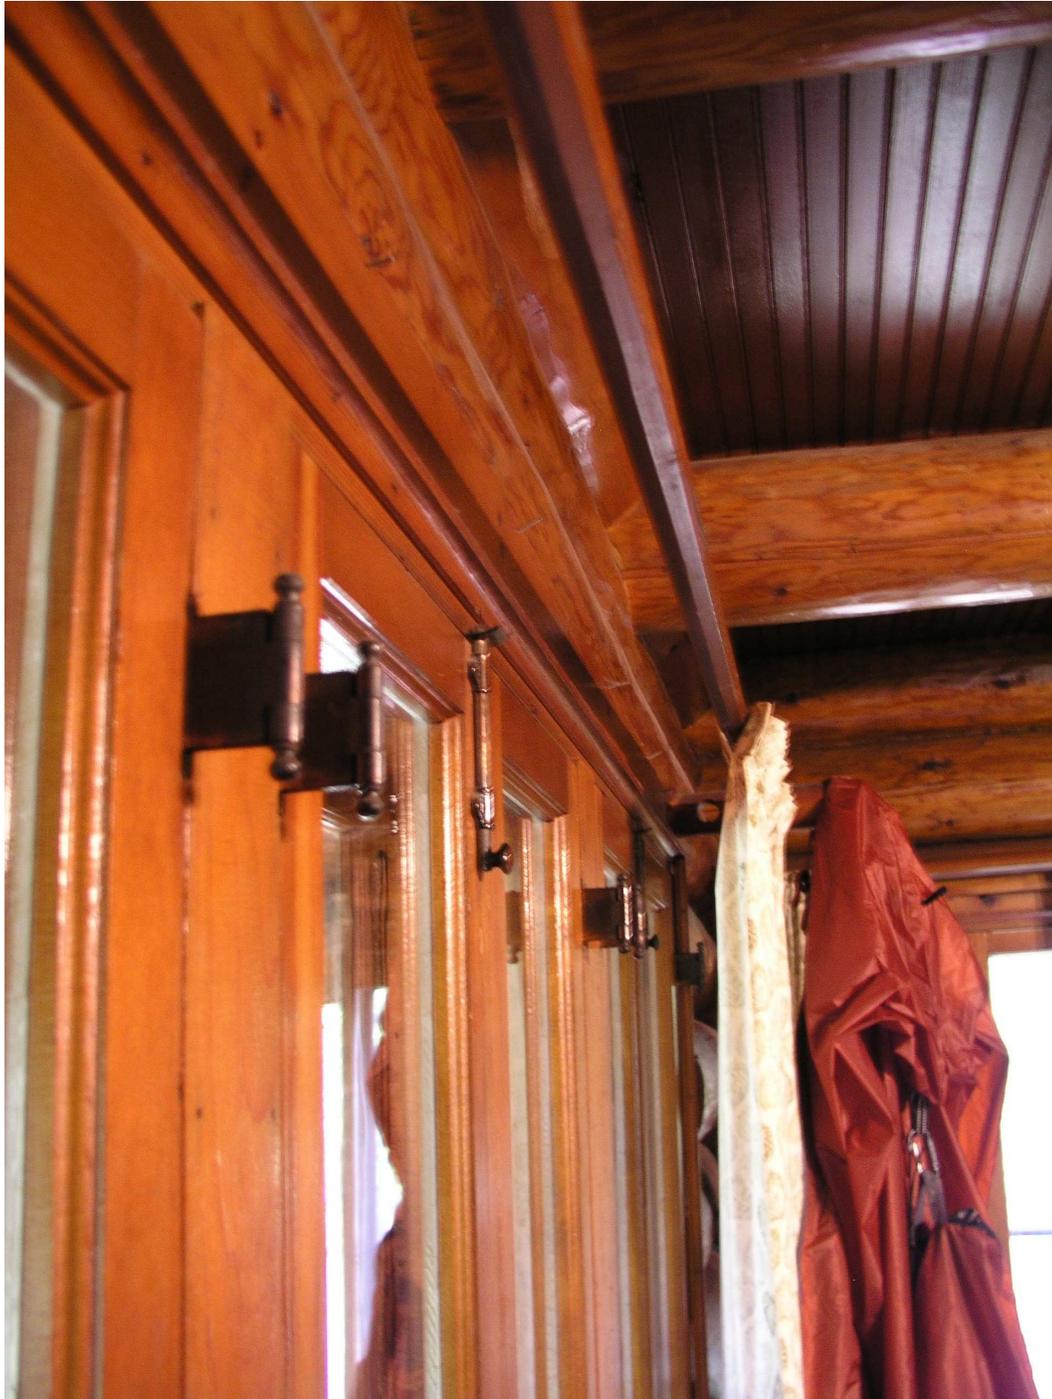
Photo 17. Close up view of the west wall of the kitchen in the Ranger Dwelling. Note the ceiling finish consisting of exposed logs and wainscoting. Also note the unusual extended door hinges.

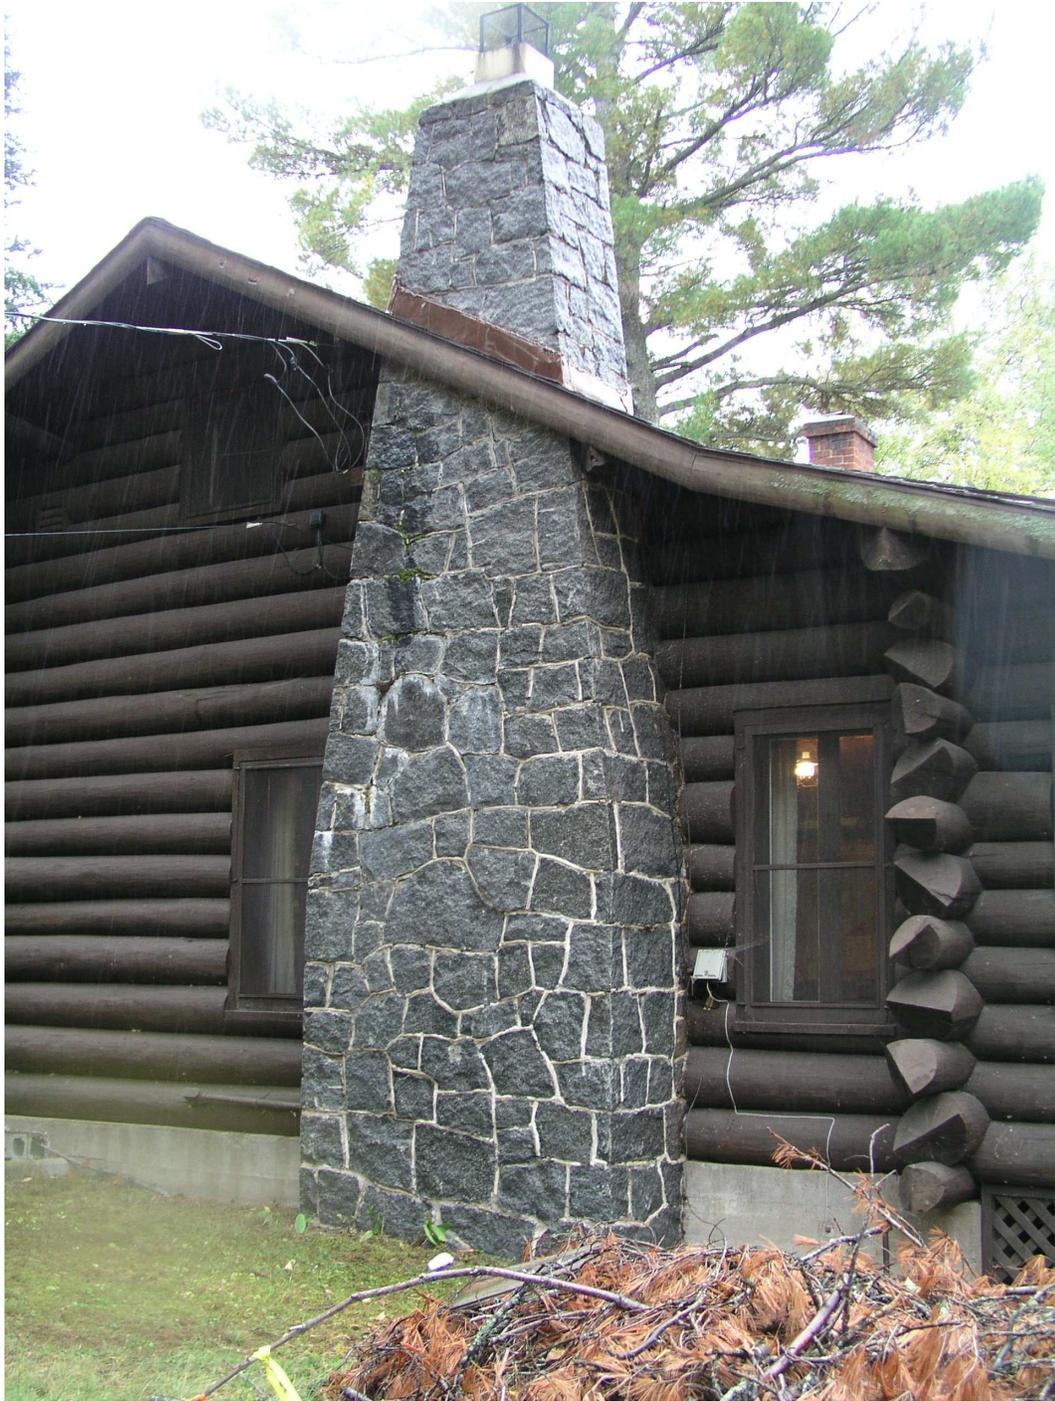
**Photo 26. Close-up view of the fireplace chimney on the north gable wall of the Ranger Dwelling. View from the north-northwest.**

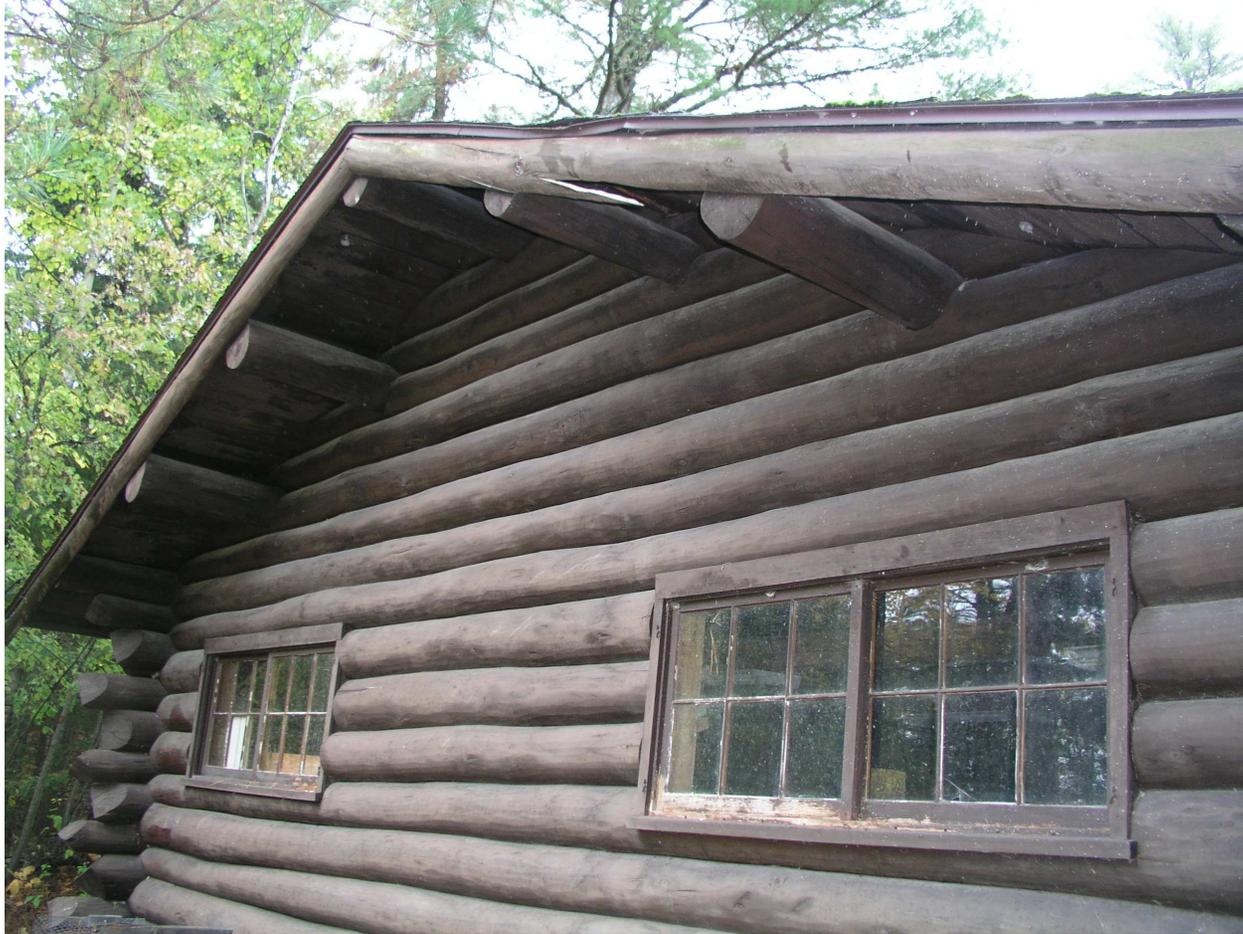
**Photo 29. View of the west gable wall of the Warehouse. Note the construction of the eaves and the fractured fascia board. Also note the original double-sash slider windows. View from the southwest.**

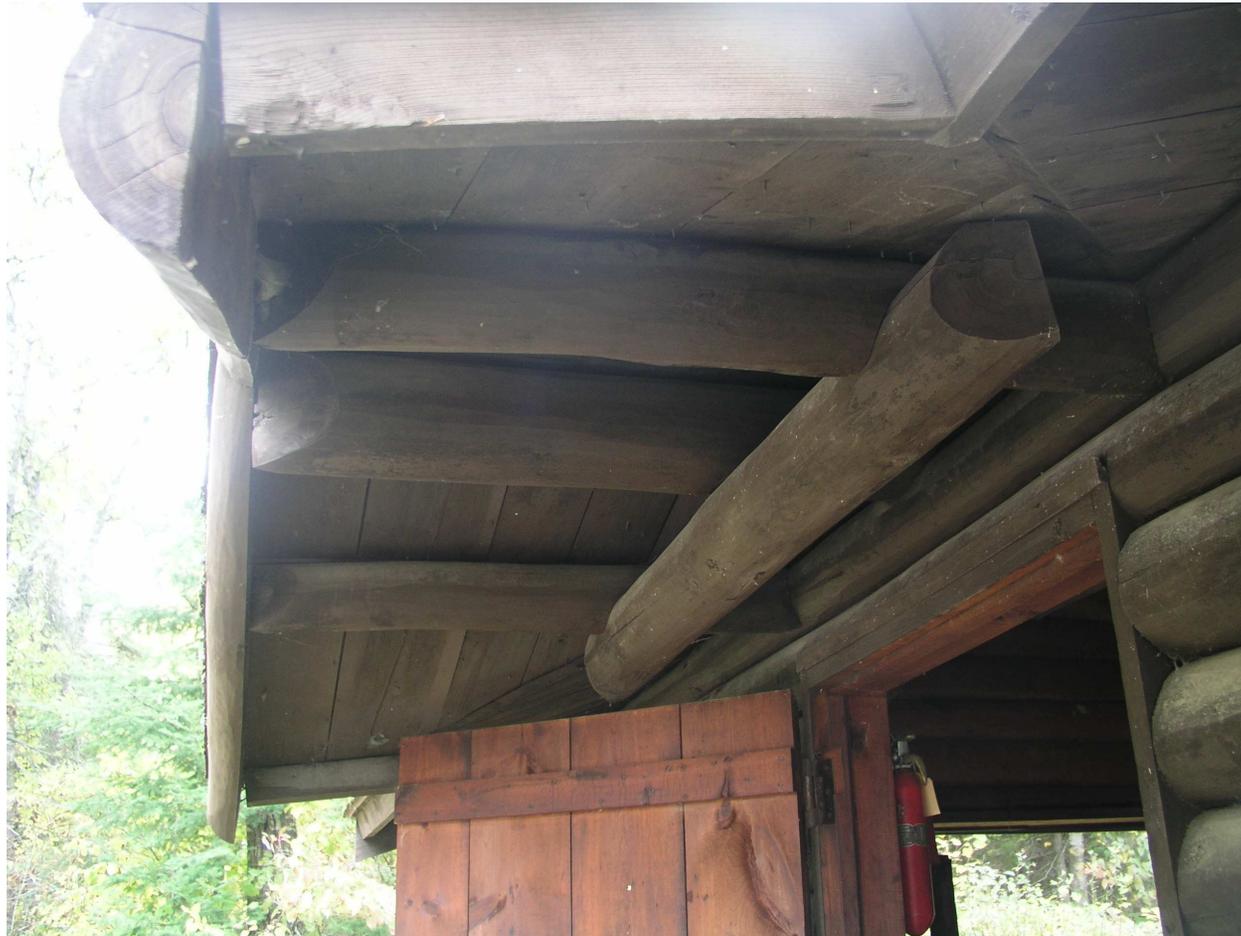
**Photo 32. View of the structural detail of the dormer roof on the Oil House. Taken from the west.**

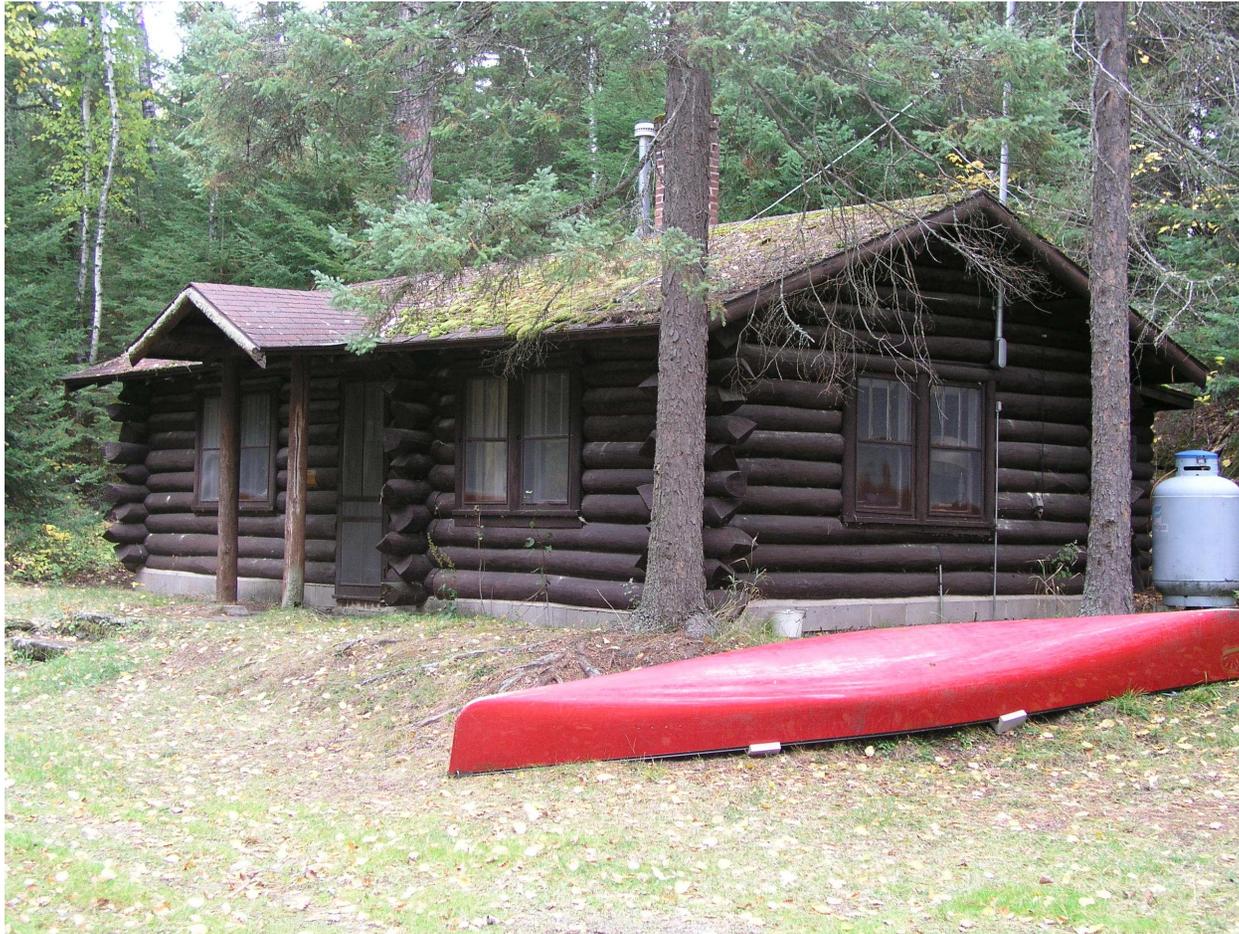
**Photo 34. Exterior view of the south gable wall and the west facade entrance wall of the District Office Building. Taken from the southwest.**
