Halfway Ranger Station Historic District  
**Historic Structure Report**

Compiled and written by William Clayton, Lee Johnson, Erin Potter, Walt Okstad  
Heritage Resources Program  
Superior National Forest  
8901 Grand Avenue Place  
Duluth, MN 55808

December 2006

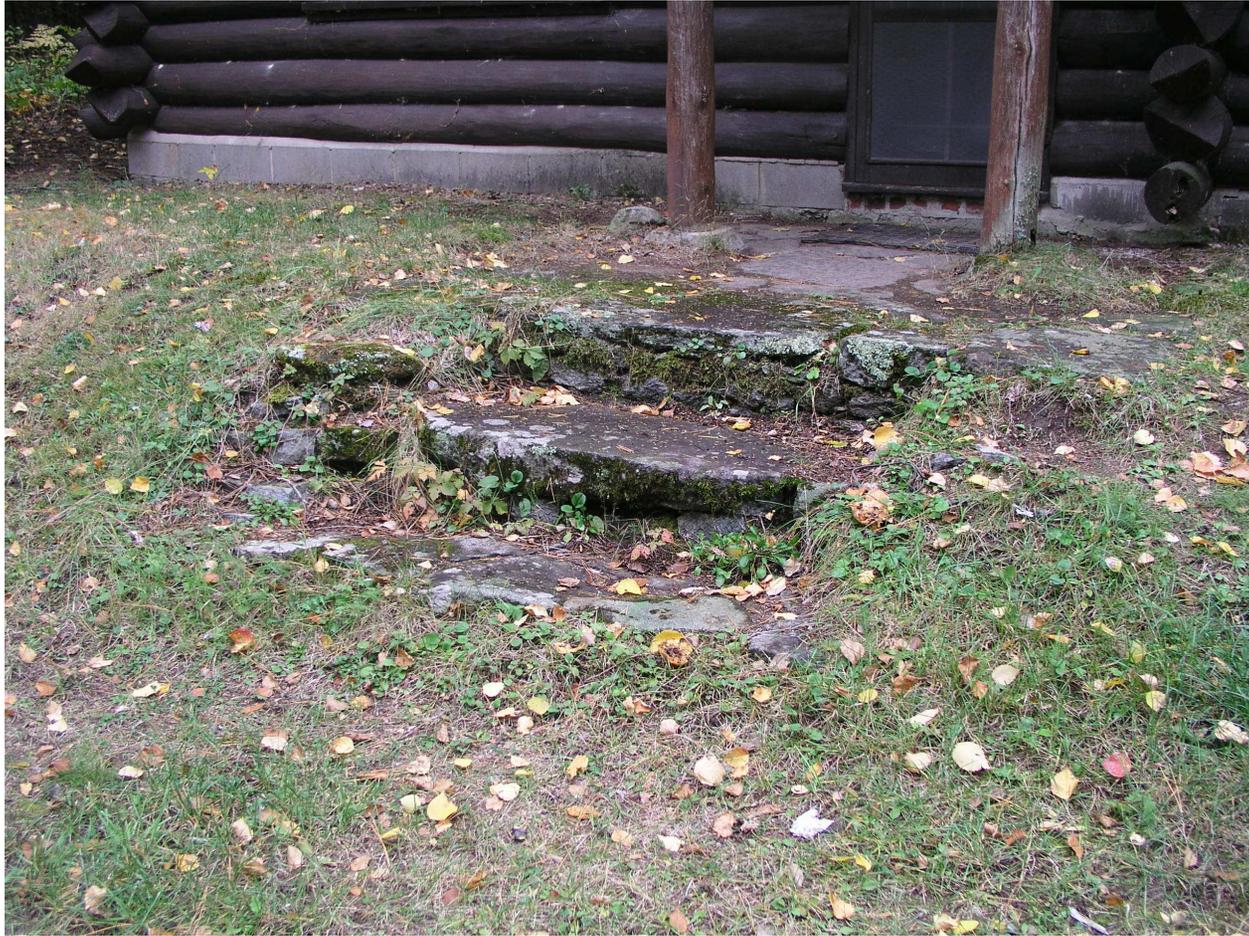
**Photo 35. View of the stone steps in front of the District Office. View from the west-southwest.**

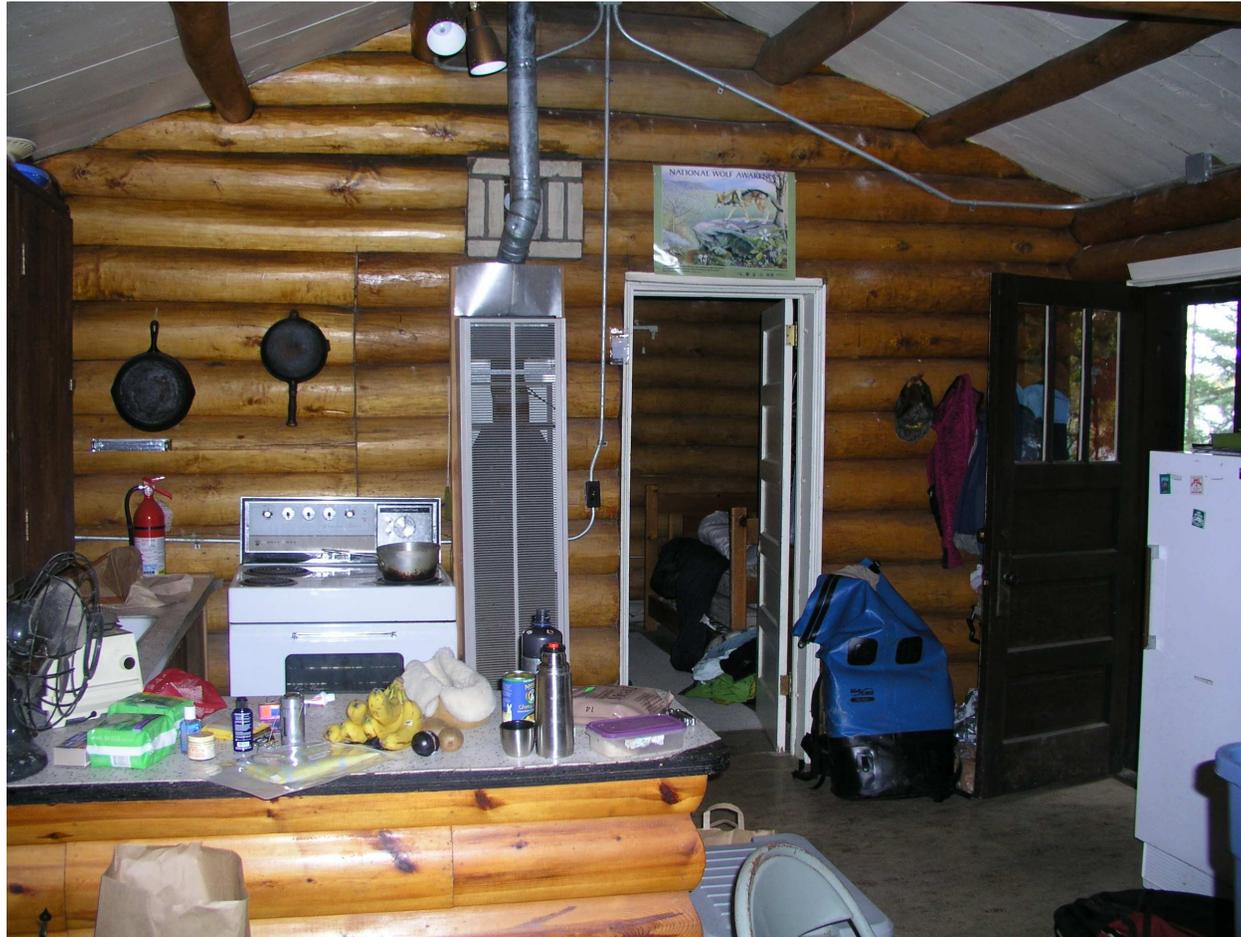
Photo 36. Interior view of the south wall of the District Office Building. This wall was probably an exterior wall before the bedroom addition was added.

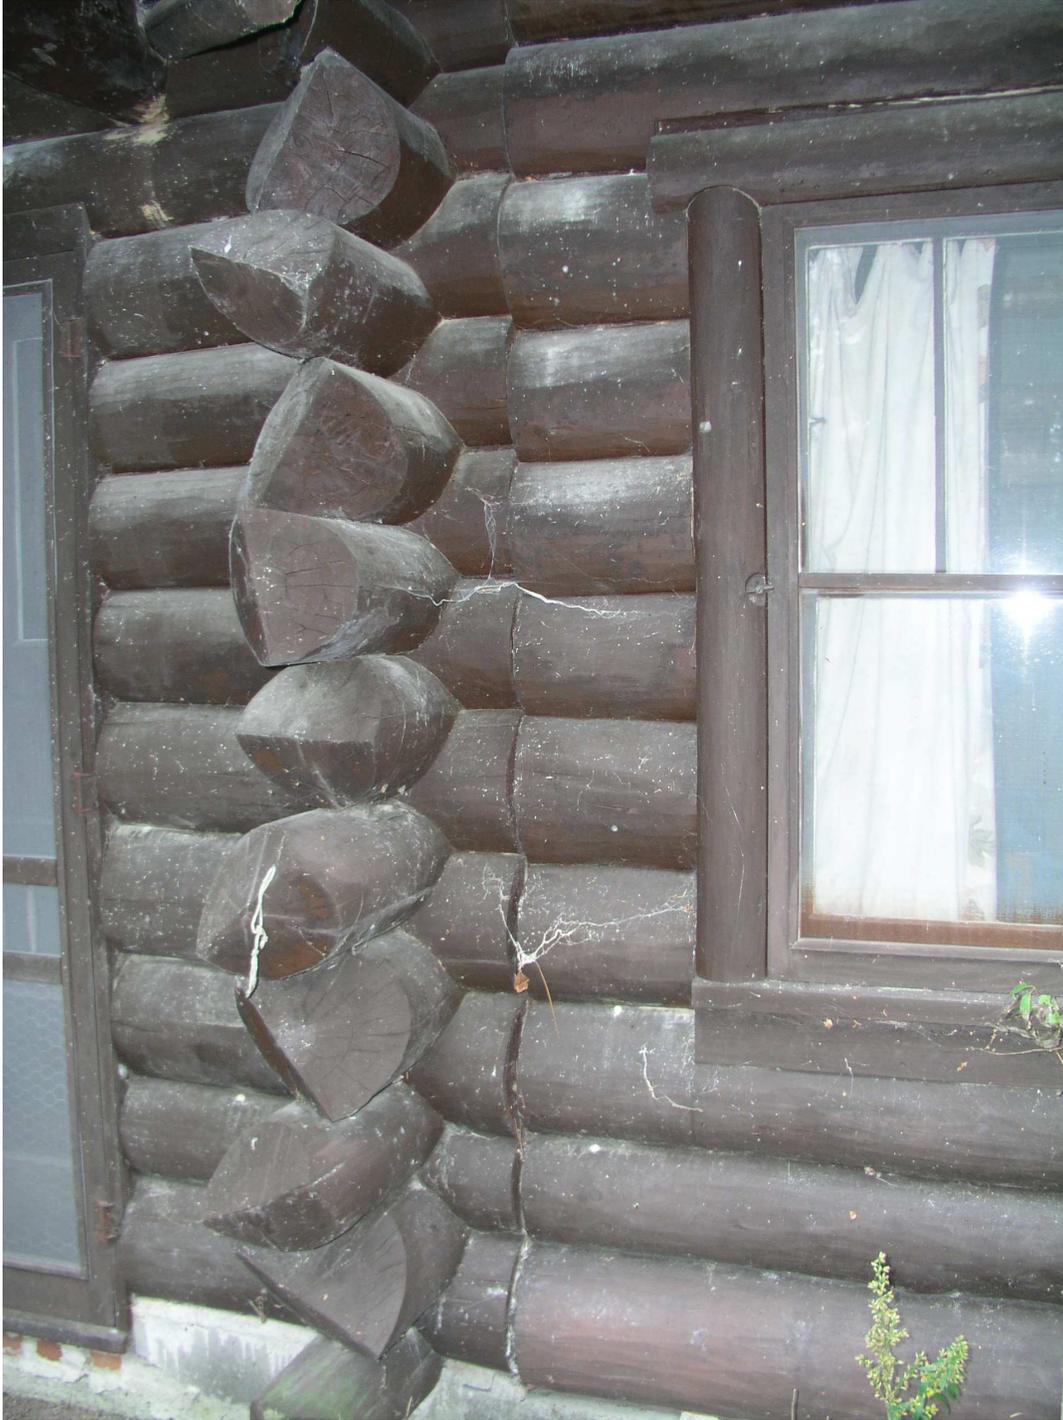
**Photo 37. Close-up view of west façade wall of the District Office Building. Note wall break between original building on left and bedroom addition on the right.**

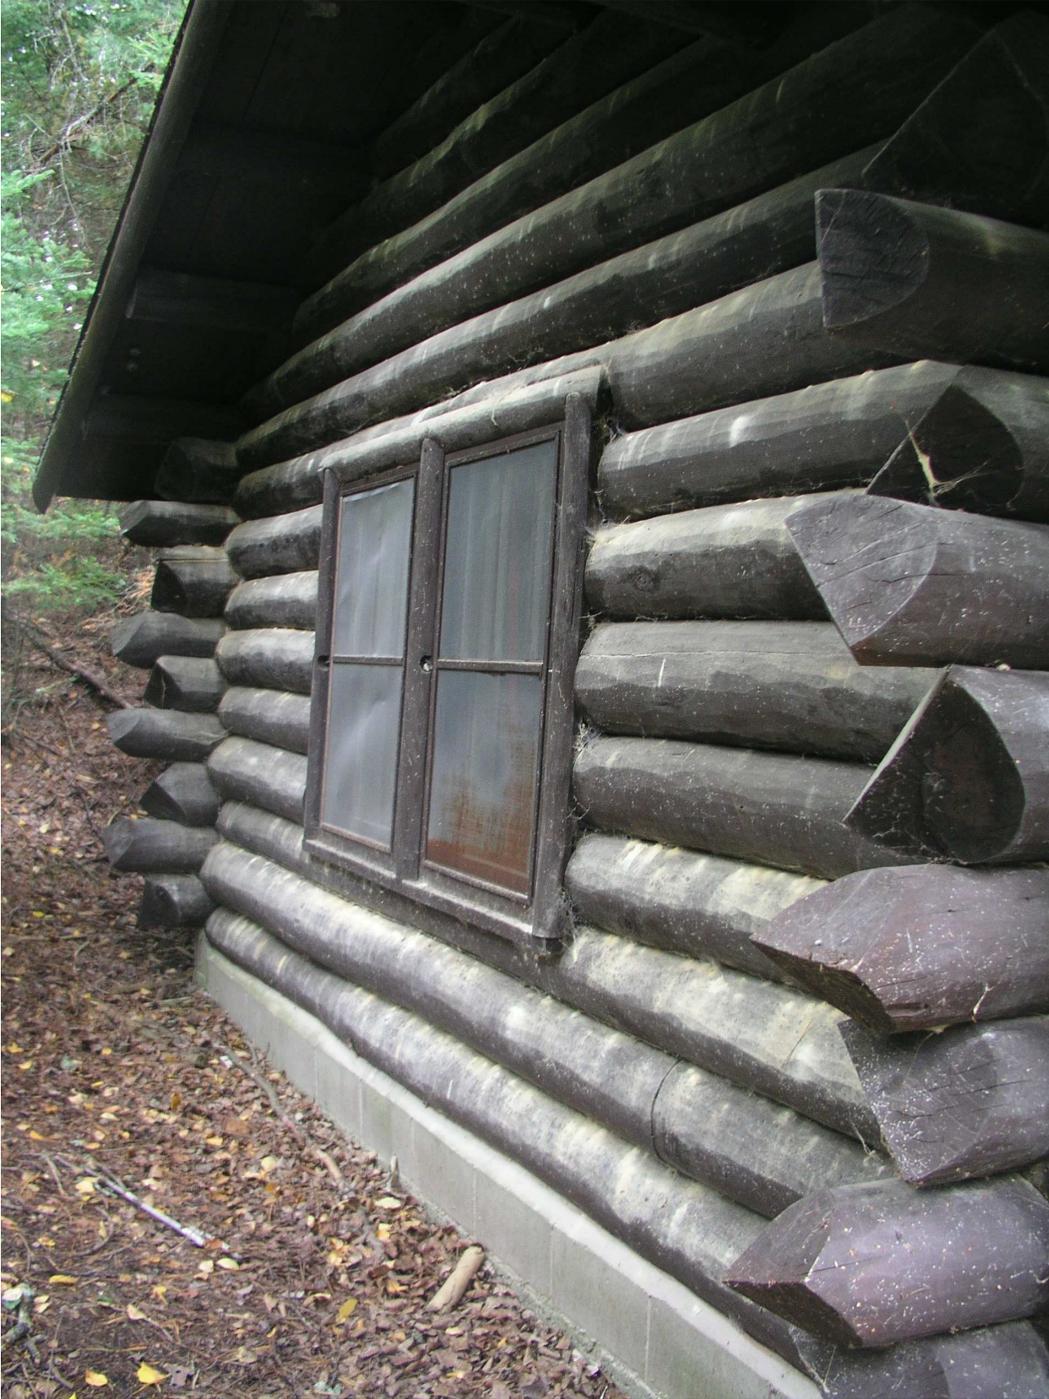
**Photo 38. Close-up of north gable wall of the District Office Building. Note dust left over as a result of powder-post beetle infestation.**

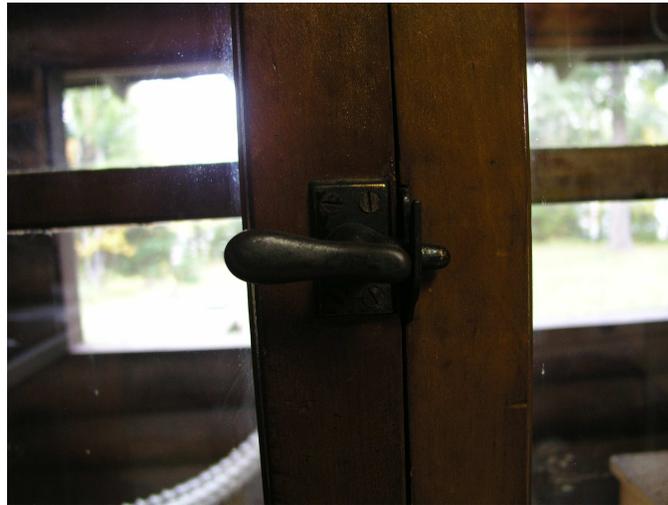
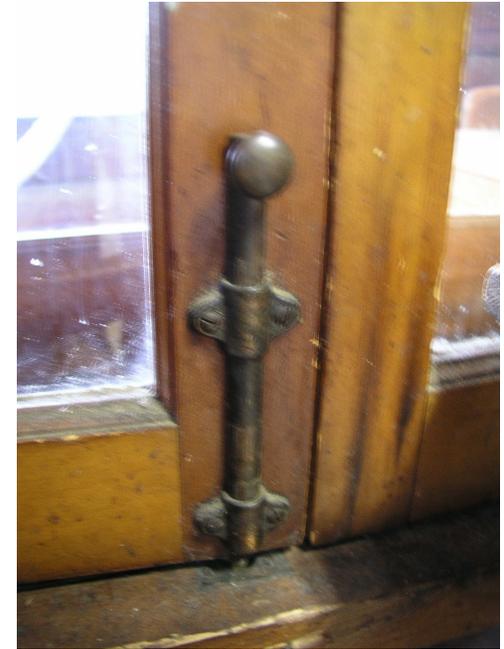
Photo 39. Window hardware used on the casement windows in the Ranger Dwelling.
