## Plugs or flood-makers? The unstable landslide dams of eastern Oregon

E.B. Safran<sup>a,\*</sup>, J.E. O'Connor<sup>b</sup>, L.L. Ely<sup>c</sup>, P.K. House<sup>d</sup>, G. Grant<sup>e</sup>, K. Harrity<sup>f,1</sup>, K. Croall<sup>f,1</sup>, E. Jones<sup>f,1</sup>

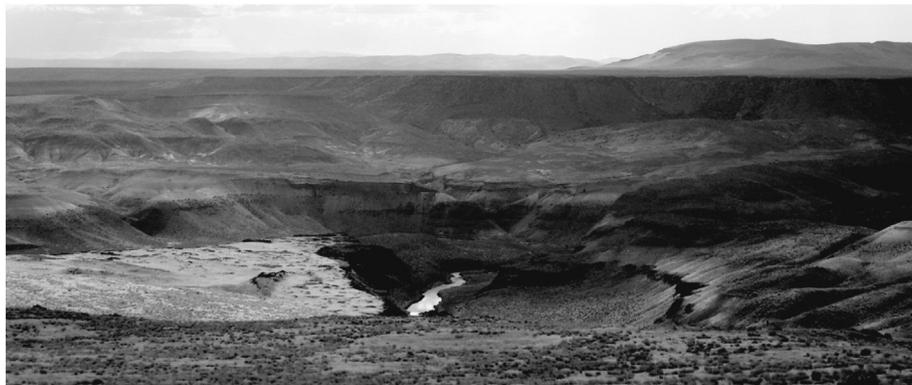
**Fig. 2.** View of Owyhee River illustrating typical regional landscape morphology. Tertiary and Quaternary lava flows form plateaus at multiple elevations, and incising river canyons create local relief of several 100 m.

This semiarid landscape lies in the rain shadow of the Cascade Range and receives on average 25–38 cm of rain/y, with local maxima of 50–75 cm/y in the Ochoco and Strawberry Mountains. The regional geology consists primarily of volcanic and volcanoclastic rocks of Tertiary and Quaternary age. Thick sequences of fluviolacustrine sediments have accumulated since the Miocene in tectonically controlled, largely extensional basins (Cummings, 1991; Christiansen and Yeats, 1992; Cummings et al., 2000). Igneous deposits ranging in composition from rhyolitic ash flow tuffs and calderas to basaltic lava flows form low-gradient plateau tops punctuated by higher-standing peaks. The region stands at an elevation of >1 km above mean sea level (amsl), rising to an average surface elevation of almost 1.4 km amsl near the shared borders of Oregon, Idaho, and Nevada (Camp and Ross, 2004). The uplifted plateaus are dissected by canyons cut by major rivers, creating corridors where local relief reaches a few 100 m (Fig. 2).

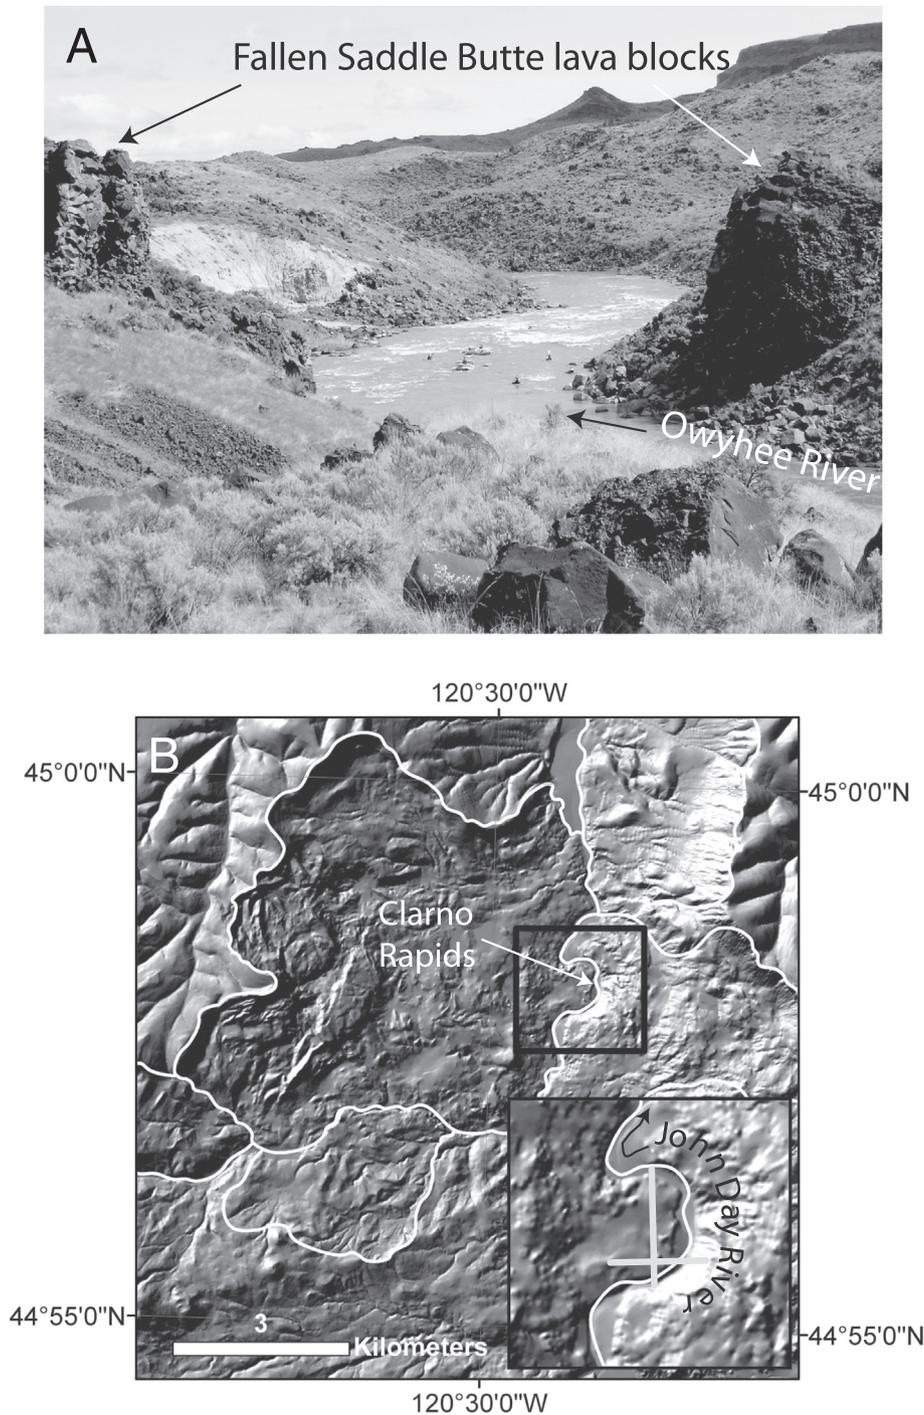
**Fig. 3.** Example indicators of former channel blockages. (A) Landslide deposits that span the present-day channel. At the Artillery site on the Owyhee River, the Saddle Butte lava flow is in place only on the western (left) side of the river. However, large blocks of Saddle Butte lava involved in a complex rotational failure are found on both sides of the river, indicating that the landslide deposit must have previously blocked the river. Rafters in center of photo for scale. (B) Sharp local deflections of the basal stream. A finger of material  $\sim 0.6$  km<sup>2</sup> within the  $\sim 33$  km<sup>2</sup> Clarno landslide complex has pushed the John Day River eastward, causing undercutting and steepening of the eastern (right) side of the valley. A sag pond on the protrusion and rapids in the adjacent channel reach, interpreted as a lag deposit, provide further evidence of a breached landslide dam. Gray lines in inset map show cross section used to determine dam height (horizontal line) and presumed length of breach zone (vertical line). Background image is a shaded relief rendering of a 10-m-resolution digital elevation model.

(e.g., Fig. 3B). In such cases, the blocking sections of the landslides do not appear as distinct invasions of a well-defined valley floor, such as those formed by rock avalanches in steep mountain valleys. The valley walls themselves are landslide masses, and the channel weaves its way among and through the failed blocks. For this reason, we defined the across-channel length of the dam as the length of failure mass in contact with the reservoir impounded by the chosen dam height at the critical dam cross section (see below; Fig. 4). This is the across-channel extent

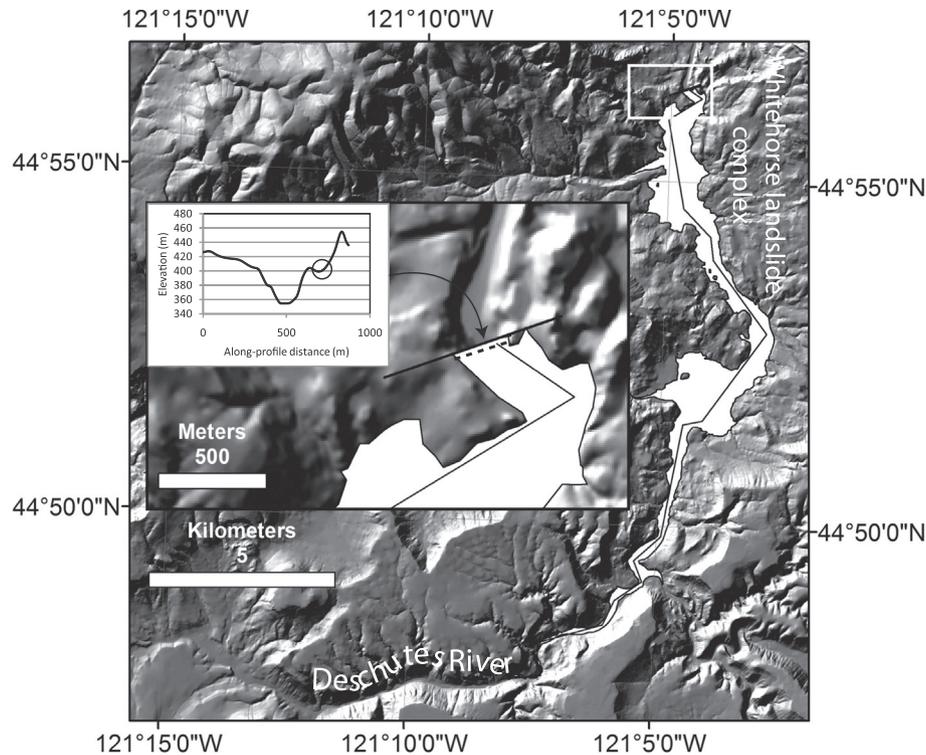
**Fig. 4.** Illustration of GIS features used to characterize landslide dam and impoundment morphologies; Whitehorse landslide dam on Deschutes River. White color indicates extent of the reservoir impoundment associated with landslide dam height determined by identifying minimum alternative spillover elevation (Section 4.1). Solid line along reservoir was used to determine reservoir length. Inset shows close-up of dam site and valley cross section at the dam location indicated by the solid black line on the main map. Elevation and location of alternative minimum spillover route circled on cross-sectional profile. Dashed line indicates dam length used in morphometric analyses.

For each landslide dam, we identified a critical site cross section and the breach zone defining the effective along-channel extent of the dam ( $W_D$ ); note that we adhere to the standard though the convention is confusing: that landslide dam width is defined in the along-channel direction and dam length ( $L_D$ ) is defined in the cross-channel direction; Costa and Schuster, 1988). These were digitized as line features into shapefiles (Supplementary data Repository items 1 and 2); examples are shown in Fig. 4.

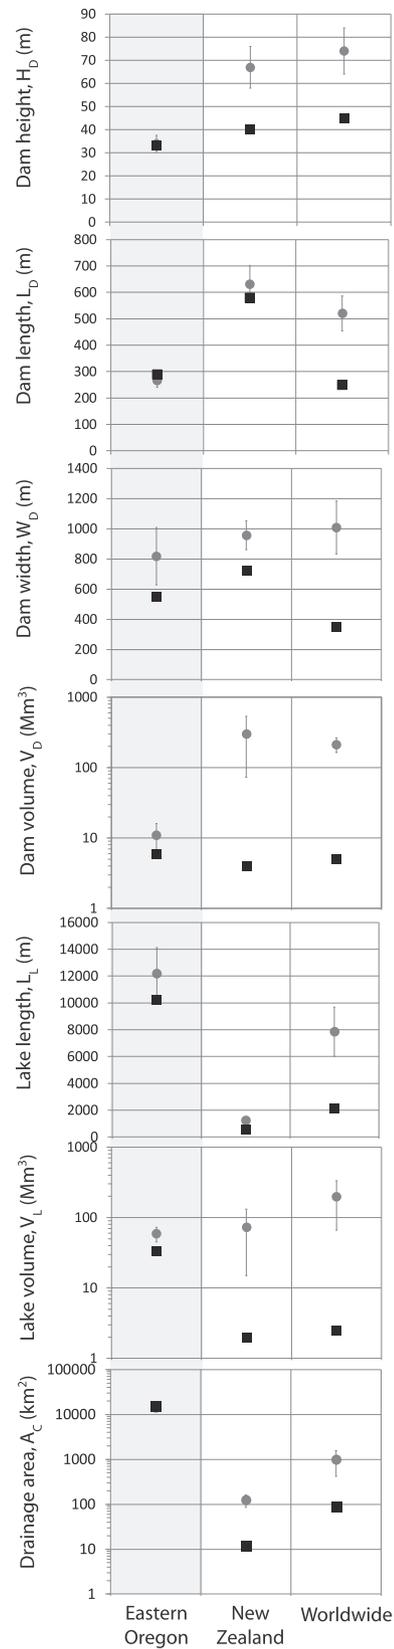
Fig. 5. Comparison of geomorphometric characteristics of eastern Oregon landslide dams with data sets from New Zealand and a worldwide compilation. New Zealand data are from Korup (2004). Drainage areas for worldwide data are from Ermini and Casaghi (2003); other statistics for worldwide data are extracted from Korup (2004). Solid black squares are median values; gray circles are mean values. Standard errors on the mean are plotted. Number of dams used for statistics are 16–17 for eastern Oregon, 49–202 for New Zealand, and 83–148 for worldwide data (i.e., not all quantities were measurable or reported for each dam). Note logarithmic axes on dam volume, lake volume, and drainage area plots.

Eastern Oregon landslide dams and their inferred impoundments differ from those in other parts of the world in several ways. Landslide dams are comparable in size or smaller in Oregon. Mean dam height ( $H_D$ ) is 50% lower for eastern Oregon dams than for New Zealand or worldwide dams, and dam volume ( $V_D$ ) is an order of magnitude lower (Fig. 5). However, the contrast is not so great considering median values; median  $H_D$  values in Oregon are only 20–30% lower than elsewhere – a difference that is probably not significant – and median dam volumes are comparable (Fig. 5).

The large volumes of the impounded lakes in eastern Oregon in part results from the larger drainage areas of channels blocked by landslide dams in our study area compared to other areas. These rivers with relatively large upstream drainage areas have lower gradients, so the landslides impound water much farther upstream. The mean and median drainage areas are, respectively, one and two orders of magnitude larger for our landslide dams than for landslide dams worldwide (Fig. 5). The mean and median drainage areas are, respectively, two and three orders of magnitude larger for our landslide dams than for New Zealand landslide dams (Fig. 5).

Low channel gradients (predominantly 0.002–0.005, except near Magone Lake: ~0.04) result in long lakes on the order of 10 km (Fig. 5). Lake volumes are also enhanced by the large landslide complexes themselves, which widen valleys by locally reducing valley wall gradients to 8–14° (Safran et al., 2011).

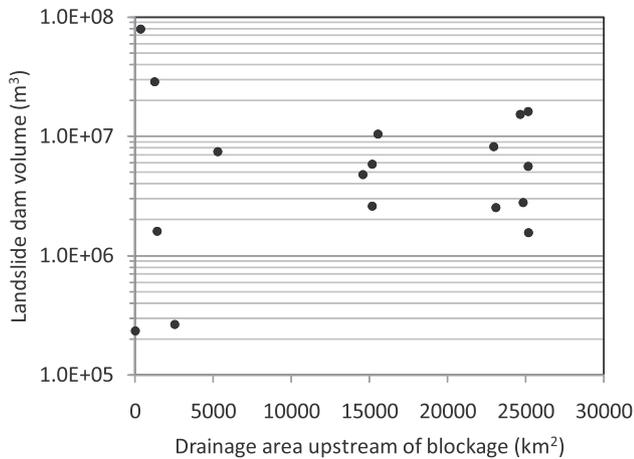
Fig. 6. Landslide dam volume plotted against drainage area upstream of blockage.

There is no systematic relationship between drainage area of the adjacent channel and dam volume. Dam volume spans three orders of magnitude (order  $10^5$ – $10^8$ ) on streams with drainage areas  $<5000 \text{ km}^2$ , but variability in dam volumes on rivers with drainage areas  $>5000 \text{ km}^2$  is confined to about one order of magnitude (Fig. 6).

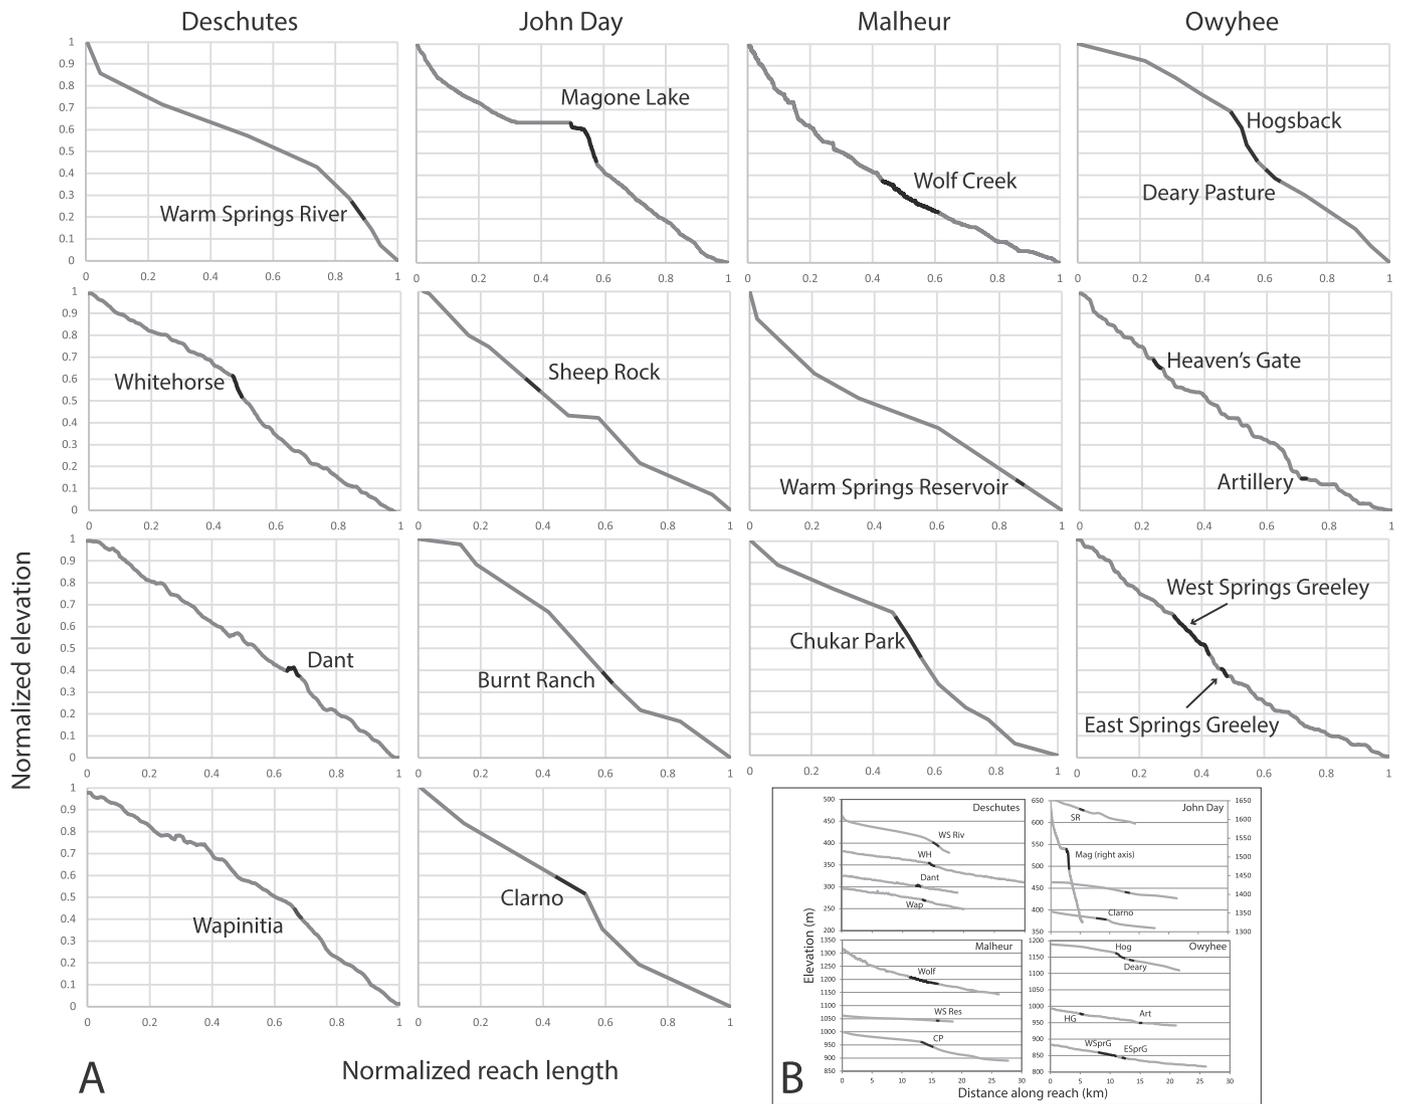
**Fig. 7.** Longitudinal profiles of stream reaches straddling landslide dam study sites. Black lines indicate segments of the profiles that cut through landslide dams. Profiles containing Whitehorse, Dant, Wapinitia, Heaven's Gate, Artillery, West Springs Greeley, and East Springs Greeley sites are derived from lidar data; profiles containing Magone Lake and Wolf Creek were extracted from National Elevation Data set 10-m DEMs; all other profiles were constructed from points where contours on 1:24,000 USGS digital topographic quadrangles crossed the study stream reaches. See Section 4.1 for details. (A) Profiles normalized by total elevation drop and distance along reach. (B) Standard longitudinal profiles. Note the dual y-axes on John Day graph: Right-hand axis pertains to Magone Lake profile; left-hand axis pertains to all other profiles. Abbreviations: WS Riv = Warm Springs River; WH = Whitehorse; Wap = Wapinitia; SR = Sheep Rock; Mag = Magone Lake; Wolf = Wolf Creek; WS Res = Warm Springs Reservoir; CP = Chukar Park; Hog = Hogsback; Deary = Deary Pasture; HG = Heaven's Gate; Art = Artillery; WSprG = West Springs Greeley; ESprG = East Springs Greeley.

Along with the Chukar Park dam site, the Whitehorse, Hogsback, and Magone Lake dam sites also show evidence of perturbing the longitudinal profiles of local stream reaches (Fig. 7). However, these sites do not all occupy the same region on the bivariate plots. The Whitehorse and Hogsback dams fall within the *unstable* domains of the Blockage, Basin, and Dimensionless Blockage index plots, while Magone Lake and Chukar Park do not. In the field, the Hogsback site lacks evidence of upstream sediment accumulation. Terraces do occur upstream from the Whitehorse dam site, but the sediment accumulation is not nearly as extensive as upstream from the Chukar Park site.

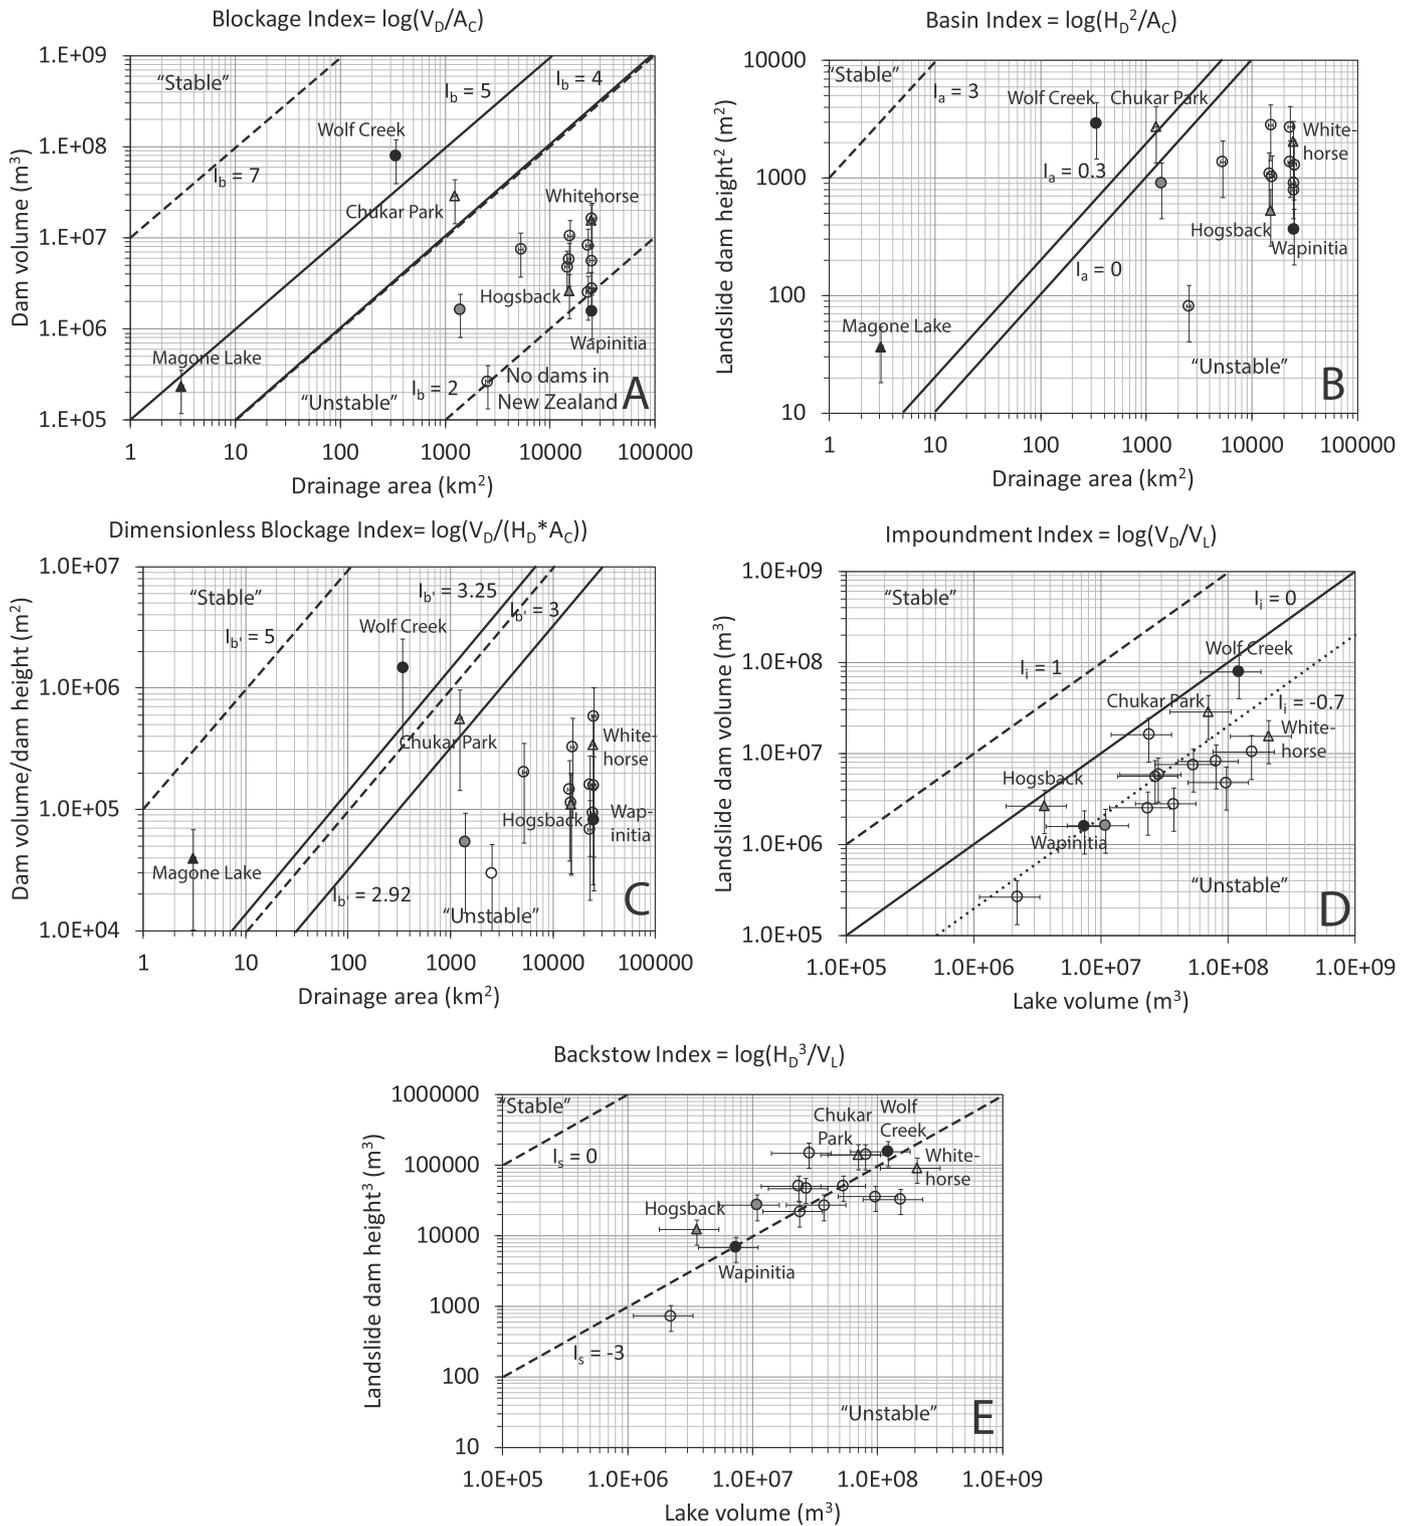
**Fig. 8.** Morphometric index values, computed from measured characteristics of landslide dams, impounded lakes, and upstream catchments. Size of error bars reflect estimated error in measured quantities (Section 4.1), which were propagated through derived quantities (e.g.,  $H_D \times A_C$ ). Lines show threshold index values separating dams that were deemed *stable* vs. *unstable* in various localities (Ermini and Casagli, 2003; Korup, 2004). Meaning of *stable* and *unstable* designations is explained in Section 1. Solid lines: Worldwide data (Ermini and Casagli, 2003; Korup, 2004). Dashed lines: New Zealand (Korup, 2004). Dotted line, fitted by eye (panel D only): eastern Oregon. Open circles are dams exhibiting evidence of outburst flooding. Gray circles are dam sites downstream of which we lack field observations. Solid black circles are dams exhibiting no evidence of outburst flooding and are labeled with site names, as are triangles: dam sites associated with knickpoints.

Morphometric characteristics of landslide dams, impounded lakes, and upstream catchments were used to compute values of five bivariate indices summarized in Korup (2004): Blockage index ( $I_b = \log(V_D / A_C)$ ), Dimensionless Blockage index ( $I_{b'} = \log(V_D / (H_D * A_C))$ ), Basin index ( $I_a = \log(H_D^2 / A_C)$ ), Impoundment index ( $I_i = \log(V_D / V_L)$ ), and Backstow index ( $I_s = \log(H_D^3 / V_L)$ ). All of these indices express some formulation of dam size relative to the amount of water available to break the dam. Impoundment index and Blockage index were introduced by Casagli and Ermini (1999), while the DBI used here was introduced by Ermini and Casagli (2002). Basin index and Backstow index were introduced by Korup (2004). As noted in Section 2, all but one of the landslide dams in our study area have been breached, so we cannot use the presence of extant lakes as a criterion for *stability*, and this approach has limitations in any case (Section 1). We focus instead on whether evidence exists for catastrophic dam failure at each site, emphasizing the instability domain rather than the stability domain emphasized by others (e.g., Korup, 2004). The absence of evidence for catastrophic failure is not evidence of absence, and results must be interpreted with caution. Nonetheless, previous studies have shown that field indications of outburst flooding are often well preserved in the area (e.g., Beebe, 2003; O'Connor et al., 2003a), creating an opportunity to explore whether morphometric indices could offer a quantitative, if simple, framework for interpreting such evidence. Fig. 8 depicts the range of values for the eastern Oregon landslides relative to threshold values reported in the literature that discriminate *stable* dams from dams that failed catastrophically or breached in an unspecified fashion in other locations. For example, landslide dams considered *stable* (intact) in New Zealand have Blockage index values of  $>7$ , while landslides characterized as intact using the worldwide data set have Blockage index values of  $>5$  (Korup, 2004; Fig. 8A). Based on New Zealand and

Consistent patterns emerge from the comparison (Fig. 8A–C). First, the index values partially separating intact from breached landslide dams in the New Zealand data set (Korup, 2004) are higher than those for the dams of eastern Oregon, particularly for the Basin index (Fig. 8C). By contrast, discriminating values of Blockage index and Dimensionless Blockage index derived from worldwide data are consistent with observations in eastern Oregon. The Wolf Creek and Lake Magone sites, which lack evidence for catastrophic failure, fall into the *stable* domain; the Chukar Park site falls into the *stable* or *marginally stable* domain; and most of the rest of the sites showing evidence of catastrophic failure are within the *unstable* domain. In the field, the Chukar Park landslide dam exhibits elements of persistence and of catastrophic failure. The reach upstream of the dam site is a broad, sediment-floored valley characterized by numerous meander cutoffs in which the river's course is highly sinuous. This gives way at the dam site to a relatively straight channel full of rapids (Fig. 9). The morphology of the reach upstream of the dam site suggests that the dam itself or a topographically significant lag persisted sufficiently long, perhaps several centuries or more, for a substantial quantity of sediment to accumulate upstream. However, boulder bars along the downstream end of the landslide attest to outburst flooding from the zone we consider the most recently active part of the landslide, indicating at least partial cataclysmic breaching. This multipronged (and multifaceted) landslide character is common to several other eastern Oregon landslides (e.g., West Springs Greeley, Warm Springs Reservoir) and complicates dam stability analysis.

Two sites, Warm Springs River and Hogsback, whose downstream reaches we were unable to observe in the field, plot in *unstable* domains of the Basin index, Blockage index, and Dimensionless Blockage index graphs (Fig. 8A–C). This result constitutes a prediction that can be tested if we gain access to those sites. One site, Wapinitia, shows no clear field evidence of catastrophic dam failure and also plots in the *unstable* region of these graphs. At Wapinitia, another landslide complex impinges on the channel immediately downstream of the dam site, possibly covering or obliterating outburst flood deposits from breaching of the Wapinitia landslide. The downstream landslide complex, which gives rise to Boxcar Rapids on the Deschutes River, is judged by Beebe (2003) to be younger than Wapinitia, based on apparent freshness of slide mass morphology, and auger data are consistent with this observation (Section 3). However, if we take the field evidence at face value, the Basin, Blockage, and Dimensionless Blockage indices all mischaracterize the Wapinitia site as being susceptible to catastrophic failure.

The Impoundment index cleanly separates the landslide dams that do and do not exhibit evidence for catastrophic failure (Fig. 8D). However, the discriminating value is  $-0.7$ , rather than 0 for worldwide data or 1 for New Zealand data. The Hogsback site is predicted not to have failed catastrophically, according to this value.

The Backstow index is the poorest at discriminating eastern Oregon dam sites with and without evidence of catastrophic dam failure (Fig. 8E). Index values for the *stable* and *unstable* dams substantially overlap. The threshold value for *stable* dams in New Zealand lies far above those from our sites, and the threshold for *unstable* dams runs through the middle of the eastern Oregon observations (Fig. 8E).

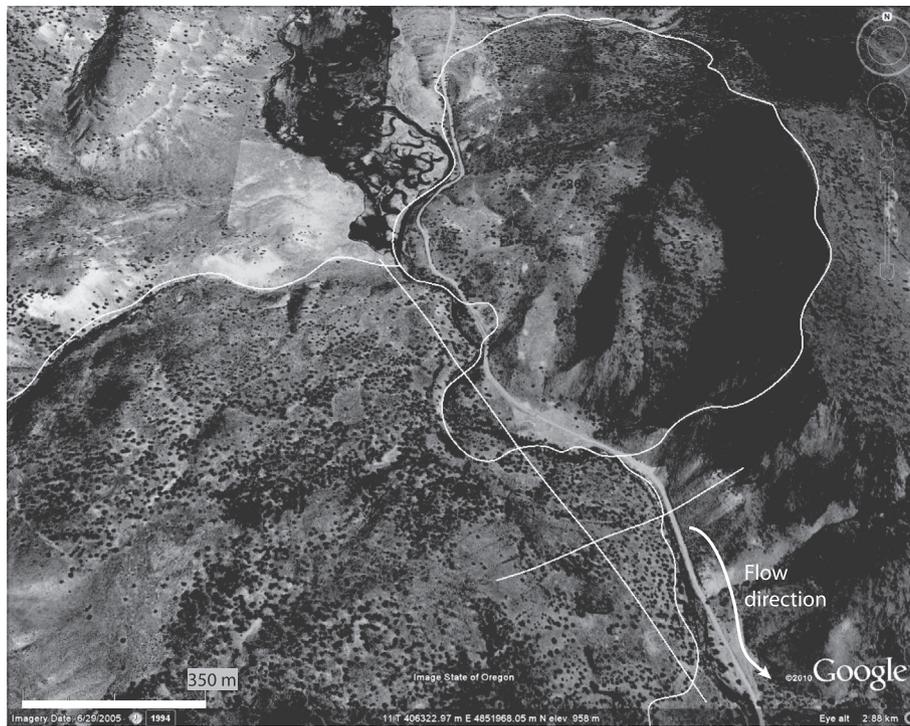
**Fig. 9.** Oblique Google Earth image of Chukar Park landslide dam site. North Fork Malheur River flows from top to bottom of image. A pair of landslide complexes, outlined in white, flank the river on both sides. Based on field observations, the landslide dam crest is believed to be along the short, valley-perpendicular line, and the breach zone is spanned by the long, valley-parallel line.

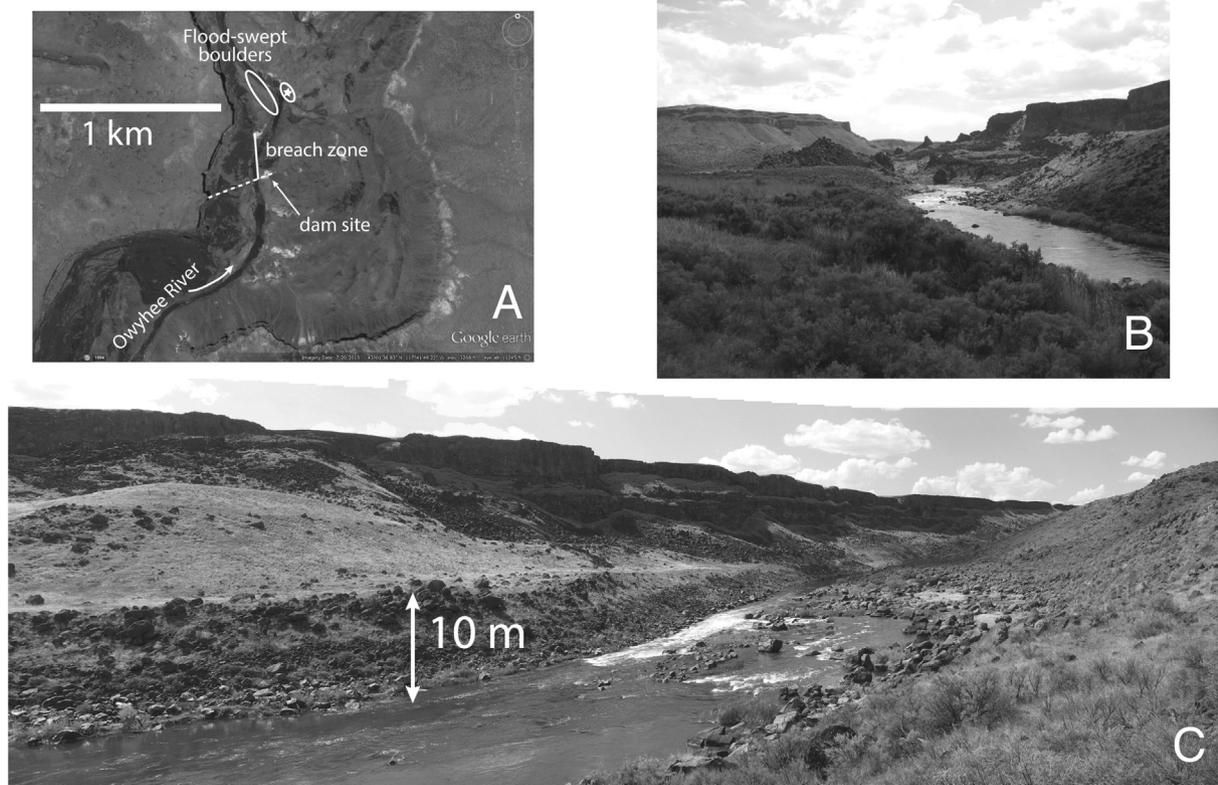
**Fig. 10.** Field evidence for outburst flooding, Artillery landslide reach. (A) Artillery landslide complex, illustrating location of critical cross-section at dam site (dashed line; near location of Fig. 3), breach zone (solid line), and terraces capped by flood-swept boulders (ellipses). Star marks location from which photos in (B) and (C) were taken. Image from Google Earth. (B) View upstream toward dam site. (C) Panoramic view across valley and downstream.

Overall, most of the ancient dam sites we analyzed in eastern Oregon appear to have been unstable. Only three of the 17 sites with channel-blocking landslides lack evidence for catastrophic outburst flooding. Fig. 10 illustrates an example of such field evidence.
