# The Geologic, Geomorphic, and Hydrologic Context Underlying Options for Long-Term Management of the Spirit Lake Outlet Near Mount St. Helens, Washington

Gordon E. Grant, Jon J. Major, and Sarah L. Lewis

General Technical Report  
PNW-GTR-954

June  
2017

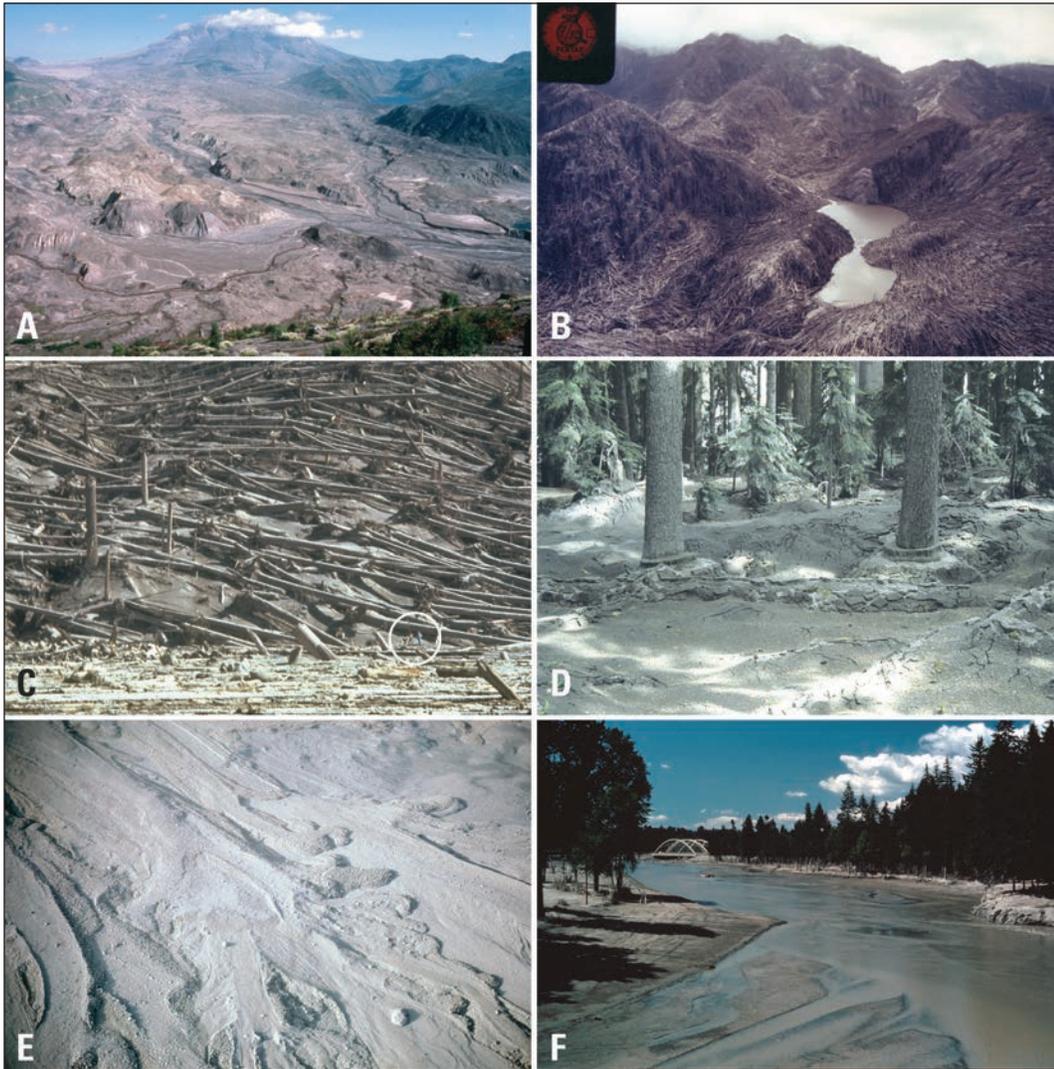
Figure 2-8—Images of landscape disturbances caused by the May 18, 1980, eruption: (A) hummocky debris avalanche in upper North Fork Toutle valley; field of view is about 4 km (2.5 mi) across; U.S. Geological Survey (USGS) photograph. (B, C) tephra-mantled hillslopes with trees blown down by blast pyroclastic density current (PDC). Note people in circle for scale. USGS, July 6, 1980, and September 24, 1980. (D) Tephra-mantled landscape east of volcano beyond zone of blast PDC, summer 1980. Tree trunks about 0.5 m (1.5 ft) across. Photograph courtesy of Joe Antos, University of Victoria. (E) Pyroclastic flow deposits mantling debris avalanche in upper North Fork Toutle valley. Individual flow lobes about 30 to 50 m (100 to 150 ft) across. USGS, October 4, 1980. (F) Lower Toutle River valley transformed from cobble-bedded channel to sand-bedded channel by large lahars. Field of view about 80 m (260 ft) across. USGS, July 6, 1980.

The blast PDC is the event that devastated ~550 km<sup>2</sup> (~210 mi<sup>2</sup>) of rugged, forested landscape in a roughly 180-degree arc north of the volcano, and blanketed the terrain with up to 1 m (3 ft) of gravel- to silt-sized tephra (figs. 2-7, 2-8B, and 2-8C) (Hoblitt et al. 1981, Waitt 1981). Close to the volcano, the blast PDC (and the debris avalanche) stripped vegetation and soil from the landscape. With increasing distance from the volcano, it toppled but did not remove trees. In the basins of Green River, Smith Creek, Bean Creek, and upper Clearwater Creek (fig. 2-7), the blast PDC ravaged hillslopes but had relatively little impact on stream channels aside from locally toppling mature trees into them.

pyroclastic flows that accumulated atop the debris-avalanche deposit (figs. 2-7 and 2-8E). Close to the volcano, tephra fall and pyroclastic flows augmented deposition on an already devastated landscape, but beyond 15 km (10 mi) east of the volcano, accumulations of fallout tephra caused the primary disturbance in many watersheds (figs. 2-8D and 2-9) (Sarna-Wojcicki et al. 1981, Waitt and Dzurisin 1981). Fallout greater than ~5 cm (2 in) thick significantly damaged the forest understory (Antos and Zobel 2005).

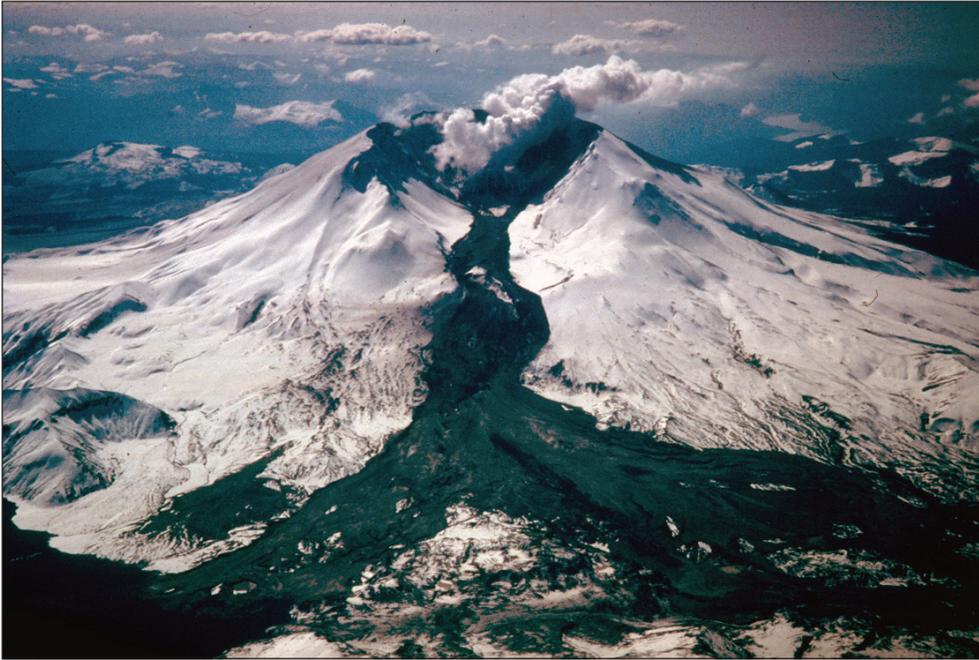
Figure 2-13—Oblique aerial photograph of March 1982 snowmelt-triggered lahar. View to south. The flow originated after a water flood from the crater entrained sediment along the steep north flank and increased its ratio of solids to fluid. Most of the flow traveled west (right) down the North Fork Toutle valley, but a substantial fraction flowed into Spirit Lake (on left). U.S. Geological Survey, March 21, 1982.

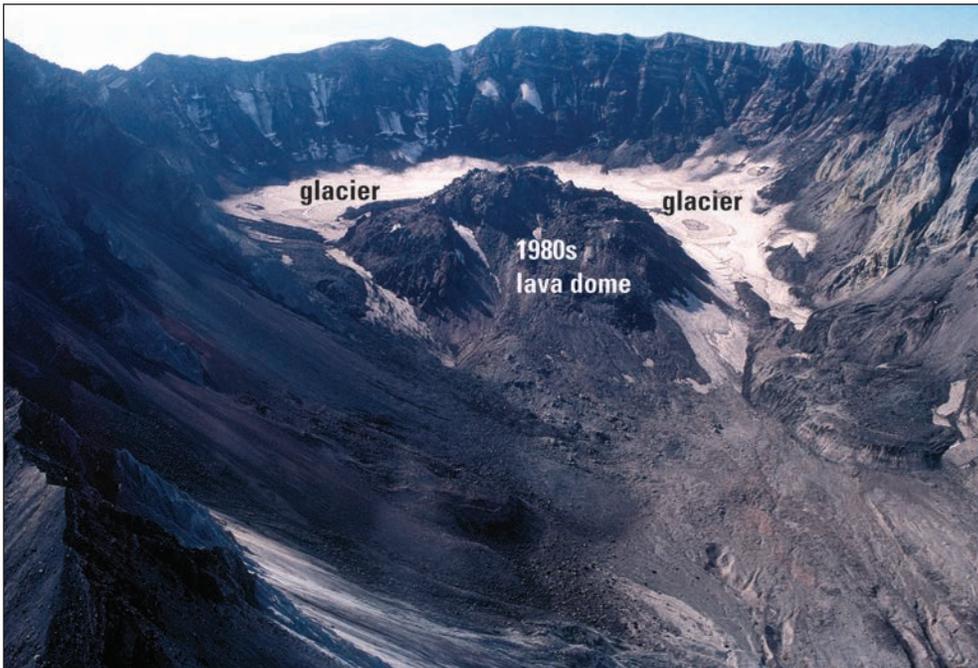
Figure 2-14—Oblique aerial view toward the southwest of Mount St. Helens crater showing 1980s lava dome and glacier that developed in rear of crater. U.S. Geological Survey, approximately October 2000.

Deposits from several smaller eruptions in 1980 augmented the landscape disturbances caused by the May 18 eruption. Eruptions from late May to October 1980 deposited additional pyroclastic fill atop the debris-avalanche deposit and veneers of fallout tephra in neighboring watersheds. Minor eruptions from 1980 through 1986 built a 90-million-m<sup>3</sup> (120-million-yd<sup>3</sup>) lava dome in the volcano's crater and triggered a few snowmelt-induced lahars (the largest ~10<sup>7</sup> m<sup>3</sup>) (fig. 2-13) and sediment-laden water floods (Major et al. 2005, Pierson 1999, Waitt et al. 1983). As volcanic activity waned, snow and rock accumulated in the shaded rear of the volcano's crater and by the late 1990s had formed a 120-million-m<sup>3</sup> (~160-million-yd<sup>3</sup>) debris-laden glacier that wrapped around the lava dome (fig. 2-14) (Schilling et al. 2004).

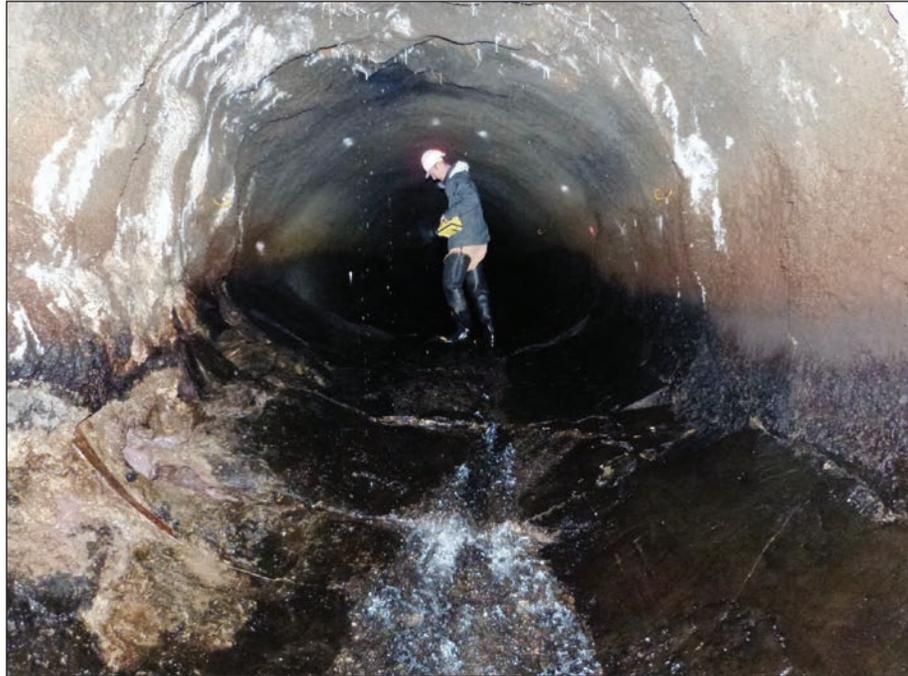
Figure 4-2—Location where tunnel floor had heaved. Note offset in tunnel floor from where person is standing to water flow in foreground (from Britton et al. 2016).
