Landslides and the weathering of granitic rocks

PHILIP B. DURGIN

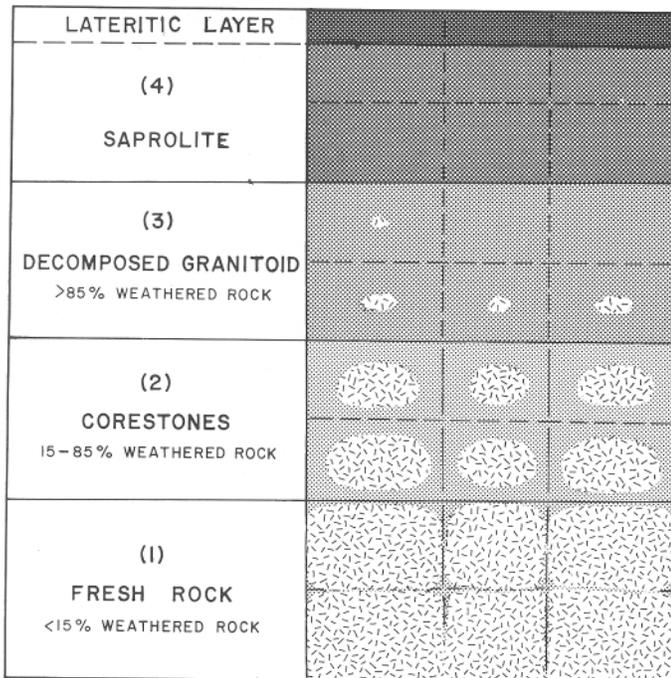
Figure 1. Stages of granitic rock weathering.

The physical appearance and properties of granitic rock change as weathering progresses. Several investigators have divided the transition into stages (Ruxton and Berry, 1957; Deere and Patton, 1971; Clayton and Arnold, 1972). This paper uses a four-stage classification of weathering products (Fig. 1): (1) fresh rock, (2) corestones, (3) decomposed granitoid, and (4) saprolite. All four stages may exist on an individual slope, but geographically the later stages of weathering increase in occurrence where there are high temperatures and ample precipitation. Fresh rock contains a maximum of 15% weathered material that forms in the joint system. The corestone stage ranges from 15 to 85% weathered rock enclosing remnants of fresh rock. Decomposed granitoid consists of 85 to 100% weathered disintegrated rock that can be broken down into granules. Saprolite is a fine-grained residual rock that generally has an upper lateritic layer.

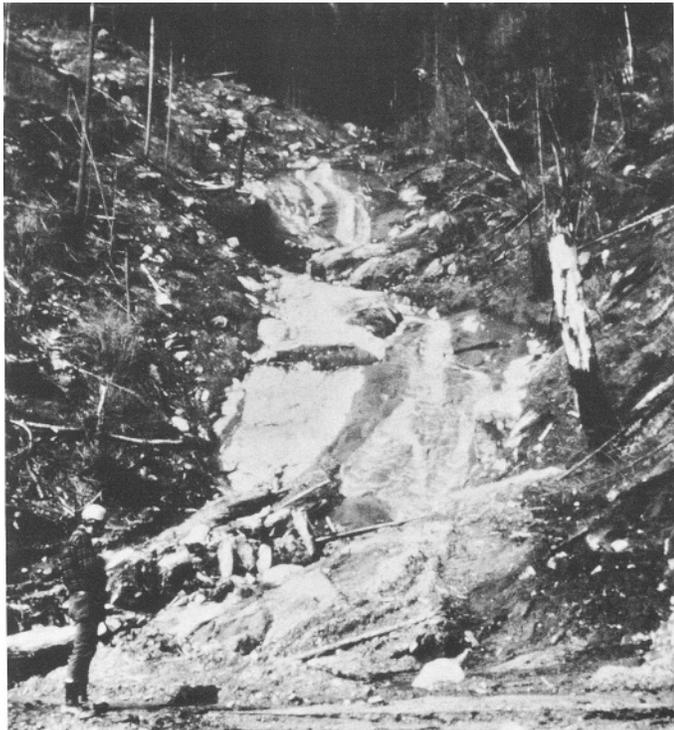
Figure 2. Debris avalanche on fresh granitoid near Sawyers Bar, California. Water is flowing on surface of rock.

Debris avalanches or debris slides can occur when fresh granite is near the surface and is covered by organic debris, colluvium, or soil (Fig. 2). Smooth-surfaced granite can reduce the effective friction angle with the overlying material. In addition, water flows through the thin permeable zone above the fresh bedrock, producing pore-water pressures and

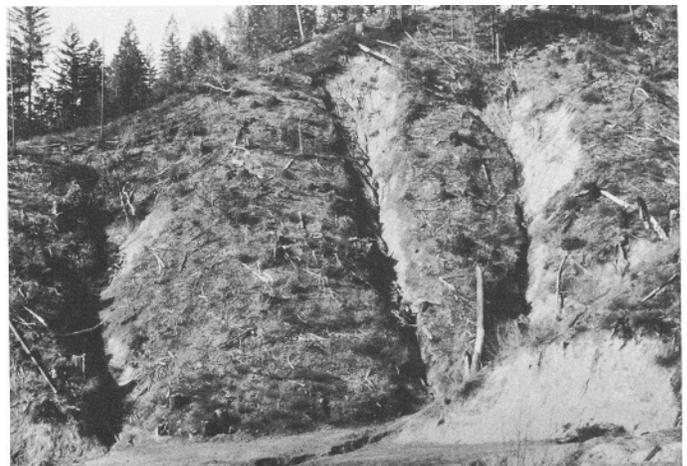
Figure 3. Debris avalanche in decomposed granitoid near Sawyers Bar, California.

Shallow debris avalanches have occurred in the Klamath Mountains batholiths of northern California and southern Oregon (Fig. 3). Tree roots growing in the decomposed granitoid help stabilize the slope. At some sites, rainstorms have triggered failures a few years after roadbuilding and clearcutting of forests.
