# Fast Response to Fast-Forwarding Nature: Instream Large Wood Habitat Restoration<sup>1</sup>

Cheryl A. Hayhurst<sup>2,3</sup> and William R. Short<sup>2</sup>

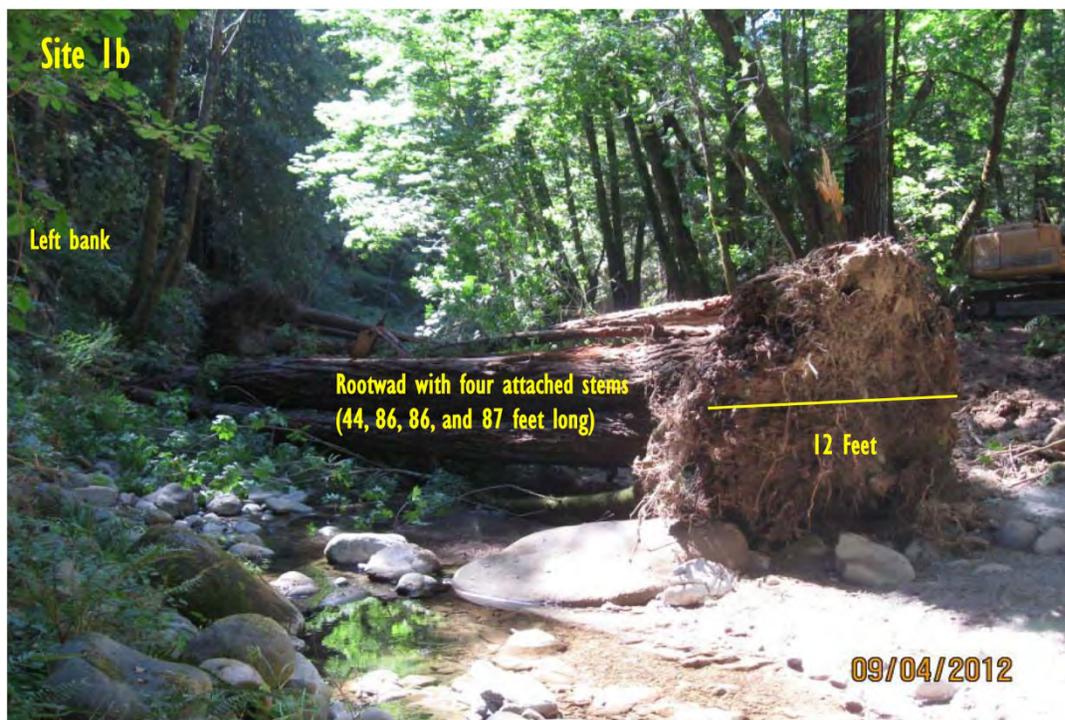
Figure 2—Site 1b Key Log.

wood elements were employed. The first is a variant of the dropped whole tree. In places where access was limited, a single large bole with rootwad attached was placed downstream of a log cluster (Site 4b). In order to achieve the requisite stability, 3.7 m to 4.6 m (12 ft to 15 ft) of the bole was buried in the stream bed with large rock (ballast) being used as backfill. The other anchored structure was a simple log vane, a large log that is buried in the bank and partially buried in the channel (Sites 2b and 4c). The logs project upstream from the bank at approximately a 30 degree angle and plunges at approximately 5 degrees. The function of this feature is to reduce pressure and erosive forces on a stream bank by locally reducing stream gradient and thus encourage deposition of bed load leading to the formation of a lateral bar. A secondary benefit is that typically downstream of the vane a pool will form. To enhance the biological value of the pool, a rootwad cover log was added to the vane. Like the vane, the rootwad is buried in the bank. In addition to the primary LW elements, broken or trimmed tops and alders or other smaller trees that came down with the falling of the primary LW elements were incorporated into the structures.

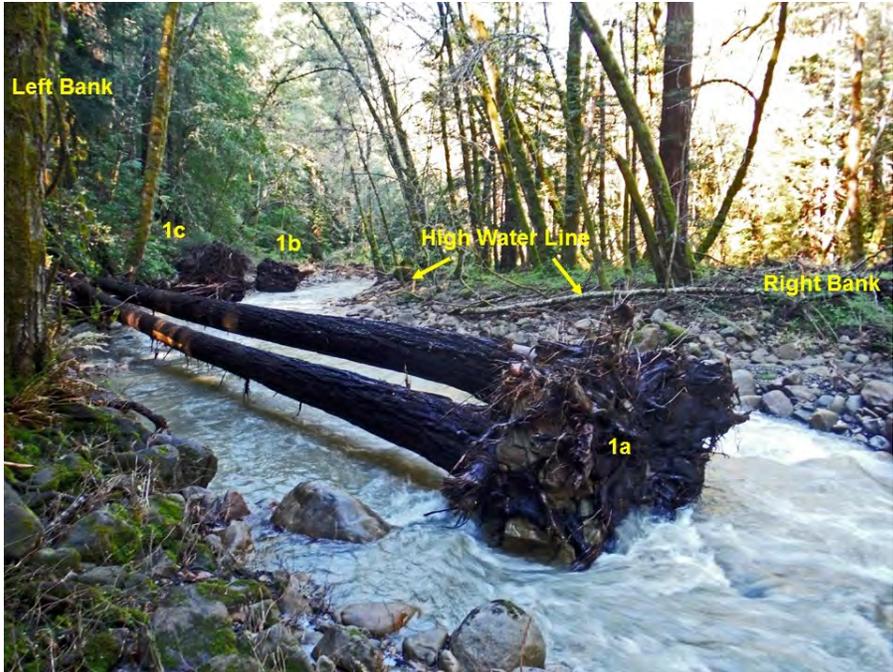
Figure 8—Site 1 showing 10-year flow features (March 17, 2016).

Instream habitat restoration at Soquel Creek utilized Key Logs in LW structures sized to remain meta-stable through a 5-year streamflow event to provide a habitat benefit and increase geomorphic complexity within each reach for a period of time (5 years) deemed significant by the fisheries biologists. In the 4 years since installation, the Site 1 structures have experienced an approximately 7-year recurrence interval streamflow event and a 10-year recurrence interval streamflow event (fig. 8). Sites 2, 4, and 5 have been in place for 3 years and experienced a 10-year streamflow event. With the exception of one of the Key Log structures, Site 2c, all of the Key Log structures remained within the general project reach vicinity and remain interacting with the stream channel. Though Site 2c mobilized downstream out of the project reach, it has lodged in a new location and will continue to add a positive benefit to the overall health and functionality of the stream. Within our monitoring reaches at Soquel Creek, we demonstrated that the channel profiles respond relatively quickly to constructed LW structures that imitate natural wood loading. All four of the sites showed increased thalweg profile complexity within the first year of installation. These changes included the development of incipient pools (less than 0.3 m [1 ft] deep) and pools (0.3 m [1 ft] and greater depth, summarized in table 1), localized aggradation and scour (particularly aggradation upstream of the wood structures), and the formation of lateral gravel bars (though not represented in the thalweg surveys; see fig. 9). What was particularly interesting is the increase in complexity at Sites 2, 4, and 5 occurred within the first year or two after installation during an extended drought characterized by low rainfall and small peak flows (1.4-year and 1.7-year events).

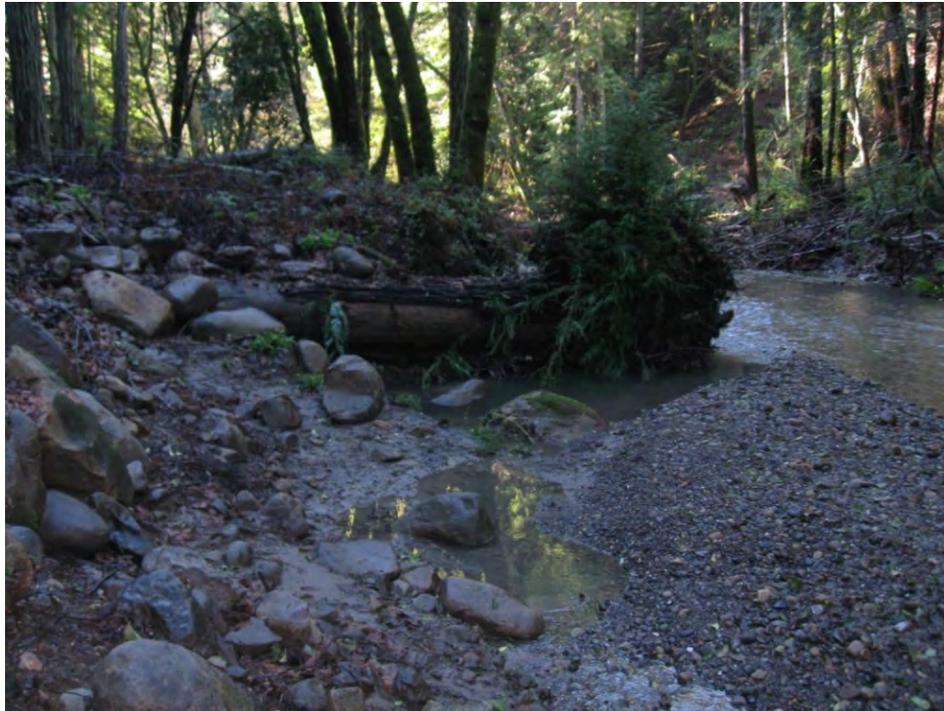
Figure 9—Site 2b gravel bar (December 23, 2014).
