Reducing Tree Root Damage to Sidewalks in California Cities: A Collaborative Study

E. Gregory McPherson, Laurence R. Costello, Ed Perry and Paula Peper

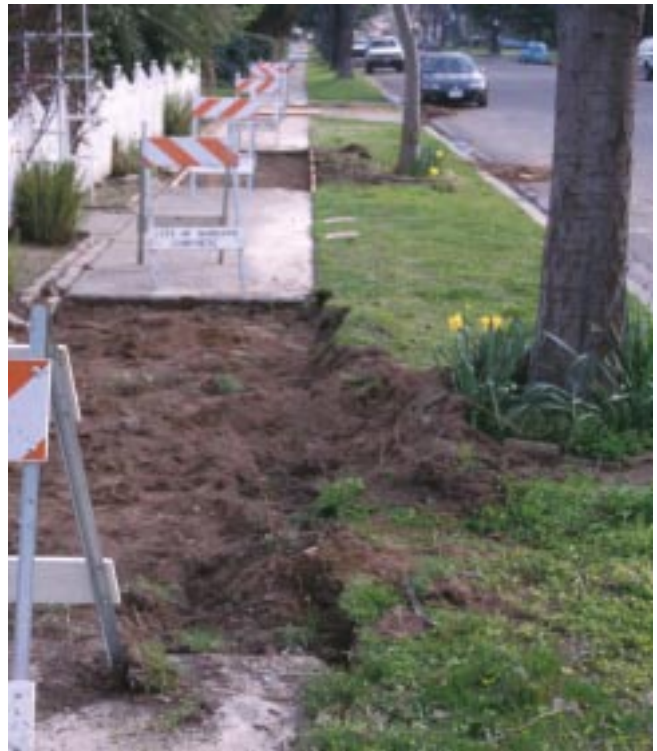
Figure 1. Sidewalk damage caused by tree roots is commonly found in California. Annual repair costs are substantial.

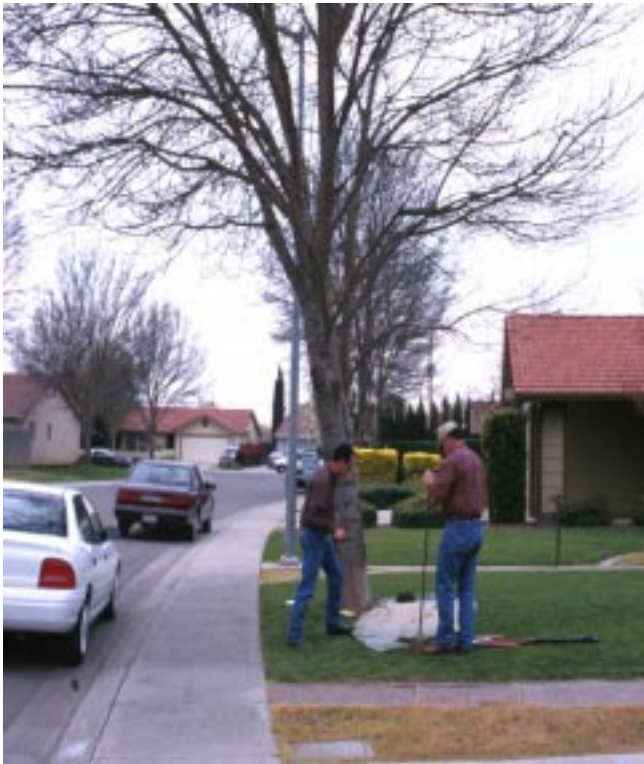
Figure 2. Soil was analyzed at sites where ash trees were growing next to sidewalks in irrigated turf. Sites with sidewalk damage were compared to sites without sidewalk damage.

At each location, soil within the dripline of the tree (approximately 5 feet from the trunk) was sampled using an augering tool which excavated a hole 4 inches in diameter and 6 feet in depth (Figure 2). In the field, evaluations of soil texture, moisture content, color, and root content were made approximately every 10 inches in depth. In addition, depth-to-hardpan was assessed at each location. Soil samples were separated on a tarp as they were removed from augered holes and notes regarding soil qualities were made. Samples then were collected at 6, 18, and 36 inches and submitted to the

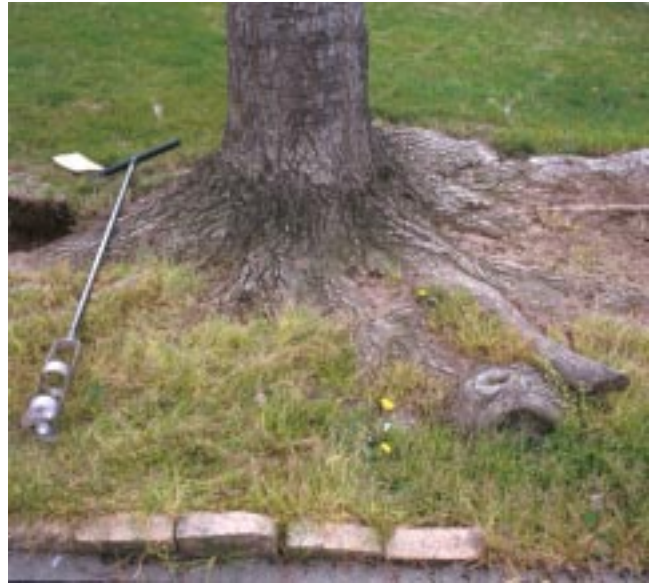
Figure 3. Various rootstocks are used for ash propagation. Certain rootstocks may have a high potential for sidewalk breakage.

An investigation of rootstocks used for ash in Modesto found that species varied. Trees purchased from a local wholesale nursery were grown on green ash rootstock, while those grown in the City of Modesto nursery were grown on *F. oxycarpa* roots, and Marshall ash were grown on Arizona ash rootstock. Although differences in rootstock were observed, we were not able to accurately identify rootstock species in the field (Figure 3). This may be a productive area for future research.
