## A Buyer's Technical Guide to Root Barriers

Paula J. Peper and Philip A. Barker

Various commercially available root barriers with internal vertical ribs are compared on a performance basis to augment their descriptions by manufacturers.

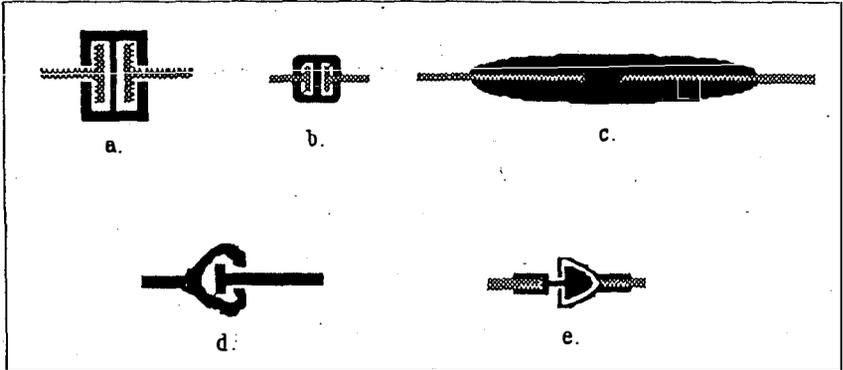
Figure 1 — A schematic of cross sections of root barrier panel connectors. Deep Root (a) and Bumble Bee (b) barriers use separate locking strips that slide over panel ends. Century (c) uses chloromethane solvent to bond connector to panels. Vespro (d) and Shawtown (e) have interlocking coupling connectors that are either extruded with the panel or bonded to the panels during manufacturing. Approximate scale.

Important in selecting a barrier is the material it is made of and various design features, notably the way in which either the panels or the ends of continuous barriers are connected together. Panels may be joined together with interlocking couplings, separate

<sup>2</sup> Illustrated in Figure 1.

connectors or locking strips, or by use of chemical bonding agents (Fig. 1). As indicated in Table 1, the panels may be made of polyethylene, polypropylene, or polystyrene. Among these three thermoplastics, polyethylene in the high density formulation is recognized in the plastics industry as most resilient and durable. By comparison, polypropylene is slightly harder and therefore eventually may chip or crack easier. Polystyrene, on the other hand, crystallizes readily in the presence of sunlight, in which case its durability is compromised.
