# Rehabilitating Depleted Riparian Areas Using Channel Structures

LEONARD F. DEBANO

WILLIAM R. HANSEN

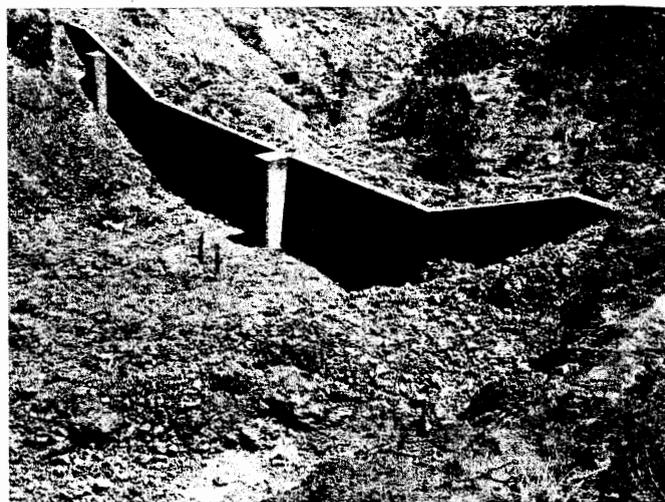
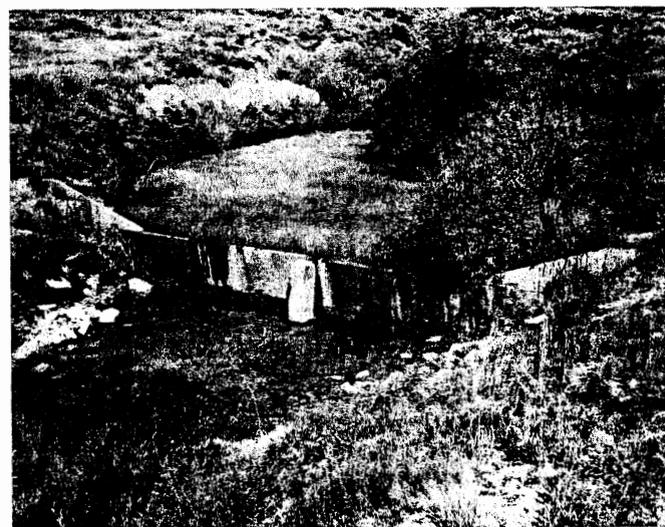
Figure 1.—The appearance of the site occupied by a large channel at the mouth of Alkali Creek: (a) immediately after treatment in 1963, (b) in 1975, and (c) 20 years later in 1981. Figure 1c is an upstream view and structure can be seen at lower right corner of photo.

During the 12 project years, check dams accumulated 1,954 m<sup>3</sup> of sediment, gully depth was substantially reduced, and erosion rates were reduced by one-fifth (Heede 1977). In addition, the streamflow duration at Alkali Creek was increased. Before treatment, streamflow occurred only about 6 weeks during snowmelt periods. Seven years after treatment, streamflow was perennial at the watershed mouth but remained ephemeral in headwater areas (Heede and DeBano 1984).

Streamflow duration was not extended long enough in headwater areas to allow riparian areas to become established, but increased grass production was apparent on sediment deposits behind check dams. In contrast, streamflow duration in main channels was increased so that riparian areas became established (Figure 1a,b,c). Streamflow duration was increased because water was stored in the deposited sediments. This storage provided for the "banking" of water in sediment deposited behind structures throughout the channel system. The slow release of this stored water from saturated sediments by unsaturated flow extended streamflow duration. This interpretation is consistent with results from lysimeter studies showing that saturated soils drain slowly by unsaturated flow and can sustain outflow for as long as 3 to 4 months after being charged with water (Hewlett and Hibbert 1963). Prolonged streamflow and increased soil moisture allowed sedges *Carex* spp. and willows *Salix* spp. to become established (Figure 1c). As additional sediment was stored, the channel became stabilized, and riparian vegetation and grass spread above check dams to the lower segments of the gully sideslopes. The size of gully check networks necessary for storing enough water to sustain perennial streamflow depends on local soil and climatic conditions and channel gradient. One hundred and thirty-two structures were sufficient to enhance riparian vegetation establishment by natural means under the prevailing climatic and topographic conditions at Alkali Creek (Heede and DeBano 1984).

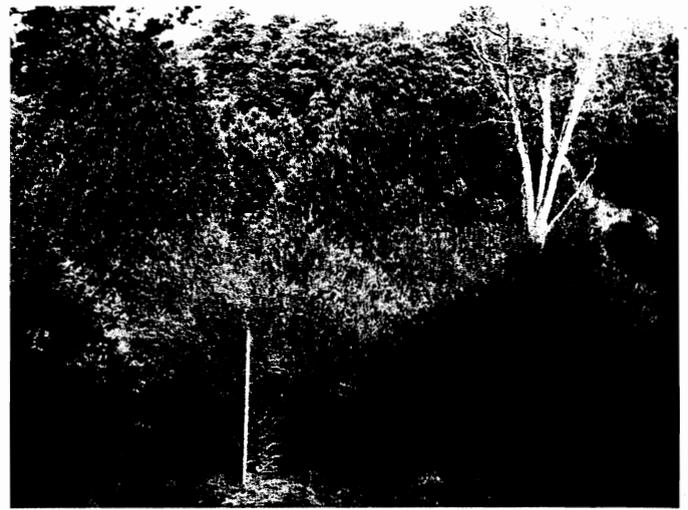
Figure 2.—Appearance of structure H-1 on the Silver City Watershed: (a) immediately after construction of the structure in 1933, and in (b) 1936, (c) 1944, and (d) 1988. Notice the rapid establishment and growth of willows between 1936 and 1944.

A typical sequence of riparian plant establishment and growth is illustrated by changes at a photo point on an unnamed drainage. Photos were taken at this photo point in 1933, 1936, 1944, and 1988 (Figures 2a,b,c, and d, respectively). This structure was constructed in 1933 (Figure 2a). Within a few years, sediment had accumulated behind the structure and a sparse stand of willows and grasses were evident by 1936 (Figure 2b). The willows grew rapidly and a dense stand had become established by 1944 (Figure 2c). Field estimates in 1988 indicated that approximately 104 m<sup>3</sup> of sediment had accumulated behind the check dam by 1944.

Photo documentation and field observations in 1988 (Figure 2d) revealed some interesting changes in riparian areas. Willow thickets were dense but becoming decadent and contained few live stems. No additional cottonwood growth or sprouting has occurred since the original planting in the 1930s. These observations suggest that installing channel structures created a favorable environment for establishment and growth of planted species. It also appears that native willows would have invaded naturally. Conditions necessary for maintaining healthy willow stands and the regeneration of cottonwoods, however, seem to be absent.

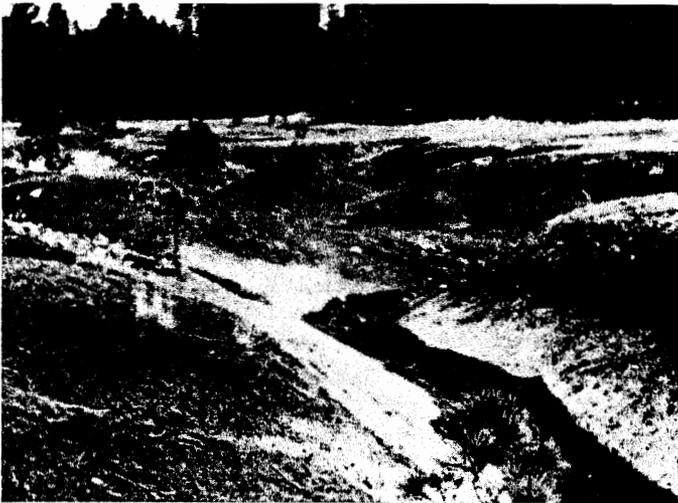
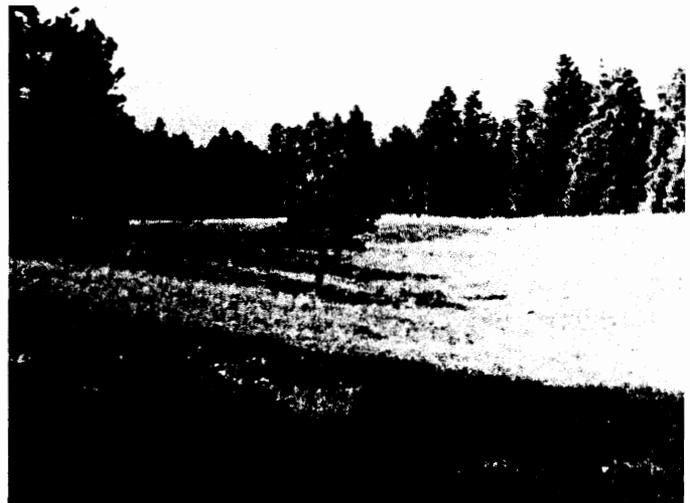
Figure 3.—A view upstream of an earthen dam on the High Clark Draw Rehabilitation Project: (a) April 1972 before treatment and (b) 10 years later in August 1982 showing the effect of sidesloping and gully shaping.

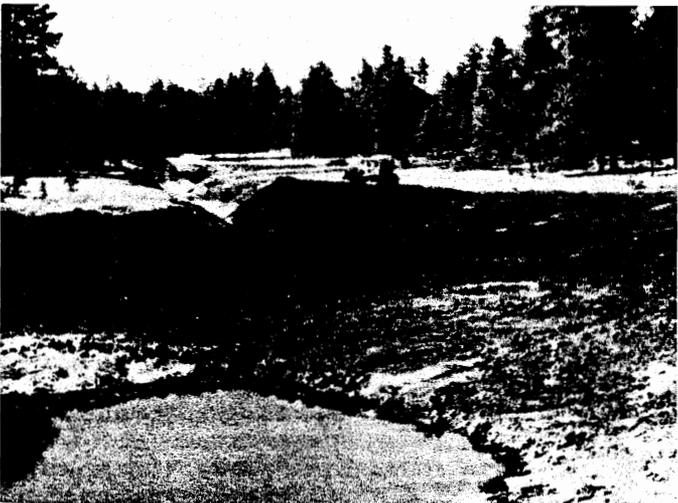
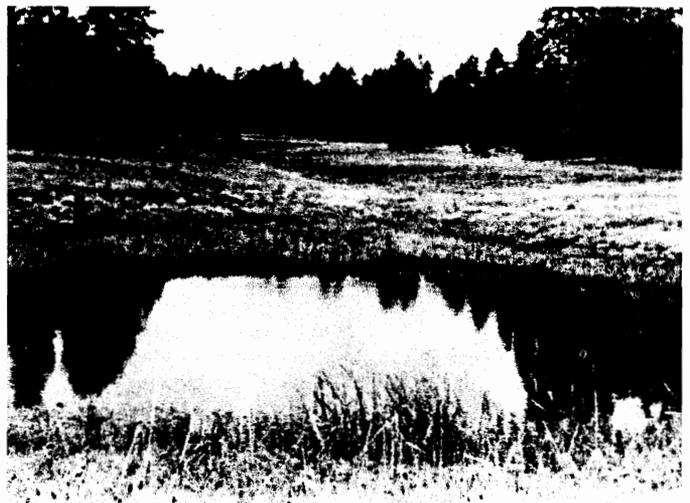
Figure 4.—A view upstream of an earthen dam on the High Clark Draw Rehabilitation Project: (a) April 1972 before treatment, and (b) 10 years later in August 1982 showing the effect of water impoundment, channel stability and sidesloping.

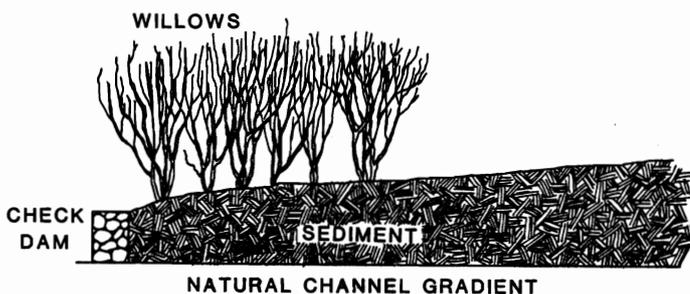
Figure 5.—Conceptual diagram showing storage of sediment resulting from structure and associated willow thickets.

The establishment of riparian vegetation on sediment deposits further stabilizes trapped sediments and may result in additional deposition that would not occur alone with channel structures (Figure 5). This occurs because trees and willows physically reduce flow velocities and capture suspended sediment. Willows are particularly effective because they produce a multi-stem barrier in the channel.
