Regeneration and Distribution of Sycamore and Cottonwood Trees Along Sonoita Creek, Santa Cruz County, Arizona¹

Richard L. Glinski ^{2/}

Abstract.--This study describes the effects of livestock grazing and streambed erosion on the regeneration and distribution of sycamore and cottonwood trees. Sycamores reproduced from root and trunk sprouts and because of this their distribution is not as likely to change significantly. Cottonwood reproduction was nearly absent in areas grazed by cattle, and was confined to the narrow erosion channel. If this regeneration pattern continues, the future maximum width of the cottonwood forest will decrease nearly 60%.

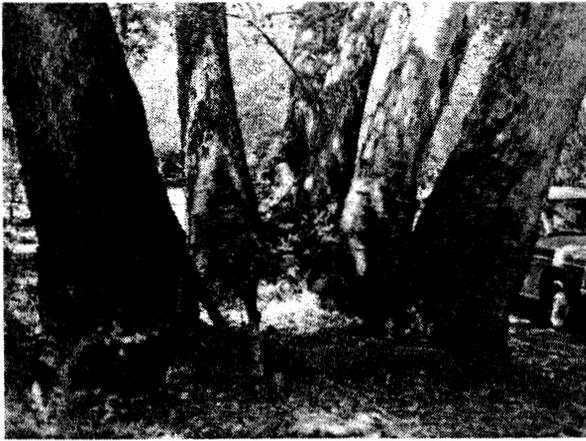
Figure 1.--Clumped mature sycamore trees.

The large variance in the size of sprouts, some of which themselves were mature trees nearly 30 cm in diameter, indicates that sprouting has been a major means of regeneration along Sonoita Creek for some time. Many even-aged, large sycamores were growing in circular clumps with their trunk bases touching or nearly touching (fig. 1), suggesting that these clumped trees had been sprouts from a common parent tree that has long since decomposed.

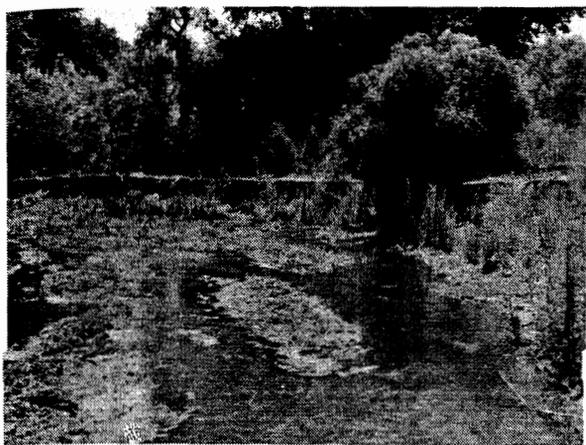
Figure 2.--Vertical-bank erosion along Sonoita Creek. Cutbank here is 1.5 m high.

Along Sonoita Creek erosion has resulted in banks that are sloped in a shallow, intermediate or vertical manner to the plane of the creekbed. In many instances the shallow and intermediate slopes probably are the result of gradual trampling of once-vertical slopes by livestock. Including the railroad levee, which accounted for 12% of the sampled banks, the average slope of the banks was 56° (SD 17). Nine percent of the sampled banks were vertically cut (fig. 2). The mean height of the banks was 2.3 m (SD 1.6, r 5.8). The width of the creekbed averaged 31 m (SD 23, r 104). There was no trend in these characteristics. Each characteristic was independently and heterogeneously distributed along the valley-floor, and probably reflected the variable alluvium deposits and geometry of the valley-floor.

The extent of erosion along Sonoita Creek is limited by both the width and depth of alluvial deposits in this narrow valley-floor, although the height of some vertically cut banks have increased up to 0.3 m from 1973 to 1976.
