Interdependence of Groundwater, Riparian Vegetation, and Streambank Stability: A Case Study¹

David P. Groeneveld and Thomas E. Griepentrog²

Abstract. Groundwater is closely coupled with streamflow to maintain water supply to riparian vegetation, particularly where precipitation is seasonal. A case study is presented where Mediterranean climate and groundwater extraction are linked with the decline of riparian vegetation and subsequent severe bank erosion on the Carmel River in Carmel Valley, California.

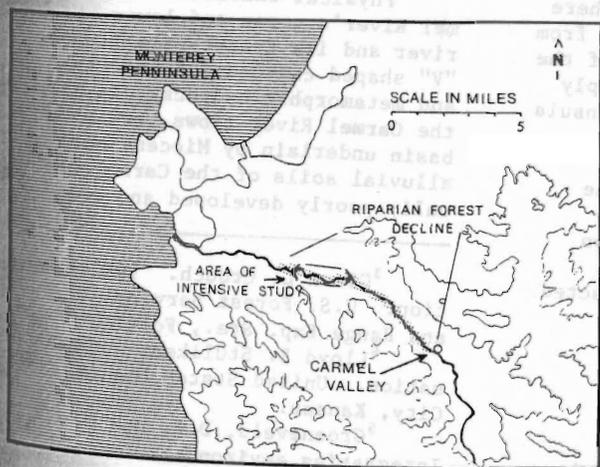
Figure 1.--The lower Carmel River Region. Contour intervals are 1,000 feet.

The next linear eight miles upstream have markedly reduced riparian cover (Fig. 1). The bank between clumps of the remaining riparian tree species is sparsely vegetated with weedy perennials, annual grasses and xeric shrub species. The denuded riverbanks here show conspicuous erosion. A 2.2 mile portion of this zone was chosen for detailed study of vegetation history.

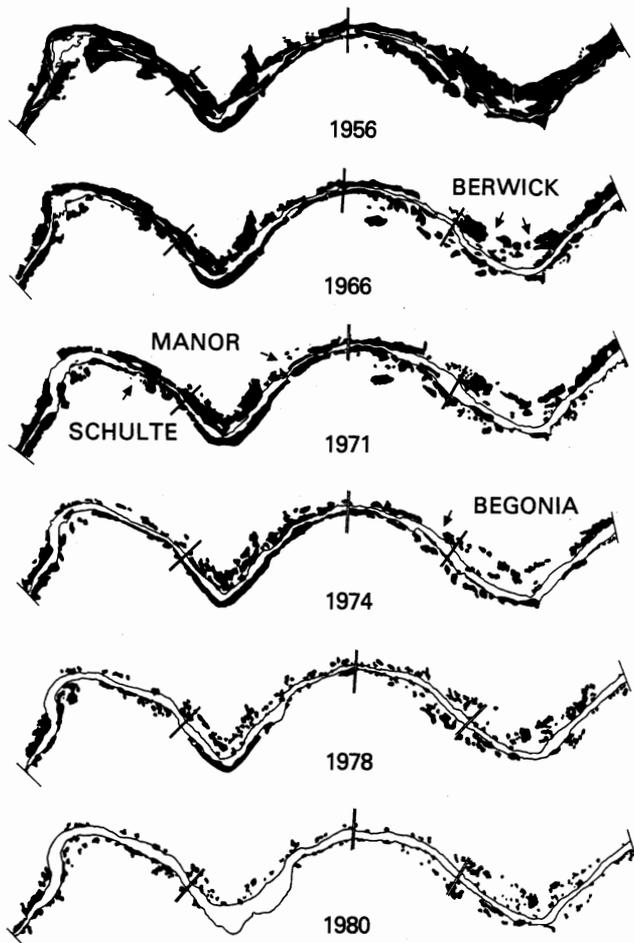
Figure 2.--Time series maps of the study area with the riparian forest indicated. The study area is divided into 4 sections according to the location of high capacity export wells.

The time series of maps shown on Figure 2 documents the thinning of the riparian forest readily observable on the photographs. Loss of riparian forest cover over the 24 year period is visible initially in the upstream section toward the right of the 1966 map. Gradually the forest cover lessens in the remaining sections of the study area until, by 1978, the riparian forest cover is discontinuous with much of the remaining vegetation surviving at some distance from the channel margins. In 1980, the riparian cover is reduced even further and the river channel has widened dramatically, particularly in the downstream sections.

Following further analysis, tree pathogens, fire and encroachment by man were ruled out as possible causal agents for the decline of the riparian forest. The decrease of riparian trees coincides with the gradual development of the Monterey Peninsula and the wells to export groundwater to meet the increasing demand. The well field extracts water from the river alluvium within the zone of vegetation impact noted both in the field and on the air photographs. The operating wells in the vegetation study area are indicated on Figure 2 in the sequence of development and use.

Each of the coartype maps shown in Fig. 2 was fitted with a clear template delimiting a riparian corridor along the river. The study area was divided into sections conforming to the location of high capacity wells designated from down to upstream; Schulte, Manor, Berwick and Begonia. A dot planimeter was used to obtain three replications of the area of the riparian forest and unvegetated river alluvium coartypes. These values were averaged to yield data documenting the temporal relationship of riparian vegetation decline, increased channel erosion and pumping⁷ plotted on Figure 4.

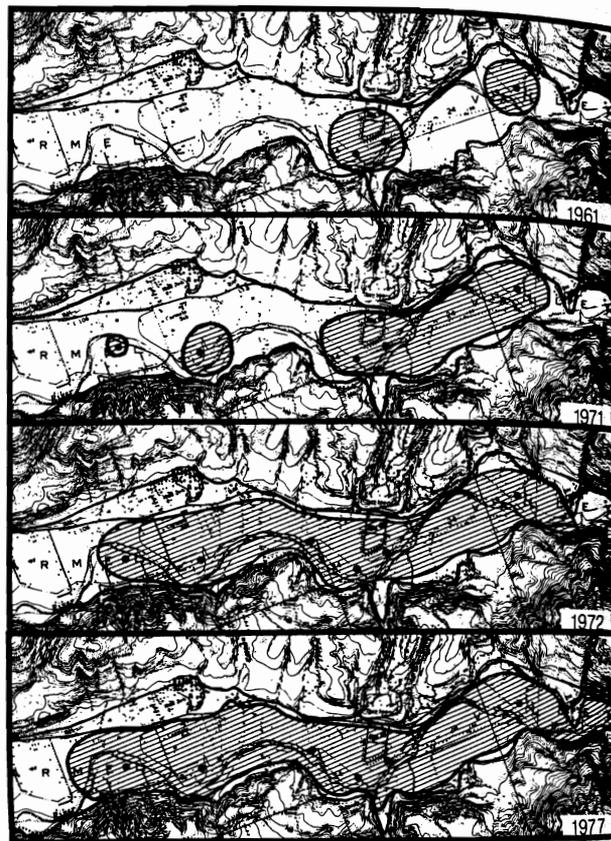
Figure 3.--Zones of influence in October for four select years. The 5 foot isocontour of drawdown from the spring high is the zone boundary. The limits of the valley fill are indicated.

down in the system so the drawdown from pumping tends to be greatest during late summer and fall. The five foot isocontour of groundwater drawdown from the spring high levels to an October low are plotted on Figure 3. These zones of influence encircle the export wells and correspond well with the zones of riparian vegetation decline on Figure 2.

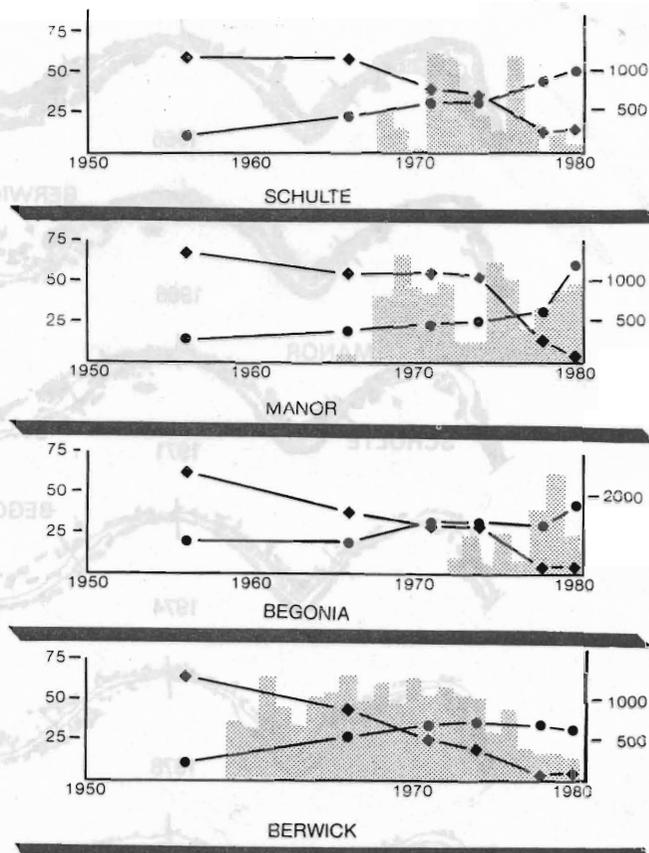
Figure 4.--Percent cover by riparian forest (diamonds) and unvegetated river channel (circles) versus pumping in acre feet from wells in each section.

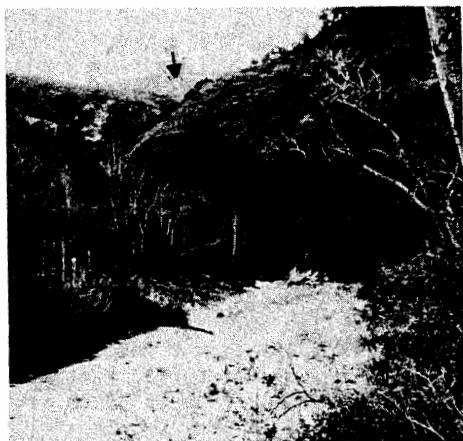
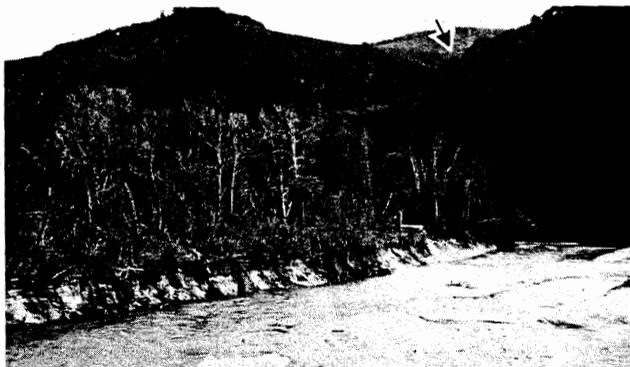
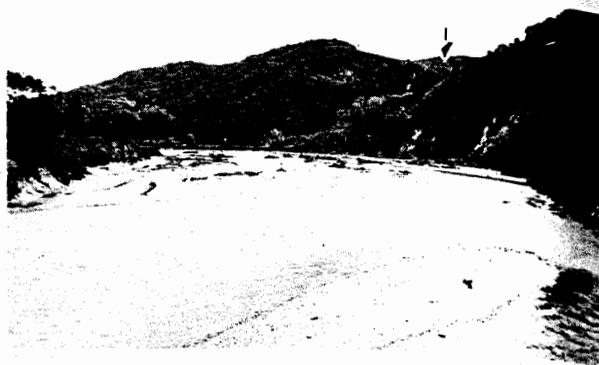
Figures 5, 6 and 7.--1976⁸, 1978⁸ and 1982 photo-
graphs of the Carmel River Channel. The
arrow indicates a reference point.

The most severe erosion of streambanks on the
Carmel River occurred within the study area. A
time series of photographs taken from the Schulte
Road Bridge looking upstream document the process
of bank erosion following loss of stabilizing
plant growth (Figures 5, 6 and 7). The photo
point can be located on the maps of Figure 2 as
the double line between the Schulte and Manor sec-
tions of the river. The 1976 photograph was taken
in late fall 1976 and shows dead cottonwoods and
willows lining the approximately 60 foot wide
channel. The 1978 photograph captures the same
scene following spring high water flows which
equate to a ten year recurrence interval (Kondolf,
1983). Note that the toe of the bank has been
eroded back about 30 feet from the channel margin
position visible in 1976. According to photogram-
metry of the 1978 air photograph set, the erosion
due to this flow resulted in an ultimate channel
width of about 150 feet within the field of view

of the photograph. A photograph following spring
high water flows in 1982 illustrates the same
scene but with aggradation of the margins to form
a channel over 400 feet wide. This erosion
occurred following two five year recurrence inter-
val flows in the intervening four year period.
