CLARK CANYON (MONO COUNTY) RIPARIAN DEMONSTRATION AREA¹

John W. Key and Mark A. Gish²

Abstract: The Clark Canyon riparian demonstration area was established in 1984 within the East Walker River subbasin of Mono County, California. Destabilization of the meadow sections of the stream and the upper stream reaches contributed to an increase of suspended sediments, turbidity, and stream channel widening in the lower stream reaches where a viable population of rainbow trout is found. Several different treatments have been implemented to (1) restore meadow riparian areas to high levels of productivity, (2) stabilize active erosion and gully development (headcutting), (3) improve aquatic habitat from poor to good condition, and (4) improve wildlife cover and downstream fish habitat. These treatments include changes in grazing management practices and the construction of several types of instream structures.

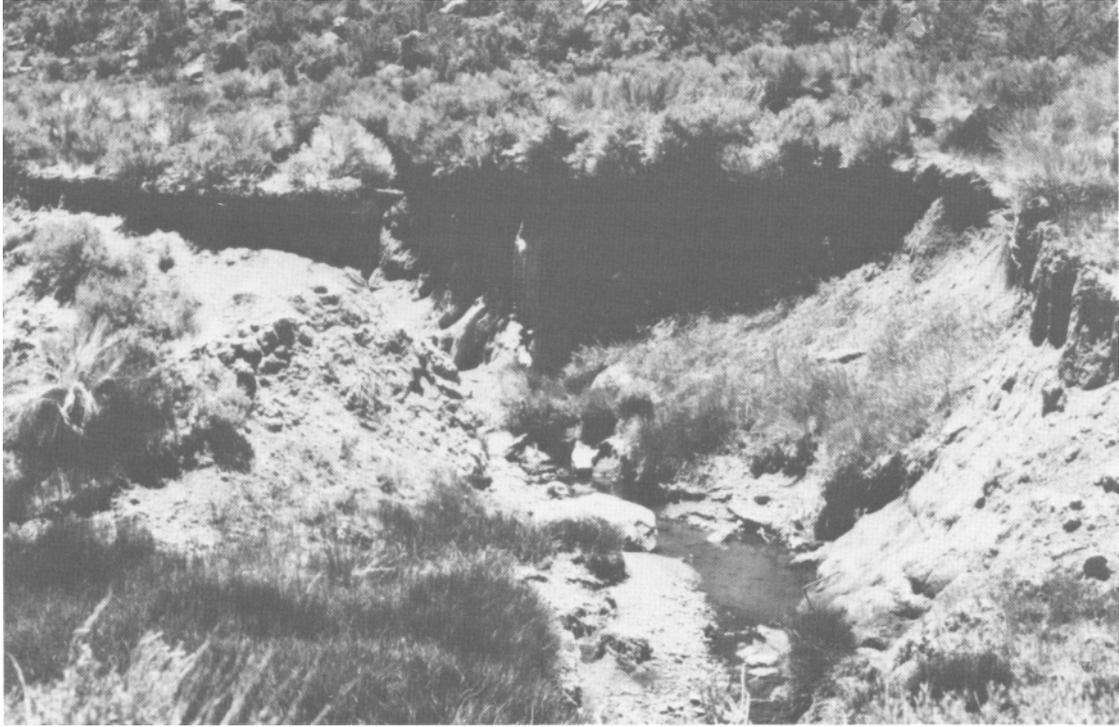
Figure 1 — Site of large wire mesh structure, Clark Canyon, California, June 22, 1983.

The two large wire mesh structures were constructed in 1984 near the head-waters of the stream, where the gulying was the most severe (fig. 1). These two structures were lined with an erosion filter fabric to trap fine soil particles behind the structures (fig. 2).

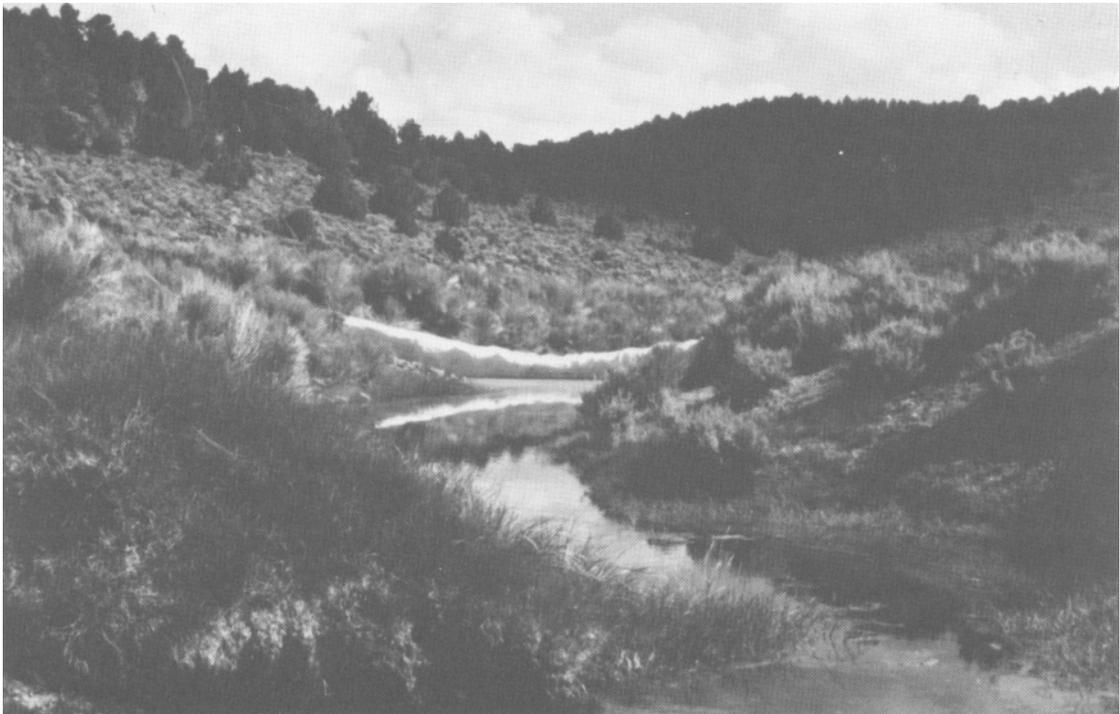
Figure 2 — Large wire mesh structure covered with an erosion control filter fabric, Clark Canyon, California, July 24, 1984.

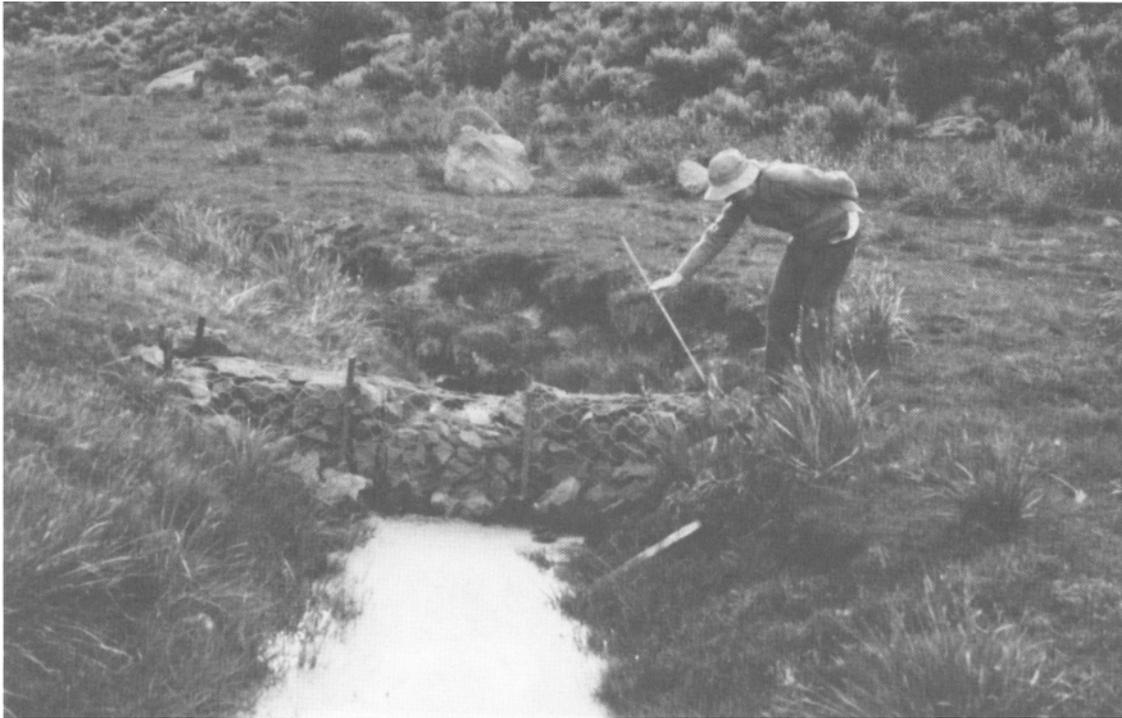
Figure 3 - Unlined gabion basket structure, Clark Canyon, California, July 28, 1984.

The three smaller gabion basket structures were constructed in 1984 in shallow gullies in the meadow area. Initially, they were not lined with erosion control filter fabric (fig. 3). In 1985, the upper gabion basket was modified and lined with erosion control filter fabric to improve its effectiveness (fig. 4).

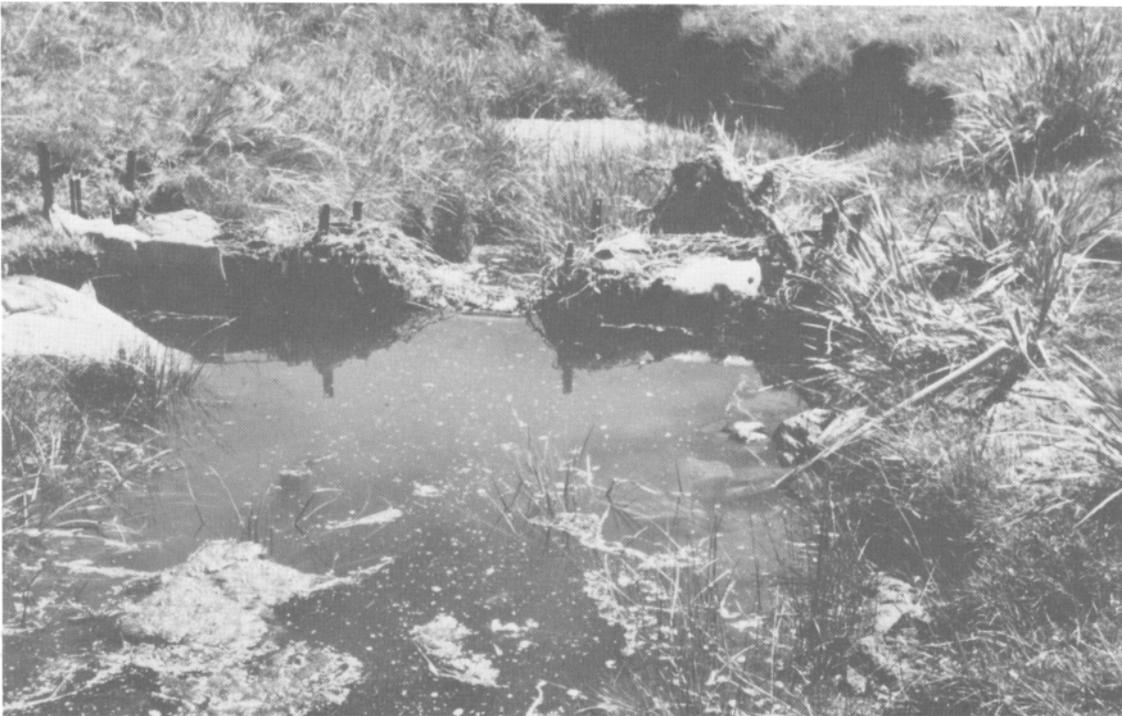
Figure 4 - Same gabion basket structure as in Figure 3 after modification and lining, Clark Canyon, California, July 17, 1986.

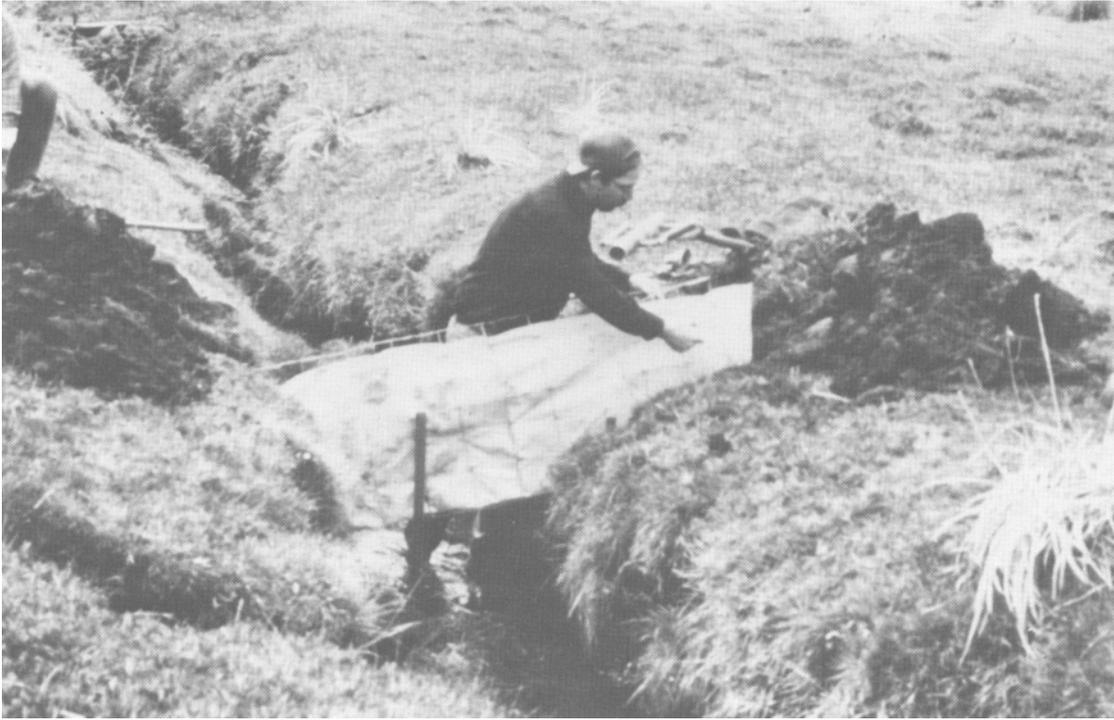
Figure 5 — Installation of single fence rock-check dam, Clark Canyon, California, October 10, 1985.

The three single fence rock-check dams were installed in October 1985 with hand labor, erosion control filter fabric, woven wire fence, and metal fence posts (fig. 5). These small instream structures have been very successful (fig. 6) in elevating the water table and controlling further erosion.

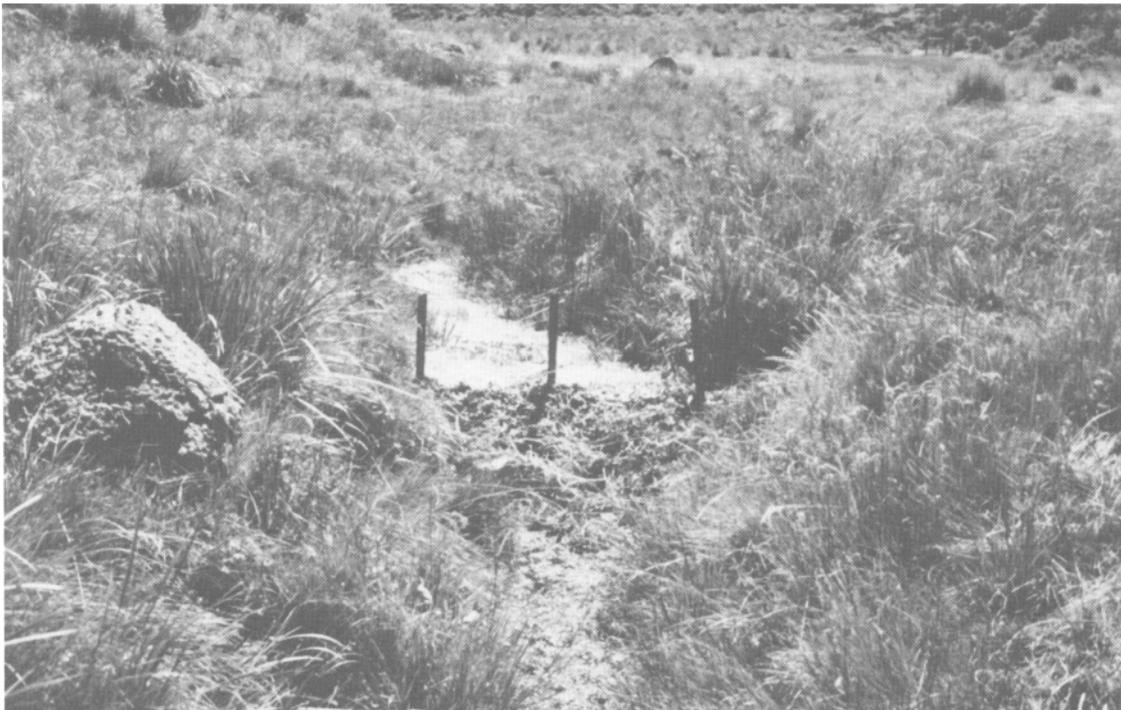
Figure 6 — Single fence rock-check dam, Clark Canyon, California, August 4, 1987.

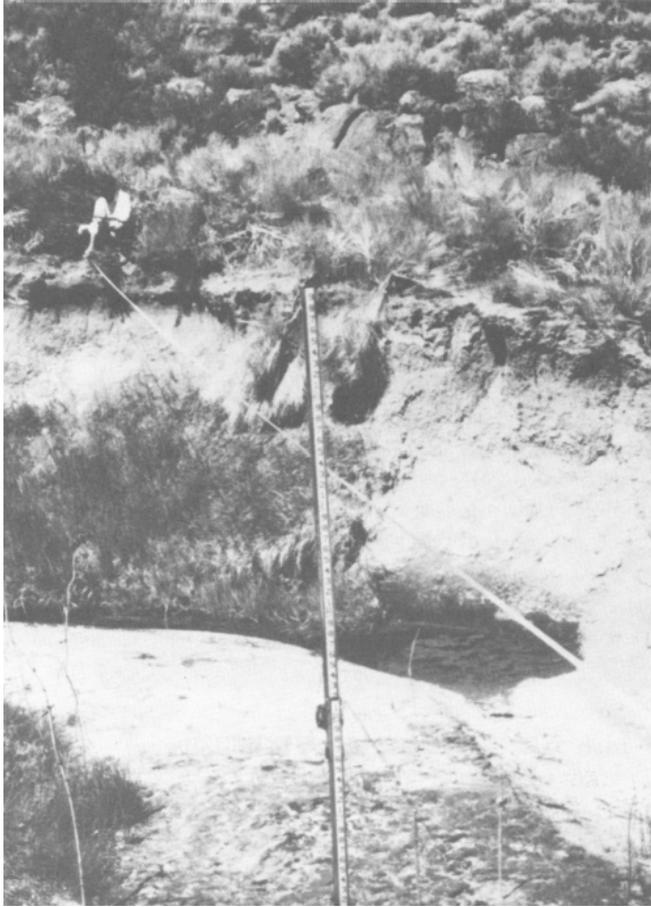
Figure 7 – Sag tape transect, Clark Canyon, California, July 17, 1986.

An initial stream profile utilizing sag tape transects was conducted at the time the two large wire mesh structures were constructed. A total of 10 sag tape transects (fig. 7) were made annually since 1984 to document changes in stream profile and sediment deposition collection behind each of the two large wire mesh structures. The transects followed procedures described by Ray and Megahan (1979).
