Restoring Wetlands after the Rodeo-Chediski Wildfire

Abstract

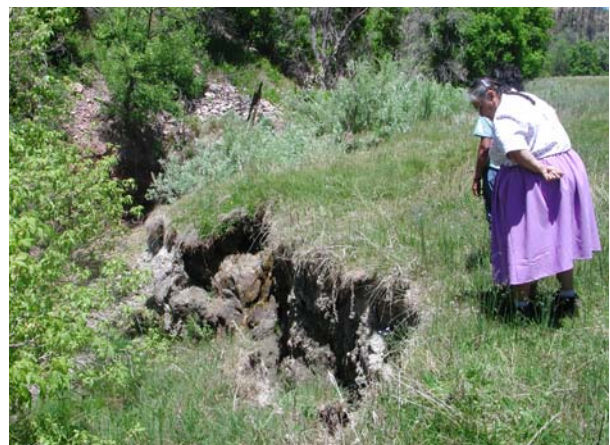
Through these assessments, we determined that two large wet meadow systems, Turkey Spring and Swamp Spring, were suffering from rapid erosion in the wake of post-wildfire floods. The erosion was causing large blocks of wetland soils to slump into the creeks (Fig. 2). This erosion threatened to increase sedimentation of downstream native fish habitats. Degradation of the creeks led to lowering of the water table in the meadows, which in turn impaired habitats for wetland plants, birds, and amphibians. Both sites sustain culturally important plants and animals such as deer, elk and turkeys. Similar wetlands in this region harbor populations of native leopard frogs, which are species of special concern in Arizona.

Figure 2: Members of the White Mountain Apache Tribe's Land Restoration Board examine erosion at the edge of the meadow at Swamp Spring.

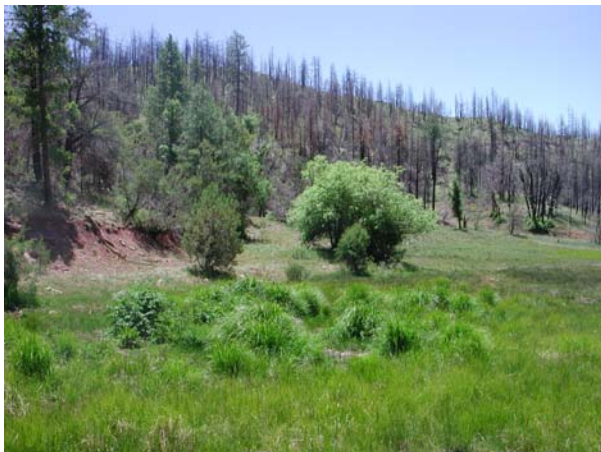
We surveyed the plants communities at each site to document key wetland species that could be used for restoration treatments. Swamp Spring has a much more diverse plant community, probably due to the larger quantity of water flowing through the meadow (Fig. 3). Key species include several kinds of sedges (*Carex senta*, *Carex aurea*, *Carex lanuginosa*) along with various spikerushes (*Eleocharis* spp.), rushes (*Juncus* spp.), small-fruit bulrush (*Schoenoplectus microcarpus*), and hard-stem bulrush (*Schoenoplectus acutus*). At Turkey Spring, spikerushes and rushes are the dominant cover along with various grasses (including *Andropogon gerardii*). Both sites are dominated by sandy soils, although extensive layers of finely-textured organic hardpans do resist erosion.

Figure 3: Clumps of swamp sedge (*Carex senta*) lie in the wettest parts of Swamp Spring.

We collected sedge and bulrush wildlings from Swamp Spring to grow out in off-site beds. Sedges are particularly desirable for restoring riparian meadows due to their capacity to bind soils and trap sediments (Steed & DeWald 2003). We also collected reeds (*Phragmites australis*) from a site close to Turkey Spring for growing out. The purpose was to augment the supply of root-binding vegetation for use in revegetating both sites. Reeds are also a culturally important plant that has declined at many wetland areas on the Reservation (Long et al. 2003). We plan to transplant the wildlings to the sites in the late summer to maximize their survival (Steed & DeWald 2003).

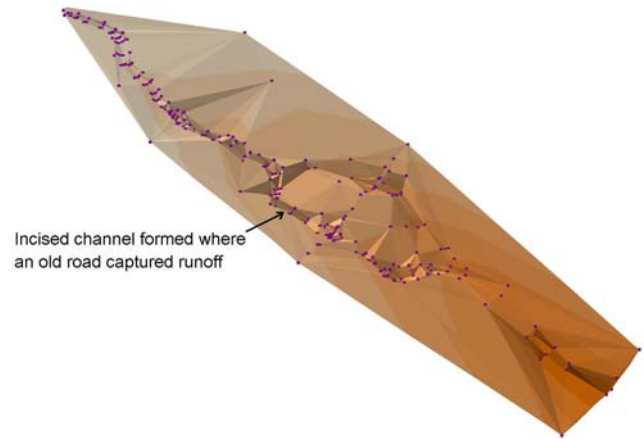
(Fig. 4). These surveys identified major nickpoints where the channels were most unstable, and they served to classify the reaches according to their degree of entrenchment and gradient.

Figure 4: Three-dimensional profile of the Turkey Spring site revealing major nickpoints and location of incised channels.

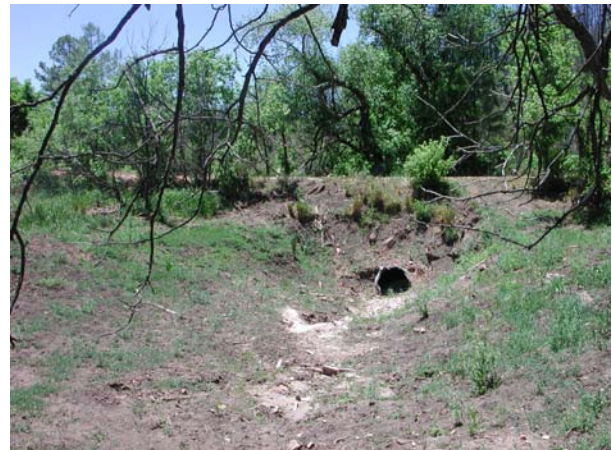
At Turkey Spring, extensive erosion occurred where old road beds had captured runoff. At Swamp Spring, old culvert crossings appeared to have caused incision of the channel (Fig. 5). This instability appeared to pre-date the fire at both sites, but severe flooding after the fires had greatly accelerated the rate of degradation.

Figure 5: This road crossing at Swamp Spring likely contributed to the extensive downcutting of the meadow by concentrating flows and failing to pass sediments and debris.

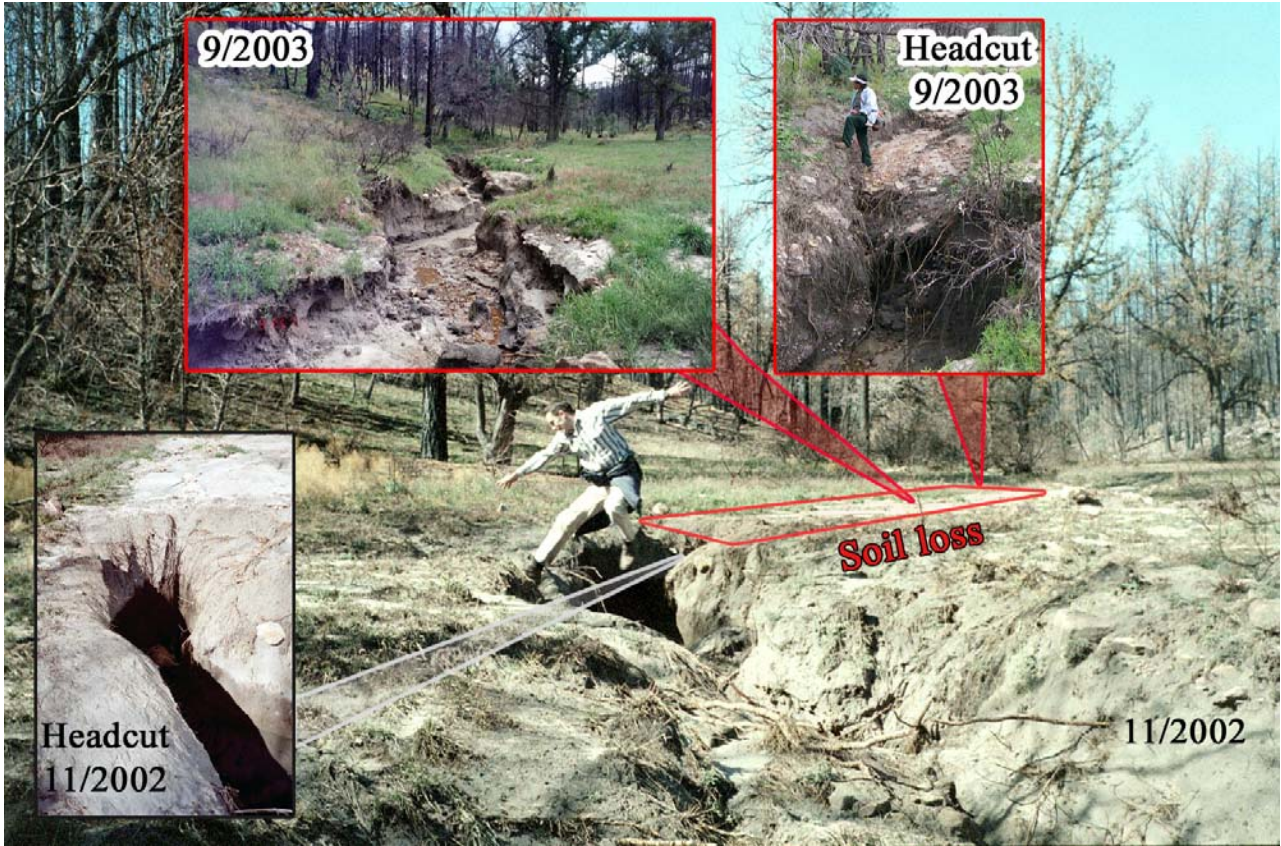
We observed rapid channel incision and streambank collapse at both sites since our initial investigations. A primary headcut at Turkey Creek retreated upstream for 50 m (Fig. 6). Extensive bank collapse and incision of the channel occurred at Swamp Spring (Fig. 7).

Figure 6: Progression of headcuts at Turkey Spring prior to treatment.

The treatment design sought to arrest the erosion of the channel through placement of stabilizing bed forms. We applied the rock riffle formation techniques that the White Mountain Apache Tribe and the Rocky Mountain Research Station had jointly developed for use in restoring high-elevation meadows (Medina & Long 2004). Due to the large flows moving through the sites, particularly at Swamp Spring, we had to use very large rock materials to form these features. The main culvert at Swamp Spring was replaced with a low-water crossing formed from over 140 limestone boulders (averaging 1 m X 0.7 m X 0.5 m in dimension). Construction has been staged with the initial low water crossings constructed in May and June, followed by placement of the initial riffle formations at each site in July.

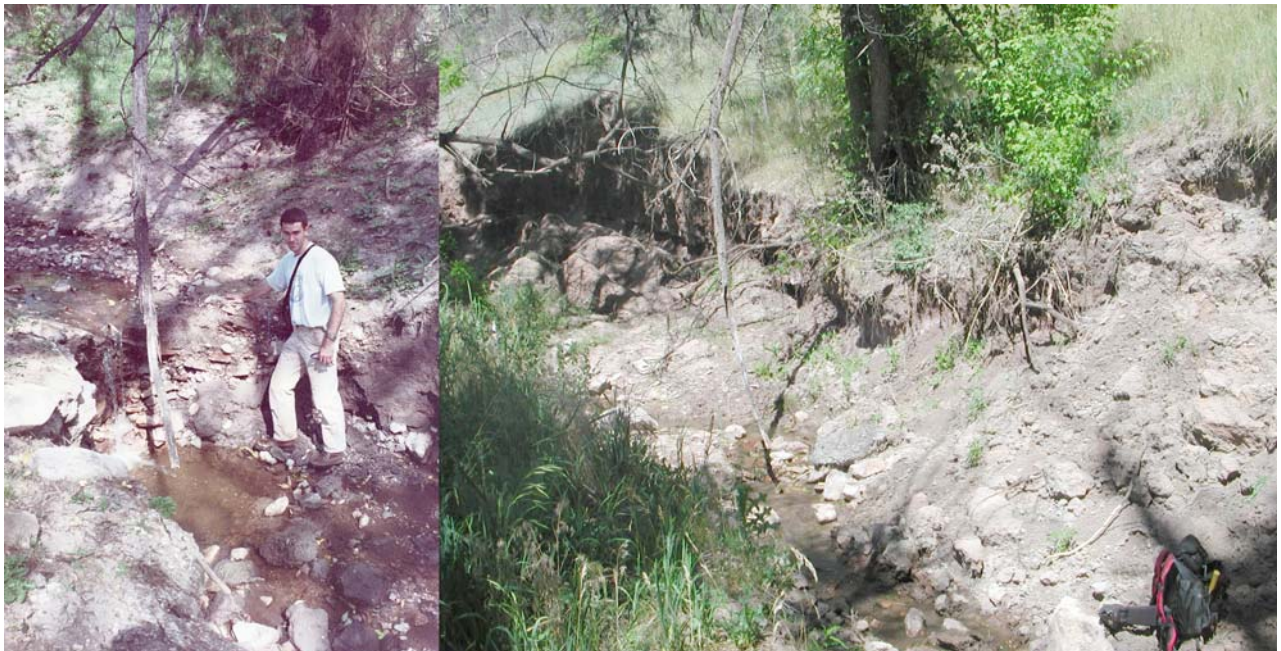
Figure 7: Channel erosion at Swamp Spring in September 2002 (left) and June 2004 (right). The nickpoint in the channel and the far bank were washed out during this period.

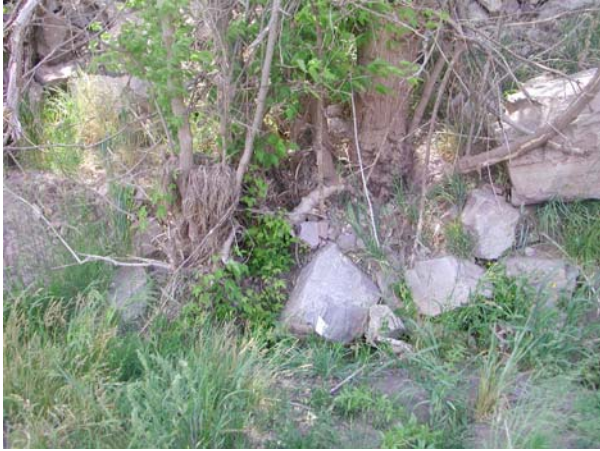
Natural rock riffles occur at Swamp Spring where debris flows have deposited large angular boulders in the upper, less incised reaches (Fig. 8). These features demonstrate the potential of these systems to stabilize themselves. However, parts of the channel were located too far from the valley side slopes and the degradation of the main channel was too rapid for the debris flows to stabilize channels throughout the reach.

Figure 8: Debris flows of angular rocks form natural riffles in the upper, unincised reach at Swamp Spring.
