7100 Engineering
November 2003
0371-2809P-MTDC
WIT-12-0004

Asphalt Paving of Treated Timber Bridge Decks

0E02H49—Paving Timber Decks

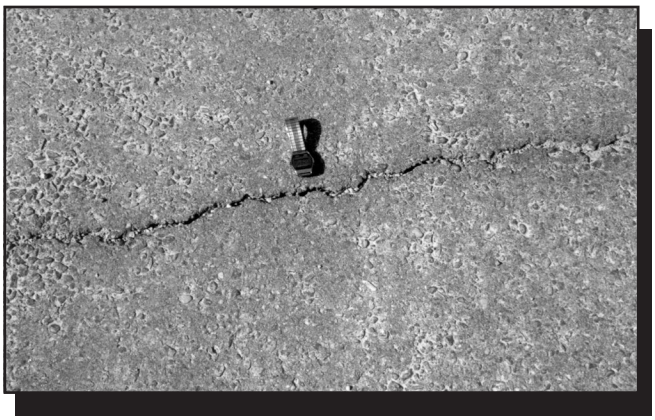
Example 1—The Watchtower Creek Bridge (figures 2 and 3) and West Fork Creek Bridge were constructed on the Bitterroot National Forest in Montana during the summer of 1989. These two-lane, single-span bridges were constructed with transverse glued-laminated deck panels on seven glued-laminated timber beams spaced 48 inches apart. The beams supporting the deck of the Watchtower Creek Bridge are 27 feet long, 8¾ inches wide, and 22½ inches deep. The beams supporting the West Fork Creek Bridge are 35 feet long, 8¾ inches wide, and 28½ inches deep. Deck panels on both bridges are nailed to the beams and were not mechanically interconnected. The decks were paved shortly after being installed. Within days, the asphalt paving showed reflective cracking (cracking that is reflected up from the deck) directly over all the deck panel joints. The deck panels were treated with pentachlorophenol carried in a heavy oil solvent. The asphalt pavement cracked as soon as the bridges were put in use. The cracking resulted from differential movement of the deck panels, not from panel shrinkage.

Figure 2—Cracking over panel joints on the Watchtower Creek Bridge at the Bitterroot National Forest, MT, in 1989.

Figure 3—Cracking over panel joints on the Watchtower Creek Bridge at the Bitterroot National Forest, MT, in 2000.

The cracks have opened and raveled somewhat over the 14-year life of the bridges. However, the bridges are functional. No timber deterioration was detected in the deck or superstructure members.

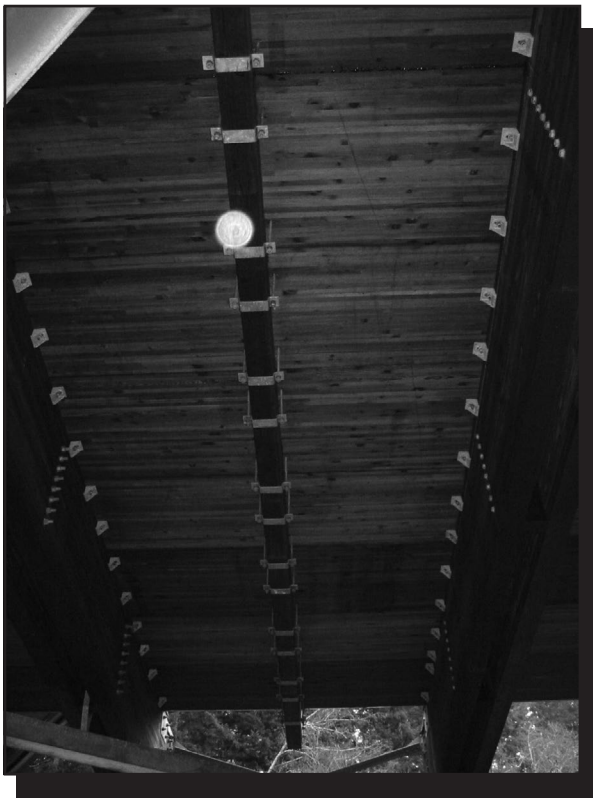
Figure 5—Distribution beam installed under the Satsop River Bridge.

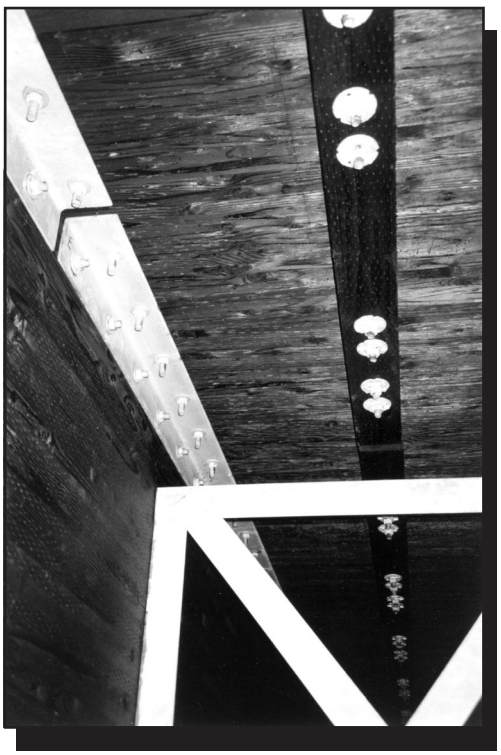
Figure 8—Deck stiffener beams installed under transverse glued-laminated deck panels on the Lighthouse Bridge near Port Angeles, WA.

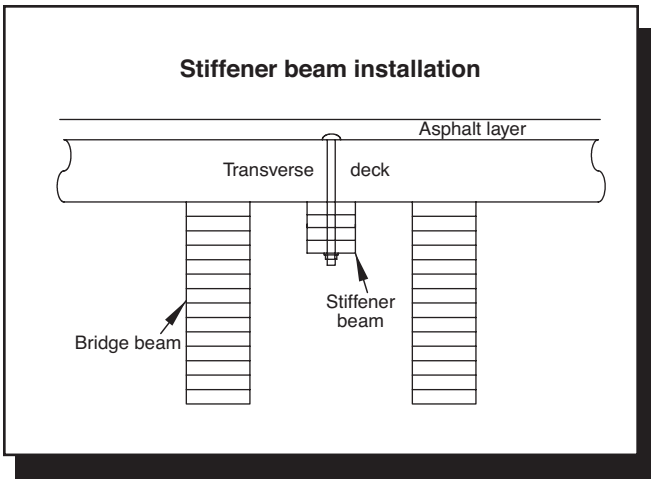
Figure 9—Stiffener beam between bridge beams.

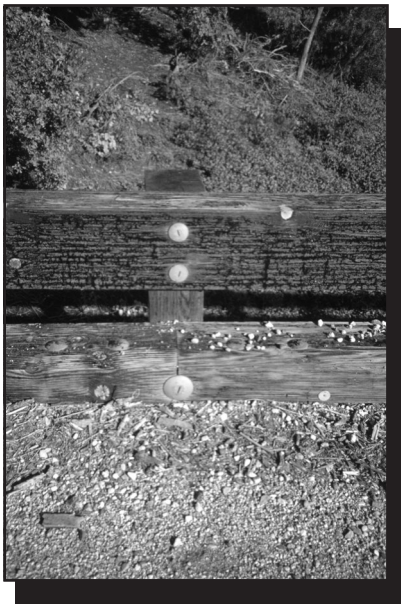
Figure 14b—Creosote-treated timbers on the Cruzen Bridge were not cleaned after treatment. Creosote is leaching from the timbers.

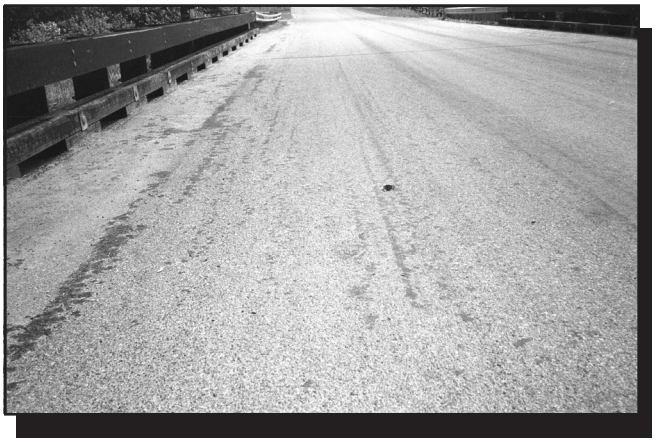
Example 8—The Cameron Bridge across the Manistee River in Crawford County, MI, was constructed in 1995 as a two-lane, two-span, stress-laminated timber box-beam bridge. The deck is comprised of a laminated box section with southern pine glued-laminated webs spaced every 24 inches. Solid pin oak dimensional wood stressed between the glued-laminated webs forms the box section. This bridge was also part of the Michigan creosote-treated bridge study. The glued-laminated webs had an average creosote retention of about 12.5 pounds per cubic foot. The solid wood had an average creosote retention of about 5.1 pounds per cubic foot. Although these are not exceptionally high retention levels, excess creosote dissolved the asphalt-impregnated paving membrane between the deck and the asphalt paving over the tops of the glued-laminated members (figure 15). The long stripes of creosote bleeding through the asphalt paving show the locations of the glued-laminated beams.

Figure 15—The Cameron Bridge in Crawford County, MI, had asphalt bleeding over glued-laminated webs.

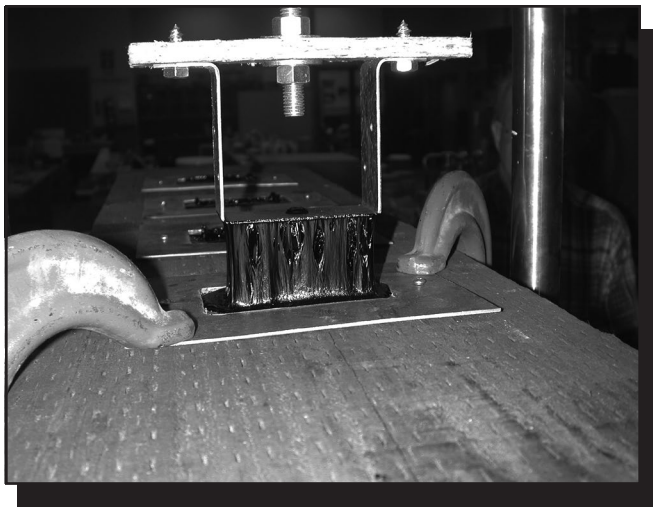
Figure 19—Asphalt adhesion test after the asphalt failed when it had elongated.

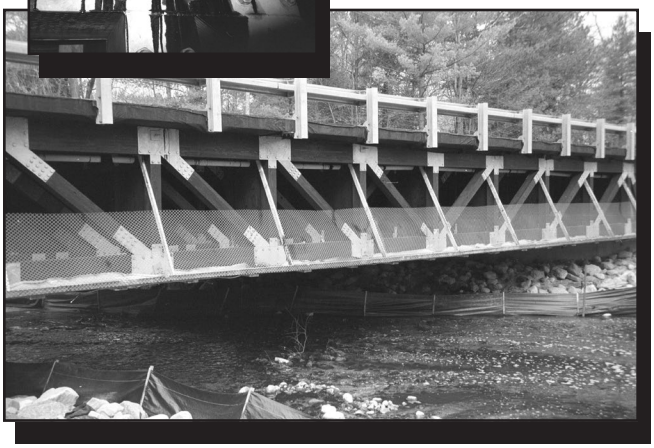
The bridge began dripping a mixture of creosote and asphalt into the Clam River the following spring. A collection system was installed under the bridge (figure 20b). The creosote and rubberized asphalt mixture was still dripping when the bridge was inspected in 2000.

Figure 20b—A collection system catches the creosote and rubberized asphalt dripping from the underside of the bridge.

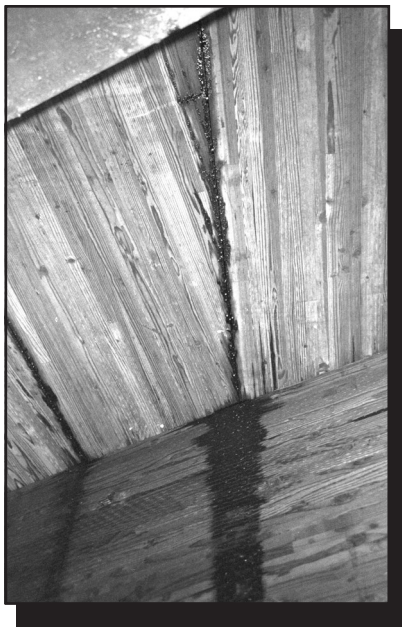
Figure 22—Rubberized asphalt dripping from paving membranes on the Rogue River Bridge near Medford, OR.
