Water/Road Interaction: Examples from Three Flood Assessment Sites in Western Oregon

Ronald L. Copstead, P.E.
USDA Forest Service
Pacific Northwest Research Station

David Kim Johansen, P.E.
USDA Forest Service
Willamette National Forest

September 1998

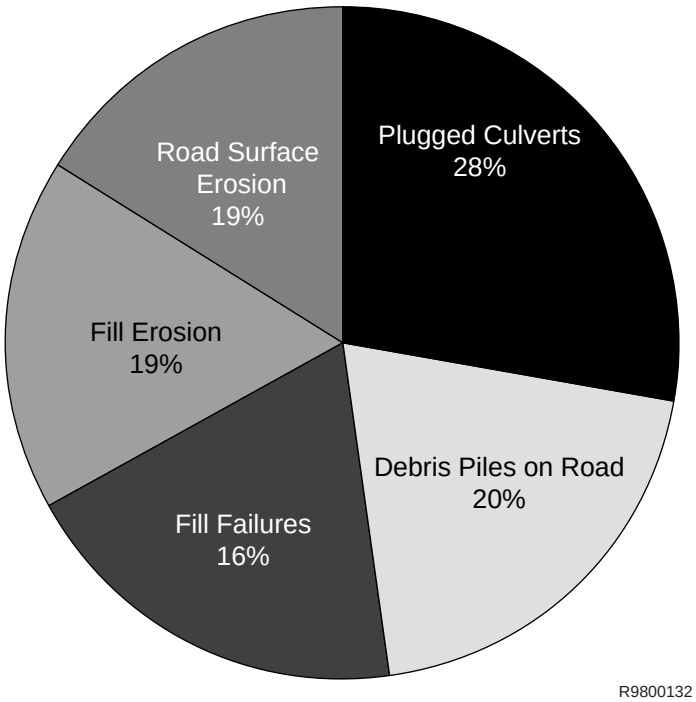
Figure 1—Road related storm damage by type (352 Sites on Detroit RD 1996).

Surveys of damage to roads and to local areas surrounding roads on the Detroit Ranger District showed that plugged culverts and road-surface and road-fill erosion accounted for most of the damage to roads and road-stream crossings (Figure 1).

Culvert plugging by stream bedload and woody debris was the most common type of failure overall (28 percent). Often a small branch caught in the culvert inlet and resulted in stream bedload accumulation and eventual burying of the inlet. Culverts that were 600 mm (24 inches) diameter or less accounted for 81 percent of the plugged culverts.

The cause of flood damage to roads from erosion of road surfaces and stream channels adjacent to roads, fill failures, and forest slides contributed about equally to road damage, each comprising 14 to 18 percent of the number of sites that were damaged. Cutslope failures contributed only 6 percent of sites that were damaged.

Damage to roads in the form of fill failures, fill erosion, road surface erosion and debris piles were all found at about the same frequency and contributed to 16 to 20 percent of the damage sites.
